Doan Brook Stream Enhancement Project

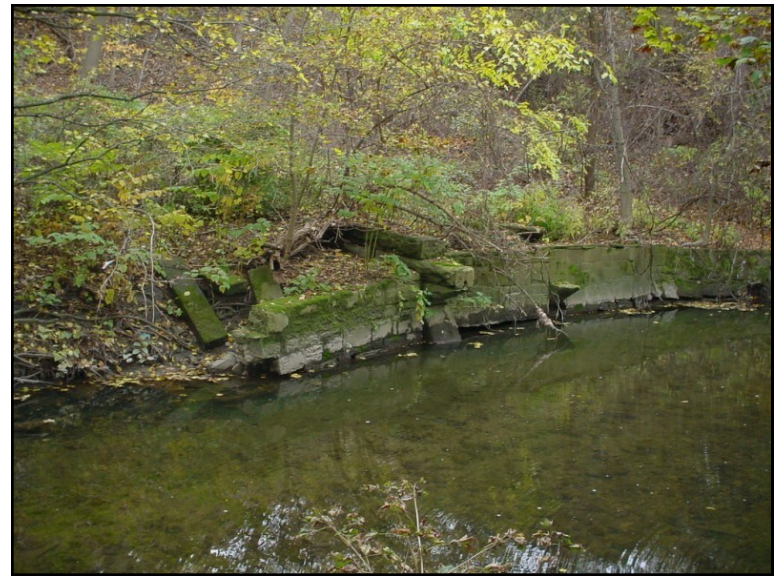
Photo 4: Looking downstream to failed stone wall (contributing), Reach 2.

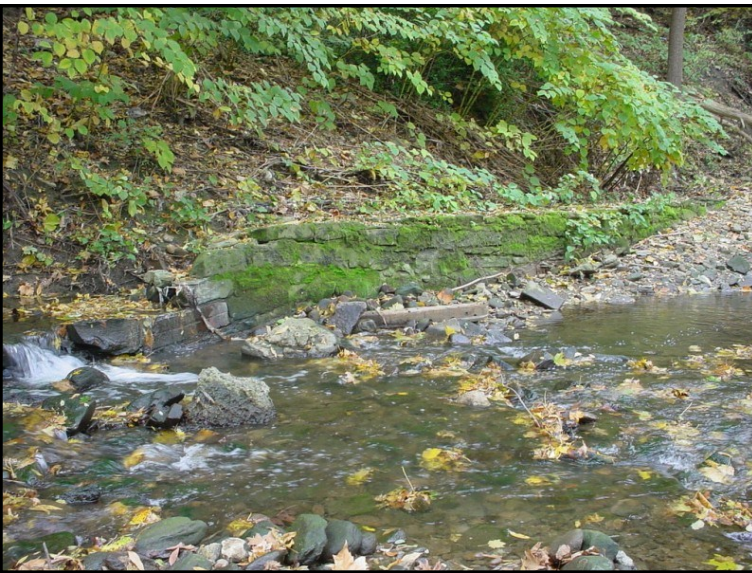
Photo 7: Looking downstream to failed stone wall (contributing) and eroding bank, Reach 2.

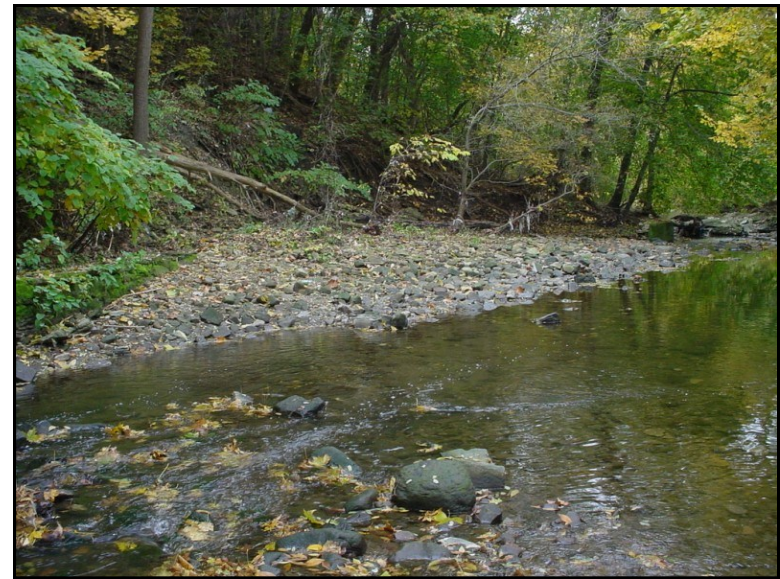
Photo 8: Looking downstream to failed stone wall (contributing) and eroding bank, Reach 2.

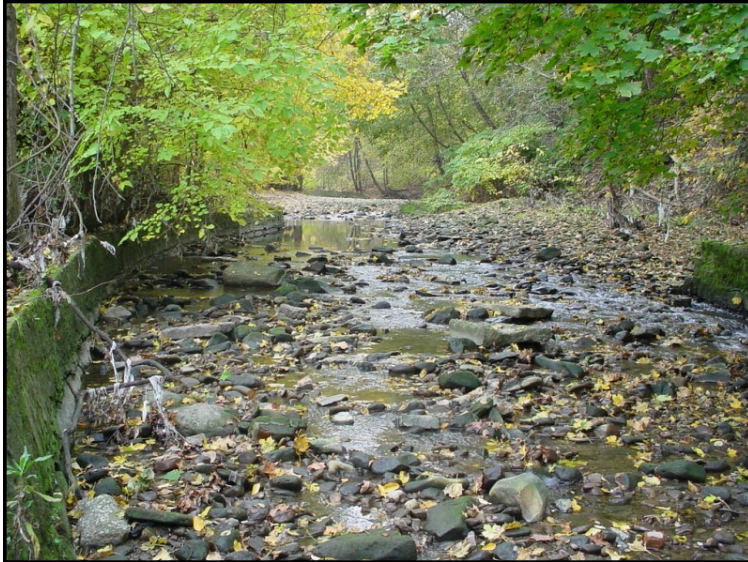
Photo 9: Looking upstream, Reach 2. Note eroding bank on right.

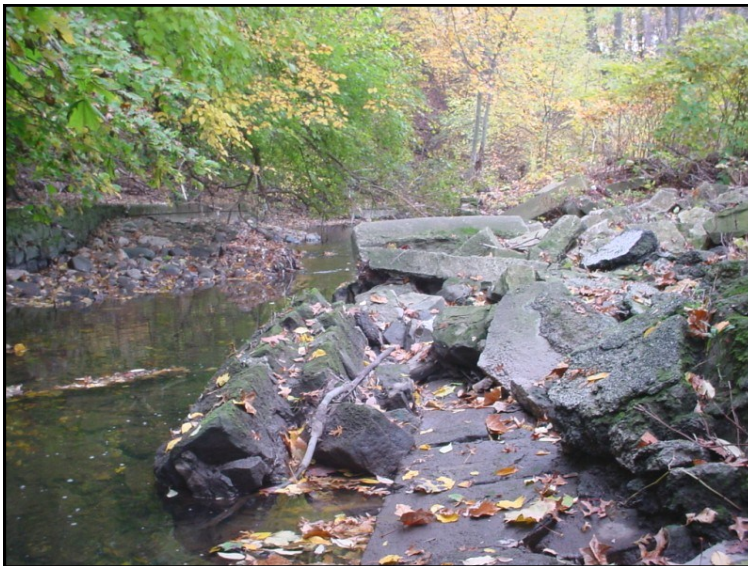
Photo 11: Looking downstream, Reach 2. Note failed stone wall (contributing) on right.

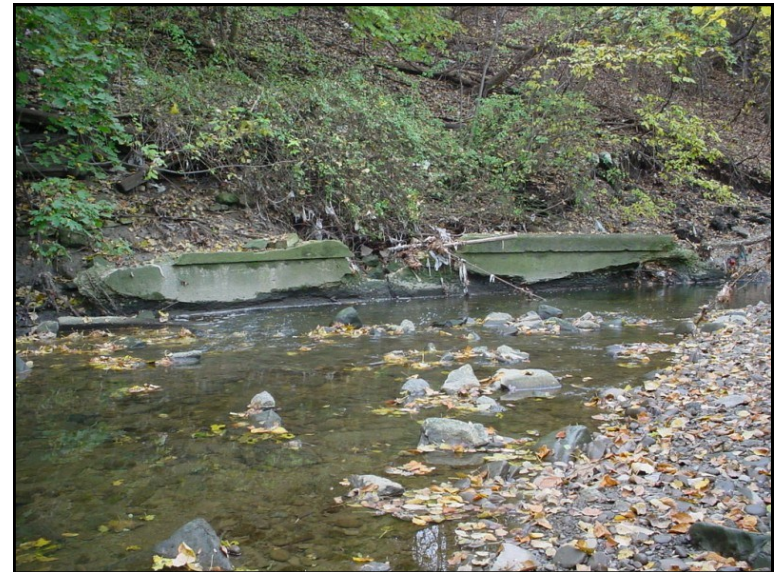
Photo 12: Looking downstream, Reach 2. Note failed concrete wall (non-contributing) on left.

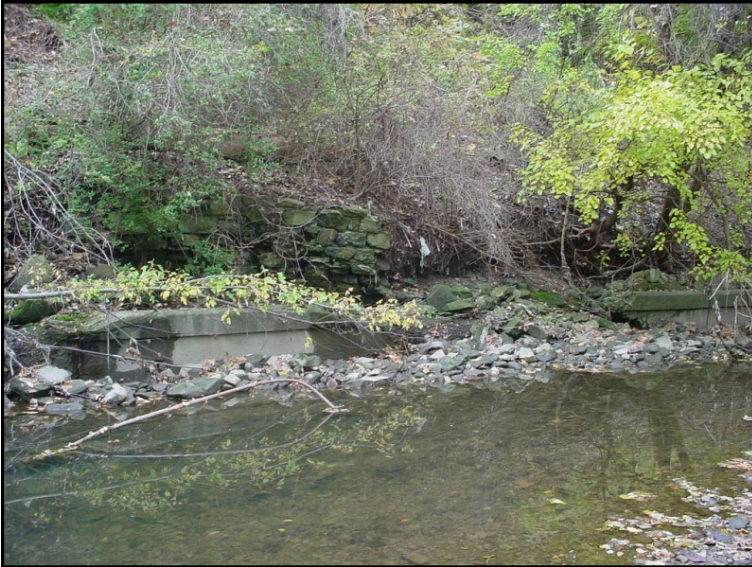
Photo13: Looking upstream, Reach 2. Note failed stone and concrete walls.

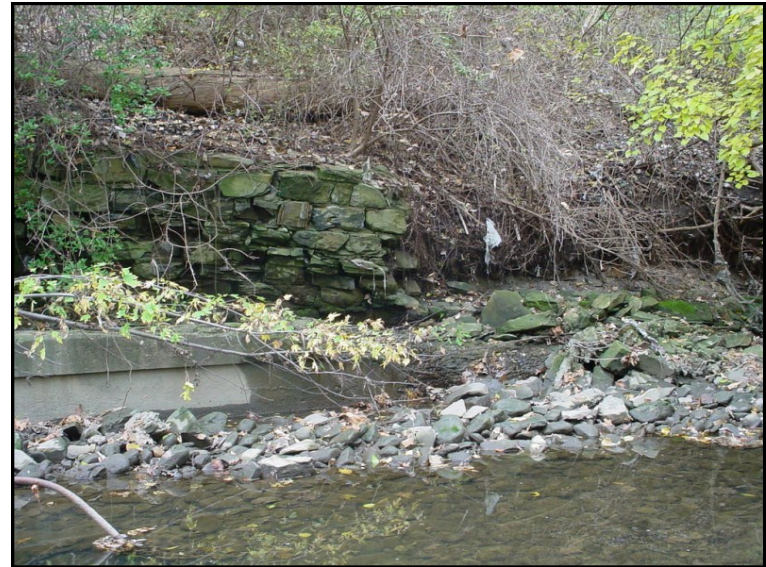
Photo 14: Close-up view of failed stone and concrete walls, Reach 2.

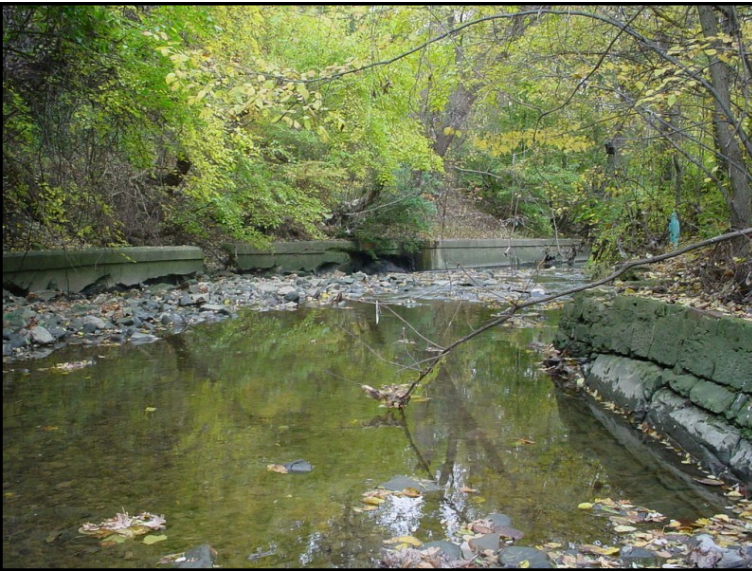
Photo15: Looking upstream, Reach 3. Note failed concrete wall (non-contributing) on left.

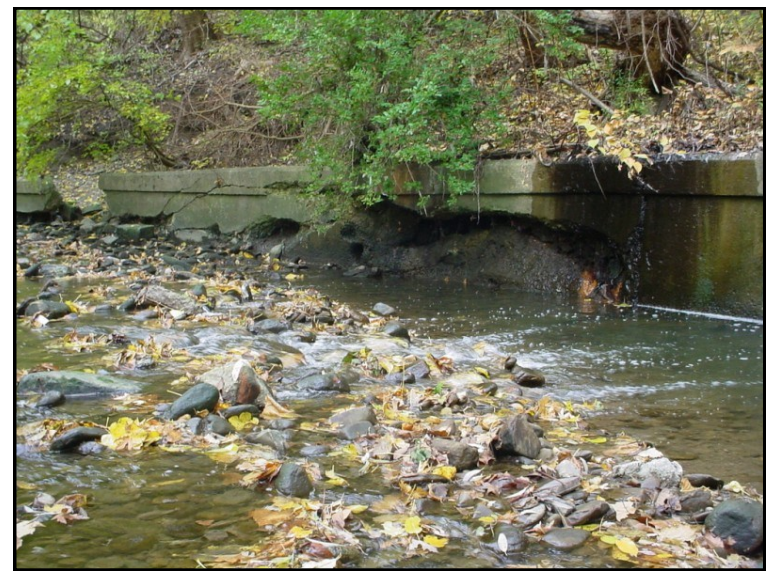
Photo16: Close-up view of failed concrete wall (non-contributing) , Reach 3.

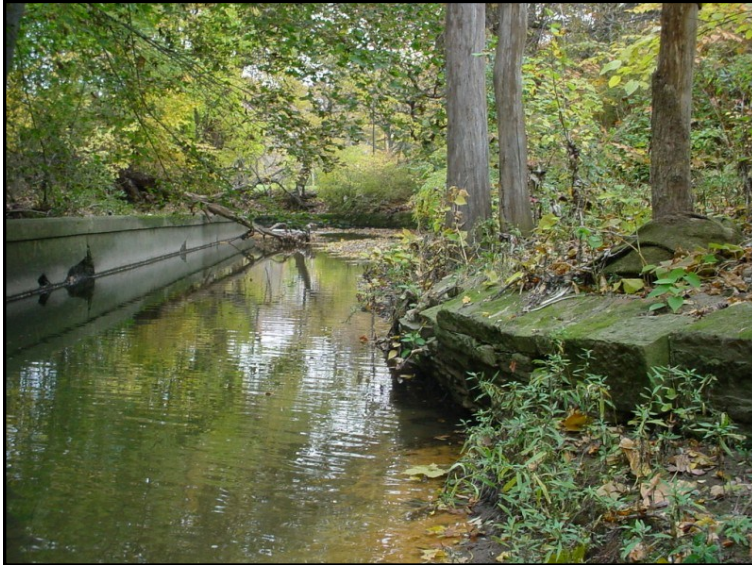
Photo17: Looking downstream, Reach 3. Note leaning stone wall on right (contributing) caused by tree roots.

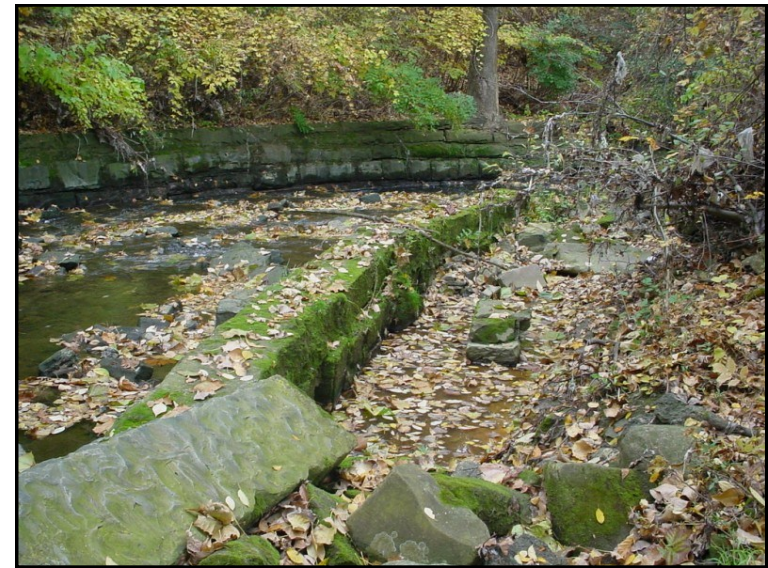
Photo 20: Looking downstream, Reach 3. Stone wall on right (contributing) damaged by stream overflow and backwash.

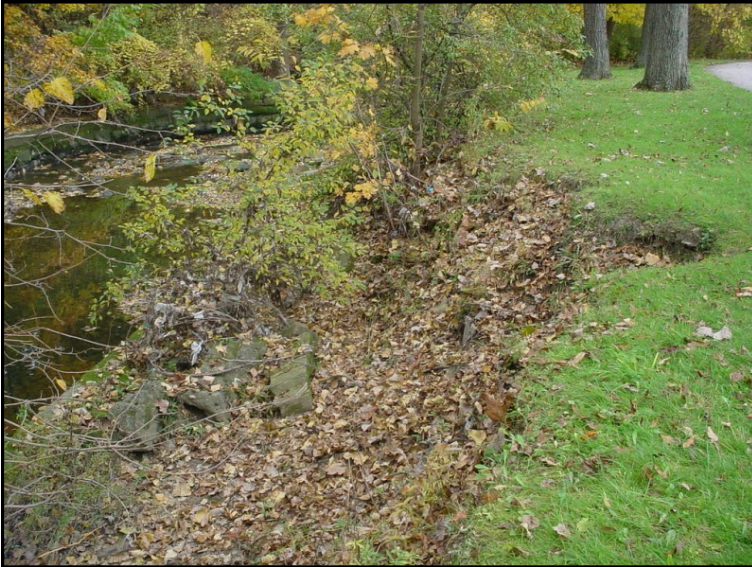
Photo 21: Eroding stream bank, Reach 3.

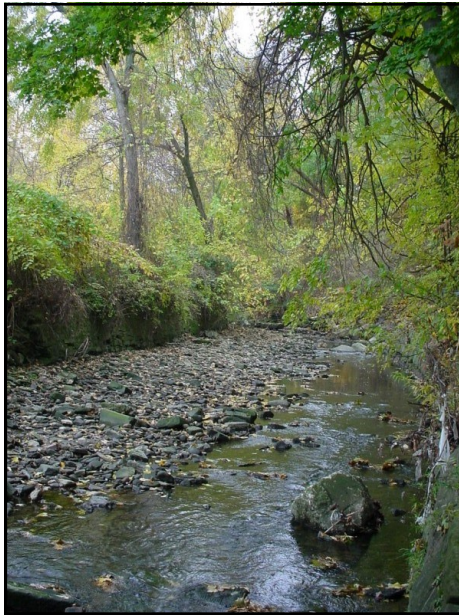
Photo 23: Looking upstream, Reach 3. Note failed stone wall on left.

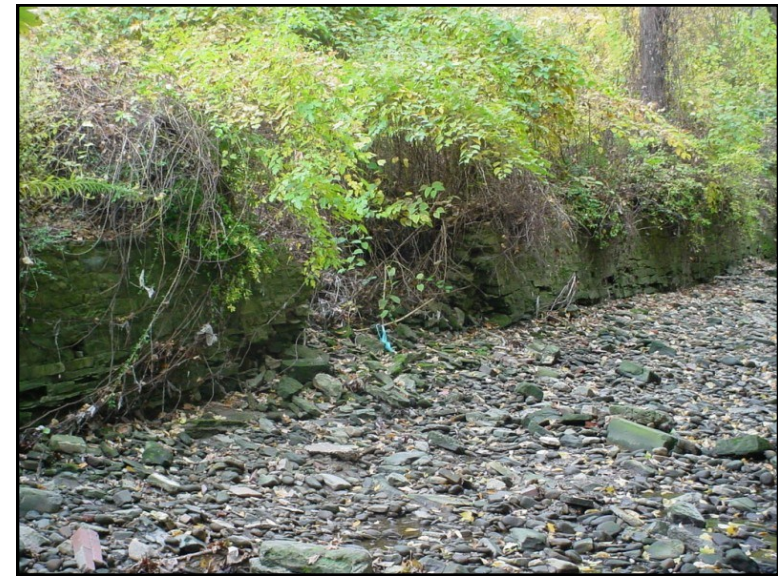
Photo 24: Close-up view of failed stone wall (contributing), Reach 3.
