# 2013 Illicit Discharge Detection and Elimination Program Annual Report

Northeast Ohio Regional  
**Sewer District**

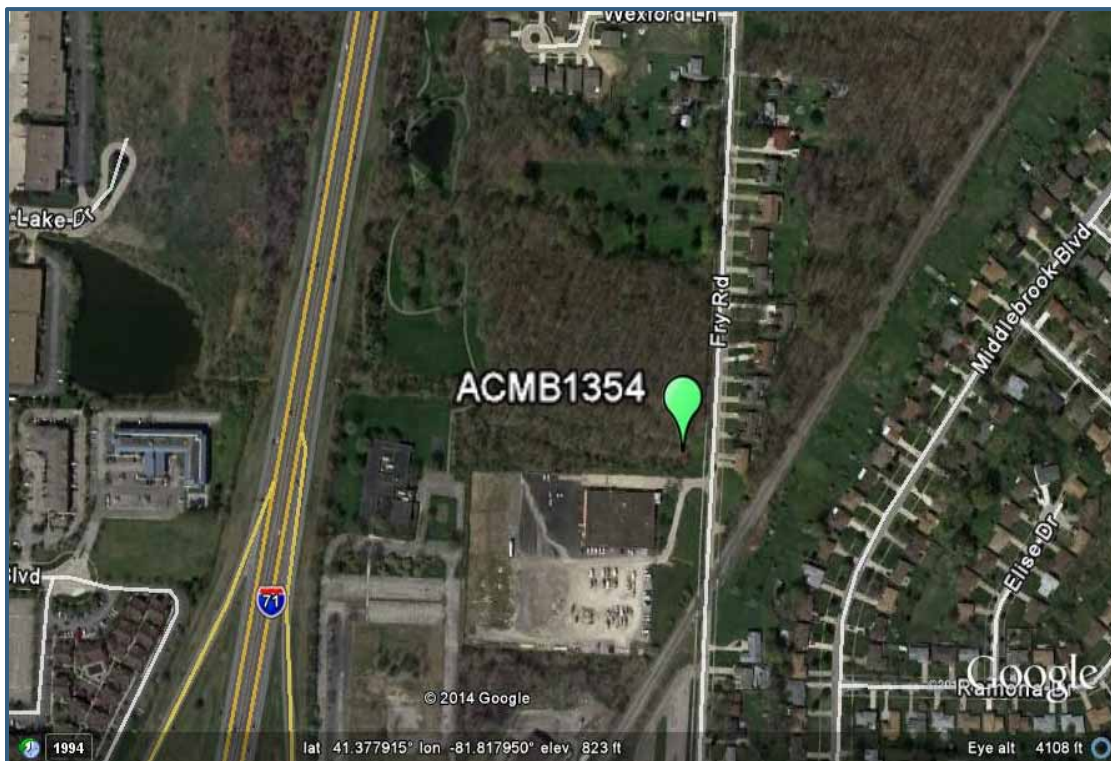
### ACMB1354

*E. coli* Density: 11,778 Most Probable Number (MPN)/100mL

**Problem Summary:** Dry weather flow was traced to between 7031 and 6975 Fry Road. Improper connections between homes and storm sewer may be present. Dye testing should be conducted to determine all sources of sanitary sewage to the storm sewer.

**Community Notification:** A letter was sent to the City of Middleburg Heights on October 11, 2013, detailing need to conduct dye testing of homes.

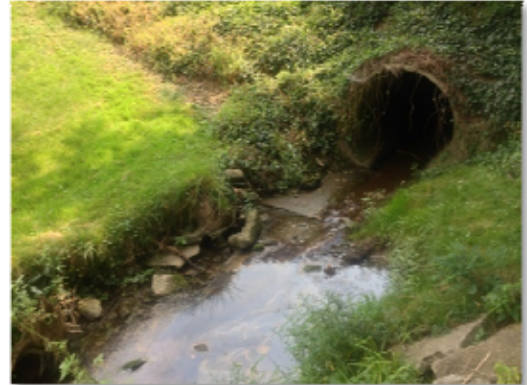
## AMH10030

Flow: 26,000 gallons/day

*E. coli* Density: 5,400 Colony-Forming Units (CFU)/100mL

**Problem Summary:** Problem is intermittent. Dry weather flow was traced to between 14200 Newton Road and 14400 Newton Road. Improper connection between the home at 14223 Newton Road and the storm sewer has already been documented. Other possible improper connections may also be present in area; dye testing by the City of Middleburg Heights should be conducted to determine all sources of sanitary sewage to the storm sewer.

**Community Notification:** A letter was sent to the City of Middleburg Heights on February 6, 2014, detailing need to conduct dye testing of homes.

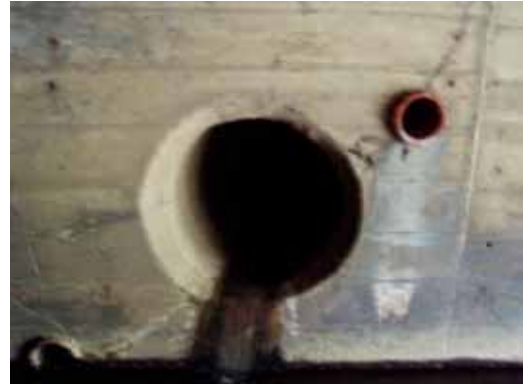
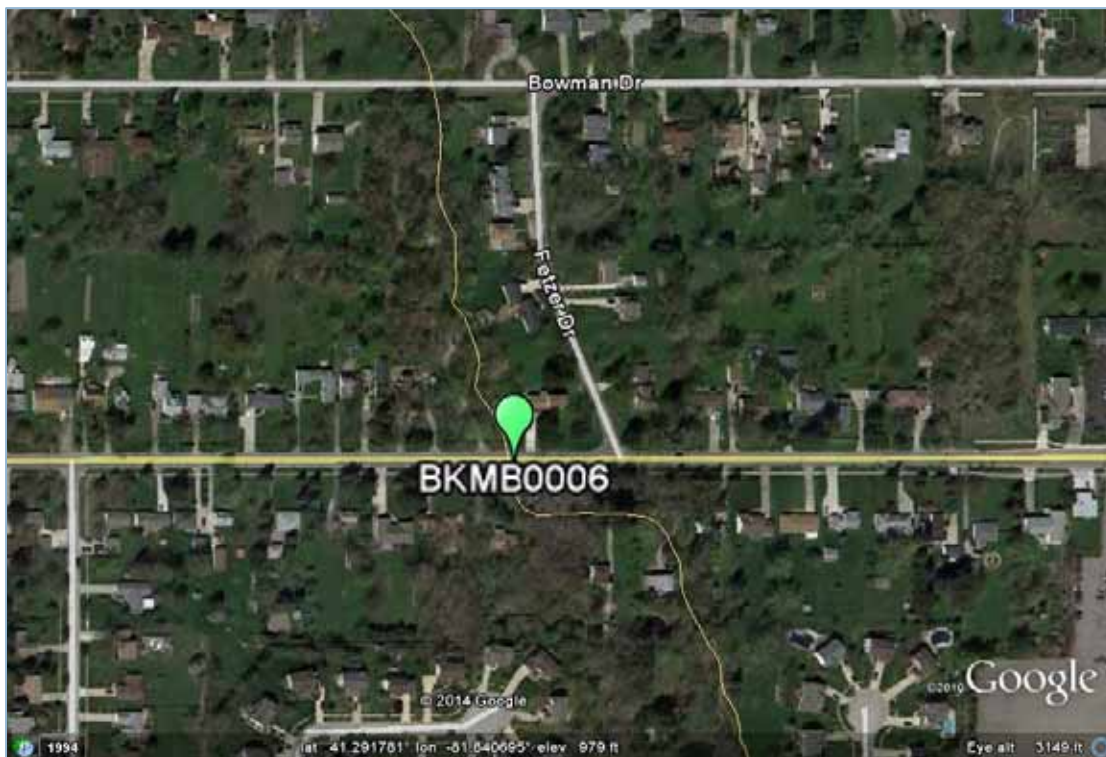
### BKMB0006

Flow: 2,000 gallons/day

*E. coli* Density: 2,150 CFU/100mL

**Problem Summary:** Homes in area have home sewage treatment systems. Problem could be due to a failing system.

**Community Notification:** A copy of the investigation report was sent to the Cuyahoga County Board of Health on January 24, 2014, detailing need to determine which systems are failing and take appropriate action to remediate them.

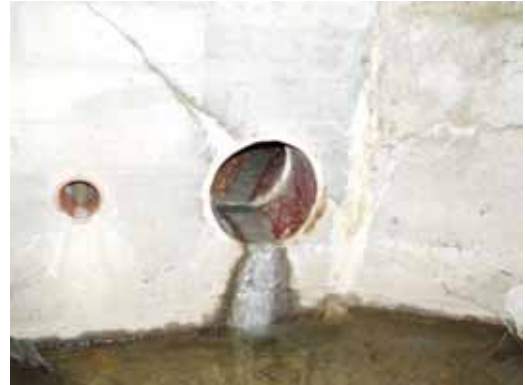
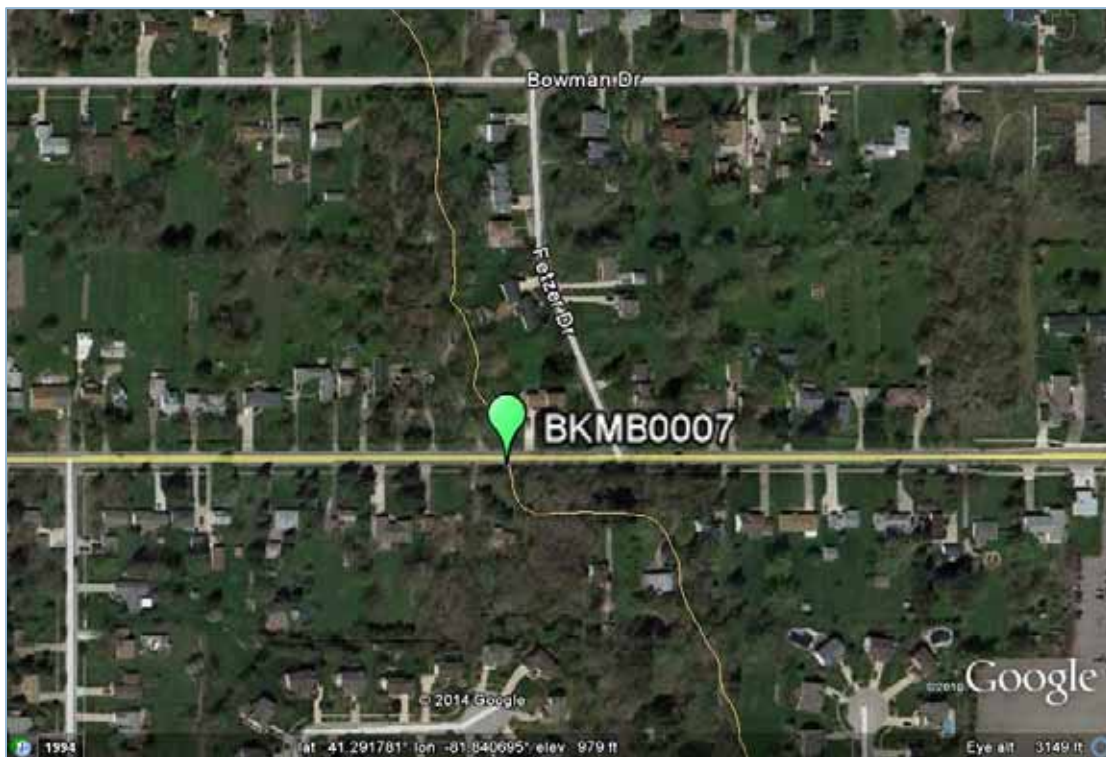
## BKMB0007

Flow: 70 gallons/day

*E. coli* Density: 9,333 CFU/100mL

**Problem Summary:** Homes in area have home sewage treatment systems. Problem could be due to a failing system.

**Community Notification:** A copy of the investigation report was sent to the Cuyahoga County Board of Health on January 24, 2014, detailing need to determine which systems are failing and take appropriate action to remediate them.

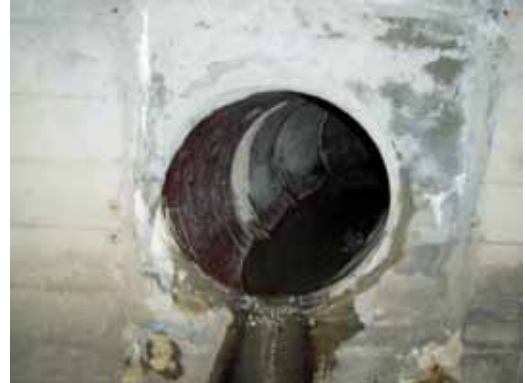
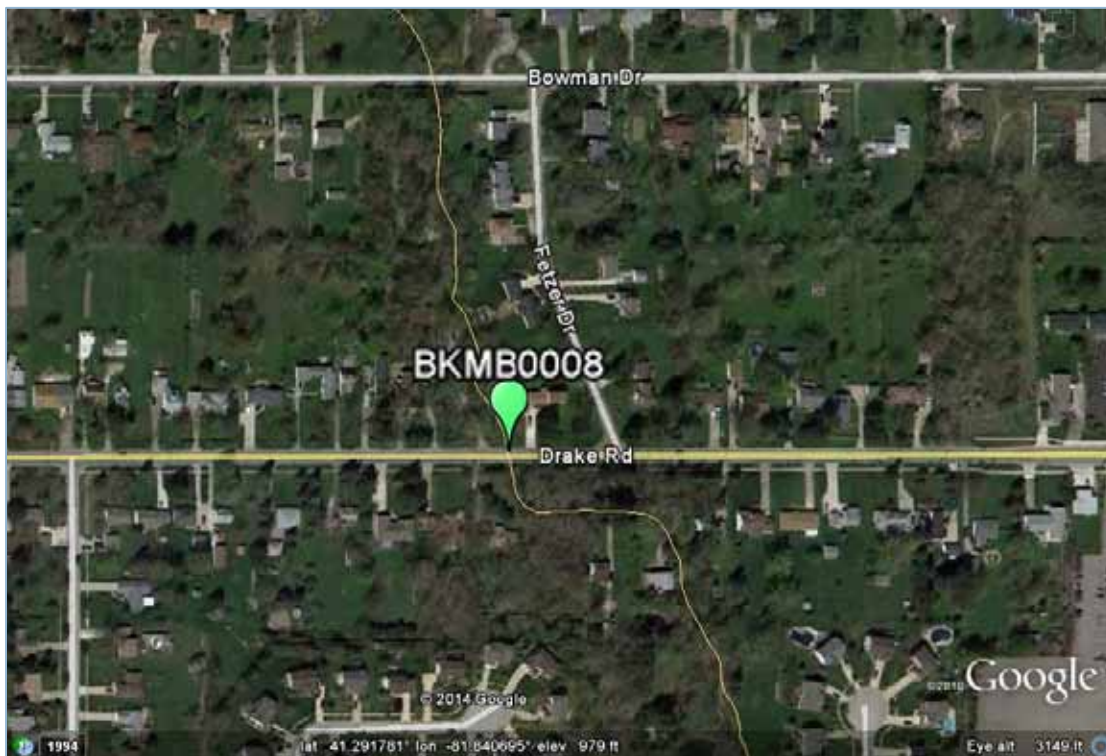
## BKMB0008

Flow: 5,000 gallons/day

*E. coli* Density: 1,000 CFU/100mL

**Problem Summary:** Homes in area have home sewage treatment systems. Problem could be due to a failing system.

**Community Notification:** A copy of the investigation report was sent to the Cuyahoga County Board of Health on January 24, 2014, detailing need to determine which systems are failing and take appropriate action to remediate them.

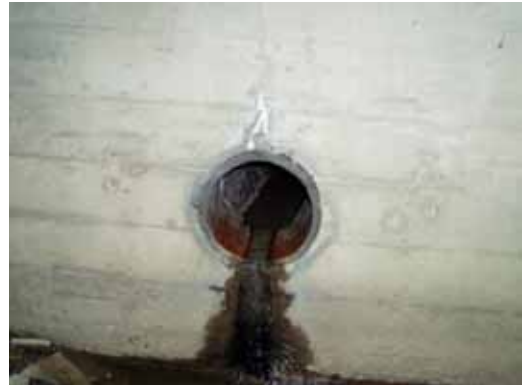
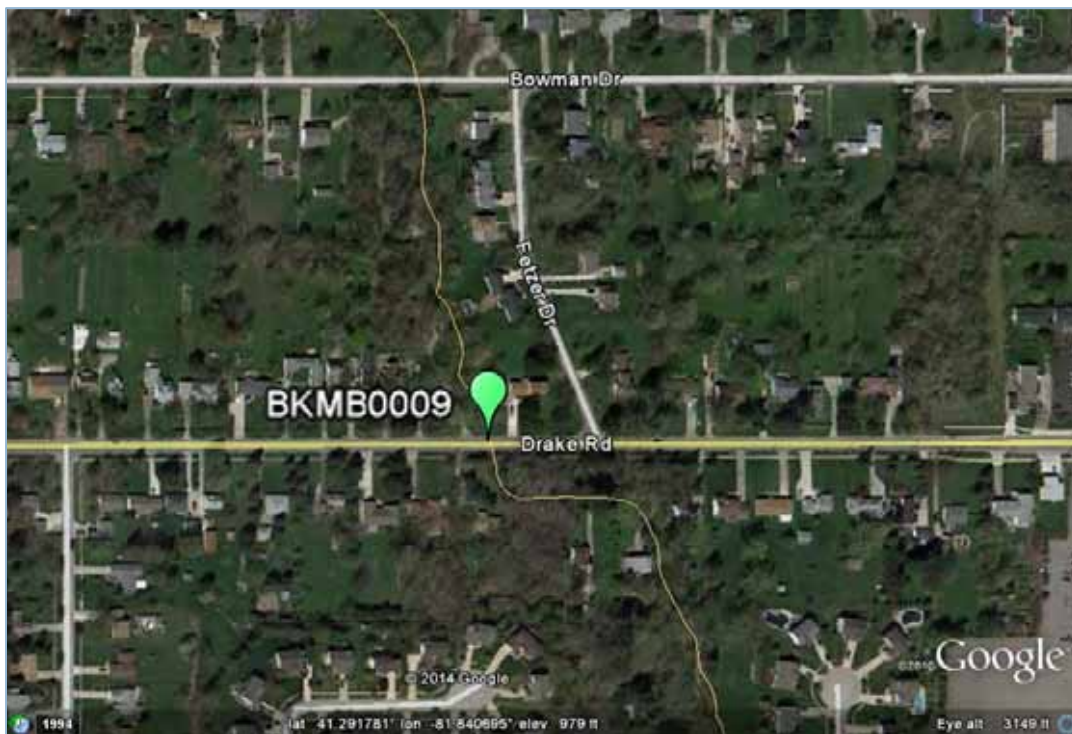
## BKMB0009

Flow: 400 gallons/day

*E. coli* Density: 212 CFU/100mL

**Problem Summary:** Previous sampling indicated elevated *E. coli* densities. Homes in area have home sewage treatment systems. Problem could be due to a failing system.

**Community Notification:** A copy of the investigation report was sent to the Cuyahoga County Board of Health on January 24, 2014, detailing need to determine which systems are failing and take appropriate action to remediate them.

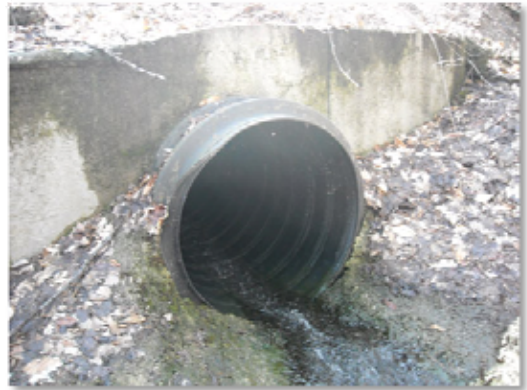
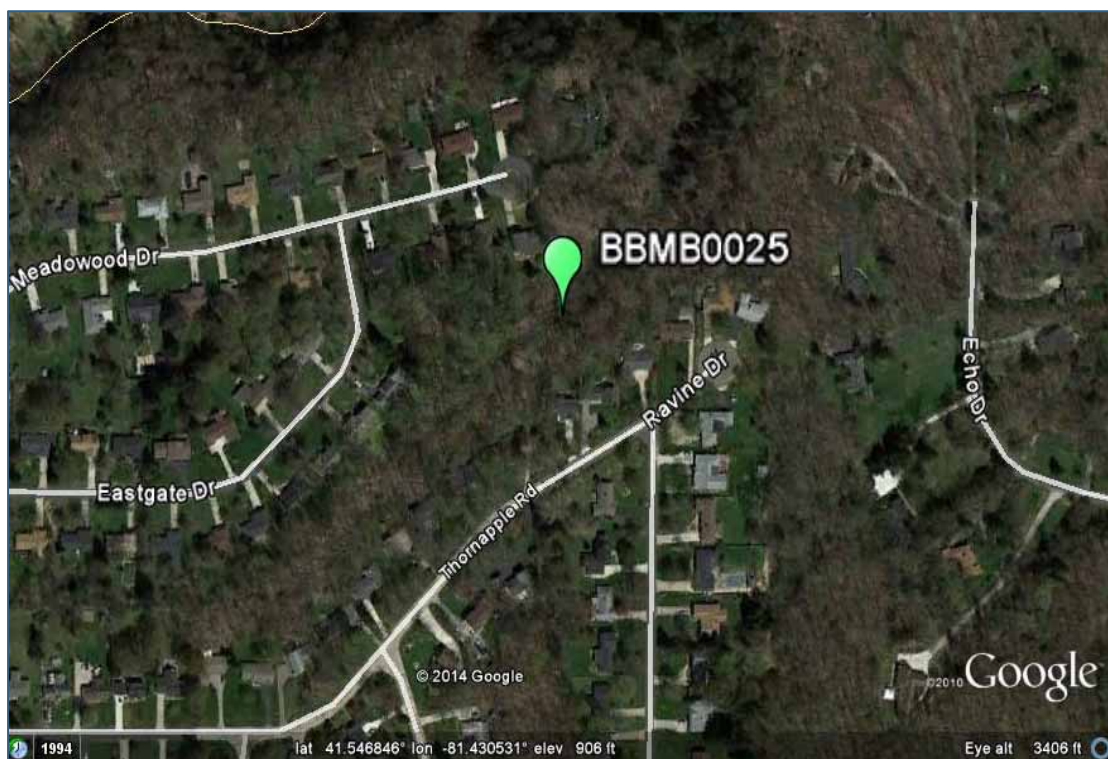
### BBMB0025

Flow: 22,982 gallons/day

*E. coli* Density: 100,800 CFU/100mL

**Problem Summary:** Some homes in area have home sewage treatment systems. Problem could be due to failing systems.

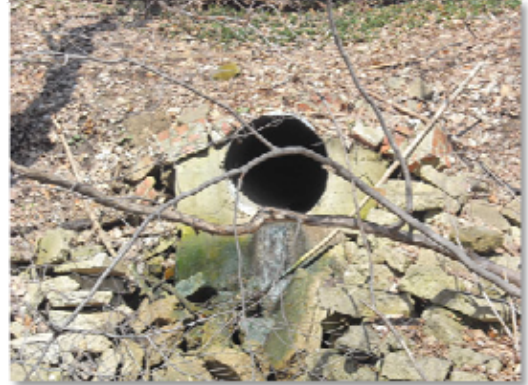
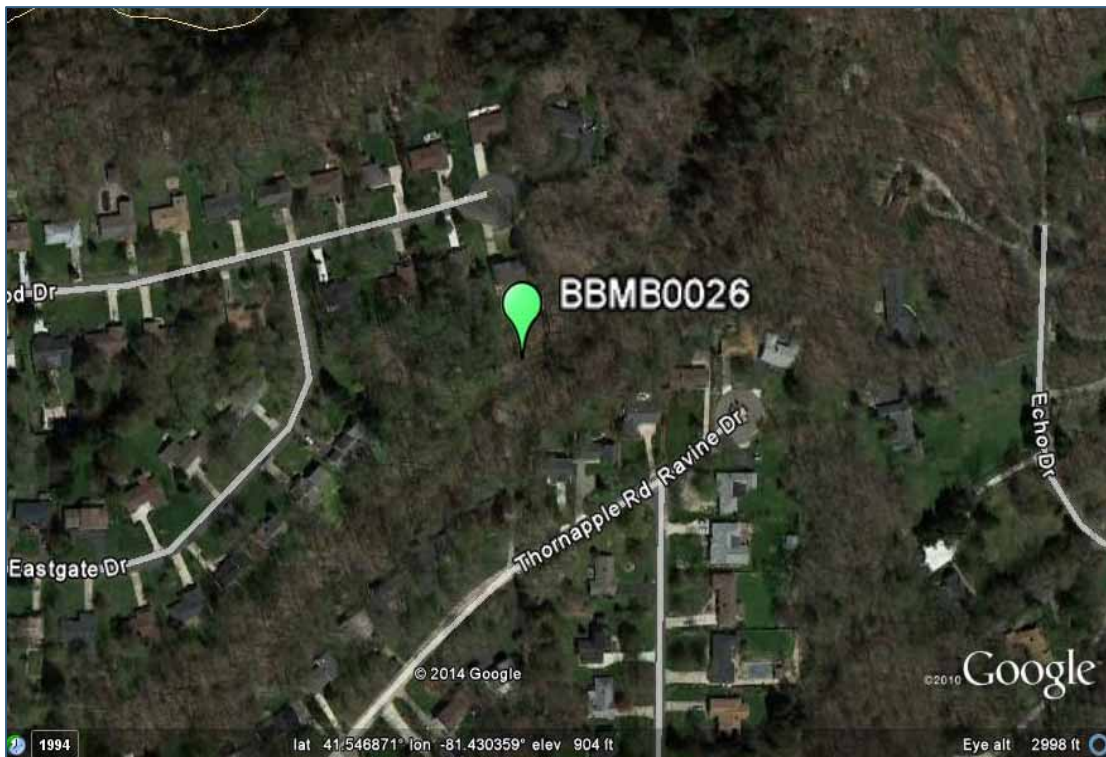
## BBMB0026

Flow: 20,377 gallons/day

*E. coli* Density: 6,800 CFU/100mL

**Problem Summary:** Some homes in area have home sewage treatment systems. Problem could be due to failing systems.

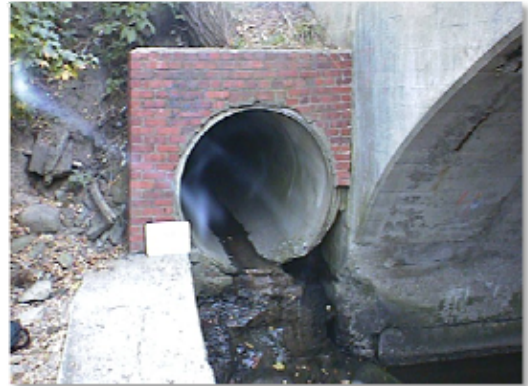
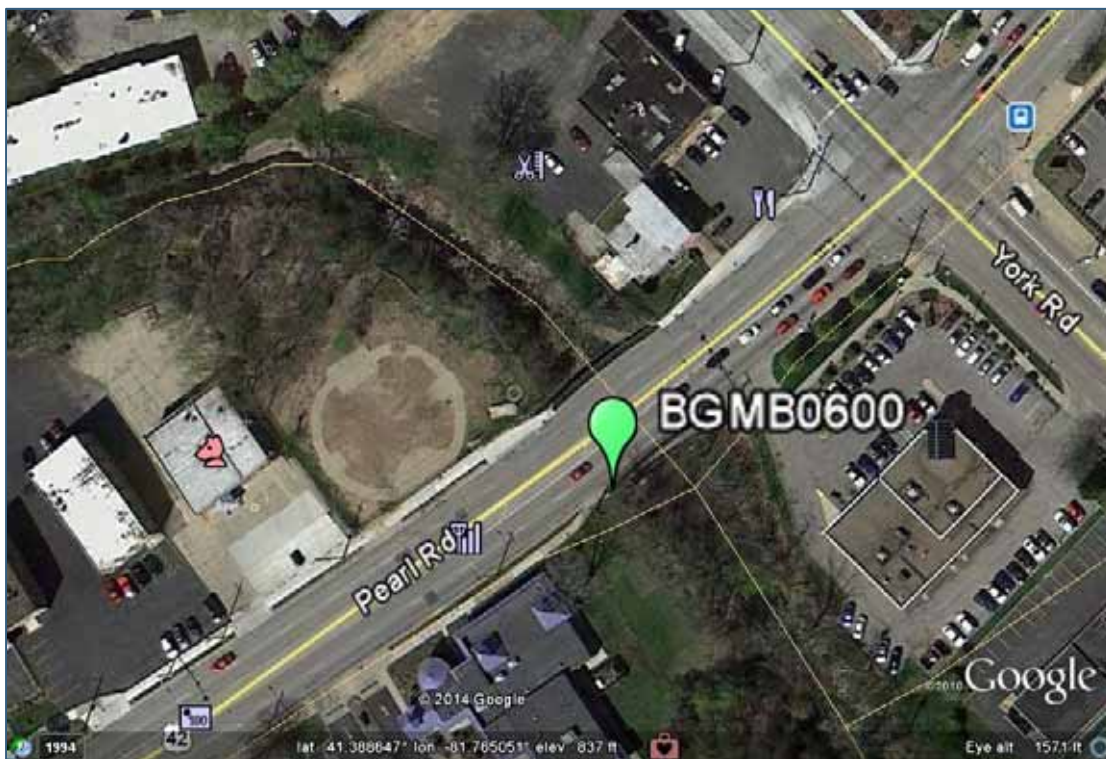
### BGMB0600

Flow: 8,640 gallons/day

*E. coli* Density: 87,040 MPN/100mL

**Problem Summary:** Dry weather flow was traced to Sherborn Drive between Glendora Lane and Appleton Drive. Improper connections between homes and storm sewer may be present. Dye testing should be conducted to determine all sources of sanitary sewage to the storm sewer.

**Community Notification:** The City of Parma Heights was contacted via email on February 10, 2014, regarding status of the problem. They are conducting a video inspection of the storm sewer to determine improper connections in the area.

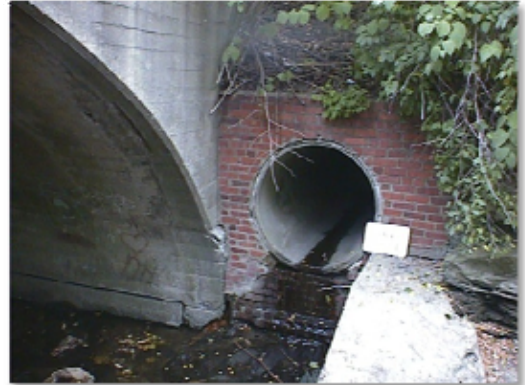
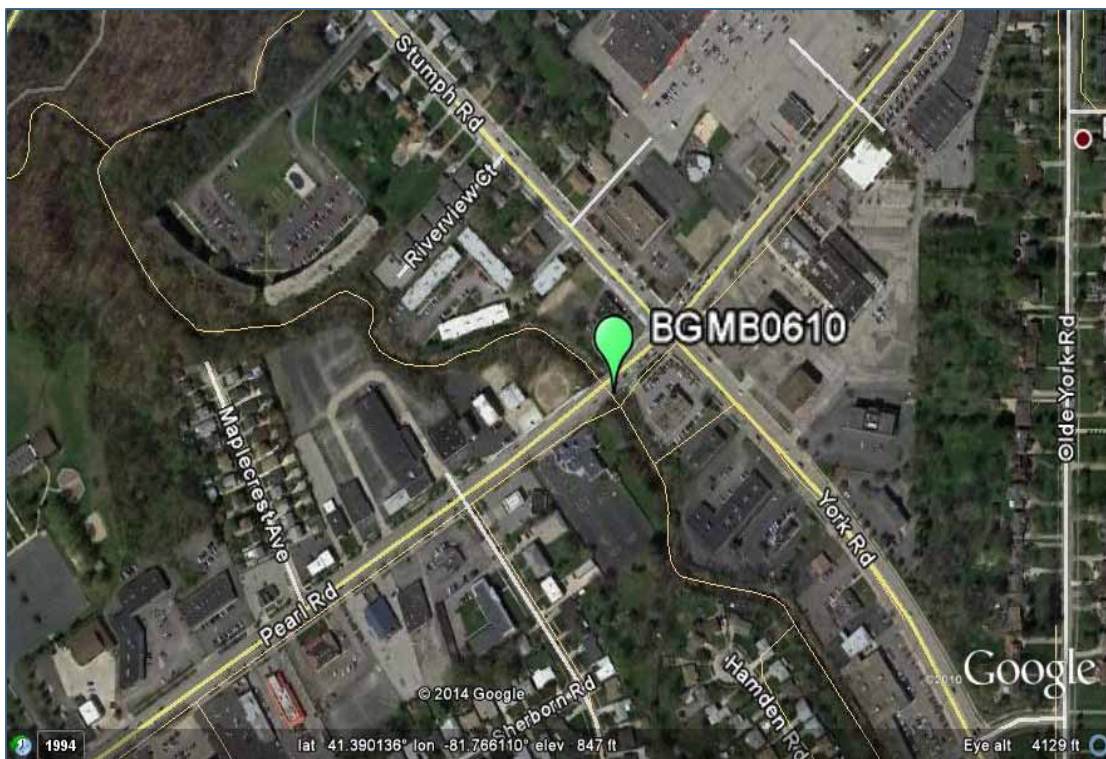
## BGMB0610

Flow: 3,000 gallons/day

*E. coli* Density: 52,310 MPN/100mL

**Problem Summary:** Dry weather flow was traced to Manorford Drive and Alyesworth Drive. Improper connections between homes and storm sewer may be present. Dye testing should be conducted to determine all sources of sanitary sewage to the storm sewer.

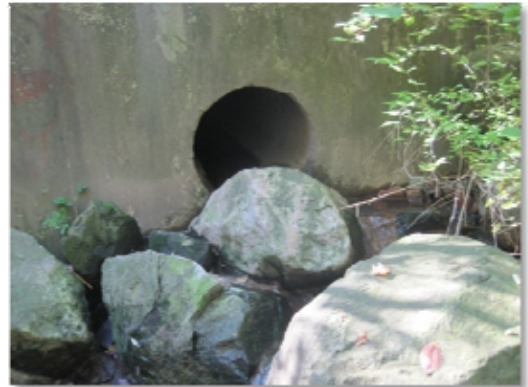
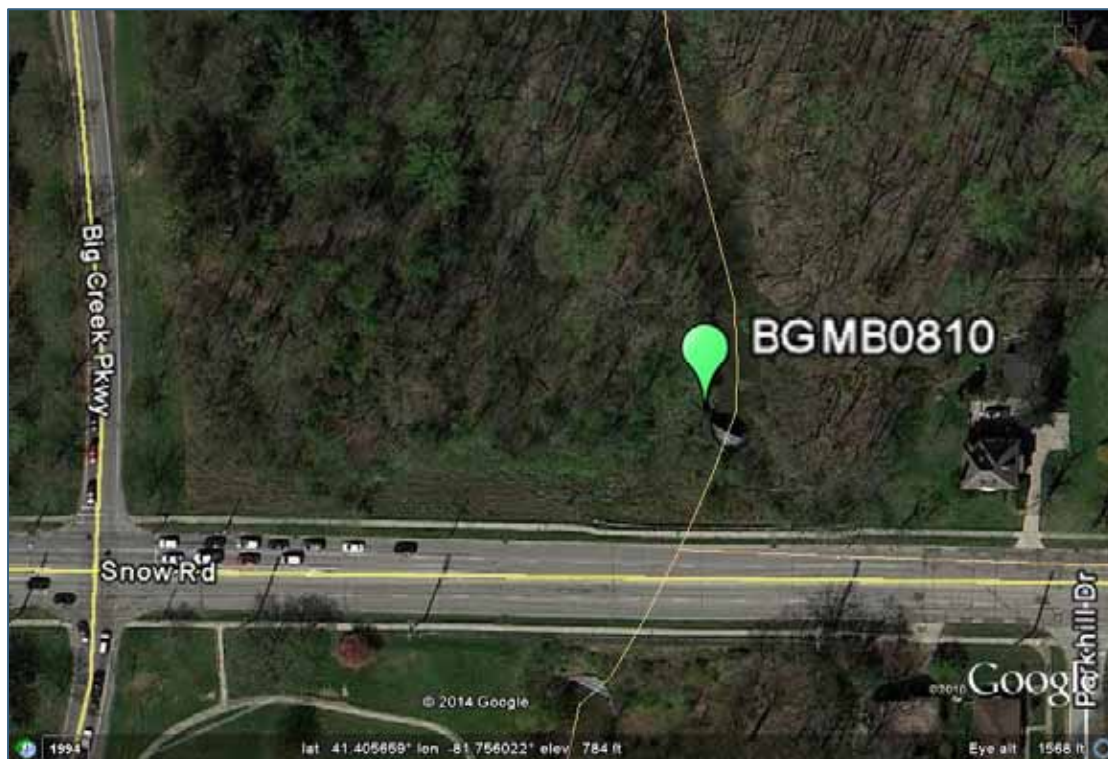
## BGMB0810

Flow: 108,000 gallons/day

*E. coli* Density: 1 MPN/100mL

**Problem Summary:** A water leak was traced to between 5846 and 5866 Royal Parkway Drive in Parma Heights.

**Community Notification:** The Cleveland Water Department was informed of the leak on 10/31/13.

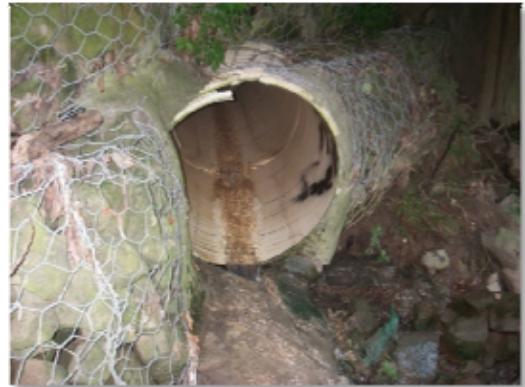
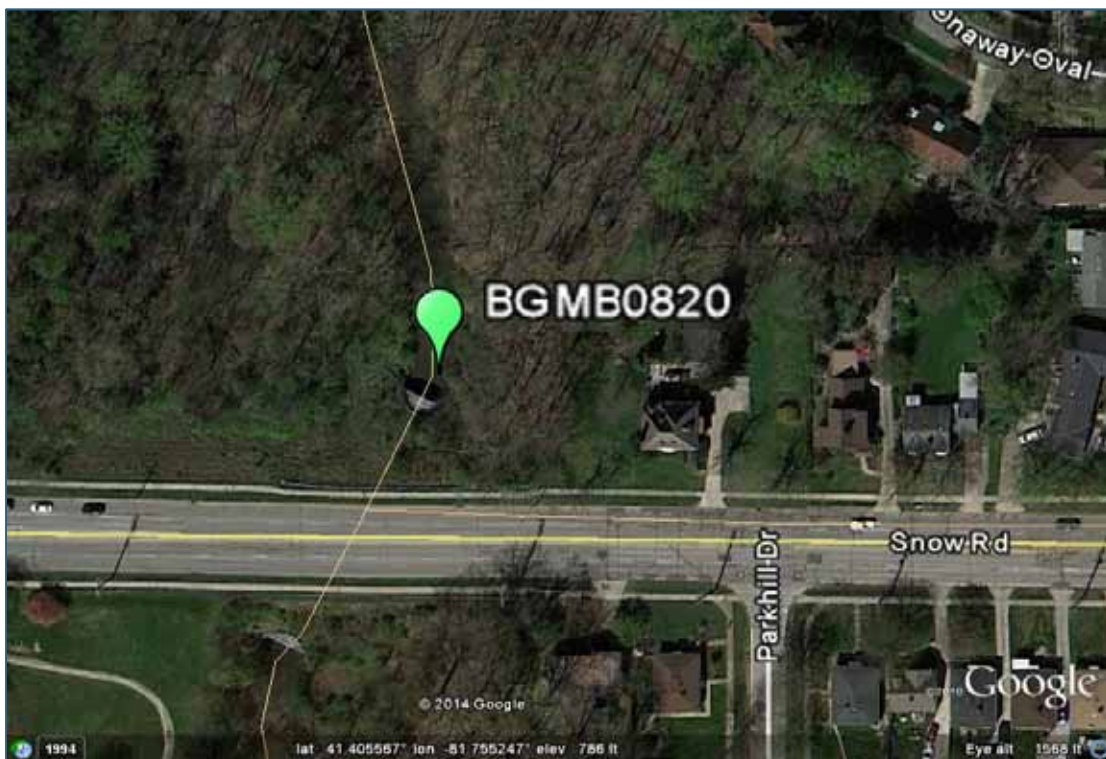
## BGMB0820

Flow: 17,280 gallons/day

*E. coli* Density: 357,800 MPN/100mL

**Problem Summary:** Dry weather flow was traced to Clearview Drive between Lucy Drive and Eureka Parkway in Parma Heights. Improper connections between homes and storm sewer may be present. Dye testing should be conducted to determine all sources of sanitary sewage to the storm sewer.

**Community Notification:** A letter was sent to the City of Parma Heights on February 10, 2014, detailing need to conduct dye testing of homes.

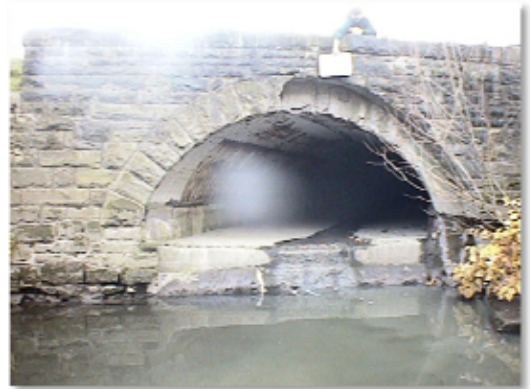
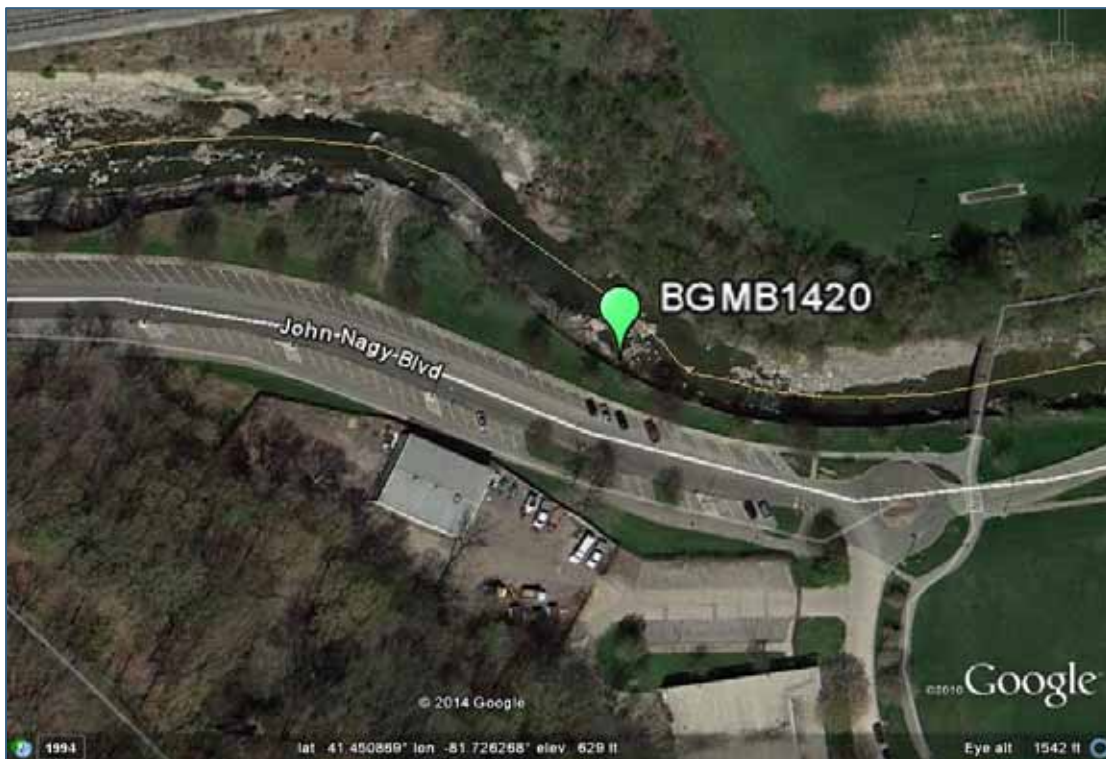
## BGMB1420

*E. coli* Density: 73,339 MPN/100mL

**Problem Summary:** A sanitary sewer was found leaking into the CSO 053 stormwater outlet near 4087 West 56th Street. Repairs to the sewer are needed.

**Community Notification:** The problem was discussed with the City of Cleveland on May 13, 2014.

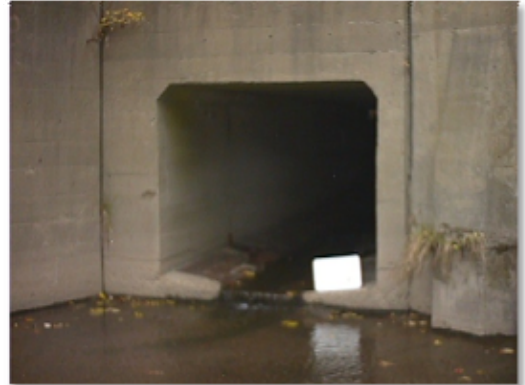
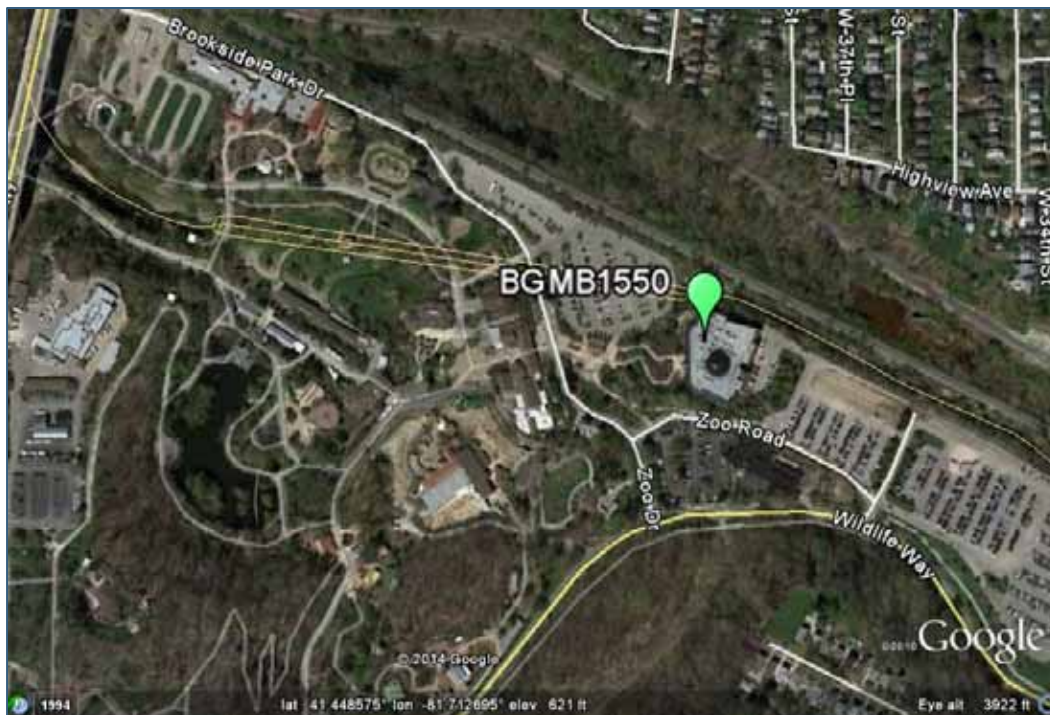
## BGMB1550

*E. coli* Density: 193,650 CFU/100mL

**Problem Summary:** Verified that a previous sanitary sewer collapse near West 38<sup>th</sup> Street and Muriel Avenue had been remediated. Dry weather flow was traced to (1) between 4007 and 4109 Clybourne Avenue and (2) between intersection of West 35<sup>th</sup> and Memphis Avenue and 3521 Memphis Avenue. Improper connections between homes and storm sewer may be present. Dye testing should be conducted to determine all sources of sanitary sewage to the storm sewer.

**Community Notification:** A letter was sent to the City of Cleveland on February 11, 2010, detailing the need to conduct video inspections of areas where improper connections may be present.

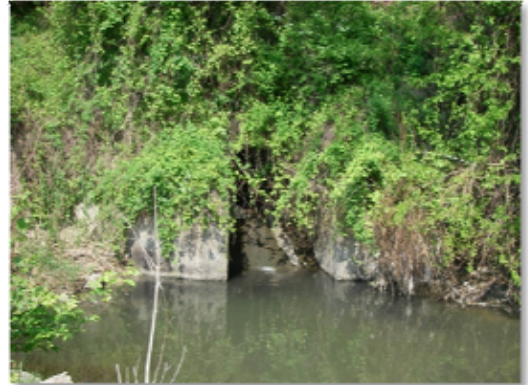
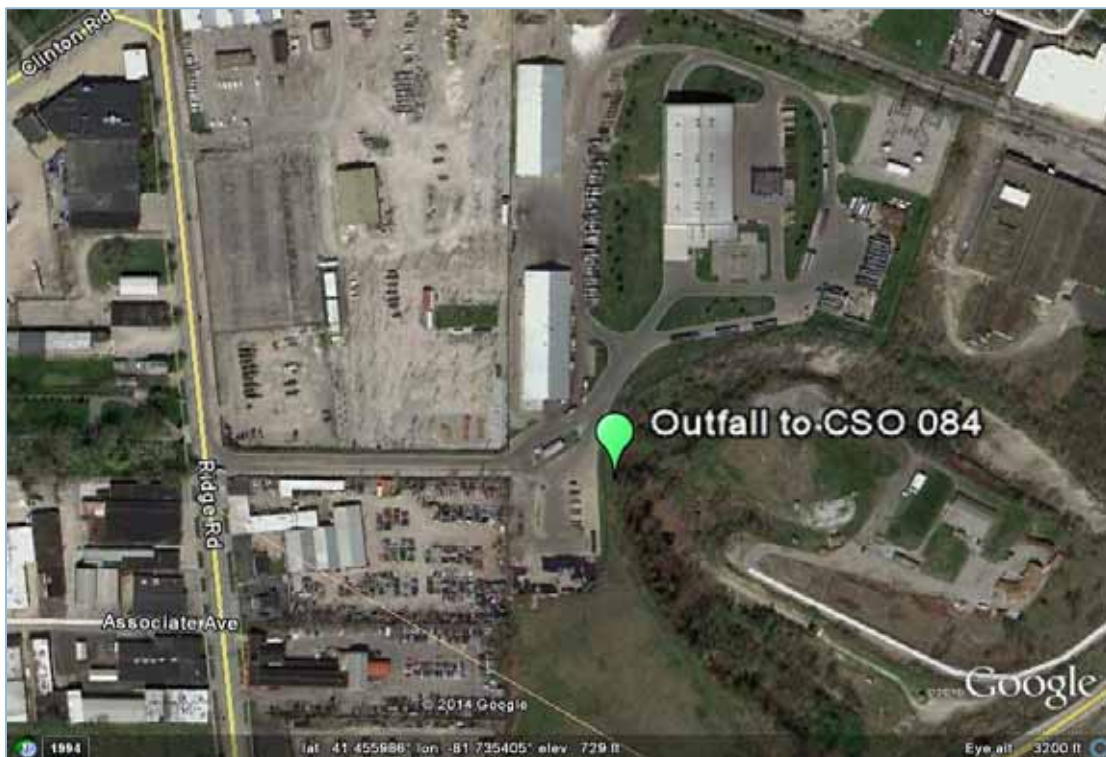
## OUTFALL TO CSO 084

**Problem Summary:** During a past investigation, it was found that flow coming from a building owned by Cartruck Packaging at 7315 Associate Avenue was going to both the sanitary and storm sewer. Dye testing confirmed that this problem was still ongoing. An investigation into the apparent structural problems in the sewers at this location is needed so that they can be remediated.

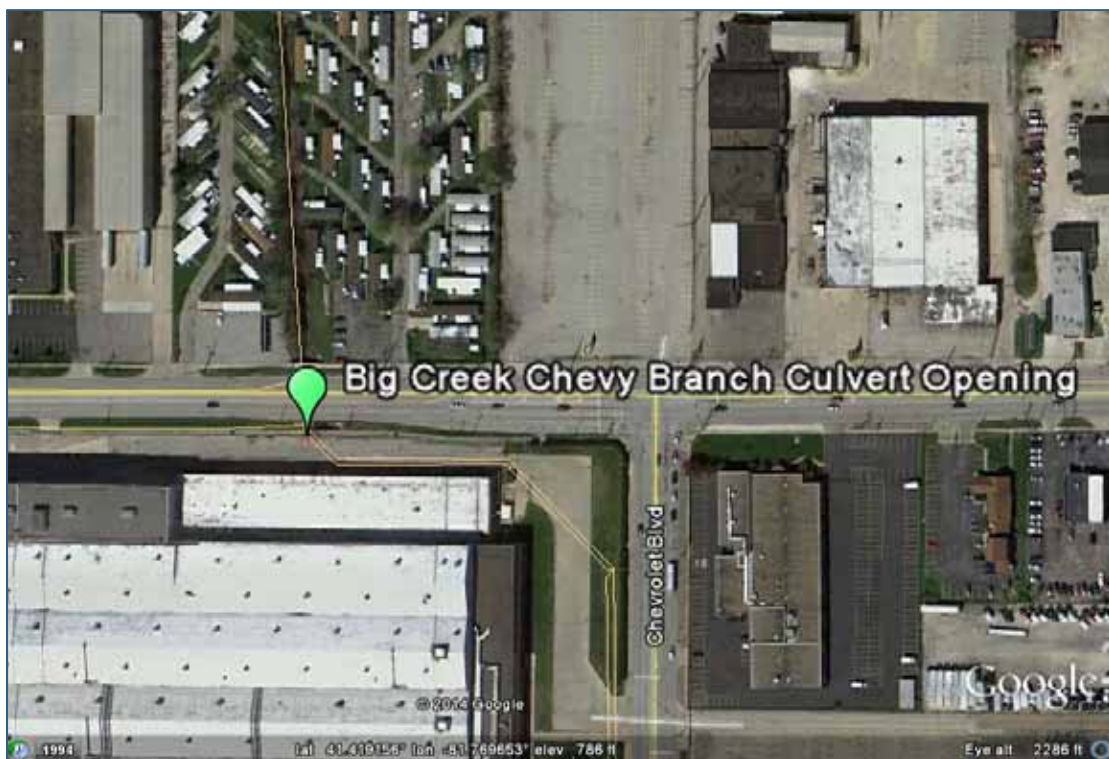
## BIG CREEK CHEVY BRANCH

**Problem Summary:** A blocked sanitary sewer at the intersection of Snow Road and Calamie Drive was found and remediated. Dry weather flow was also traced to (1) between 5910 and 5949 Stumph Road and (2) the south end of Doxmere Drive. Improper connections between homes and storm sewer may be present. Dye testing should be conducted to determine all sources of sanitary sewage to the storm sewer.

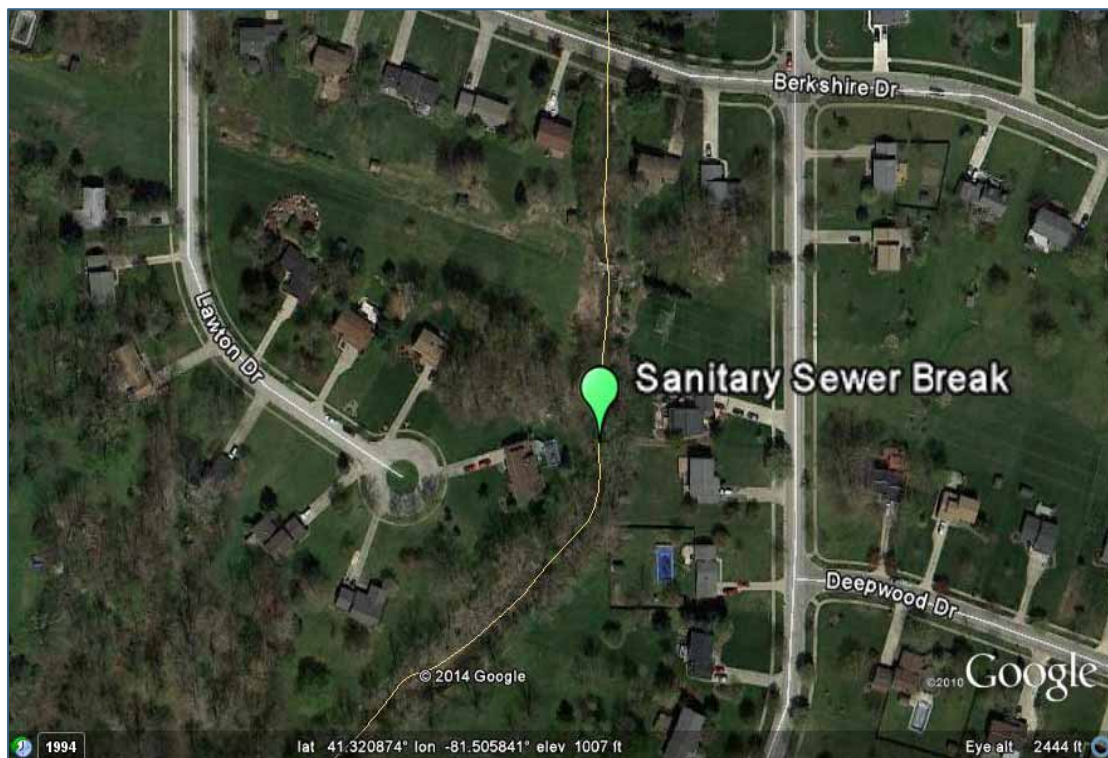
**Problem Summary:** A concrete slab fell onto a sanitary sewer pipe that crosses the stream, causing a rupture. A sample collected downstream of the discharge had an *E. coli* density of 2,173,980 MPN/100mL.

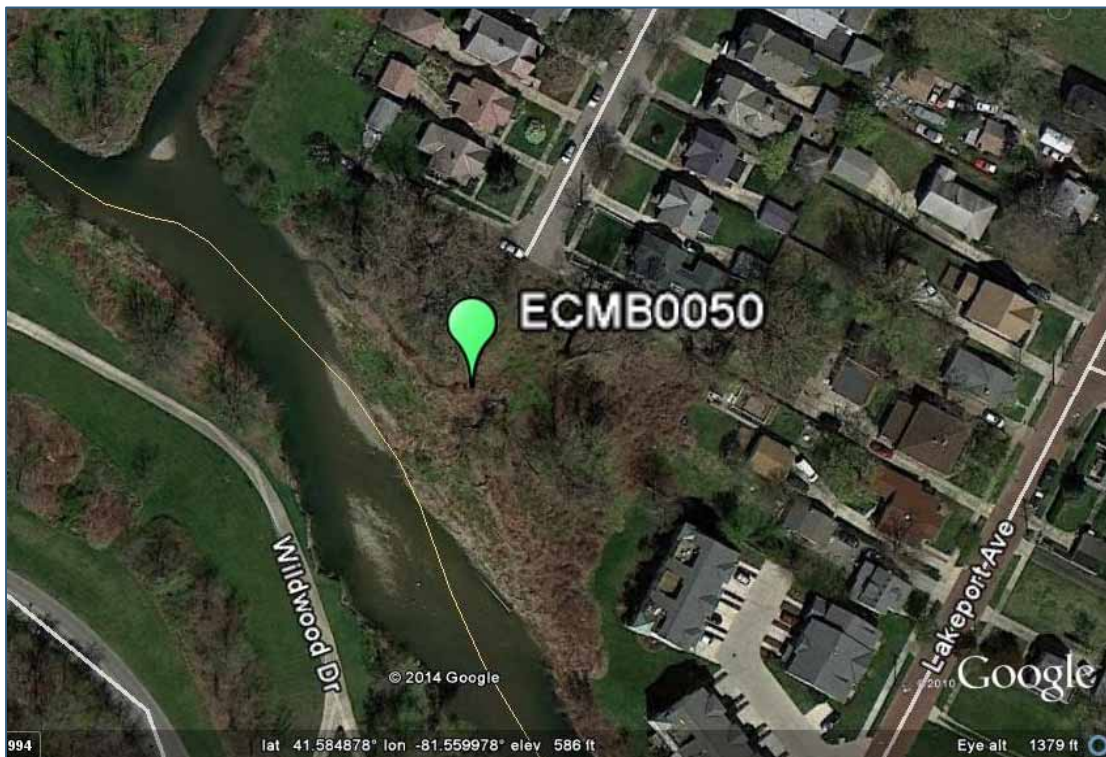
**Problem Summary:** An improper connection between the basement of a home at 817 Hoover Avenue and the storm sewer still needs to be remediated.

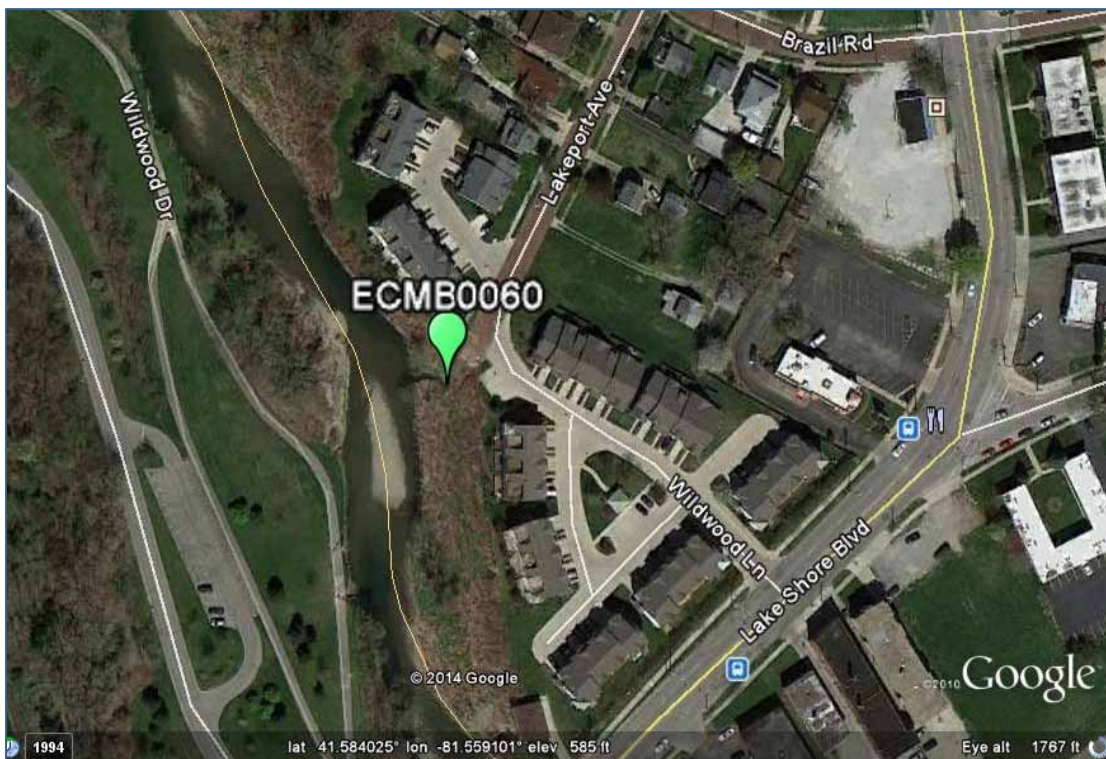
## ECMB0060

**Problem Summary:** A sanitary sewer connection to storm sewer near 17506 Lakeport Boulevard still needs to be remediated. Other possible improper connections may be present on Brazil Road and at 17515 and 17516 Lakeport Boulevard. Dye testing should be conducted to determine all sources of sanitary sewage to the storm sewer.

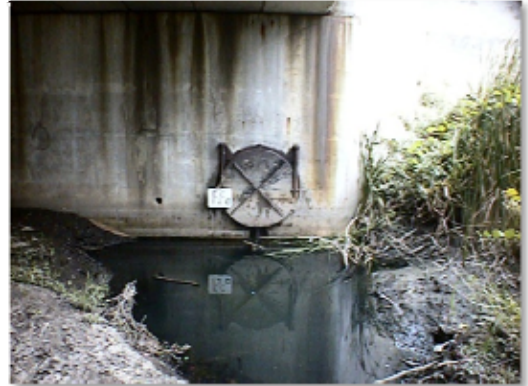
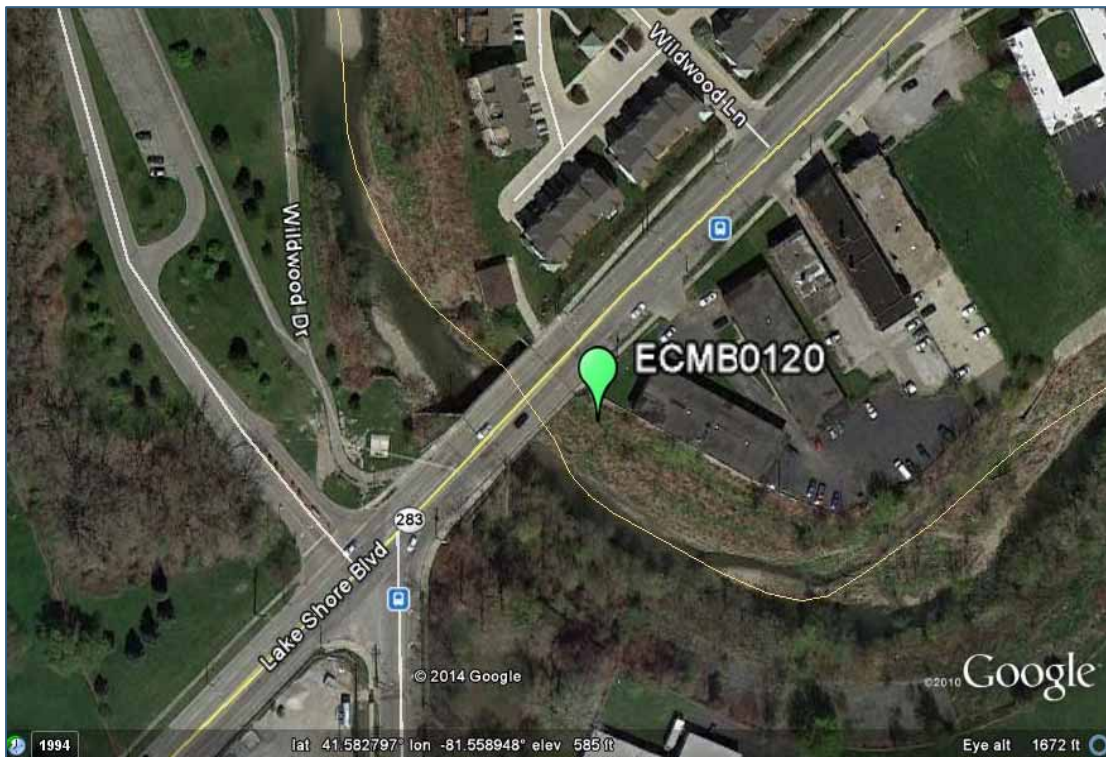
## ECMB0120

*E. coli* Density: 230,550 MPN/100mL

**Problem Summary:** An improper connection between the apartment building at 17530 Lake Shore Boulevard and the storm sewer still needs to be remediated.

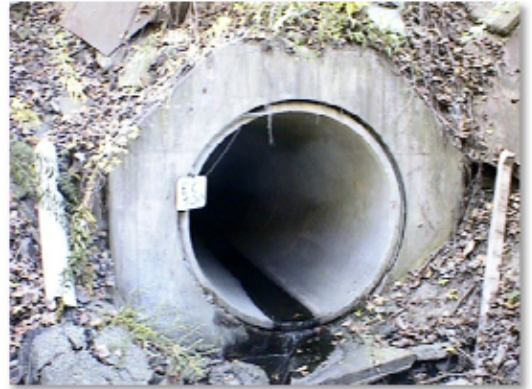
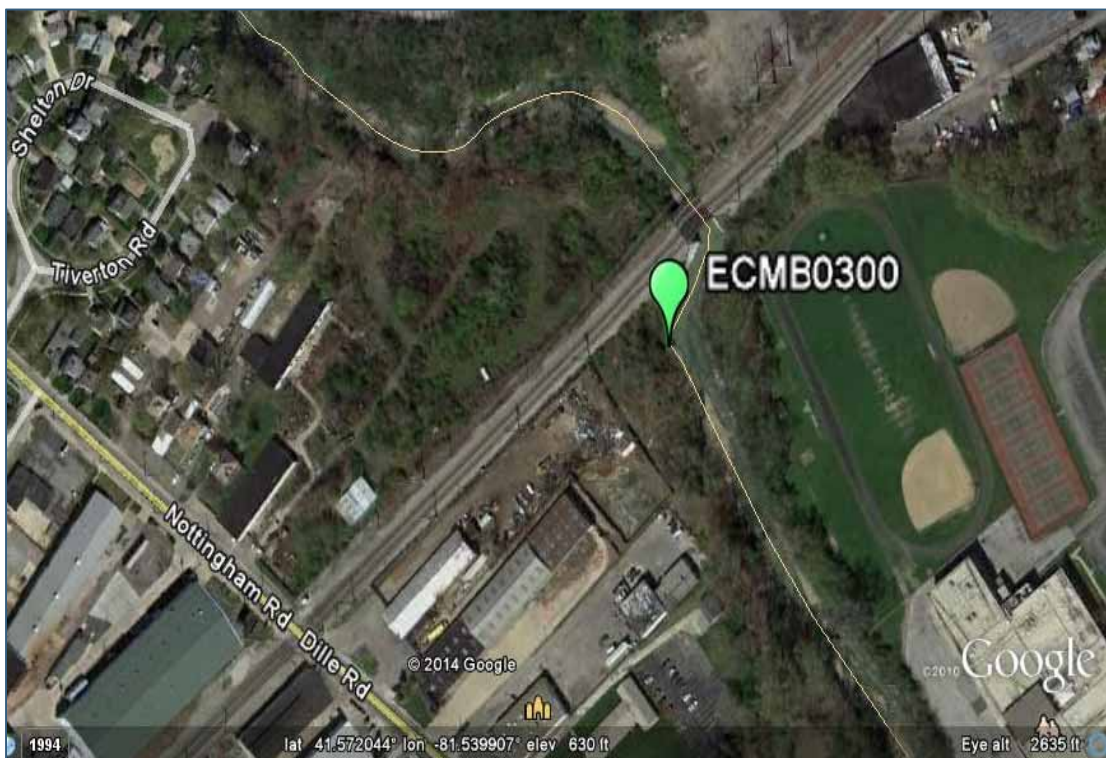
## ECMB0300

**Problem Summary:** Improper connections were found between two of the buildings at Indian Hills Apartments and the storm sewer.

**Community Notification:** On September 6, 2013, WQIS Investigators met with the City of Euclid to discuss current problems and what needed to be fixed. One of the improper connections was remediated; the other is scheduled to be fixed in 2014.
