# 2013 Illicit Discharge Detection and Elimination Program Annual Report

Northeast Ohio Regional  
**Sewer District**

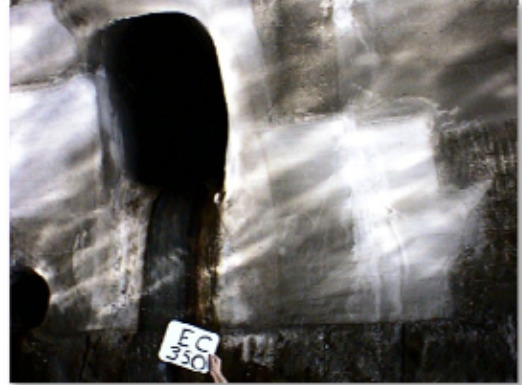
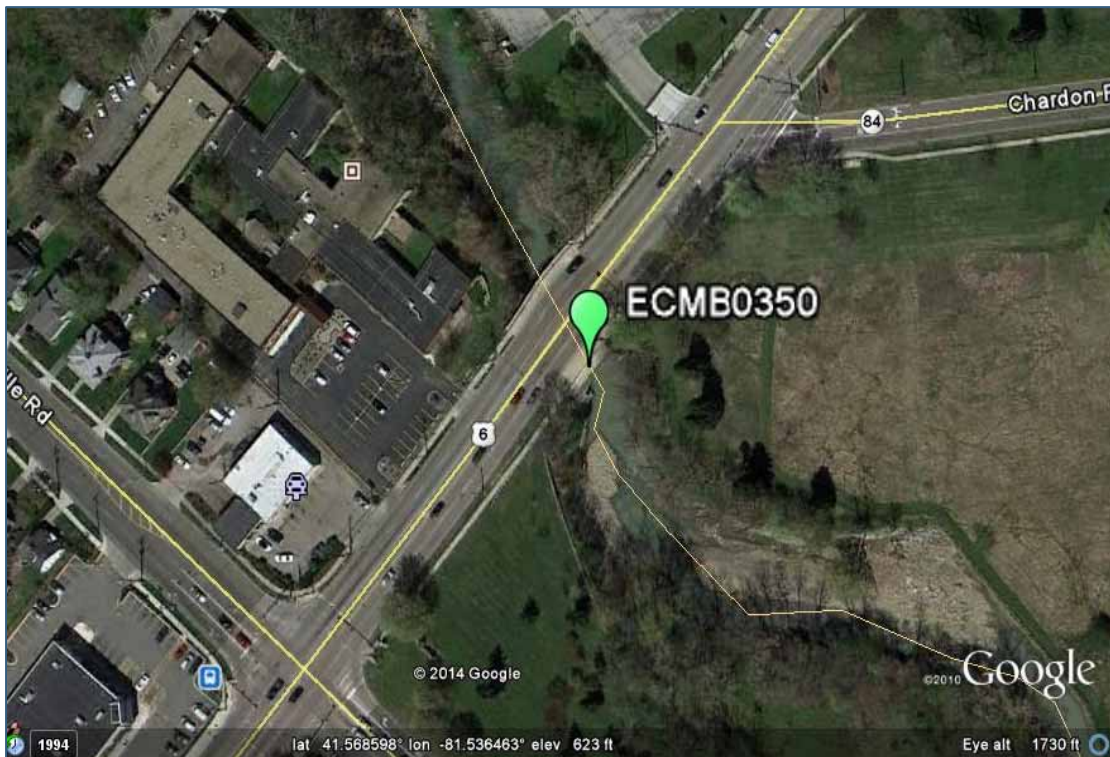
## ECMB0350

**Problem Summary:** Flow with elevated *E. coli* densities was traced along Euclid Avenue to Grand Boulevard. A video inspection of the indicated improper connections between the apartment buildings located at 20200 and 20240 Grand Boulevard and the storm sewer. The City of Euclid needs to conduct dye testing to verify improper connections.

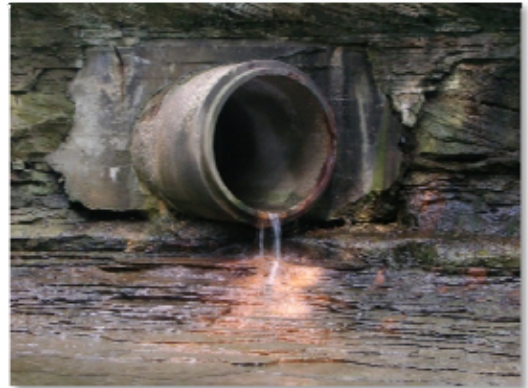
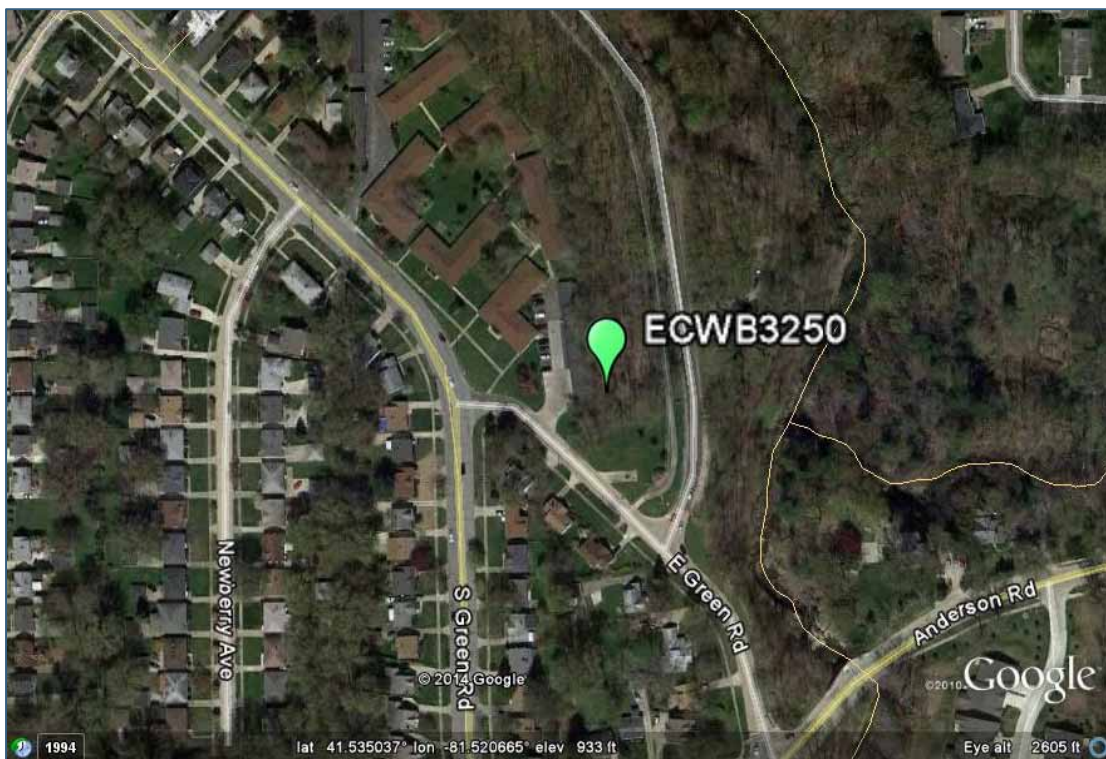
## ECWB3250

*E. coli* Density: 4,540 MPN/100mL

**Problem Summary:** Dry weather flow with elevated *E. coli* densities was traced to Adrian Road. Improper connections between homes and the storm sewer may be present. Dye testing should be conducted to determine all sources of sanitary sewage to the storm sewer.

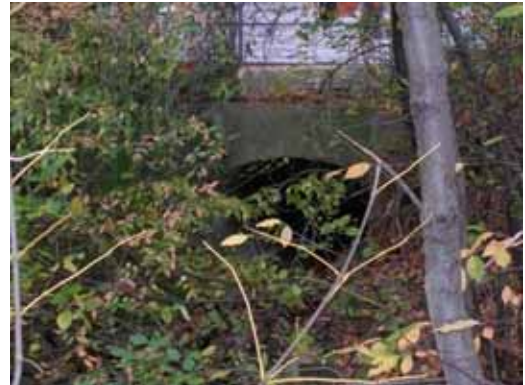
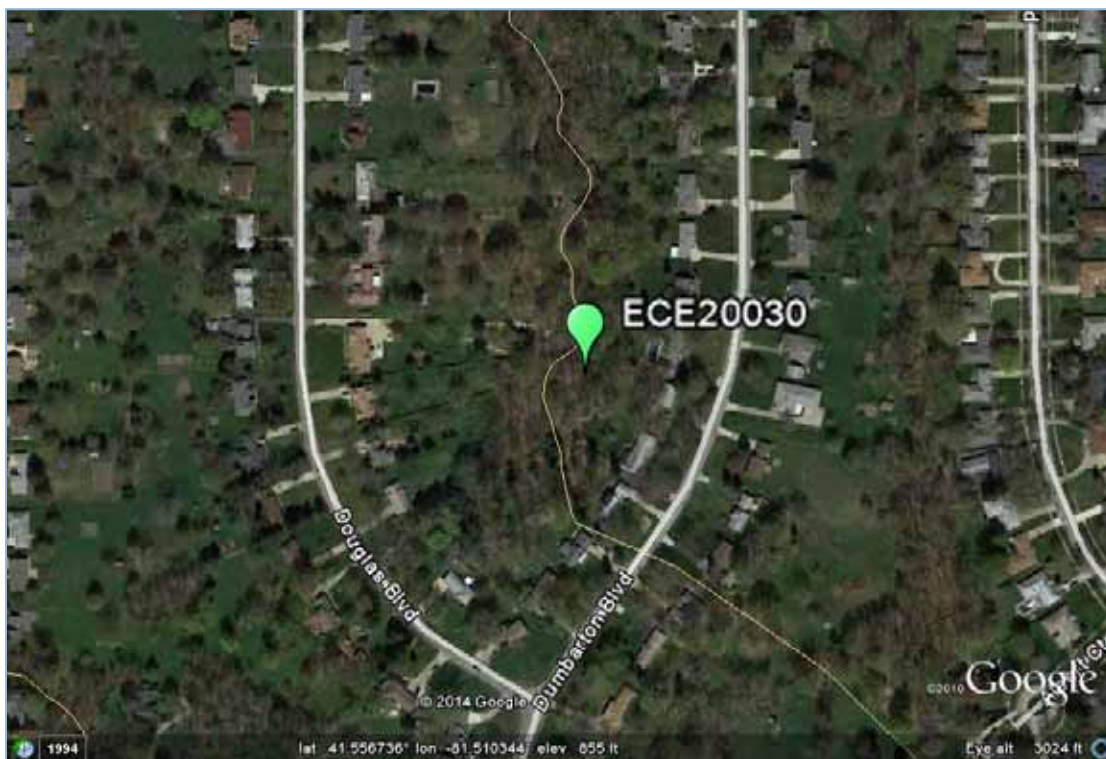
## ECE20030

*E. coli* Density: 1 MPN/100mL

**Problem Summary:** During a previous investigation, dry weather flow with elevated *E. coli* densities was traced to Foxwynde Trail. The City of Richmond Heights has conducted a series of dye tests in the area and found some improper connections between homes and the storm sewer.

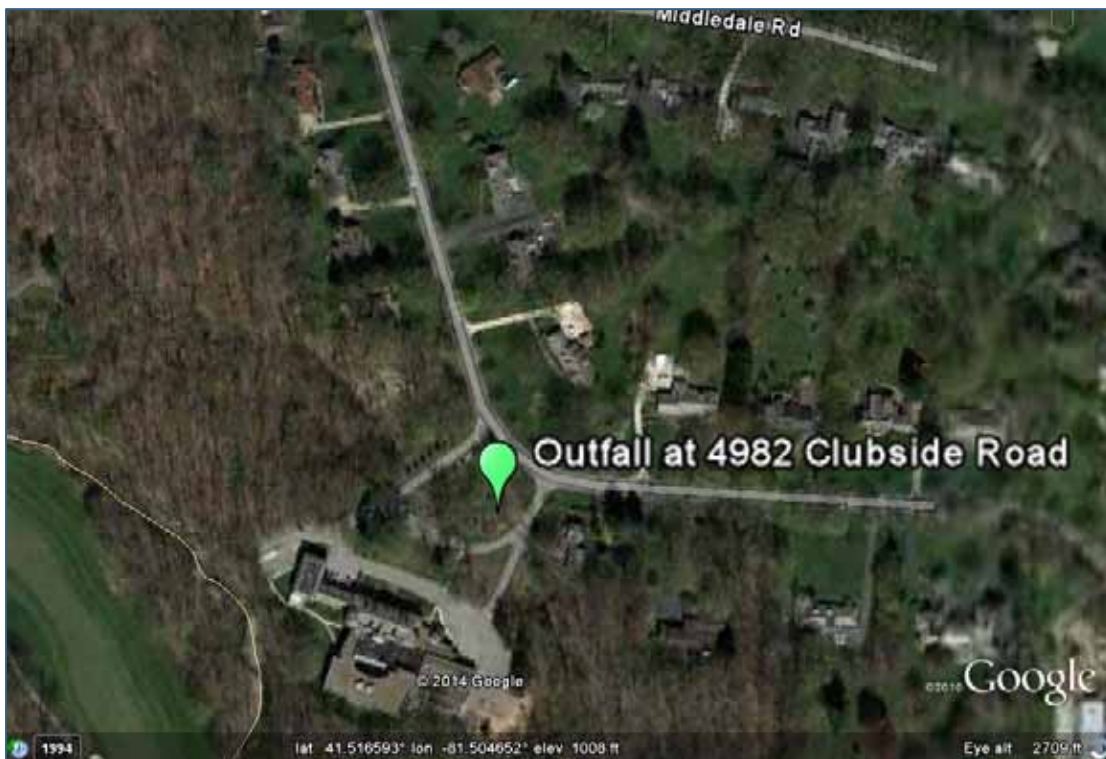
## OUTFALL AT 4982 CLUBSIDE ROAD

**Problem Summary:** During a previous investigation, it was found that the presence of an over/under sewer system in the area had resulted in intermittent discharges of sanitary sewage to the outfall. Plans for separation of the sewers are intended to remediate this problem.

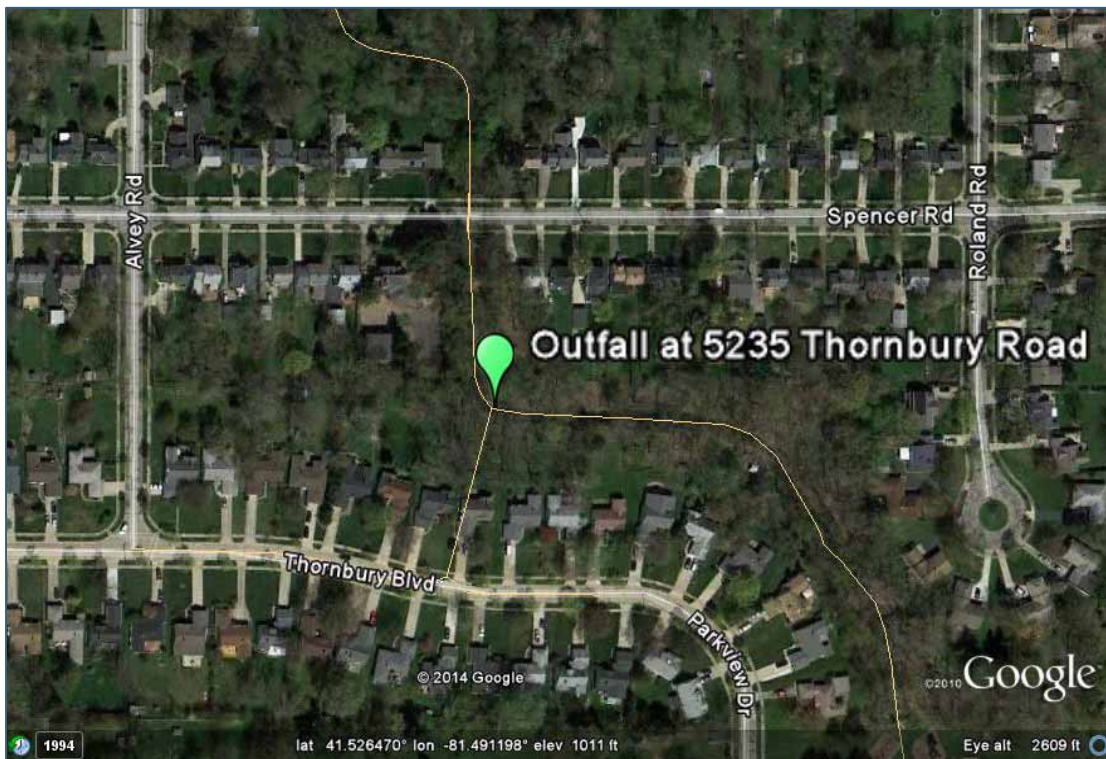
## OUTFALL AT 5235 THORNBURY ROAD

**Problem Summary:** During a previous investigation, dry weather flow with elevated *E. coli* densities was traced to between 5138 and 5235 Thornbury Road. Improper connections between homes and the storm sewer may be present. Dye testing should be conducted to determine all sources of sanitary sewage to the storm sewer in that area.

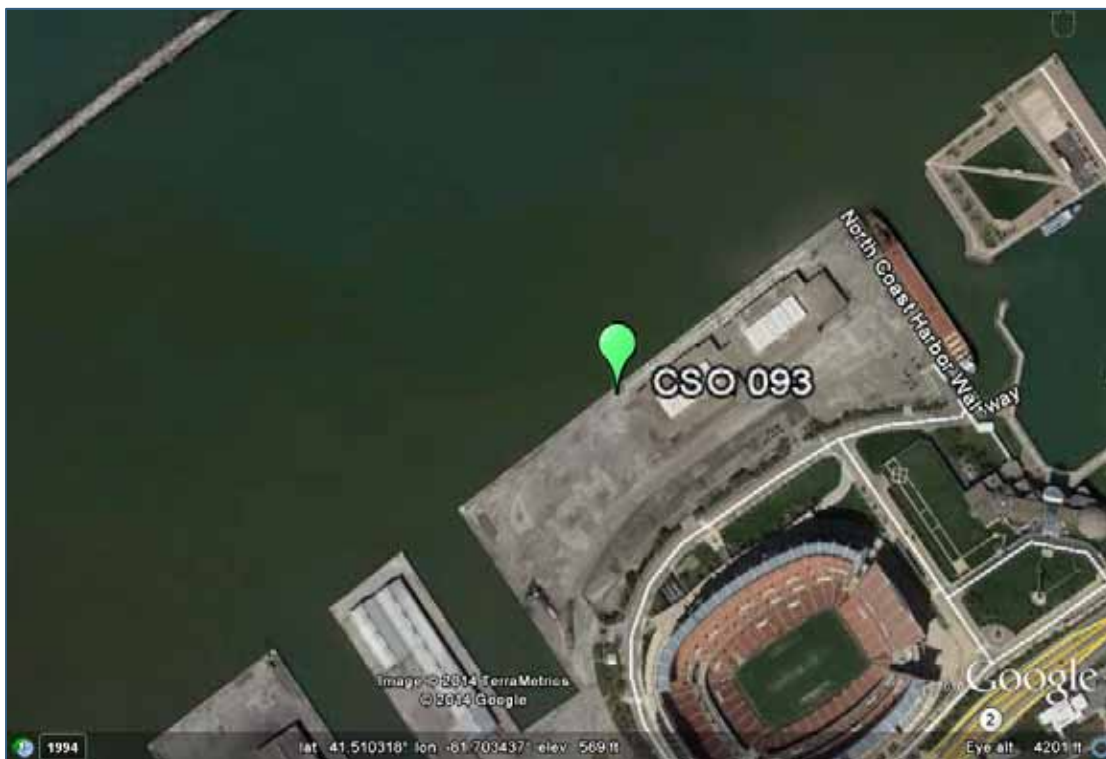
**Problem Summary:** Buildings at 1150 West 3<sup>rd</sup> Street and 310 Lakeside Avenue are improperly connected to the CSO 093 stormwater outlet.

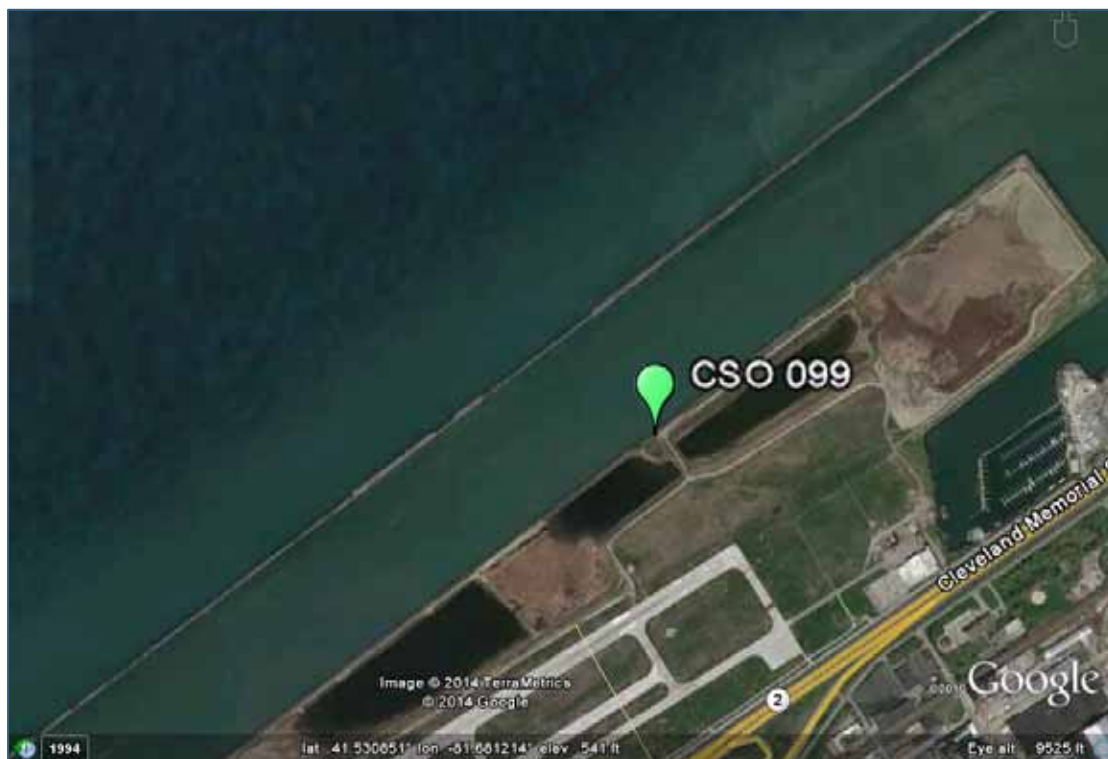
## CSO 099

**Problem Summary:** An improper connection exists between Par-One Golf Specialties located at 3807 King Avenue and the CSO 099 stormwater outlet.

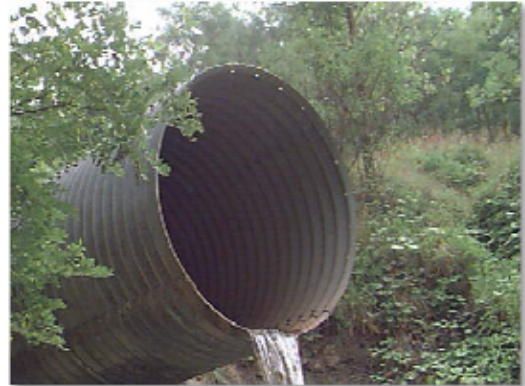
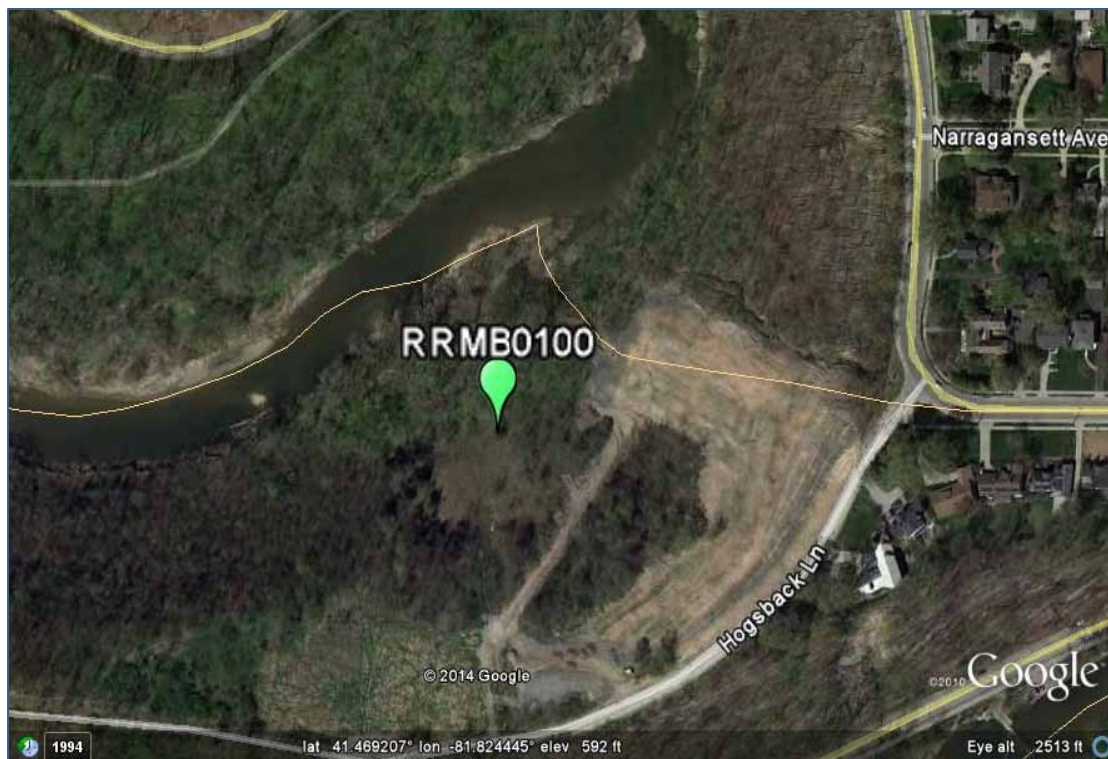
*E. coli* Density: 6,822 MPN/100mL

**Problem Summary:** Dry weather flow with elevated *E. coli* densities was traced to Montrose Avenue and upstream locations. Improper connections between homes and the storm sewer may be present. Dye testing should be conducted to determine all sources of sanitary sewage to the storm sewer in that area.

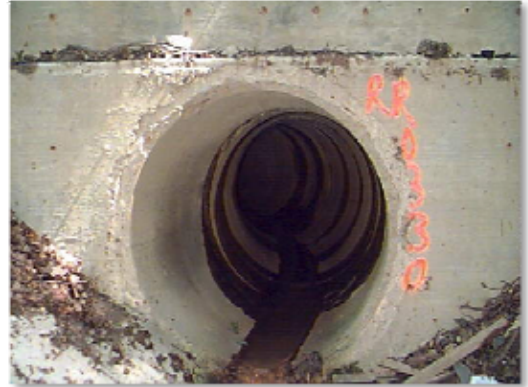
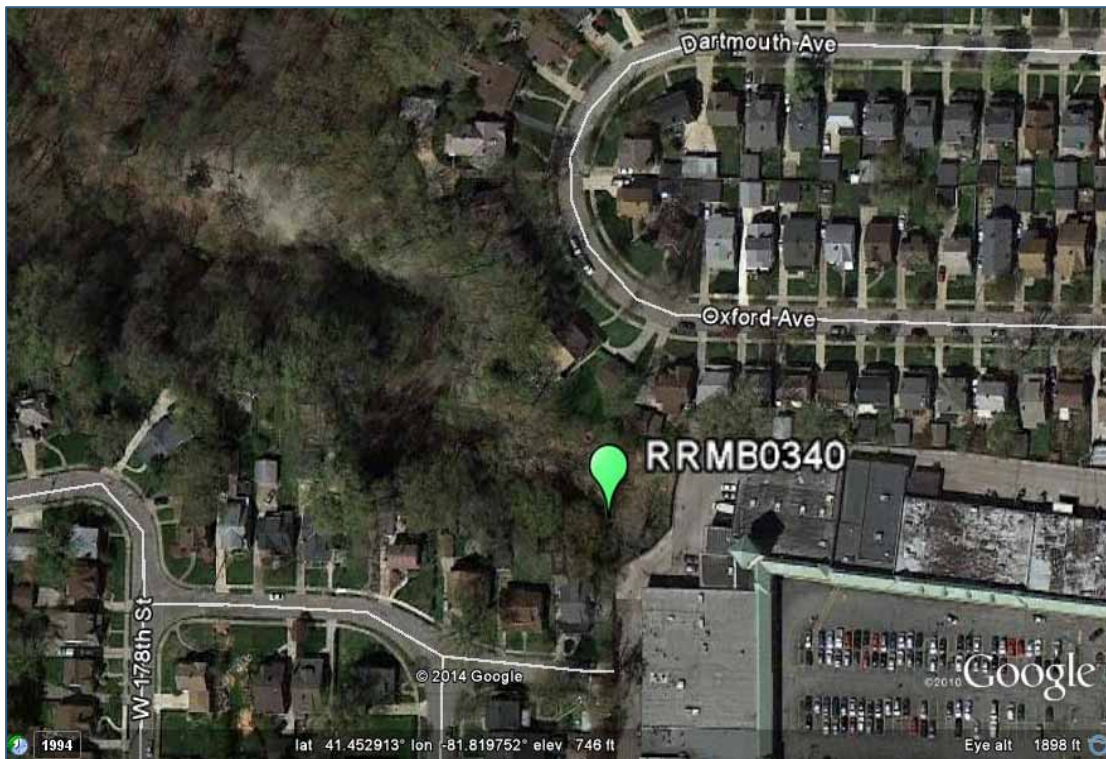
## RRMB0340

*E. coli* Density: 44,000 MPN/100mL

**Problem Summary:** During a previous investigation, an improper connection between the Abbeyshire Apartments located at 4037 and the storm sewer was found. This improper connection still needs to be remediated.

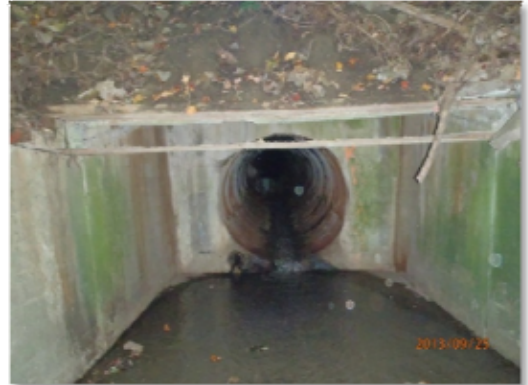
## RRMB0630

*E. coli* Density: 190,000 CFU/100mL

**Problem Summary:** A collapsed sanitary was discovered on Rocky River Drive near Sedalia Avenue and fixed. Dry weather flow with elevated *E. coli* densities was also traced to Valleyview Avenue and upstream locations and from 4370 Rocky River Drive to the intersection of Rocky River Drive and Elsienna Avenue. Improper connections between homes and the storm sewer may be present. Dye testing should be conducted to determine all sources of sanitary sewage to the storm sewer in this area.

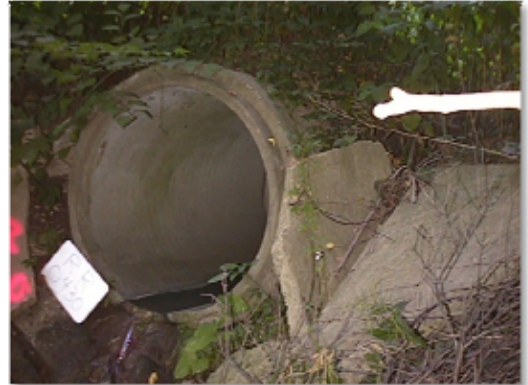
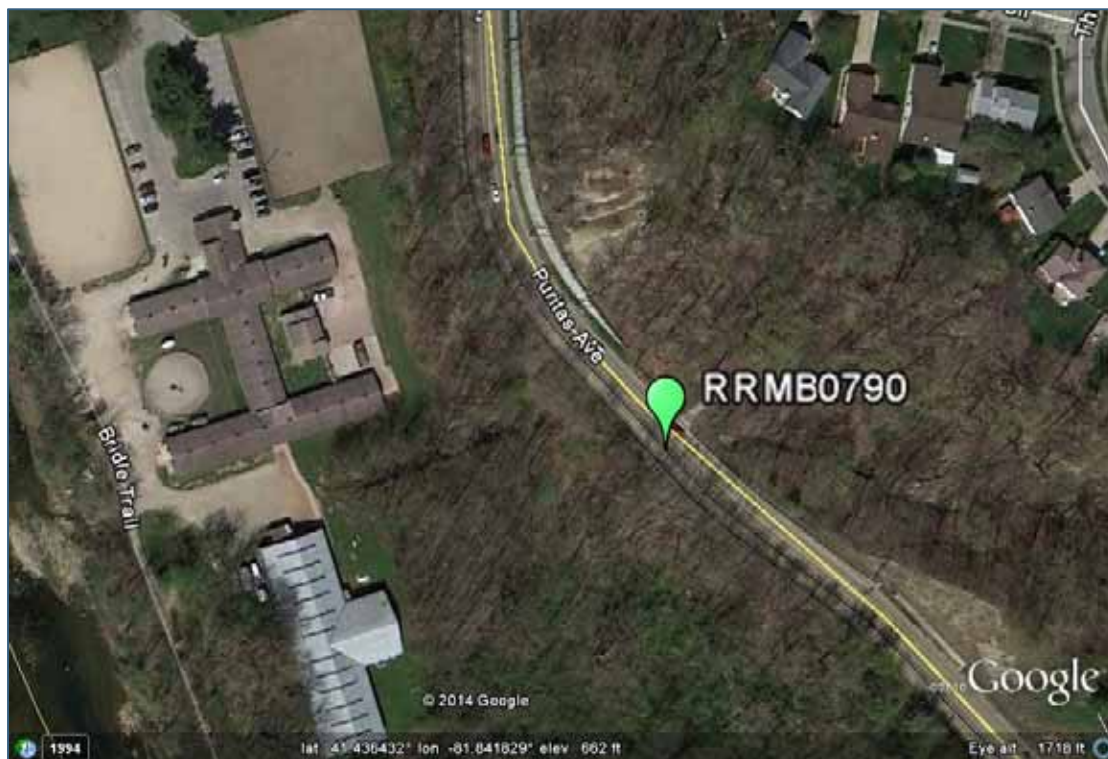
**Problem Summary:** The Clara Westropp School, located at 19101 Puritas Road, was found to be improperly connected to the storm sewer. The City of Cleveland Division of Water Pollution control was notified and the school was connected to the sanitary sewer.

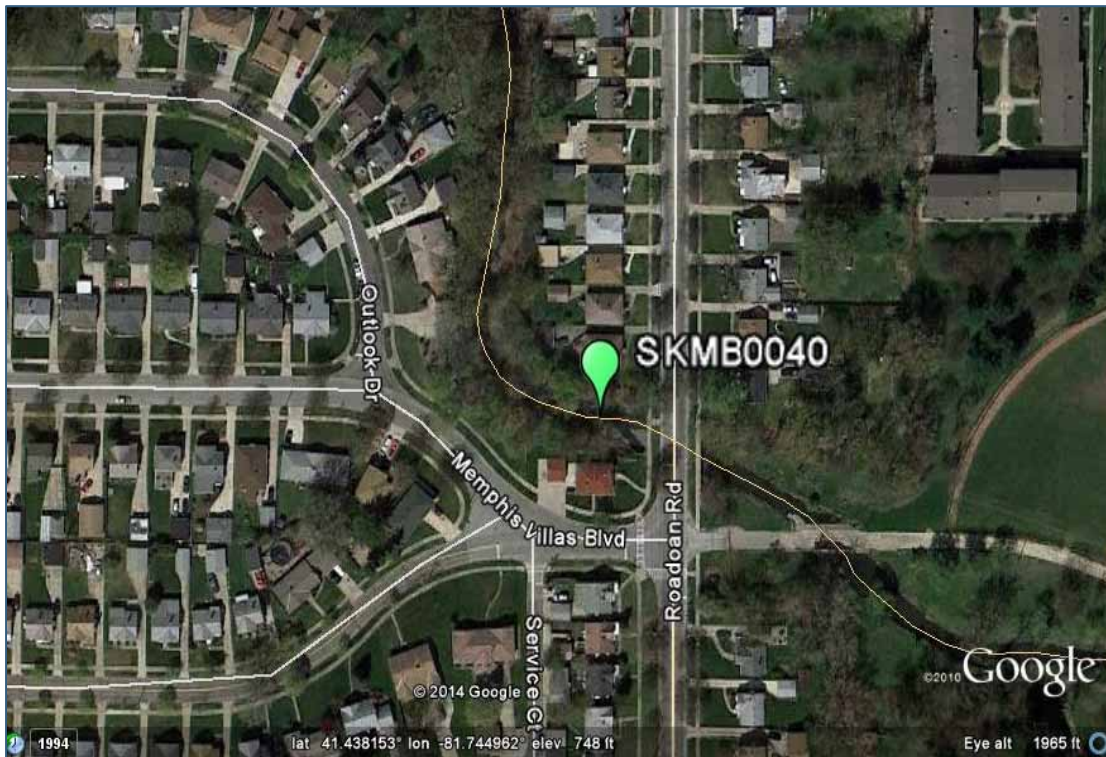
**Problem Summary:** Dry weather flow was traced to Outlook Drive, Memphis Villas Boulevard, Rodoan Road, Forest Edge Drive, and Northlane Drive. Improper connections between homes and the storm sewer may be present. Dye testing should be conducted to determine all sources of sanitary sewage to the storm sewer.

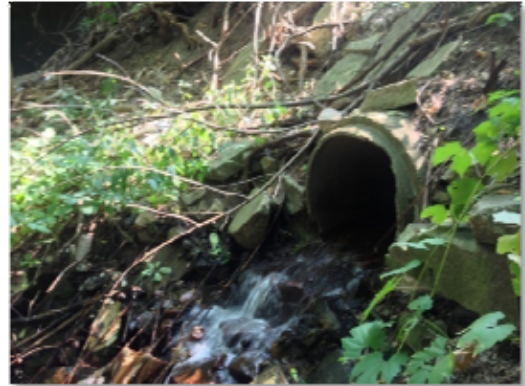
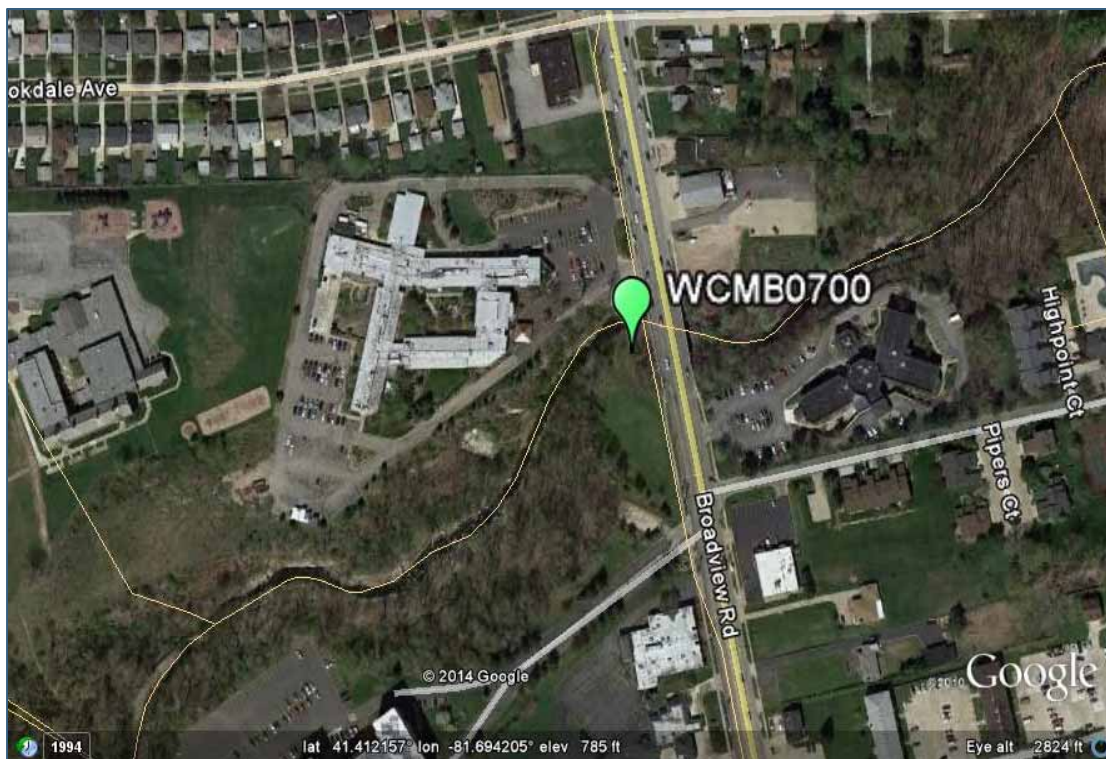
*E. coli* Density: 9 CFU/100mL

**Problem Summary:** A sanitary sewer blockage was found at the intersection of Broadview Road and Broadrock Court. The City of Parma was notified and the blockage was cleared. Repairs to the storm sewer are needed to prevent future discharges to the outfall.

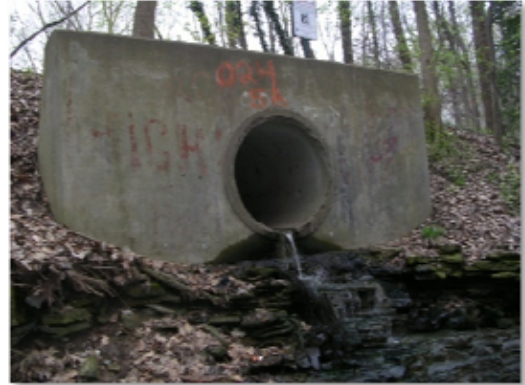
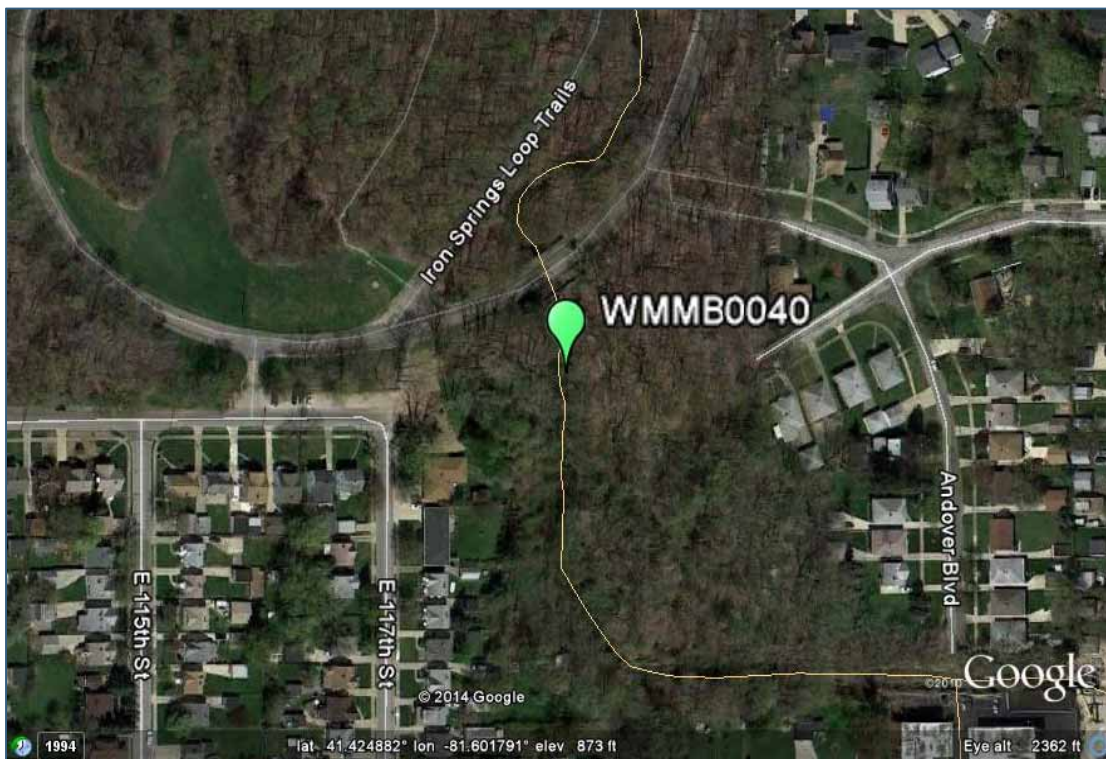
*E. coli* Density: 7,719 CFU/100mL

**Problem Summary:** A previous investigation at the outfall in 2007 resulted in the discovery of numerous improper connections between homes in the area and the CSO 245 stormwater outlet. As a result of the Phase 3 Mill Creek Tunnel project, all flows due to these improper connections are now diverted to the Mill Creek Tunnel. The small amount of flow present is a result of leakages through stop logs installed upstream of the CSO.

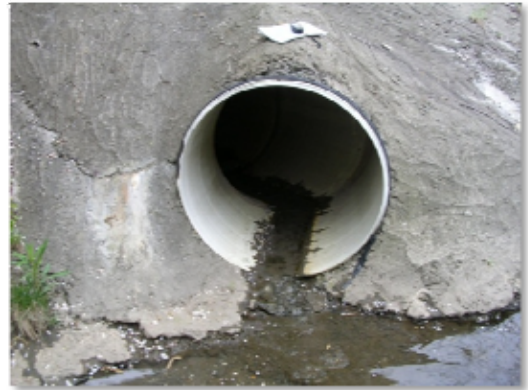
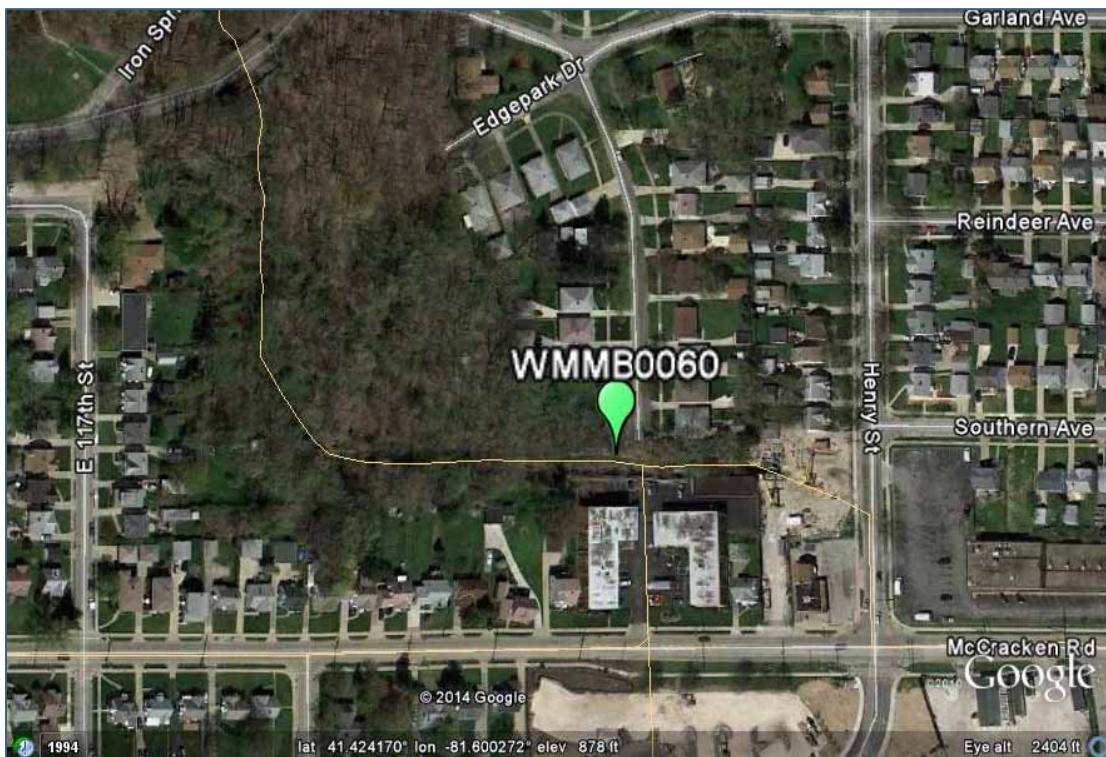
## WMMB0060

*E. coli* Density: 119,100 CFU/100mL

**Problem Summary:** During a previous investigation in 2010, dry weather flow with elevated *E. coli* densities was traced to between 4931 Henry Street and the intersection of Henry Street and Crest Avenue. Improper connections between homes and the storm sewer may be present. Dye testing should be conducted to determine all sources of sanitary sewage to the storm sewer in the area.

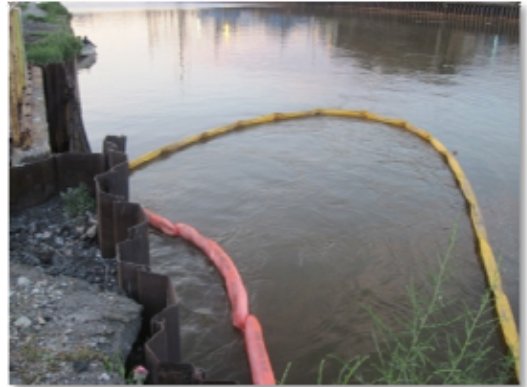
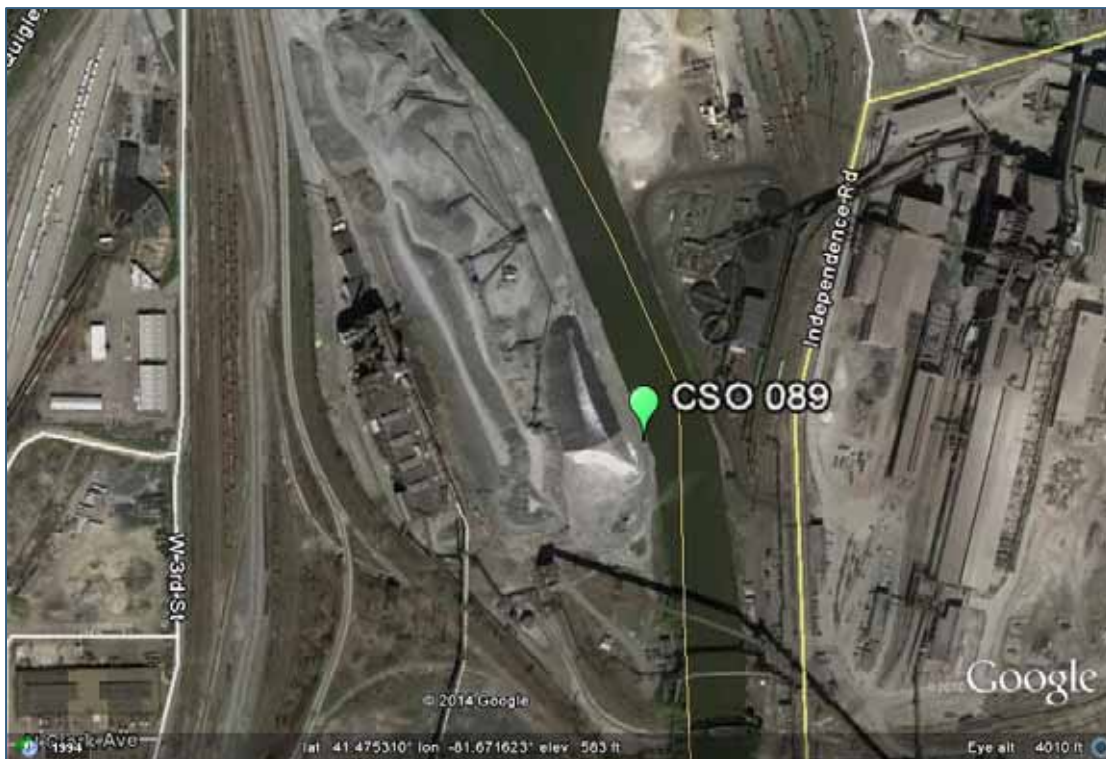
## CSO 089 (TURBINE OIL)

**Problem Summary:** On July 14, 2013, the United States Coast Guard requested NEORS D assist them in determining the source of an oil discharge to the Cuyahoga River. It was found that the oil was coming from CSO-089, located on the ArcelorMittal property. After discovery of the discharge, absorbent booms were installed in front of the CSO to capture any remaining discharge. According to ArcelorMittal employees, a leaking heat exchanger on a generator was the source of the light turbine oil that had been discharged.
