2014 Illicit Discharge Detection and Elimination Program Annual Report

Northeast Ohio Regional
Sewer District

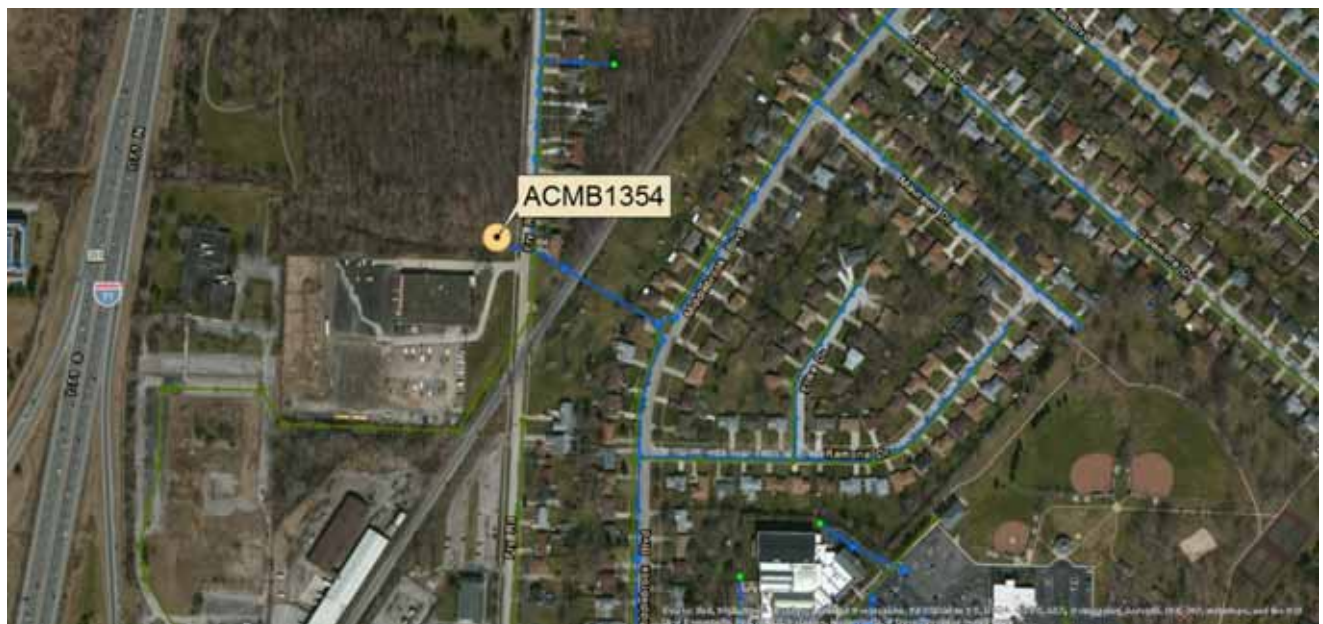
ACMB1354

Problem Summary: Dry-weather flow was traced to between 7031 and 6975 Fry Road. Improper connections between homes and storm sewer may be present. Dye testing should be conducted to determine all sources of sanitary sewage to the storm sewer.

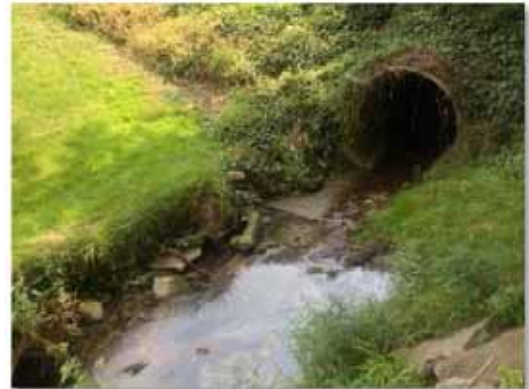
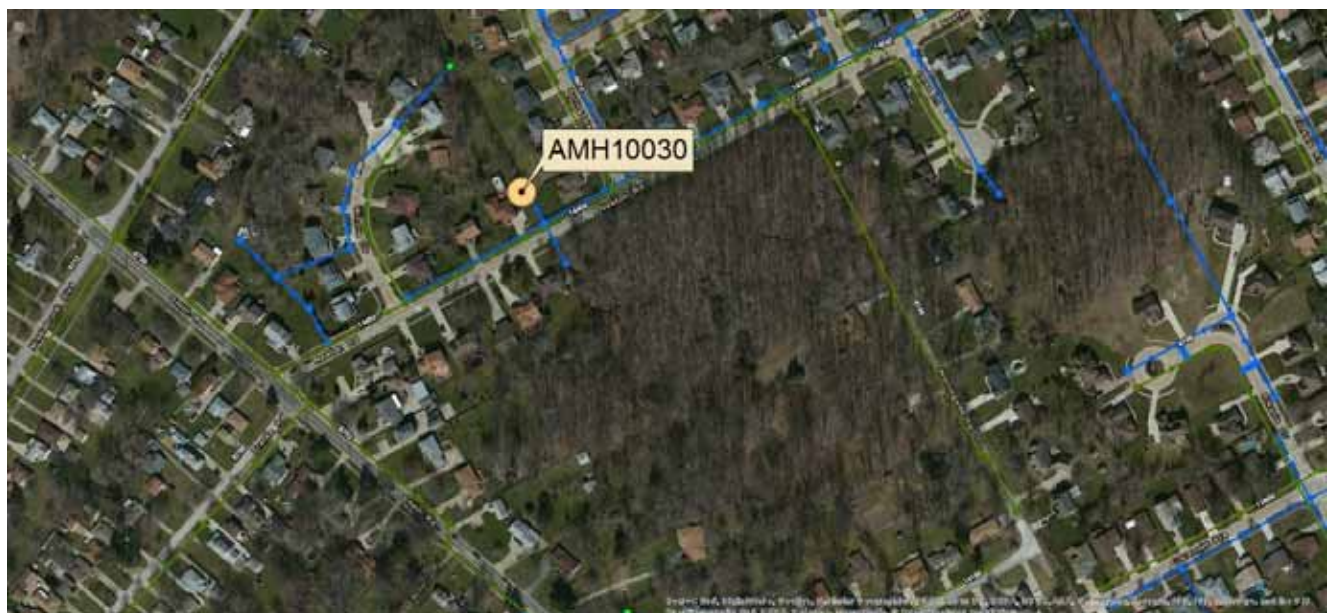
AMH10030

Problem Summary: Problem is intermittent. Dry-weather flow was traced to between 14200 Newton Road and 14400 Newton Road. Improper connection between the home at 14223 Newton Road and the storm sewer has already been documented. Other possible improper connections may also be present in area; dye testing by the City of Middleburg Heights should be conducted to determine all sources of sanitary sewage to the storm sewer.

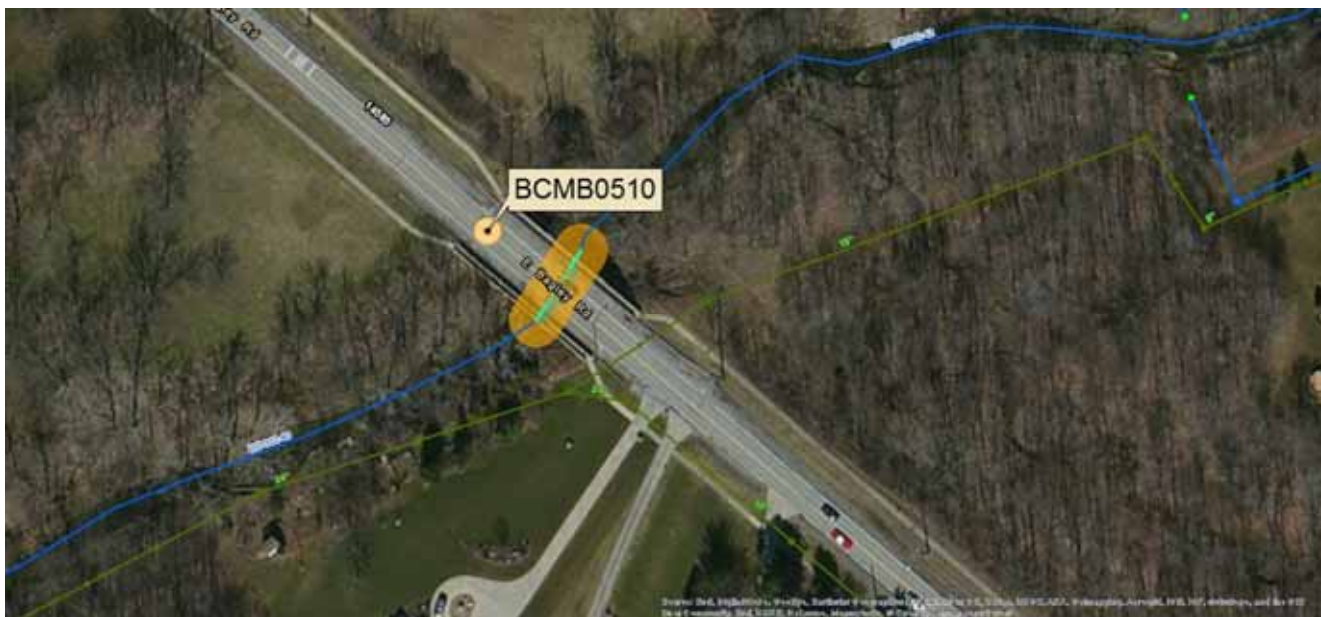
BCMB0510

Problem Summary: Water leak located upstream of outfall near 7259 Pearl Road.

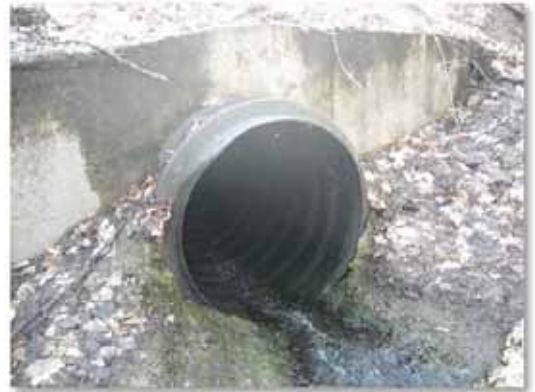
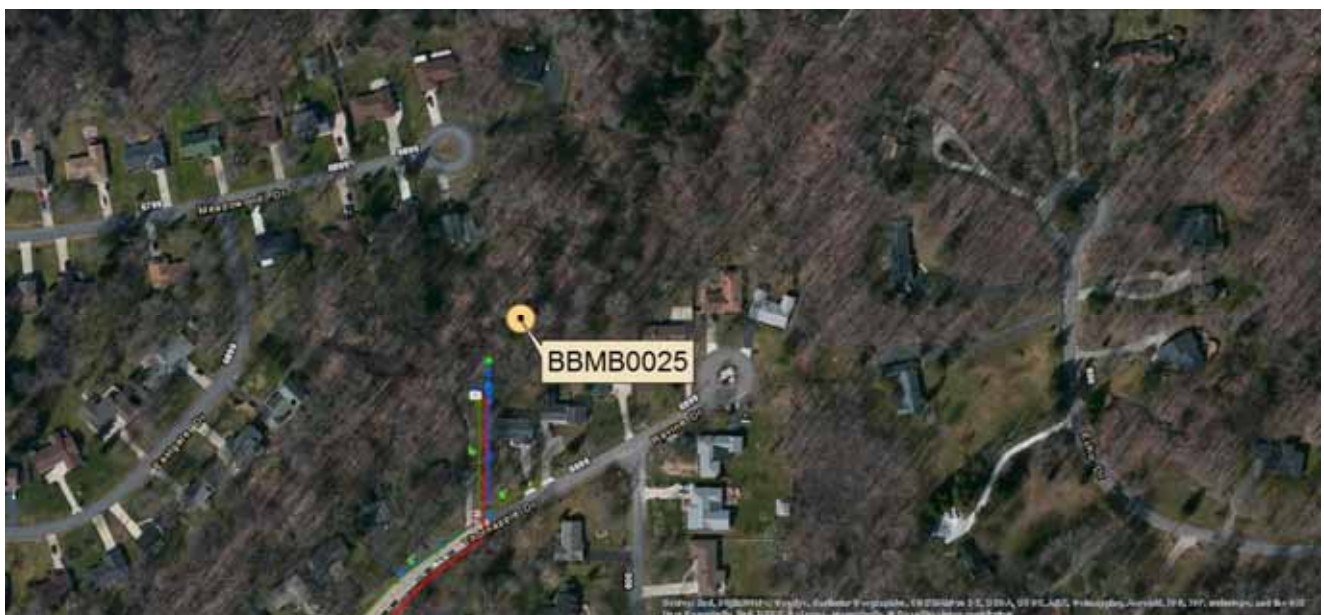
BBMB0025

Problem Summary: Some homes in area have home sewage treatment systems that may be failing. According to the Mayfield Village Service Director, these homes will be connected to the sanitary sewer within the next three to five years.

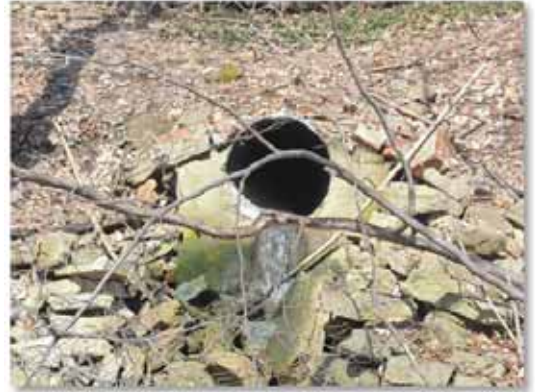
BBMB0026

Problem Summary: Some homes in area have home sewage treatment systems that may be failing. According to the Mayfield Village Service Director, these homes will be connected to the sanitary sewer in 2015.

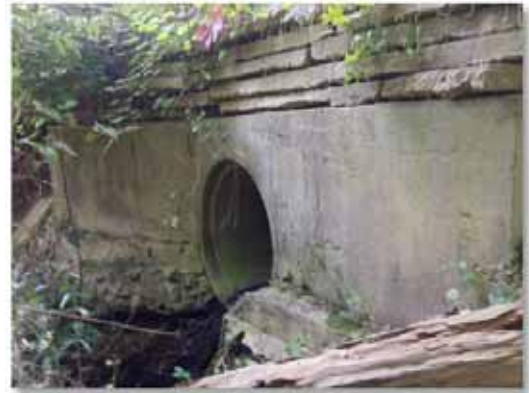
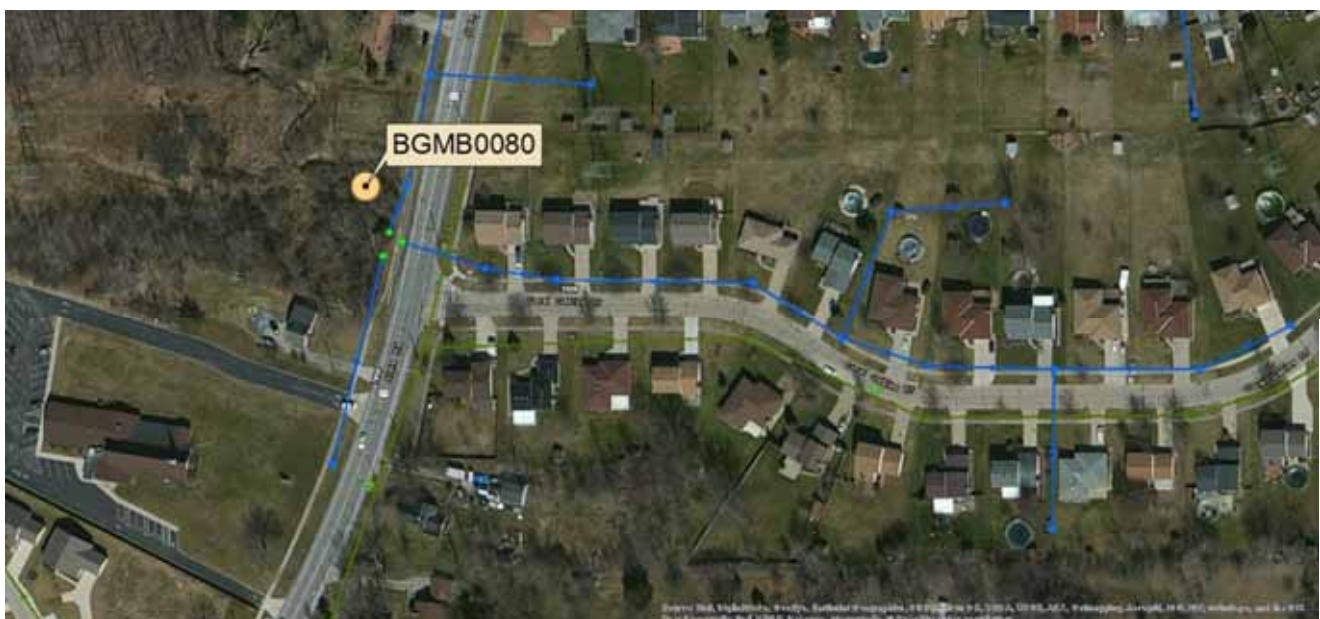
Problem Summary: Dry-weather flow with elevated *E. coli* densities was traced to between the intersection of State Road and Coral Gables Drive and 4865 Coral Gables Drive and to between the intersection of State Road and Ocala Drive and 4419 Ocala Drive. Recommend dye testing homes in these areas to determine improper connections.

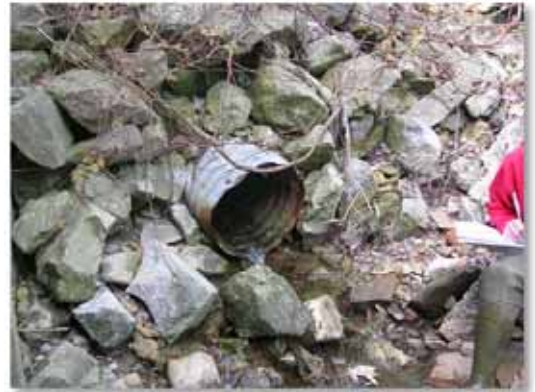
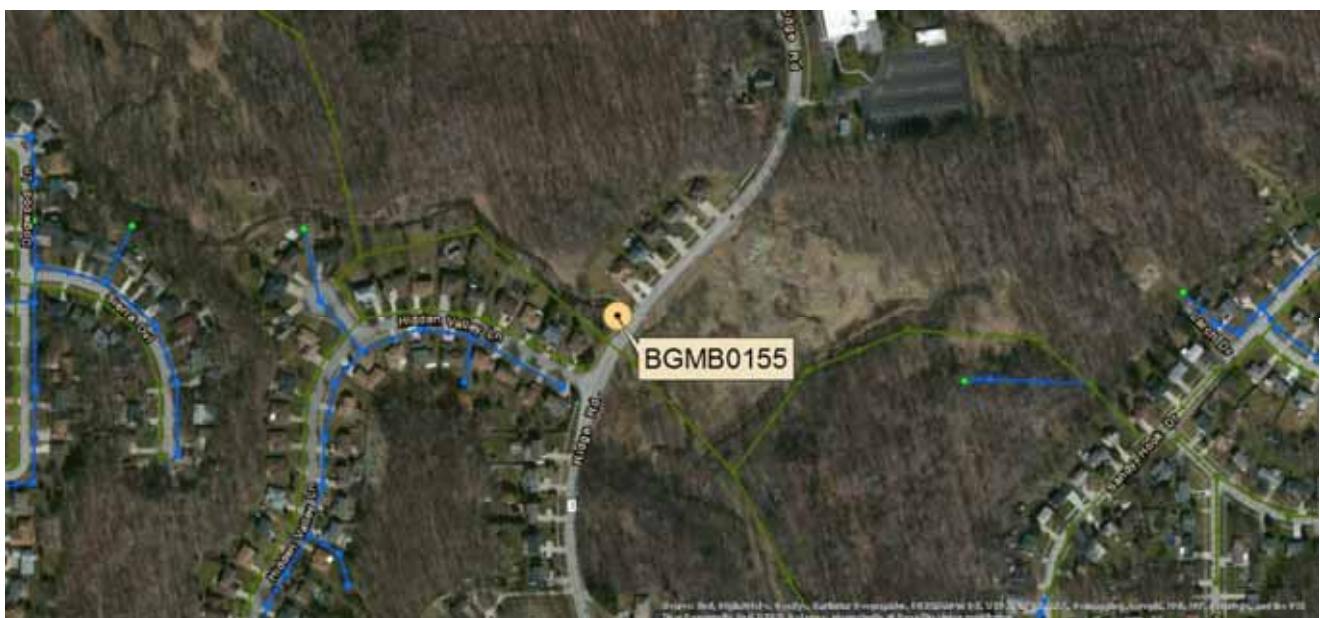
BGMB0155

Problem Summary: Dry-weather flow with elevated *E. coli* densities was traced to between 7580 and 7592 Ridge Road. Recommend dye testing homes in this area to determine improper connections.

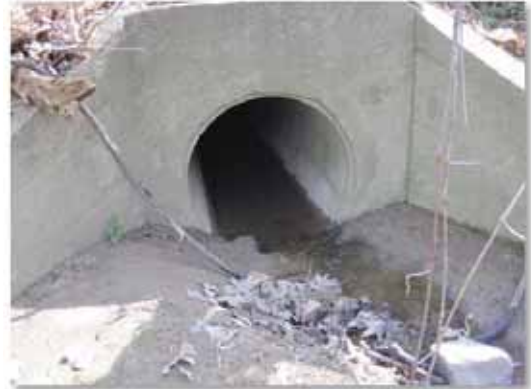
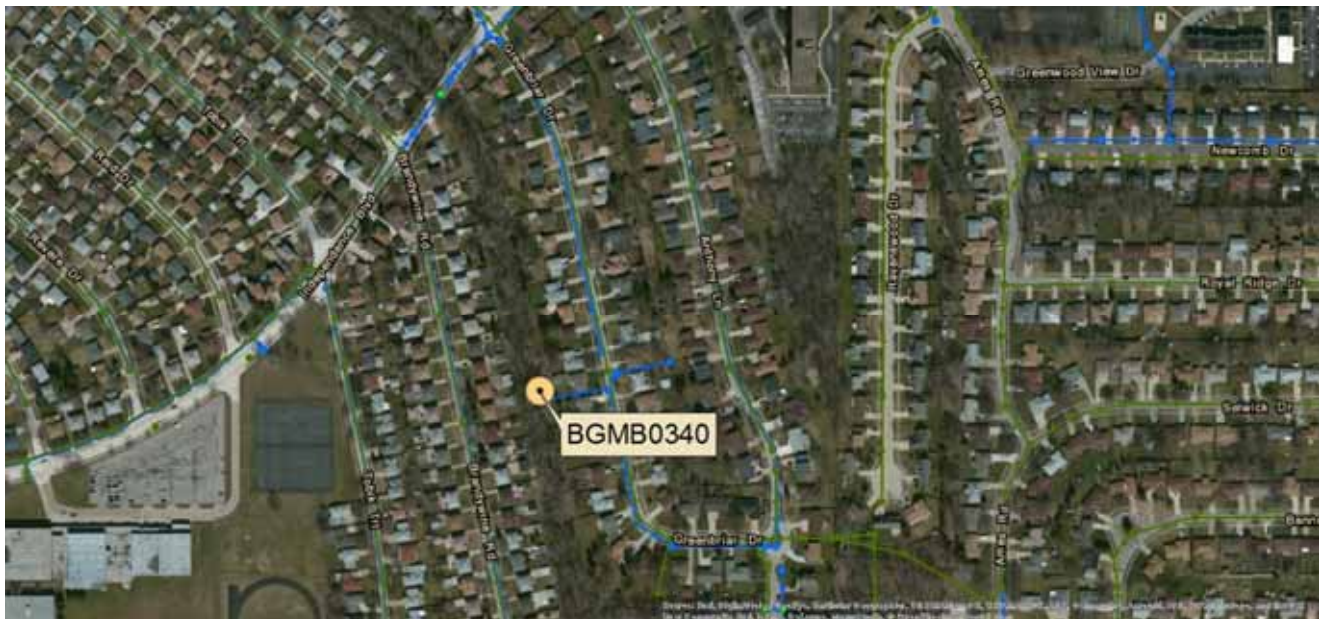
BGMB0340

Problem Summary: Dry-weather flow with elevated *E. coli* densities was traced to between 7026 and 7041 Greenbriar Drive. Recommend dye testing homes in area to determine improper connections.

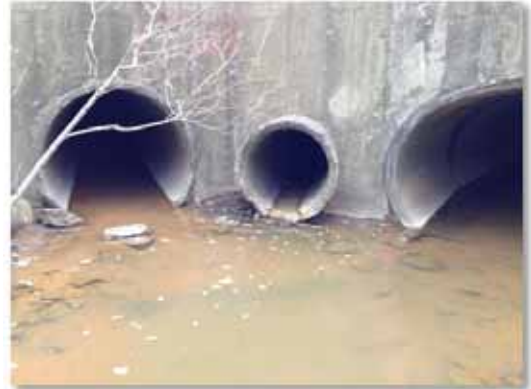
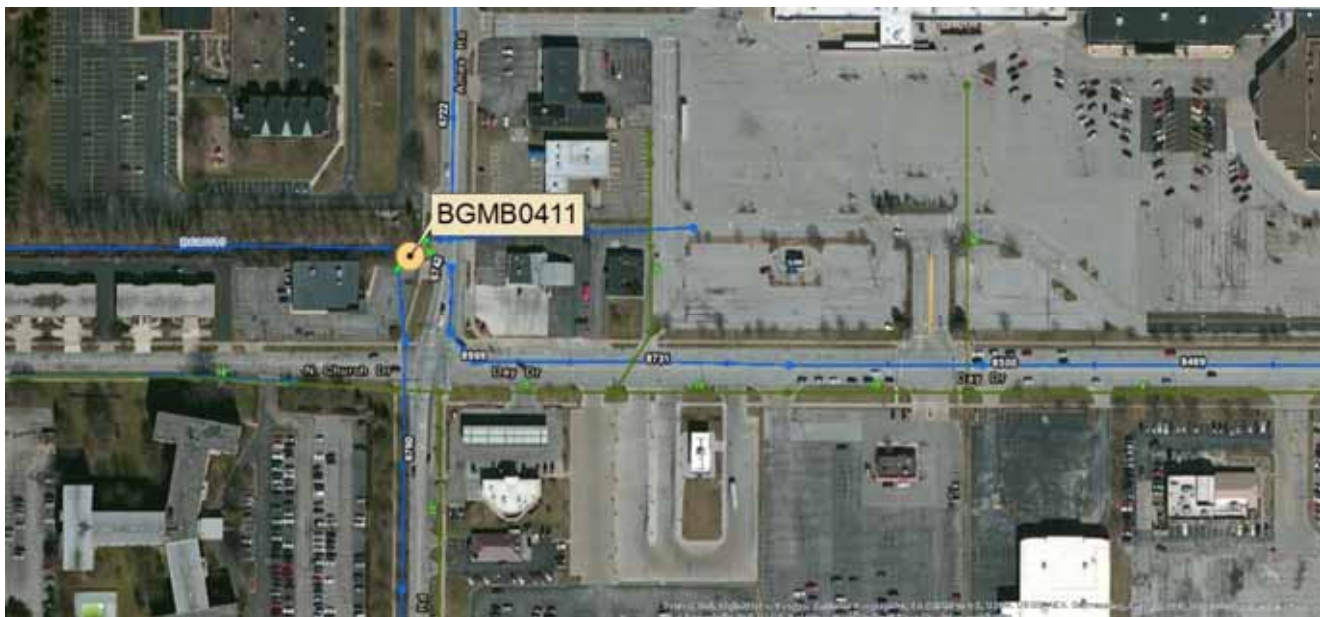
BGMB0411

Problem Summary: Flow tracing and source tracking in the system were started, but no causes for the elevated *E. coli* densities at the outfall have been found, yet.

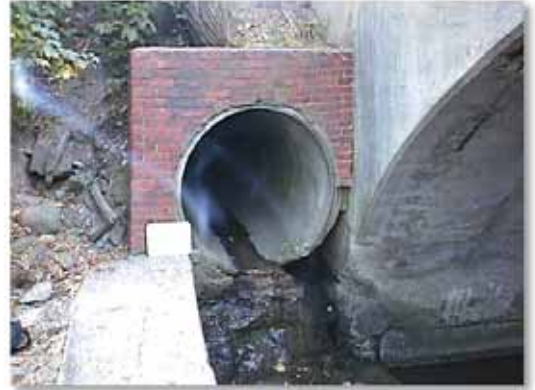
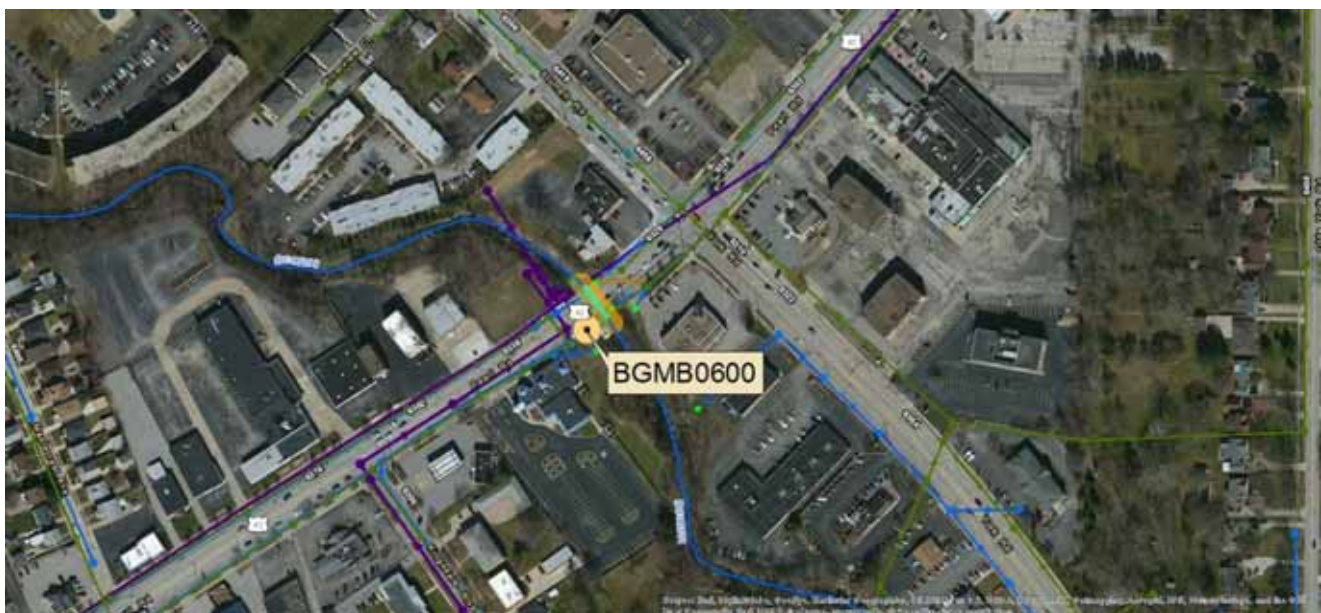
BGMB0600

Problem Summary: Dry weather flow was traced to Sherborn Drive between Glendora Lane and Appleton Drive. Recommend dye testing of homes between 11661 and 12067 Appleton Drive and on Sherborn Road between Appleton Drive and Glendora Avenue.

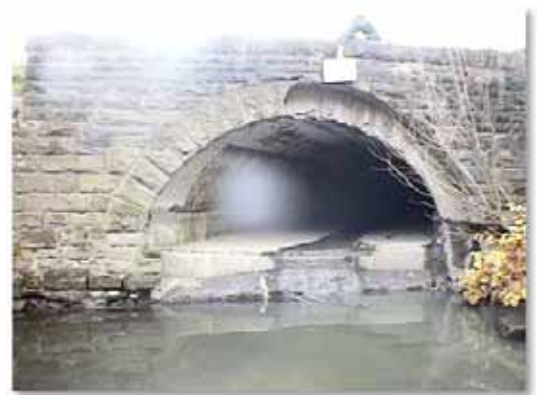
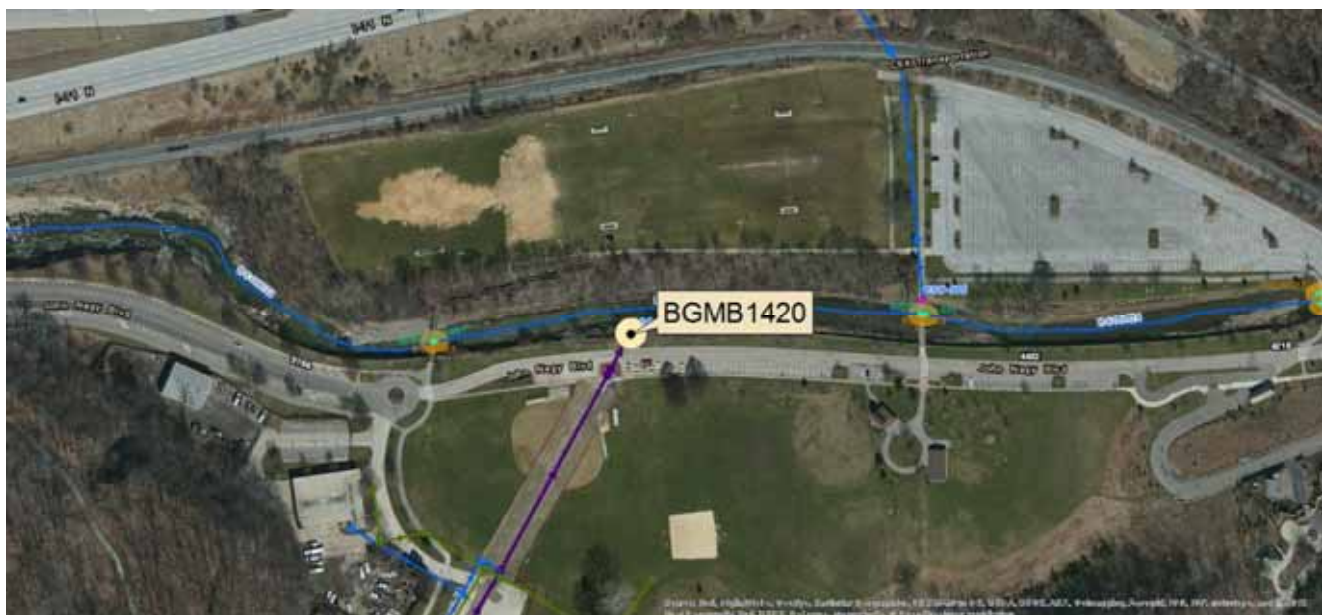
BGMB1420 (CSO 053)

Problem Summary: A sanitary sewer was found leaking into the CSO 053 stormwater outlet near 4087 West 56th Street. Repairs to the sewer were completed September 8, 2014.

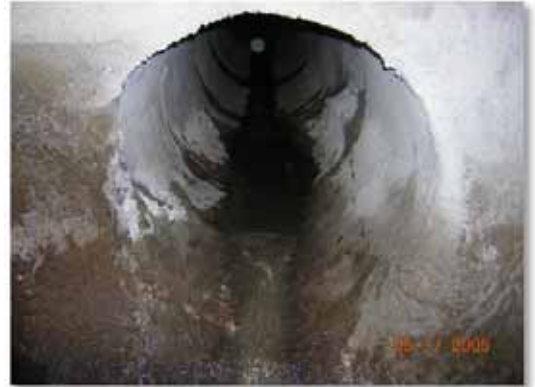
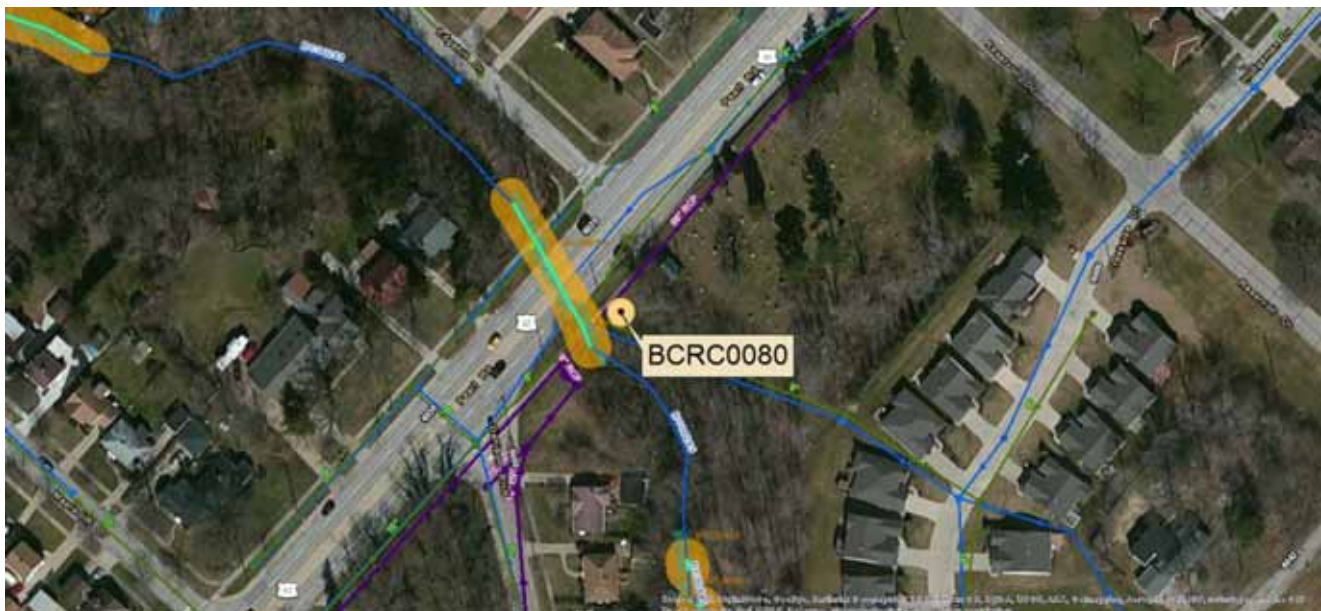
BCRC0080

Problem Summary: NEORSD was notified of an improper connection to storm sewer by a resident. Dry-weather flow with elevated *E. coli* densities was traced to Pearl Road.

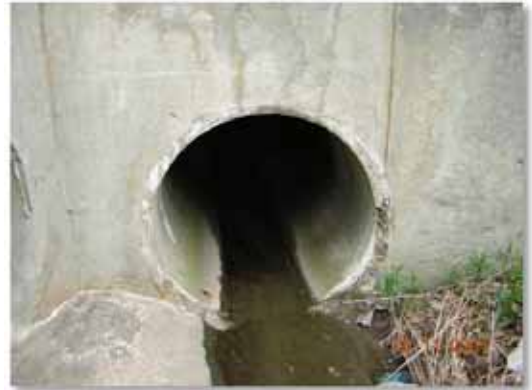
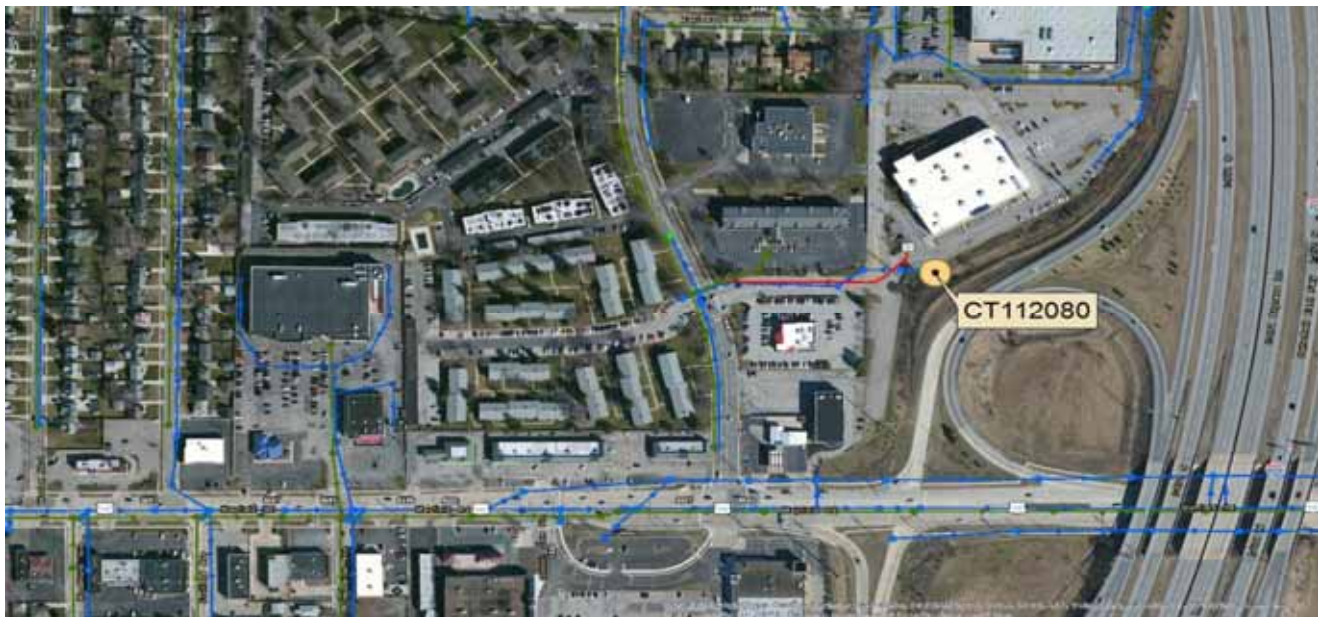
CT112080

Problem Summary: Dry-weather flow with elevated *E. coli* densities was traced to between the intersection of Golden Gate Boulevard and Maplewood Road. Recommend that the City of Mayfield Heights conduct dye testing to determine any improper connections in the area. The City of Mayfield Heights is working with Cuyahoga County Public Works Department to identify and remediate these problems.

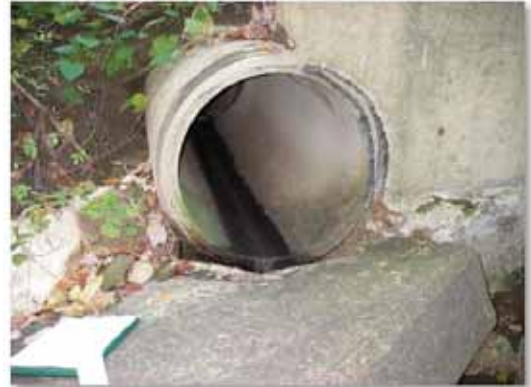
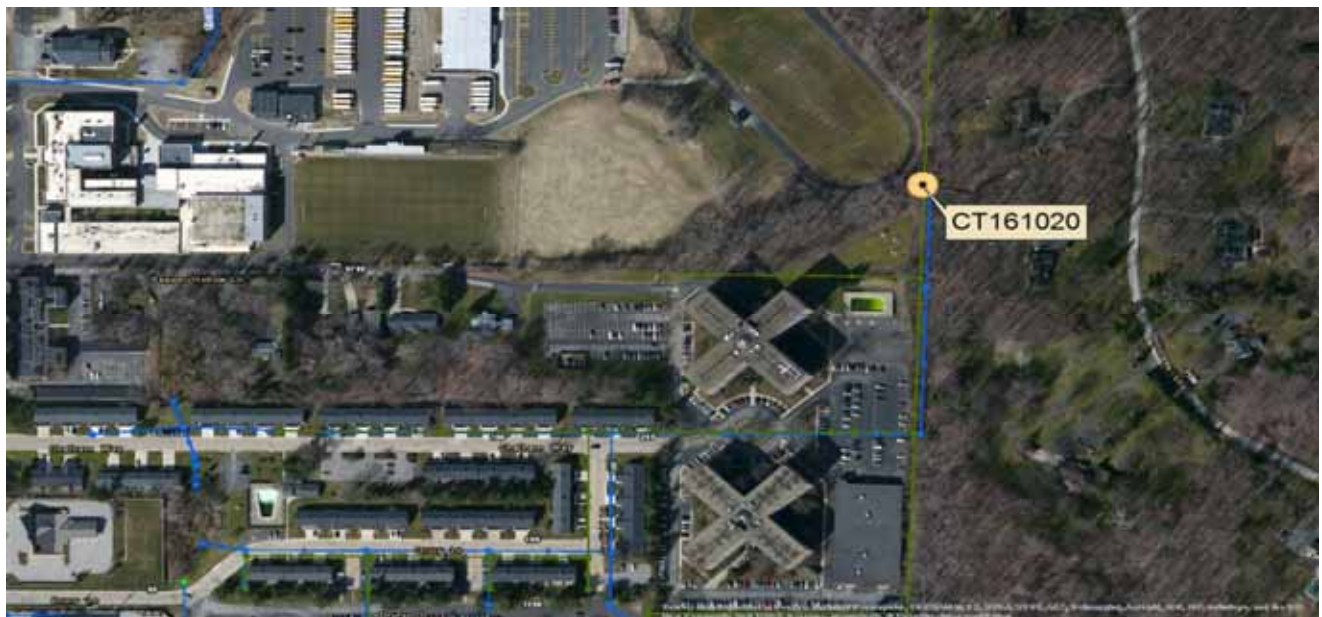
CT161020

Problem Summary: The headwall of the outfall is cracked and has fallen partially northward into the tributary. Additionally, approximately five feet upstream of the outfall opening, the storm sewer pipe has completely separated from the remainder of the pipe and flow is discharged into the ground through the crack and not through the opening of the outfall. The concrete headwall and exposed pipes are in the process of being fixed by the City of Mayfield Heights.

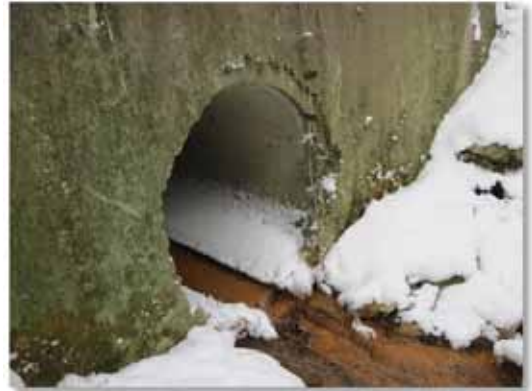
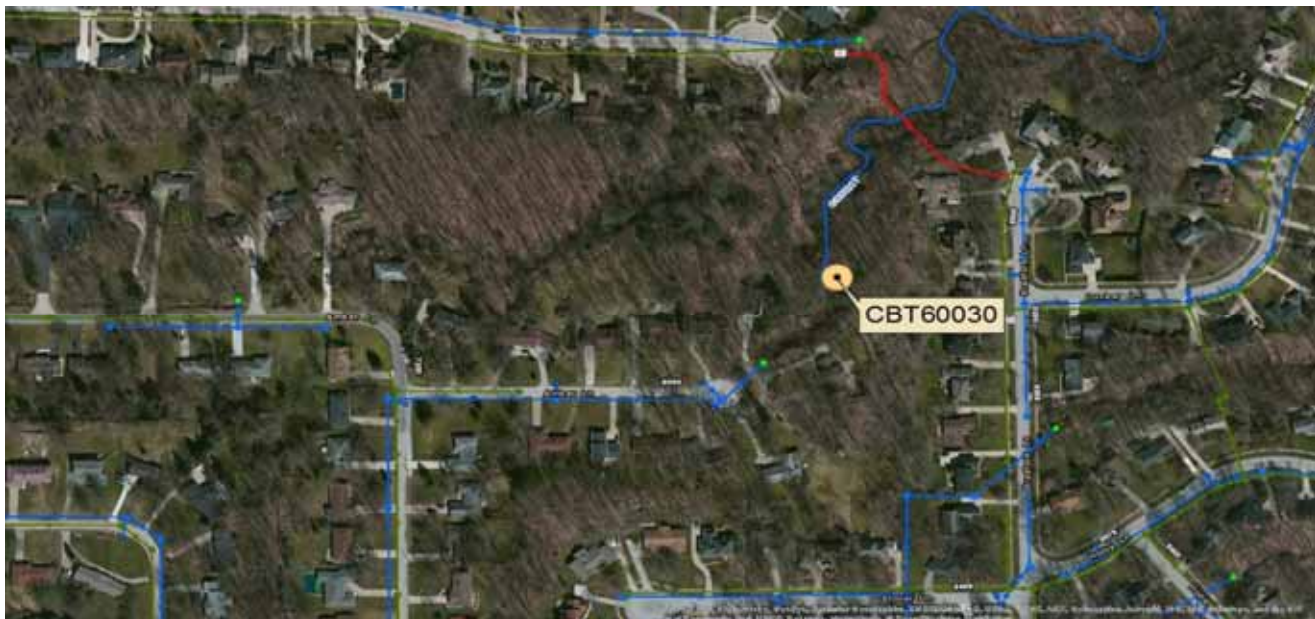
Problem Summary: Failing home sewage treatment systems are located immediately upstream of the outfall. Dry-weather flow with elevated *E. coli* densities was also found upstream of 7395 Winding Way. The City of Brecksville is working to identify and remediate any improper connections to the storm sewer.

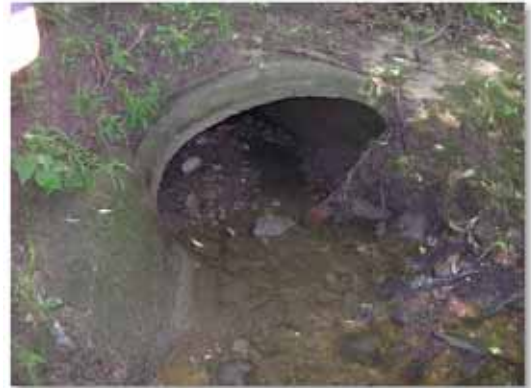
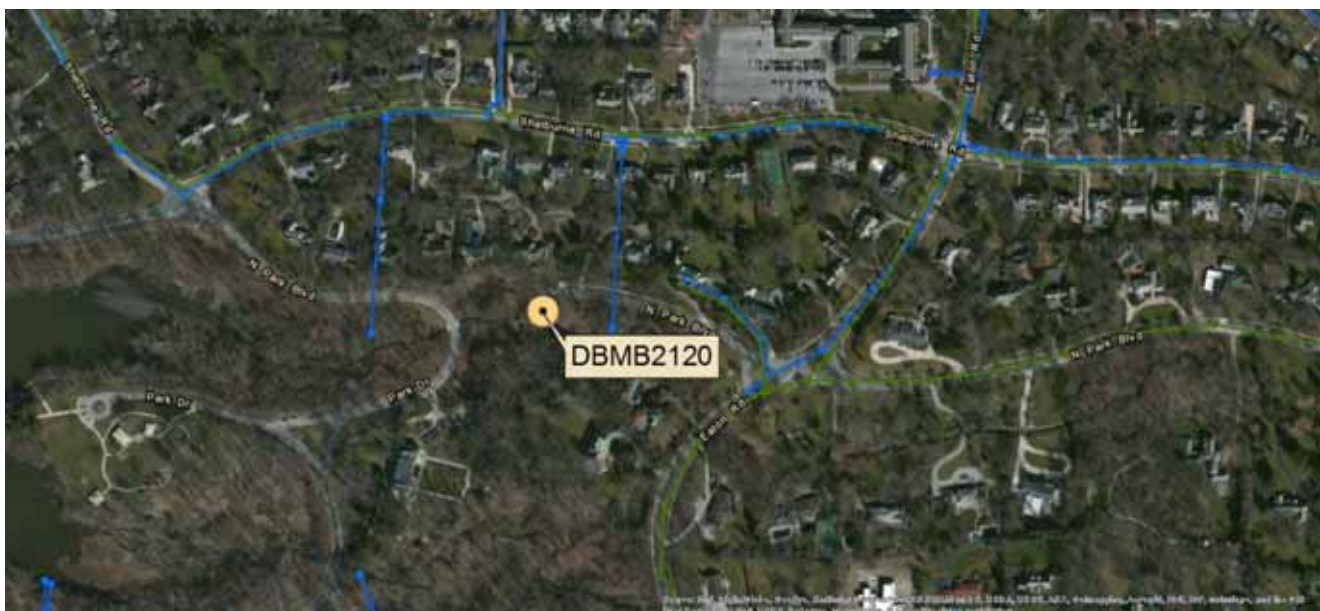
DBMB2120

Problem Summary: Dry-weather flow with elevated *E. coli* densities was traced to Shelburne Avenue. Recommend that City of Shaker Heights conduct dye testing to determine any improper connections on that street.

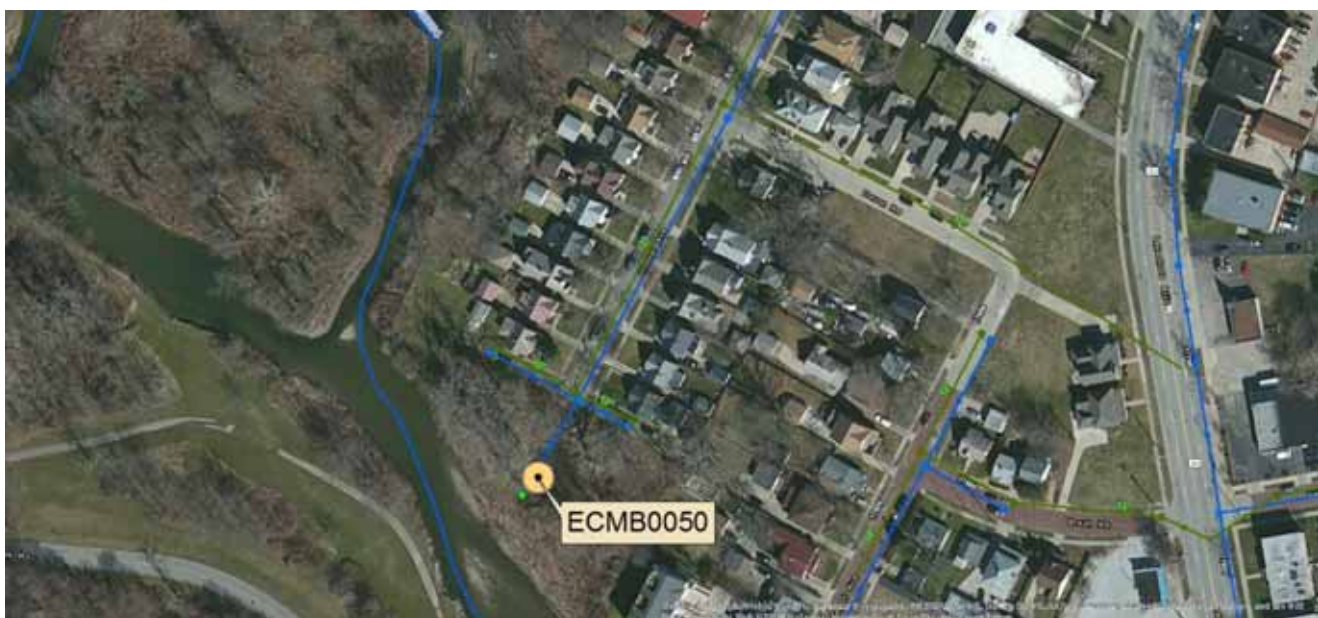
ECMB0050

Problem Summary: An improper connection was found between the basement of a home at 817 Hoover Avenue and the storm sewer. The problem was fixed on August 29, 2014.

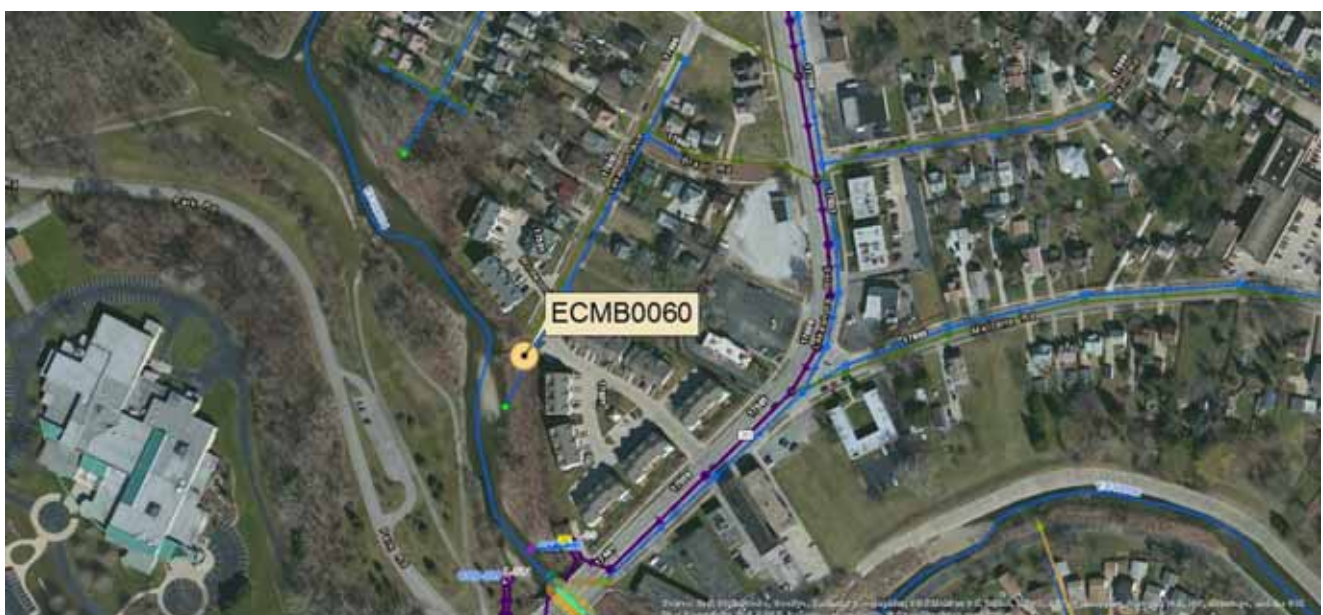
ECMB0060

Problem Summary: A sanitary sewer connection to the storm sewer near 17506 Lakeport Boulevard still needs to be remediated. Sanitary sewer flow was also found to be leaking to the storm sewer through a catch basin, which was then fixed on September 22, 2014. Dye testing still needs to be conducted at several homes on the street in order to determine any other improper connections.

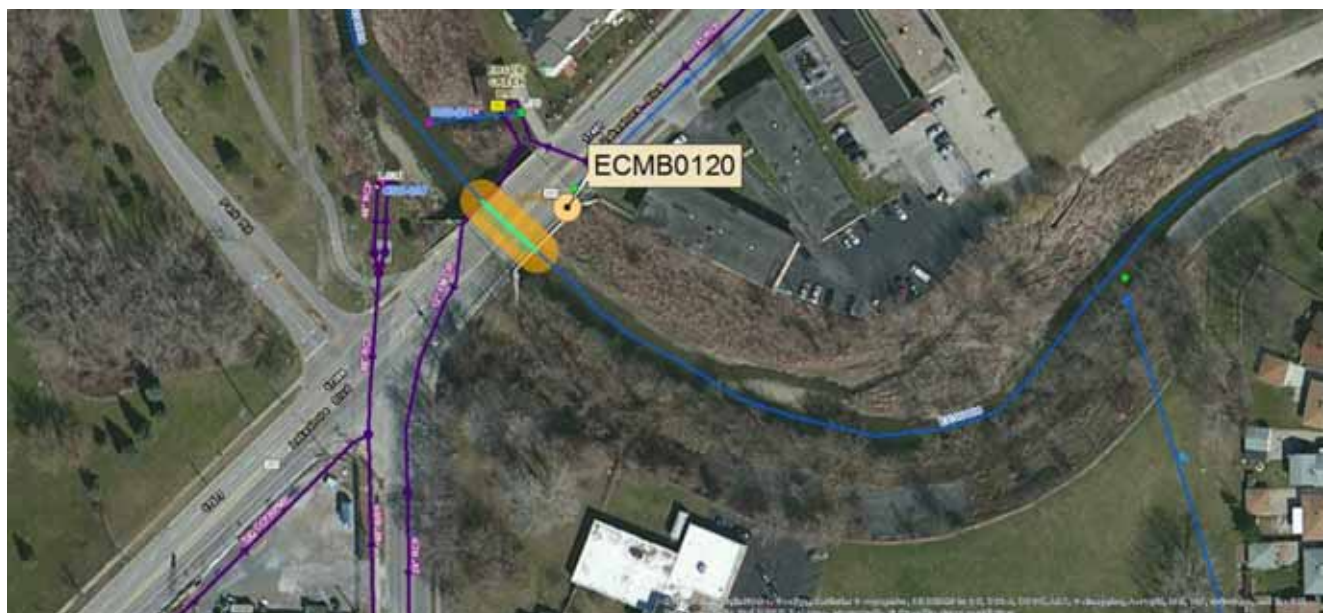
ECMB0120

Problem Summary: An improper connection between the apartment building at 17530 Lake Shore Boulevard and the storm sewer was found. The problem was remediated on October 23, 2014.

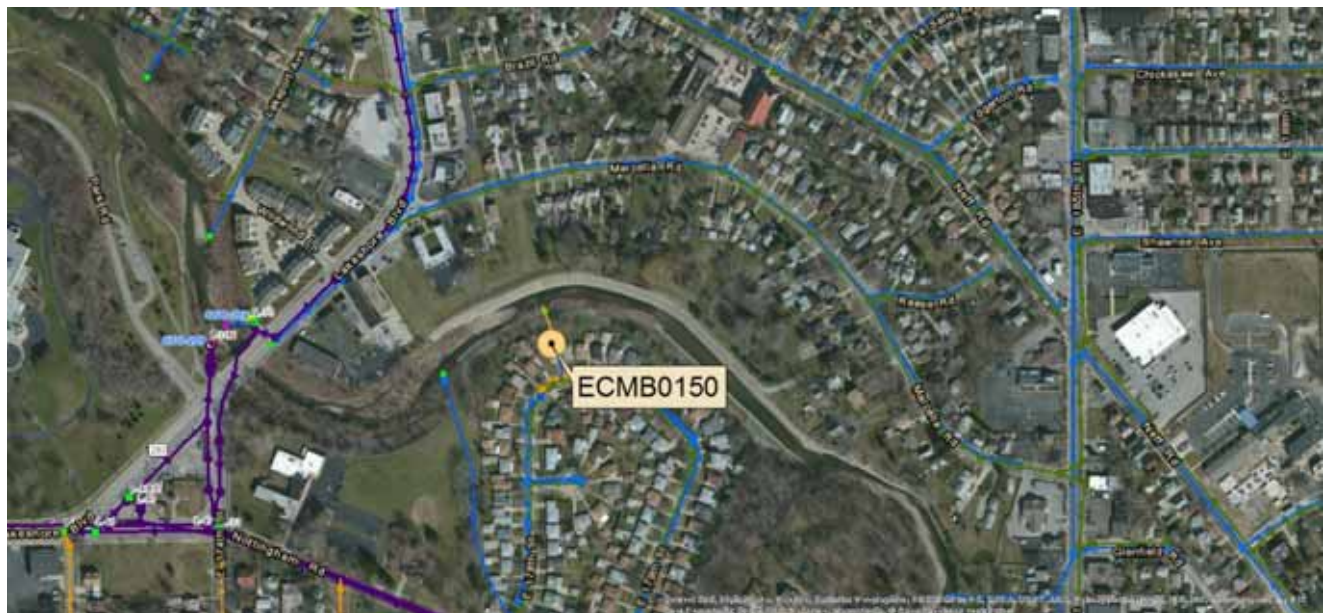
ECMB0150

Problem Summary: A sanitary sewer overflow (SSO) located at 959 E. 178th Street has not been remediated. The City of Cleveland Division of Water Pollution Control monitored the SSO in 2014 to determine the frequency of activation; no events were found.

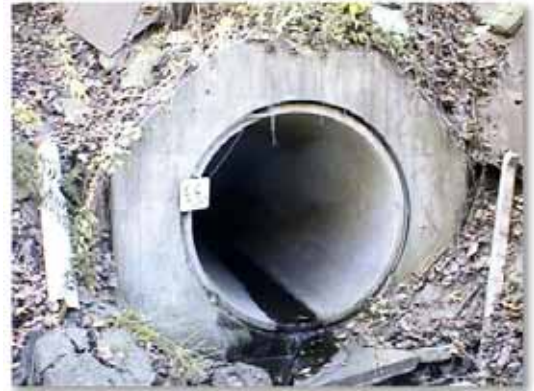
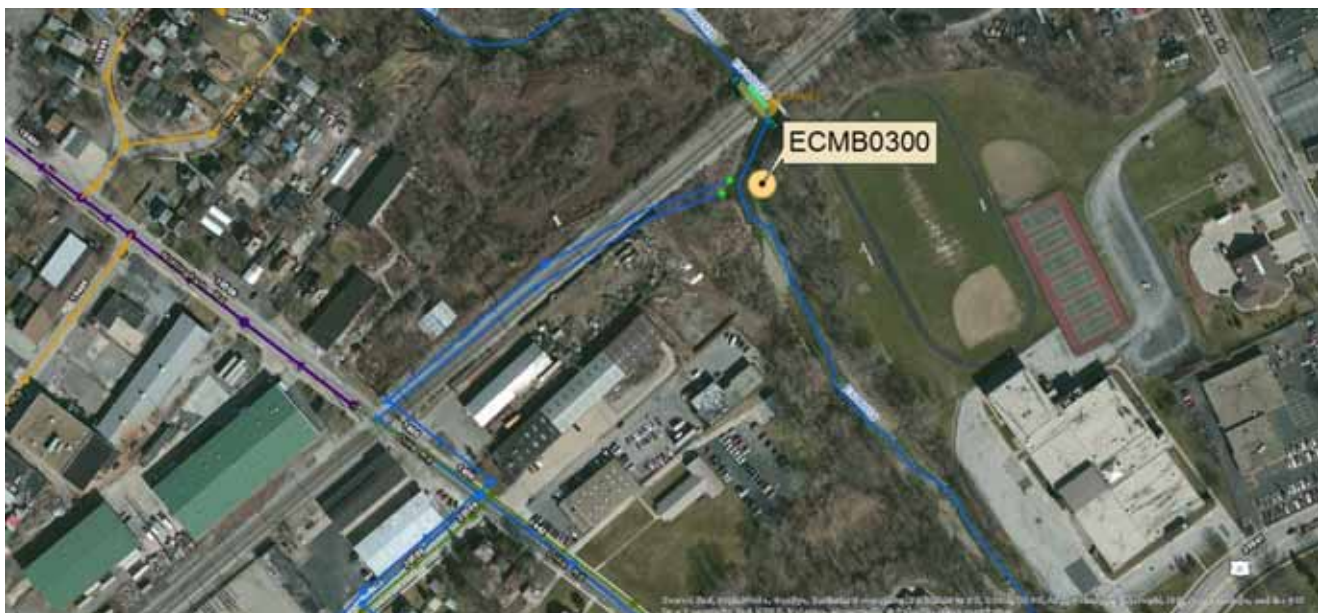
ECMB0300

Problem Summary: Improper connections were found between two of the buildings at Indian Hills Apartments and the storm sewer; these problems were remediated. Additional improper connections from one of the buildings were found on October 15, 2014.

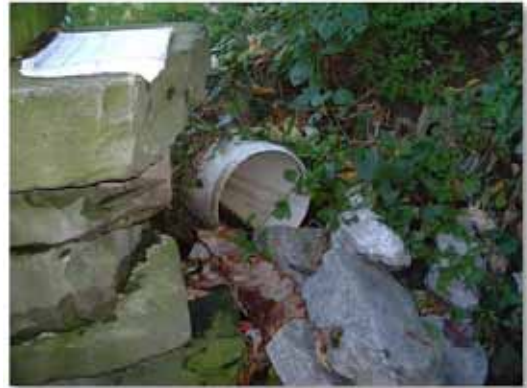
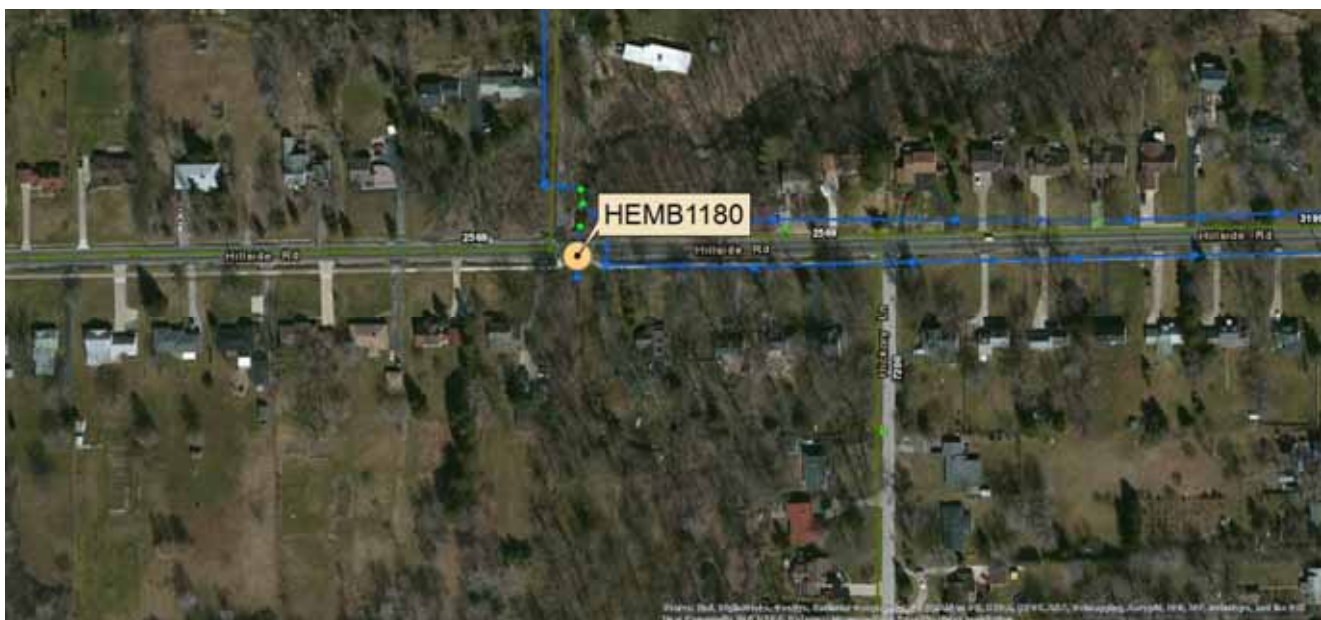
HEMB1180

Problem Summary: A home sewage treatment system is located upstream of property. Elevated *E. coli* densities could be due to a failing system.

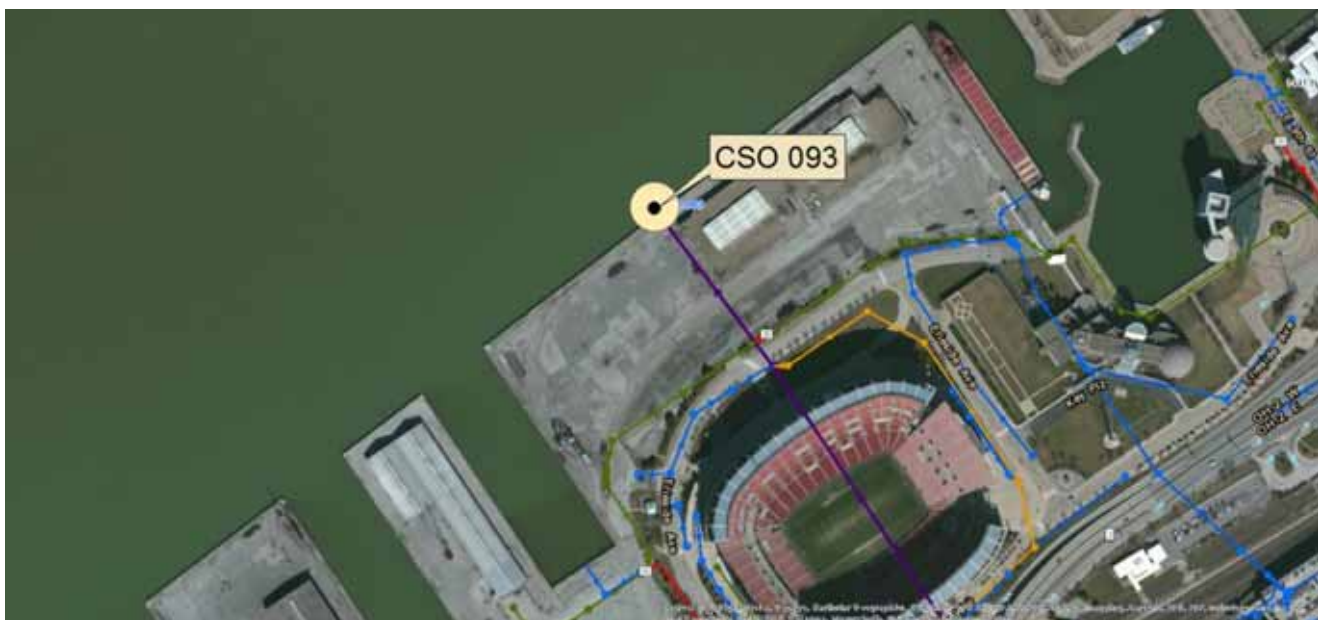
Problem Summary: Buildings at 1150 West 3rd Street and 310 Lakeside Avenue are improperly connected to the CSO 093 stormwater outlet. The City of Cleveland is working with the property owners to remediate these problems.
