2014 Illicit Discharge Detection and Elimination Program Annual Report

Northeast Ohio Regional
Sewer District

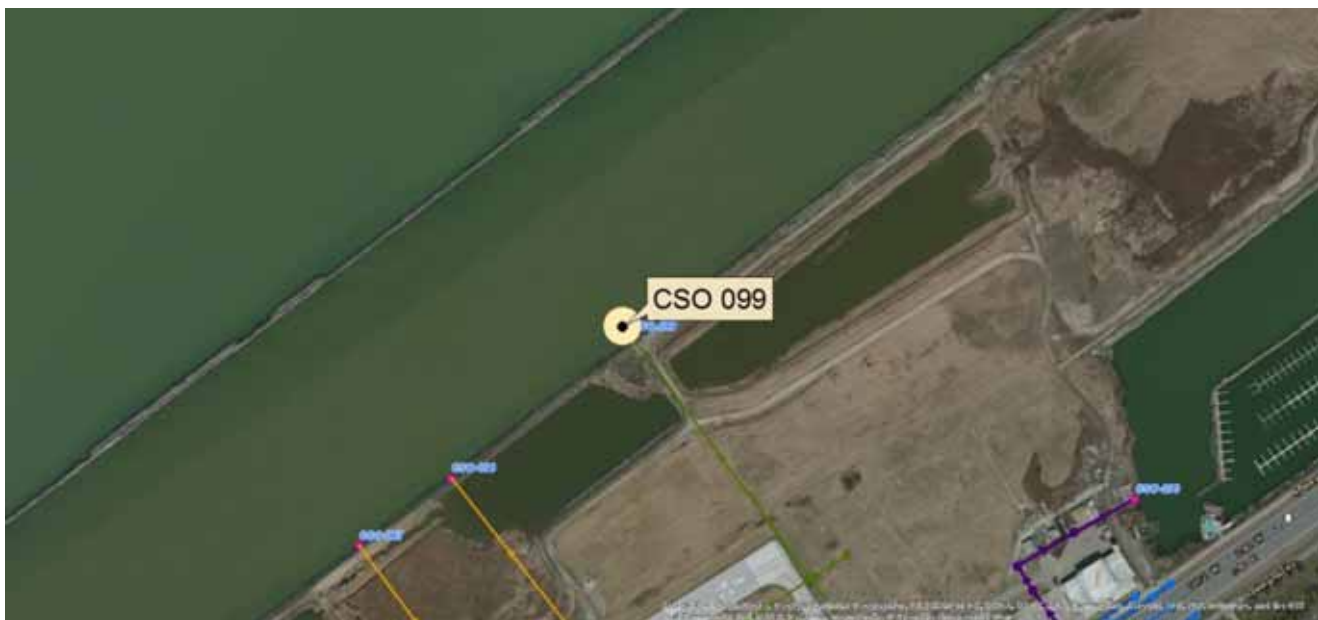
Problem Summary: An improper connection exists between Par-One Golf Specialties located at 3807 King Avenue and the CSO 099 stormwater outlet. The City of Cleveland is working with the property owner to remediate the problem.

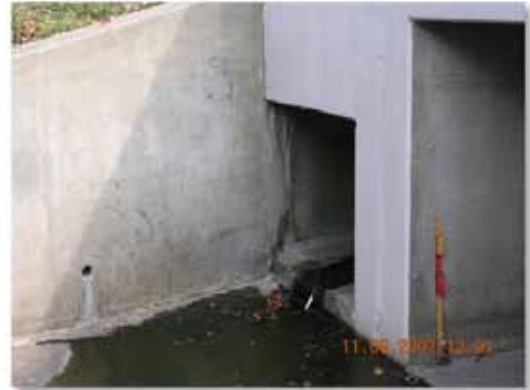
MCMB2005

Problem Summary: A blocked sanitary sewer was found in Shaker Heights along Warrensville Center Road. This blockage was cleared on March 14, 2104. Dry-weather flow with elevated *E. coli* densities was still present in area afterwards. One water leak was found and remediated, while a second has not been fixed. An improper connection to the storm sewer was also found at 20207 Harvard Avenue.

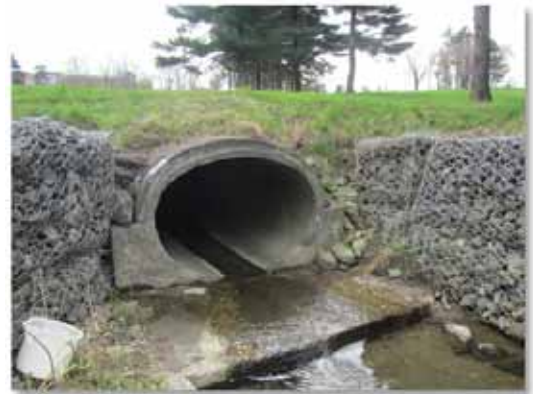
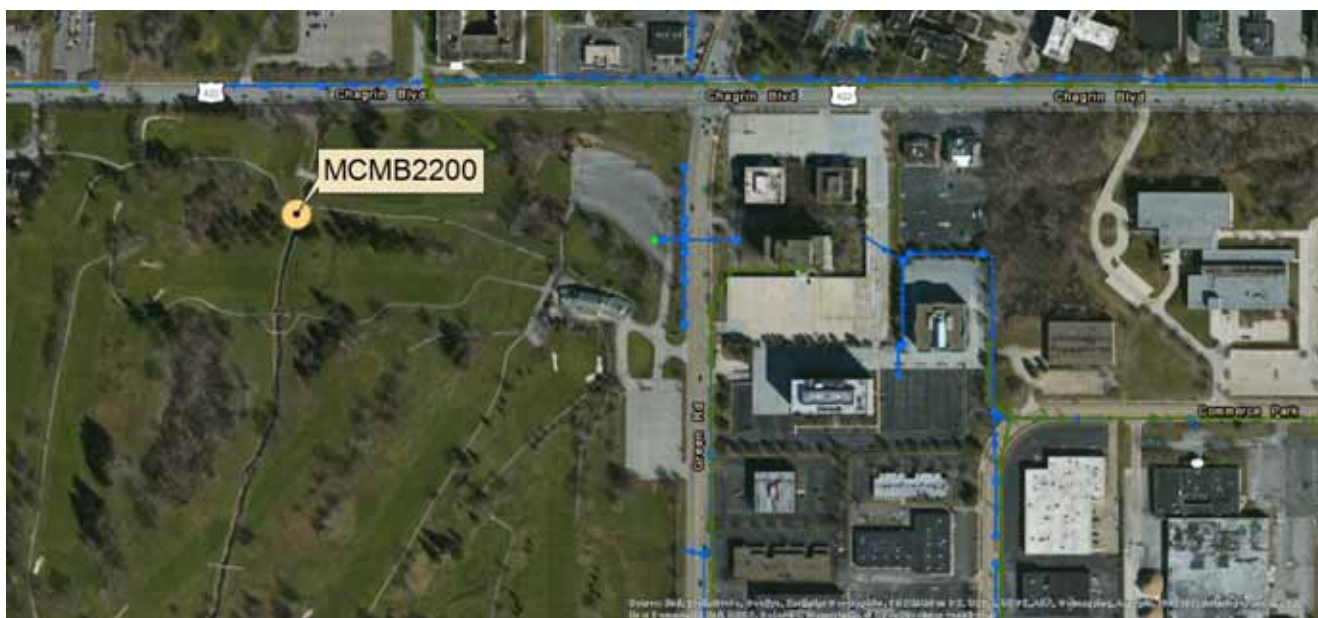
Problem Summary: Flow tracing and source tracking in the system were started, but no causes for the elevated *E. coli* densities at the outfall have been found, yet.

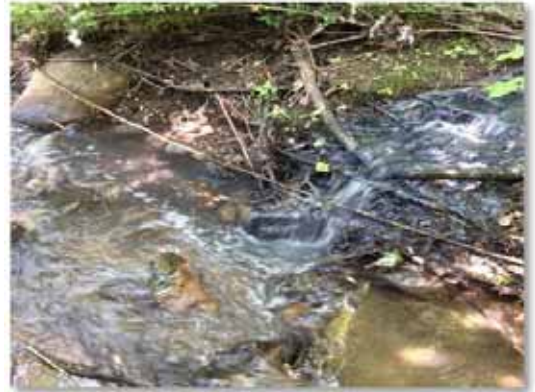
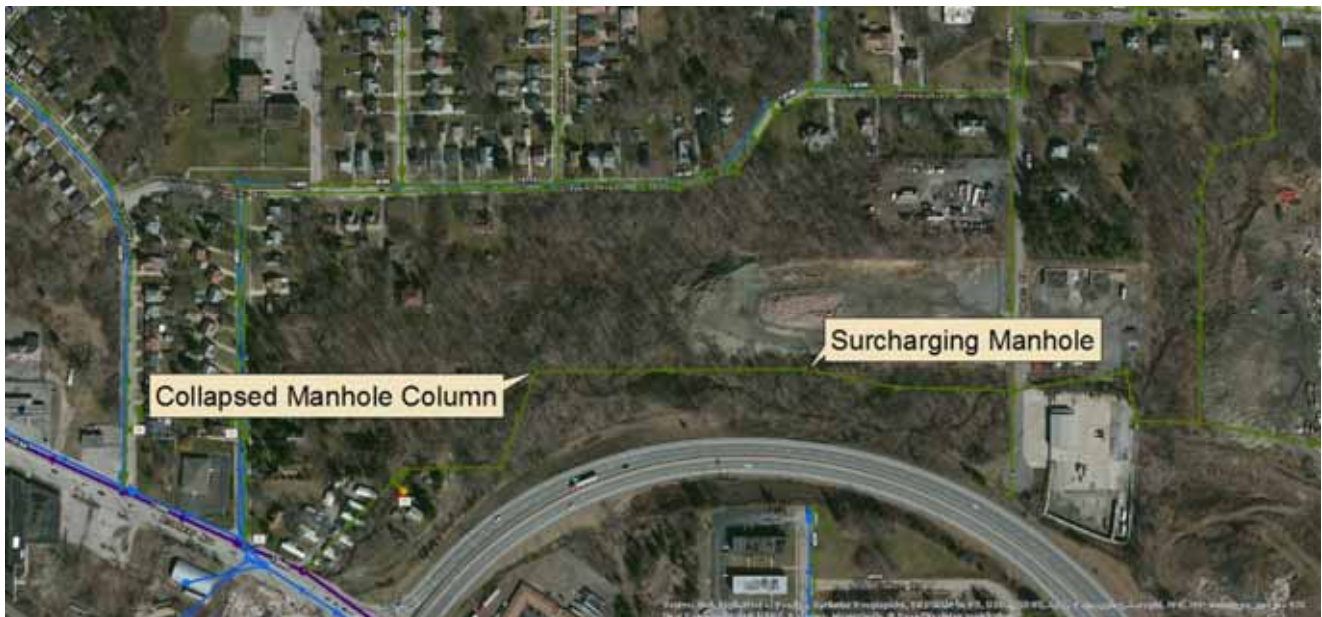
ASSET ID MC00089

Problem Summary: A sanitary sewer blockage resulted in the surcharging of sewage through a manhole cover and into Mill Creek. The blockage was cleared on August 8, 2014. A collapsed manhole column was also found and repaired.

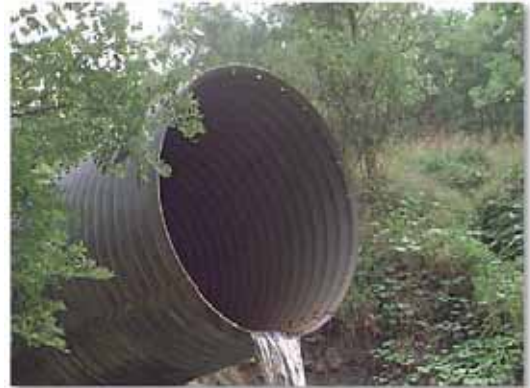
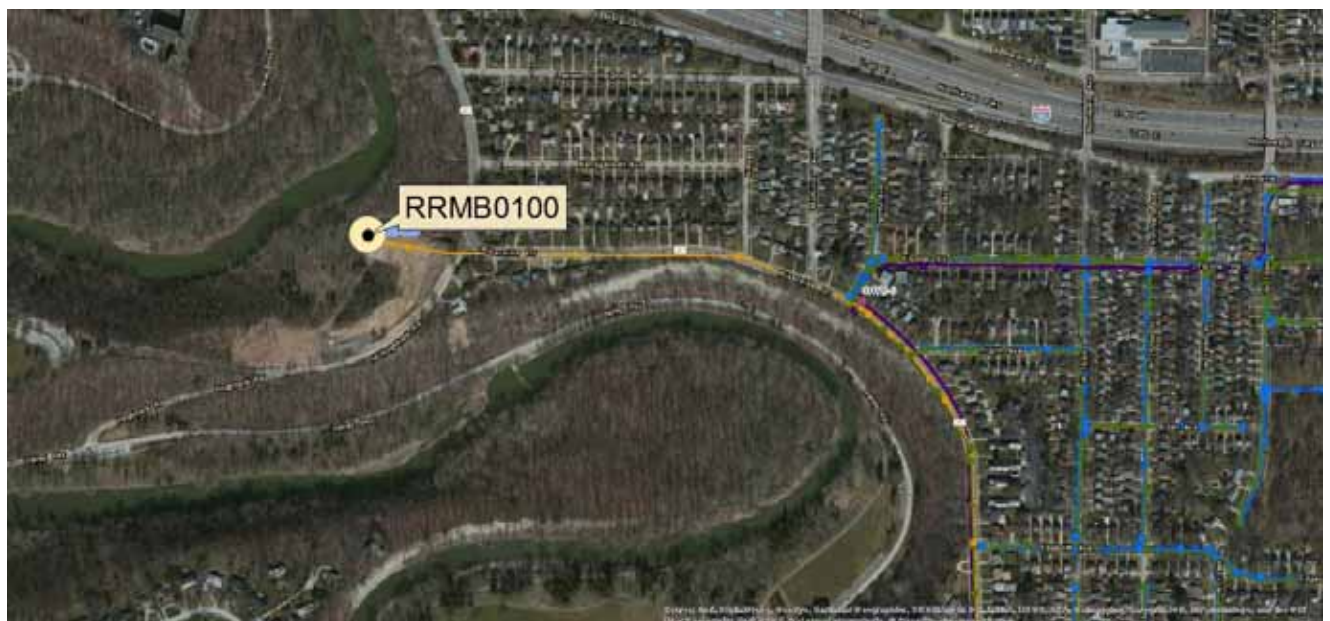
Problem Summary: Dry-weather flow with elevated *E. coli* densities was traced to Montrose Avenue and upstream locations. Improper connections were found between St. Mark School and Rectory and the storm sewer. The City of Cleveland is working with them to remediate the problems. Dye testing should be conducted to determine all other sources of sanitary sewage to the storm sewer in that area.

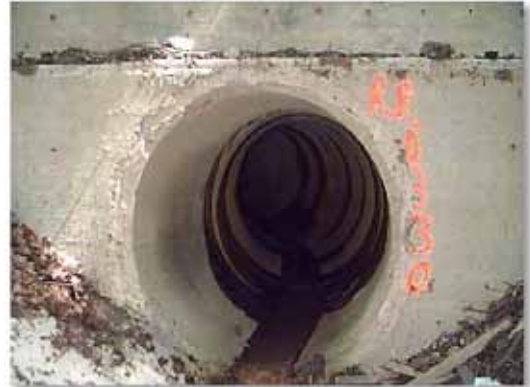
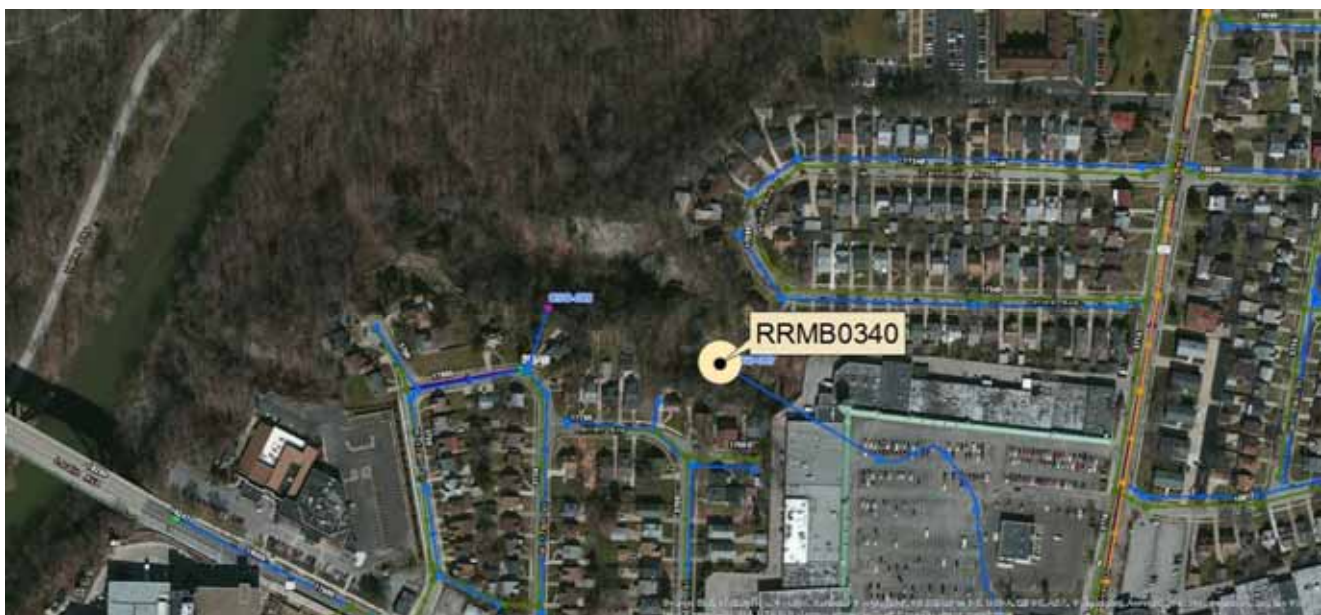
RRMB0340 (CSO-067)

Problem Summary: Improper connections to the storm sewer were found at 4037 and 4049 Rocky River Drive.

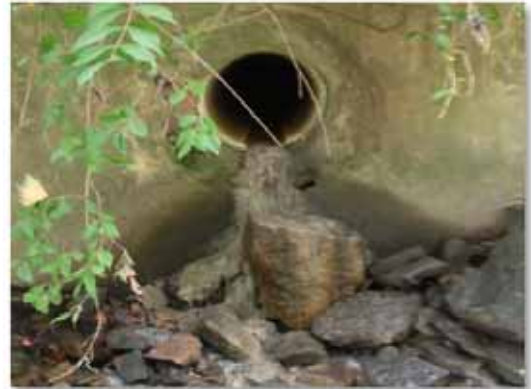
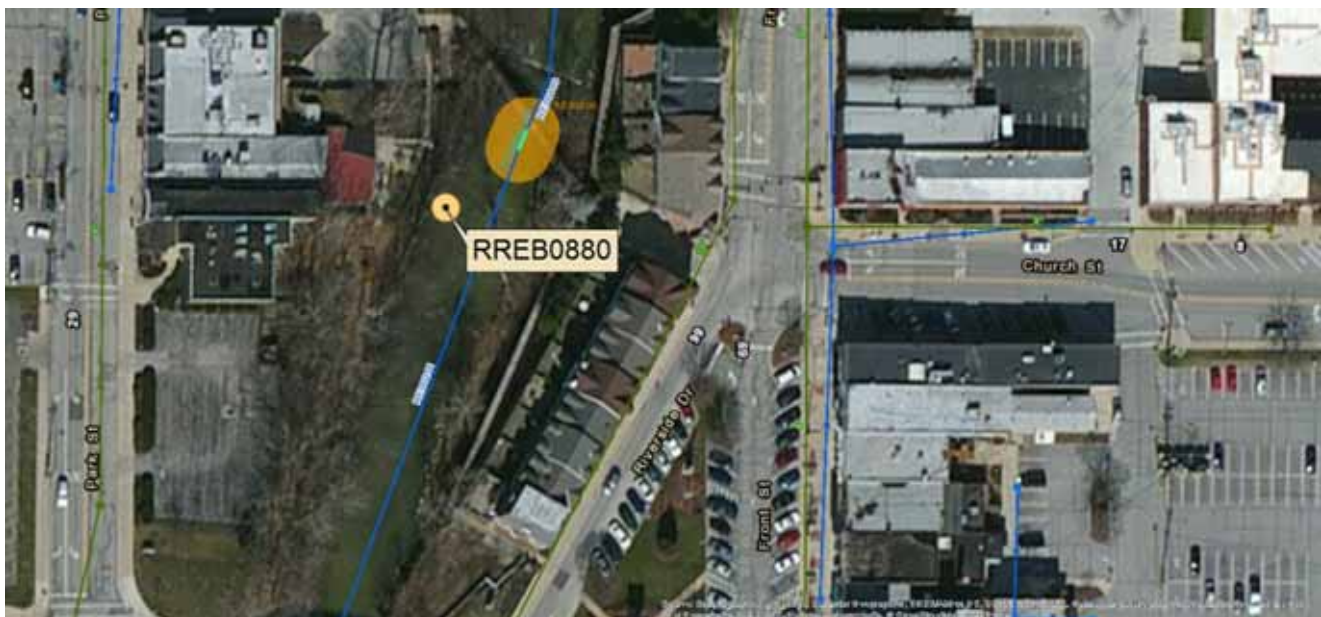
RREB0880

Problem Summary: Dry-weather flow with elevated *E. coli* densities was traced to Front Street between 31 Riverside Drive and 87 Front Street. A water main break was also found between 44 and 54 Front Street. The City of Berea is conducting dye tests and working to remediate any problems with improper connections and water leaks in the area.

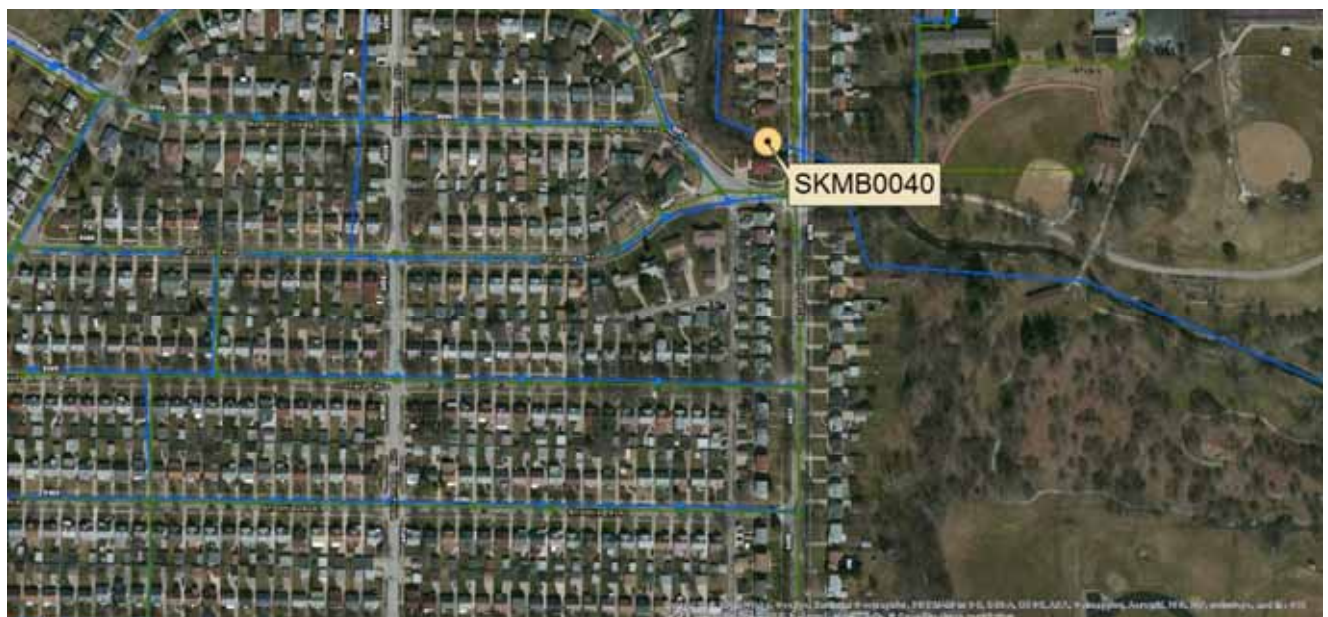
Problem Summary: Dry-weather flow with elevated *E. coli* densities was traced to Outlook Drive, Memphis Villas Boulevard, Rodoan Road, Forest Edge Drive, and Northlane Drive. The City of Brooklyn is currently working with the Cuyahoga County Department of Public Works to identify and remediate any improper connections to the storm sewer.

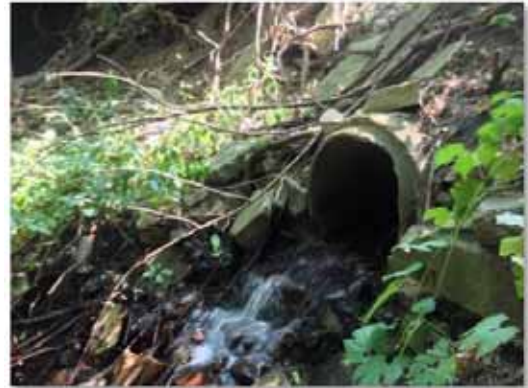
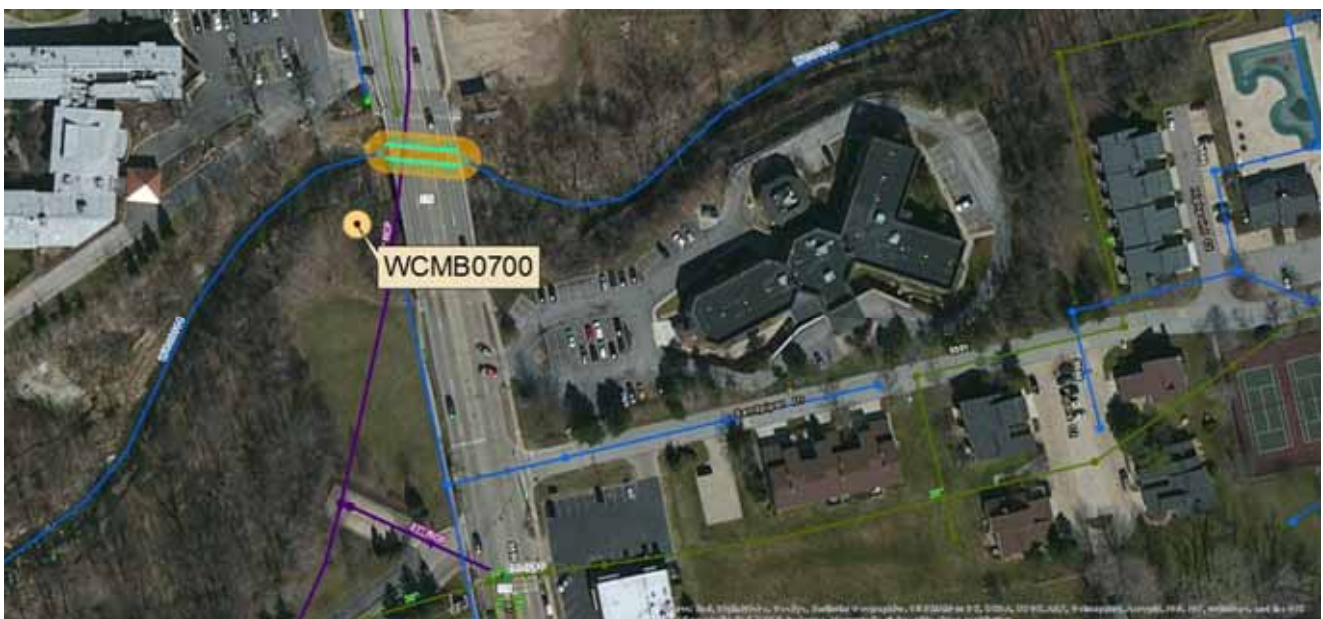
Problem Summary: Cracks and holes were found in a storm sewer at the intersection of Broadview Road and Broadrock Court that allowed sanitary sewage to discharge during sewer blockages. Repairs to the storm sewer were made to prevent future discharges to the outfall.

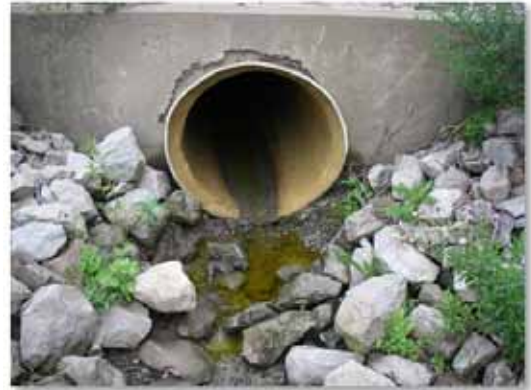
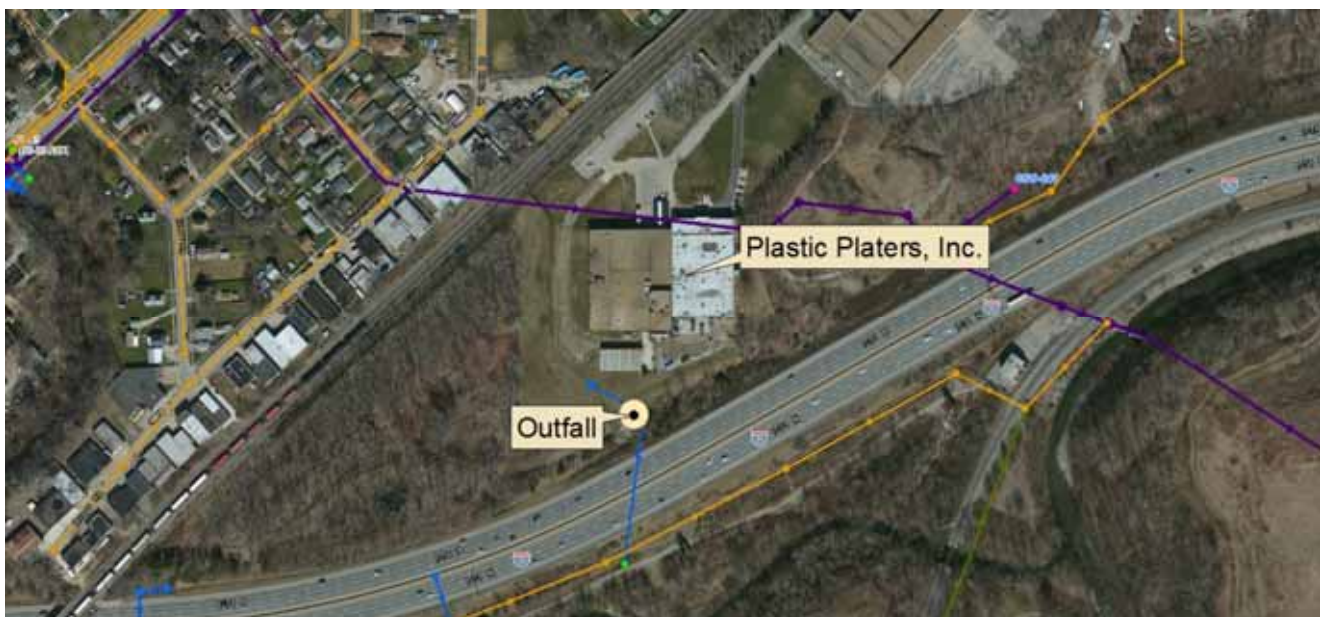
Problem Summary: On July 13, 2014, a water line at Plastic Platers, Incorporated ruptured over a hexavalent chrome recovery tank, flooding the area. Some of the contaminated water made it to the nearby storm sewer and, eventually, to a tributary to Big Creek. Enviroscience, Incorporated was contracted to provide cleanup of the spill, which included pumping out the water from pools in the stream bed.

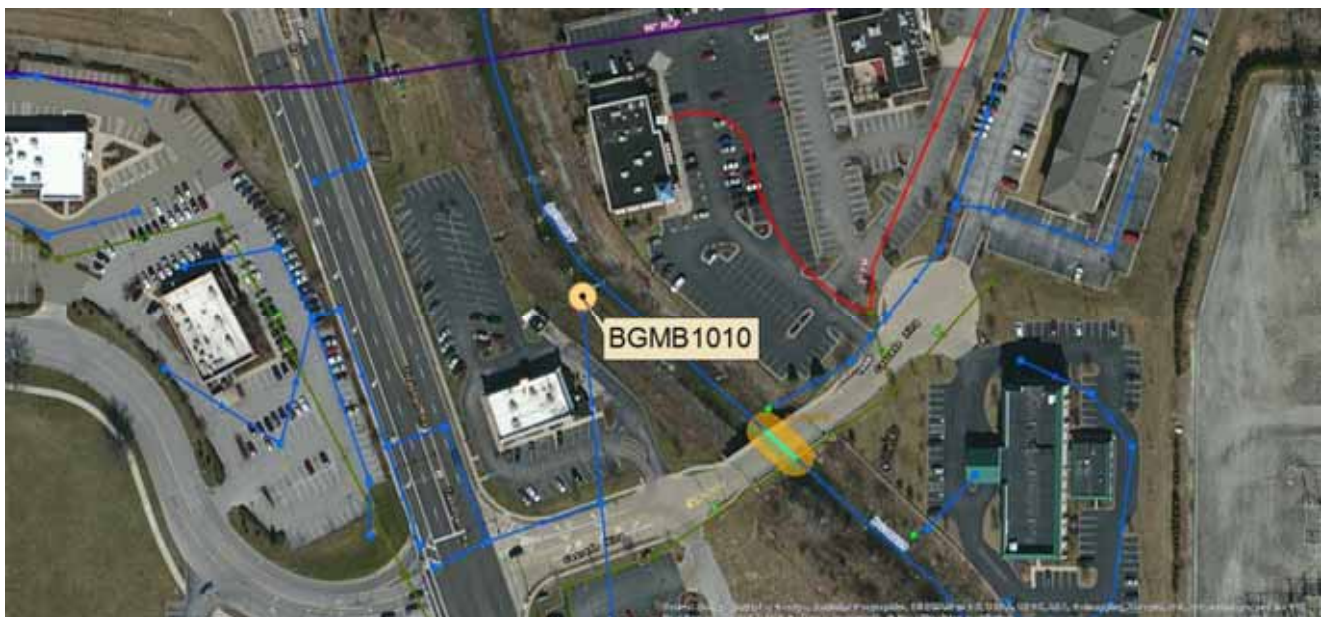
BGMB1010 (GASOLINE)

Problem Summary: On February 12, 2014, a gasoline leak occurred from a Buckeye Pipeline valve fitting. Once the spill was found, an absorbent boom was placed in front of the outfall.

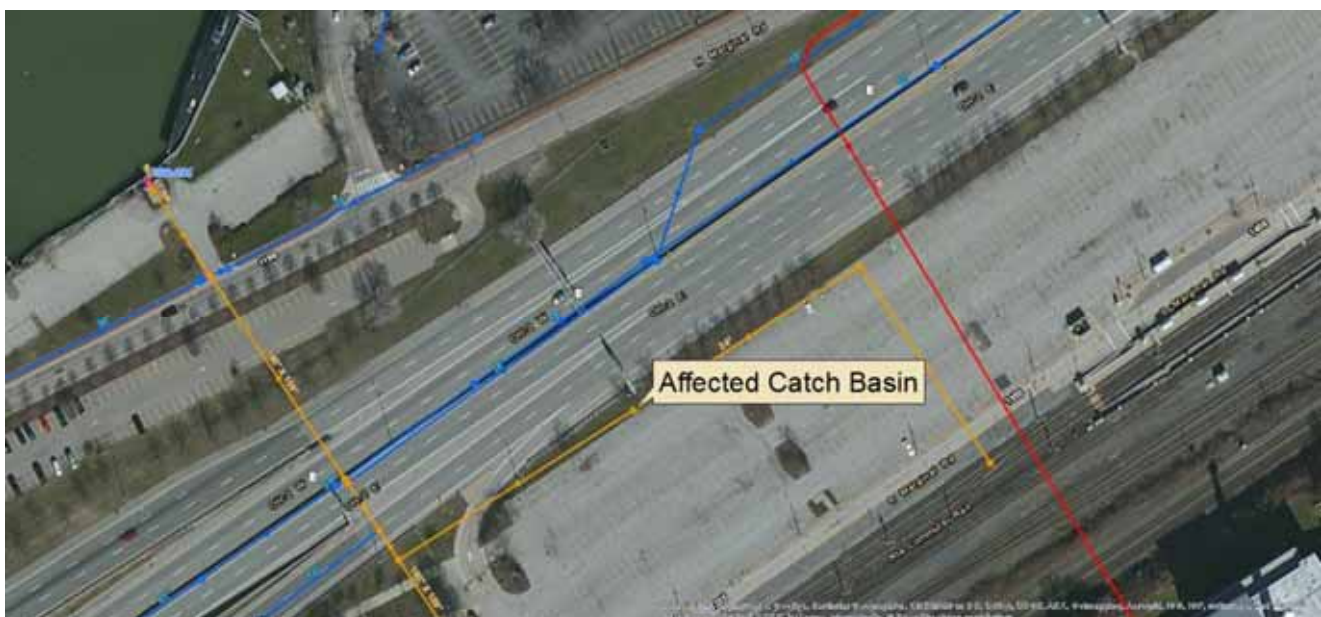
CSO-094 (SANITARY SEWAGE)

Problem Summary: On October 12, 2014, owners of a recreational vehicle parked at the City of Cleveland Municipal Lot dumped sanitary waste from the vehicle into a nearby catch basin. It was determined through dye testing that this catch basin was tributary to CSO 094.
