2015 Illicit Discharge Detection and Elimination Program Annual Report

Northeast Ohio Regional
Sewer District

IDDE Investigations-2015 Report

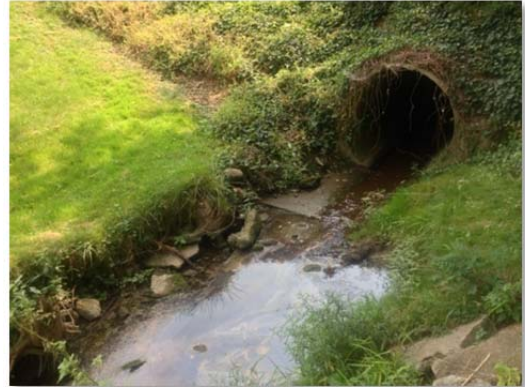
AMH10030

Problem Summary: Problem is intermittent. Dry-weather flow was traced to between 14200 Newton Road and 14400 Newton Road. Improper connection between the home at 14223 Newton Road and the storm sewer has already been documented. Other possible improper connections may also be present in area; dye testing by the City of Middleburg Heights should be conducted to determine all sources of sanitary sewage to the storm sewer.

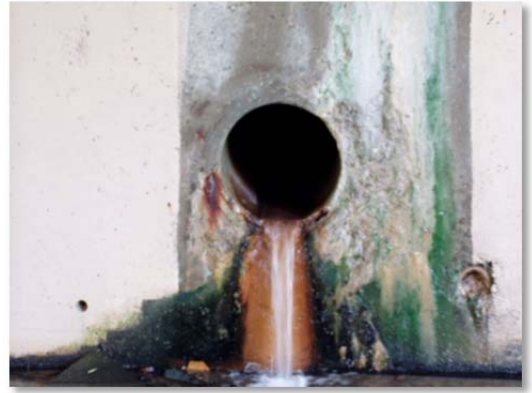
BCMB0510

Problem Summary: Water leak located upstream of outfall near 7259 Pearl Road. The water leak was repaired on August 25, 2015.

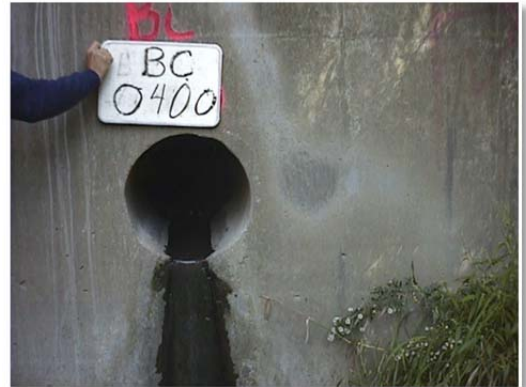
BCMB0400

Problem Summary: Some homes in area have home sewage treatment systems that may be failing. Parma confirmed no sanitary sewer projects are scheduled to begin design within the near term. CCBH provided City & NEORS D HSTS failure records for addresses listed on West Pleasant Valley Drive within the investigation area listed above. A meeting to discuss this matter will be scheduled with CCBH and NEORS D.

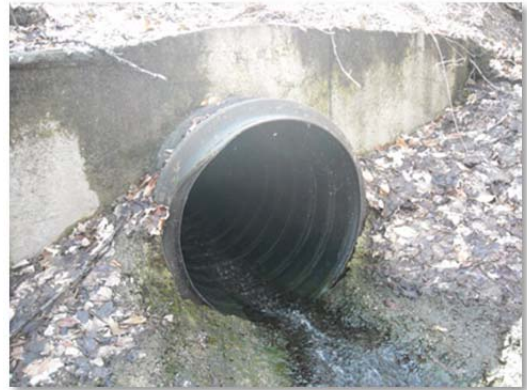
BBMB0025

Problem Summary: Some homes in area have home sewage treatment systems that may be failing. According to the Mayfield Village Service Director, these homes will be connected to the sanitary sewer within the next three to five years.

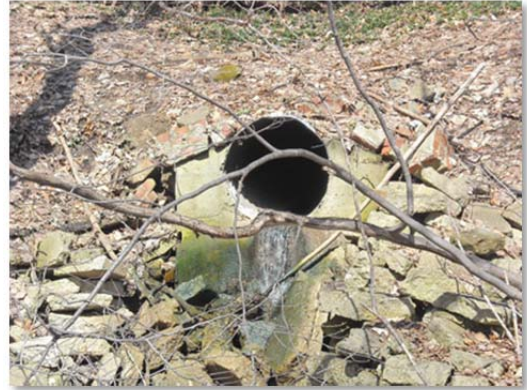
BBMB0026

Problem Summary: Some homes in area have home sewage treatment systems that may be failing. According to the Mayfield Village Service Director, these homes were to be connected to the sanitary sewer in 2015, but only some of them were

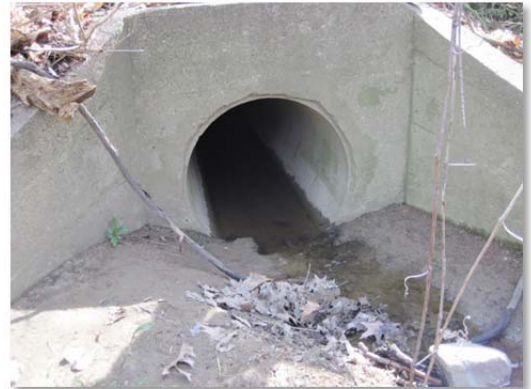
BGMB0340

Problem Summary: Dry-weather flow with elevated *E. coli* densities was traced to between 7026 and 7041 Greenbriar Drive. Recommend dye testing homes in area to determine improper connections. Dye testing in process.

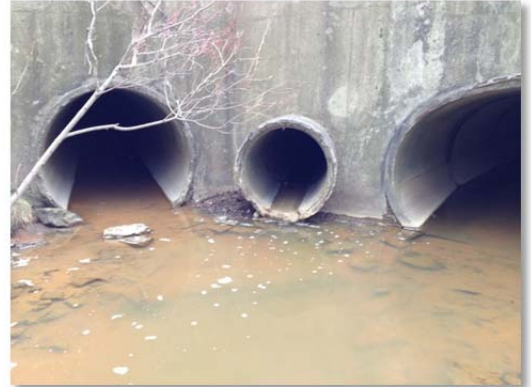
BGMB0411

Problem Summary: Flow tracing and source tracking in the system were started, but no causes for the elevated *E. coli* densities at the outfall have been found, yet. CCTV is being completed on Day Drive by the CCDPW to determine structural integrity of sewers.

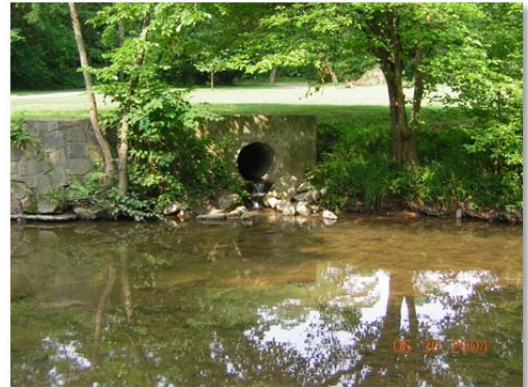
BGMB0885

Problem Summary: Water leaks were found on Sharon Drive and Deborah Drive. Cleveland Water Department repaired leak on Deborah Drive and partially repaired leak on Sharon Drive. Additional source tracking to be completed once all water leaks are repaired.

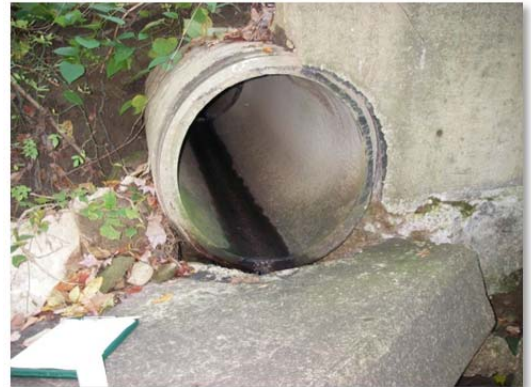
Problem Summary: The headwall of the outfall was cracked and had fallen partially northward into the tributary. Additionally, approximately five feet upstream of the outfall opening, the storm sewer pipe completely separated from the remainder of the pipe and flow was discharged into the ground through the crack and not through the opening of the outfall. The concrete headwall and exposed pipes fixed by the City of Mayfield Heights.

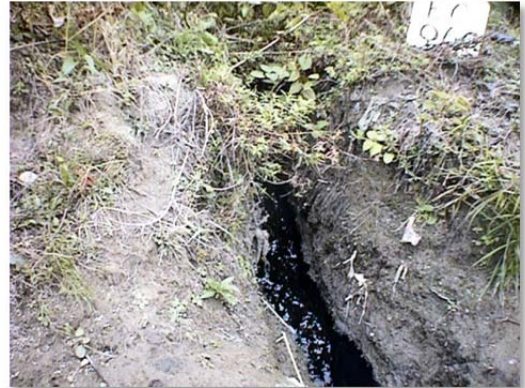
ECMB0060

Problem Summary: An improper residential sanitary sewer lateral connection to the storm sewer exists at 17516 Lakeport Road. WPC issued NOV 11-25-15 to property owner. Note: WPC to dye-test 17651 Lakeport Road, which will be the final residential property to be dye-tested in Lakeport Rd - Brazil Road sewershed.

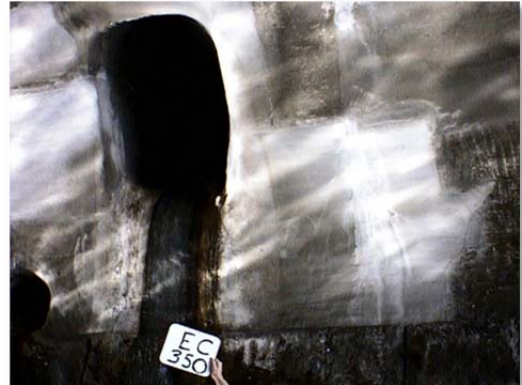
ECMB0350

Problem Summary: Flow with elevated *E. coli* densities was traced along Euclid Avenue to Grand Boulevard. A video inspection of the area indicated improper connections between the apartment buildings located at 20200 and 20240 Grand Boulevard and the storm sewer. Recommend that the City of Euclid conduct dye testing to verify improper connections.

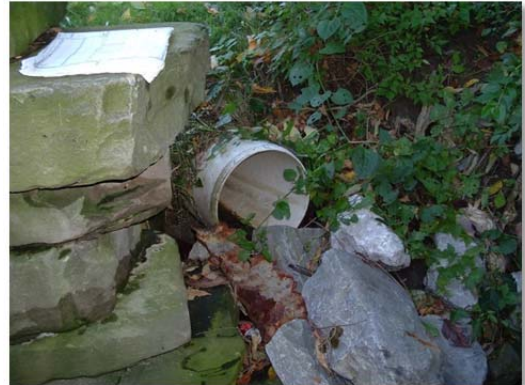
HEMB1180

Problem Summary: A home sewage treatment system is located upstream of property. Elevated *E. coli* densities could be due to a failing system. City, CCBH & District coordinated on procedural decommissioning of HSTs by CCBH, notification to City and confirmation by City Bldg Dept. to review interior plumbing prior to sanitary lateral connection approval following completion of HCWSS Project.

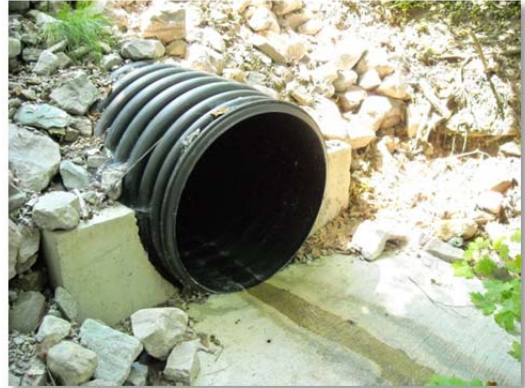
HET11020

Problem Summary: Dry-weather flow with elevated *E. coli* densities traced to Vezber Drive. City to complete, via AECOM contract, 7 dye-tests of residences w/ positive smoke test results, both for possible improper connections and downspout connections to sanitary sewer (inflow) during December 2015. Next meeting scheduled for February 2016.

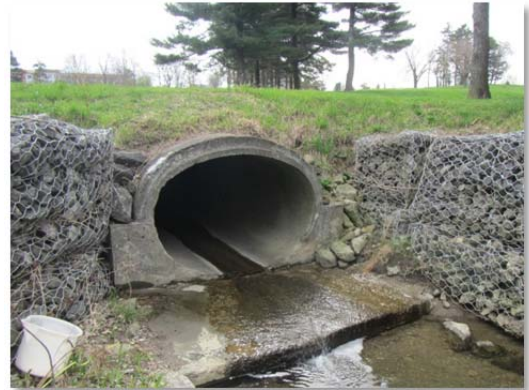
MCMB2200

Problem Summary: Flow tracing and source tracking in the system were started, improper connection found at a multiple occupancy building with Galaxy Payroll, The Gathering Place and Jay Berk, Ph.D. & Associates.

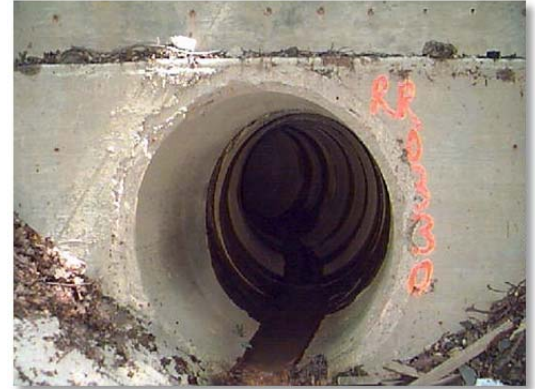
RRMB0340 (CSO-067)

Problem Summary: Improper connections to the storm sewer were found at 4037 and 4049 Rocky River Drive.

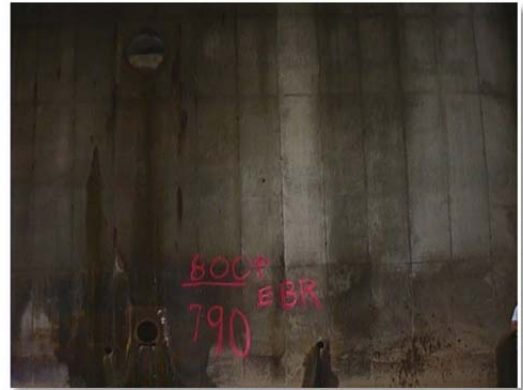
RREB0790, CSO-062

Problem Summary: WPC to schedule CCTV and dye-test confirmation of all facility connections at Clara E. Westropp School (19101 Puritas Avenue) to determine any other improper lateral connections; then oversee remediation by Cleveland Metropolitan School District for one known improper connection. WPC & WQIS performed joint dye-test 10-2-15 to confirm improper connection from custodian restroom facility.

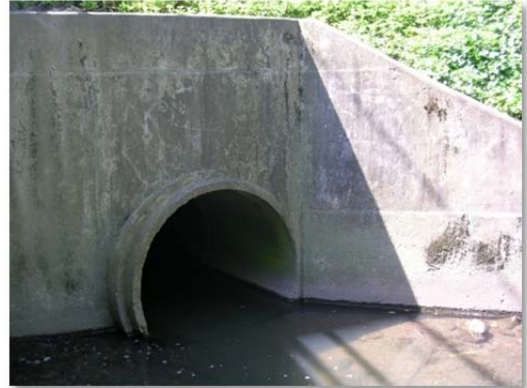
SKMB0040

Problem Summary: Dry-weather flow with elevated *E. coli* densities was traced to Outlook Drive, Memphis Villas Boulevard and Rodoan Road. Dye tests and CCTV revealed several houses on Rodoan Road with improper connections. One confirmed and seven suspected improper connections (awaiting confirmation by CCDPW via dye testing) for SKMB0040.

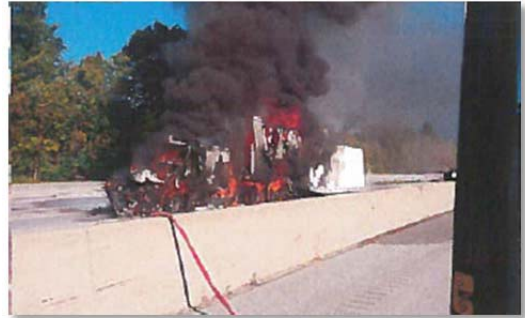
CONTAMINATED RUNOFF FROM A TRUCK FIRE

Problem Summary: A truck fire occurred on I-271 near Wilson Mills Road on September 22, 2015.

The truck contained hazardous materials related to hair products and the Chagrin/Southeast Regional Hazardous Material Team was called out to assist. The contaminated runoff flowed out to Euclid Creek and, although there was a dam constructed to contain the flow, some traveled down the creek prior to the dam being built. A fish kill resulted, with approximately 500 fish dead of 8 species. The flow contained oil/grease, zinc and copper, all exceeding the Aquatic Life Tier 2 Outside Mixing Zone Maximum standard. Sunpro Inc. was in charge of the clean-up and they vacuumed the creek multiple times.

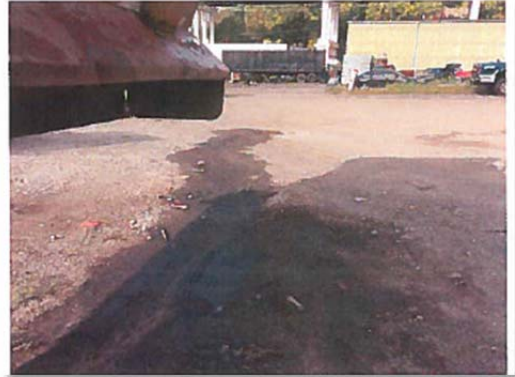
BGMB1620 (OIL DISCHARGE)

Problem Summary: Oil was leaking from several pieces of equipment owned by Terrace Construction at 3965 Pearl Road and Brookside Auto at 3979 Pearl Road. The oil was collecting in the storm system and then discharging from outfall BGMB1620 on Big Creek. Terrace Construction and Brookside Auto were issued notices of interest from the Ohio EPA and asked to clean up their sites and stop illicit discharges.
