CONCEPT PLAN (Basin CC00231 and Culverted Stream CC00230)

Concept for Proposed Stormwater Infrastructure Improvements

Basin CC00231

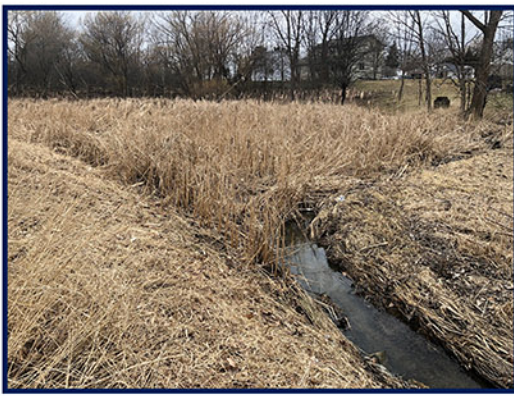
Existing Basin Vegetation

- Accumulated sediment has reduced storage capacity
- Invasive vegetation limits native vegetation and complicates maintenance
- Outlet structure is deteriorating

- Remove sediment to increase storage capacity
- Remove invasive species
- Replace the basin outlet with a new structure that optimizes storage and improves operations and maintenance

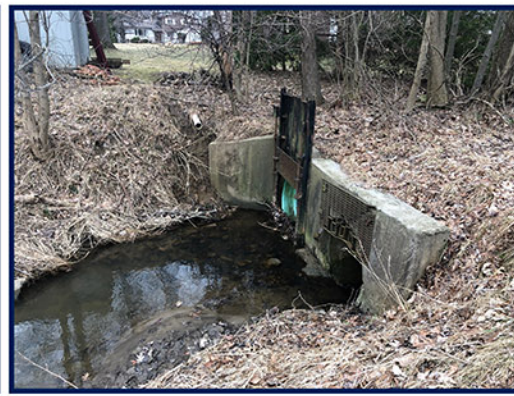
Existing Basin Outlet Structure

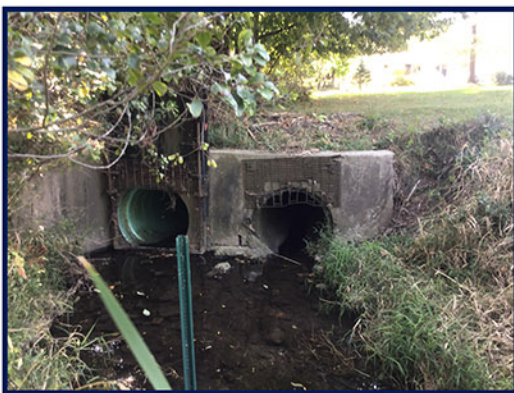
Existing Culverted Stream Inlet at Basin CC00231

- Existing culverted stream has multiple pipe sizes, materials, and slopes which reduce capacity and contribute to flooding
- Existing alignment presents operations and maintenance challenges

- Replace with a new, larger storm sewer (60-inch diameter) with increased capacity
- Proposed alignment is primarily within existing right-of-way

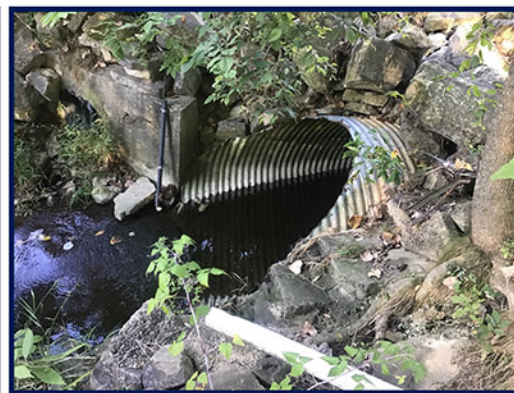
Existing Culverted Stream Outlet at Stream CC00184

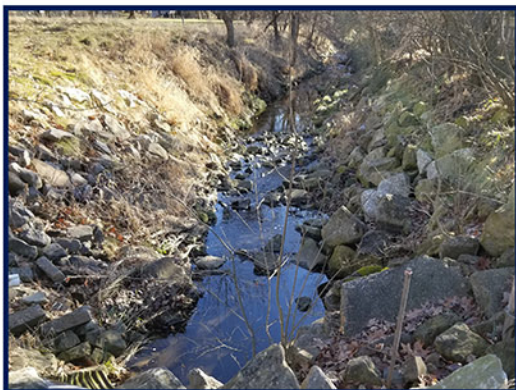
Existing Stream Channel

- Stream channel has been modified over time to accommodate development
- Linear drainage channel has insufficient floodplain storage

- Realign the stream channel to restore a more natural, winding stream with dedicated floodplain storage
- "Daylight" segments of the existing culverted stream

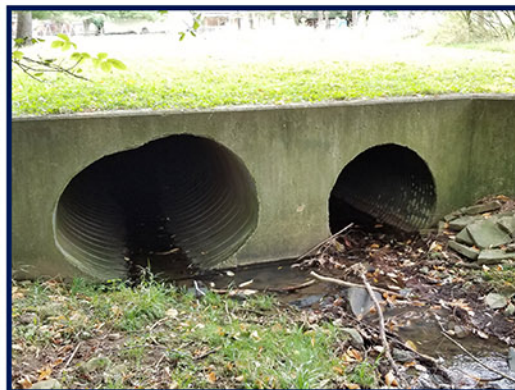
Existing Stream Outlet at Culverted Stream CC00183

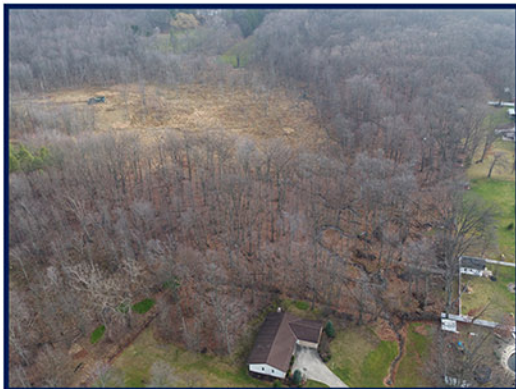
Aerial Photo of the Local Stream, Looking Northeast from Echo Lane

| EXISTING | PROPOSED |
|---|---|
| <ul style="list-style-type: none"> ▪ Stream channel enters the existing stormwater system just east of Echo Lane ▪ Insufficient local storage and undersized storm sewers contribute to flooding on Echo Lane and Briarwood Drive | <ul style="list-style-type: none"> ▪ Construct a berm to provide local storage within the existing open space east of Echo Lane ▪ Install new storm sewers to convey stormwater runoff to Stream CC00184 ▪ Diameters of new storm sewers range in size from 18 inches to 48 inches |

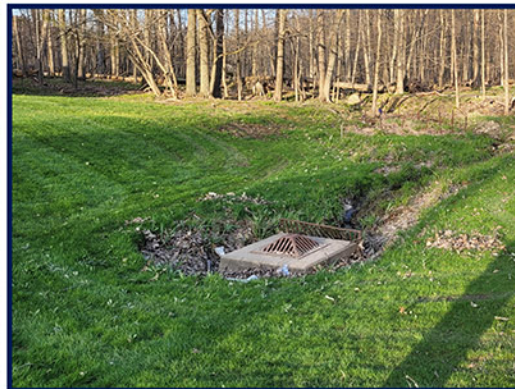
Inlet to the Local Stormwater System at the Eastern End of Echo Lane
