Doan Brook Enhancement Project

**Pre-Design Meeting
January 18, 2011**

Doan Brook Enhancement Project Overview

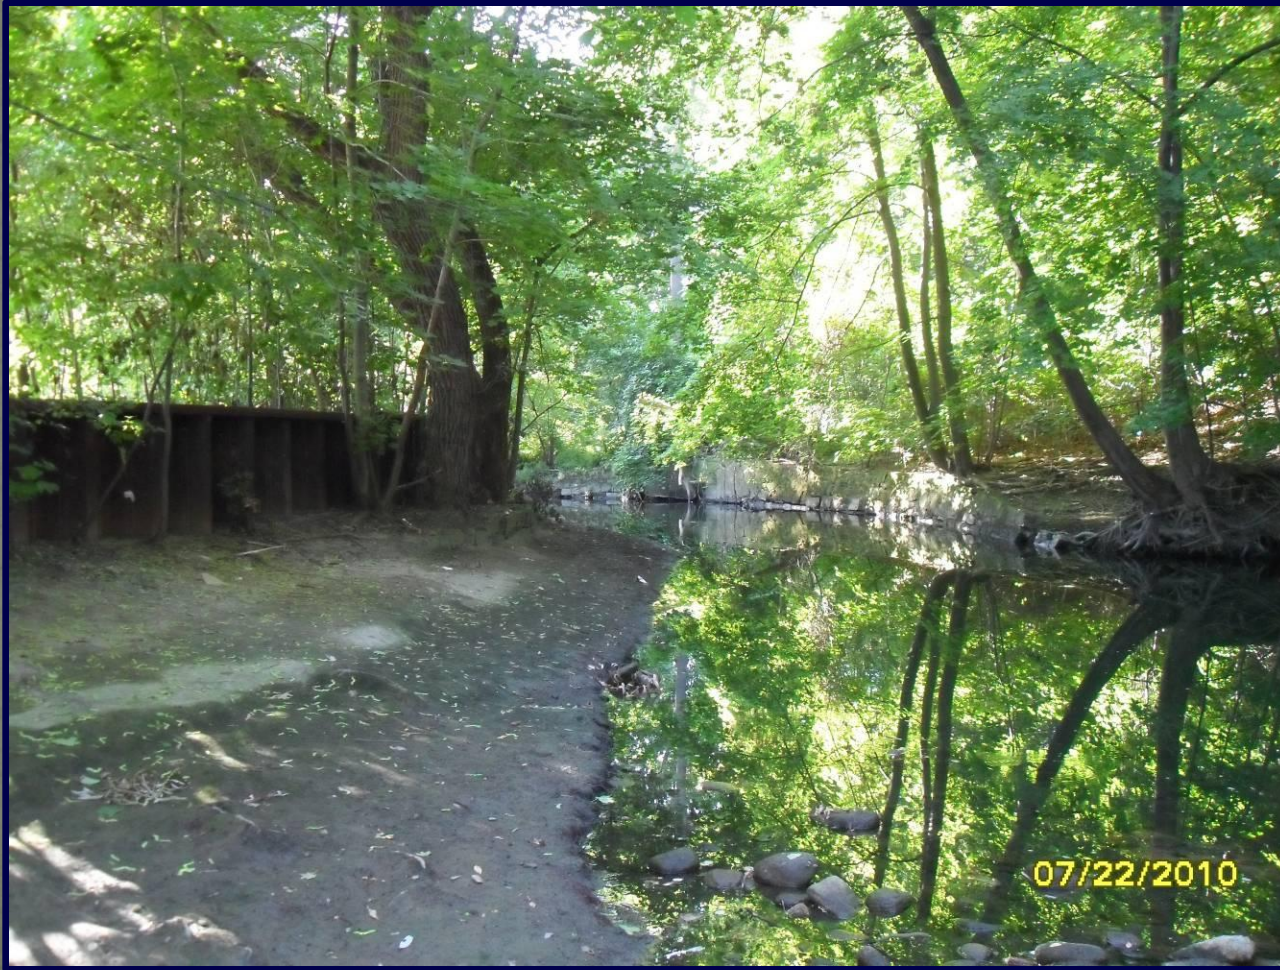
Reach 2 – East 105th Street Culvert to Rockefeller Park Lagoon

This sheet pile wall along the east bank and stone masonry wall along the west bank of Doan Brook adjacent to the Rockefeller Park Lagoon Area is representative of the mix of existing walls within the project area.

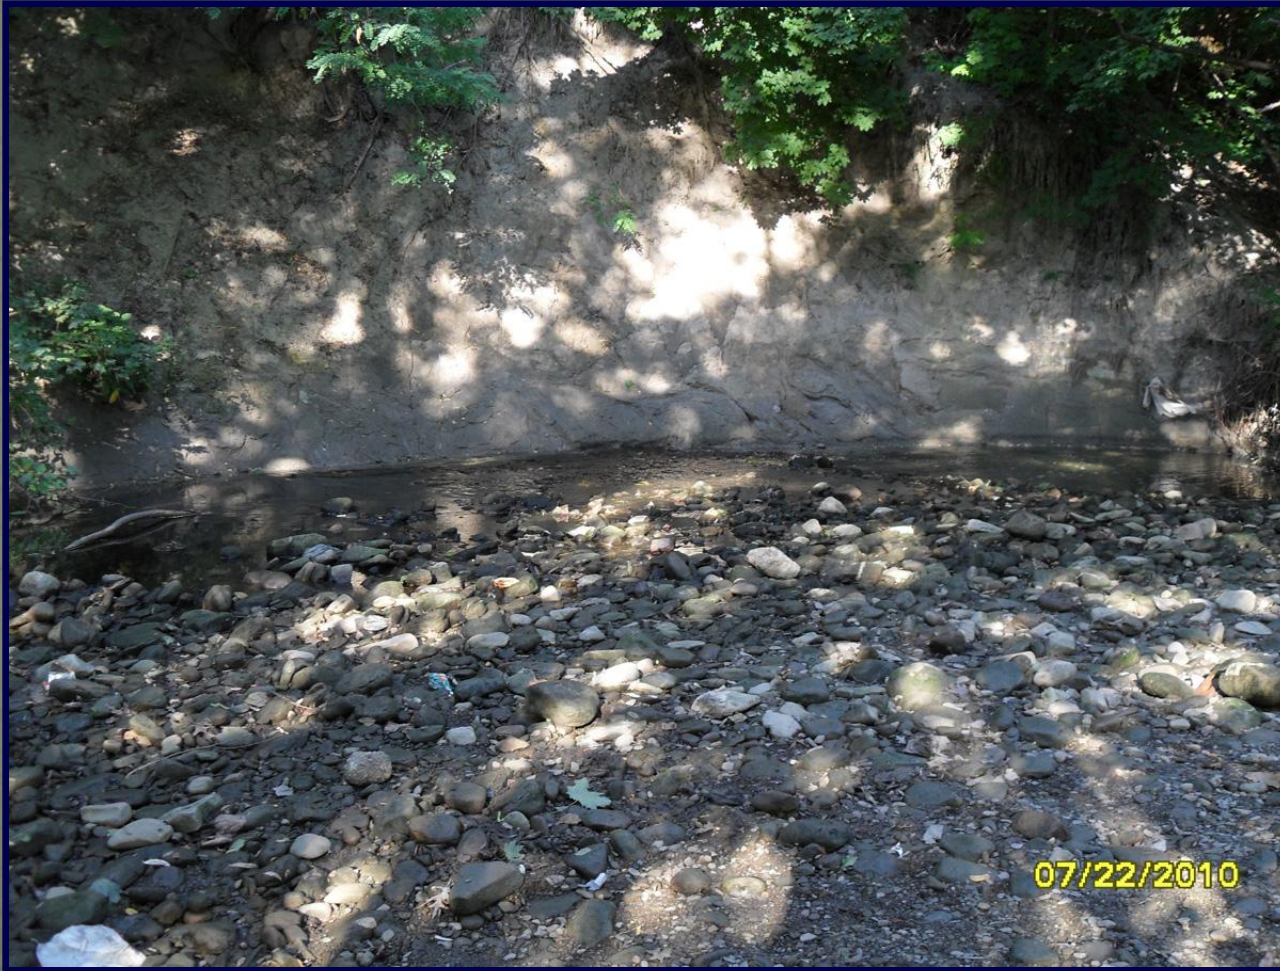
Reach 2 – East 105th Street Culvert to Rockefeller Park Lagoon

This area shows a severe slope failure along the west bank of Doan Brook adjacent to the Rockefeller Park Lagoon Area.

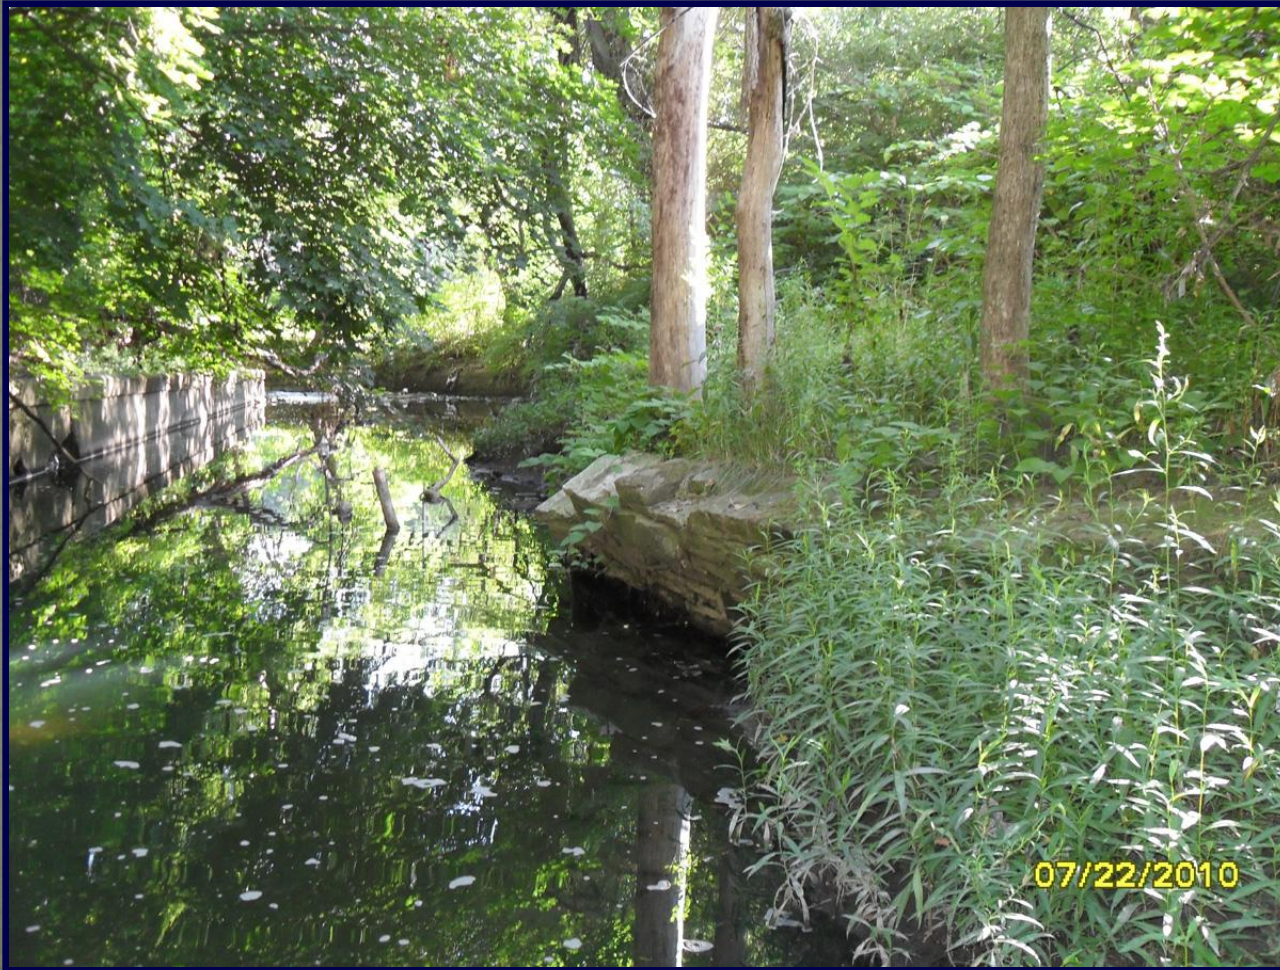
Reach 3 - Rockefeller Park Lagoon to Martin Luther King, Jr. Boulevard Culvert

The east bank opposite the concrete retaining wall also shows a stone masonry wall that is severely damaged, leaning and near failure adjacent to the Rockefeller Park Lagoon Area

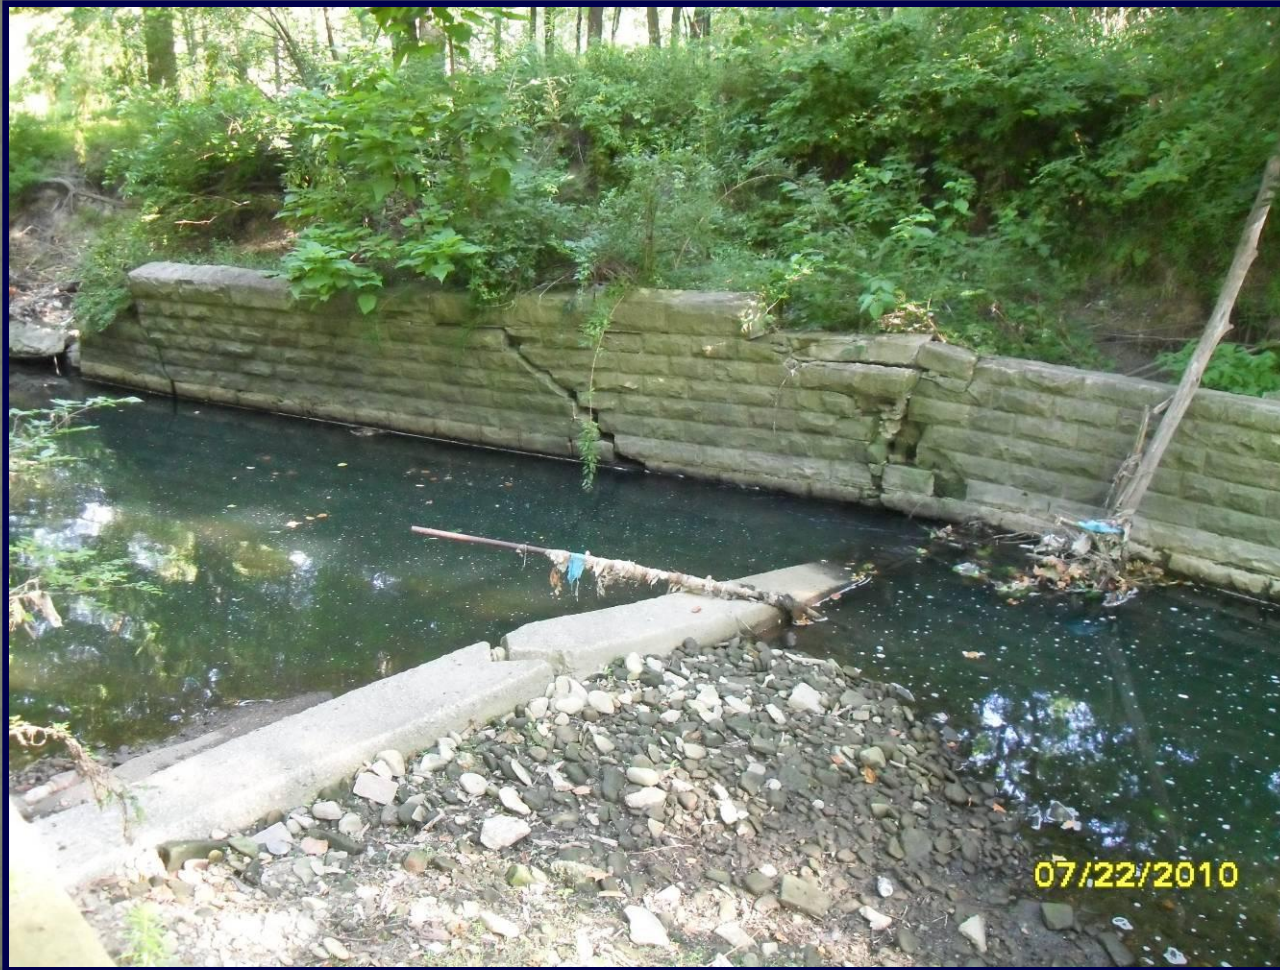
Reach 5 - Wade Park Boulevard Culvert to Old Bridge Abutment

This shows a section of wall along the east side of Doan Brook to the north of Wade Park Avenue buckling and leaning toward the brook. This may be a result of the wall being undermined at this check dam area.
