Doan Brook Enhancement Project

30% Conceptual
Design Meeting
May 24, 2011

Doan Brook Stream Enhancement Project – 30% Conceptual Design

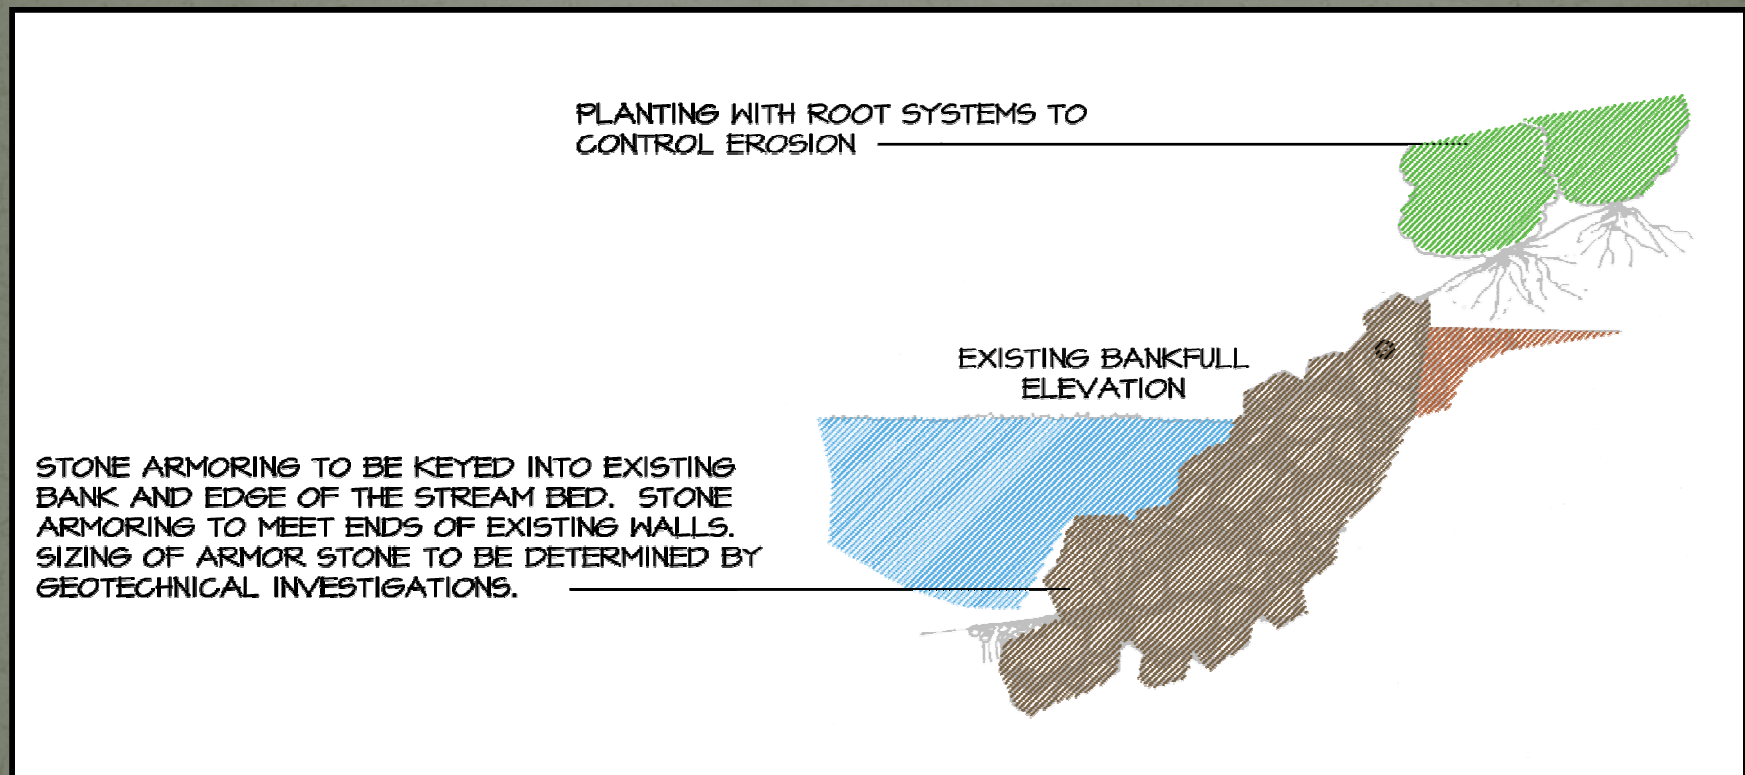
Stone Armoring w/Vegetation

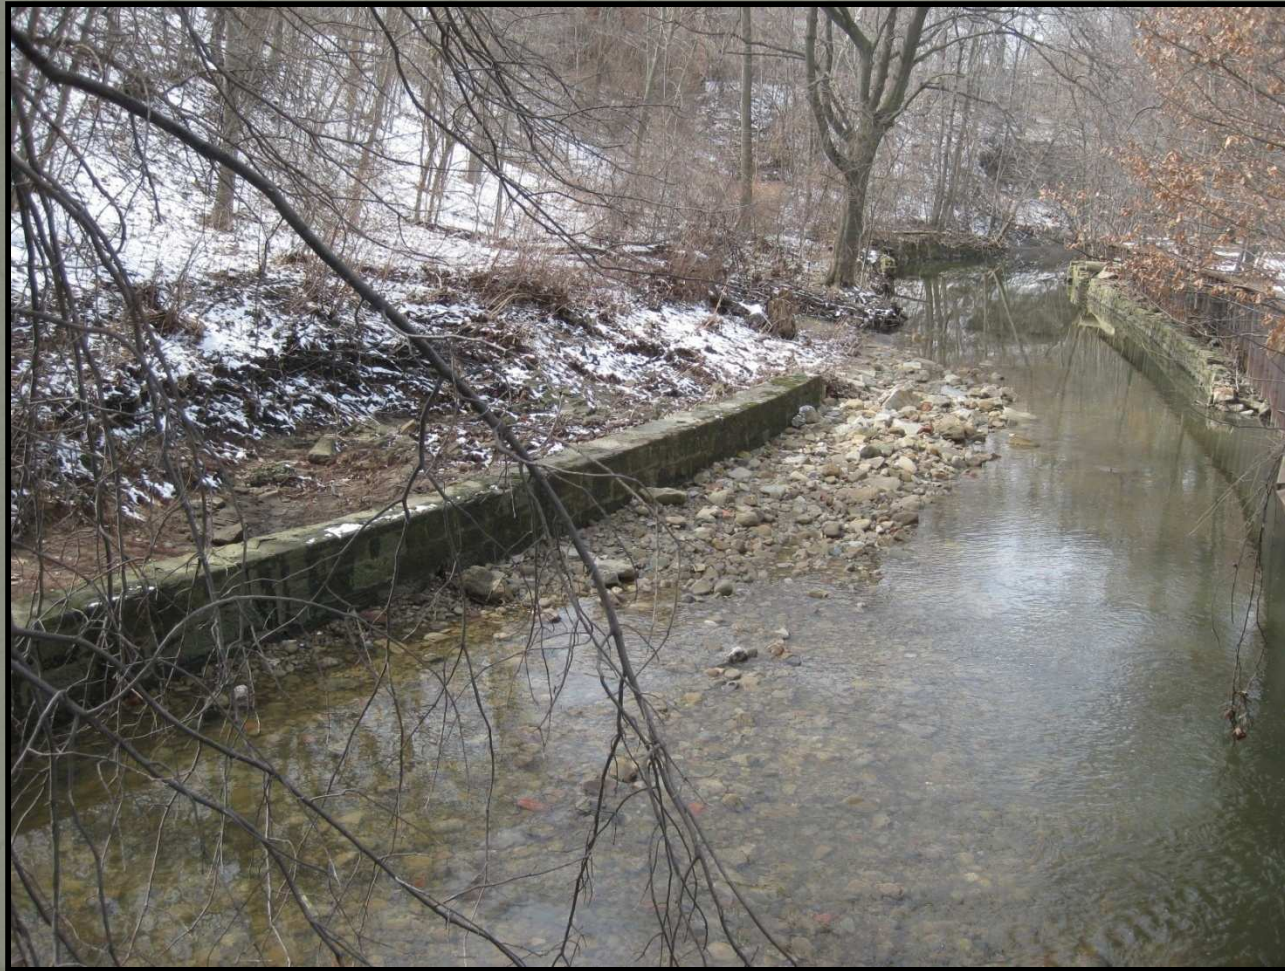
Stone Armoring /Vegetation

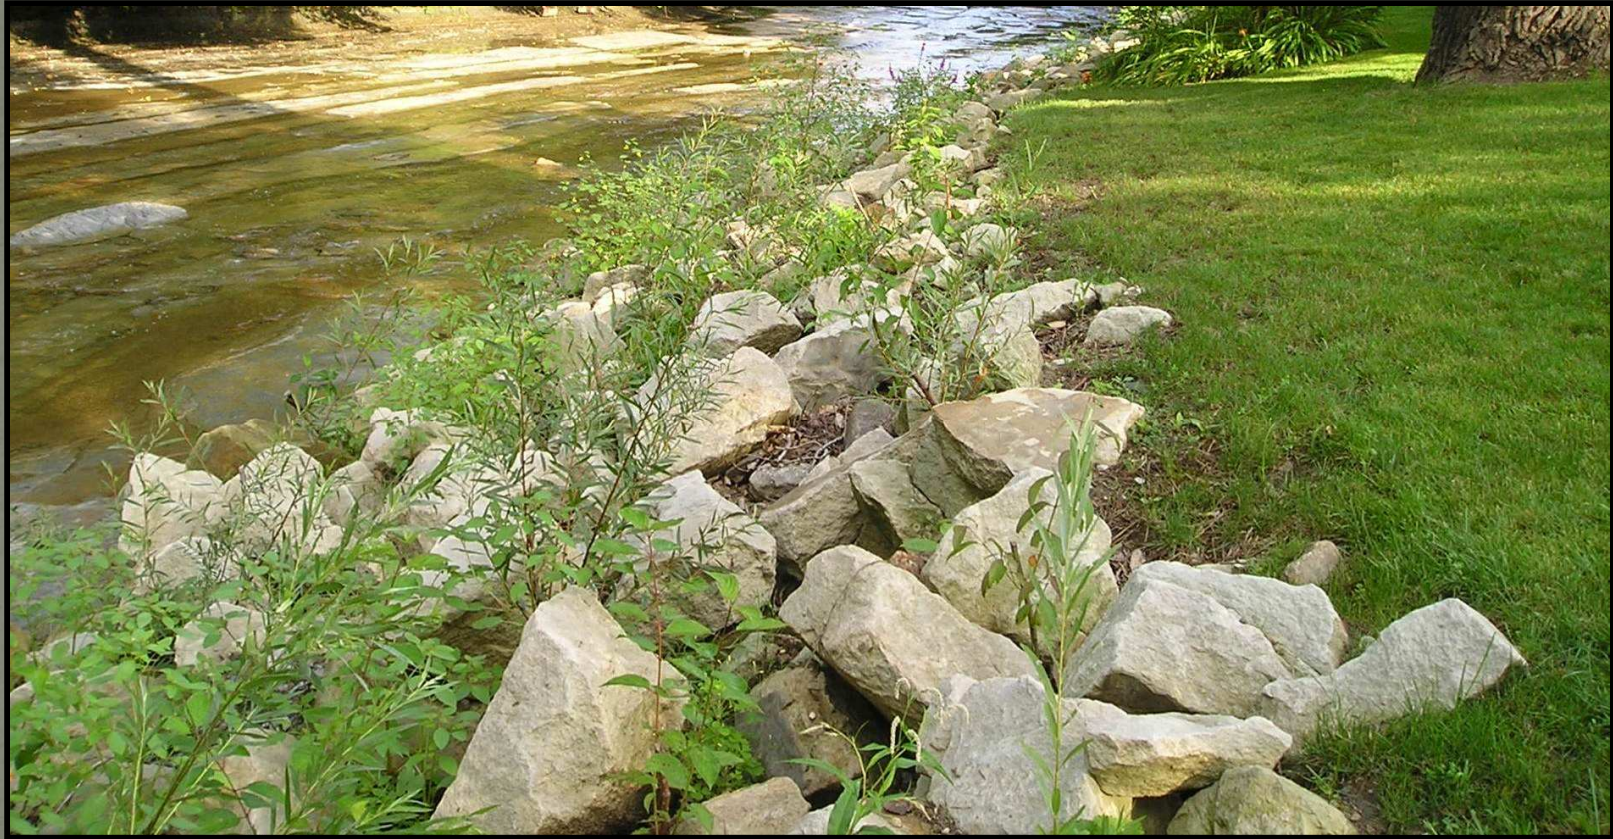
Reach 2 – Existing Failed Metal Sheet Piles

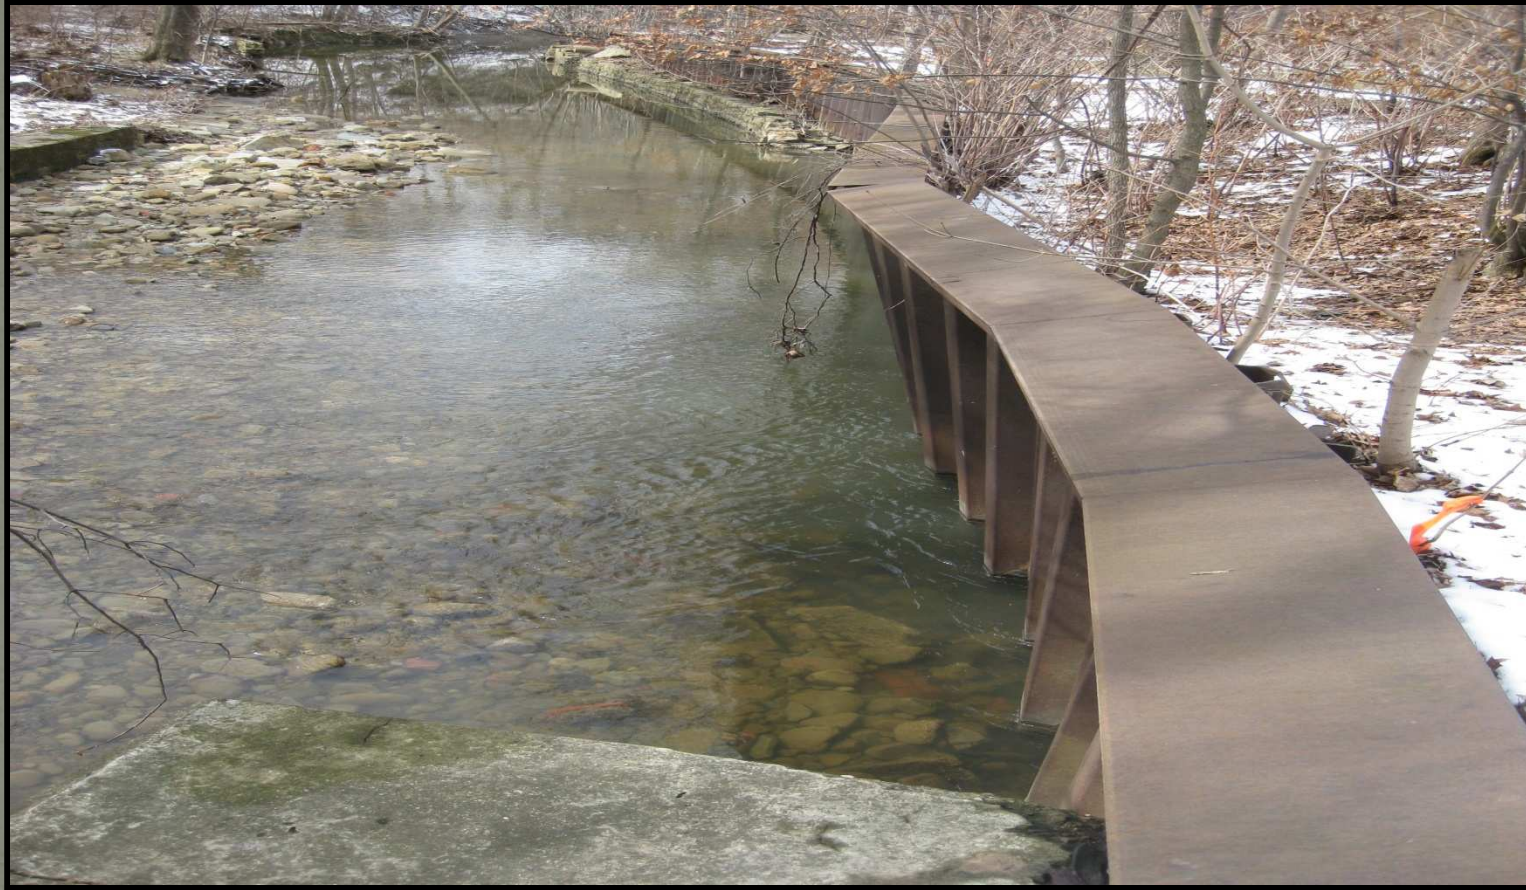
Wall Removed with Stream Bank Improvements

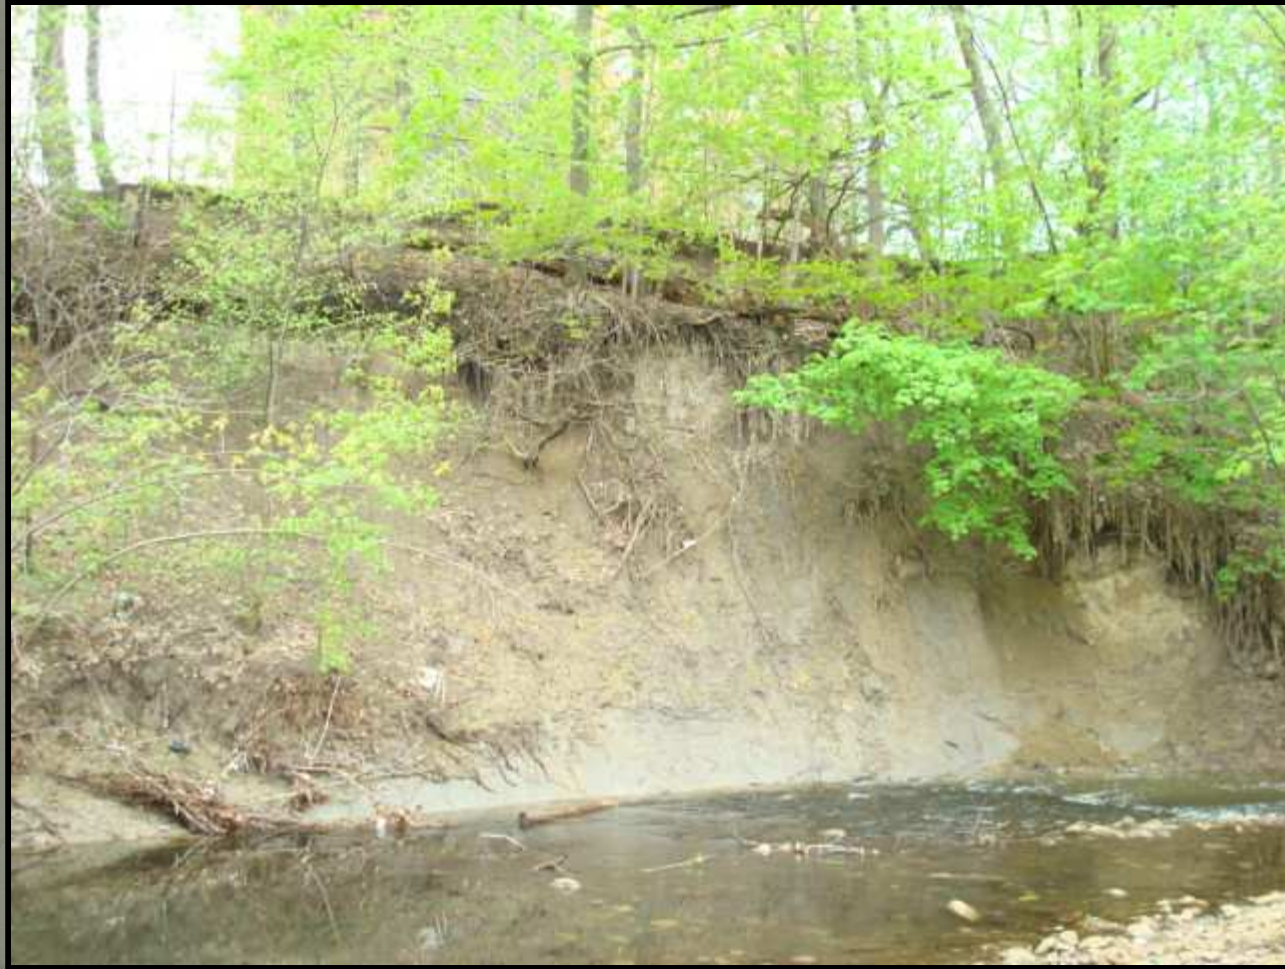
Bank Erosion

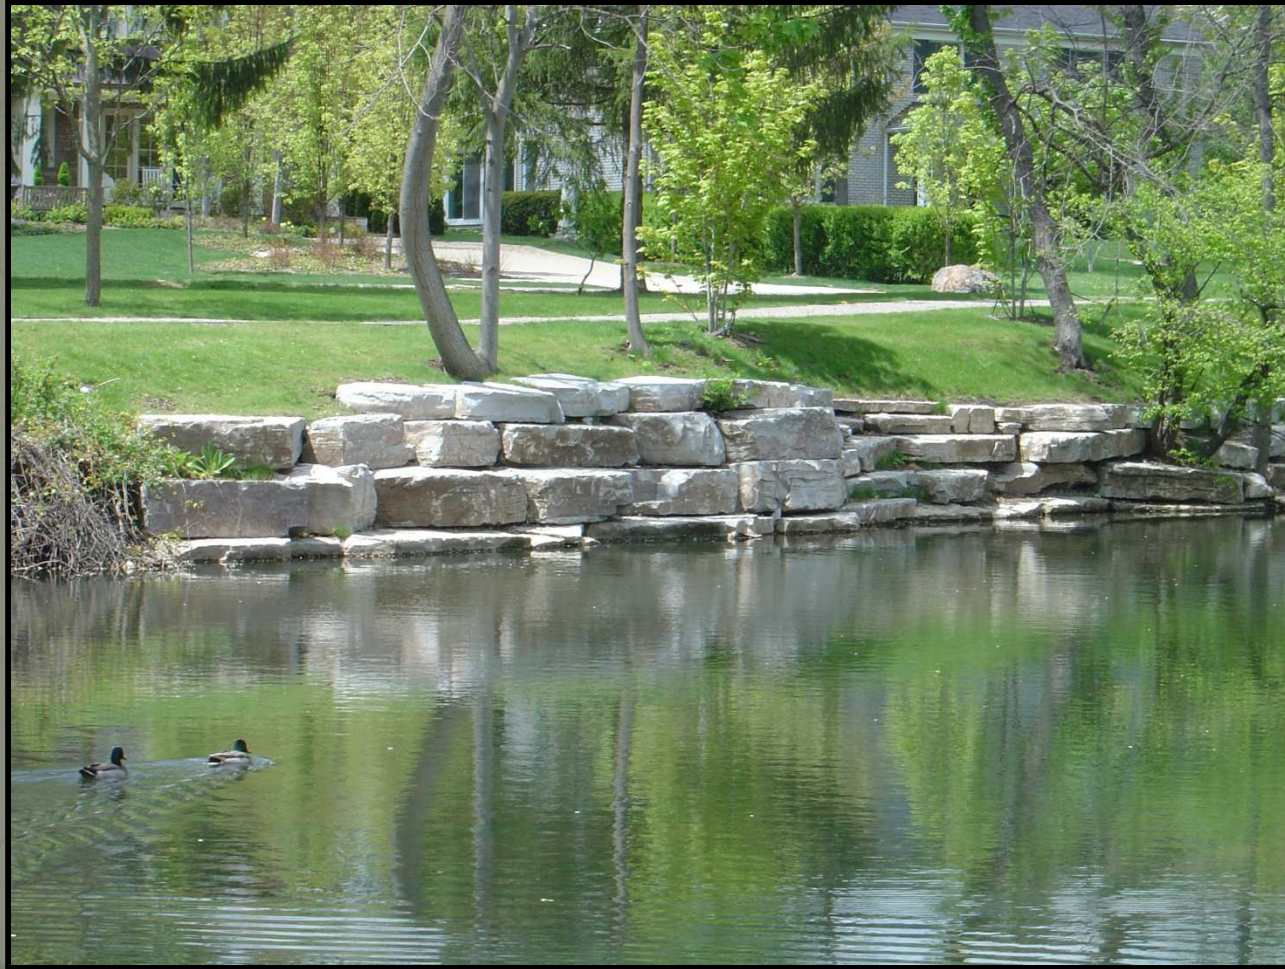
Example - Stone Armoring & Upper Banks Planted

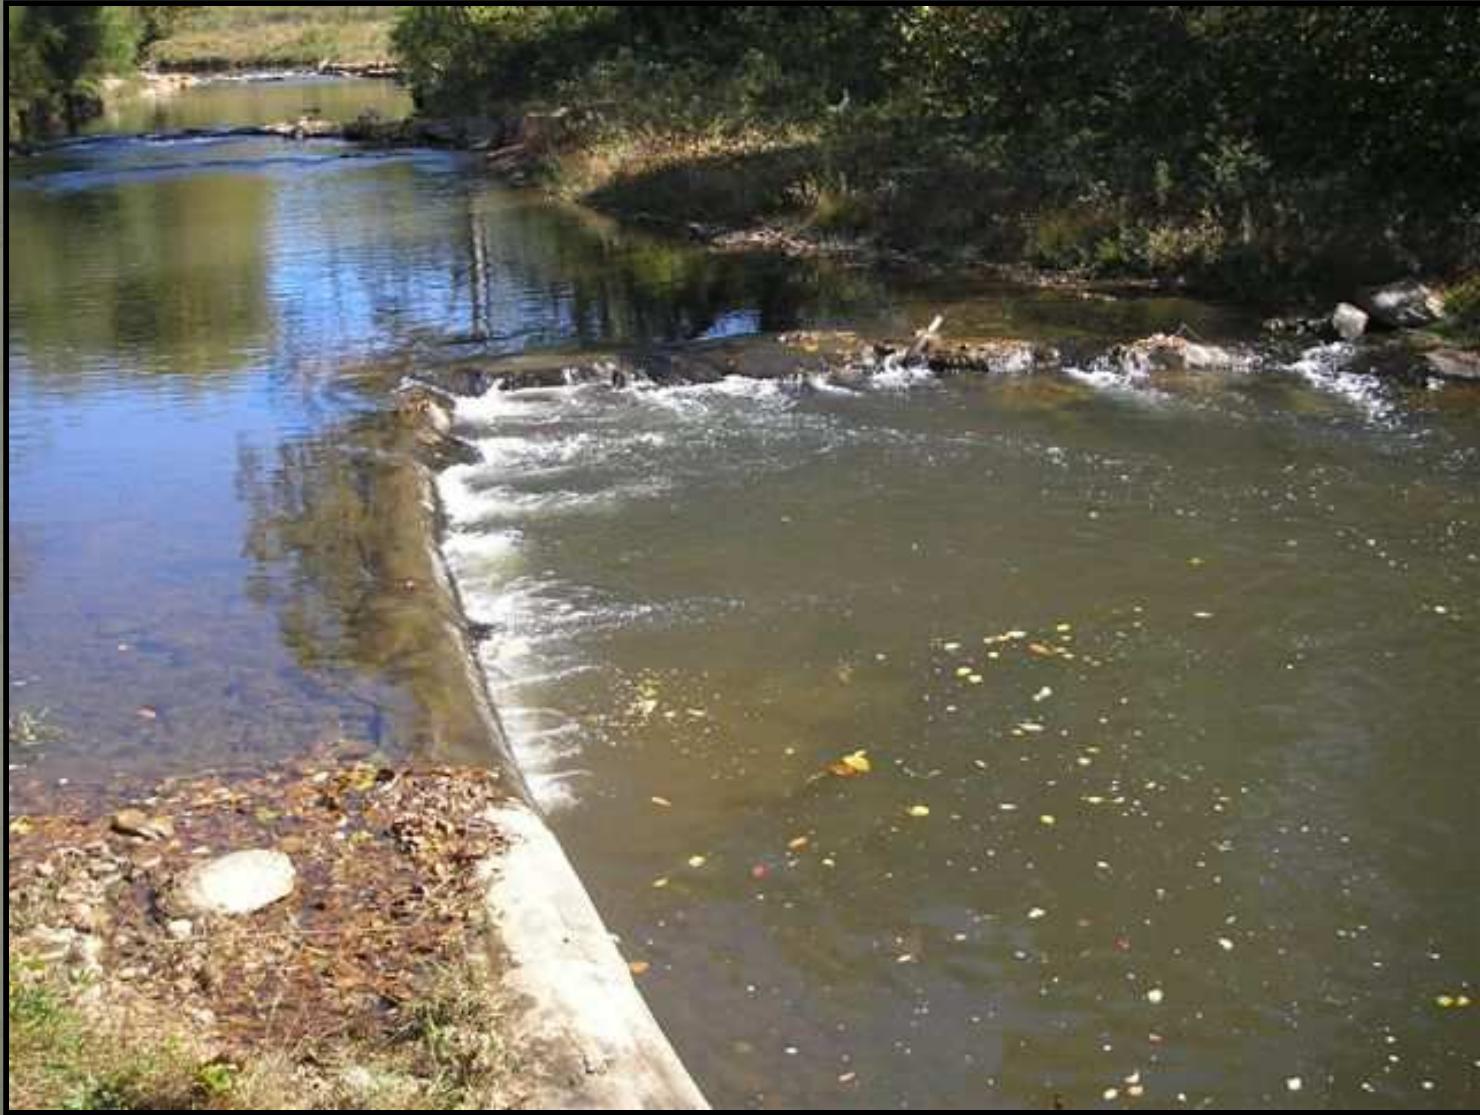
Streambed Improvements

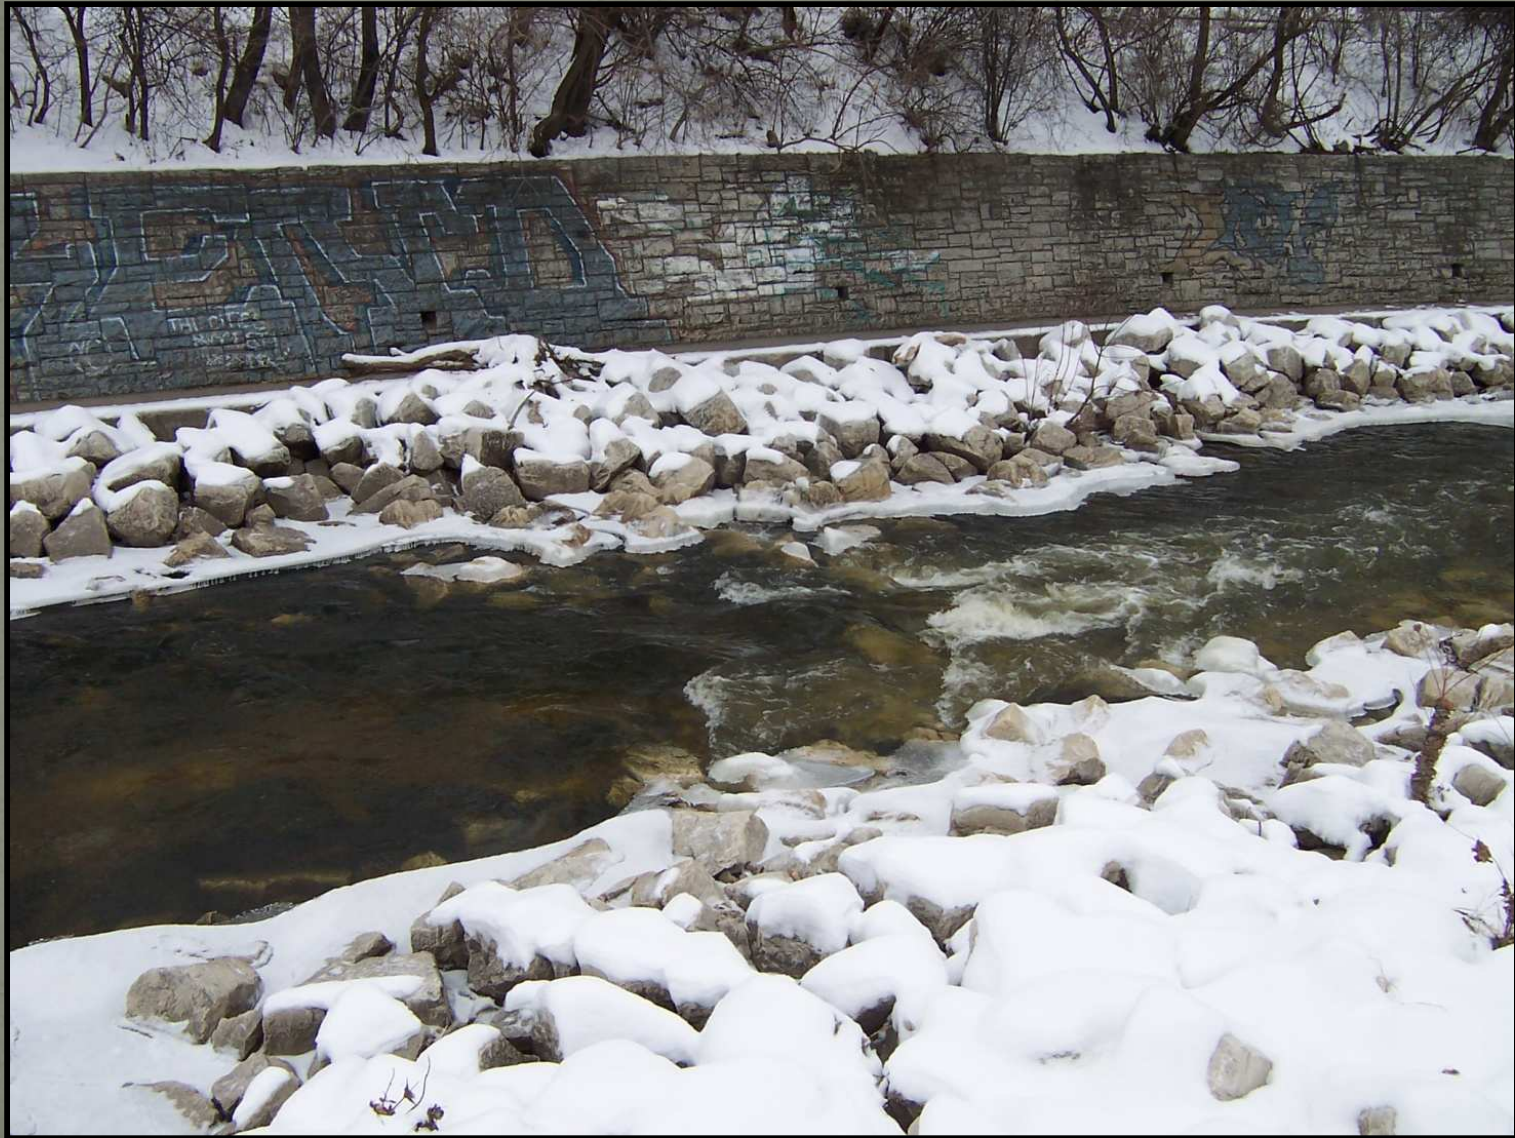
Riffle /Pool Structures

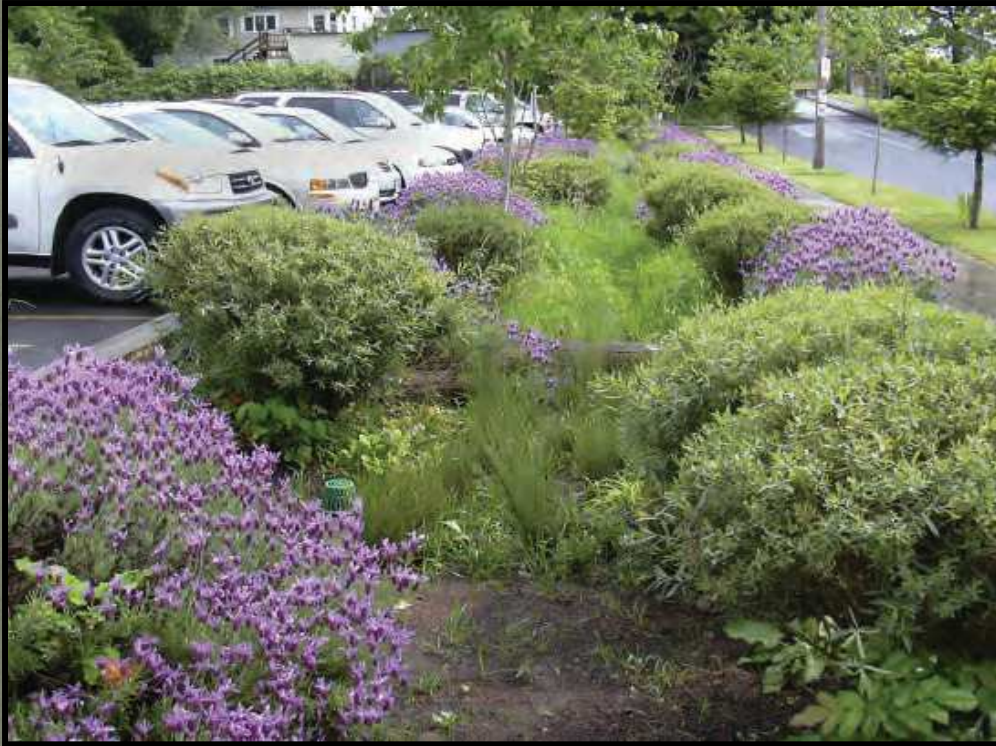
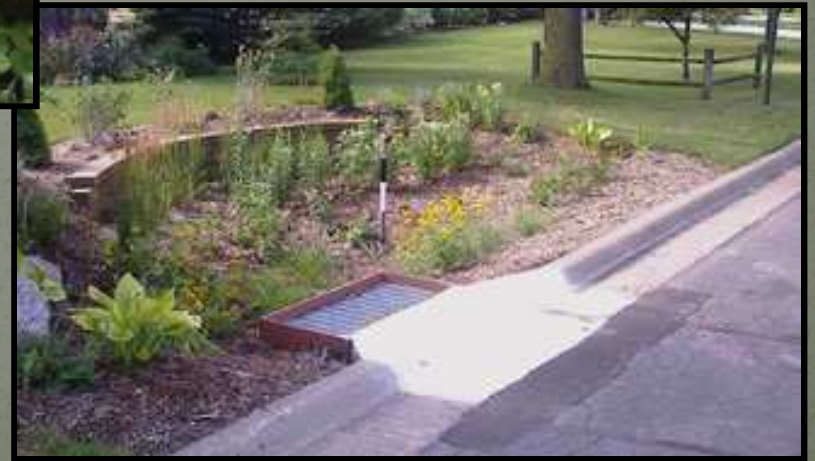
Rain Garden Enhancement

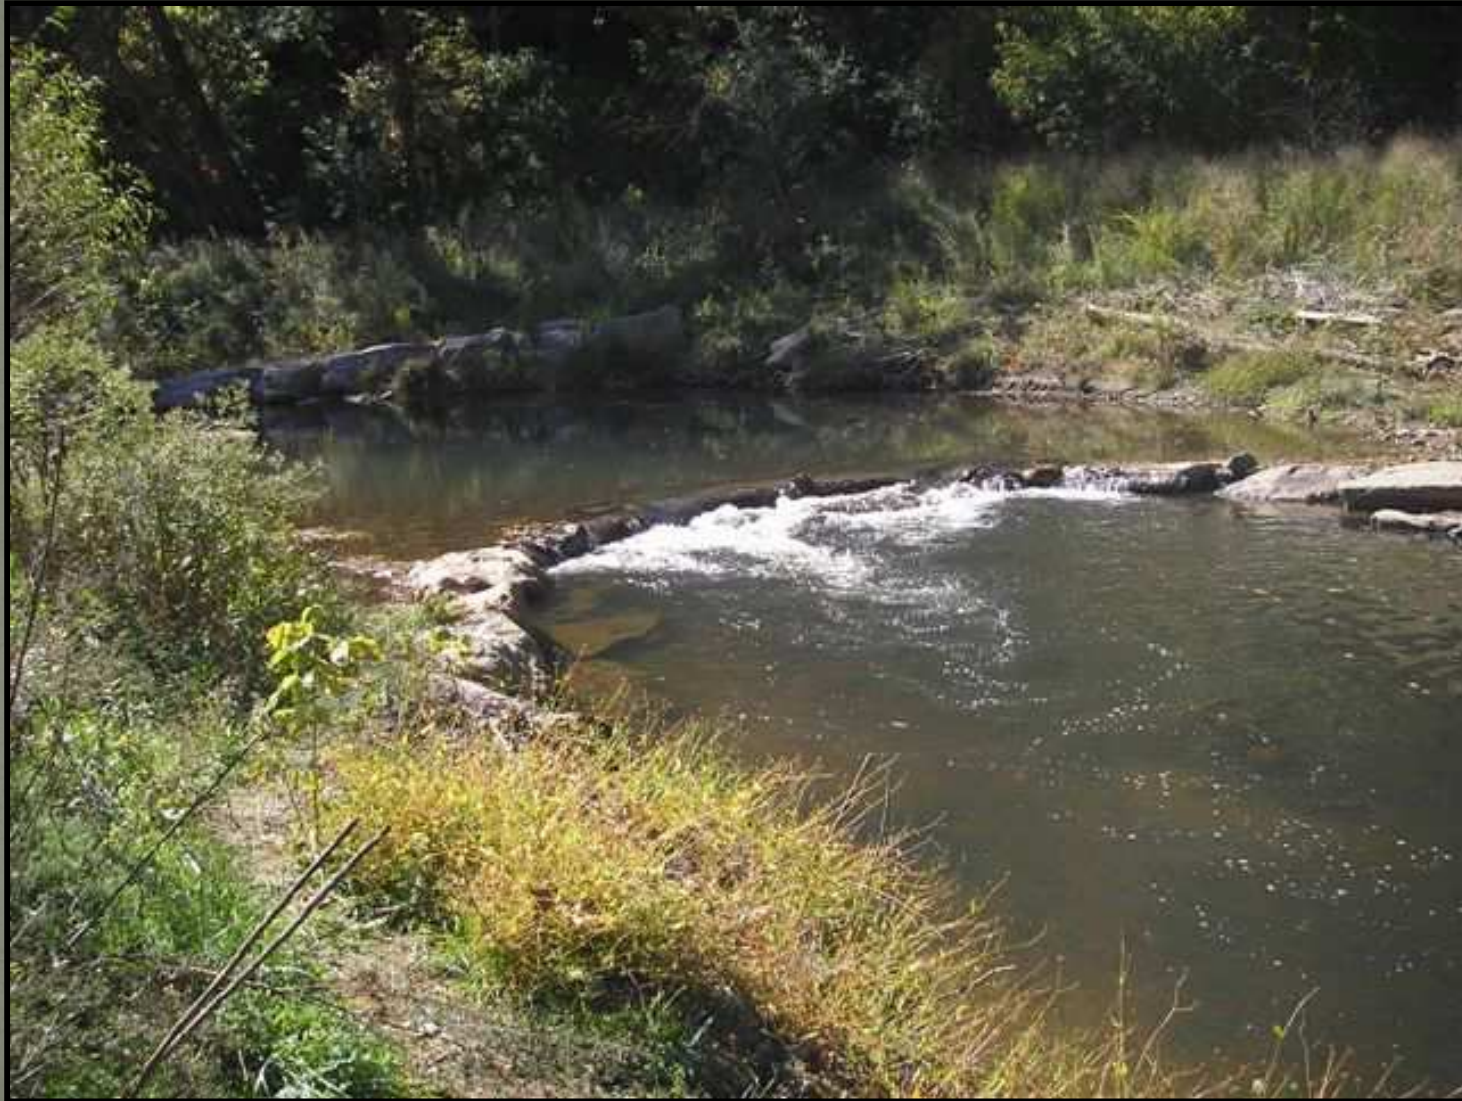
Streambed Improvements

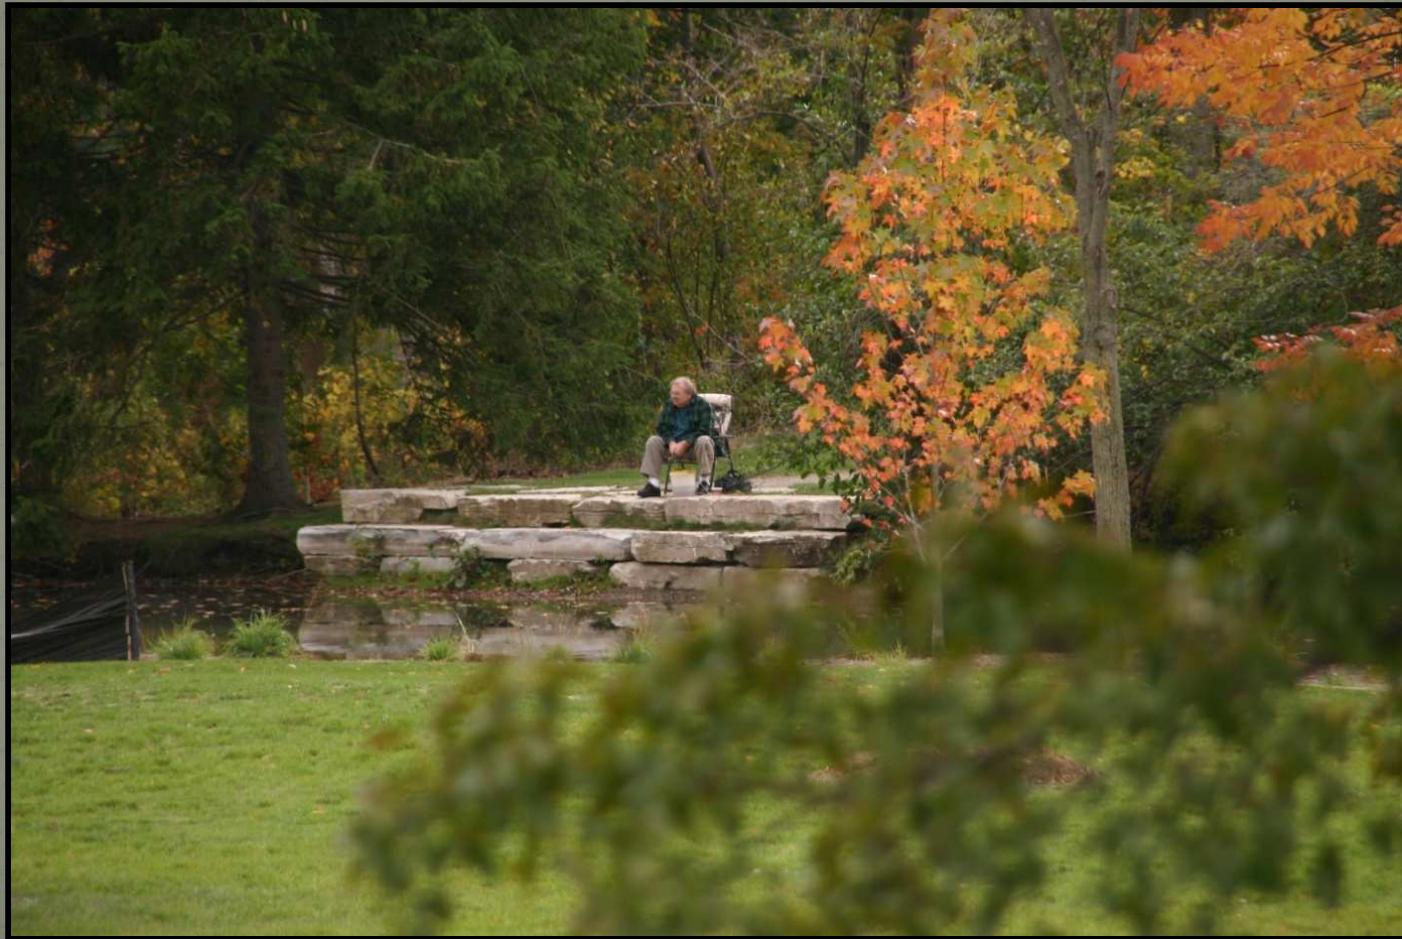
Wall Removed with Stream Bank Improvements for Public Access

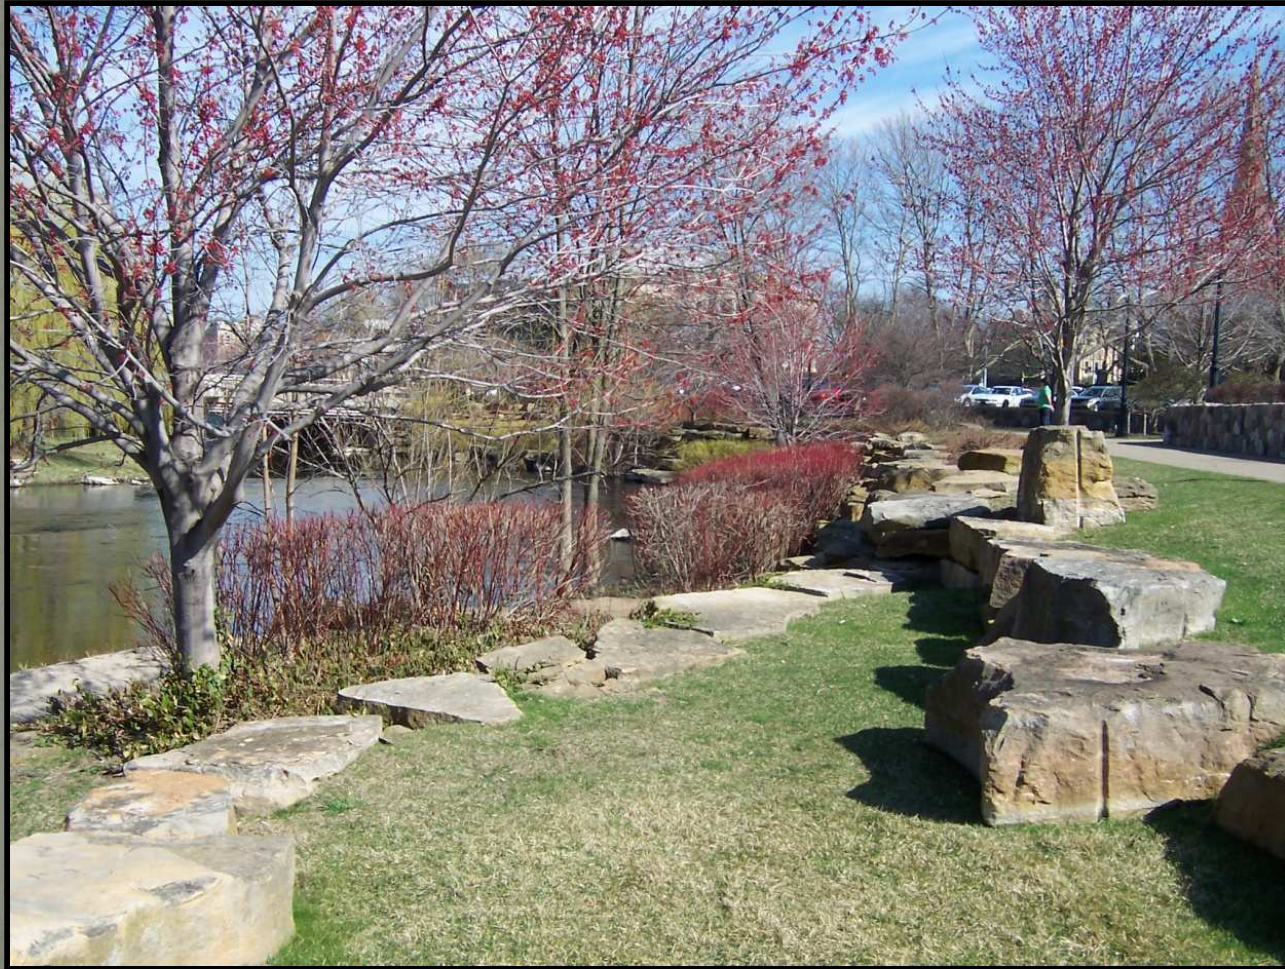
Wall Removed with Stream Bank Improvements for Public Access

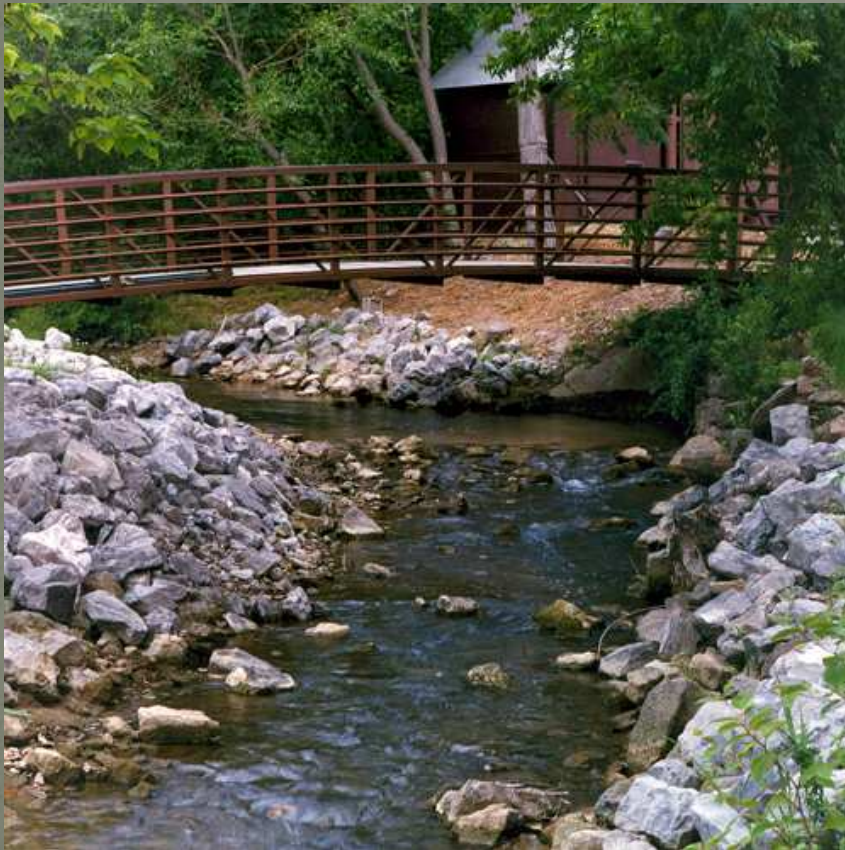
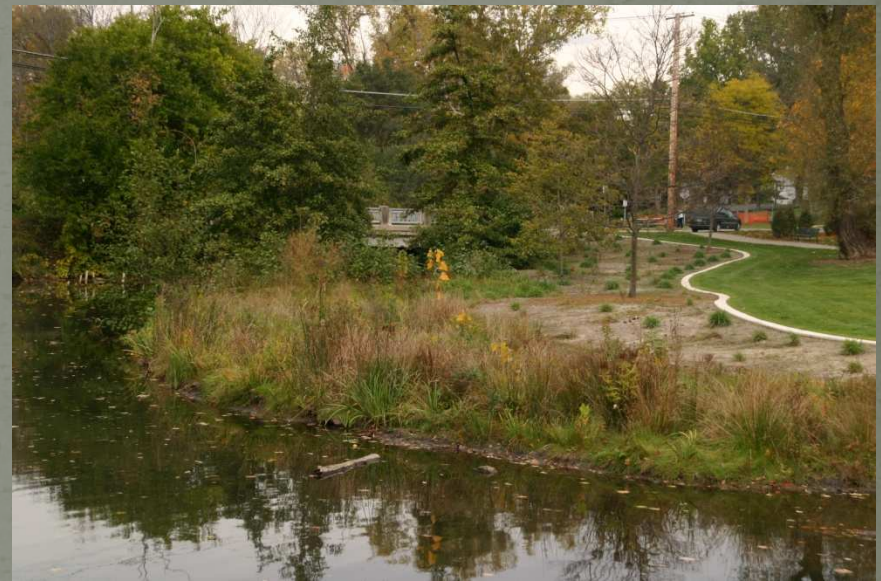
Wall Removed and Stream Bank Improvements

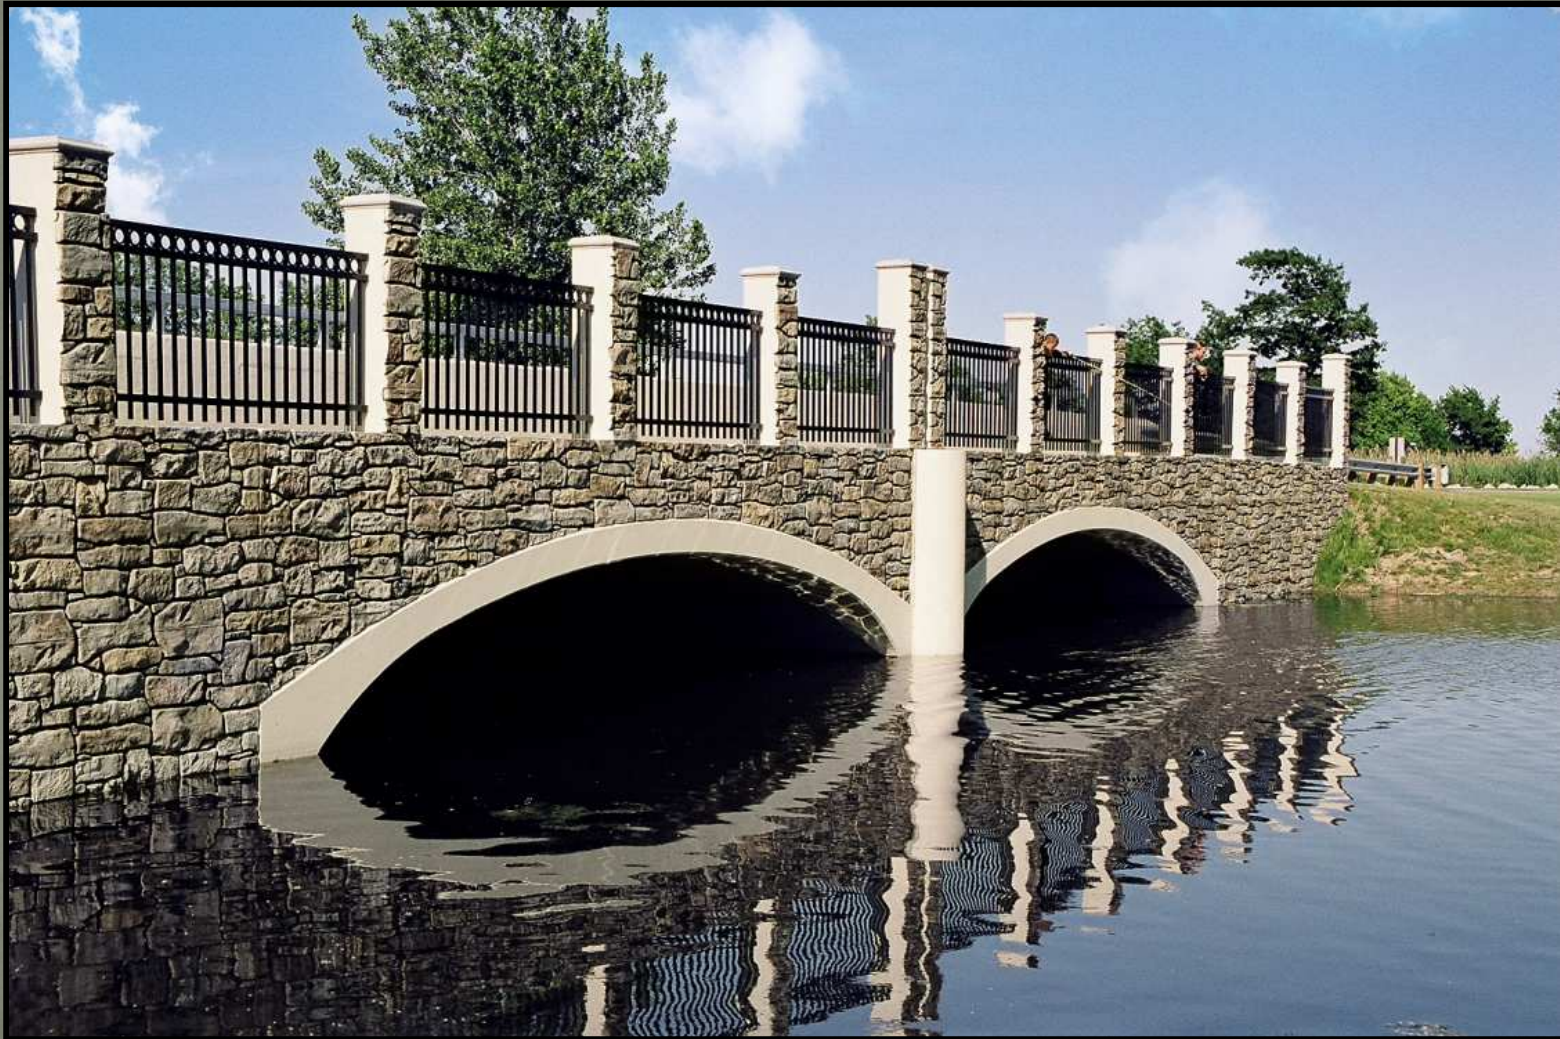
Concrete Retaining Wall with Stone Facing

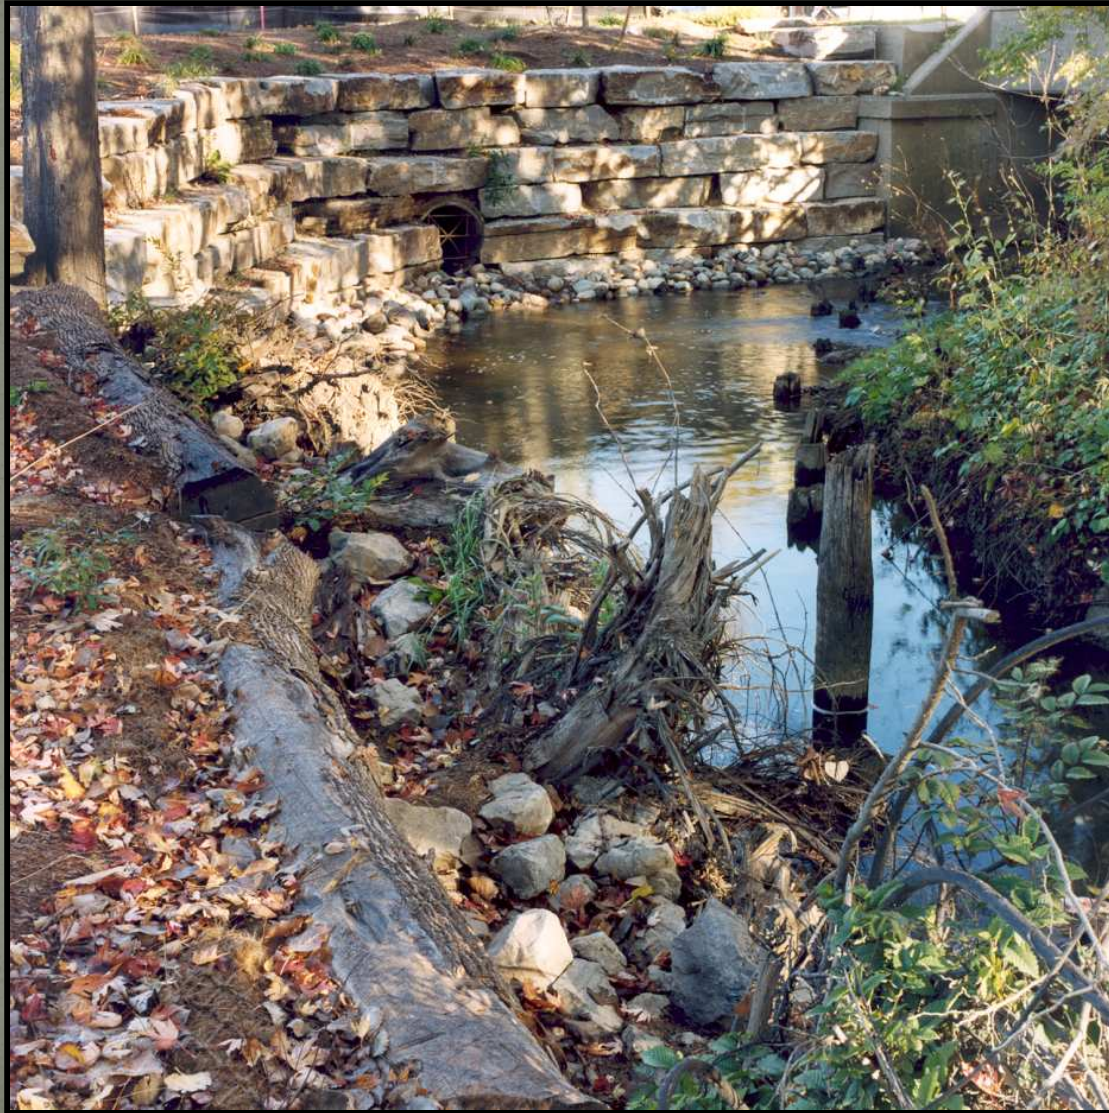
Stone Armoring with Vegetation
