Doan Brook Enhancement Project

**Pre-Design Meeting
January 18, 2011**

Current Doan Brook Enhancement Project

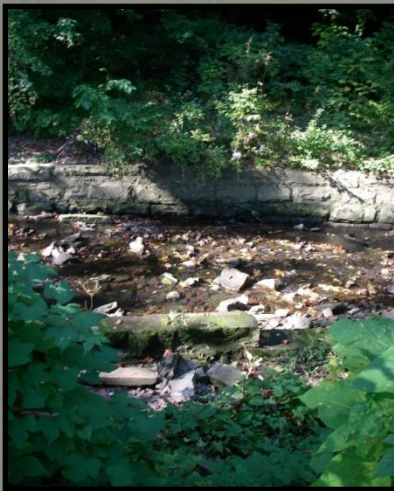
*Failing Wall
with Eroded
Foundation*

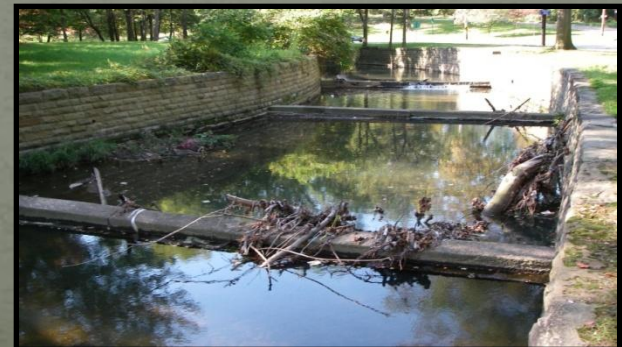
Concrete Check Dams

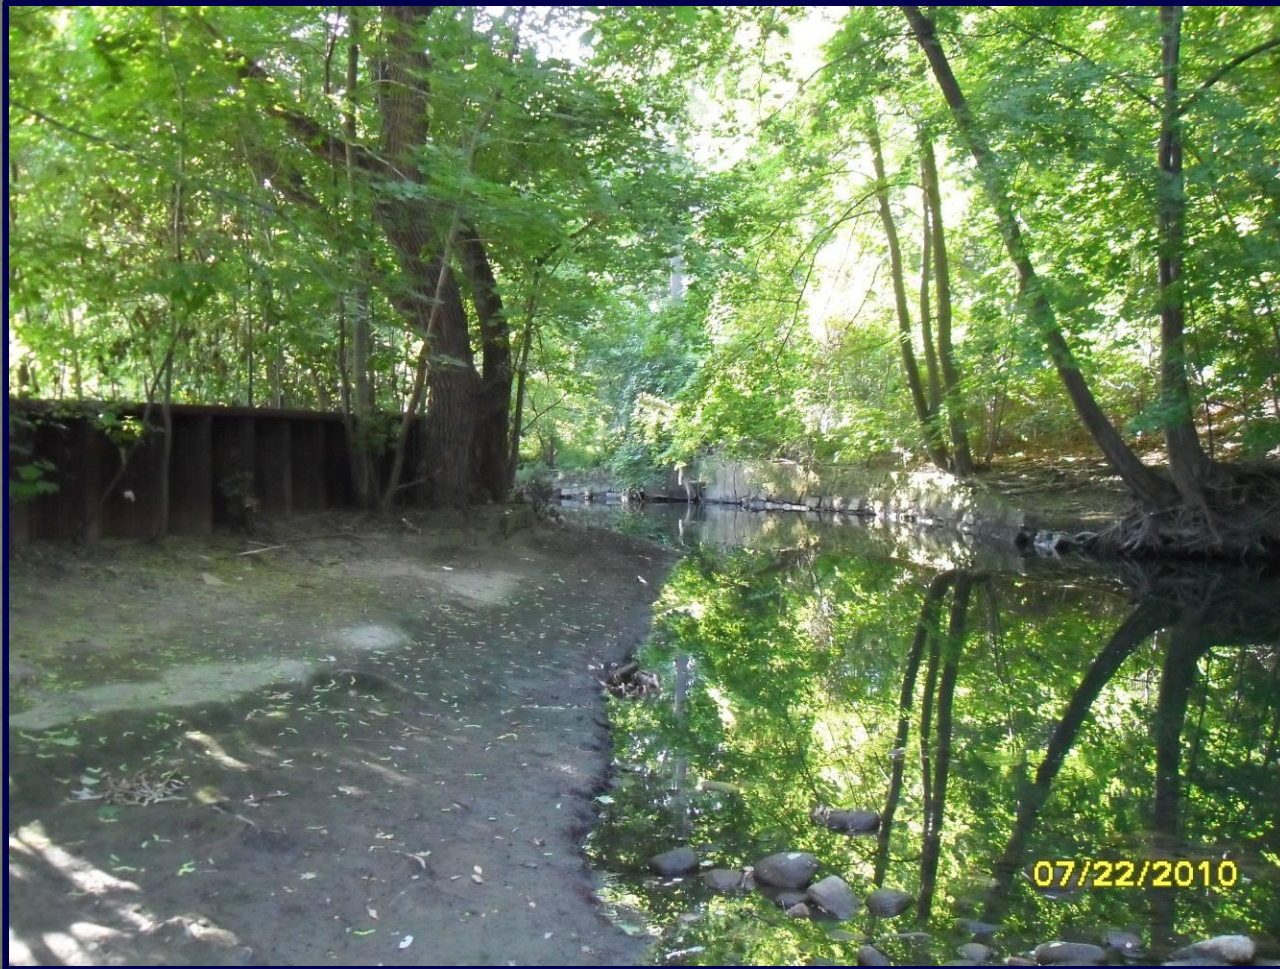
Reach 2 – East 105th Street Culvert to Rockefeller Park Lagoon

This sheet pile wall along the east bank and stone masonry wall along the west bank of Doan Brook adjacent to the Rockefeller Park Lagoon Area is representative of the mix of existing walls within the project area.

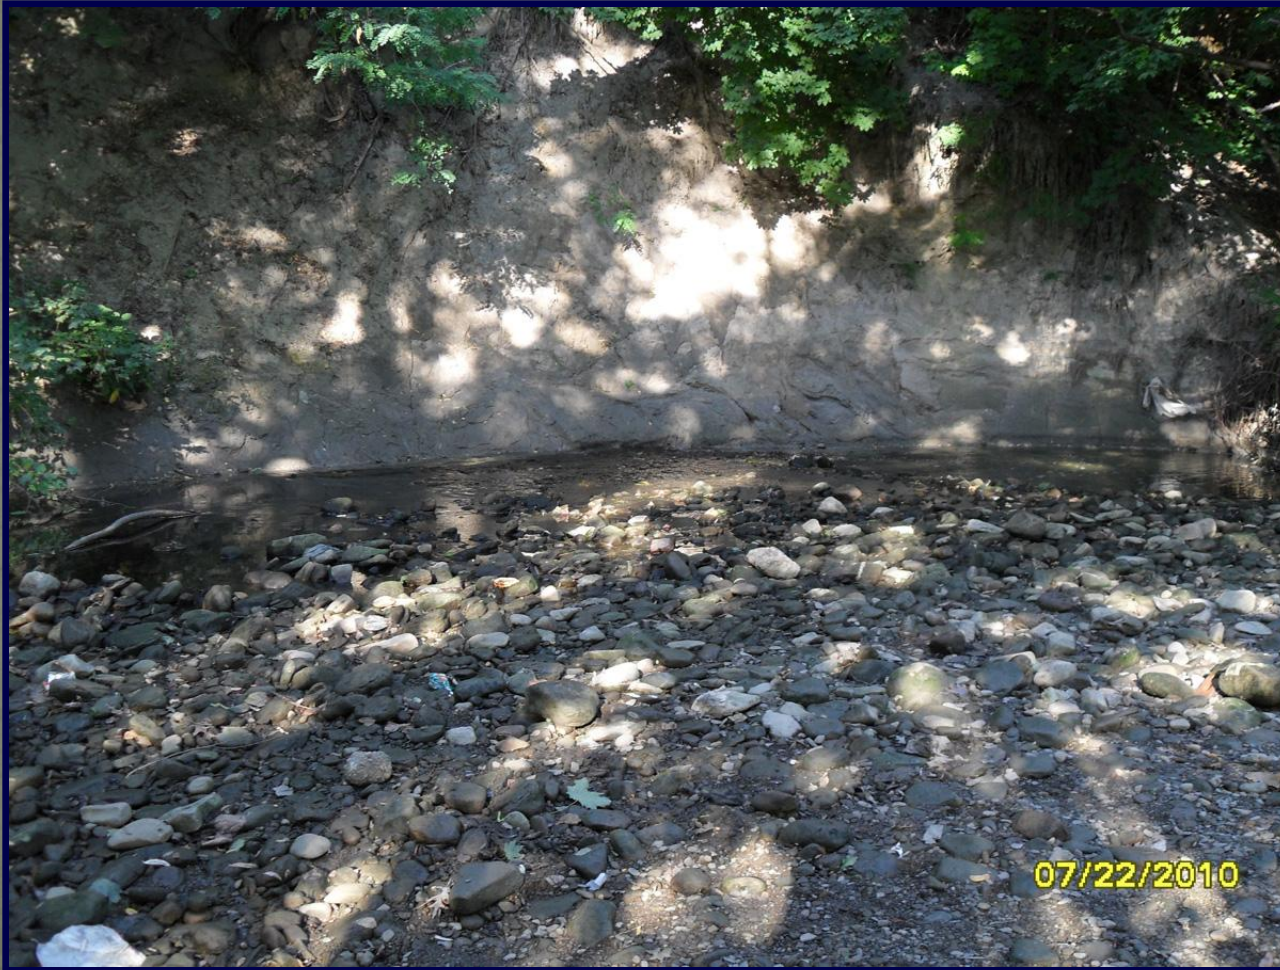
Reach 2 – East 105th Street Culvert to Rockefeller Park Lagoon

This area shows a severe slope failure along the west bank of Doan Brook adjacent to the Rockefeller Park Lagoon Area.

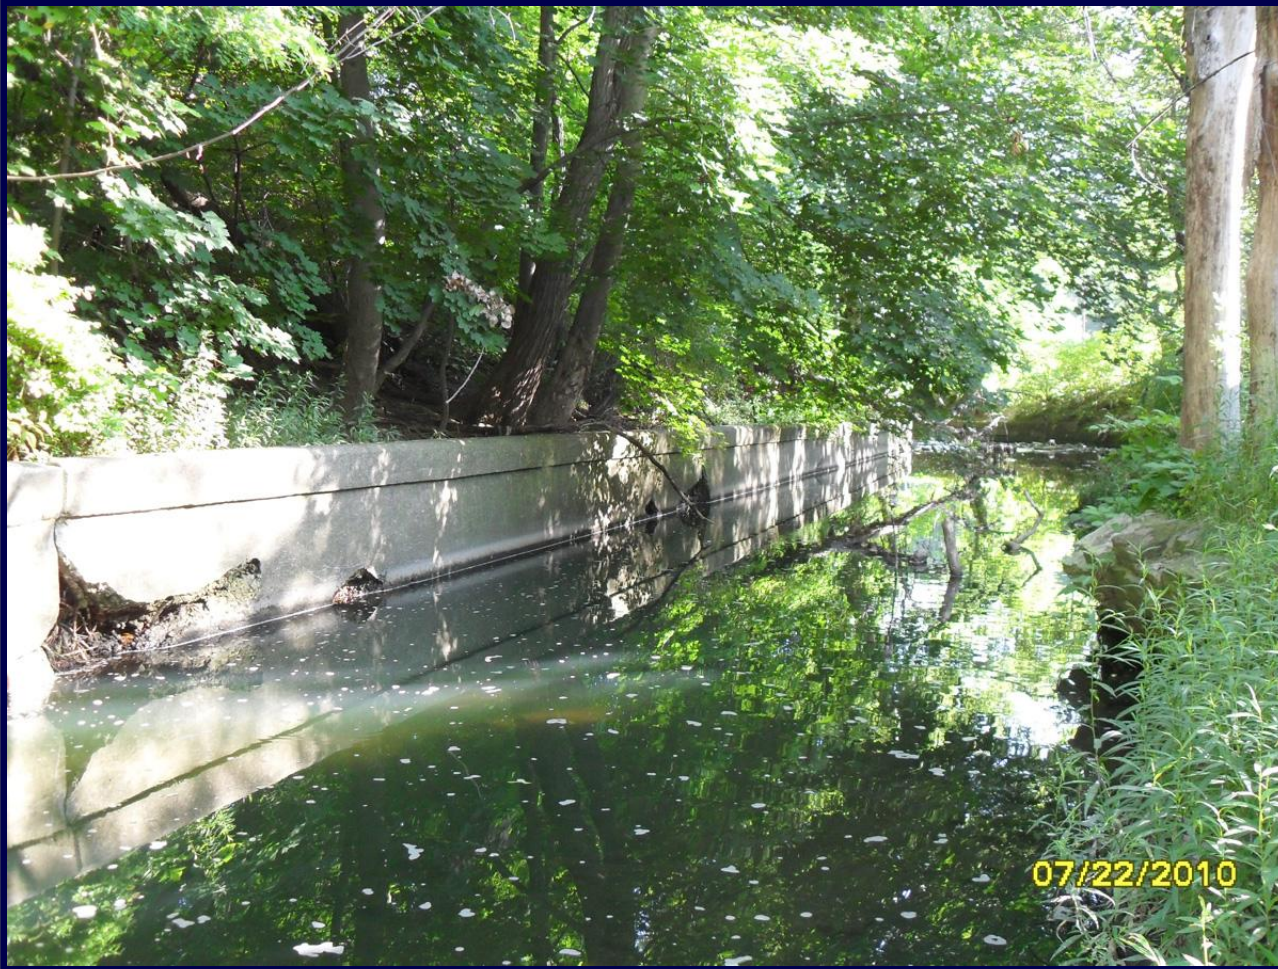
Reach 3 - Rockefeller Park Lagoon to Martin Luther King, Jr. Boulevard Culvert

This concrete retaining wall along the west bank of Doan Brook is representative of failures in the existing wall/walls adjacent to the Rockefeller Park Lagoon Area.

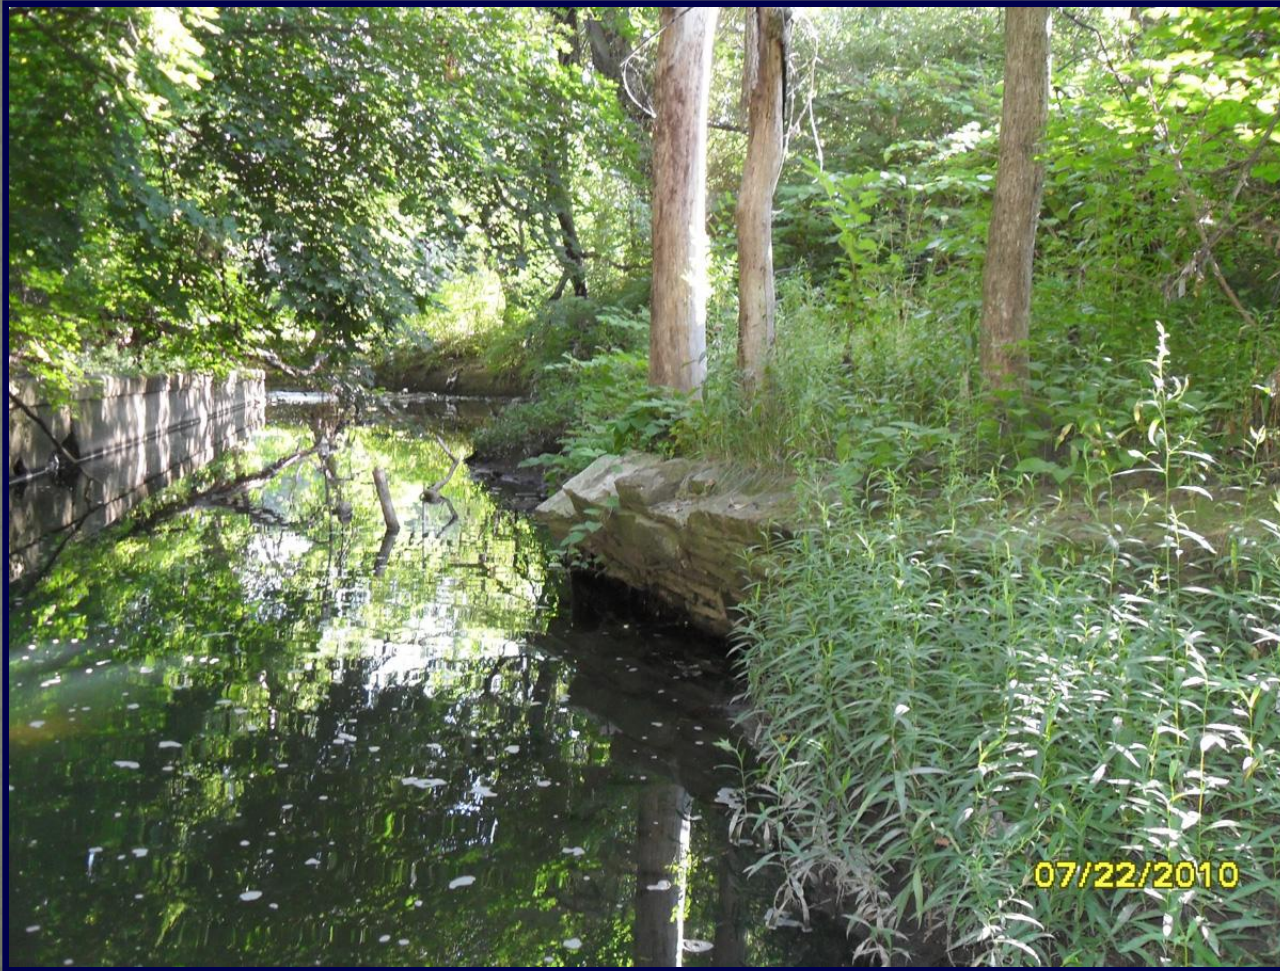
Reach 3 - Rockefeller Park Lagoon to Martin Luther King, Jr. Boulevard Culvert

The east bank opposite the concrete retaining wall also shows a stone masonry wall that is severely damaged, leaning and near failure adjacent to the Rockefeller Park Lagoon Area

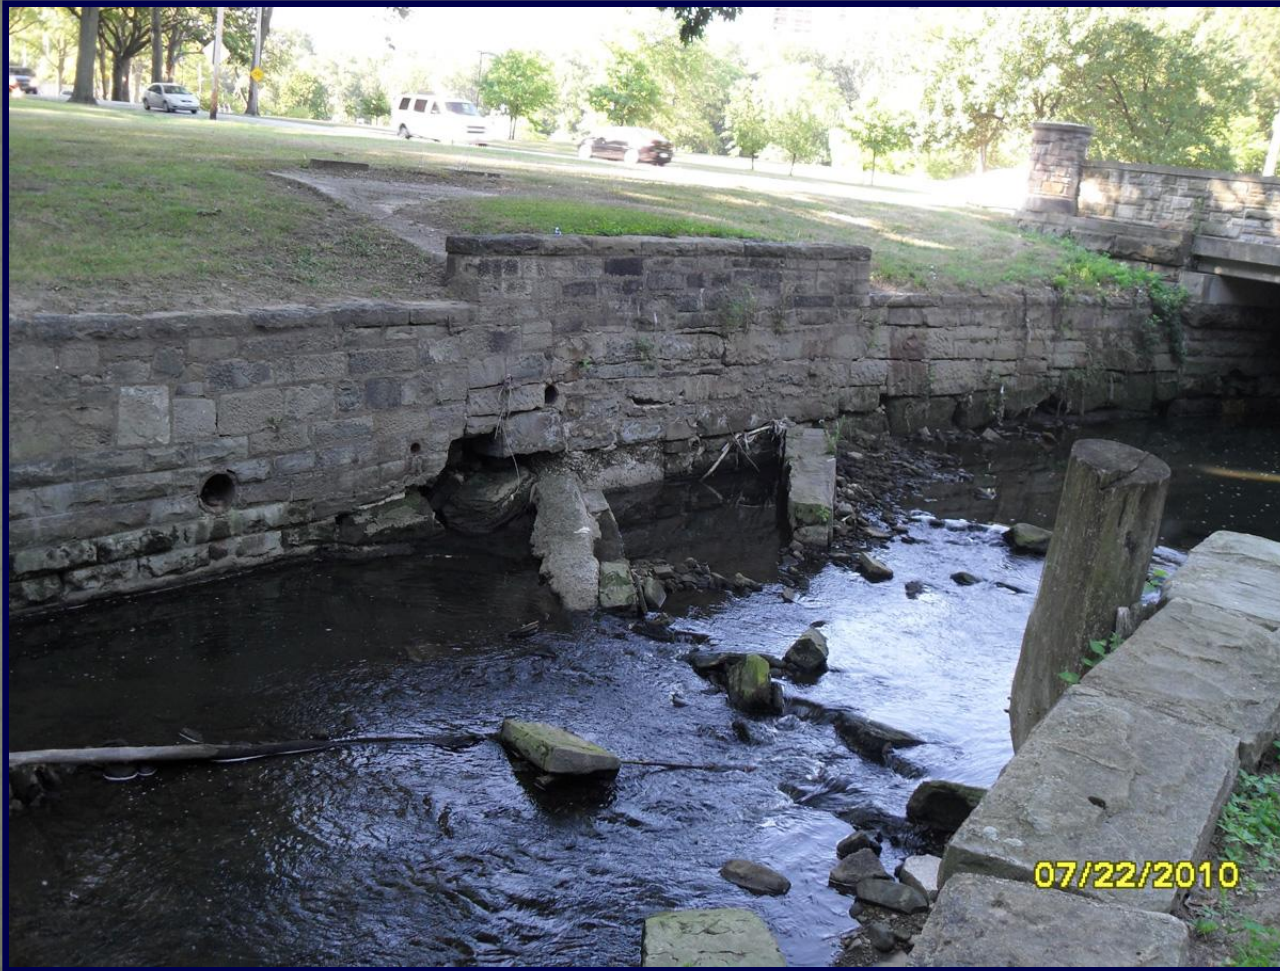
Reach 4 - Martin Luther King, Jr. Boulevard Culvert to Wade Park Boulevard Culvert

This shows a section of wall along the east side of Doan Brook that is being undermined just to the north of the Martin Luther King Jr. Boulevard culvert over Doan Brook south of Wade Park Avenue. This may have been a result of the flow diversions not being properly placed within the brook.

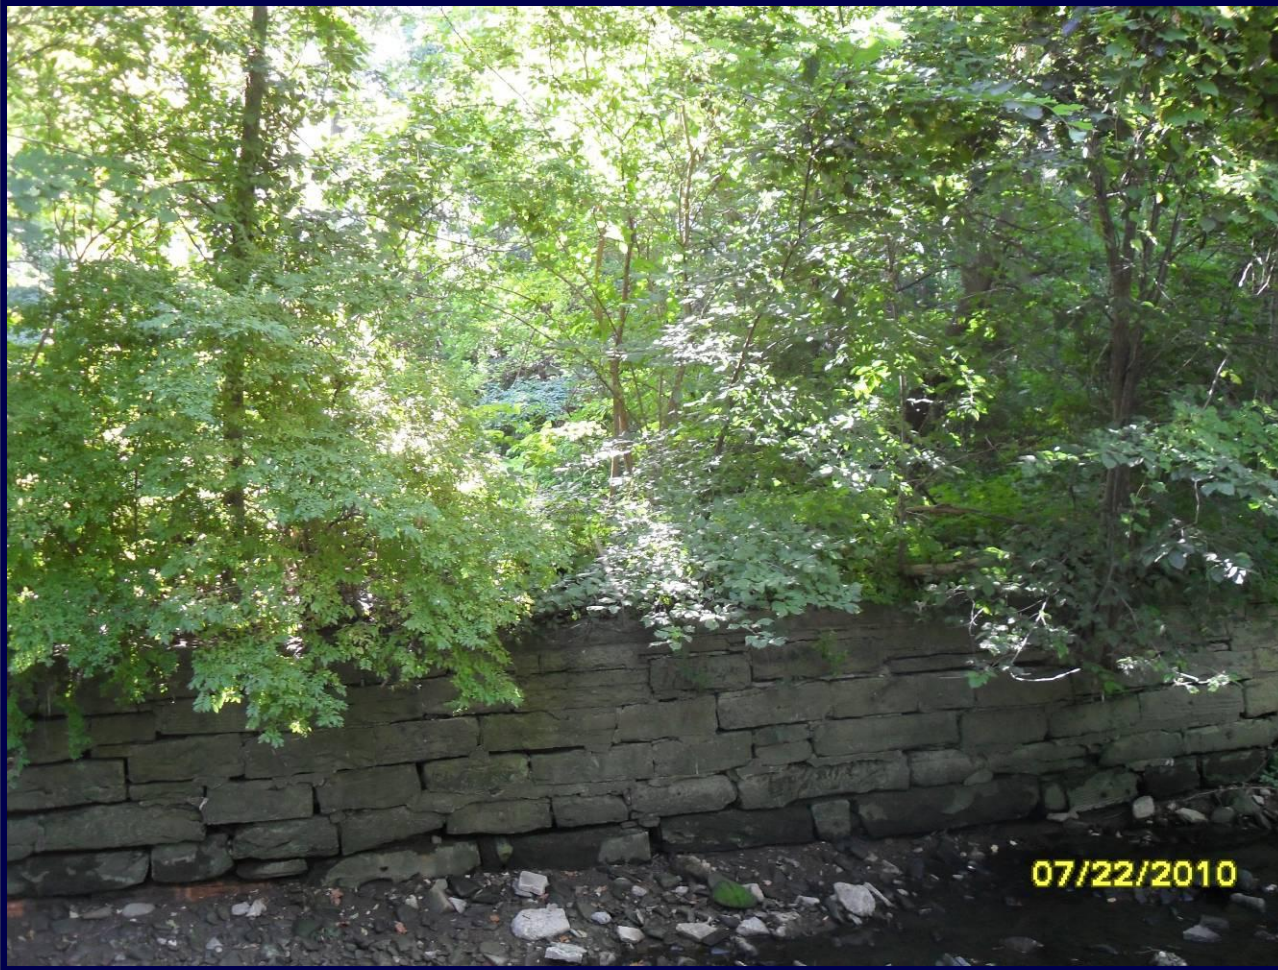
Reach 4 - Martin Luther King, Jr. Boulevard Culvert to Wade Park Boulevard Culvert

This shows a section of wall along the east side of Doan Brook just south of Wade Park Avenue that has lost a considerable portion of concrete mortar interlocking the stone wall. This wall is susceptible to crumbling and future structural failures.

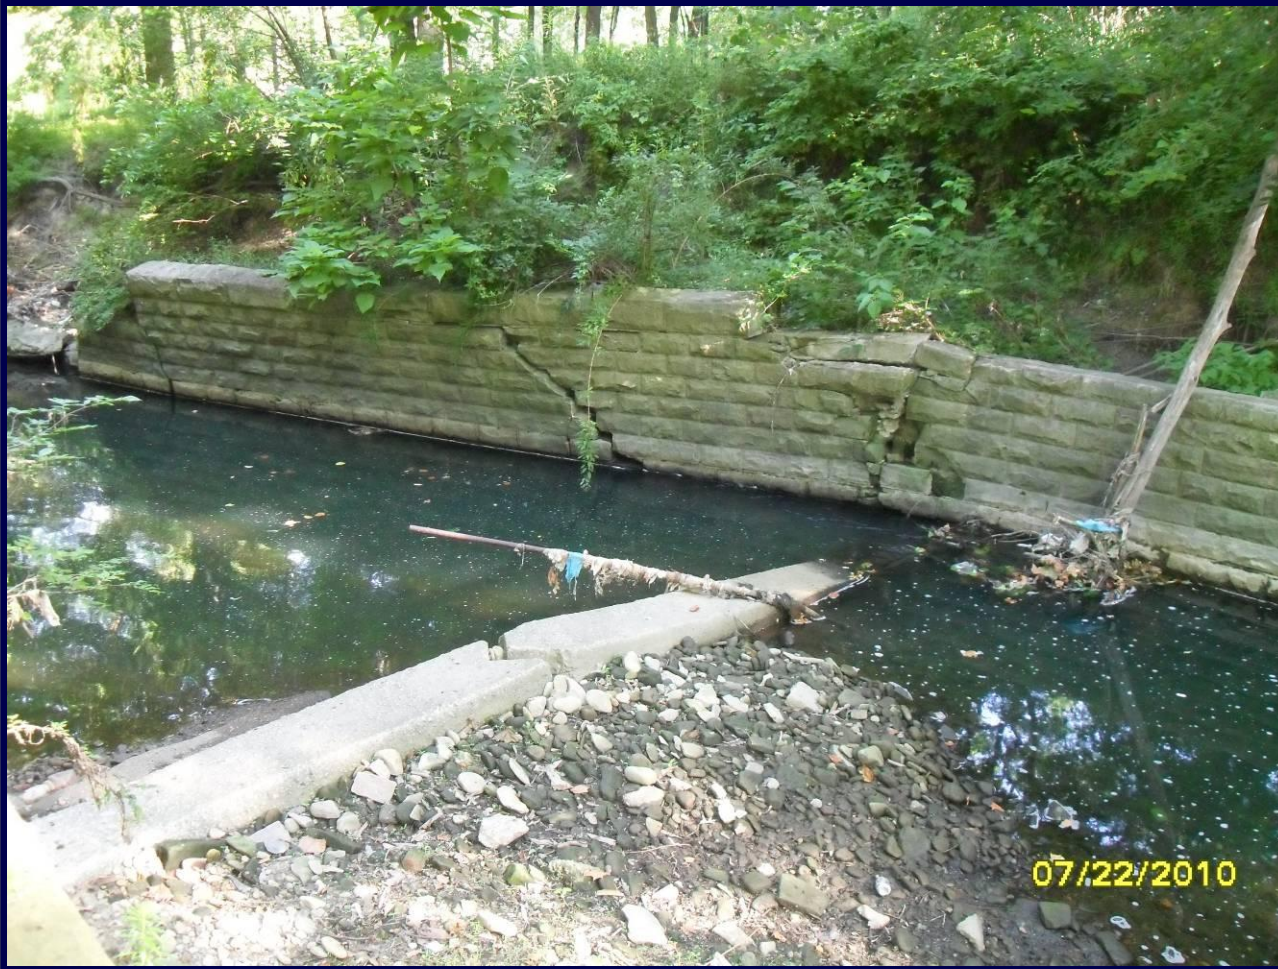
Reach 5 - Wade Park Boulevard Culvert to Old Bridge Abutment

This shows a section of wall along the east side of Doan Brook to the north of Wade Park Avenue buckling and leaning toward the brook. This may be a result of the wall being undermined at this check dam area.

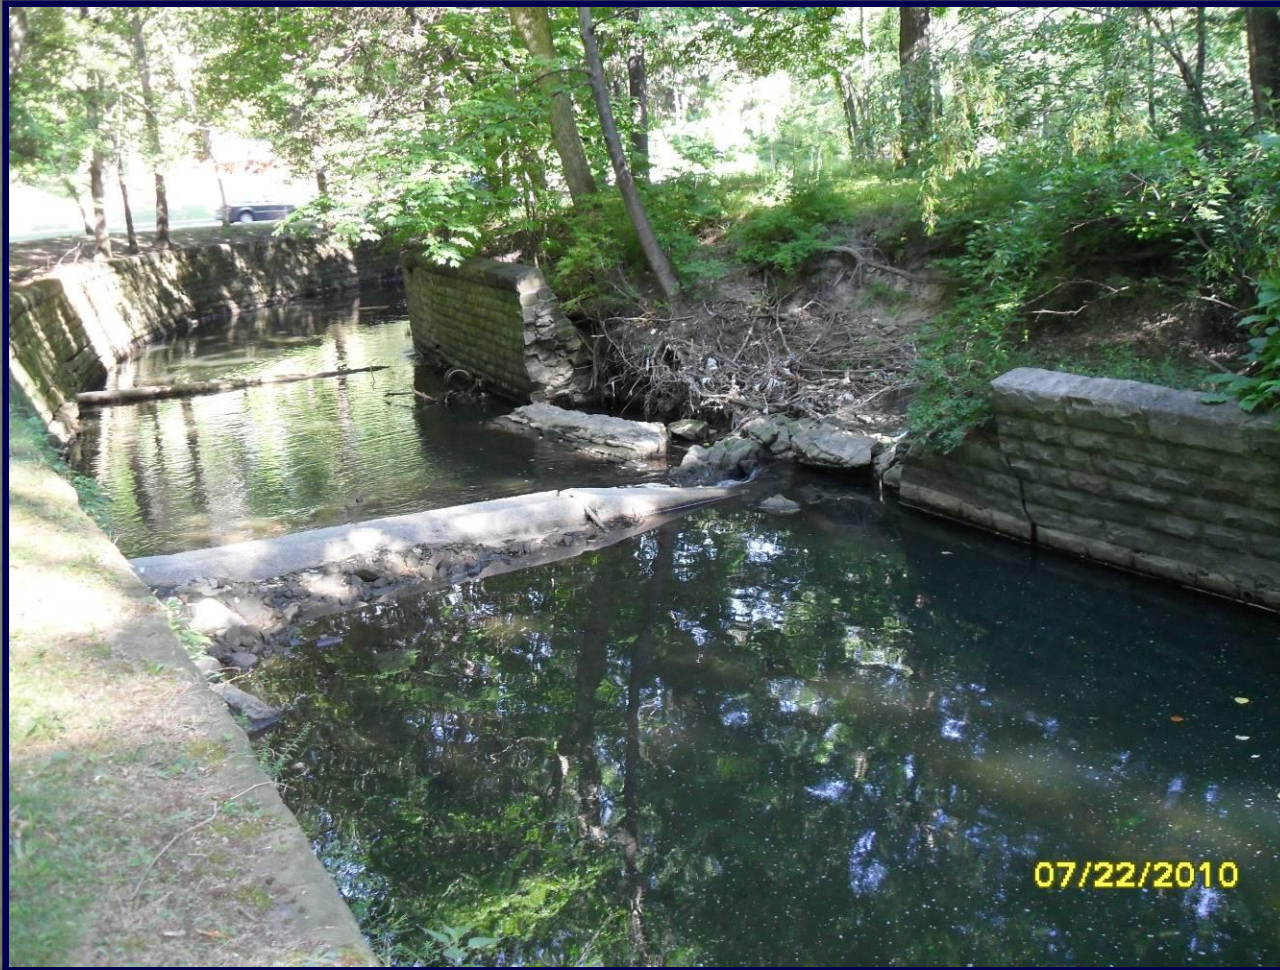
Reach 5 - Wade Park Boulevard Culvert to Old Bridge Abutment

This shows a section of wall along the east side of Doan Brook that is completely washed out between Wade Park Avenue and Superior Avenue. This may have been a result of the wall being undermined at this check dam area.

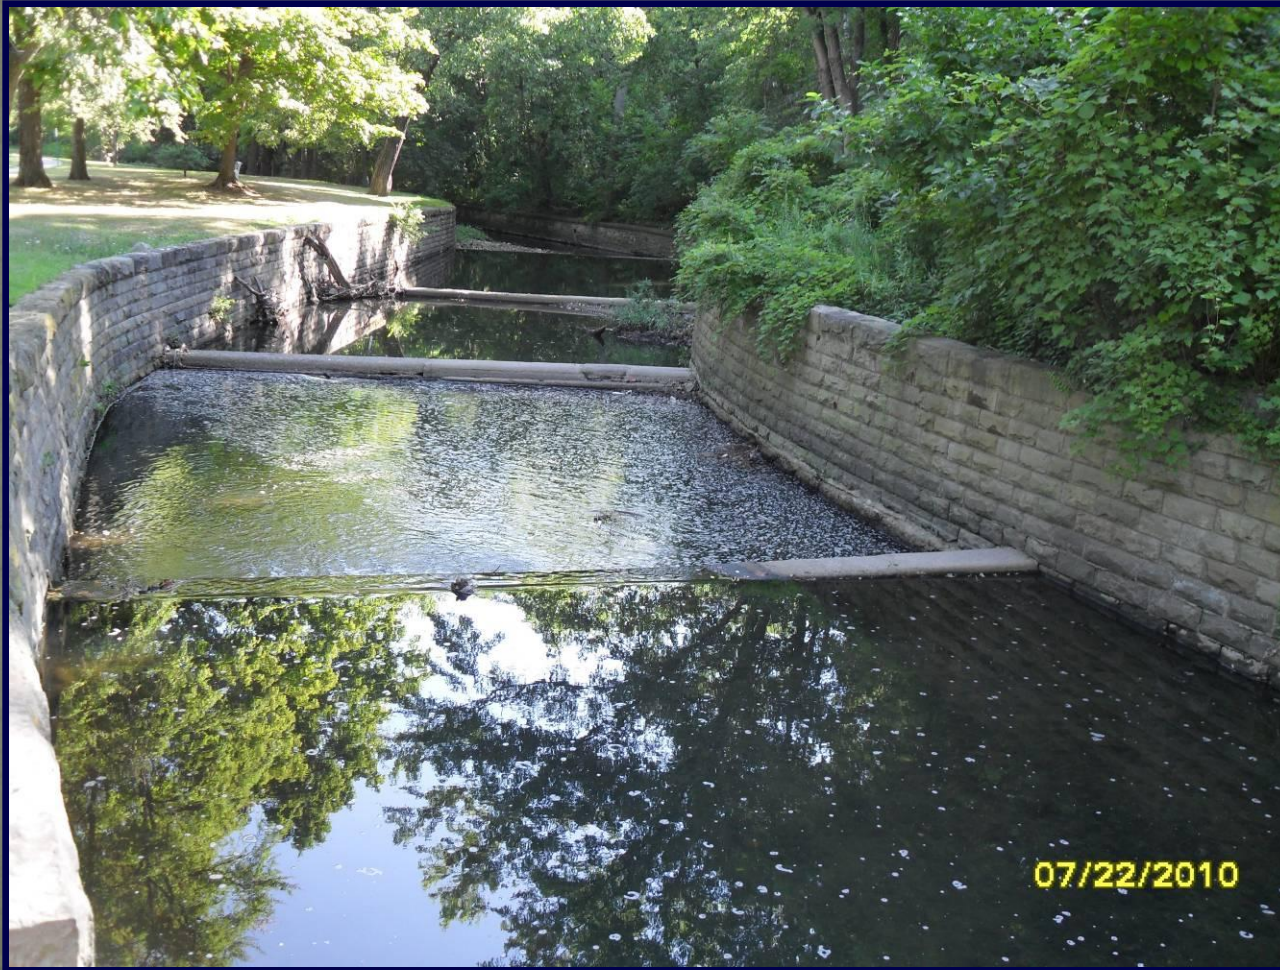
Reach 5 - Wade Park Boulevard Culvert to Old Bridge Abutment

This shows a series of check dams along Doan Brook between Wade Park Avenue and Superior Avenue. Doan Brook drops approximately 7 feet in elevation through this 600 foot section of the Brook. These check dams create sections of stagnant water and heavy sediment/material accumulation.

- Plan should be to improve water quality in future.
- Need to keep water moving. Check dams, create stagnant ponds.
- How are you dealing with "canyons" where there is an 8 foot drop? Lower stretches (reaches 4 & 5) where walls are vertical.

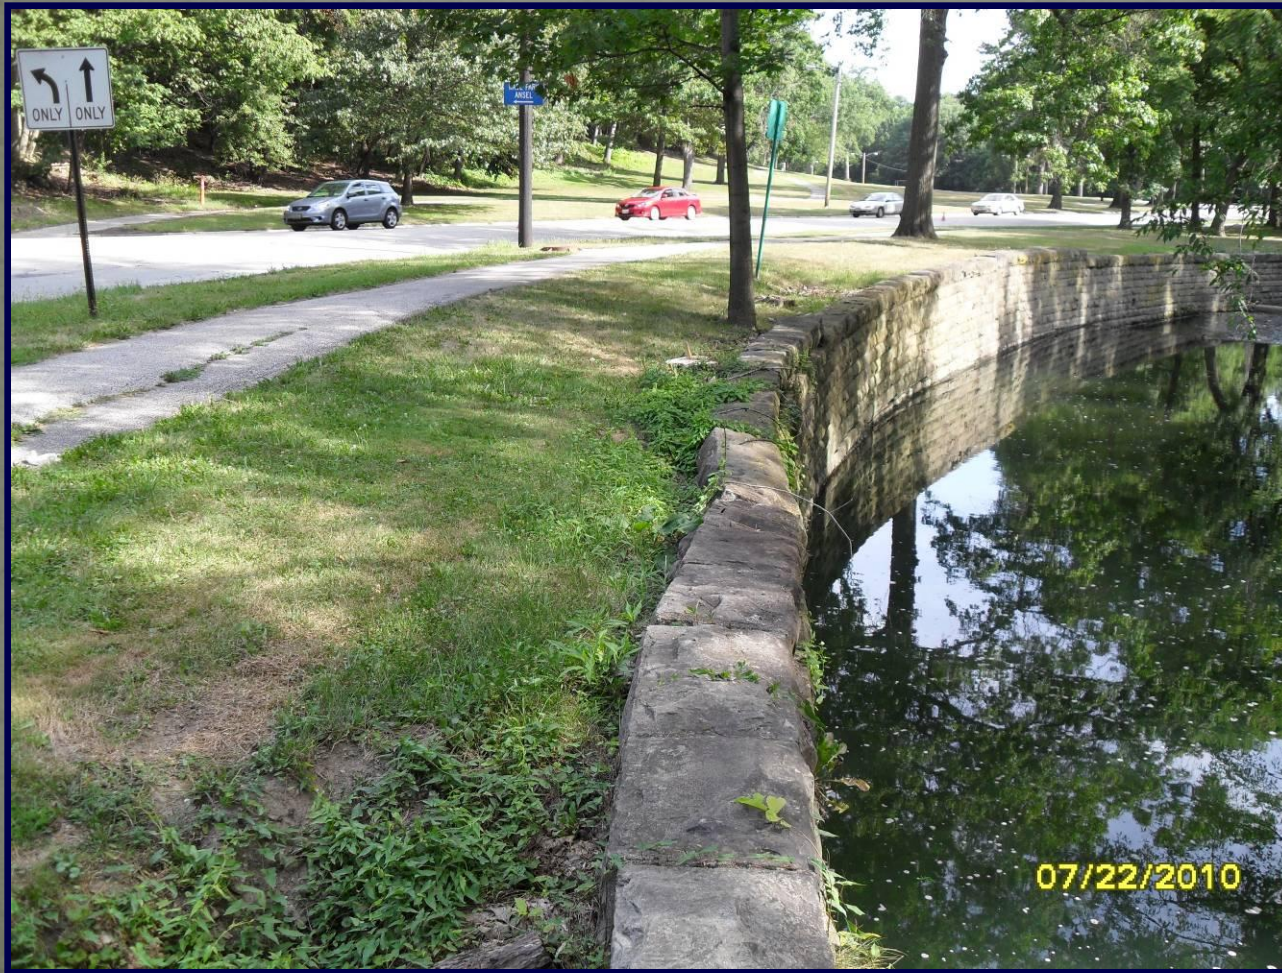
Reach 5 - Wade Park Boulevard Culvert to Old Bridge Abutment

This shows a section of wall along the west side of Doan Brook that has buckled with a potential to collapse. This area is very close to Martin Luther King Boulevard between Wade Park Avenue and Superior Avenue. This section of wall appears to be failing as a result of the check dam undermining the wall at this location. Note the pedestrian trail damage.

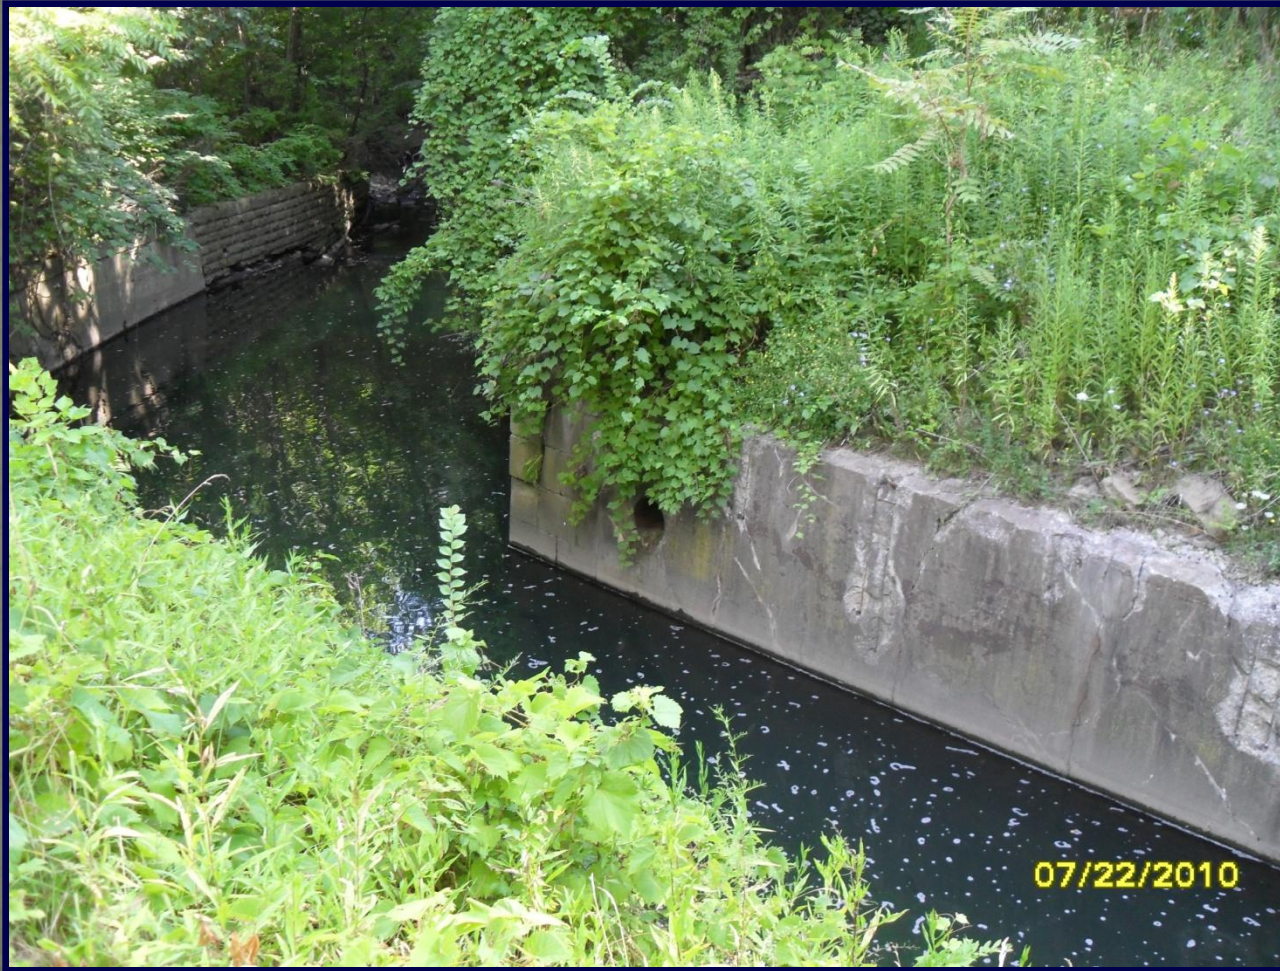
Reach 5 - Wade Park Boulevard Culvert to Old Bridge Abutment

This shows a concrete retaining wall section along the east side of Doan Brook at the Old Bridge Abutment. This section of the brook narrows to nearly one half of the typical width of Doan Brook, severely reducing the flow capacity of Doan Brook at this location south of Superior Avenue.
