*Watershed Advisory Committee
Lake Erie Direct Tributaries
& Chagrin River
October 24, 2019*

NORTHEAST OHIO REGIONAL SEWER DISTRICT

REGIONAL
STORMWATER
MANAGEMENT
PROGRAM

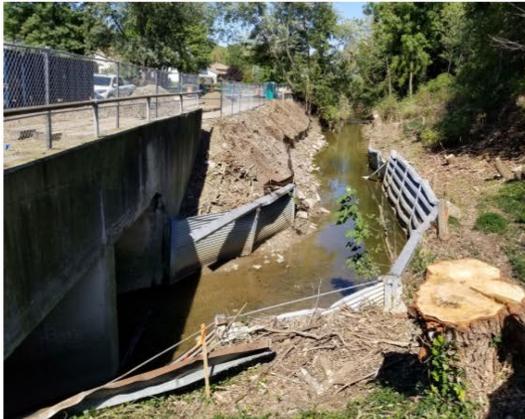
5 Baldwin Creek Bank Stabilization

Community: Parma

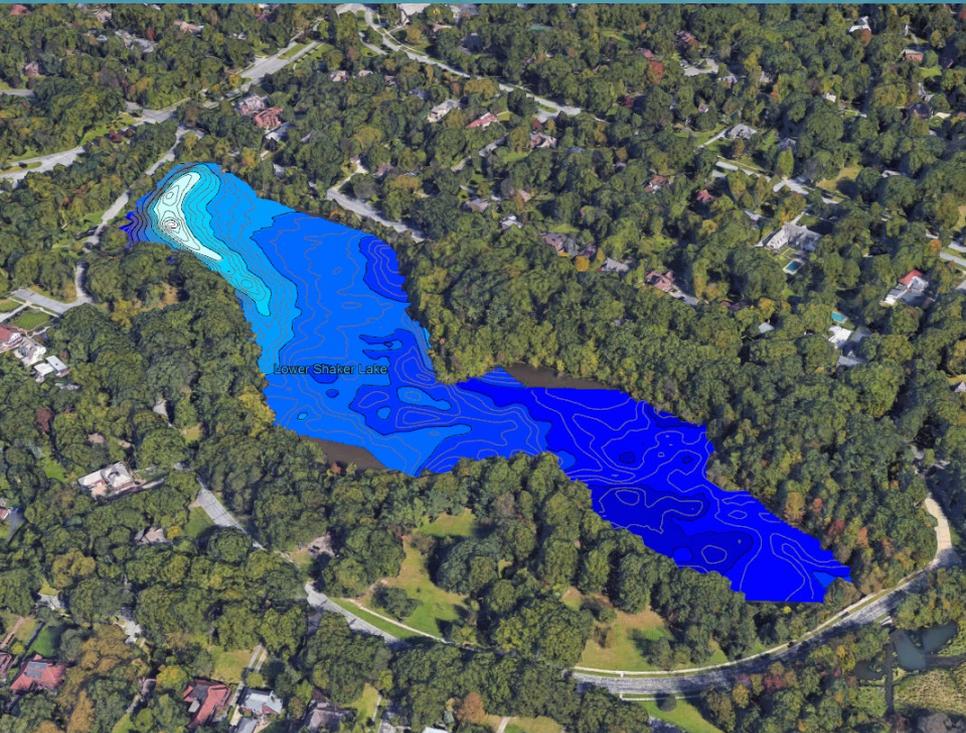
Chagrin River / Lake Erie Direct Tributaries

Significant work: thru October 2019

- Spherical Imagery Collection
- Completion of Geomorphic Field Inspections
- Installation of 17 HWM Gauges & 9 Level Sensors
- CCTV/PACP Inspection of Culverts
- Field Inspection & Bathymetric Data Collection of Basins
- Commence Development of Doan Brook SWMM Model
- Development of SWMP Model Management Protocols

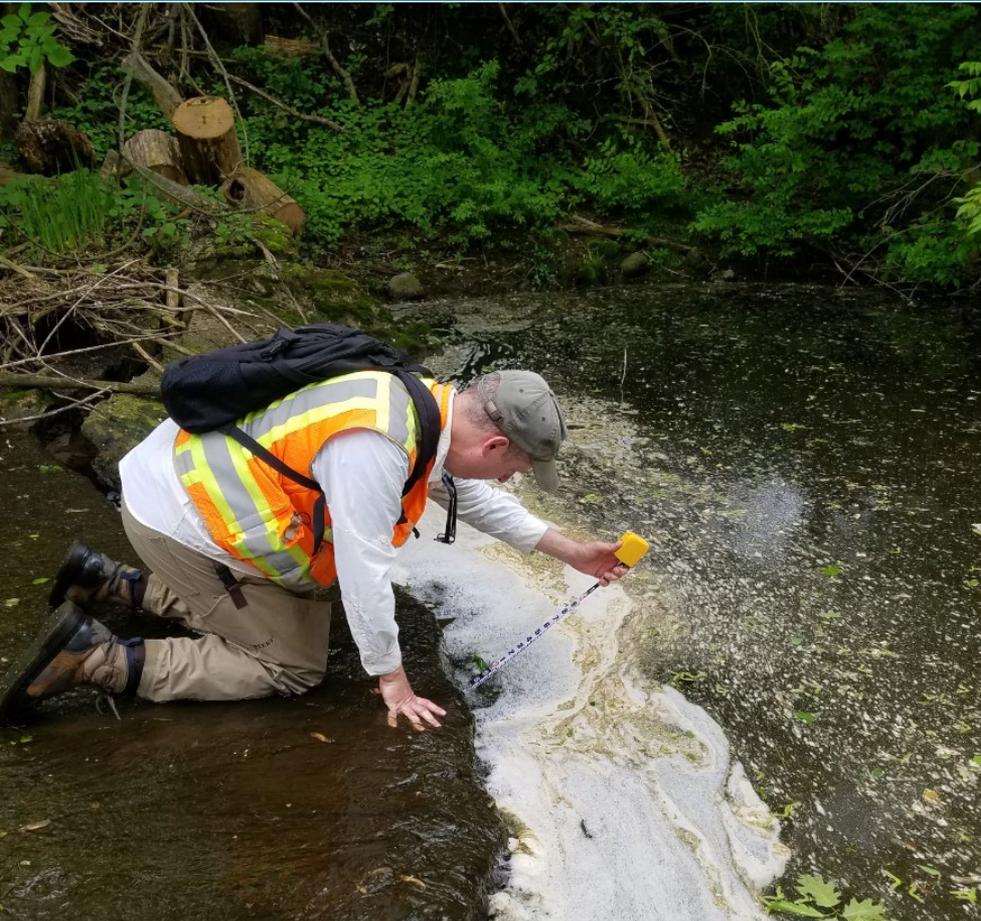
Field Work Project Status

Task Item Status – 62% Complete

CCTV Inspection

28.4 miles completed

- 23 miles Combined Sewer System
- 5.2 miles Culverted Stream

Basin Inspection

16 basins inspected

Geomorphic Inspection

62.7 miles inspected (approximate)

- 1115 reach segments drawn

Survey

- 2/5 Complex Bridge
- 67/118 Cross Section
- 128/212 Culvert
- 96/154 Invert Only
- 57/78 Simple Bridge

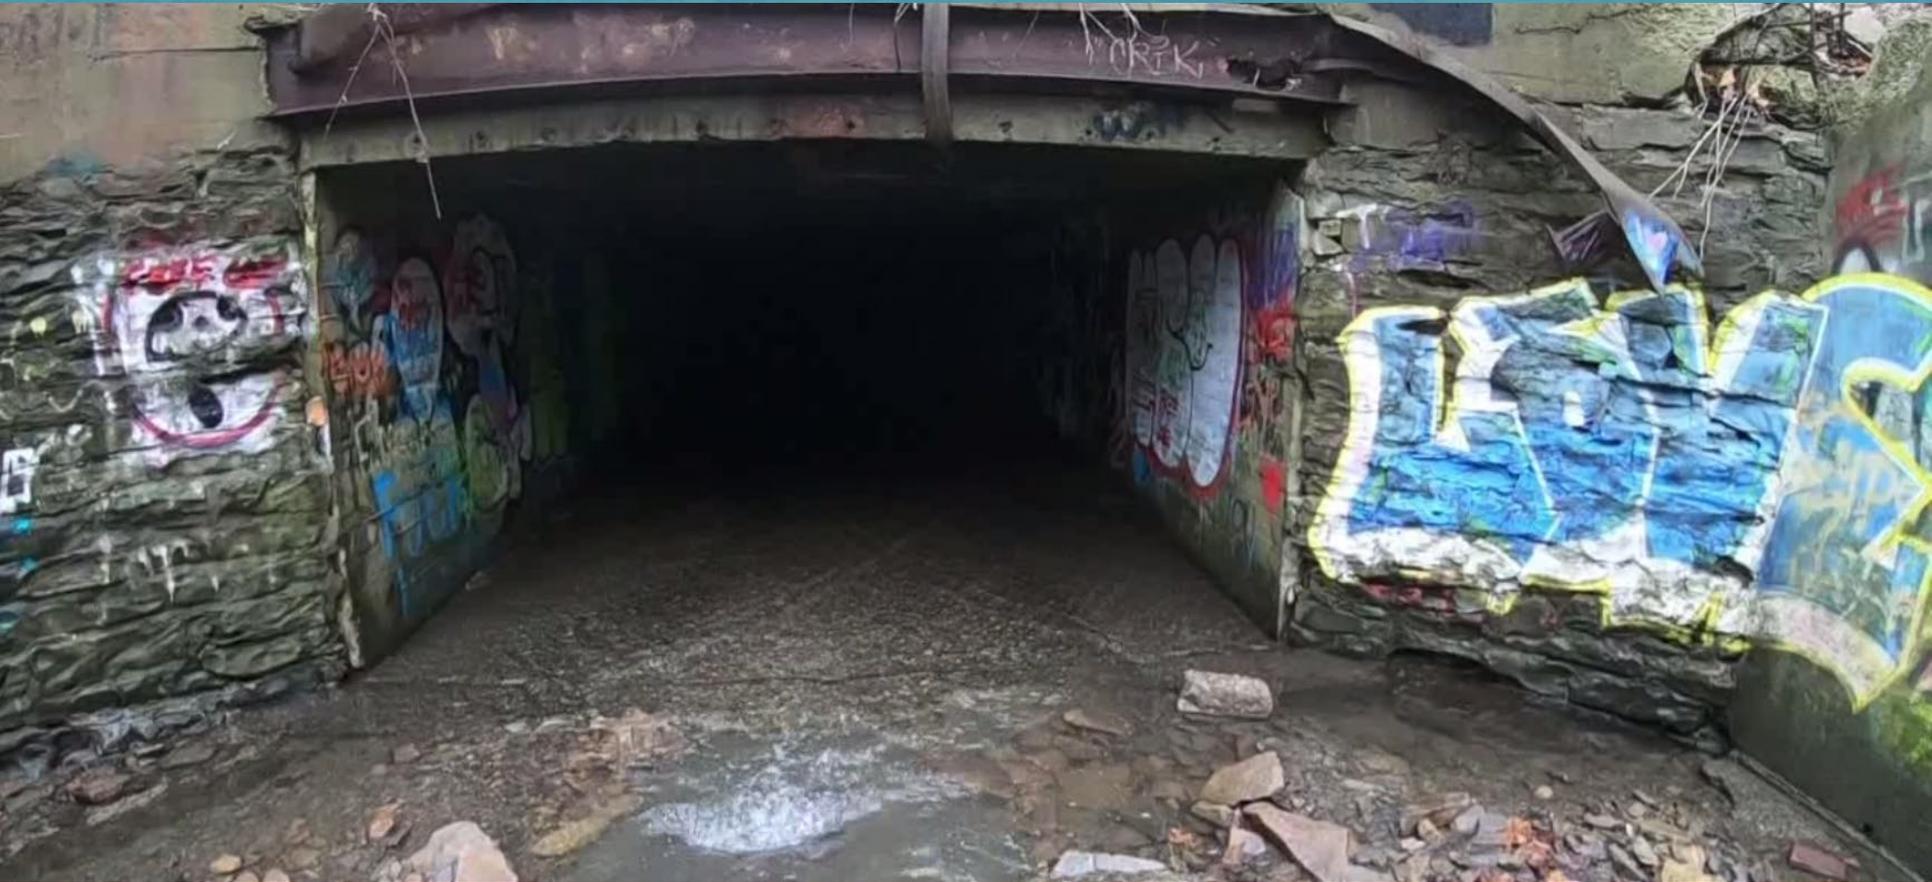
Culverted Stream Condition Assessments

Stormwater Master Plan Culverted Stream Inspection Progress

- 33 miles in scope
- 28 miles inspected
 - Remaining:
 - Nine Mile (0.3 mi)
 - Green Creek (3 mi)
 - Doan Brook (1 mi)
 - Shaw Brook (0.1 mi)
- 25 miles evaluated with rehab recommendations

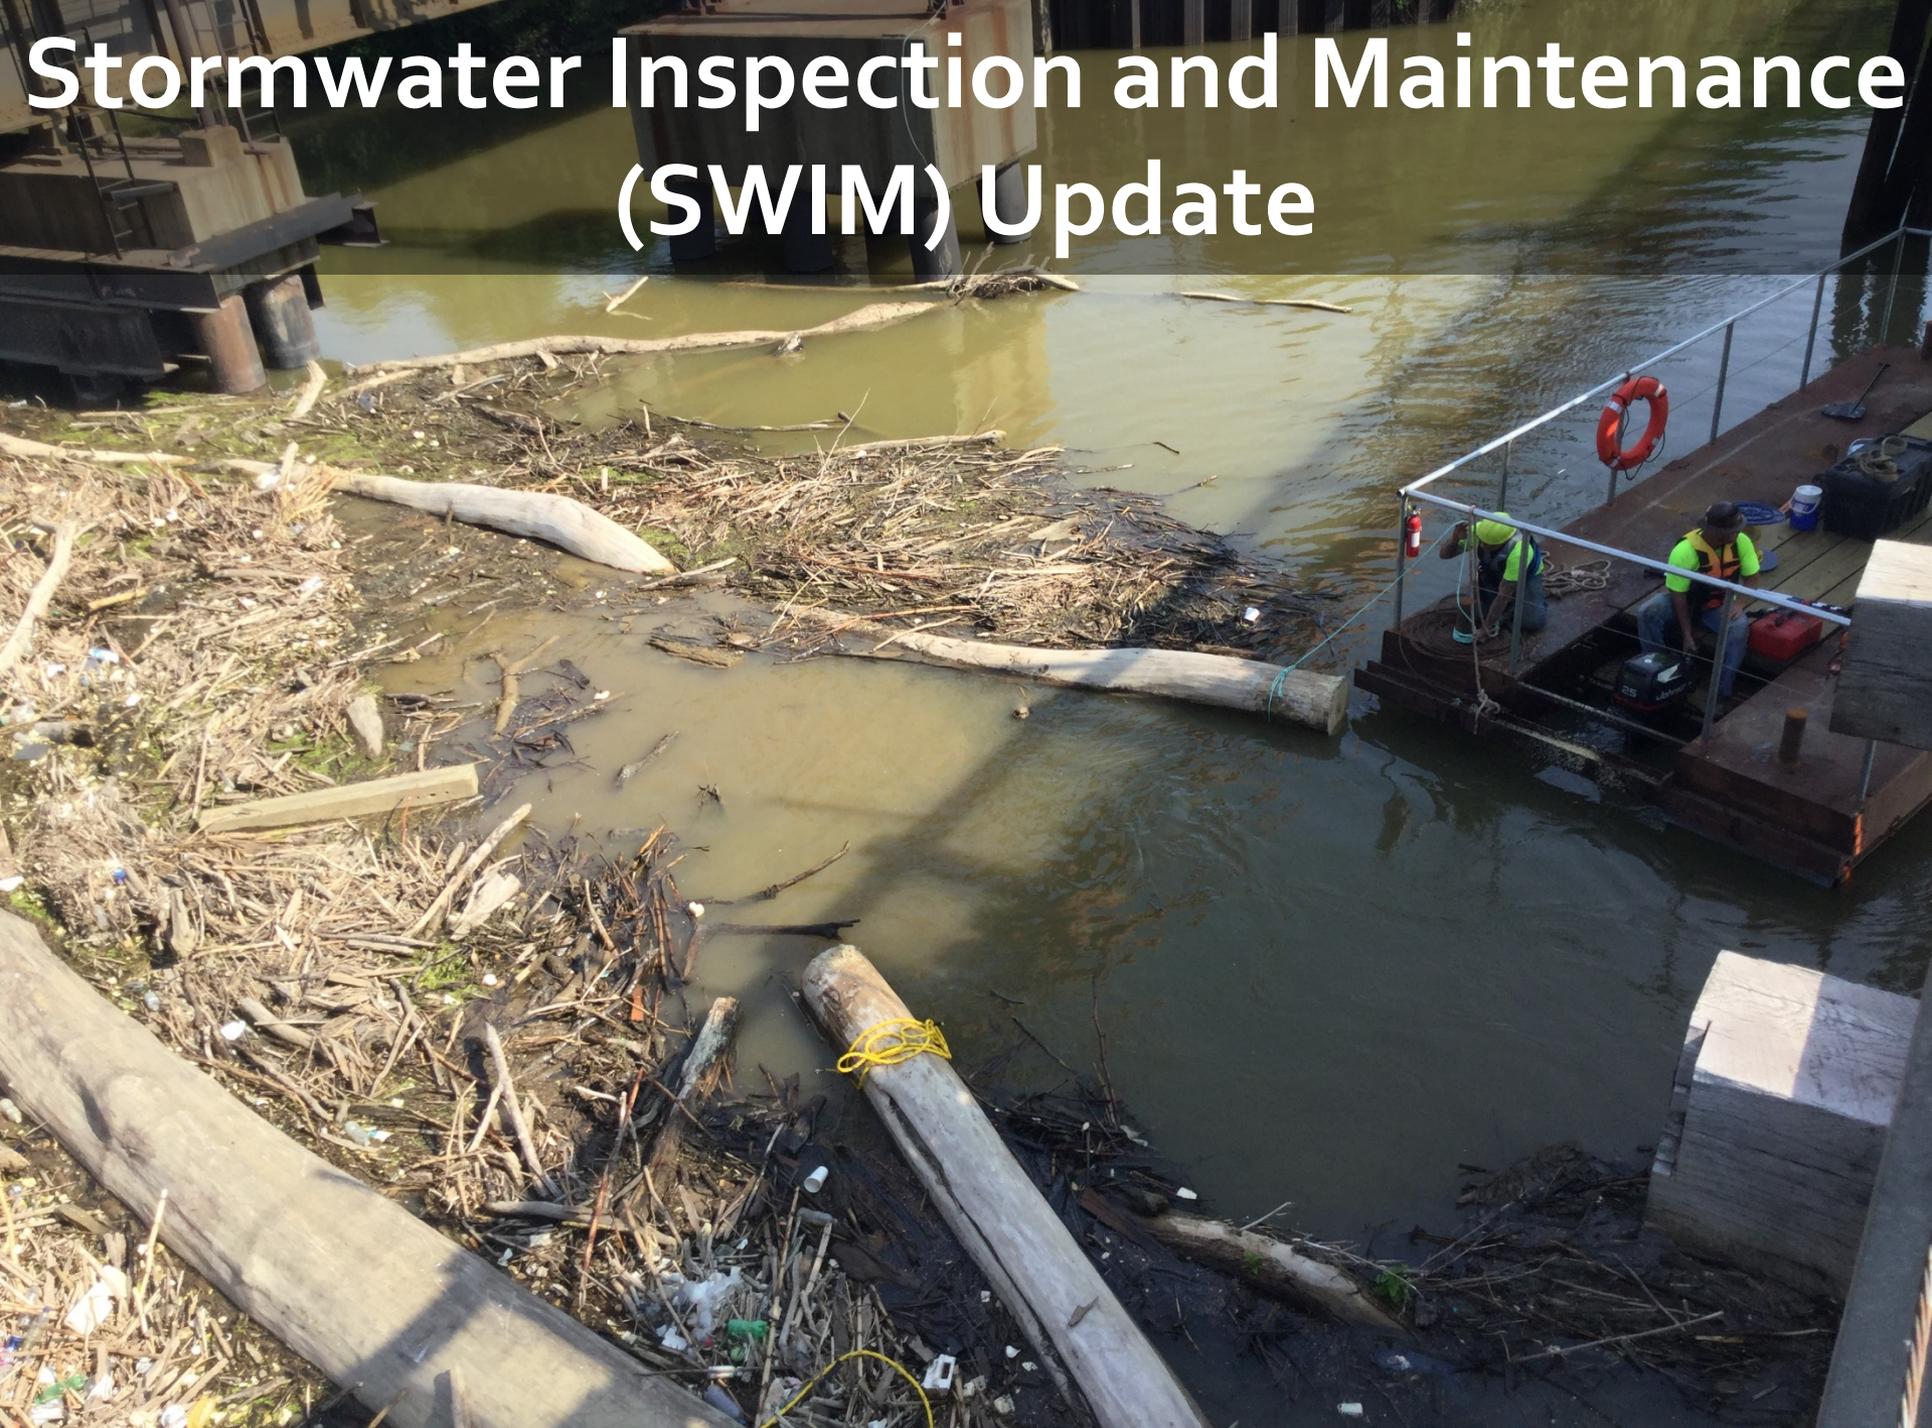
State of the Infrastructure: Crossing Beecher's Brook

Asset #: BE00022
Mayfield: Beta Dr.
Crossing Structural BRE= 24

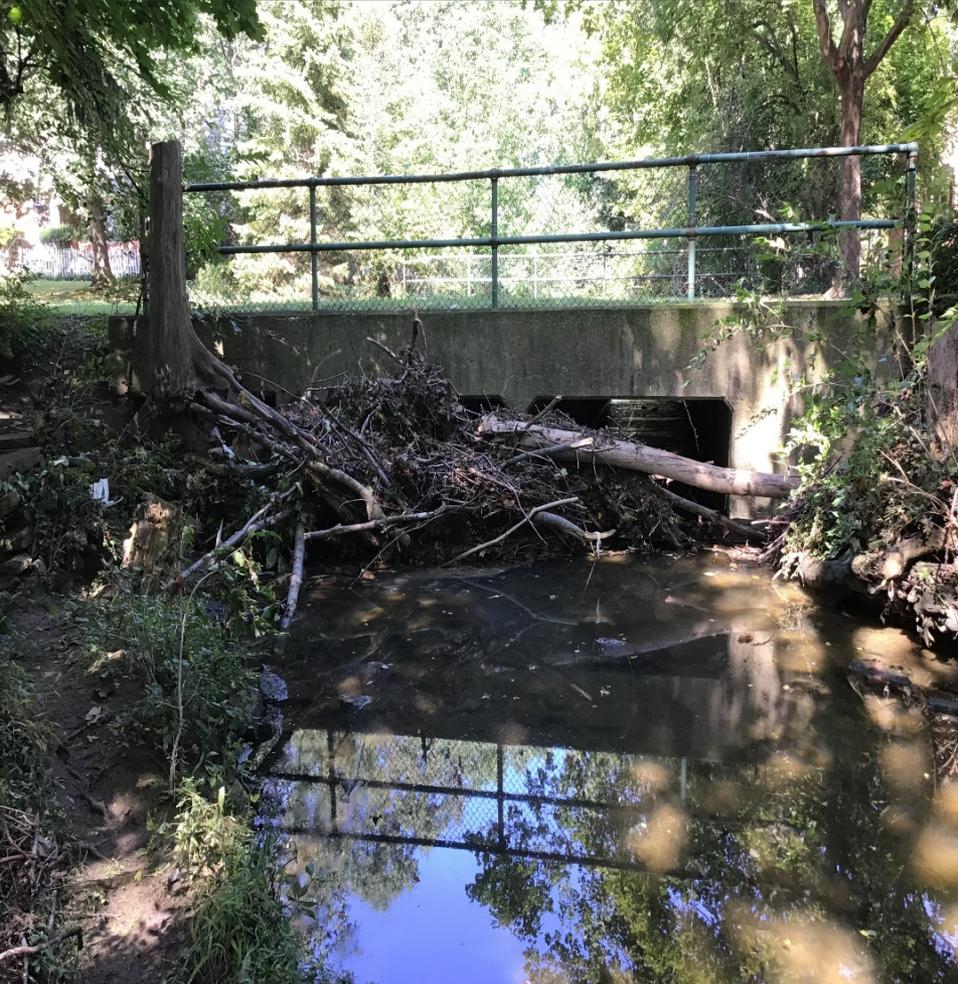
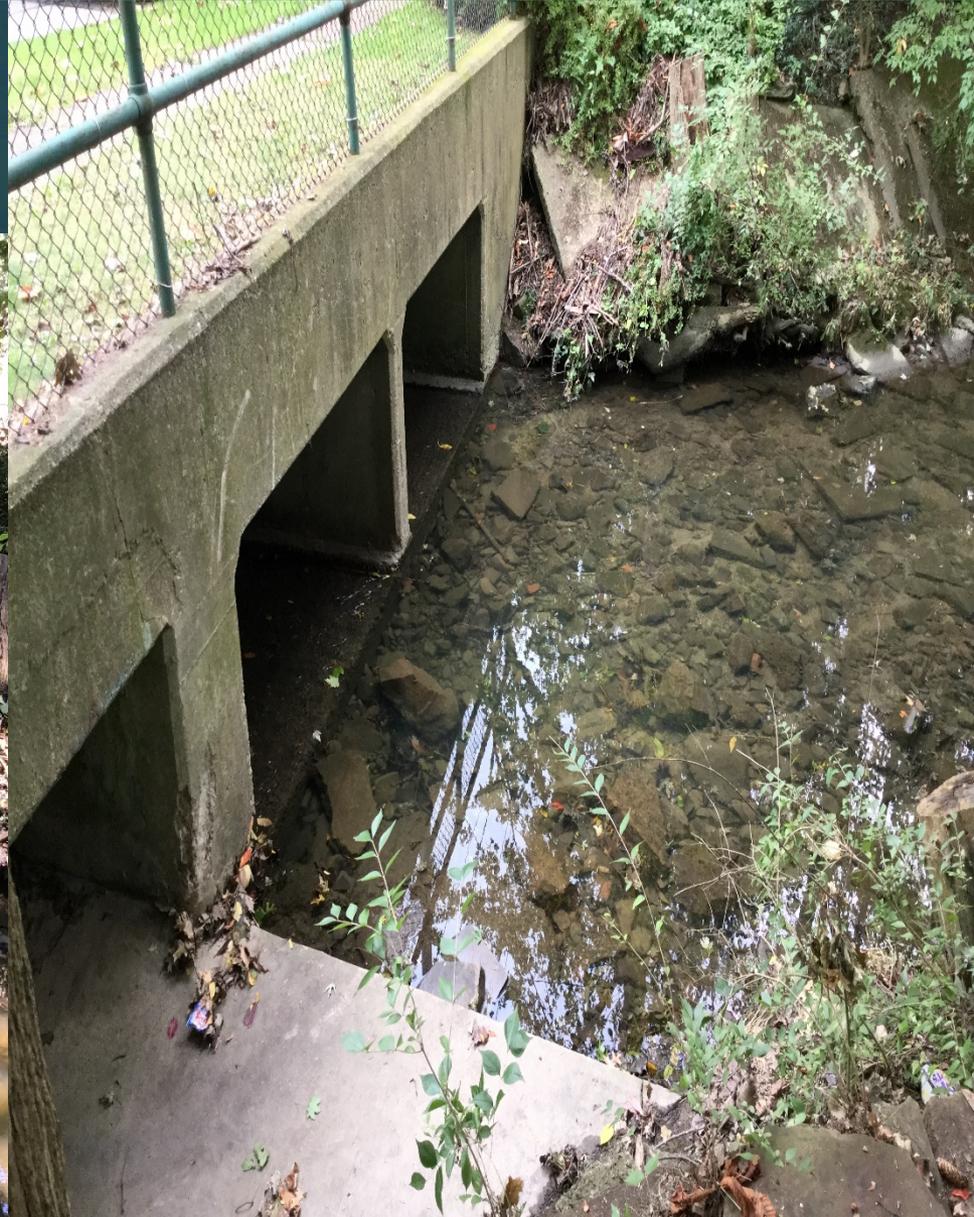
Debris Maintenance: Debris Removal Euclid Creek West

Asset #: EW00057

Lyndhurst: Edenhurst Rd.

Debris BRE=24

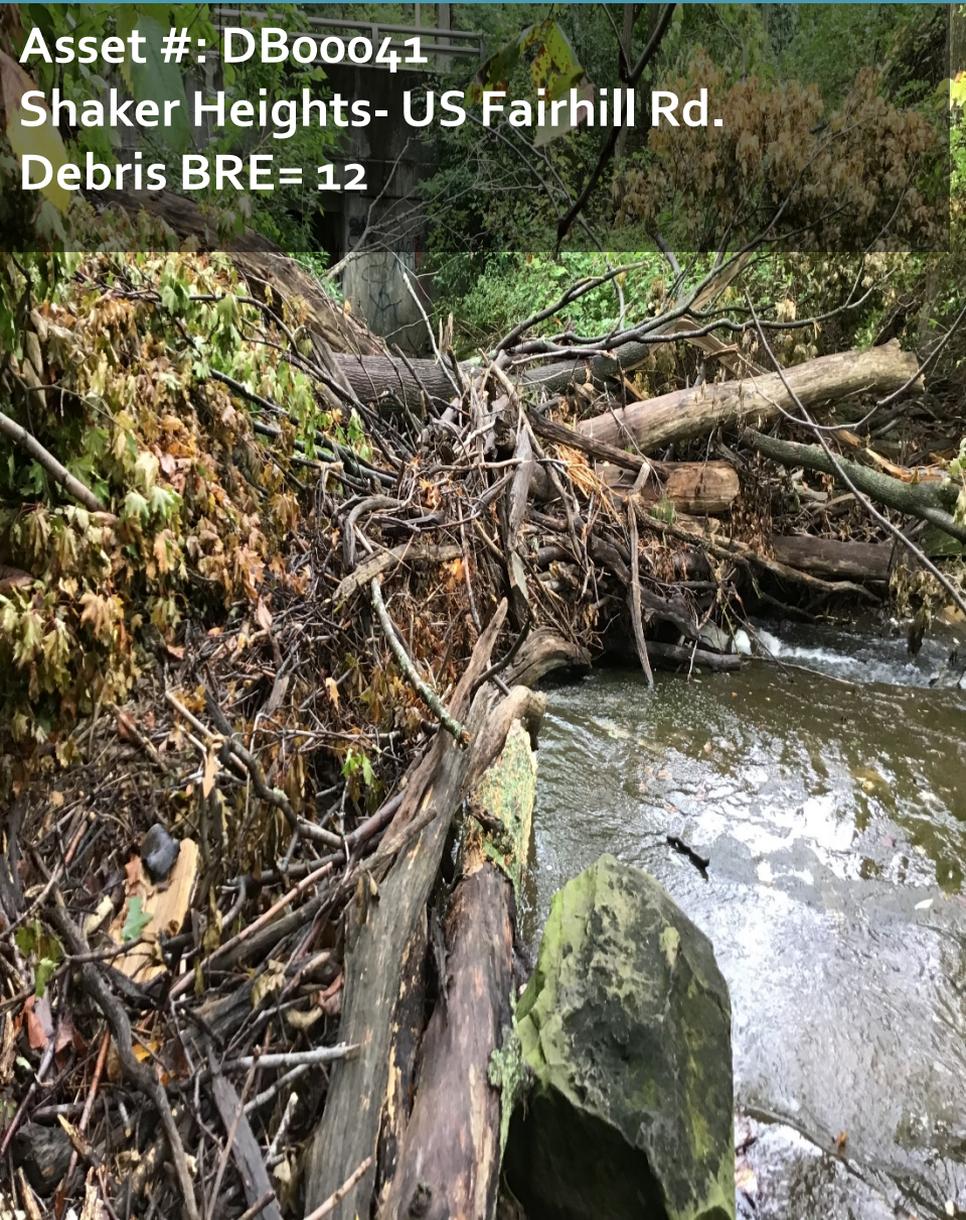
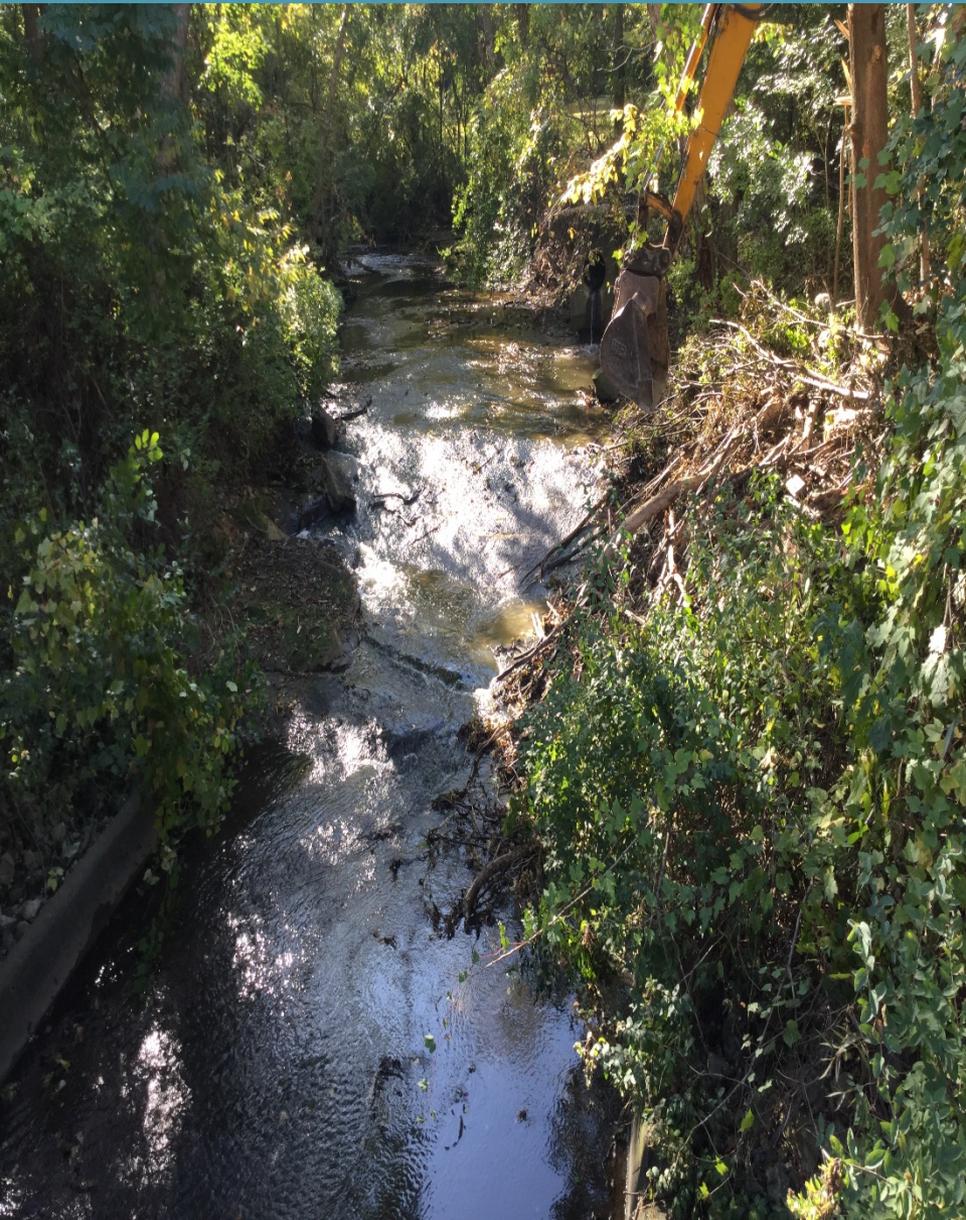
Debris Maintenance: Debris Removal Doan Brook

Asset #: DB00041
Shaker Heights- US Fairhill Rd.
Debris BRE= 12

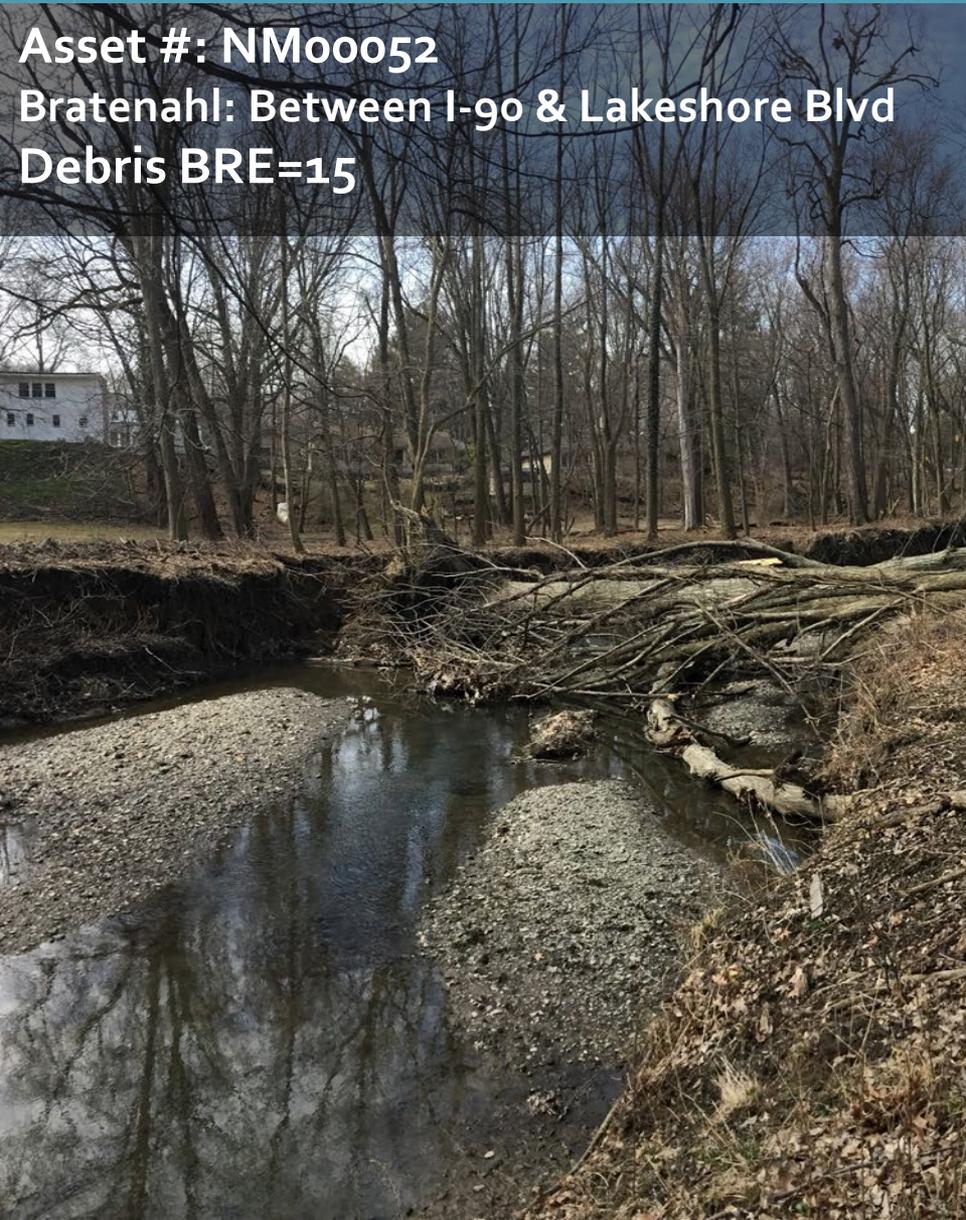
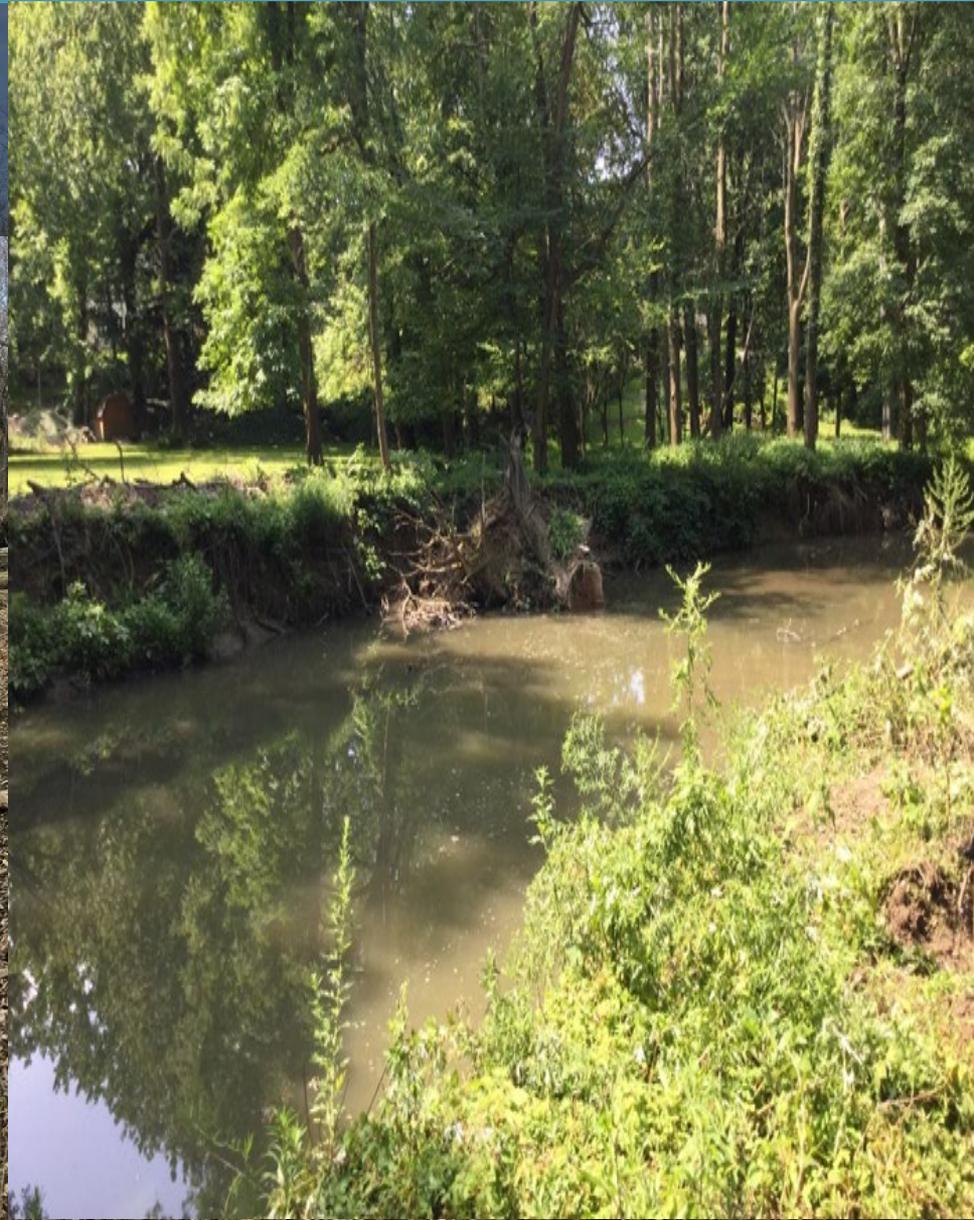
Debris Maintenance: Debris Removal Nine Mile Creek

Asset #: NM00052

Bratenahl: Between I-90 & Lakeshore Blvd

Debris BRE=15

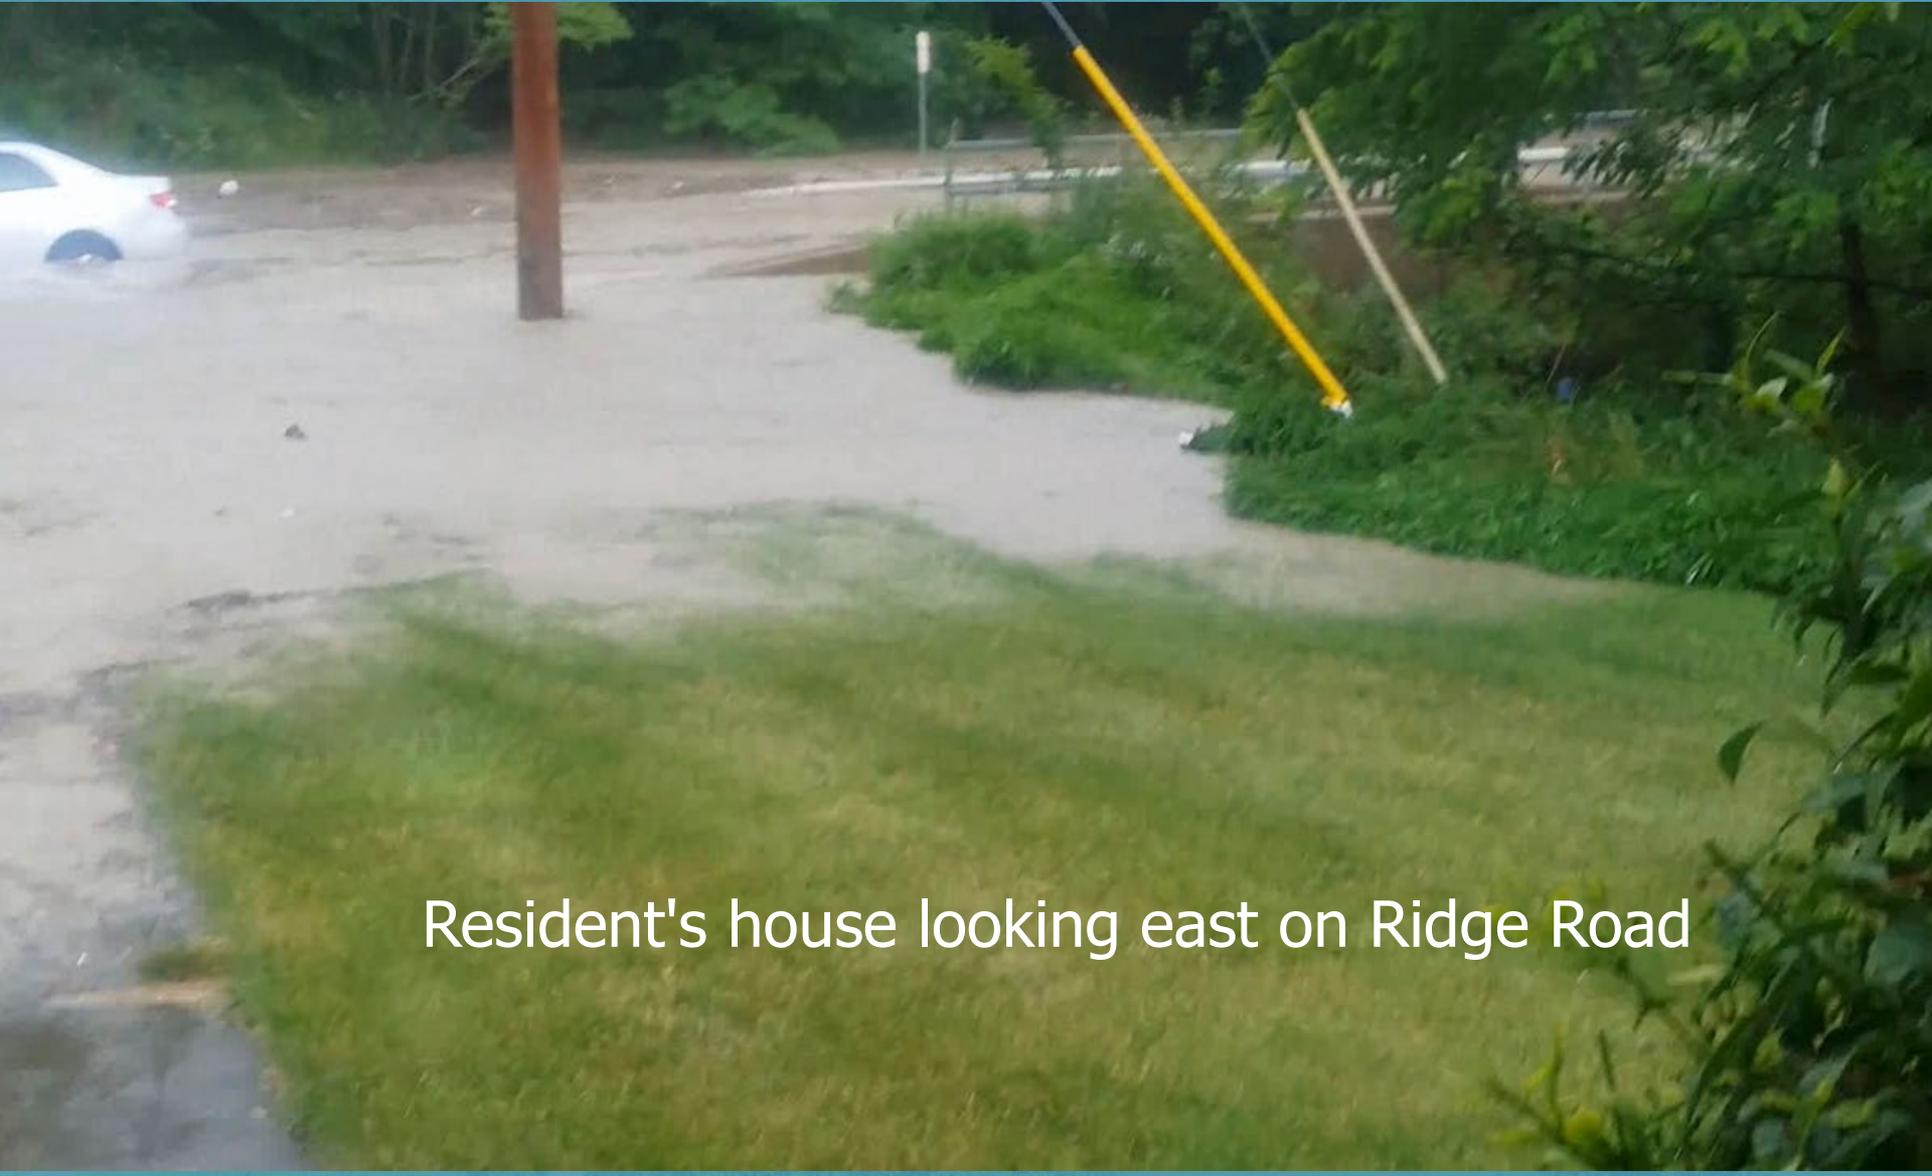
Resident's house looking east on Ridge Road

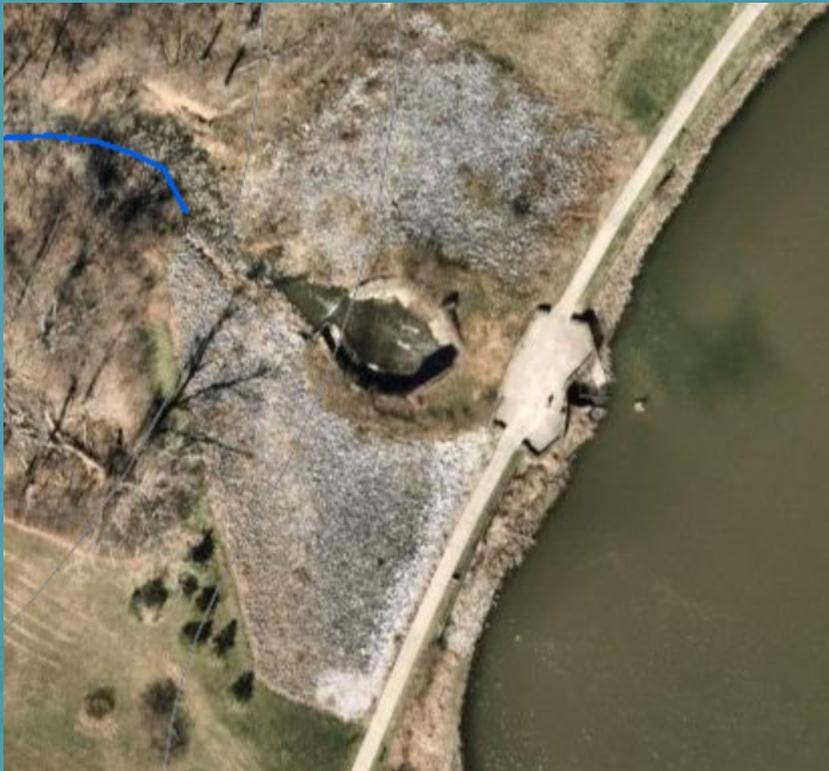
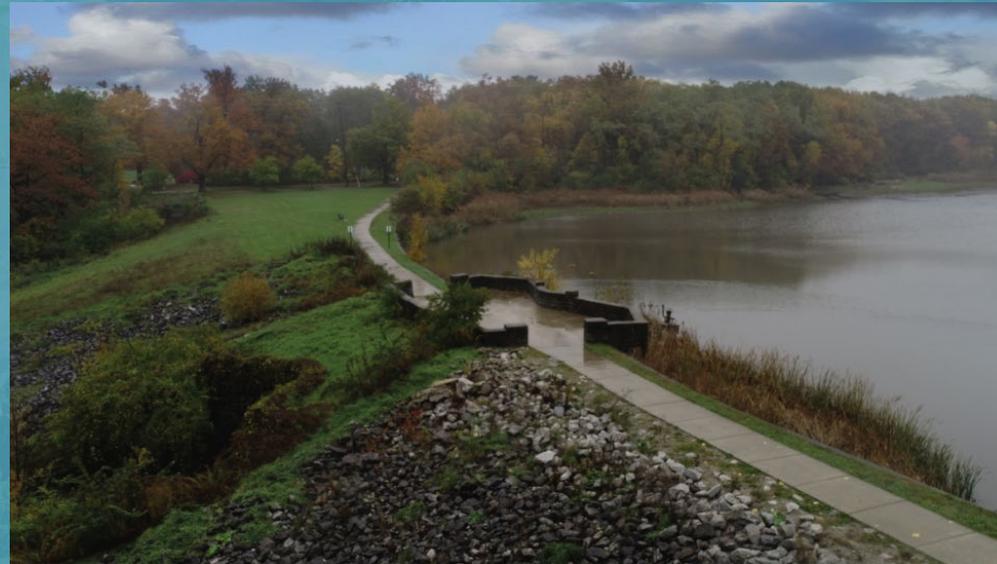
Shaker Lakes – Upper Lake Dam Improvements

Goals:

- Repair Class 1 dam to meet ODNR requirements

Current Design Phase:

90% Design

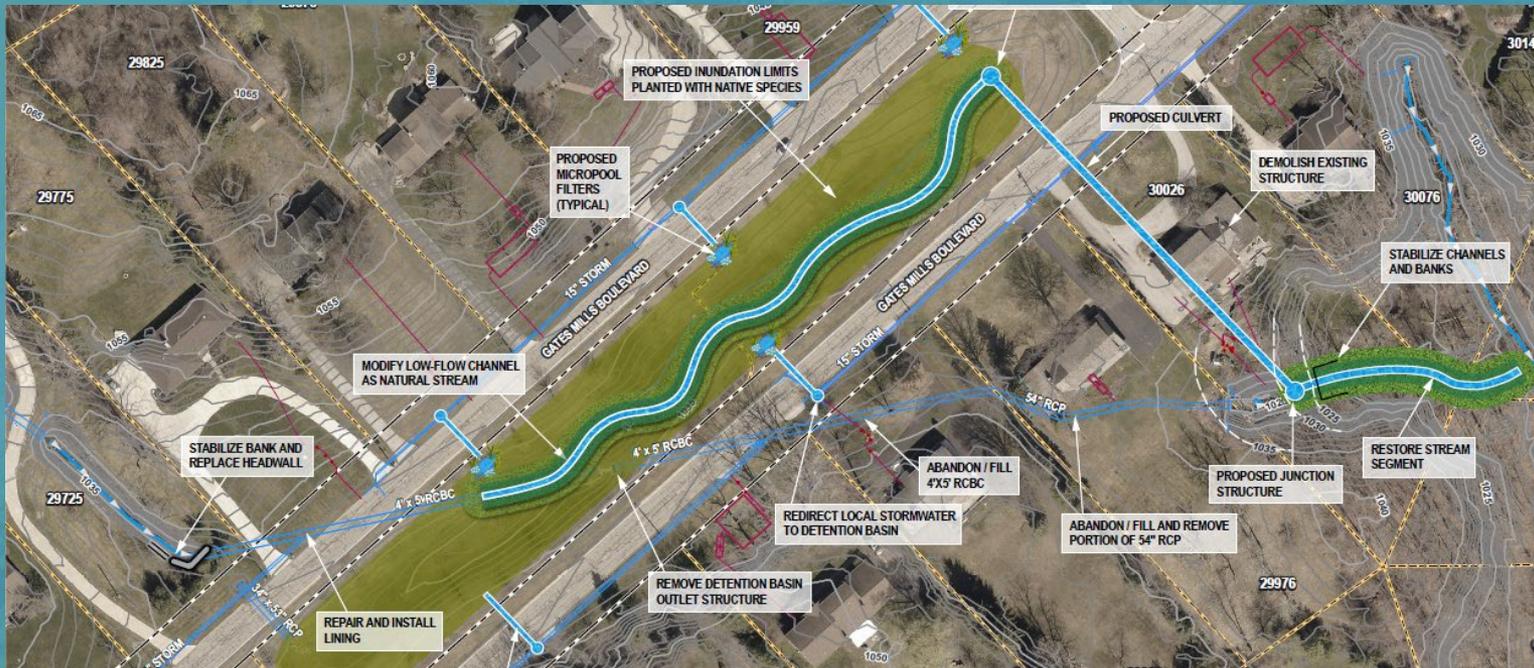
Pepper Luce – Improvements at Gates Mills Blvd

Goals:

- Arrest bank erosion
- Improve stream function
- Increase storage
- Relocate collapsed culvert

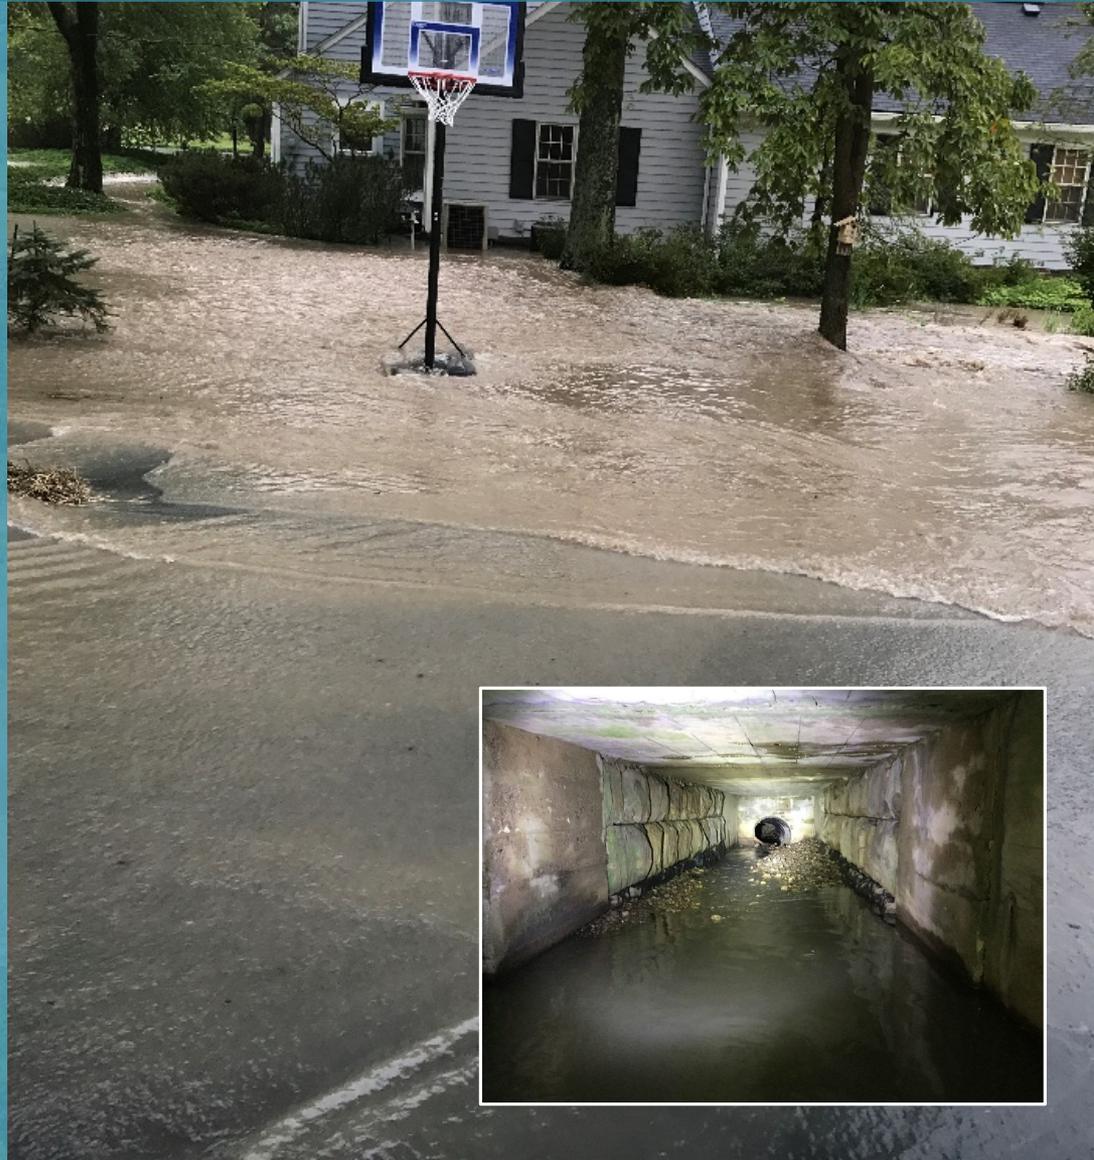
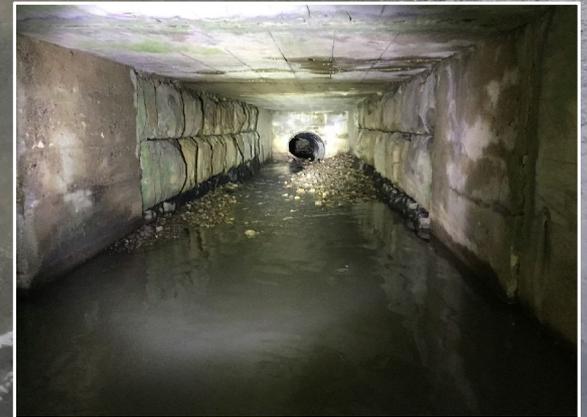
Pepper Luce at Shaker Blvd Culvert Daylighting

Goals:

- Alleviate flooding of Shaker Blvd and nearby homes
- Improve stream function

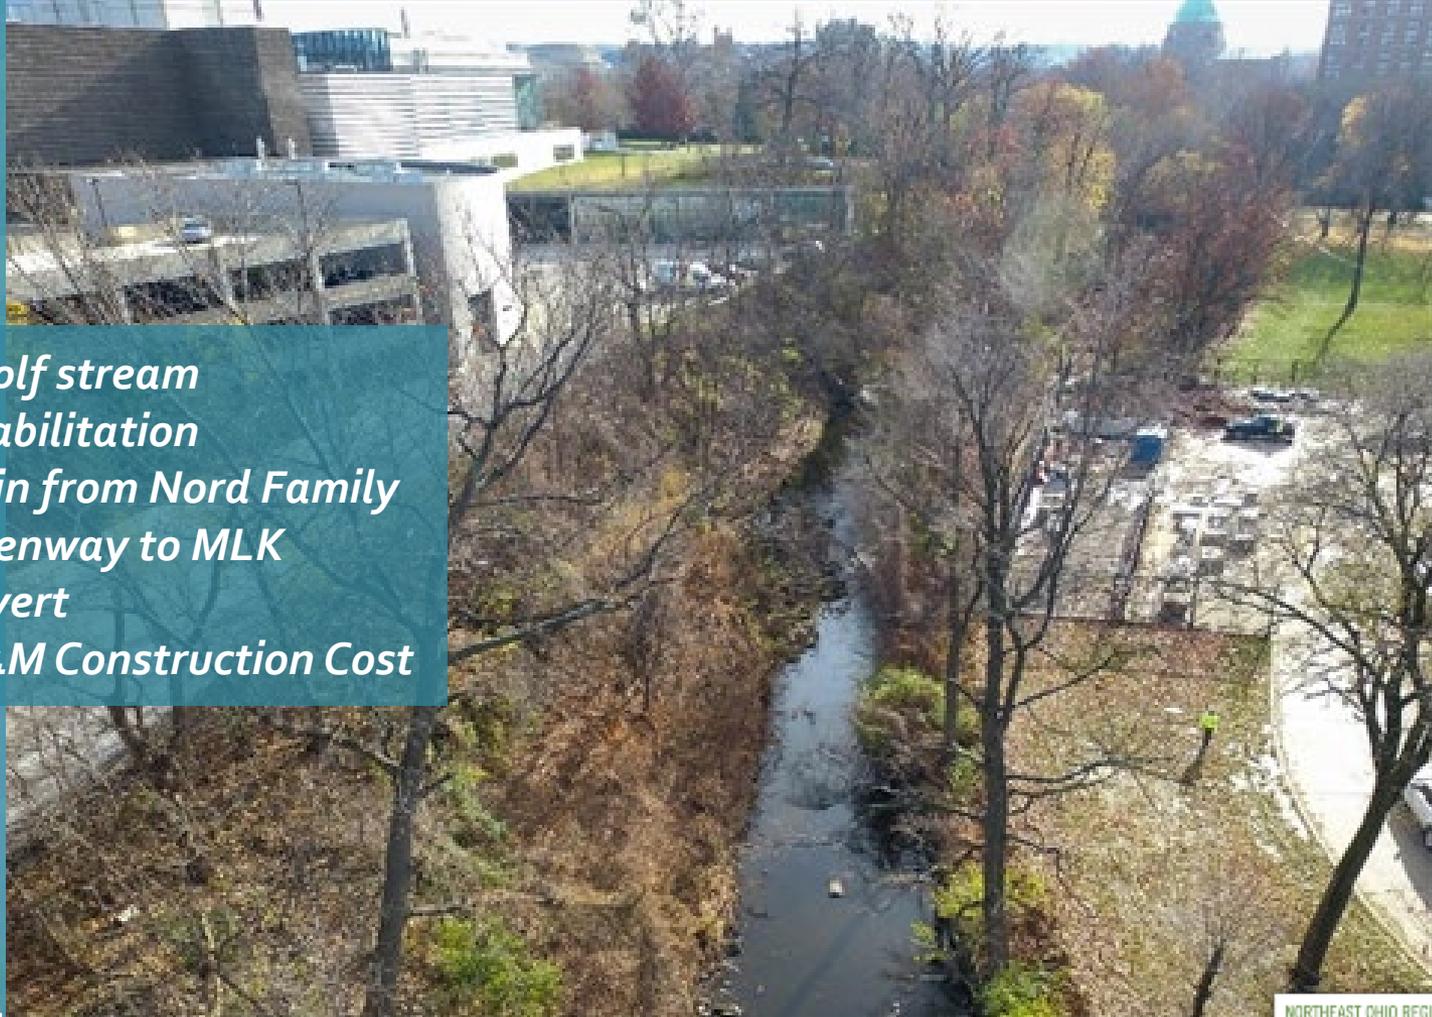
Doan Brook Streambank Stabilization

- *1000lf stream rehabilitation*
- *Tie in from Nord Family Greenway to MLK Culvert*
- *\$2.4M Construction Cost*

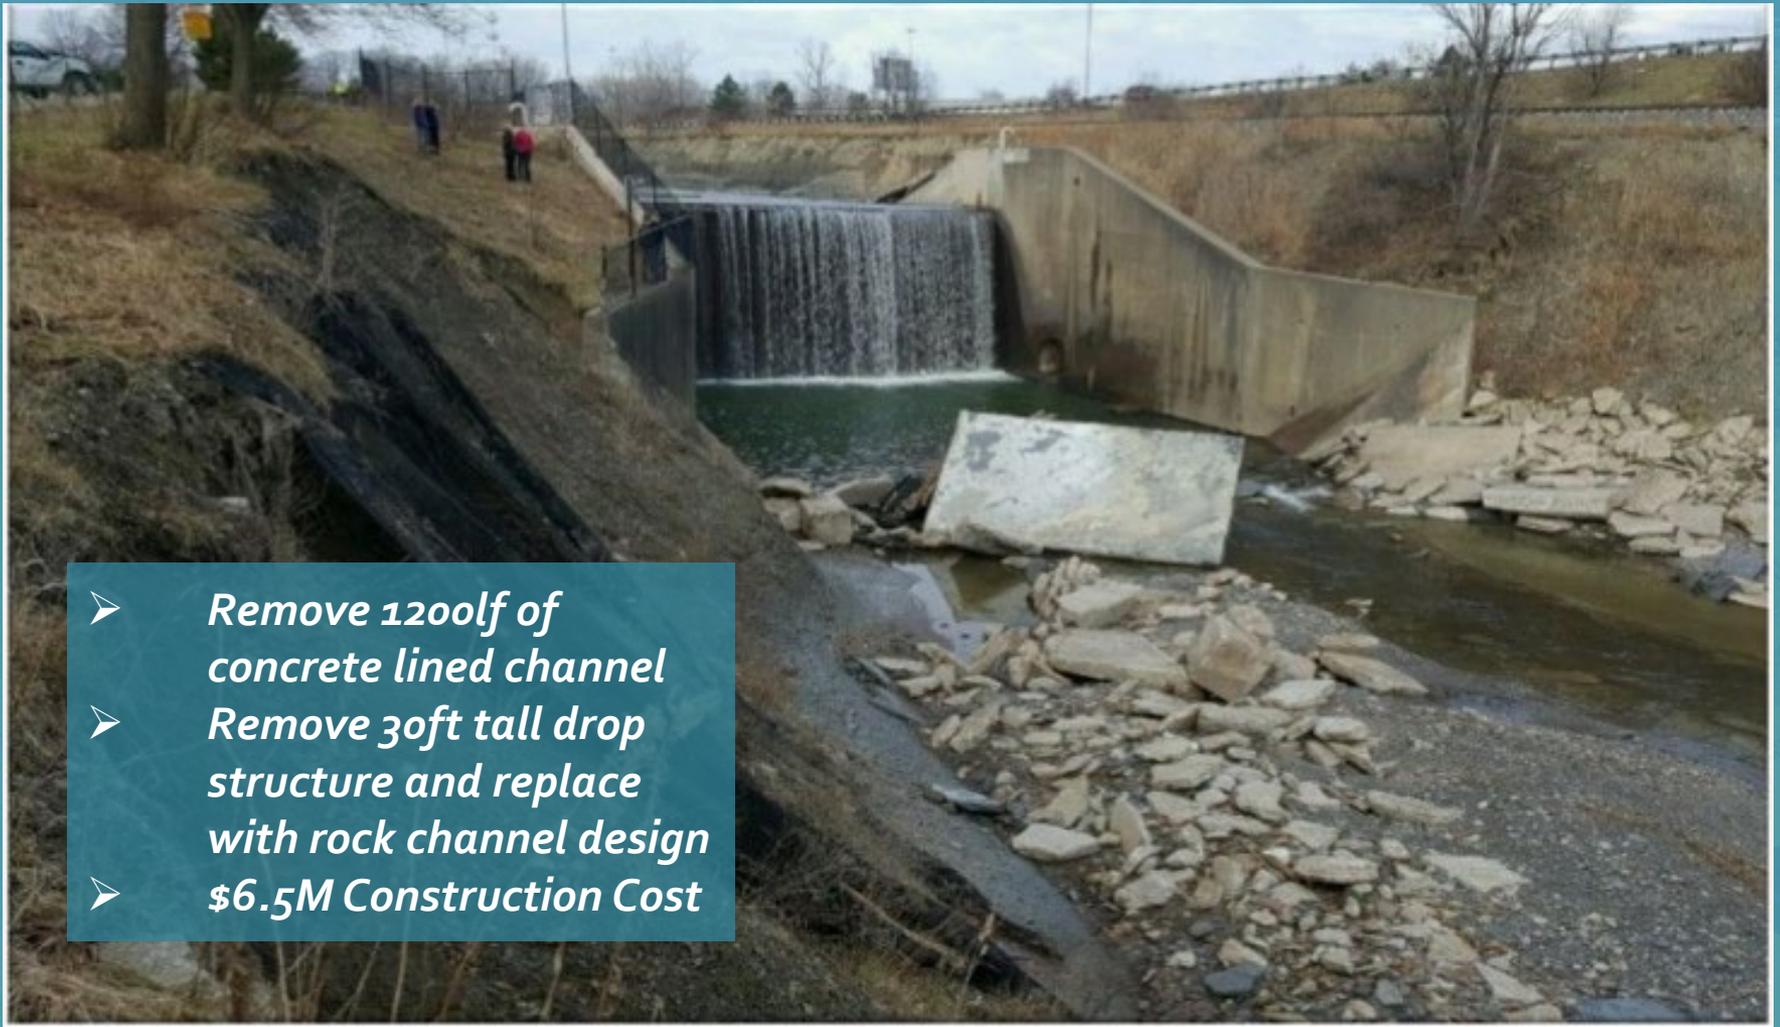
Big Creek Stabilization

When I-71 was constructed in 1966, Big Creek was straightened

- *Remove 1200lf of concrete lined channel*
- *Remove 30ft tall drop structure and replace with rock channel design*
- *\$6.5M Construction Cost*
