*Watershed Advisory Committee
Lake Erie Direct Tributaries
& Chagrin River
October 24, 2019*

NORTHEAST OHIO REGIONAL SEWER DISTRICT

REGIONAL
STORMWATER
MANAGEMENT
PROGRAM

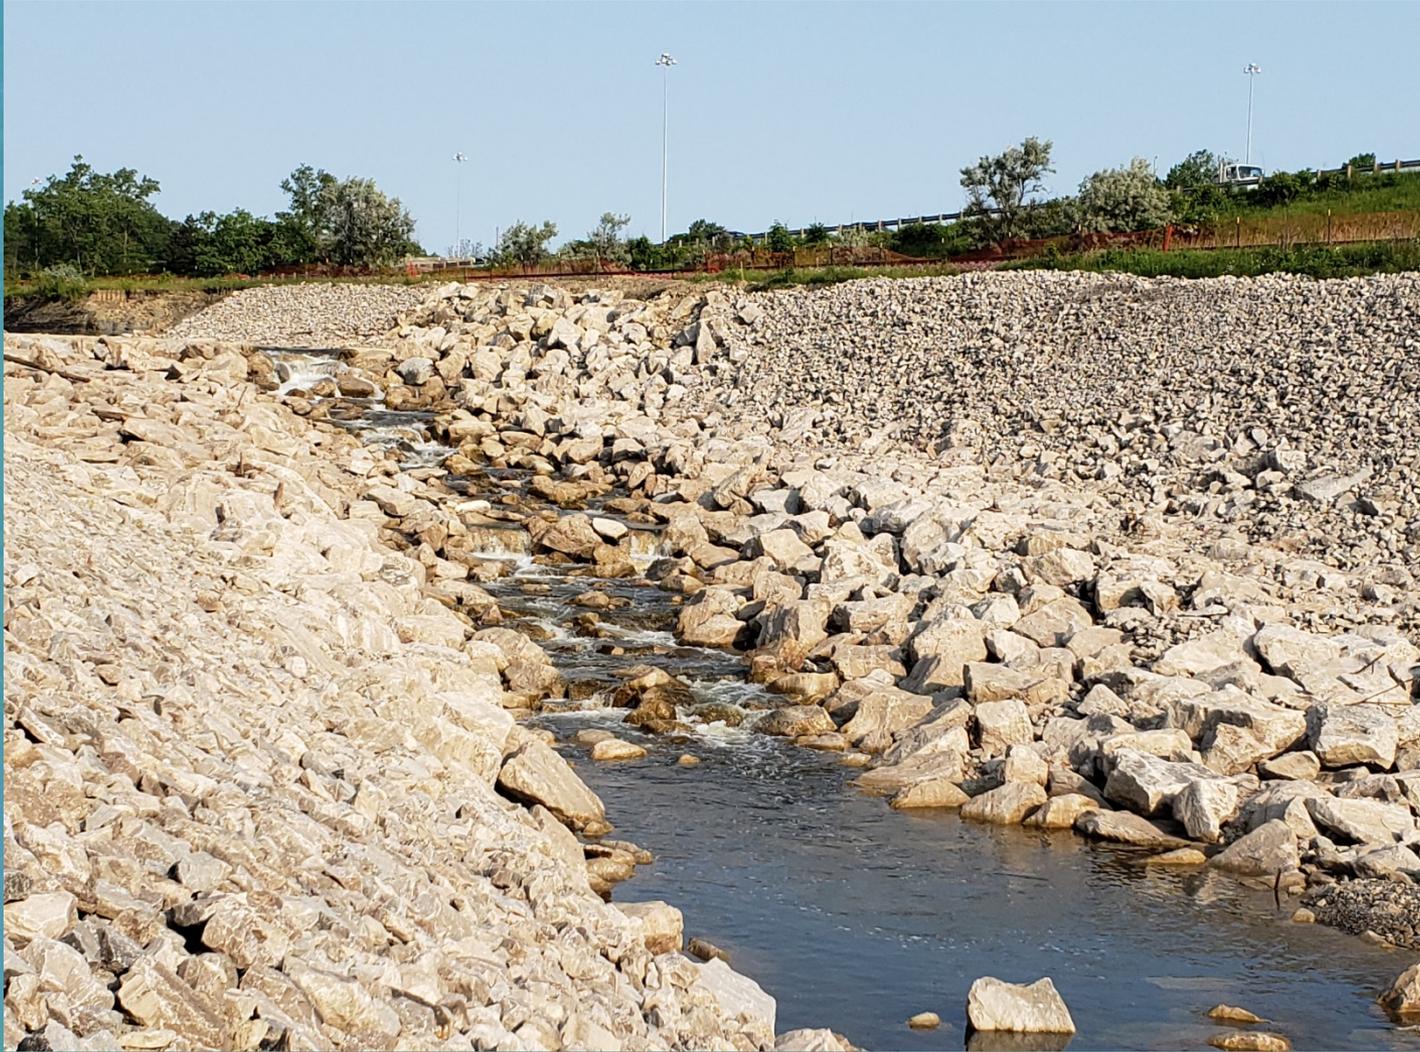
Big Creek Stabilization in Cleveland; tributary to Cuyahoga River

- *Remove 1200lf of concrete lined channel*
- *Remove 30ft tall drop structure and replace with rock channel design*
- *\$6.5M Construction Cost*

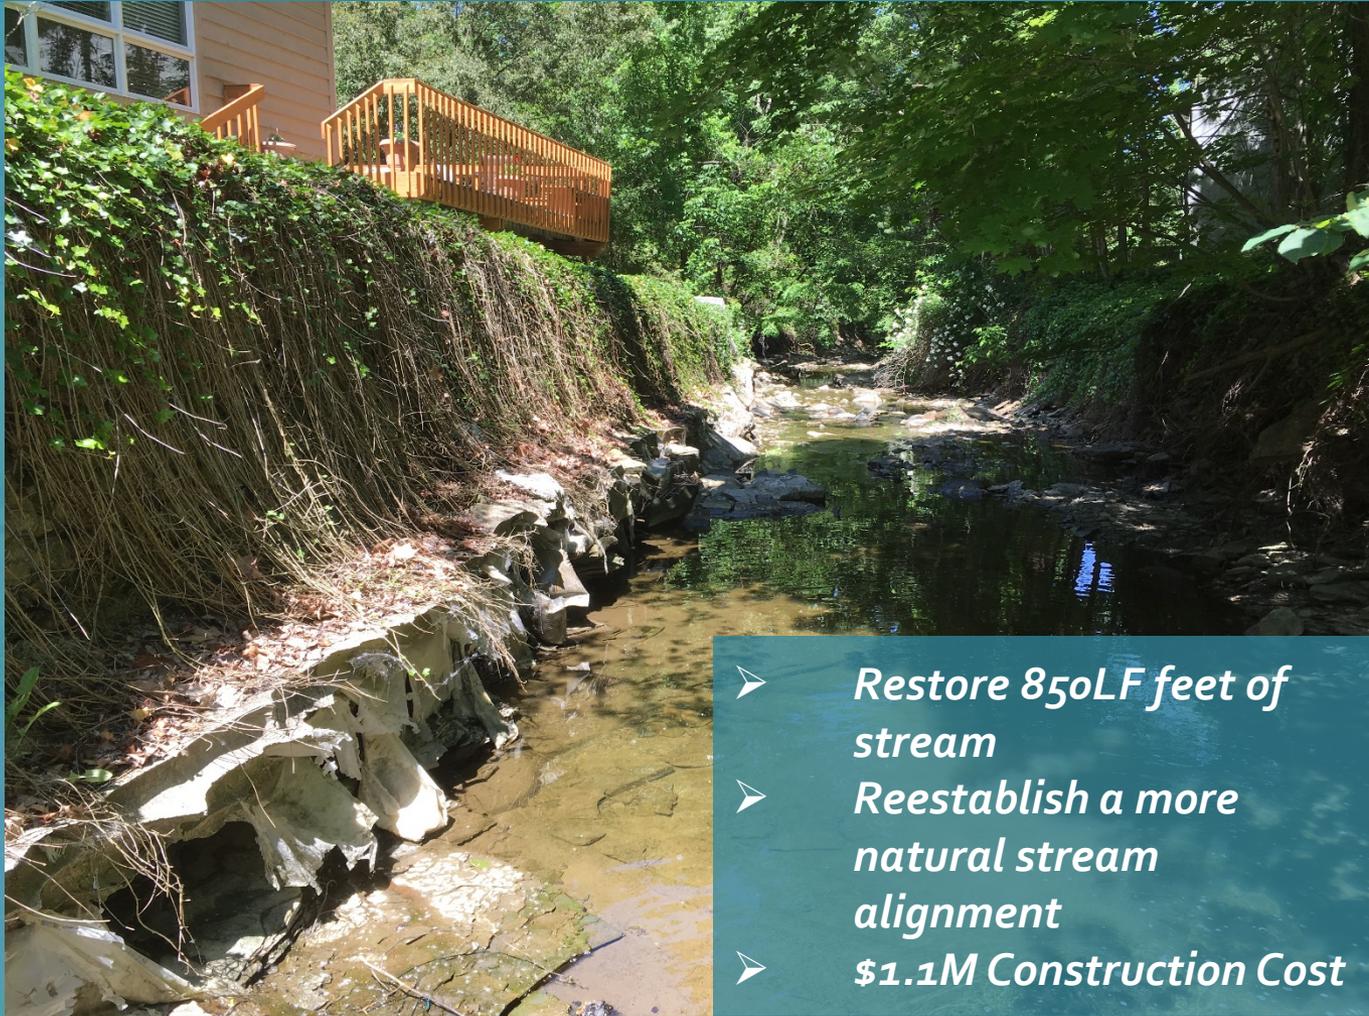
Pepper Creek Bank Stabilization

Severely eroding
stream segment
near Shaker
Blvd.

- *Restore 850LF feet of stream*
- *Reestablish a more natural stream alignment*
- *\$1.1M Construction Cost*

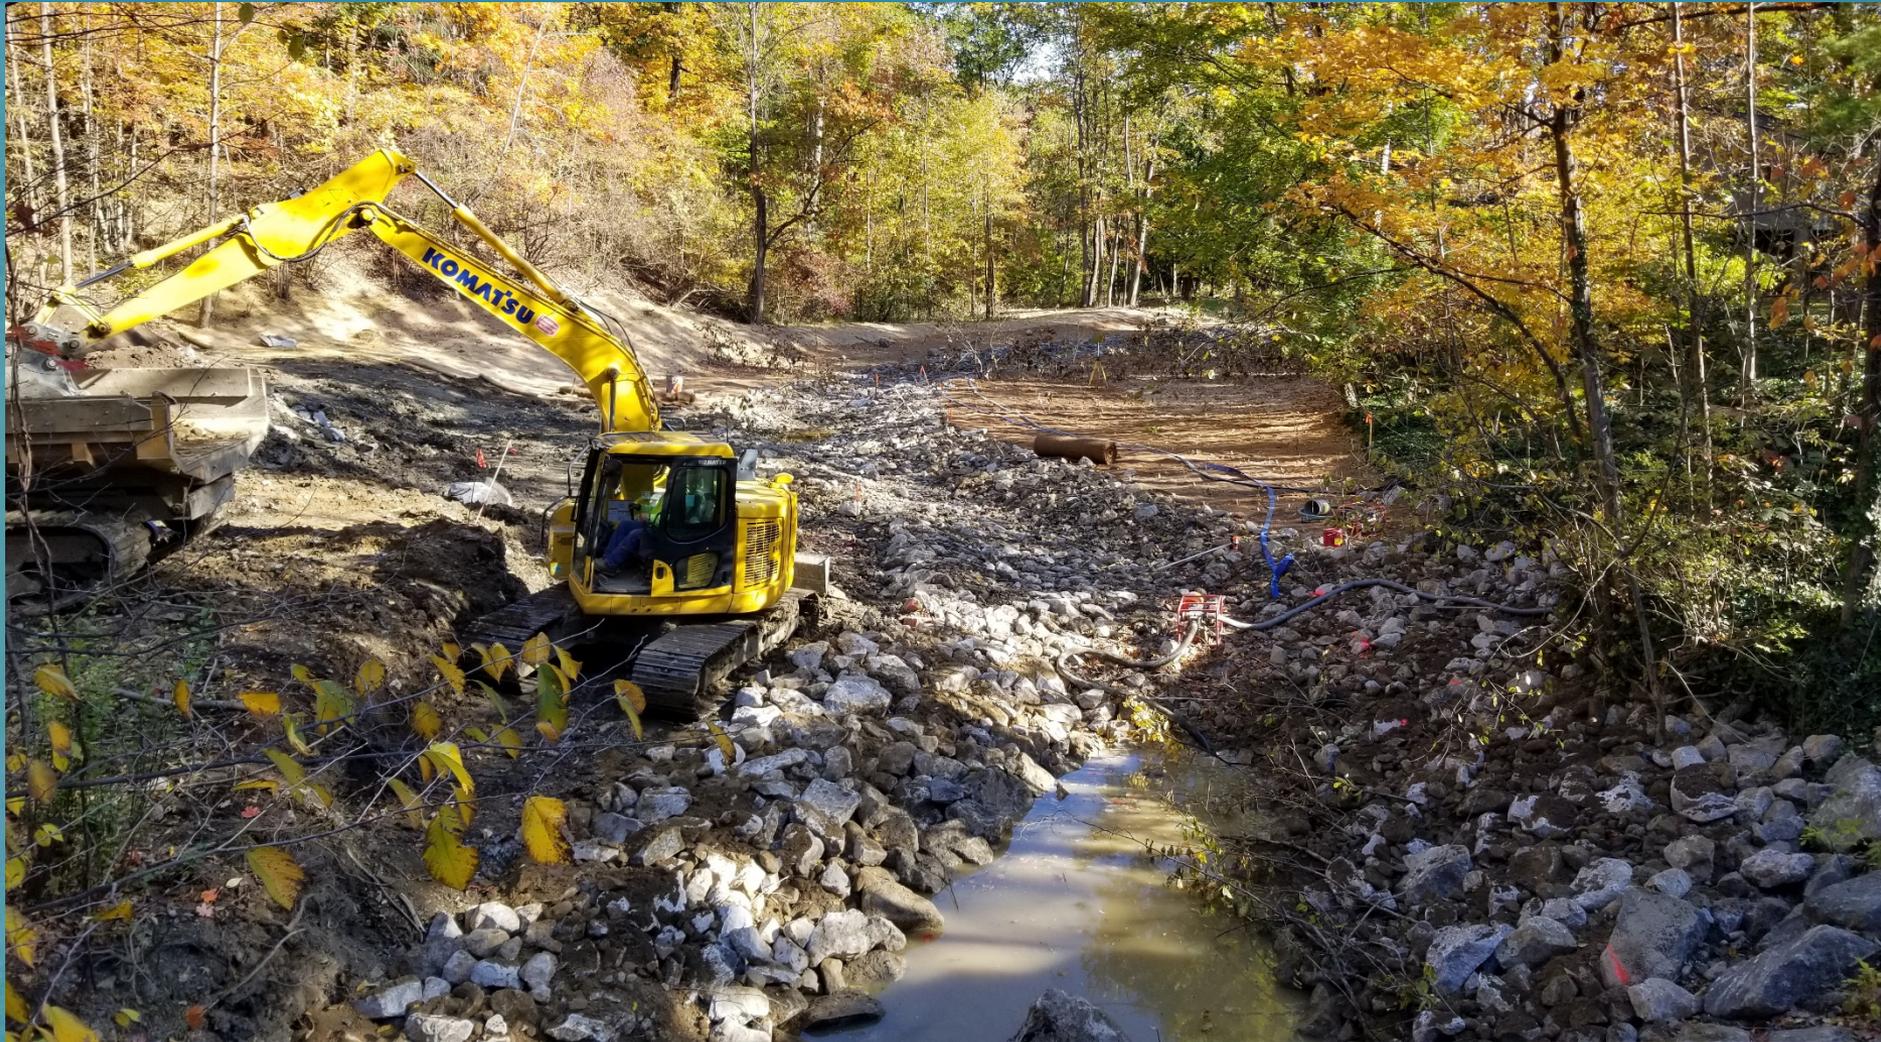
Pepper Creek Bank
Stabilization in
Pepper Pike;
tributary to
Chagrin River

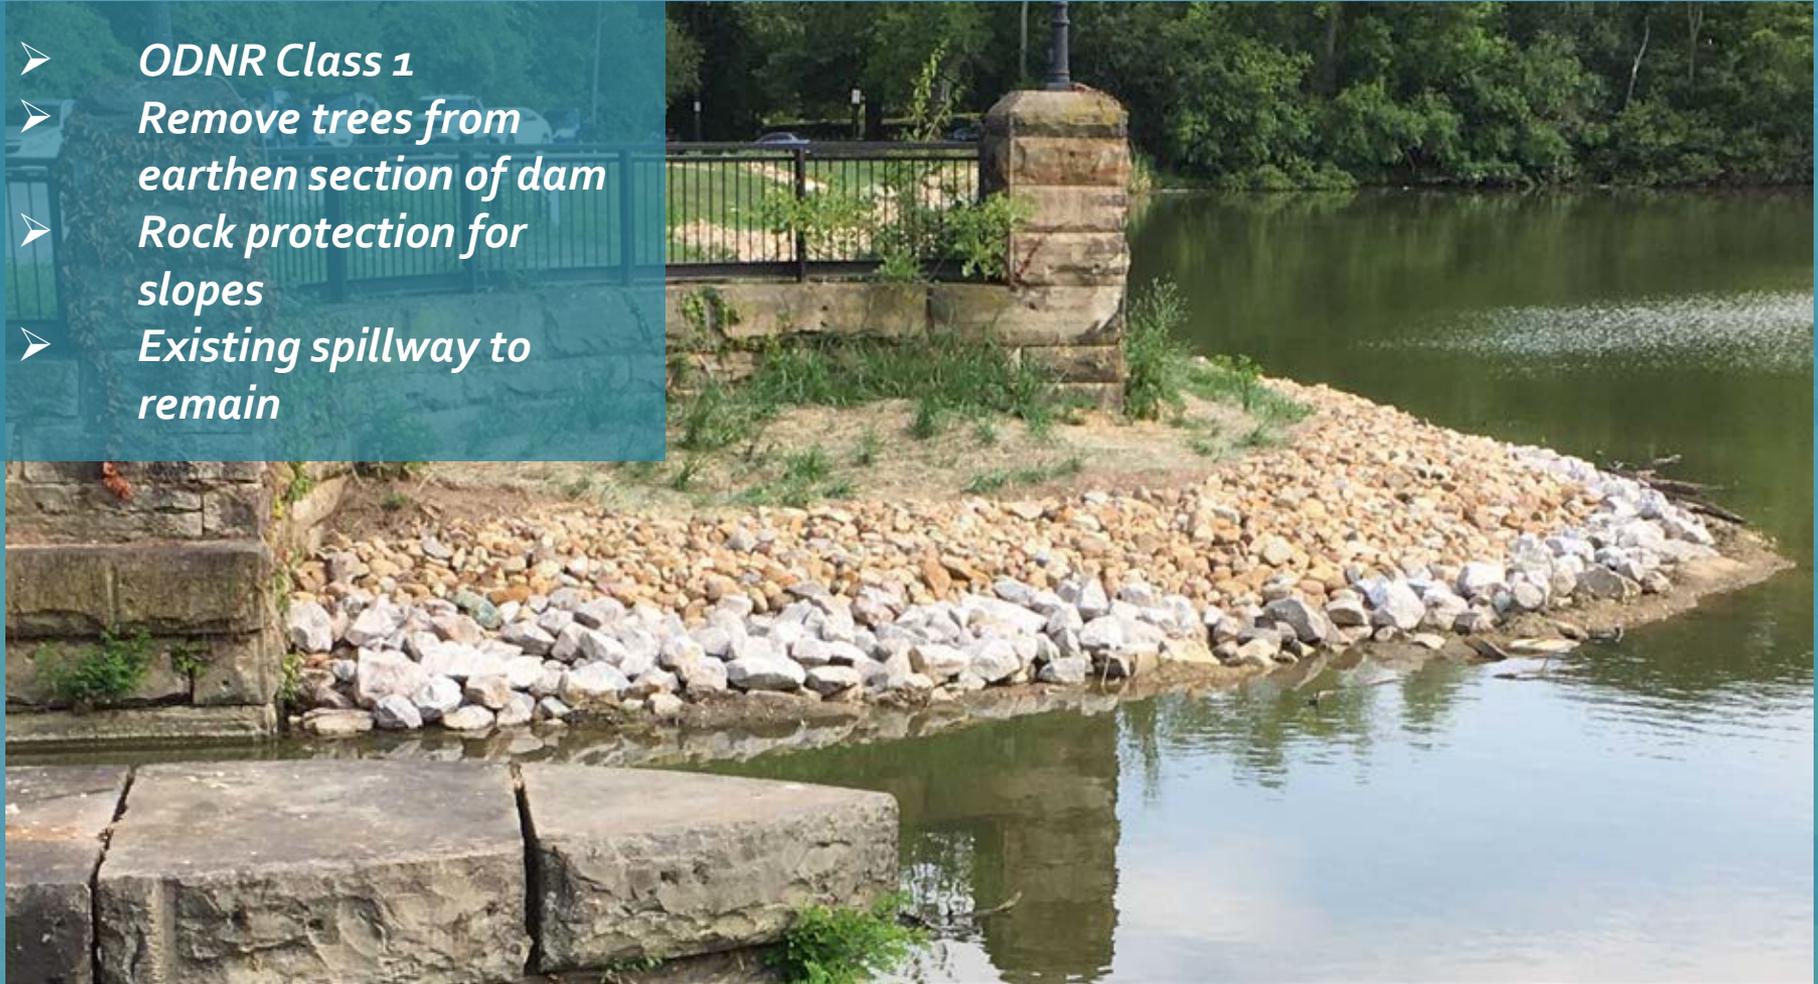
Lower Lake Dam Rehabilitation

- *ODNR Class 1*
- *Remove trees from earthen section of dam*
- *Rock protection for slopes*
- *Existing spillway to remain*

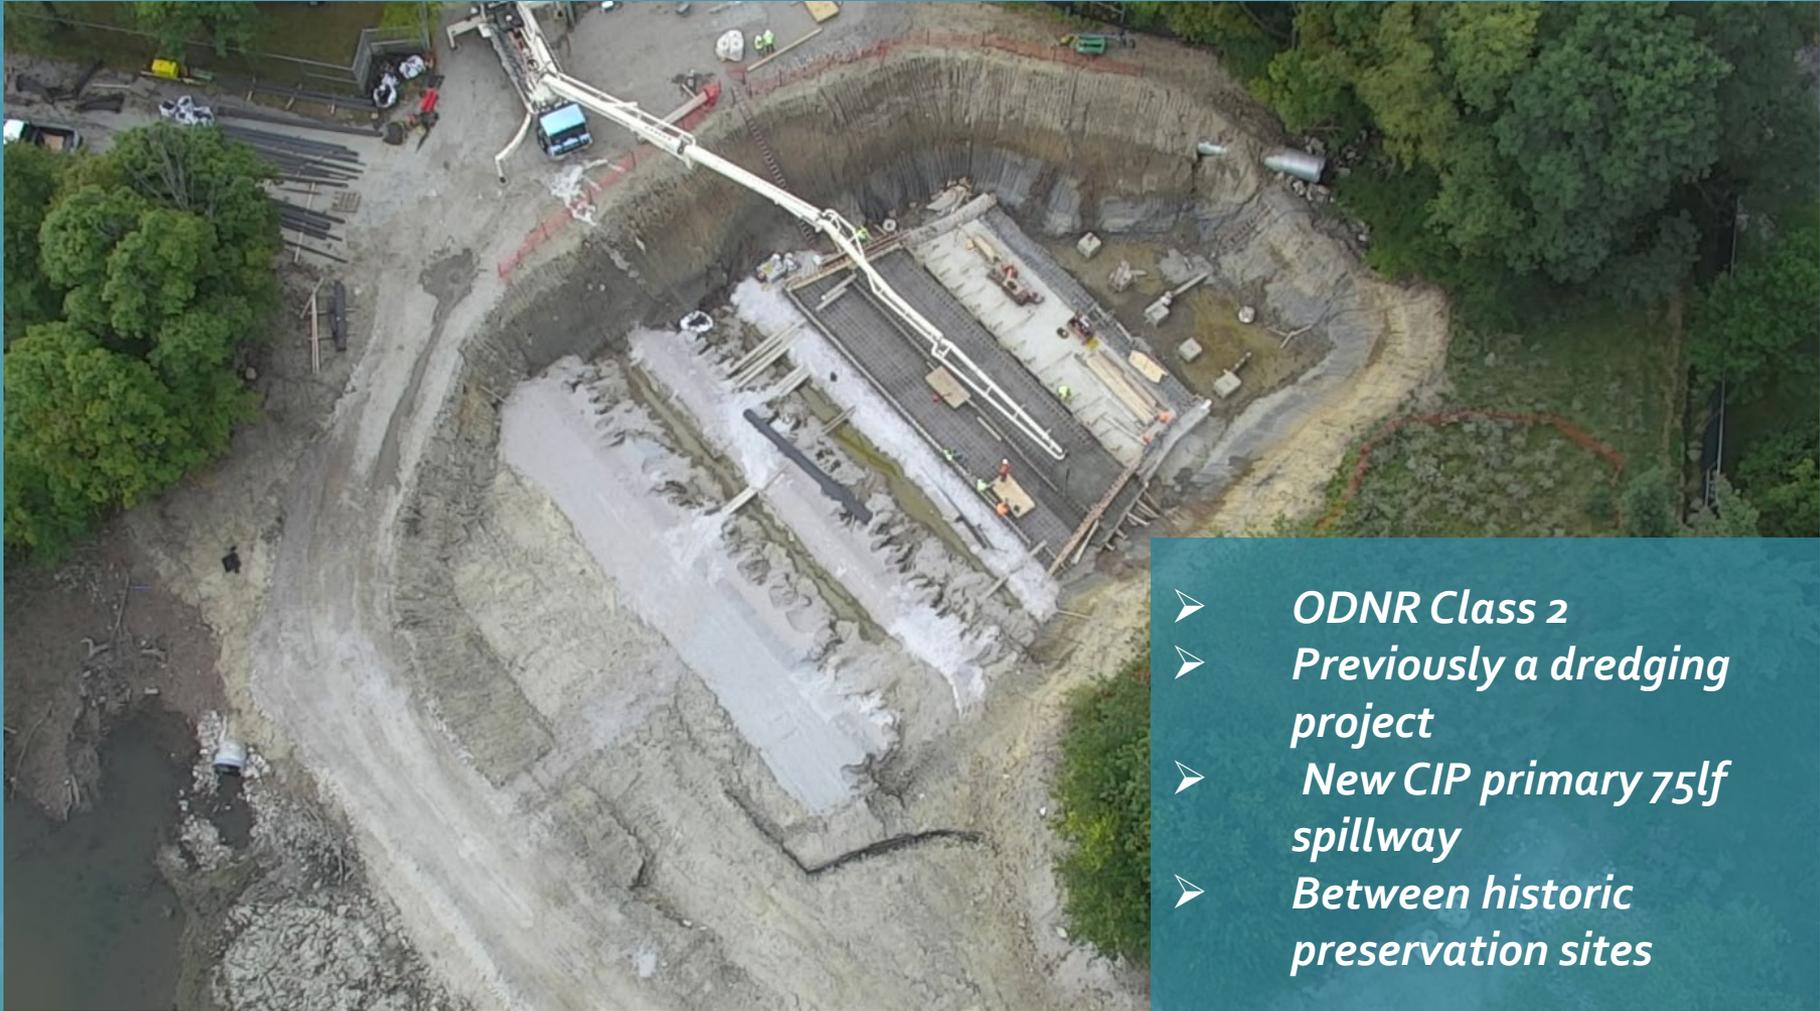
Green Lake Dam Rehabilitation

- *ODNR Class 2*
- *Previously a dredging project*
- *New CIP primary 75lf spillway*
- *Between historic preservation sites*
