Watershed Advisory Committee

Cuyahoga River North

NORTHEAST OHIO REGIONAL SEWER DISTRICT

REGIONAL
STORMWATER
MANAGEMENT
PROGRAM

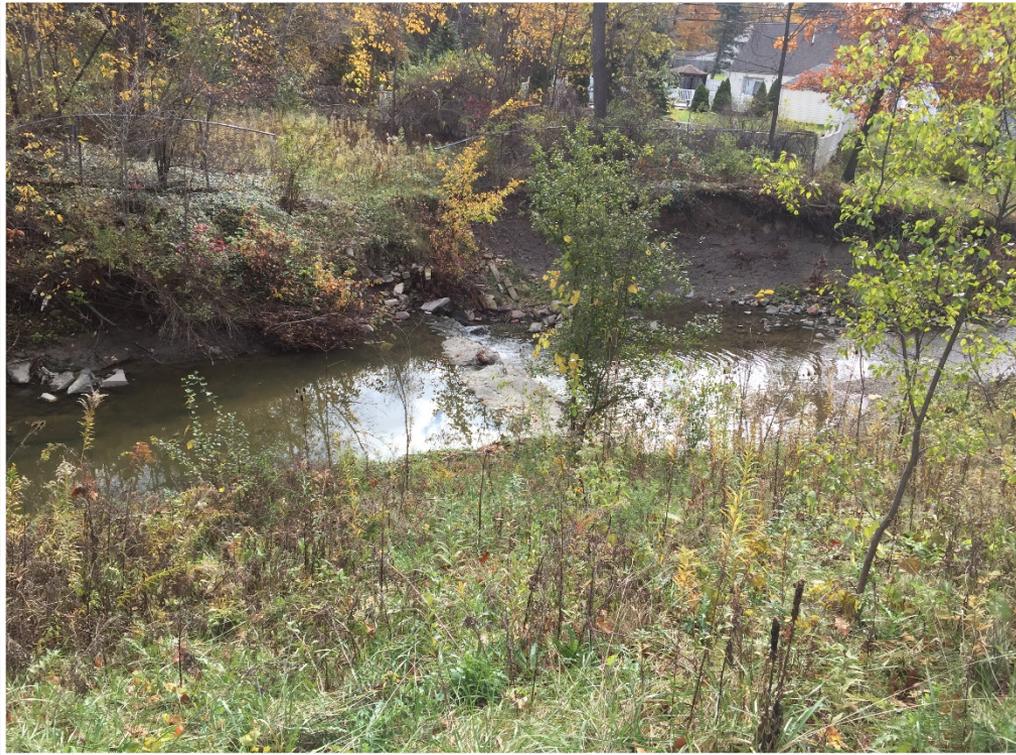
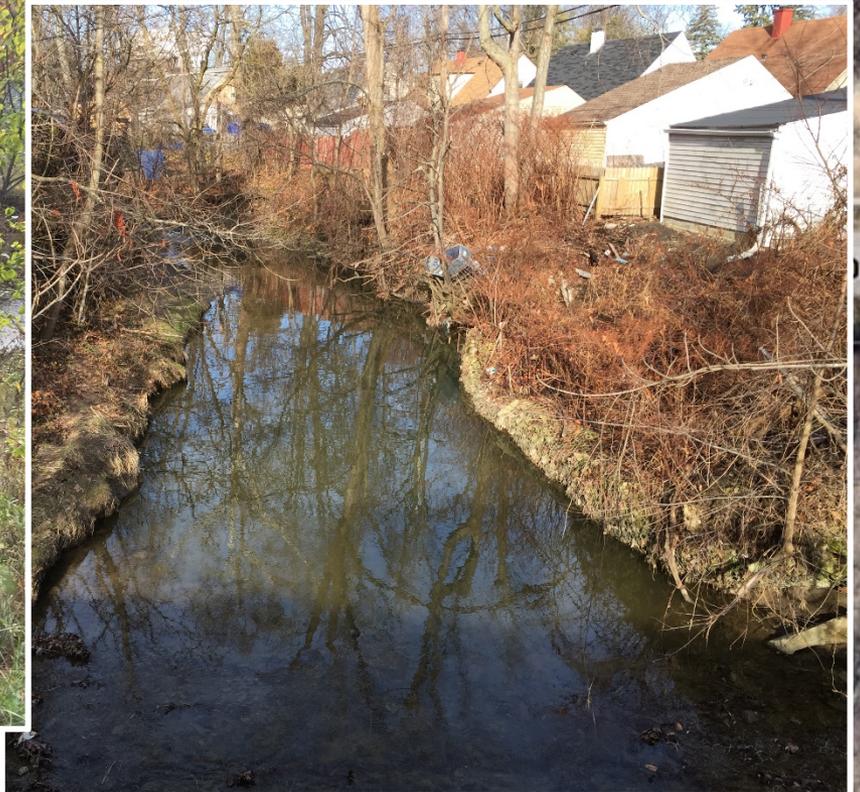
Mill Creek - Existing Conditions

Mill Creek in Warrensville Heights

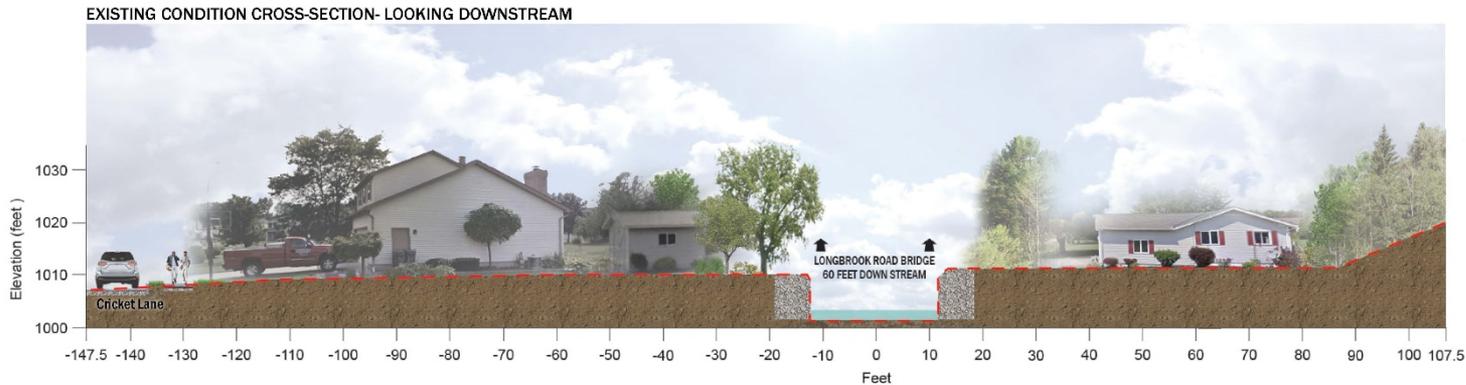
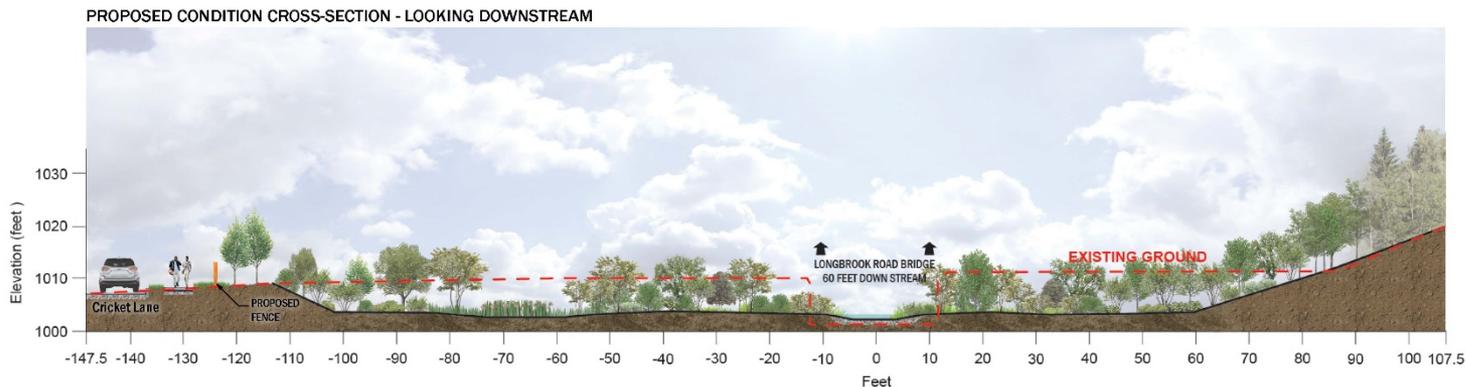
Proposed Concept
Cross-Section

Mill Creek
Warrensville Heights, OH

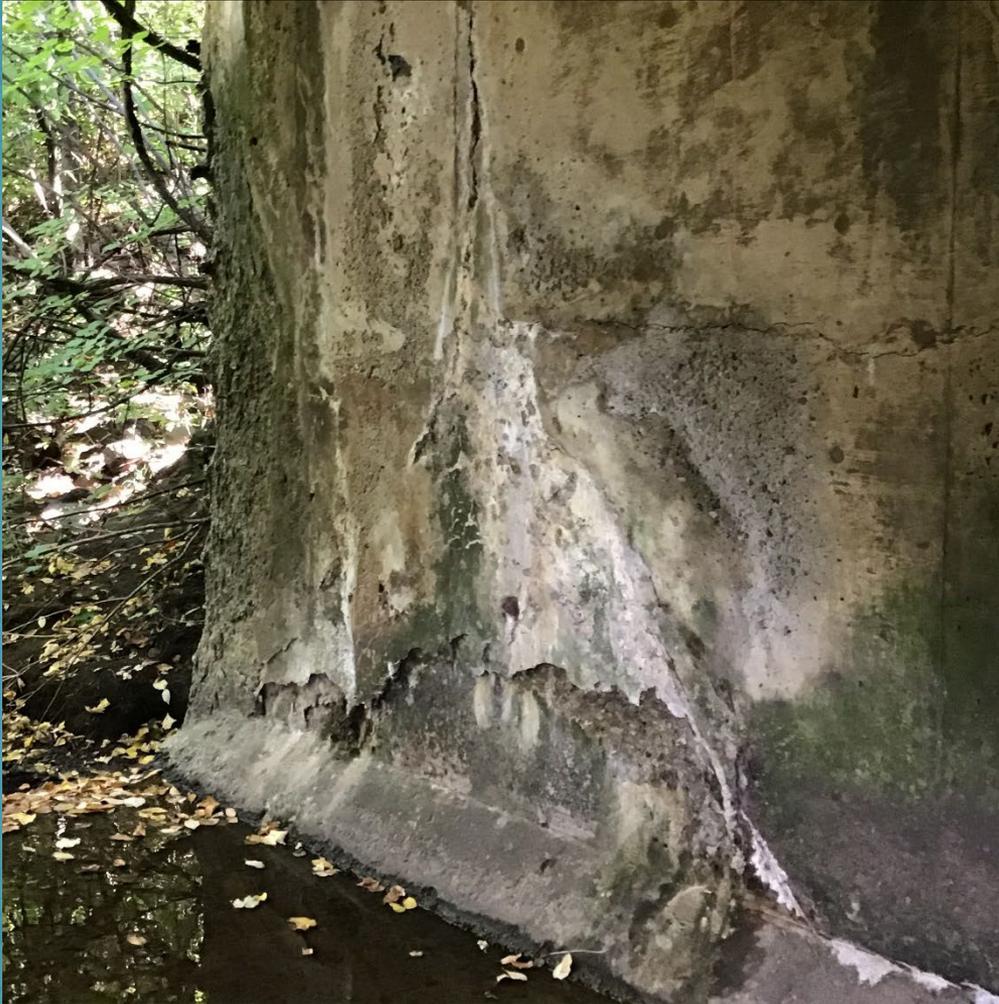
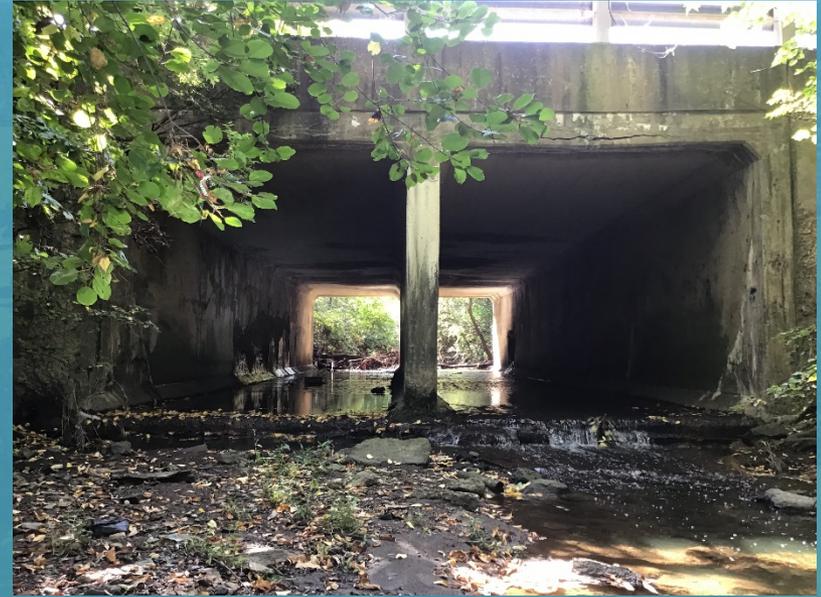
State of the Infrastructure: Crossing Cuyahoga River North: Big Creek West Branch

Asset ID: WBoo183

Brook Park: Commerce Park Drive

Structural BRE = 24 [Grade = D]

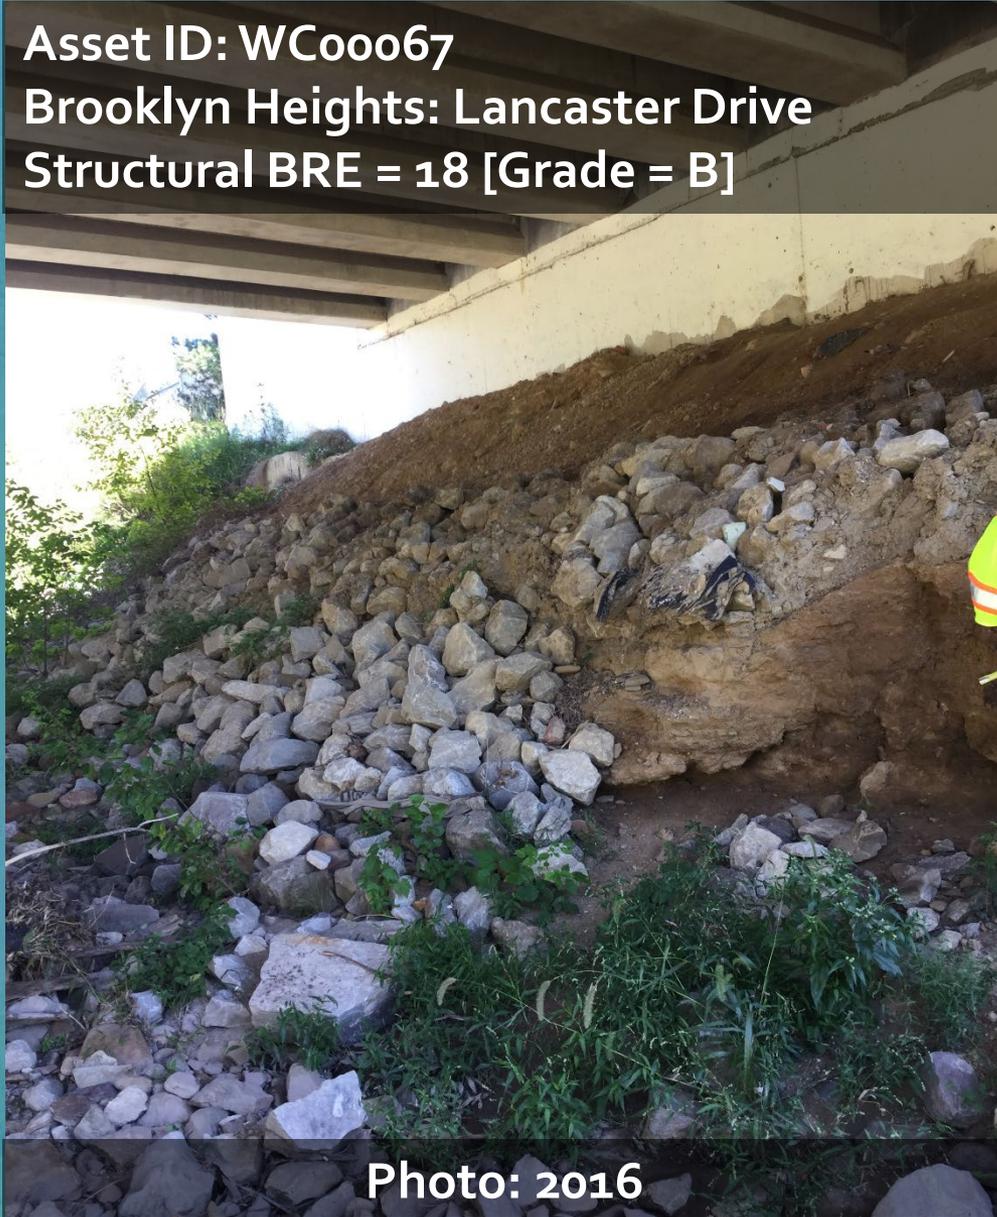
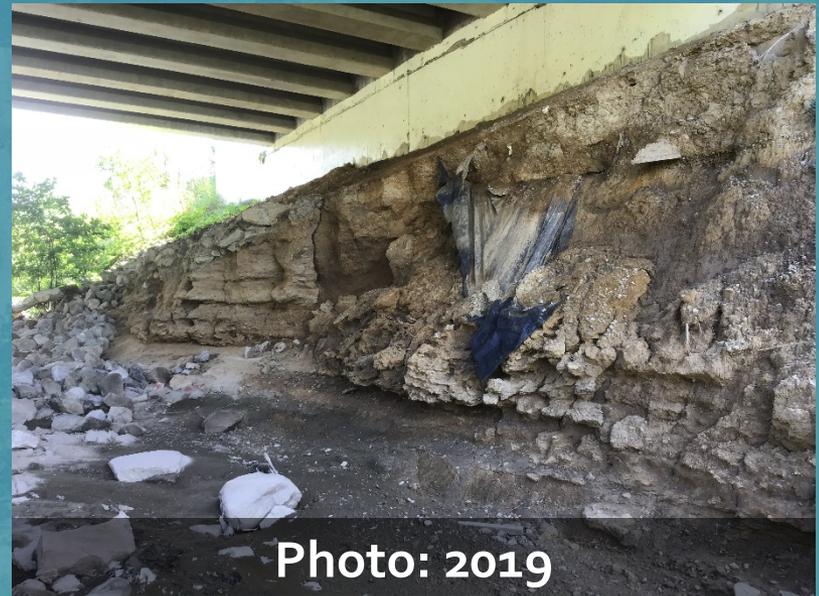
State of the Infrastructure: Crossing Cuyahoga River North: West Creek

Asset ID: WC00067
Brooklyn Heights: Lancaster Drive
Structural BRE = 18 [Grade = B]

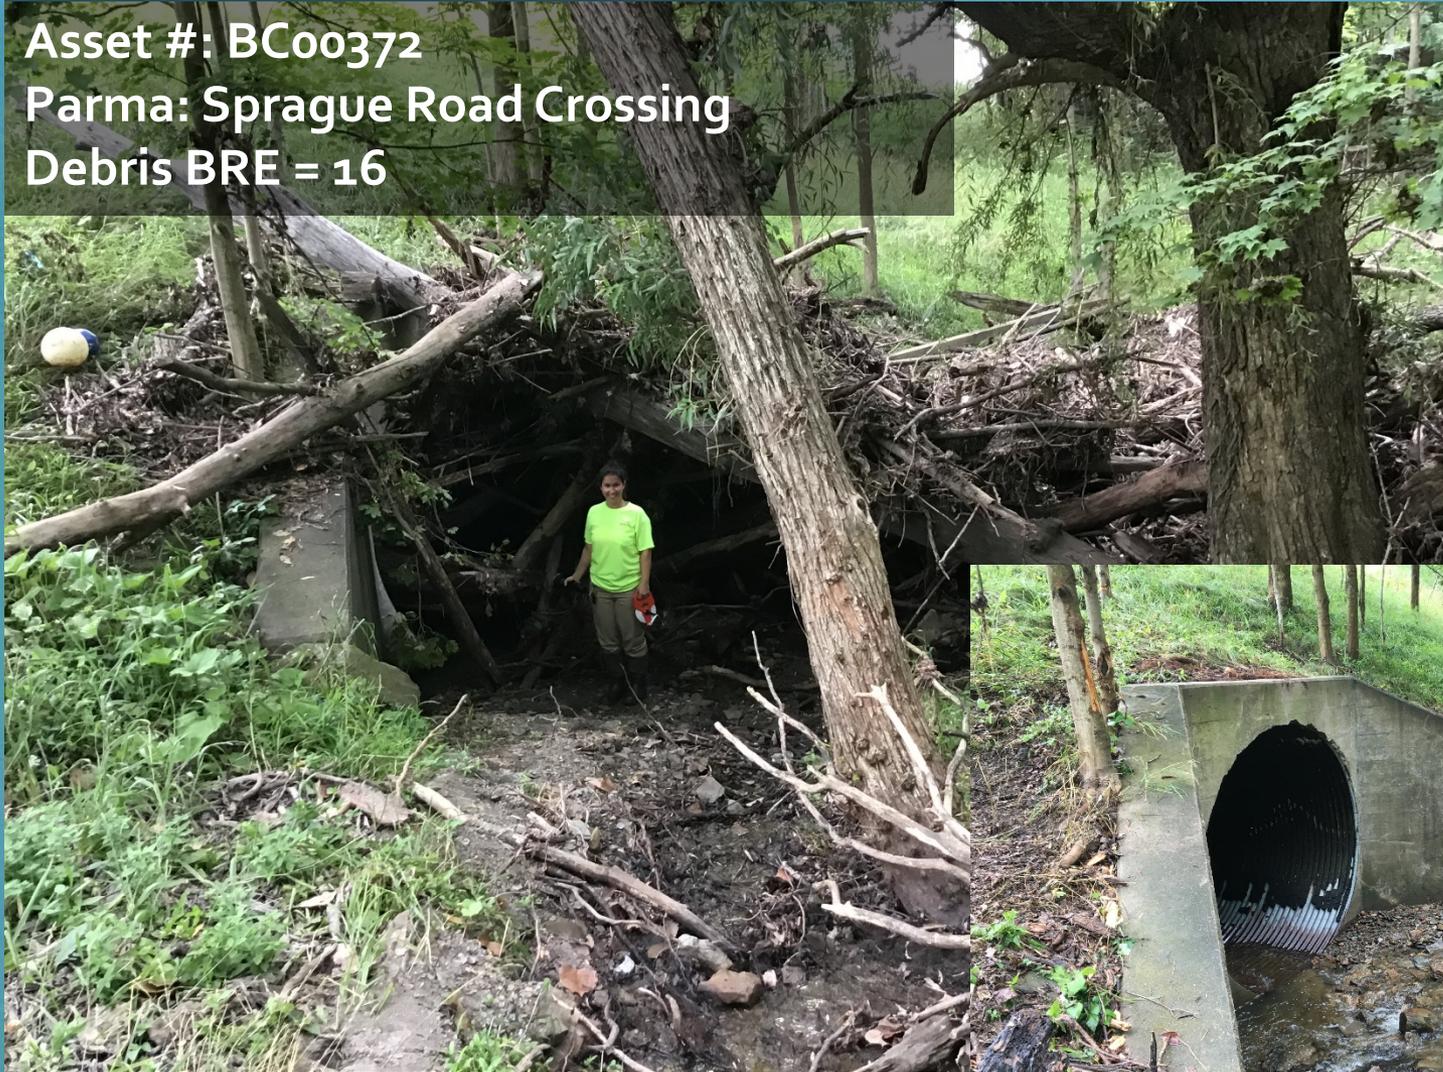
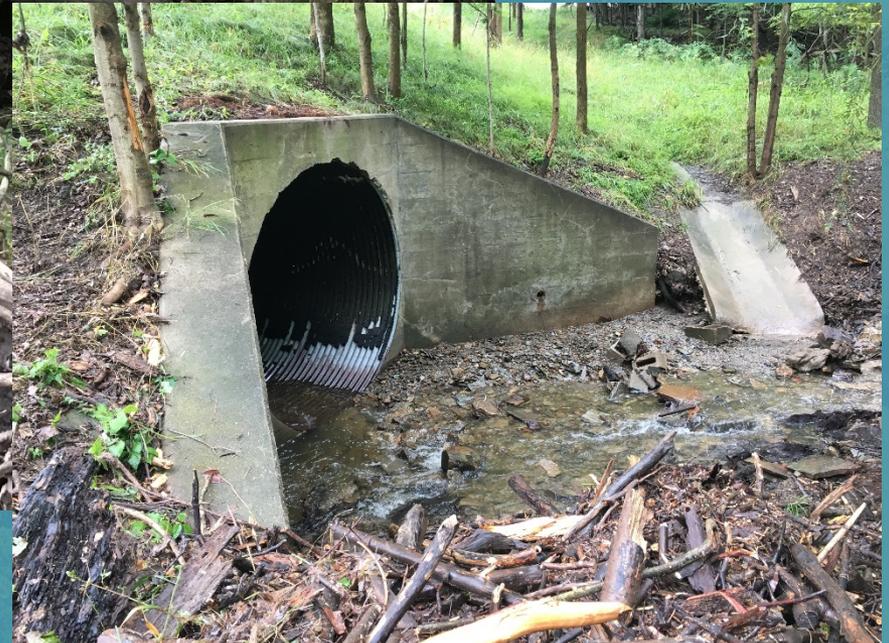
Inspection and Maintenance: Debris Removal from Crossing Cuyahoga River North: Big Creek

Asset #: BC00372

Parma: Sprague Road Crossing

Debris BRE = 16

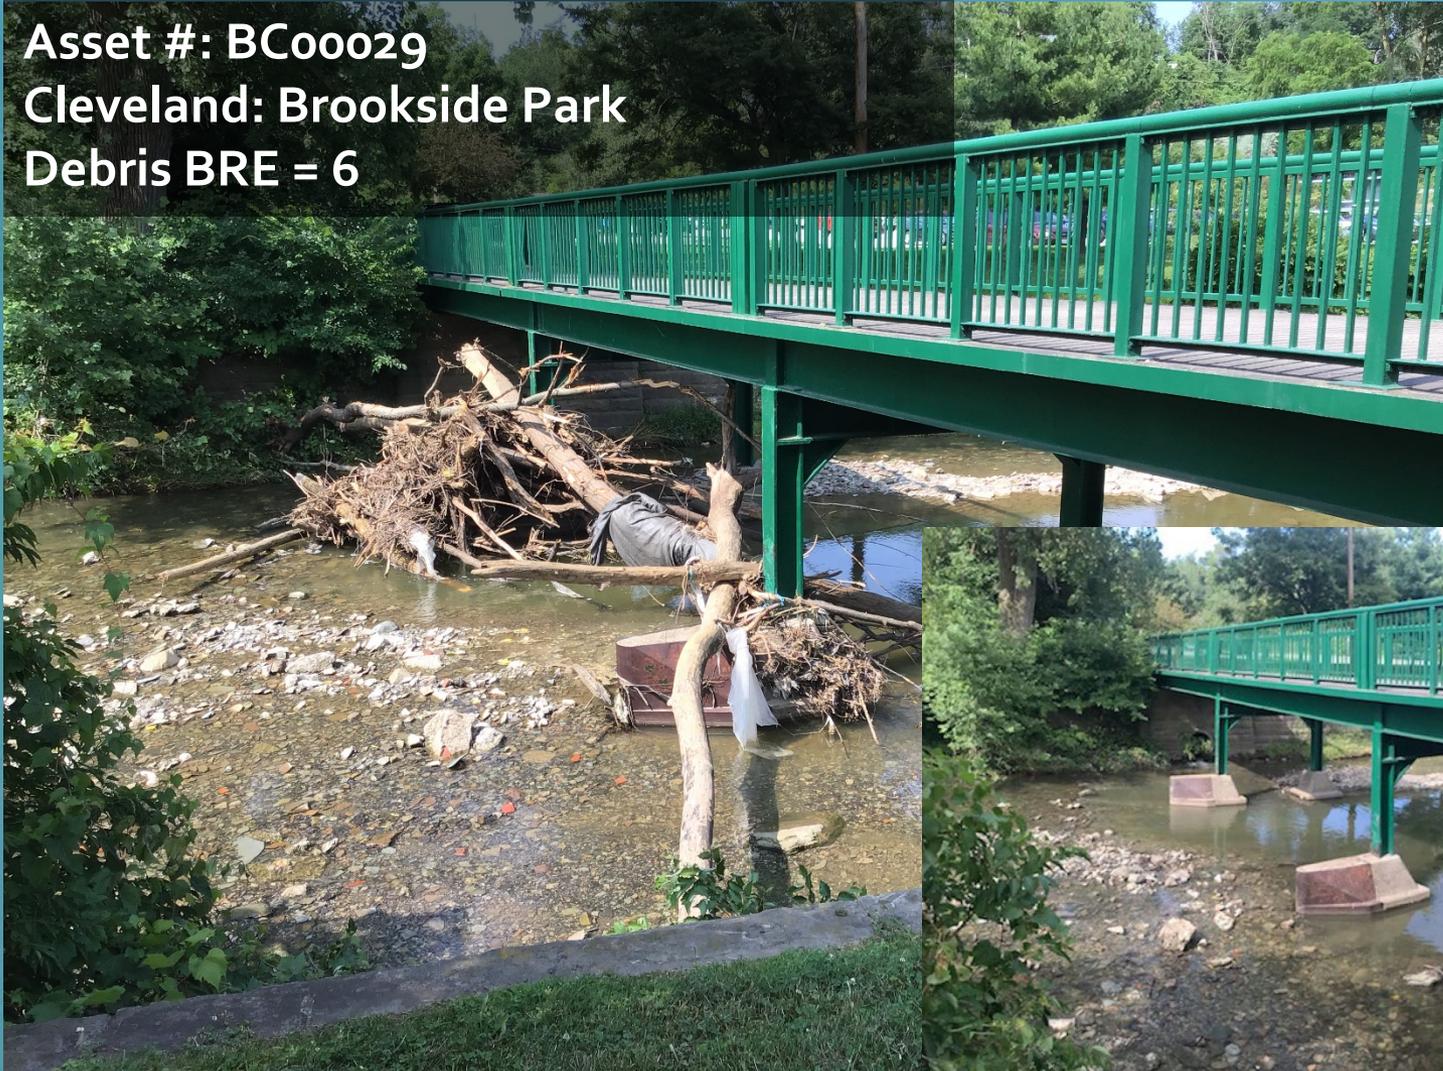
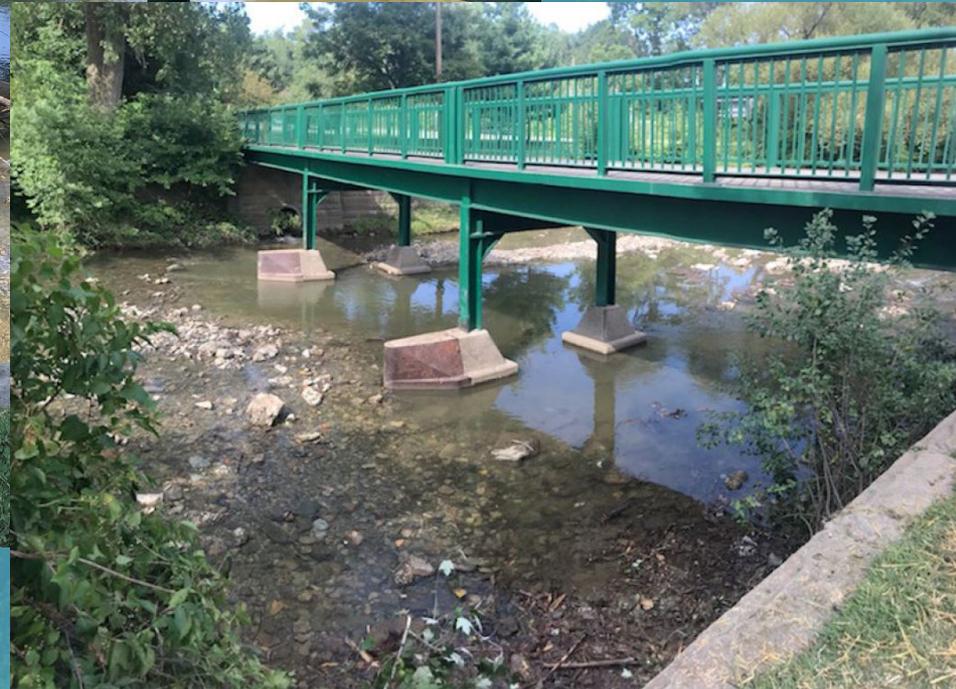
Inspection and Maintenance: Debris Removal Cuyahoga River North: Big Creek

Asset #: BC00029

Cleveland: Brookside Park

Debris BRE = 6

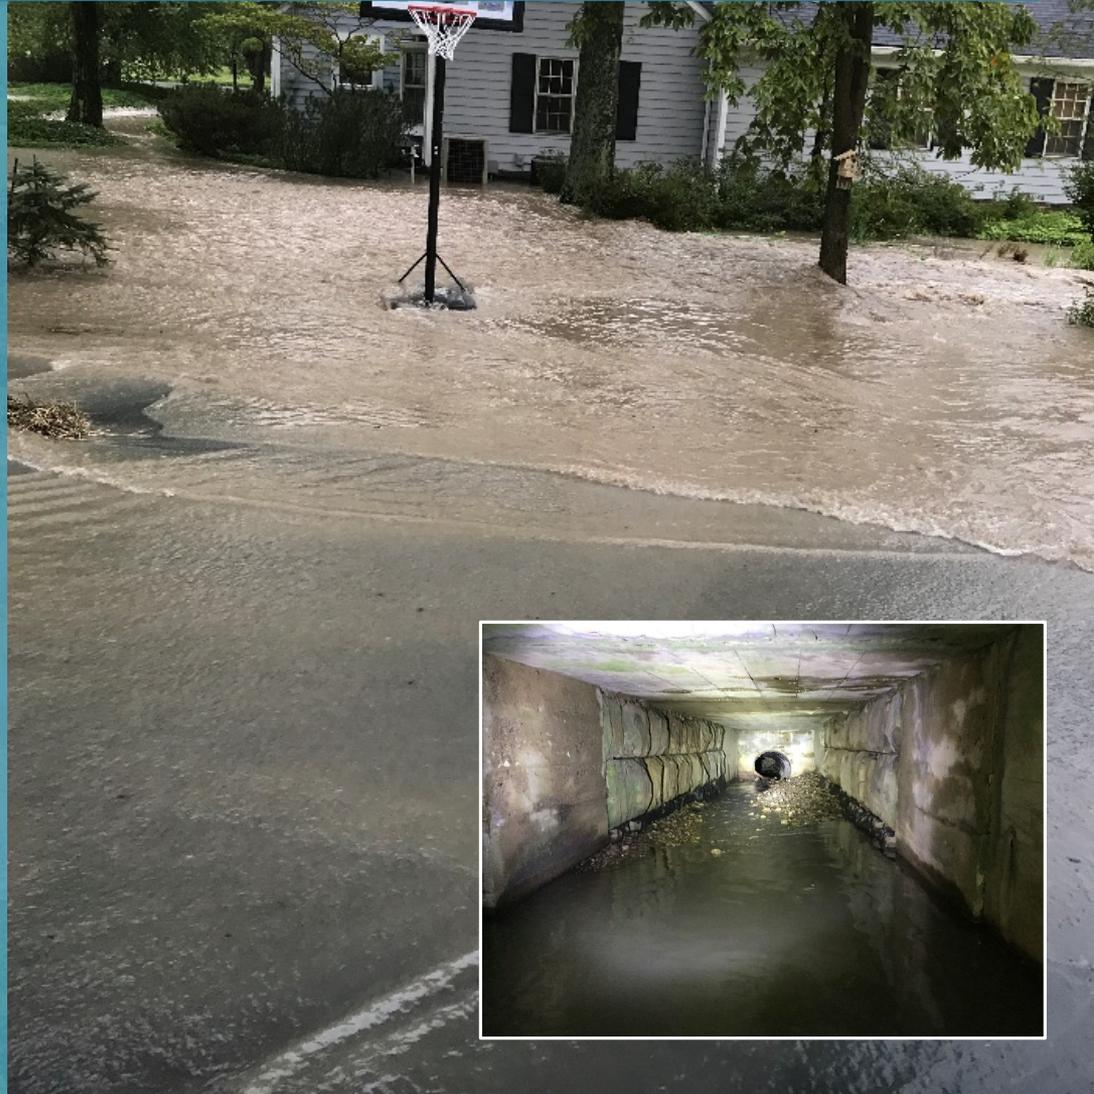
Pepper Luce at Shaker Blvd Culvert Deterioration

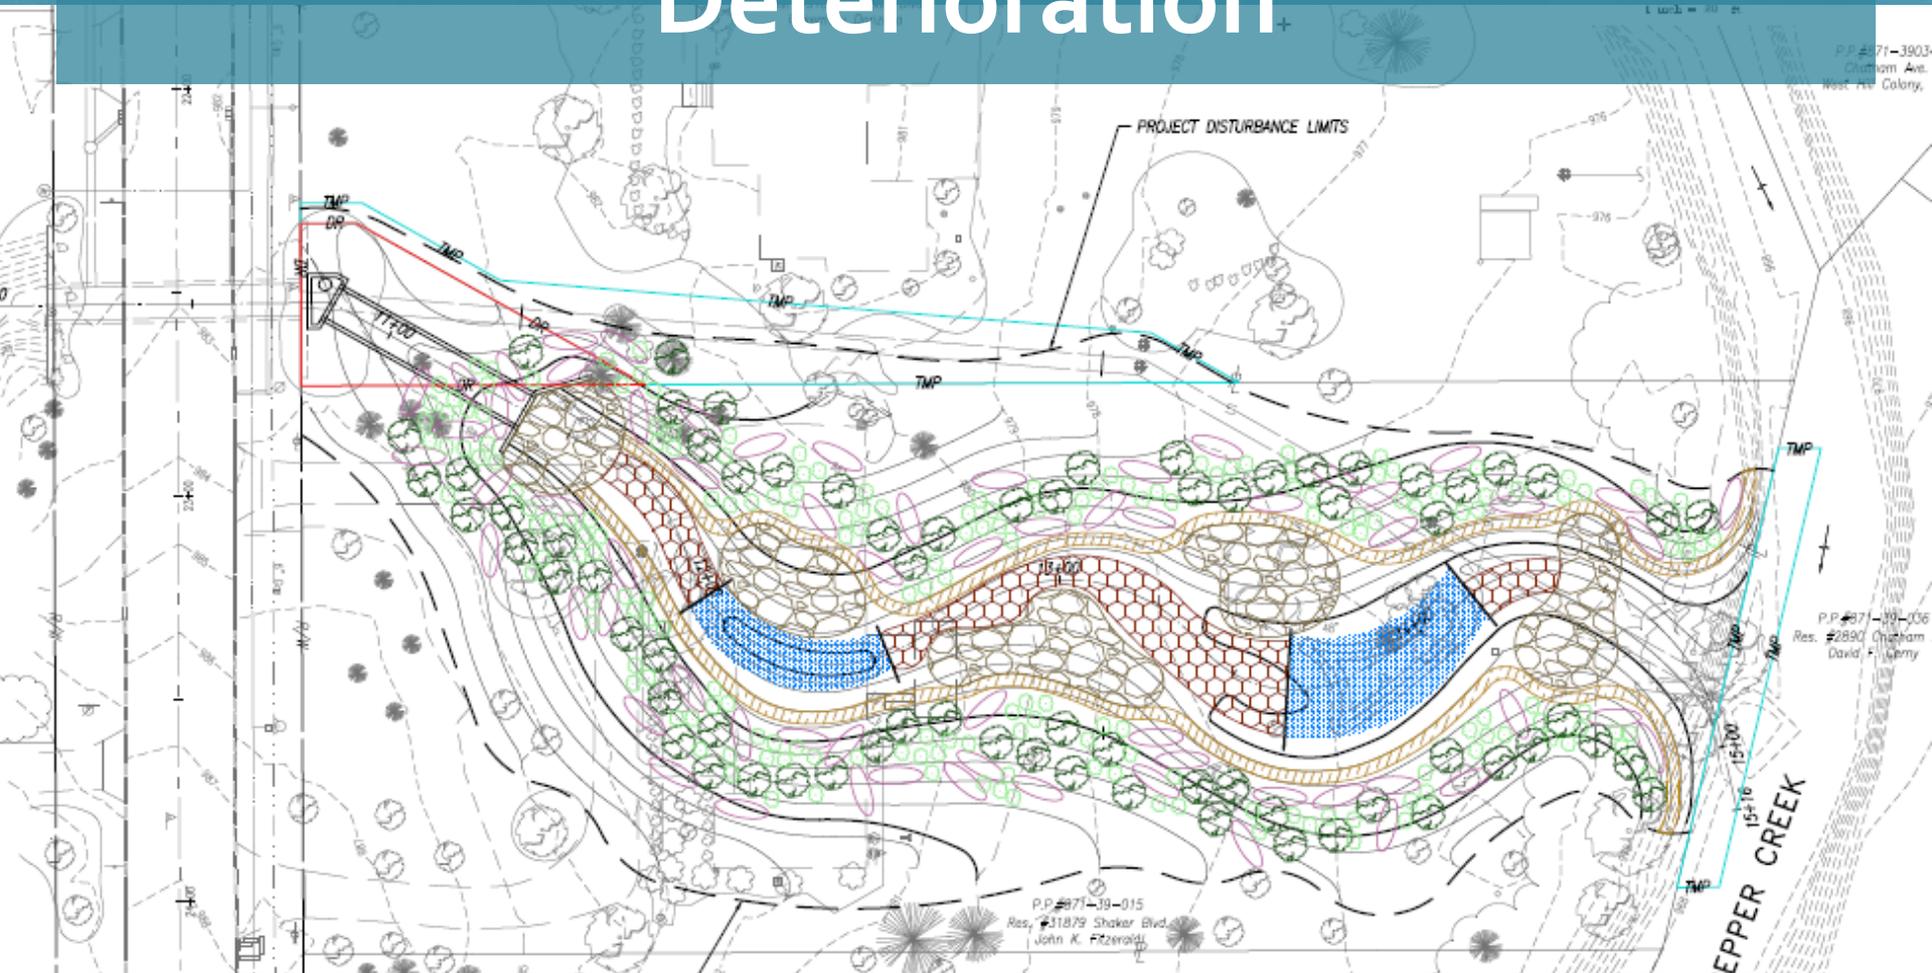
Pepper Luce at Shaker Blvd Culvert Deterioration

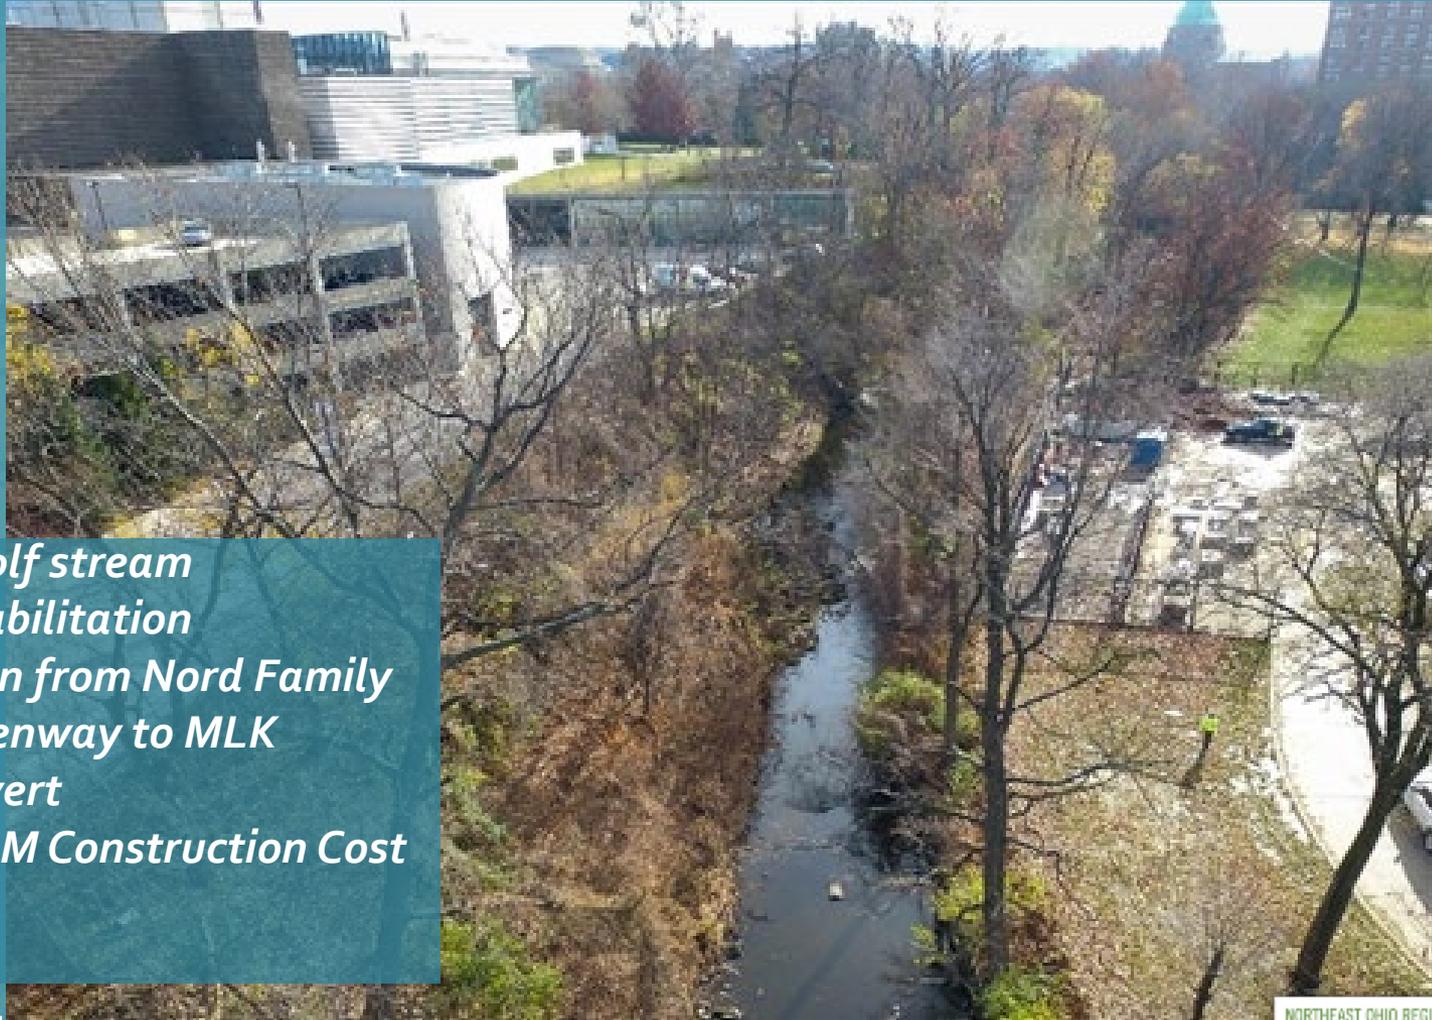
Doan Brook Streambank Stabilization

- *1000lf stream rehabilitation*
- *Tie in from Nord Family Greenway to MLK Culvert*
- *\$2.4M Construction Cost*

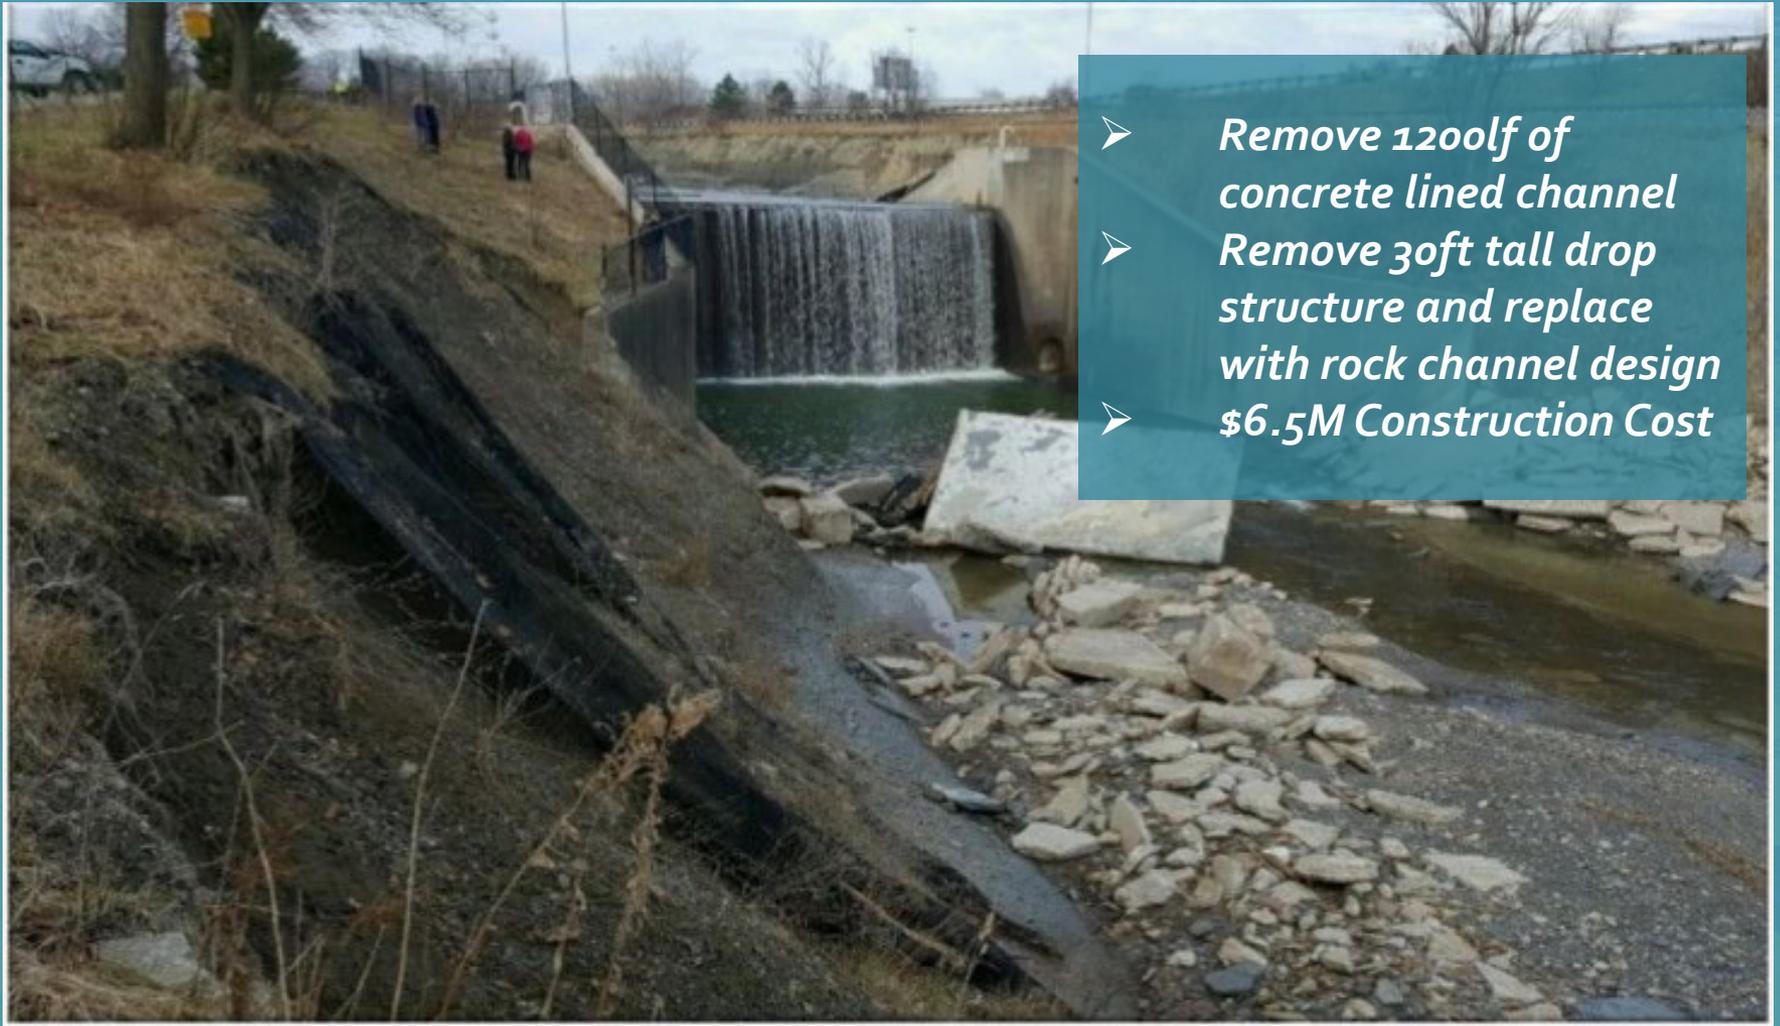
Big Creek Stabilization

- *Remove 1200lf of concrete lined channel*
- *Remove 30ft tall drop structure and replace with rock channel design*
- *\$6.5M Construction Cost*

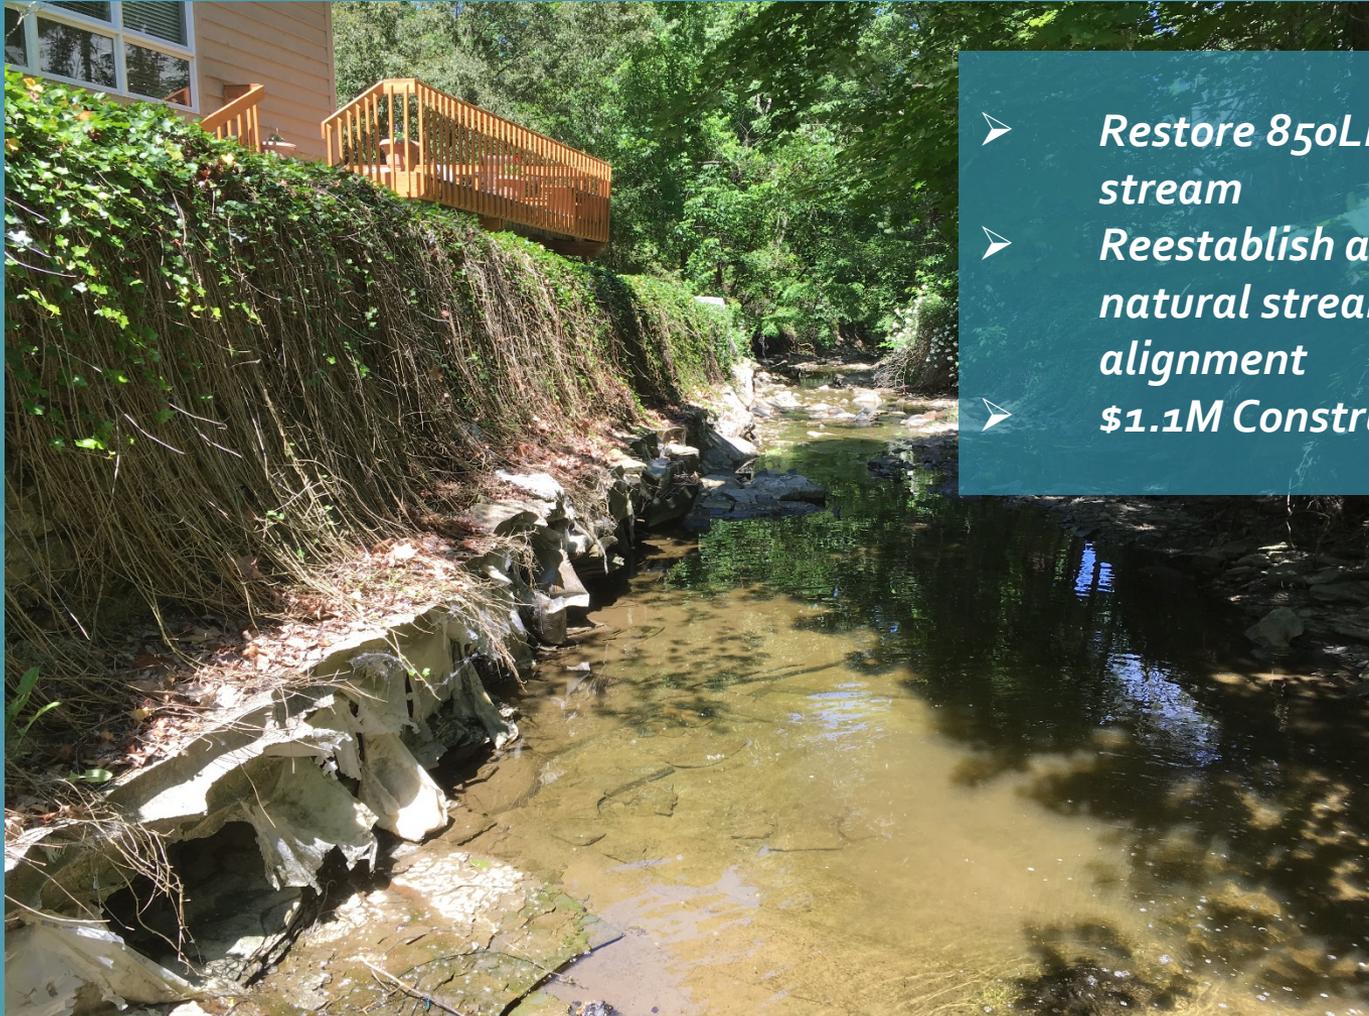
Pepper Creek Bank Stabilization

- *Restore 850LF feet of stream*
- *Reestablish a more natural stream alignment*
- *\$1.1M Construction Cost*

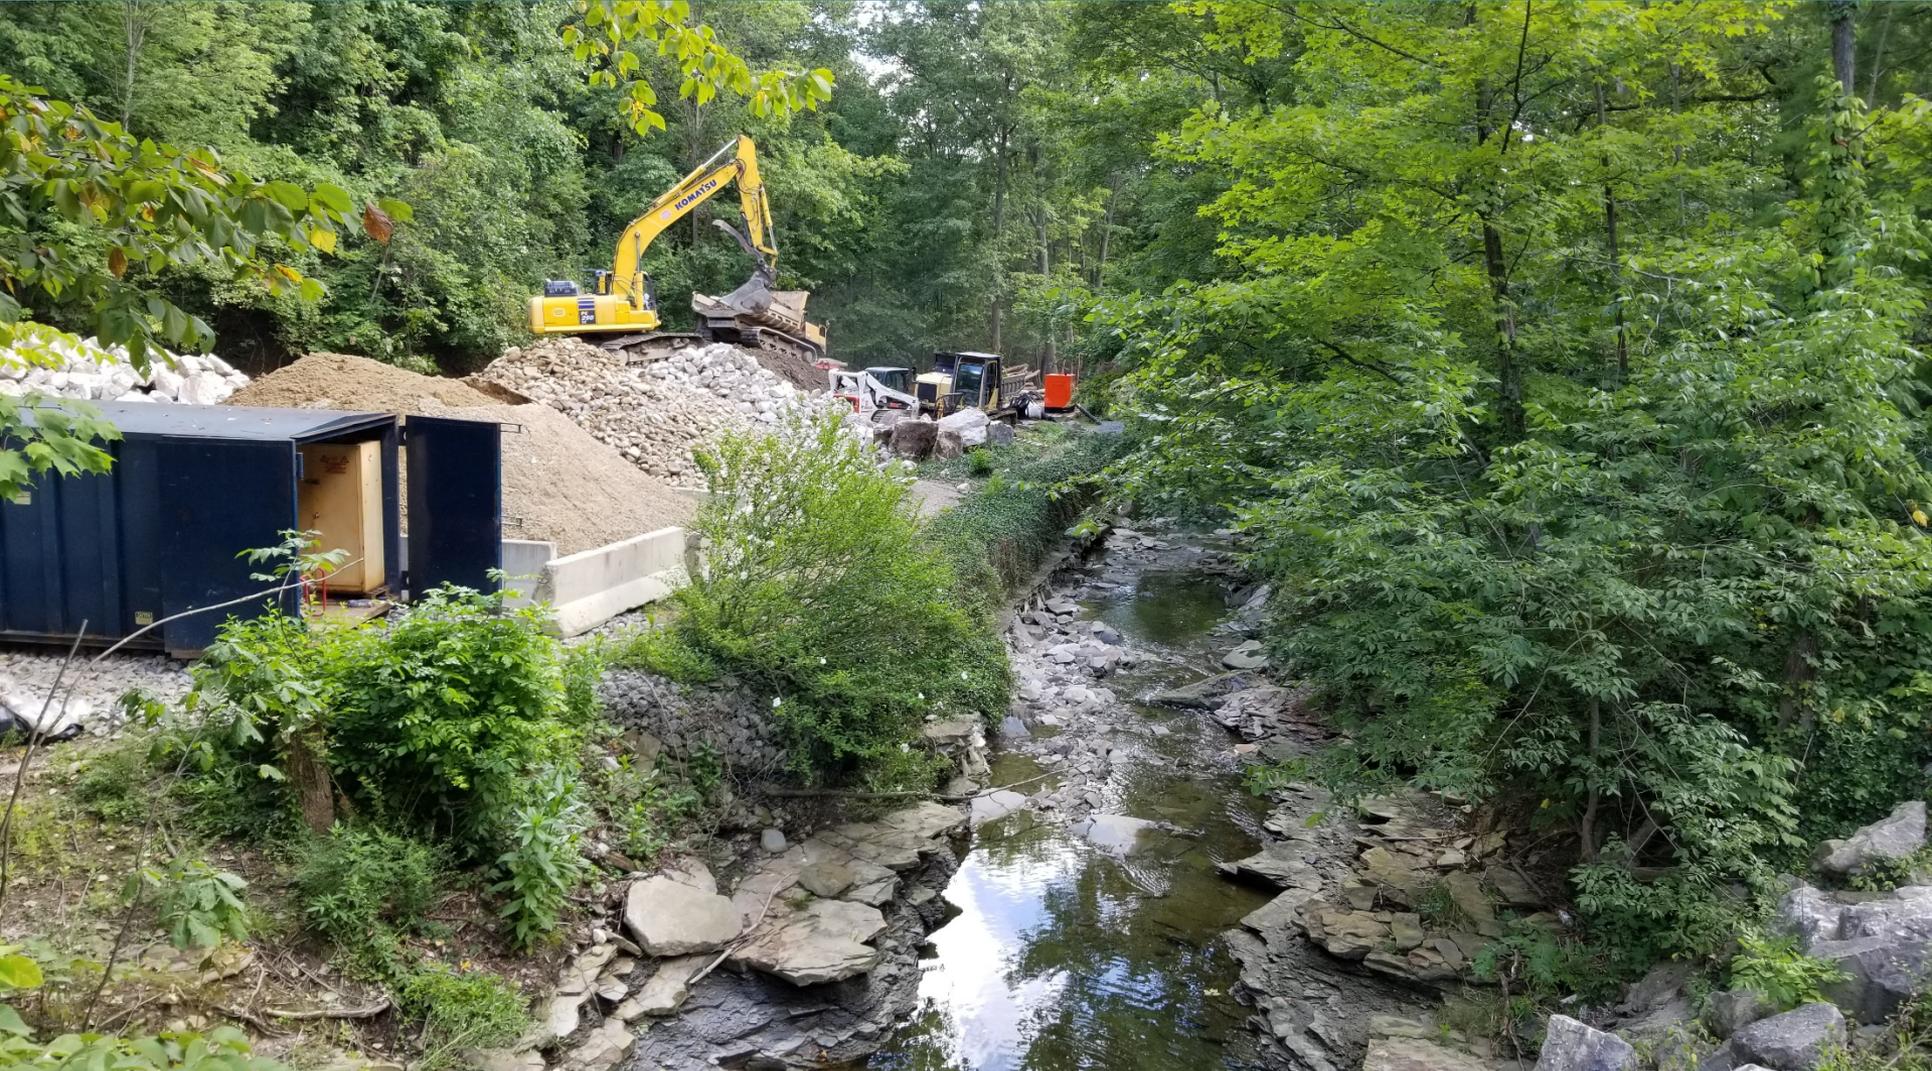
Pepper Creek Bank Stabilization

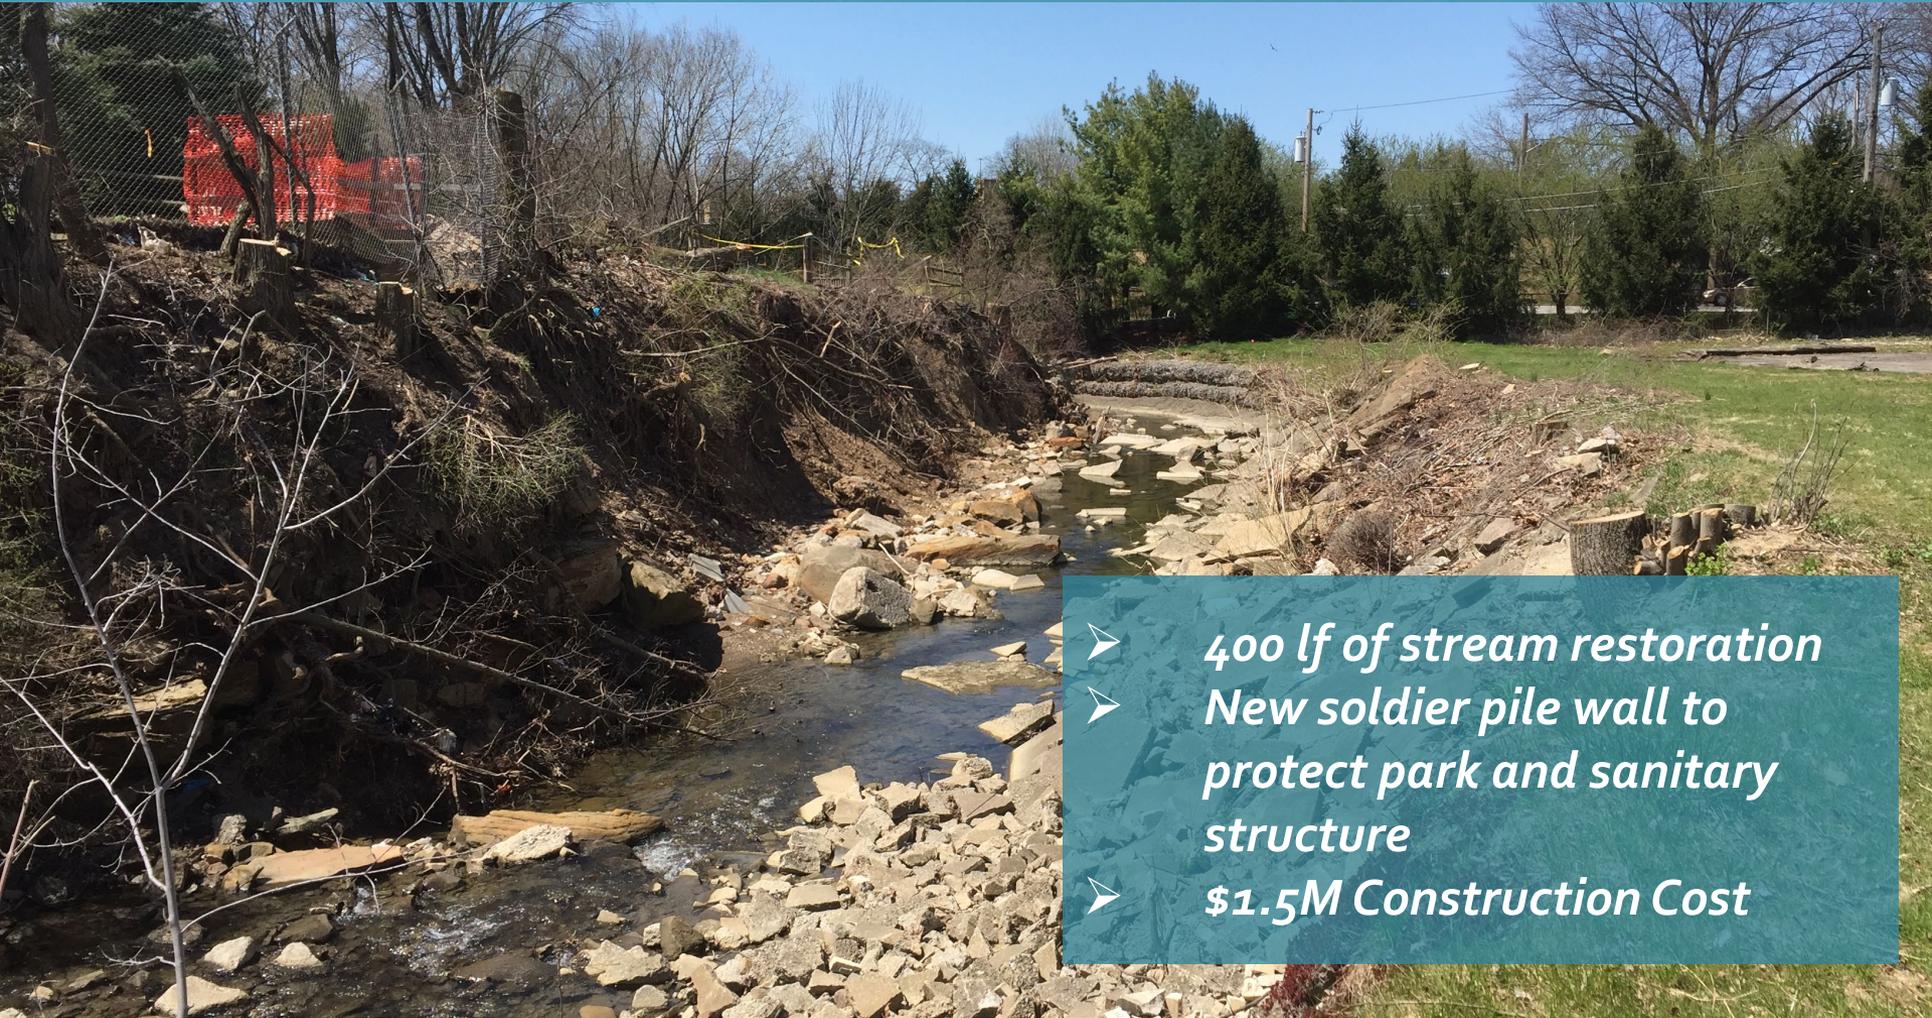
Colombo Park Stream Restoration

- 400 lf of stream restoration
- New soldier pile wall to protect park and sanitary structure
- \$1.5M Construction Cost
