Watershed Advisory Committee

Cuyahoga River North

NORTHEAST OHIO REGIONAL SEWER DISTRICT

REGIONAL
STORMWATER
MANAGEMENT
PROGRAM

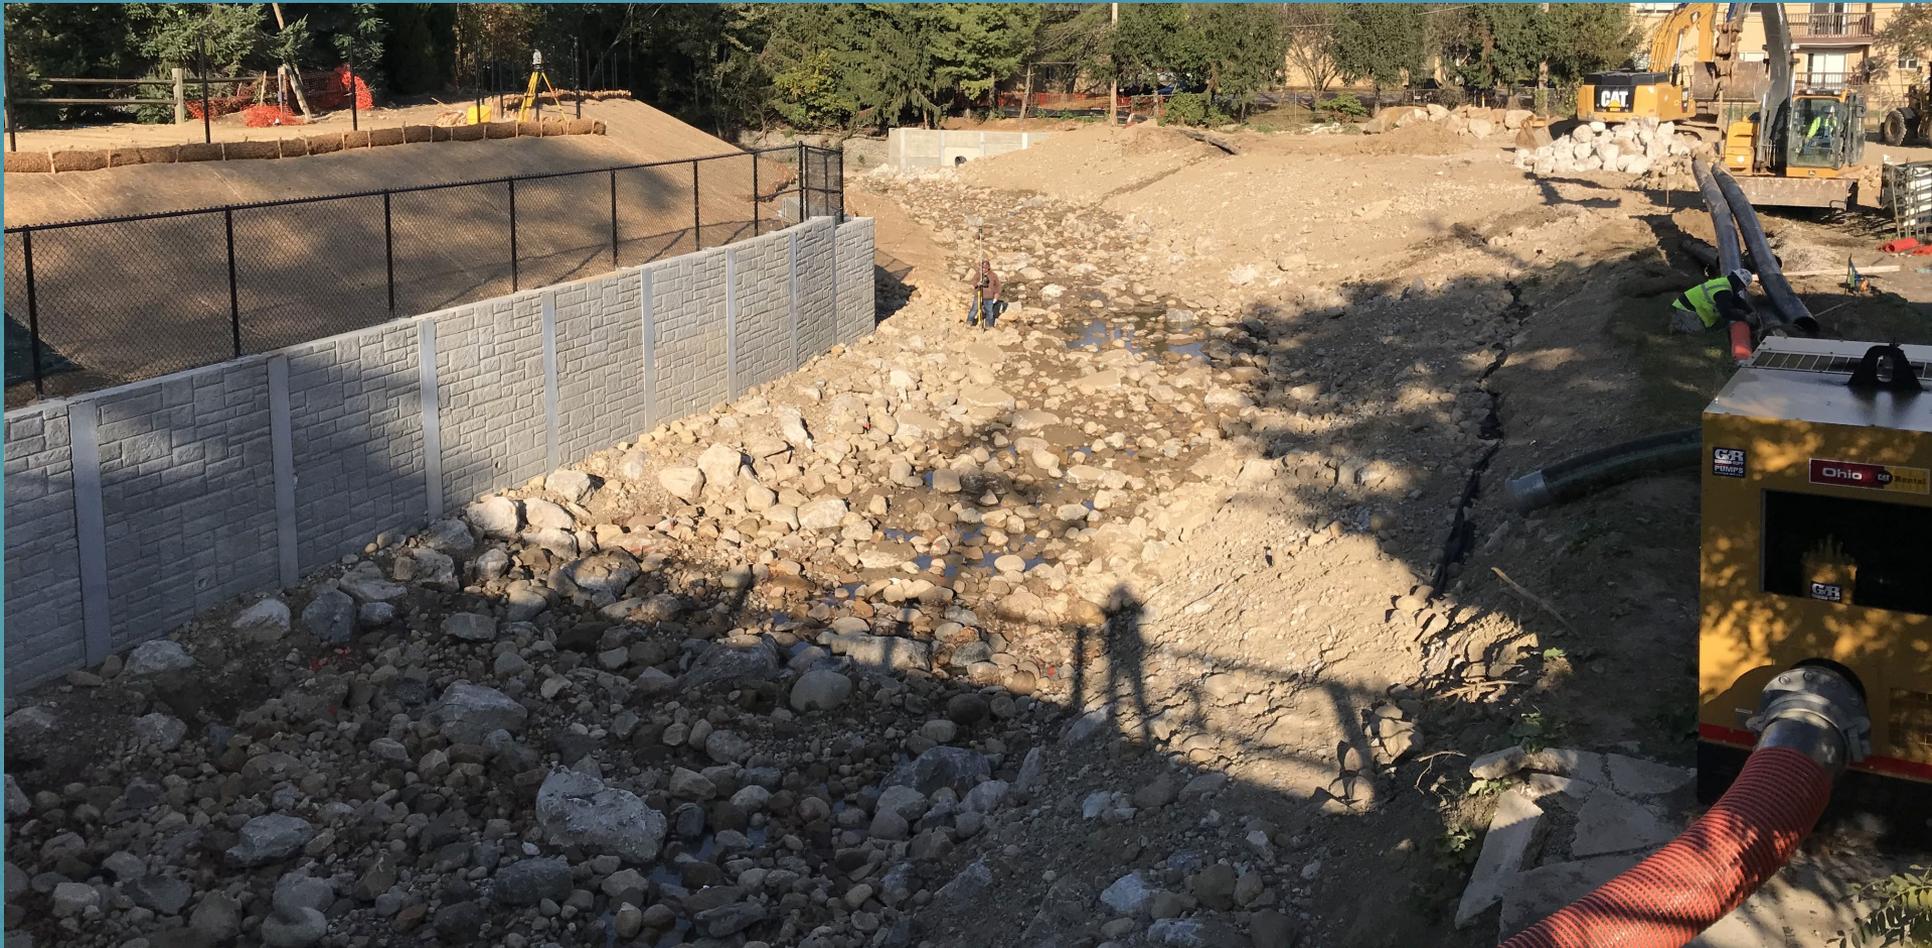
- 400 lf of stream restoration
- New soldier pile wall to protect park and sanitary structure
- \$1.5M Construction Cost

Colombo Park Stream Restoration

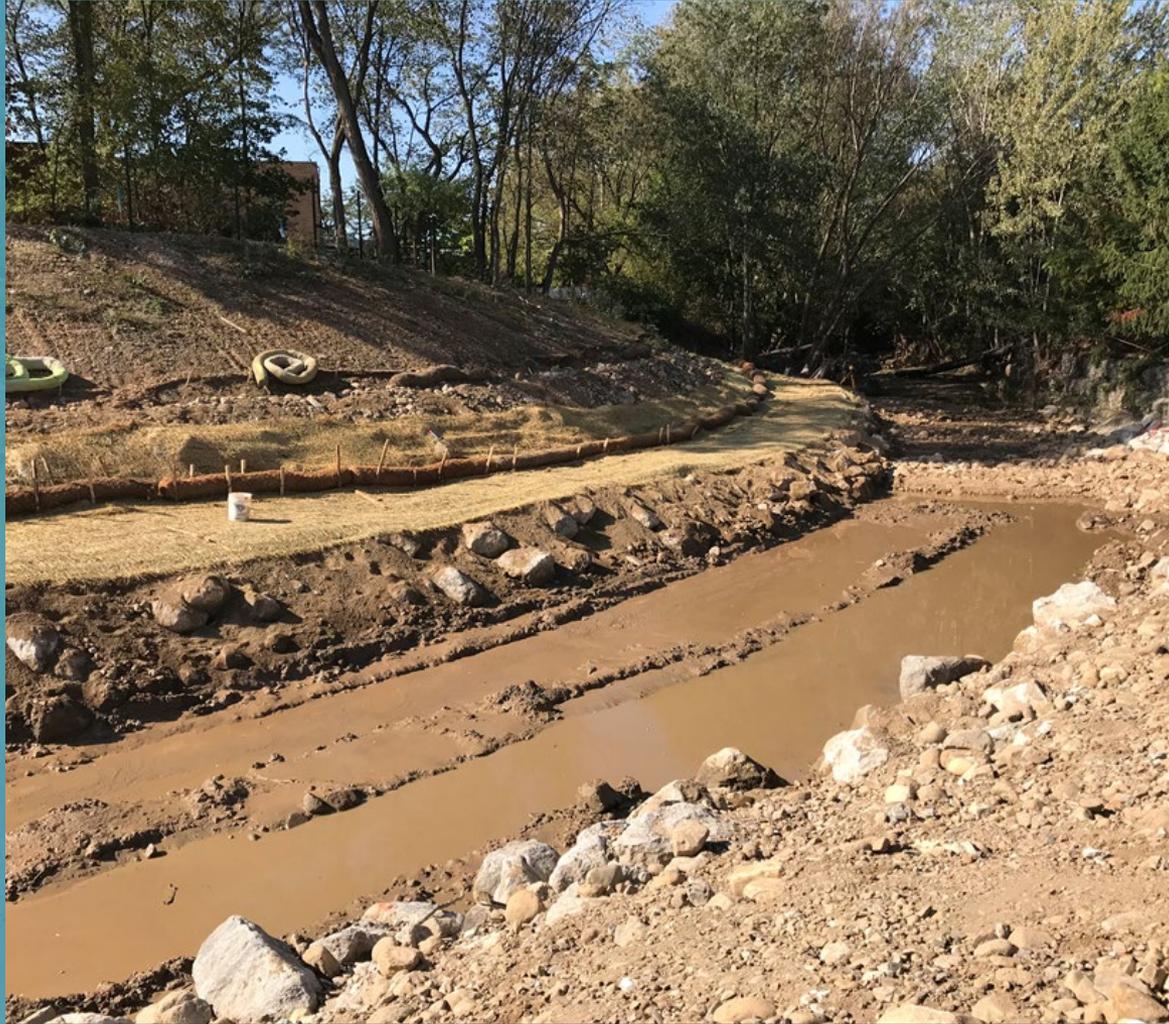
Colombo Park Stream Restoration

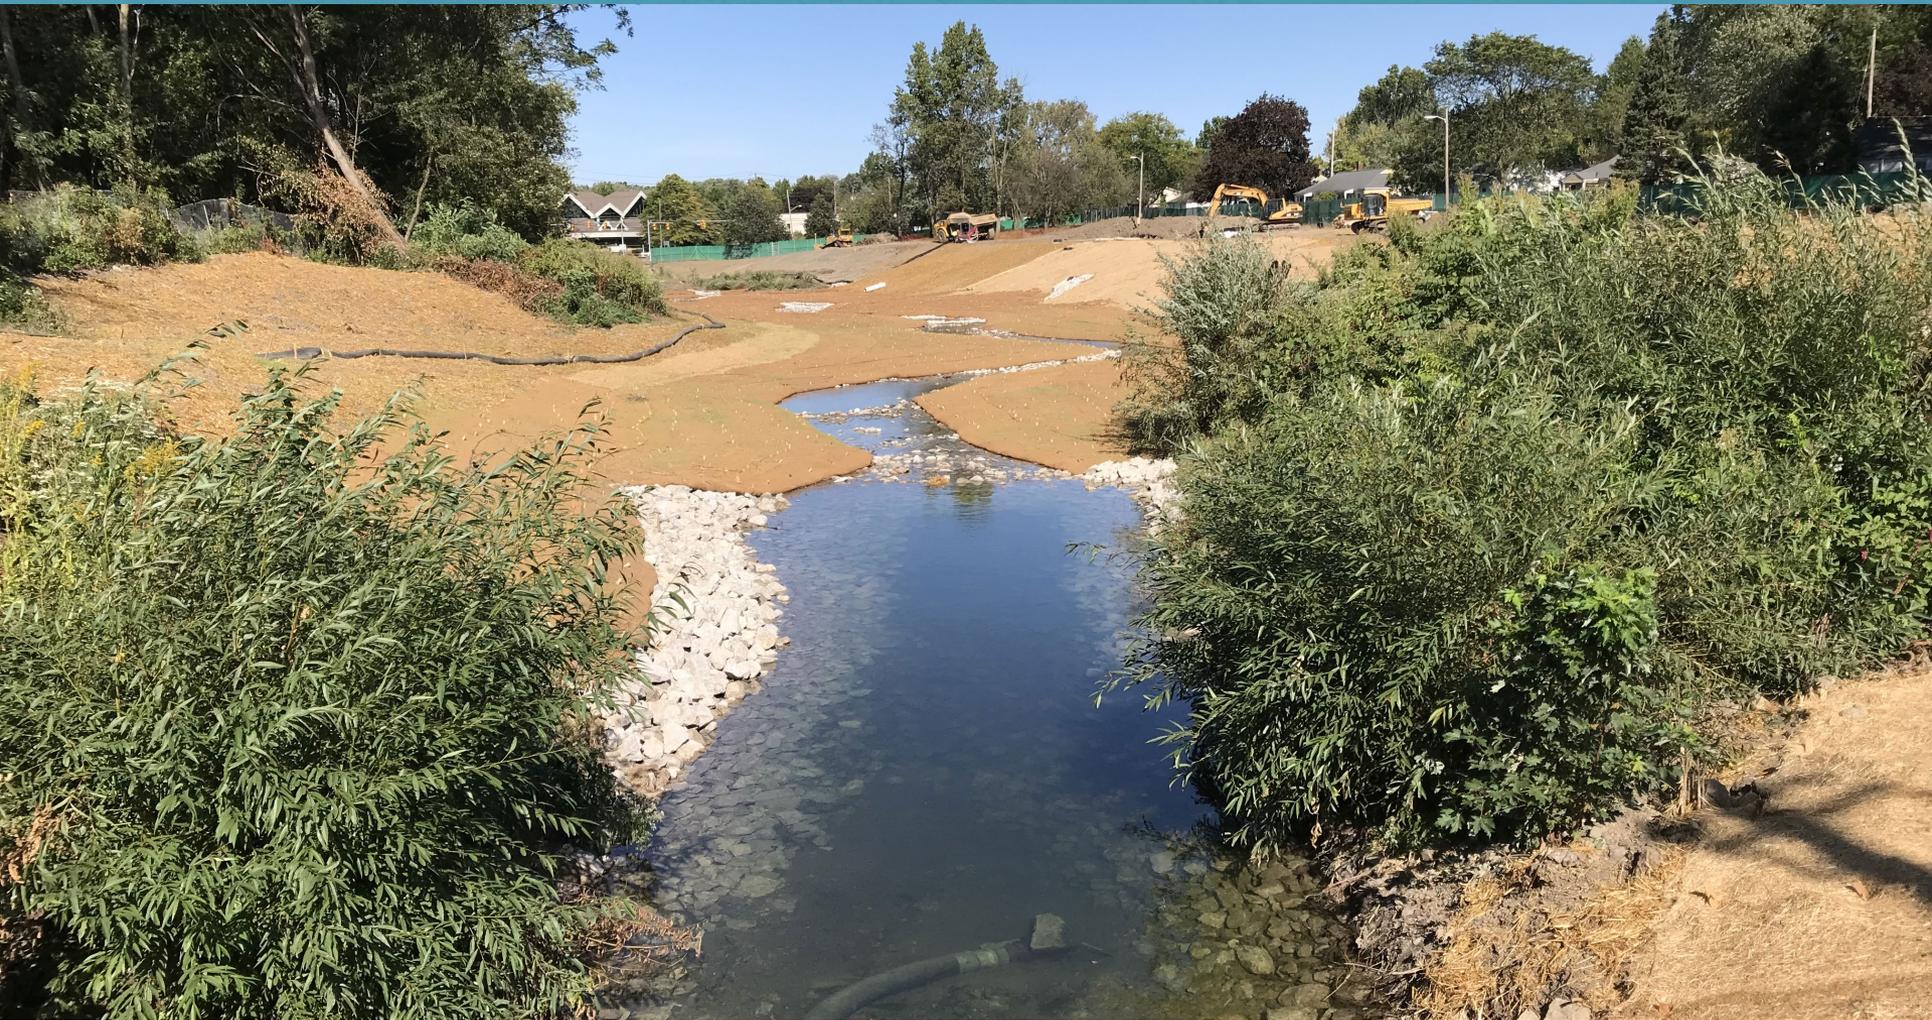
Stickney Creek Restoration and Utility Relocation

- *430 LF of sewer replacement and realignment*
- *900 LF of stream restoration*
- *\$3.16 M Total Project Cost*

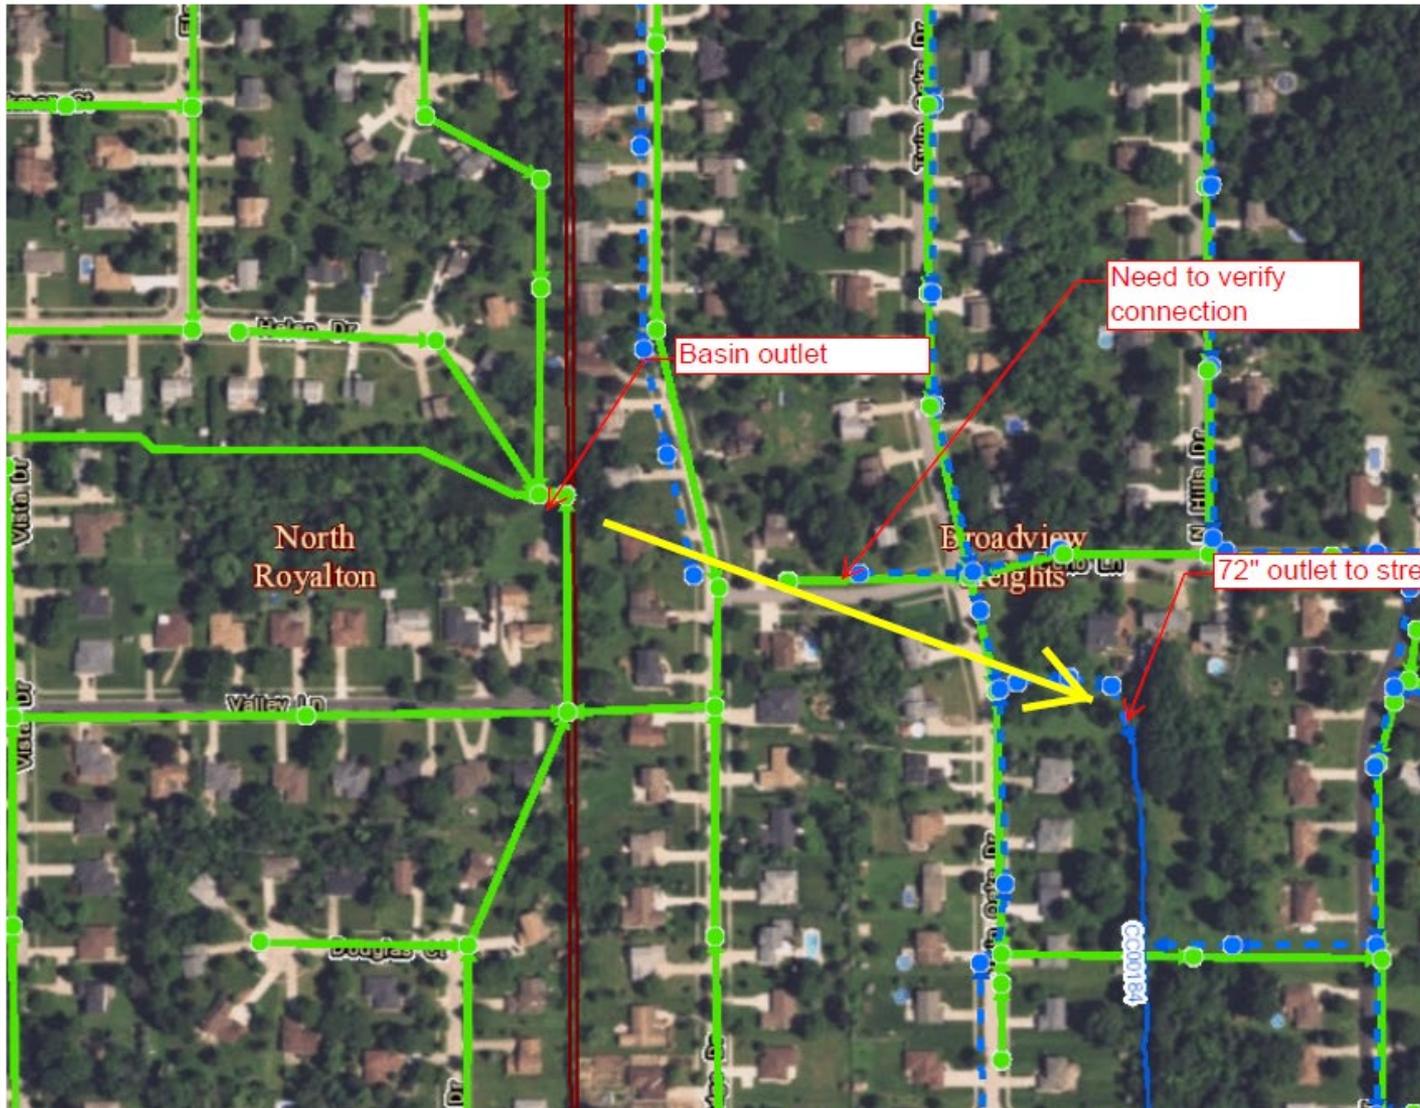
Basin Inspection- Broadview Heights/North Royalton

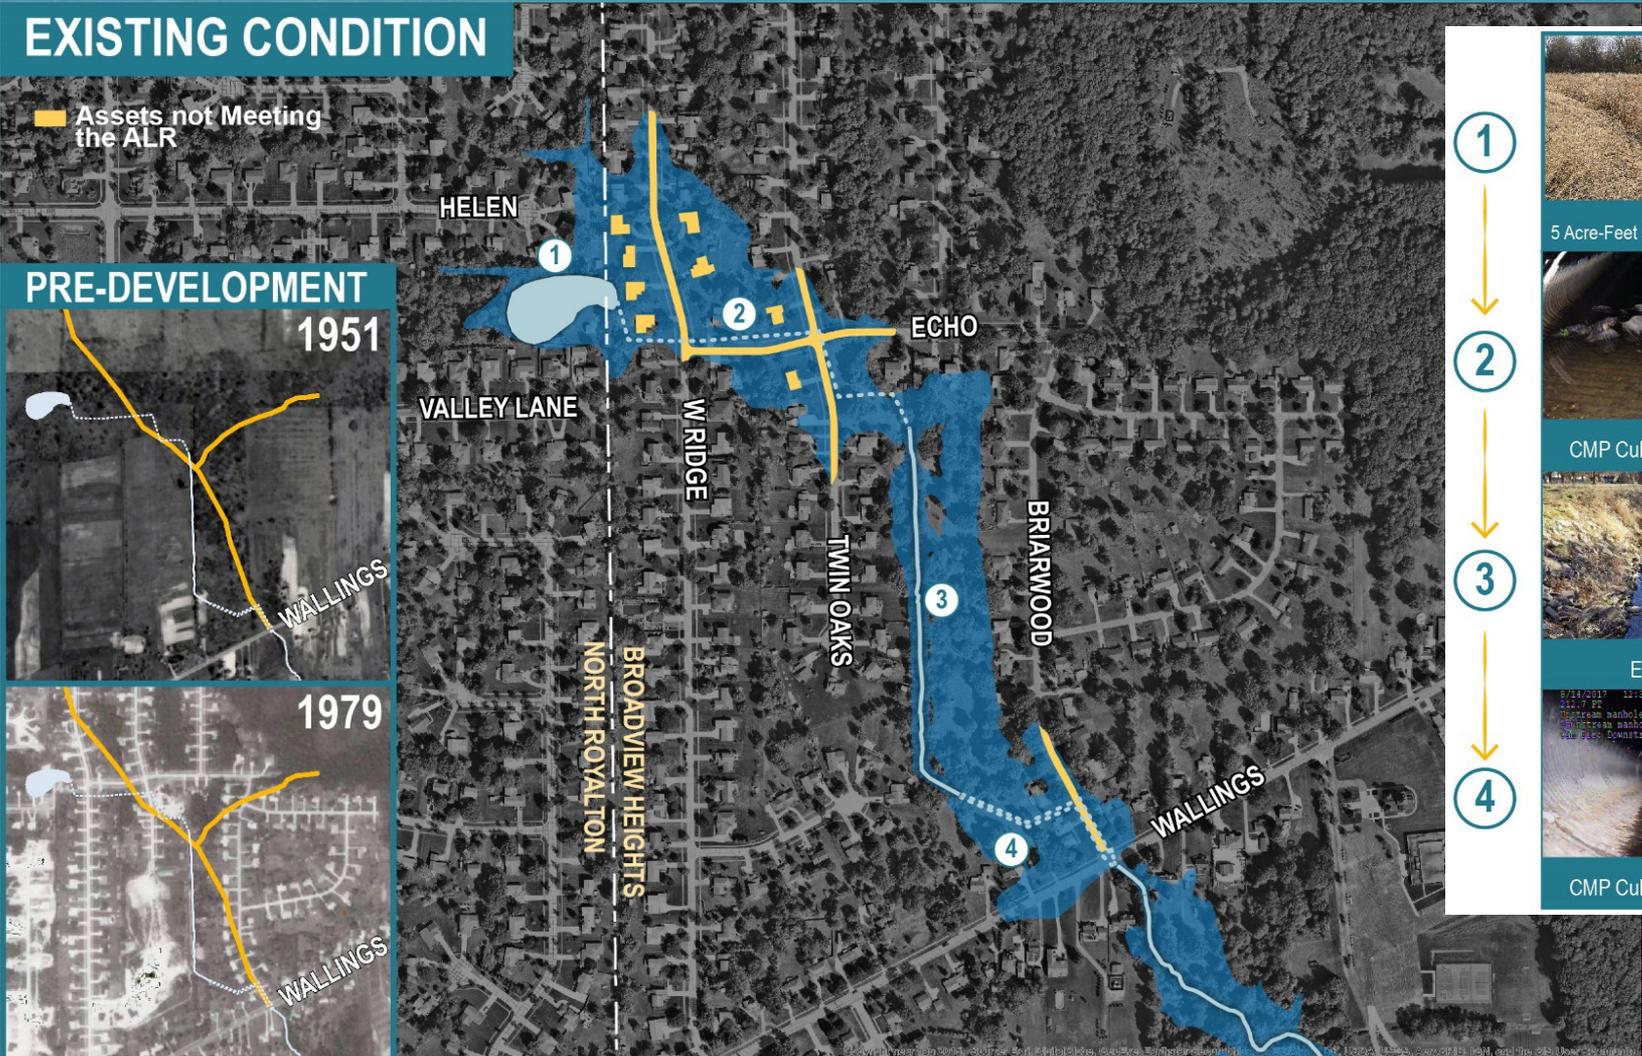
Problem Area Components

Assets not Meeting the ALR

CC00231
5 Acre-Feet Detention Basin

CC00230
CMP Culverted Stream

CC00184
Existing Stream

CC00183
CMP Culverted Stream

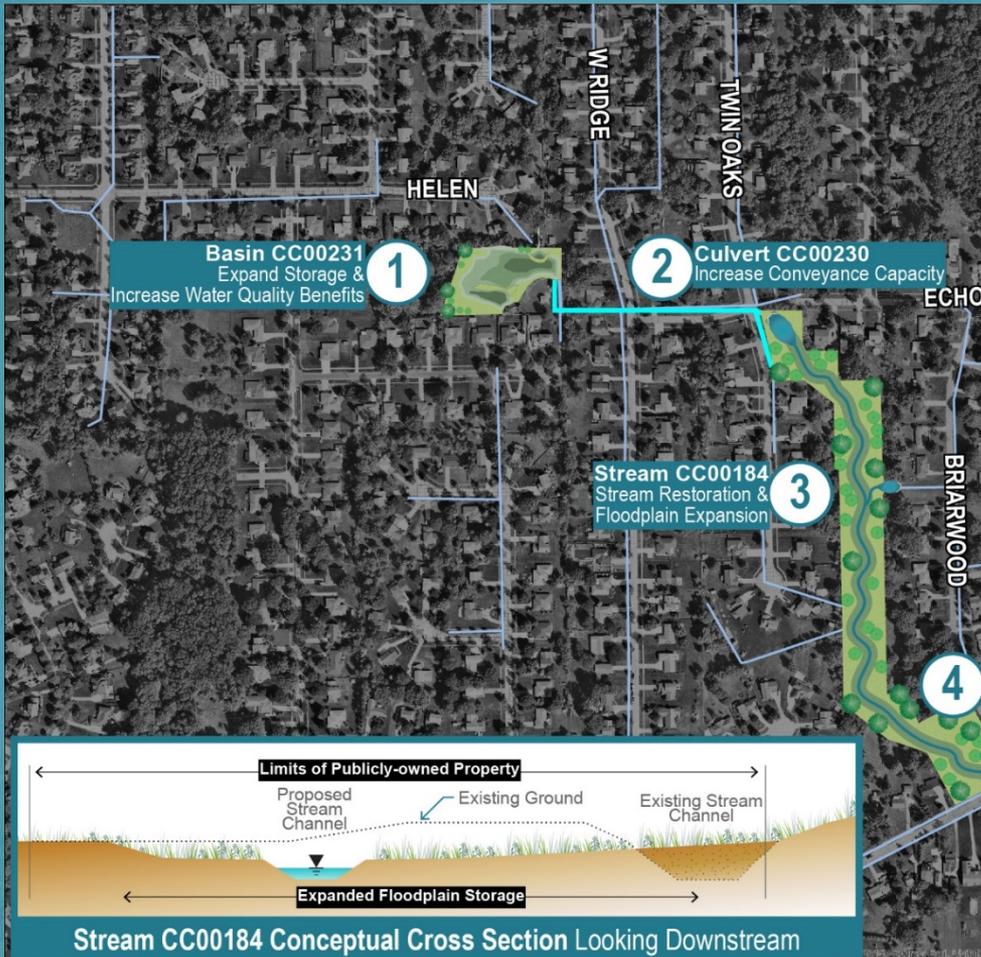
Stream CC00184 Conceptual Cross Section Looking Downstream

- Reduce flood risks to residential structures and roads
- Improve hydrology of basin by maintaining baseflow and regulating storm flow
- Increase channel roughness and sinuosity and reconnect channel to floodplain
- Biological and chemical water quality goals to be determined following collection of baseline data by WQIS
