*Watershed Advisory Committee
Chagrin River/Lake Erie Direct
Tributaries
March 18, 2021*

NORTHEAST OHIO REGIONAL SEWER DISTRICT

REGIONAL
STORMWATER
MANAGEMENT
PROGRAM

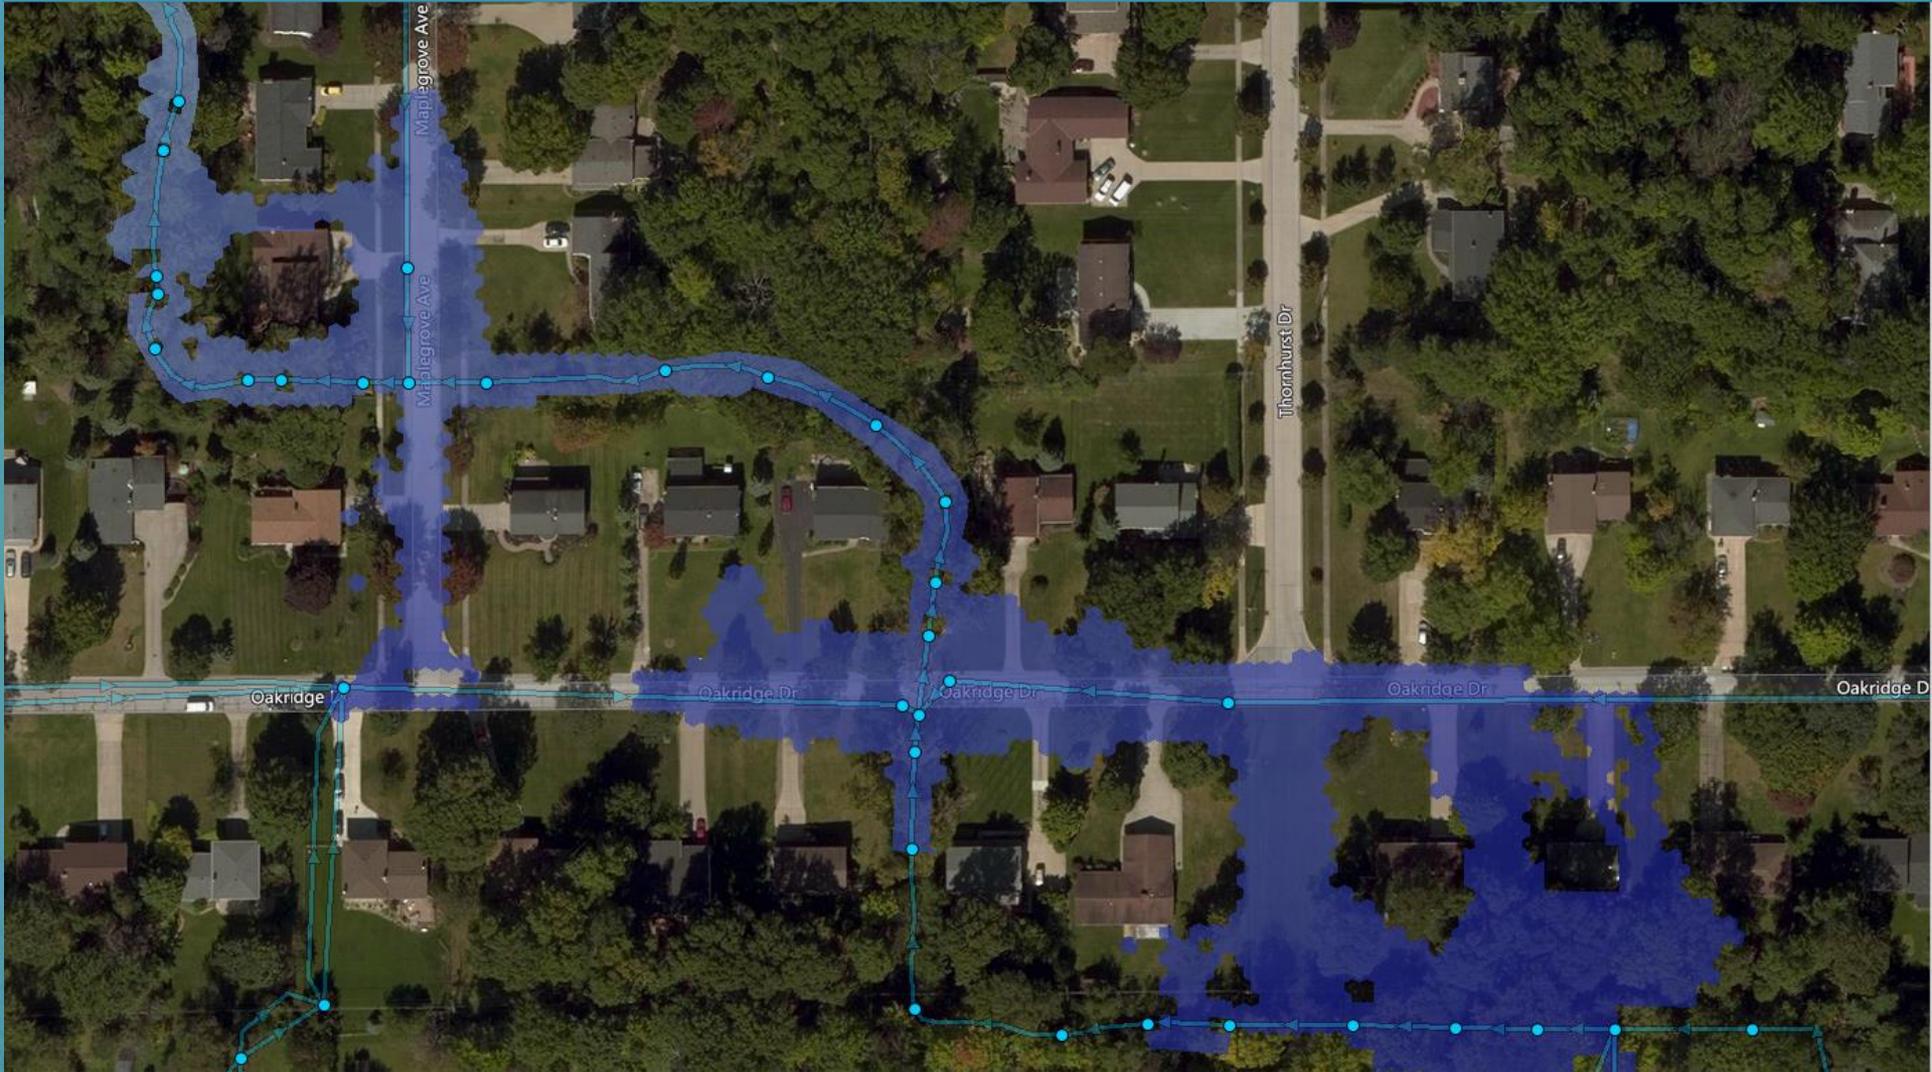
Updated Model: 10-year design storm

- Model updated with additional detail
- Model verified using customer reports of flooding during historical storm events
- Developing alternatives to mitigate both RSS and LSS flooding

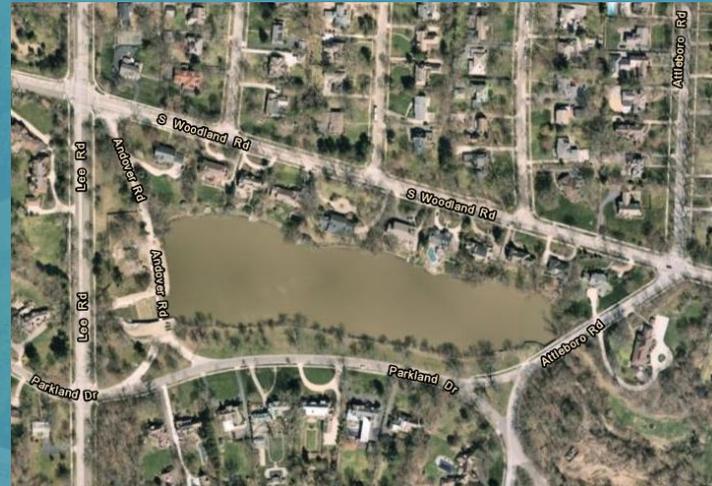
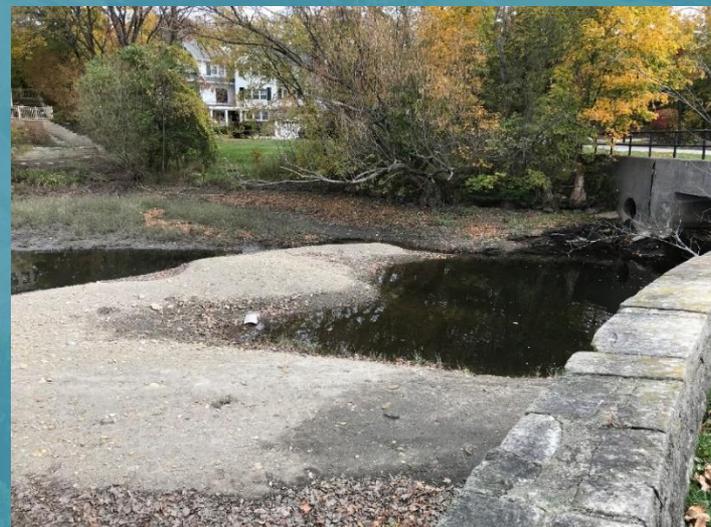
- Green Lake in Shaker Heights, Doan Brook Subwatershed
- Systemic erosion throughout the upstream tributary
- Sediment accumulation in Green Lake requires repeated maintenance

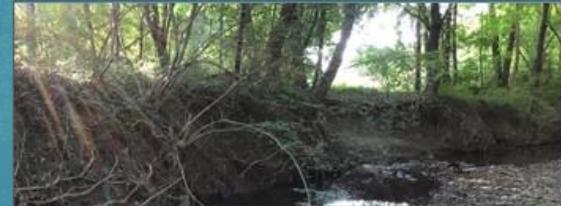
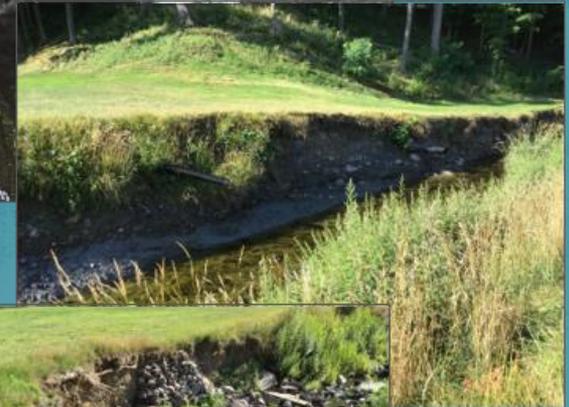
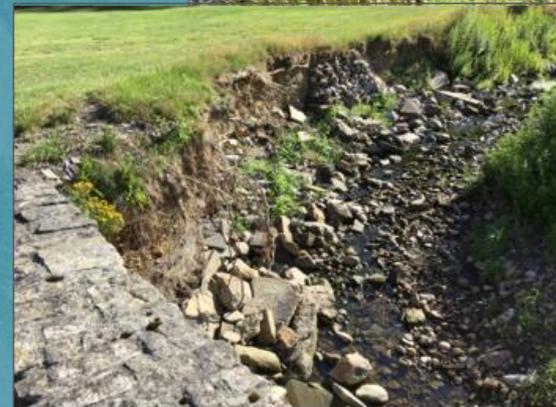
- Incorporate streambank stabilization projects prioritized by highest sediment contributors.
- Projects incorporate grading back the banks to more gradual slopes, installation of native plantings with dense root structures, establishing clearly defined riparian buffer zones, installation of rip-rap protection, and hard armament where necessary.

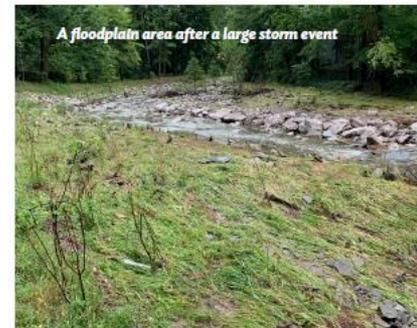
Pools & Riffles

Pools are deeper sections of the stream usually built on the outside of bends. Riffles are shallow areas of the stream with protruding rocks at the surface. Both structures work together to reduce the energy of the stream.

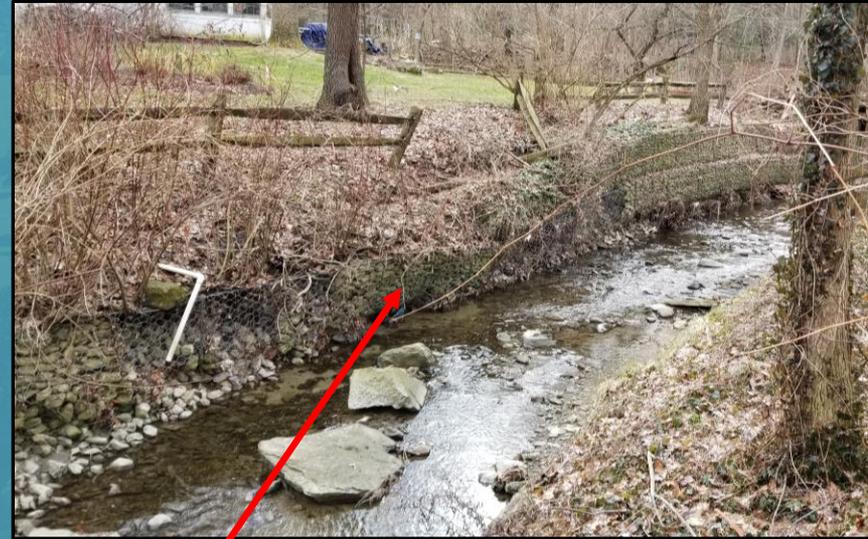
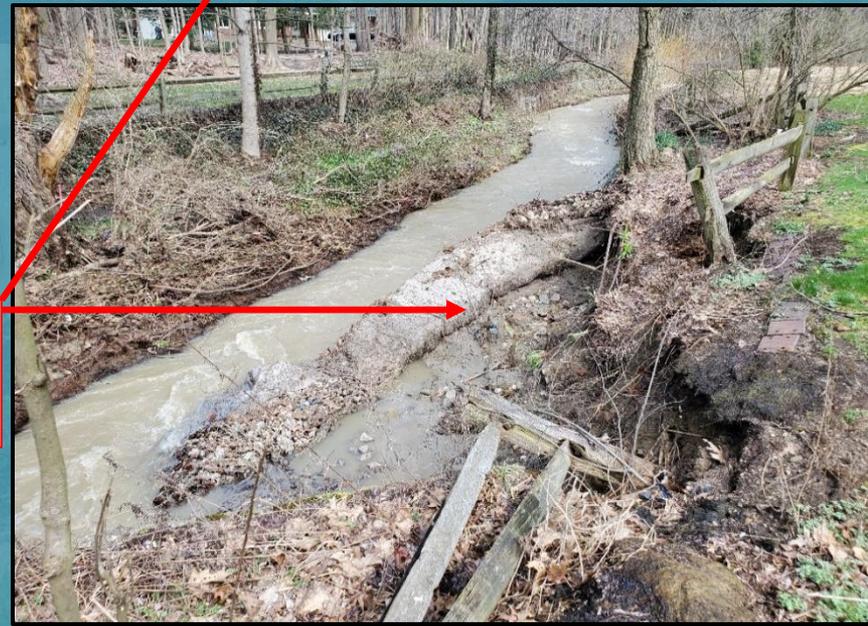
Pepper Luce Creek Streambank Stabilization

- Arrest streambank erosion
- Protect utility assets
- Create & expand floodplain

**Failed gabion baskets &
streambank erosion**

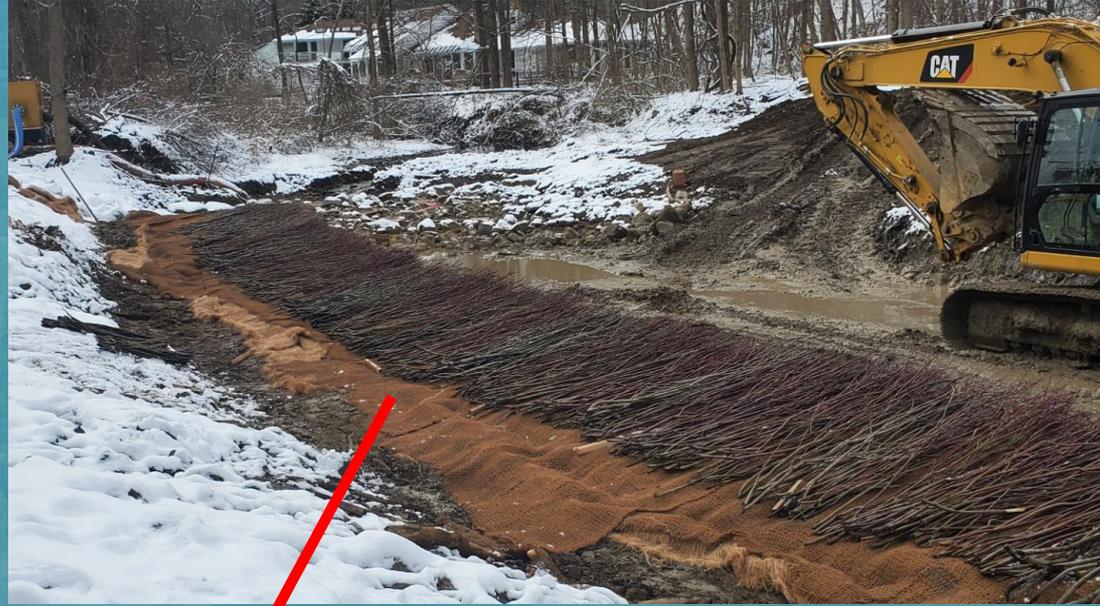
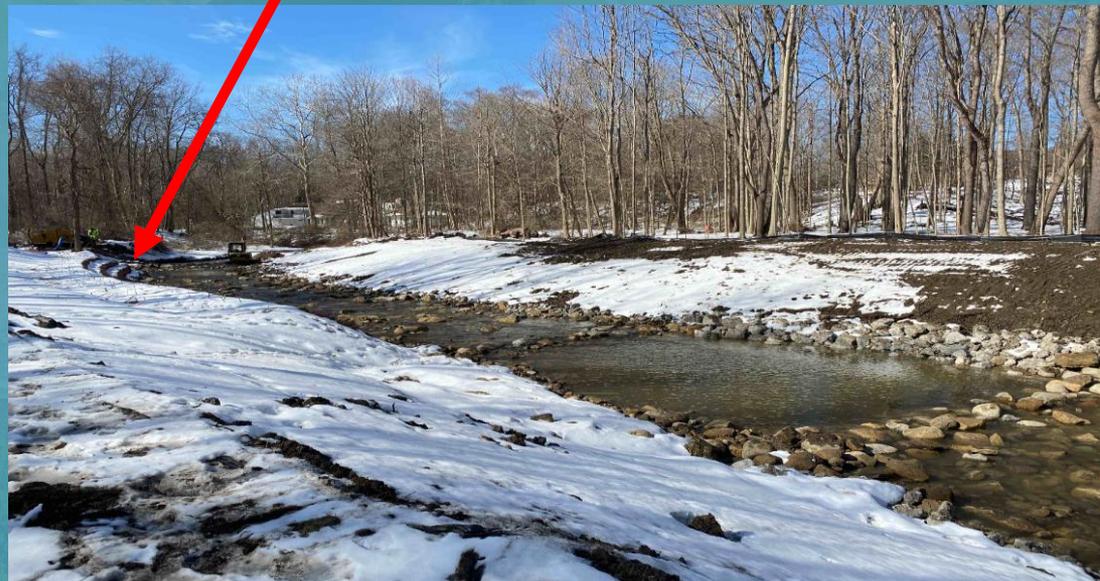
Pepper Luce Creek at Lander Road City of Pepper Pike

- Purchased 1 residential property and acquired easements on several others
- Installation of Fabric Encapsulated Soil Lifts (FESLs)
- Expanding floodplain
- Tied into gabions at downstream end of project (had to shorten project due to easement refusal from 1 property owner)

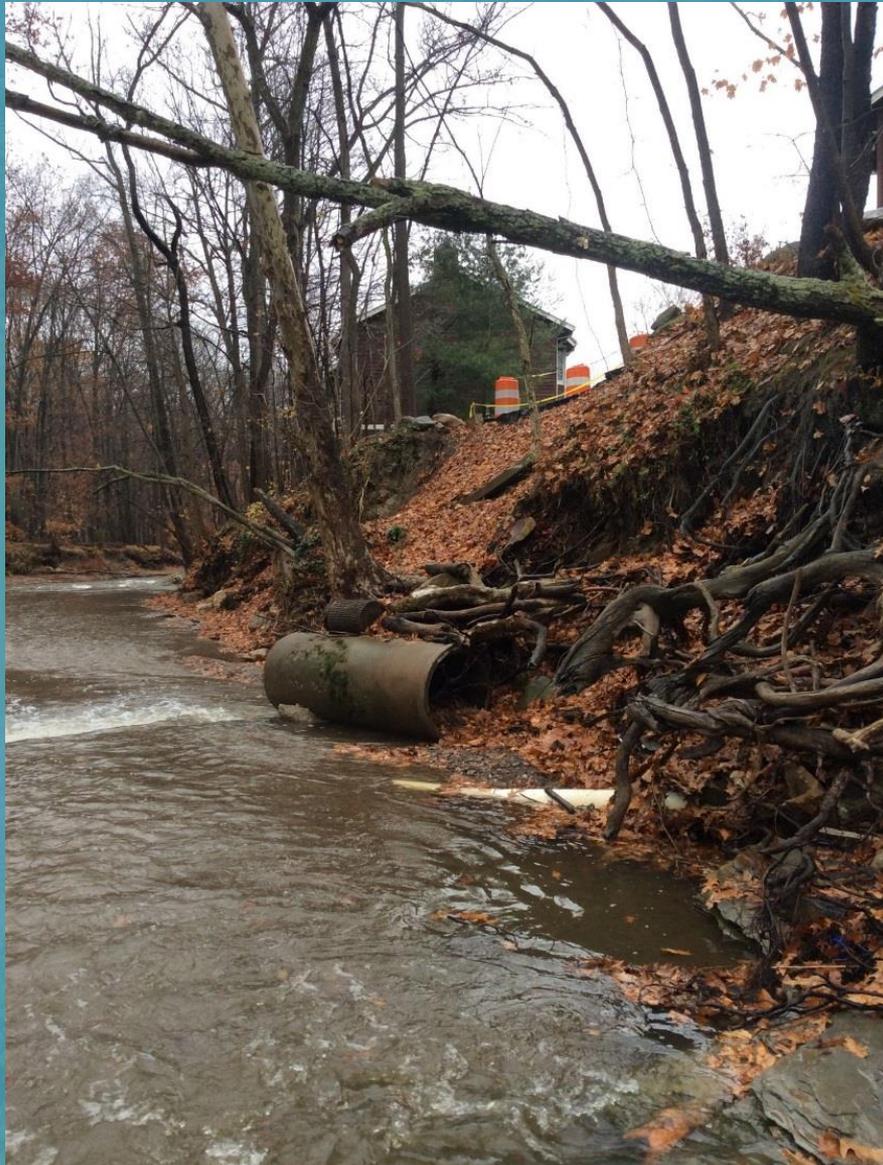
Chippewa Creek Stabilization at Condominiums in Brecksville

- *Eroding streambank within 12 ft of the condominiums*
- *Erosion within 6 ft of local sanitary sewer*
- *Stream infrastructure more cost effective than acquisition*
- *Construction Award: \$1,282,013*
- *Excavate Floodplain on left bank*

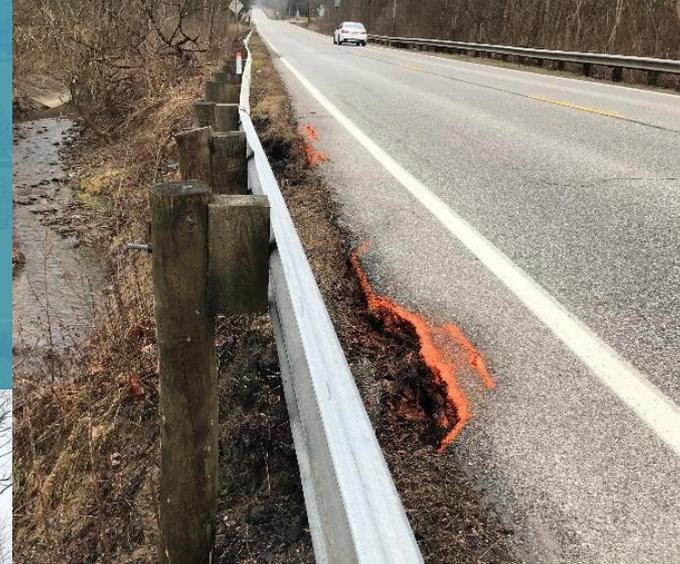
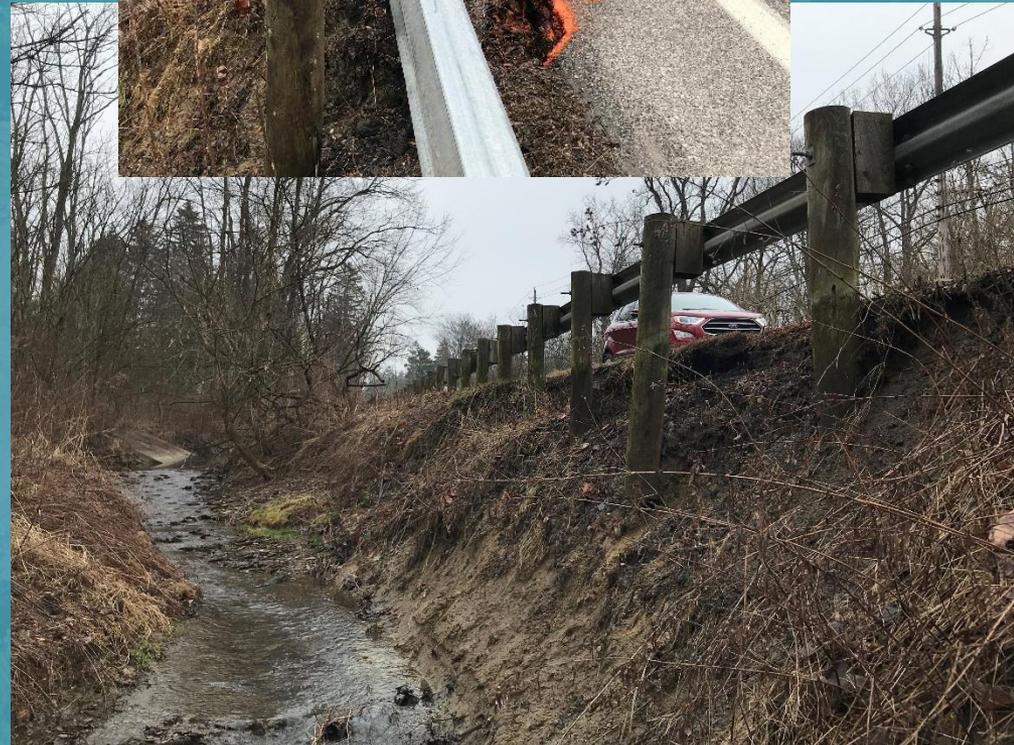
City of North Royalton - Ridge Road Repair and Rocky River Tributary Stabilization

Problem: Bank erosion adjacent to Ridge Road

- Reduces sediment deposition
- Creates a new stable stream channel

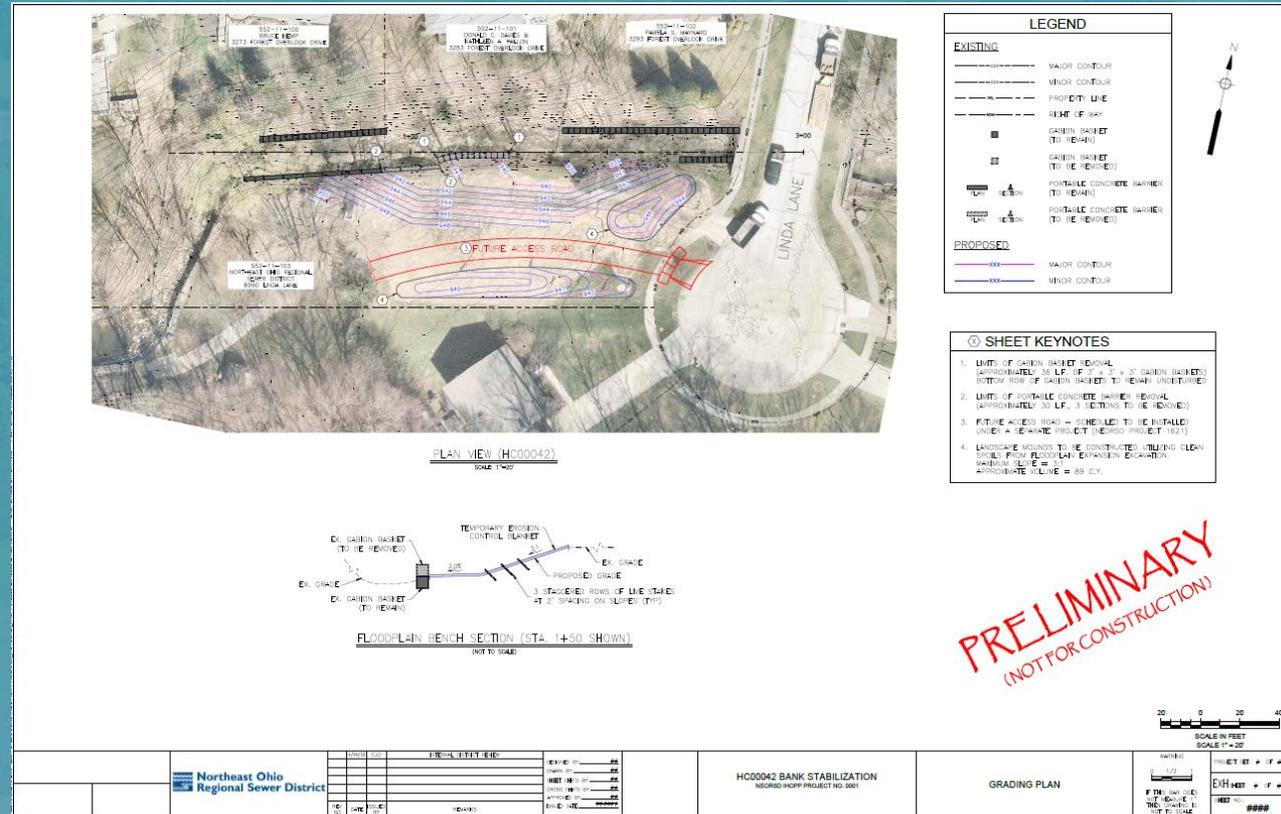
Hemlock Creek in Seven Hills

- Excavate and grade south bank of stream to increase cross section and create more floodplain area to reduce energy on north eroding bank
- To be constructed 2nd Qrt 2021

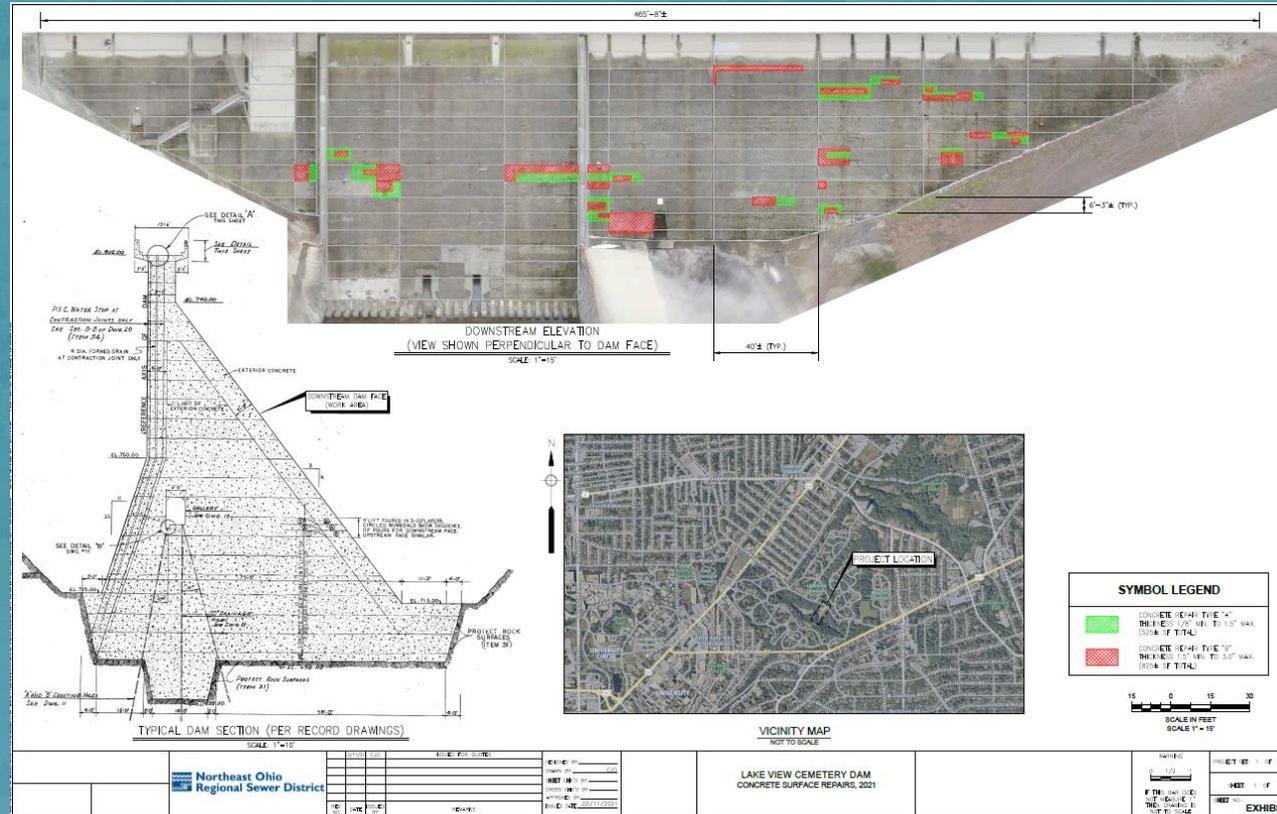
Lakeview Dam Repairs

- ODNR inspection report maintenance items
- Concrete surface repairs on downstream face of dam
- Air vent modifications
- To be constructed 2021
