NORTHEAST OHIO REGIONAL SEWER DISTRICT

2011 Doan Brook Environmental Monitoring

**Prepared by
Water Quality and Industrial Surveillance Division**

2011 Doan Brook
Environmental Monitoring Survey
January 30, 2013

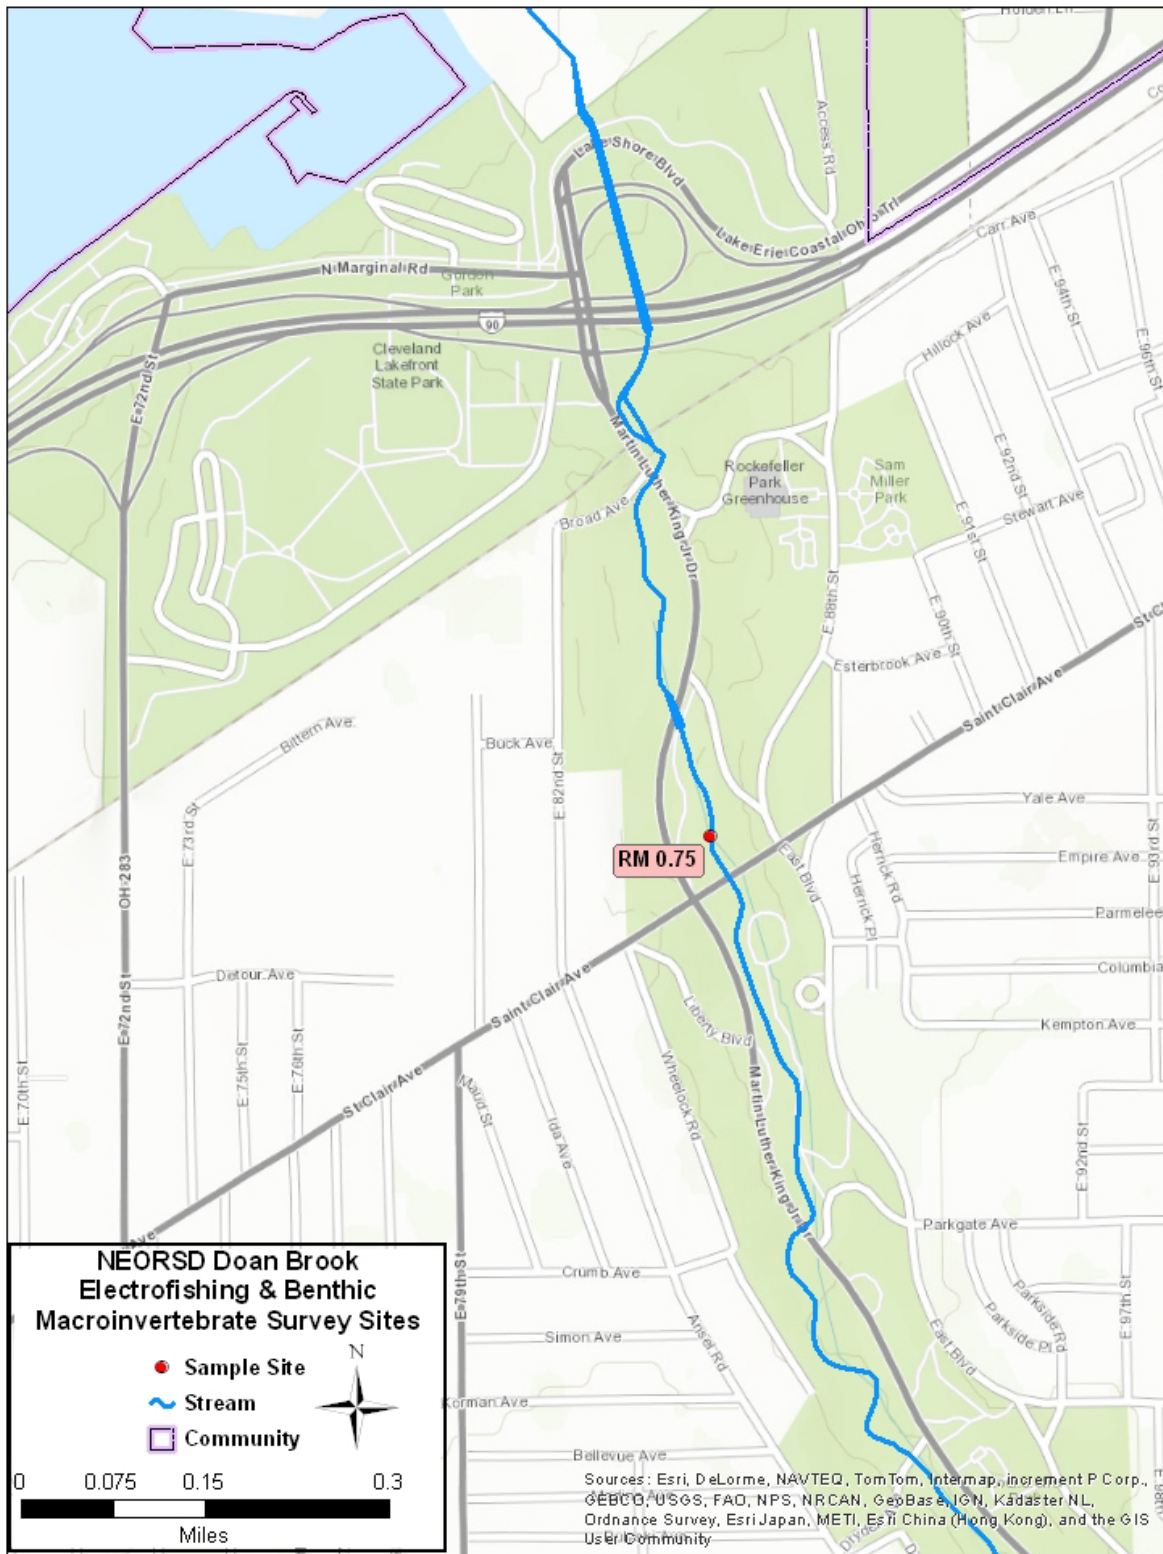
Figure 1. Sampling Location

Figure 1 is a map of the sampling location evaluated during the study, and Table 1 indicates the sampling location with respect to river mile (RM), latitude/longitude, description, and the types of surveys conducted.

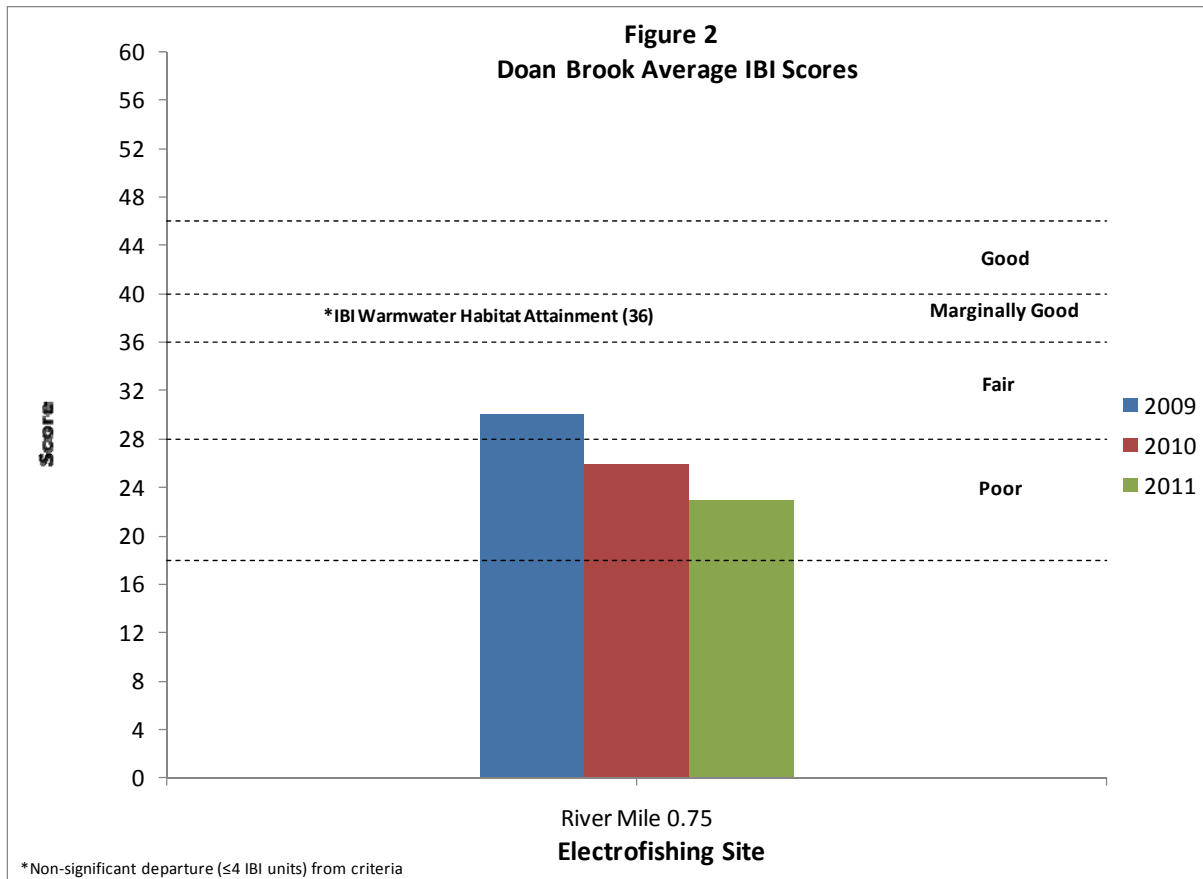
In 2011, RM 0.75 obtained an average IBI score in the *Poor* range (23), failing to meet the WWH IBI criterion of 36 (Table 7 and Figure 2). Of the fish collected, 63% were highly pollution tolerant, consisting of common white suckers, brown and yellow bullheads, green sunfish, creek chubs and goldfish. The bluegill sunfish and pumpkinseed sunfish were the only moderately pollution-tolerant fish collected. The score decreased slightly from a score of 26 (*Poor*) in 2010 to a score of 23 in 2011. The decreased score was likely due to a lower score in the proportion of DELT anomalies metric, correlating to a high incidence of multiple lesions on the goldfish and eroded barbels and lesions on the brown and yellow bullheads. Twenty-four or 15% of the fish collected on June 15, and August 1, 2011, had DELT anomalies present. 2009 IBI scores were within the *Fair* range (30). The 2011 QHEI score of 60 (*Good*) shows the habitat being able to support WWH species; however, poor water quality may be one reason why a better diversity of fish was not present, and the fish that were present were not as healthy.

The fish community also appeared to be impacted from the water quality conditions. From 2009 thru 2011, four longline electrofishing passes were completed at the Doan Brook site (RM 0.75). Of the four passes completed, three rated *Poor* for the IBI fish community scores. A *Fair* value was obtained once, in 2009. Six out of the eight species of fish collected at RM 0.75 were highly pollution-tolerant fish. Because the habitat in Doan Brook met Ohio EPA's target for warmwater habitat, it is not expected that the fish community will be in attainment of the warmwater habitat criterion until water quality improves in the stream.
