Watershed Advisory Committee

CHAGRIN RIVER/LAKE ERIE DIRECT TRIBUTARIES | OCTOBER 19, 2021

REGIONAL
STORMWATER
MANAGEMENT

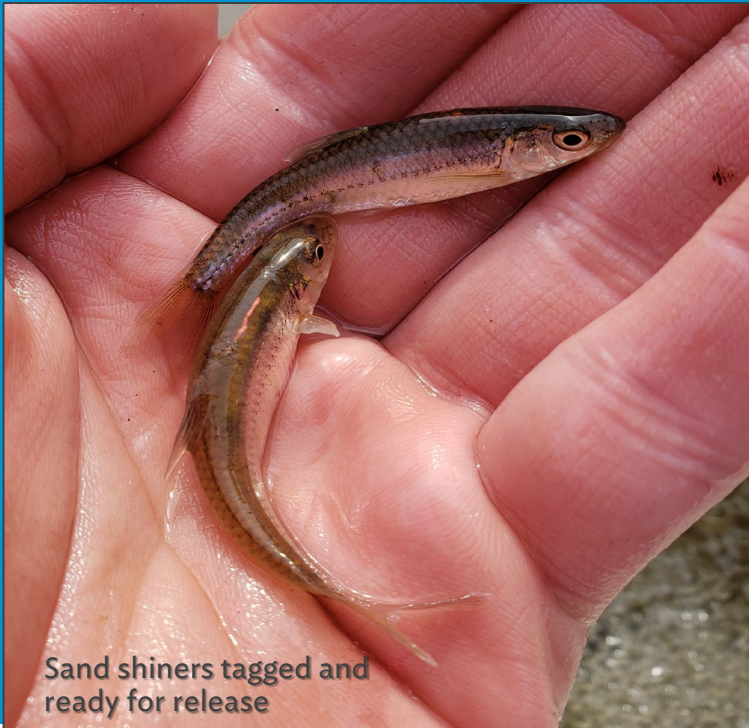
Sand shiners tagged and ready for release

- Tagging fish benefits:
 - Color coded by year
 - Determine long-term or multi-year survivability success
 - Determine recruitment (successful spawn) immediately upon fall sampling of Plum Creek
 - Document movement throughout the stream

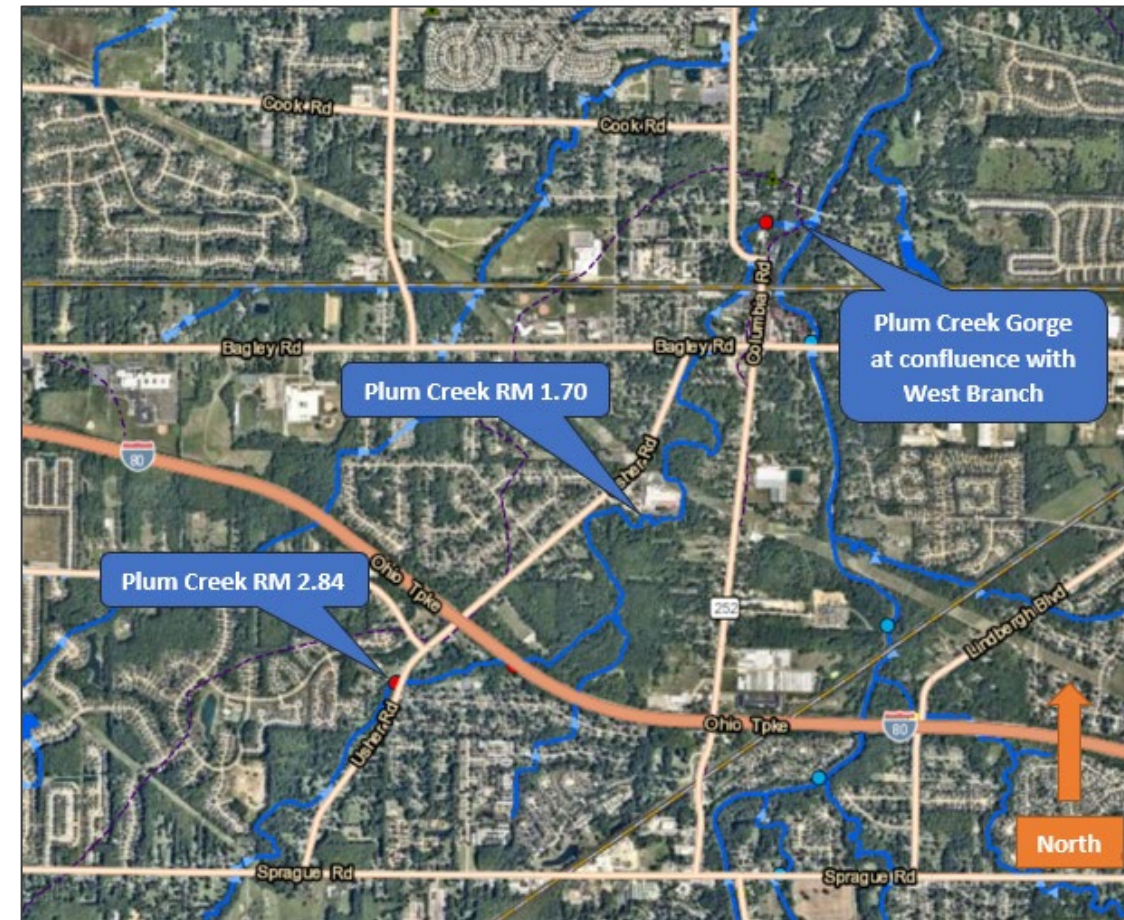
Plum Creek seed/translocation locations

- All source locations within the Rocky River watershed
- Goal: minimum of 200 fish/species/year into Plum Creek at two seed locations
- Minimum of 3 consecutive years of translocation
 - Reduces environmental variability of a bad spawning/weather year
 - Increases genetic diversity
 - Increases number of fish introduced and chance of success
- Translocate in the spring before fish spawn
- Tag every fish with a visual implant elastomer
- Perform a fall sampling to determine survivability

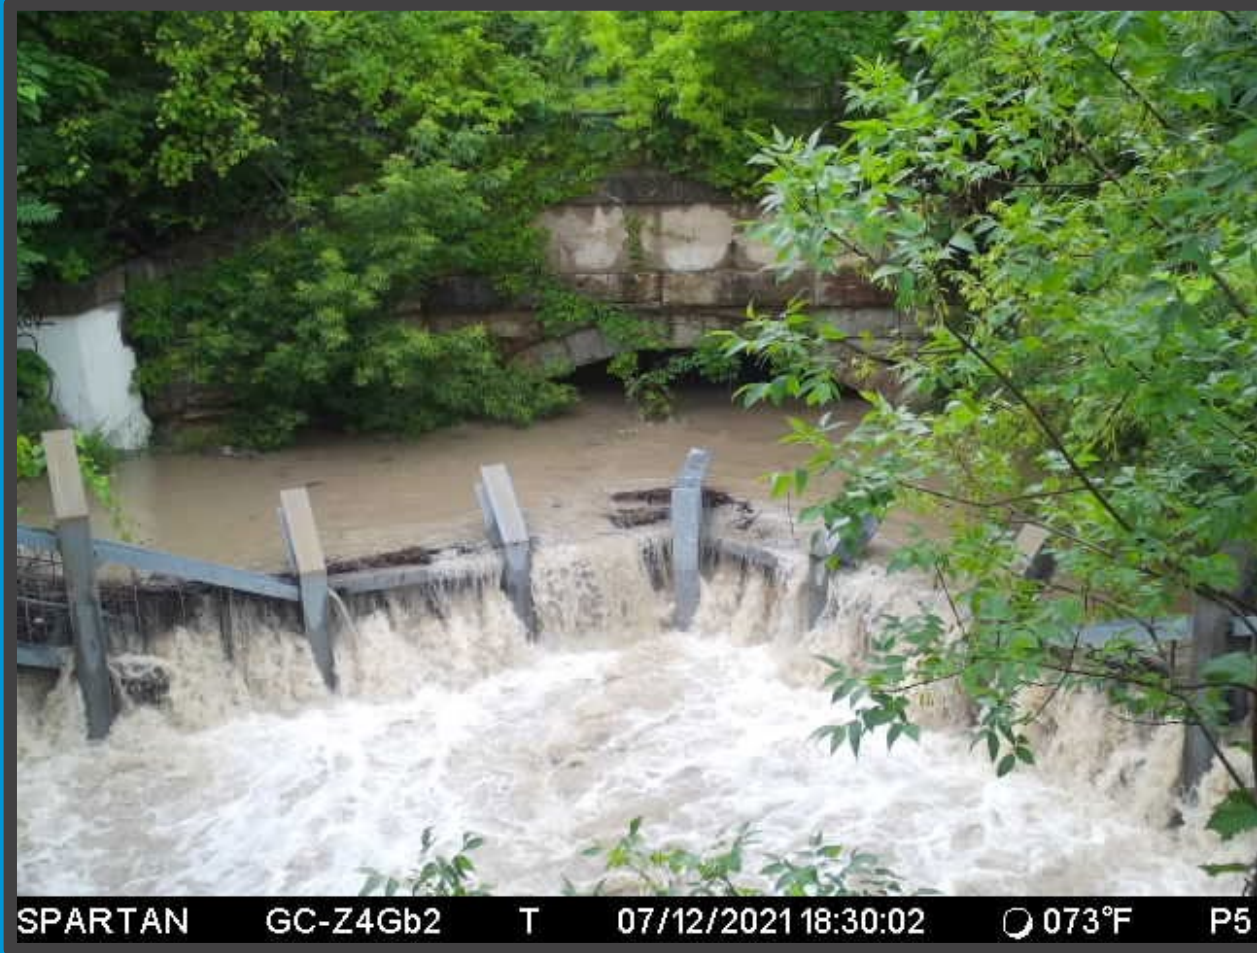
Airport Debris Rack

Trail Cams are Reviewed to Identify Potential Stormwater Issues for Field Response

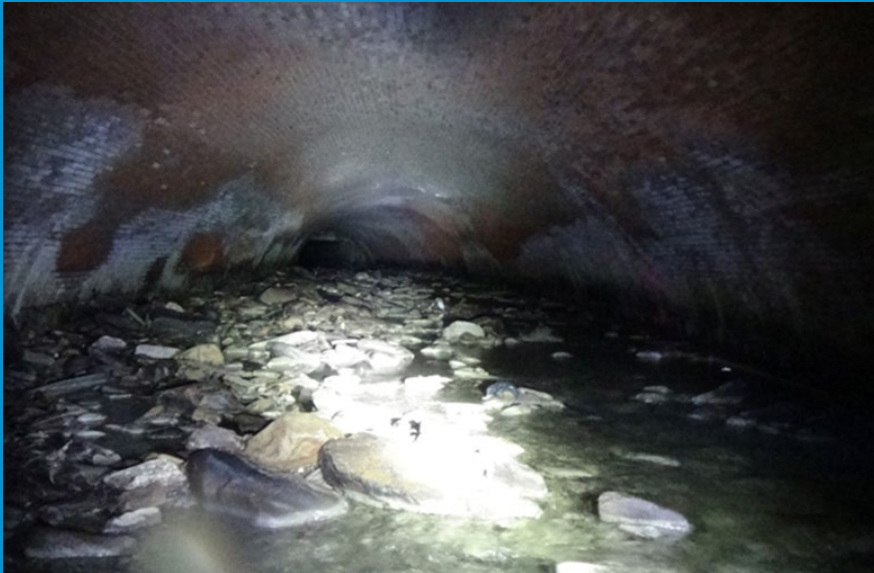
- SWMP Study inspection of Doan Brook culvert confirmed a ~40% debris blockage beneath Euclid Avenue & ~15% blockage near culvert outfall
- Debris consisted of small pebbles to large cobbles
- Debris blockage resulting in a <5-year Level of Service

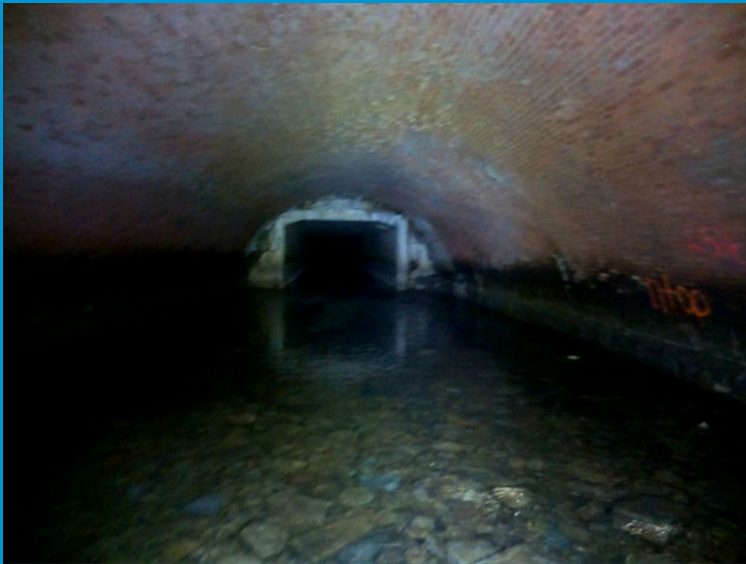
- 1,950 Cu. Yd. debris removed as of end of February 2021
- Removal of debris increased the Level of Service from the 5-year to 10-year storm event
- SWMP Study investigating additional alternatives that may raise the Level of Service to ~25-year storm event

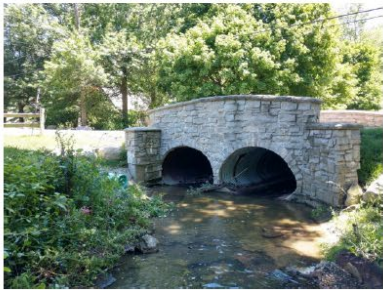
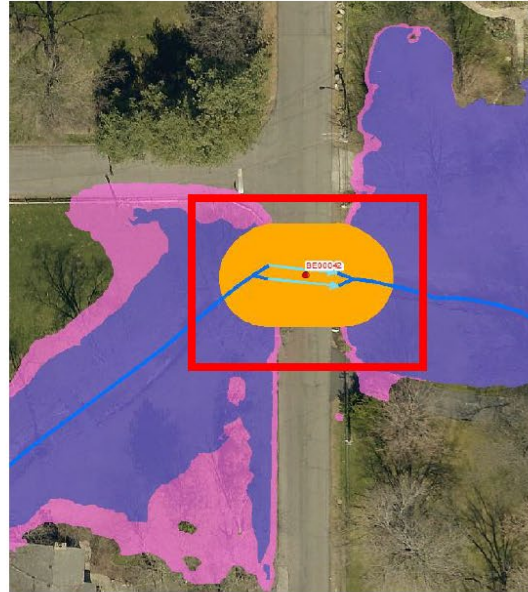
BE00042 – Worton Park Drive

- Replace Worton Park Double-barrel CMP with 4'x16' rectangular box
- Two property acquisitions
- Create expanded floodplain on parcel located at 6213 N. Woodland Dr.
- Channel improvements between BE0001 and Woodland Dr.
- Bank stabilization at 6206 N. Woodlane Drive parcel.

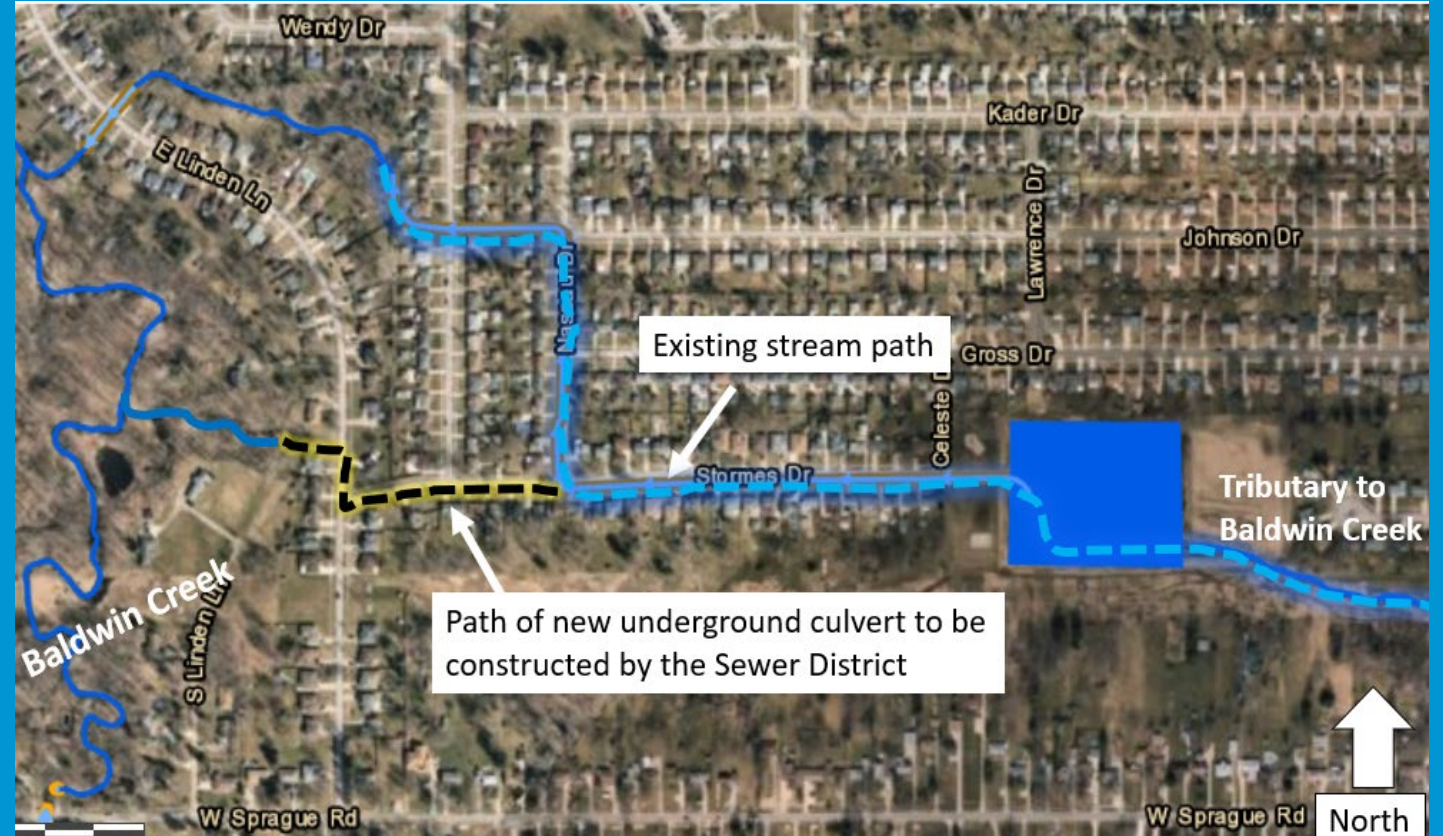
Baldwin Creek Relief Culvert at Stormes Drive

- Reduce flood risk
- Increase conveyance with new culvert

- Almost all work is being performed in public R/W
- Future basin expansion project will continue to reduce flood risk in this neighborhood

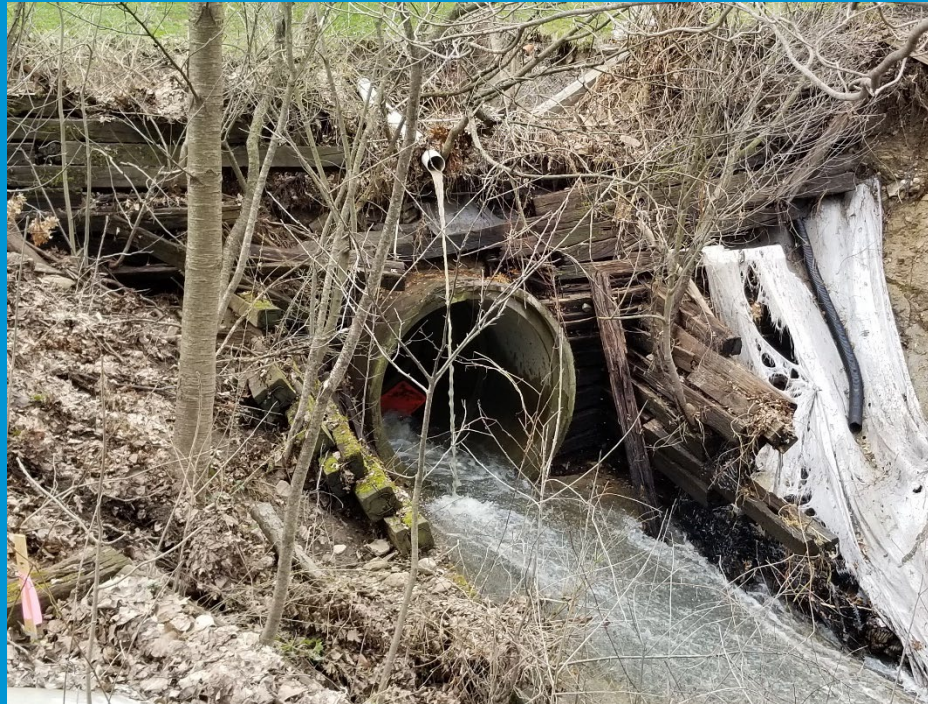
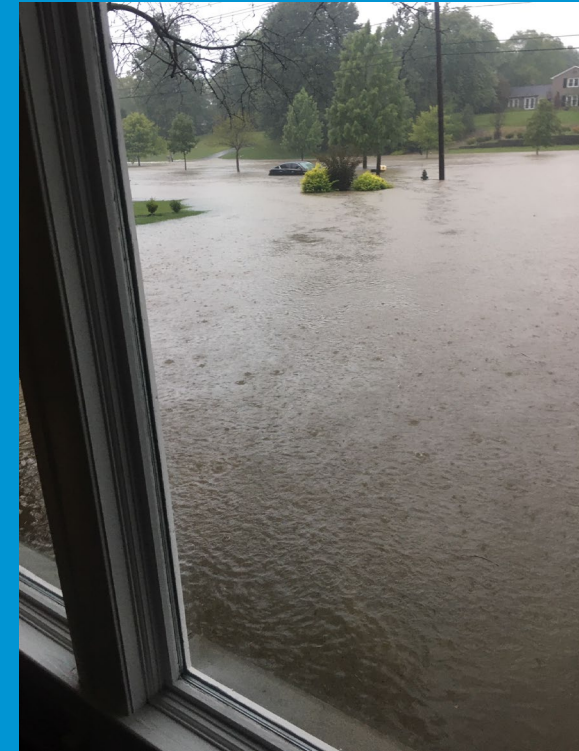
Pepper Luce Creek Culvert Replacement & Rehabilitation at Gates Mills Boulevard

- Rehabilitate and replace failing culverts
- Enlarge a detention basin to reduce flood risks to Gates Mills Blvd

- City of Pepper Pike is utilizing Community Cost Share for the rehabilitation of the upstream culvert

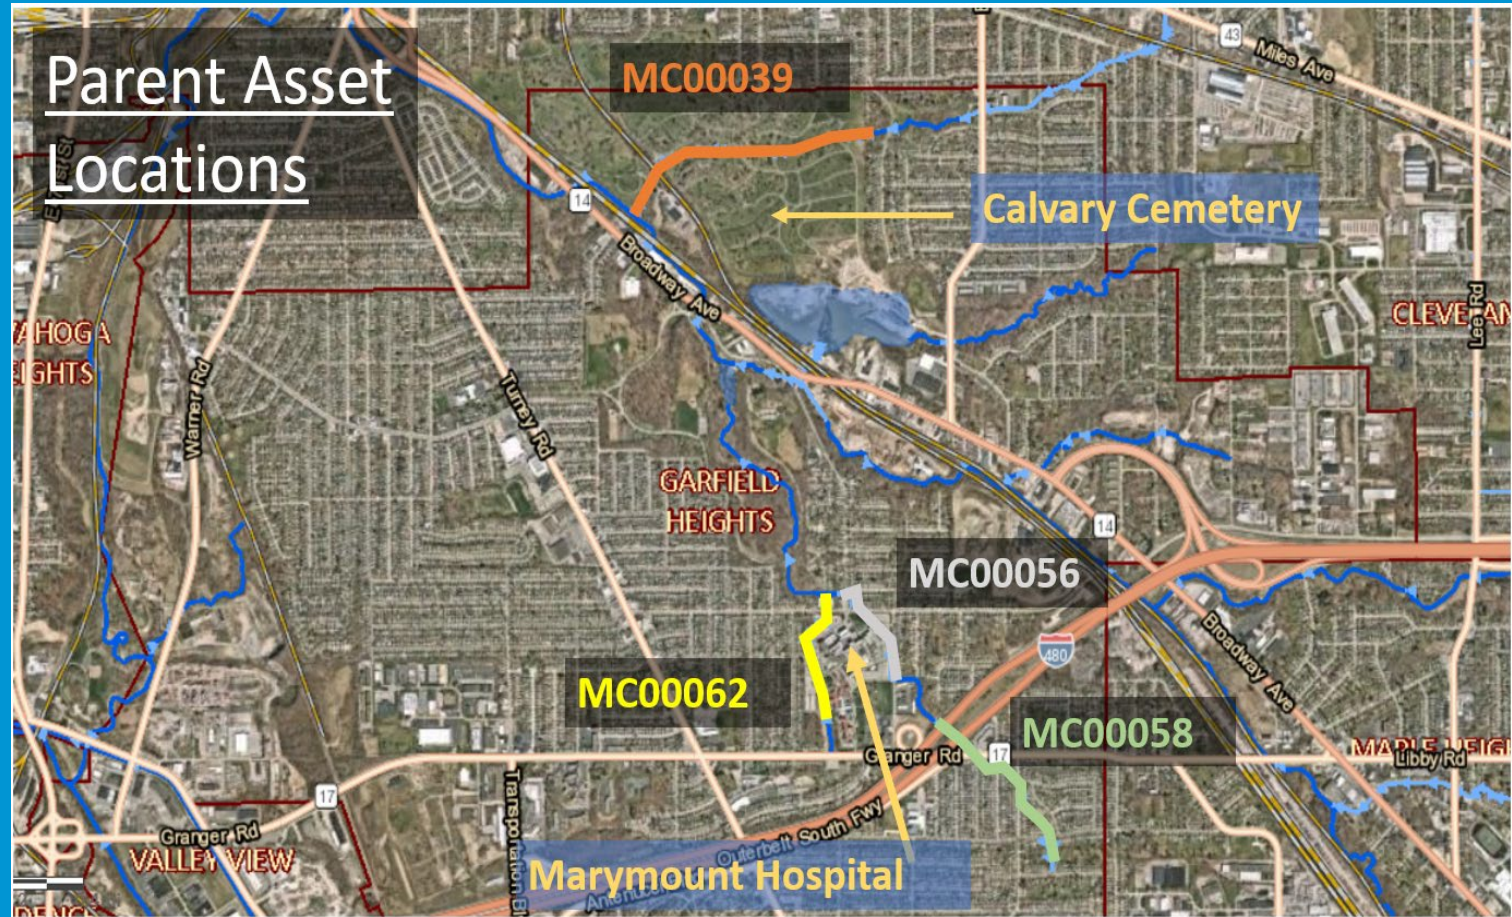
Mill Creek Culverted Streams Rehabilitation

- Rehabilitate several culverted stream assets in the Mill Creek Subwatershed

- Daylighting alternative of MC00058 to be evaluated as alternative

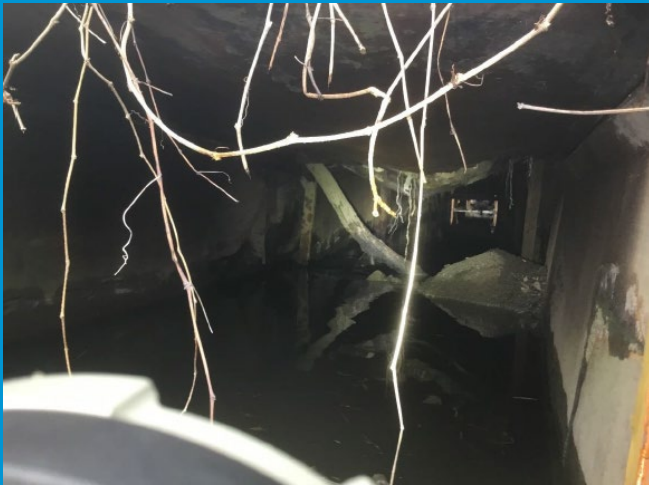
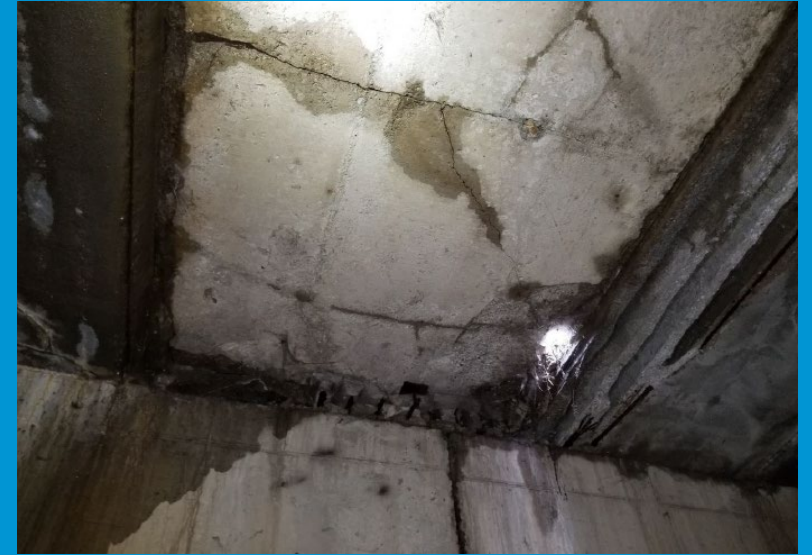
Culverted Streams Rehabilitation District-wide

- Rehabilitate/replace culverted streams to reduce risk of failure
- Daylight streams currently in culverts, if feasible, to open streams to floodplains and increase water quality
- **Budget ~\$1.5M annually for rehab of these assets**

A	B	C	D	
1	Rank	Asset	Material	SWIM Score	Notes
2	1	WB00084	CMP	4	Under the junkyard. Very poor condition. Milligan neigh
3	2	WB00173	RCP	5	Kollieda Ditch. Failure at the crown. Rest of pipe is "fair"
4	3	HC00053	CMP	4	Potential impact to Brecksville Road. Transitions to CMP
5	4	CH00175	CMP/RCP	5	Concrete has full depth spalling in the box. CMP with tot
6	5	BK00520	CMP	4	Compressed with open joint. Invert loss. Driveways imp
7	6	BD00296	CMP	4	Worse condition than BK00520 but in backyards. Not un
8	7	DE00015	CMP/RCP	4	Concrete with large voids in the invert. Past history of fai
9	8	PC00226	CMP/RCP	4	DS of Ursuline College. Ripped invert at the inlet. Perform
10	9	EW00145	CMP	4	Invert with perforations. Previously lined. Potential impa
11	10	BC00037	CMP/RCP	4	Under multiple businesses. RCP with spalling and expose
12	11	DE00017	RCP	4	Holes in the concrete invert, missing brick, infiltration ru
13	12	DW00091	RCP	4	Sagging crown. Under driveway/local roadway.

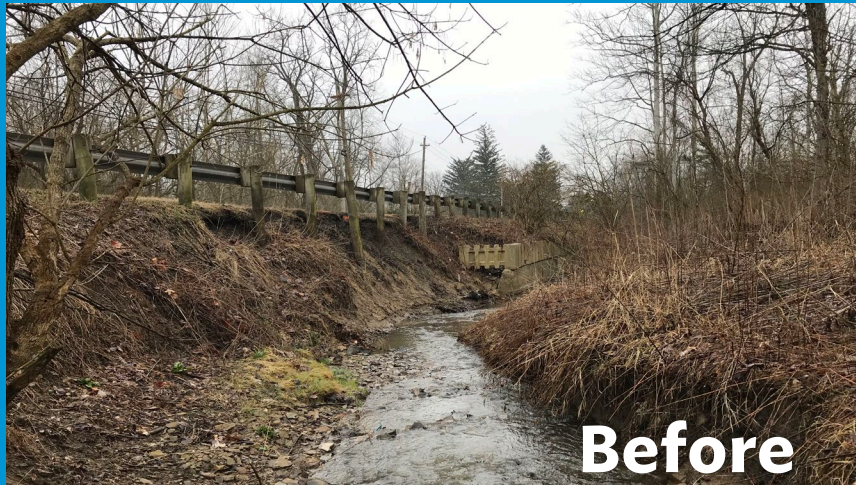
Rocky River Tributary Stabilization and Re-Alignment Along Ridge Road in City of North Royalton

Lineal Feet of Stream Work: 323'

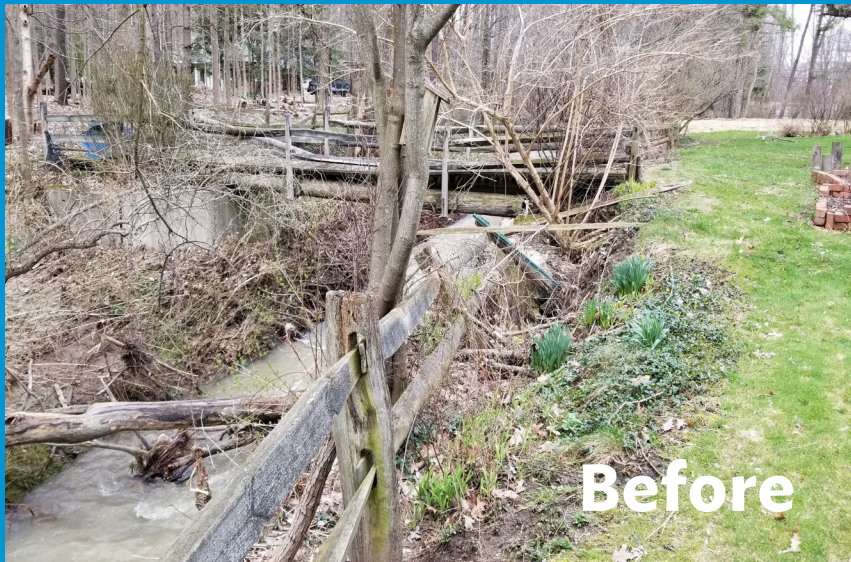
Pepper Luce Creek Stabilization Near Lander Road

Lineal Feet of Stream Work: 575'
