# Watershed Advisory Committee

## March 2018

**NORTHEAST OHIO REGIONAL SEWER DISTRICT**  
**REGIONAL STORMWATER MANAGEMENT PROGRAM**

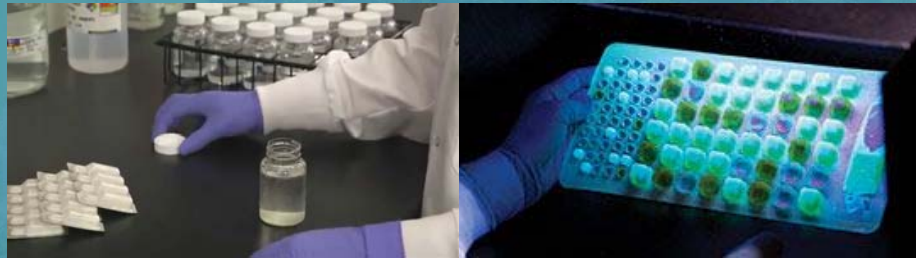
## Illicit Discharge Detection & Elimination Summary of 2017 Sampling

- Outfalls Inspected = **4,148**
- Outfalls with *E. coli* >10,000 MPN/100 mL = **140**
- Outfalls with flow >10,000 GPD = **65**

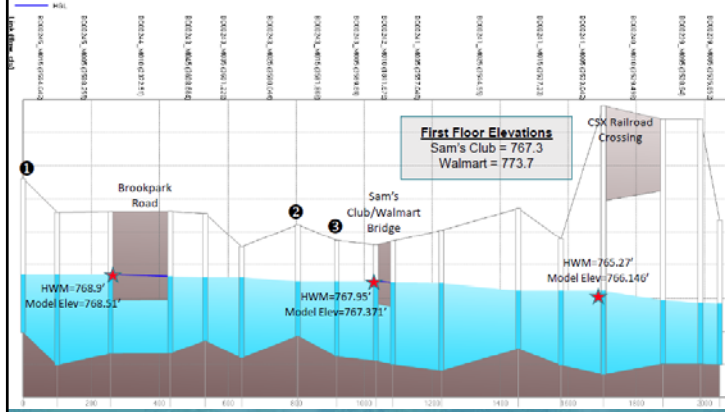
## Brooklyn/Sam's Club Profiles – April 19<sup>th</sup>

# SW Master Plan Modeling – Big Creek

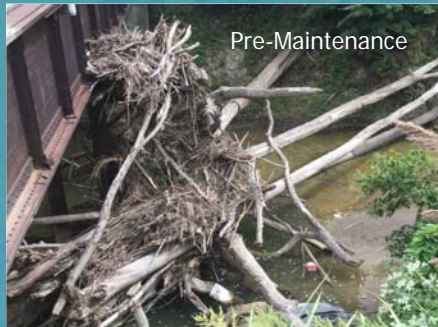
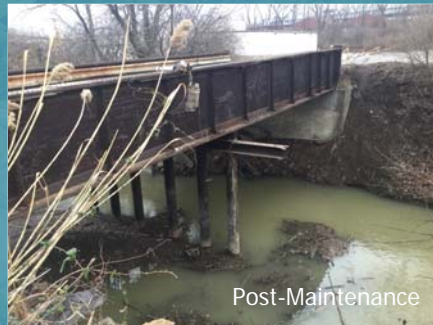
Asset ID: WC00017

Cuyahoga River North: West Creek  
Independence

Maintenance Project: Large Woody Debris Removal (80 CY)

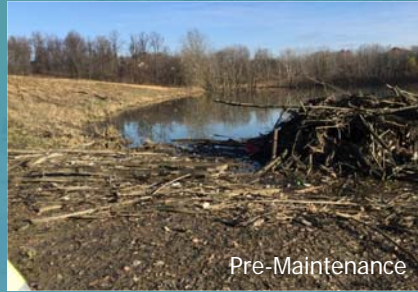
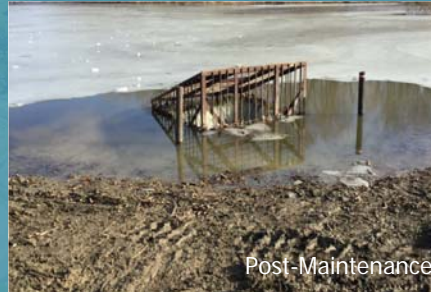
Asset ID: MC00117

Cuyahoga River North: Mill Creek

Maintenance Project: Large Woody Debris Removal (35 CY)

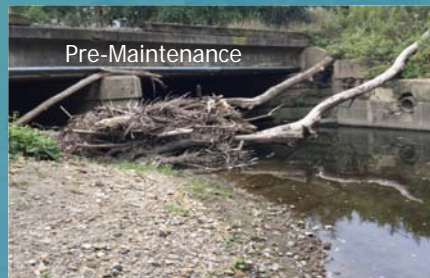
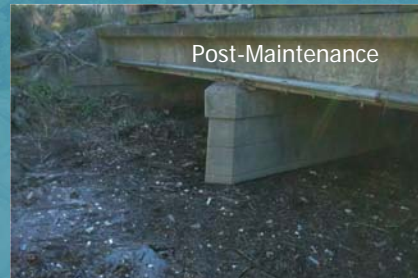
Asset ID: MC00043

Cuyahoga River North: Mill Creek

Maintenance Project: Large Woody Debris Removal (28 CY)

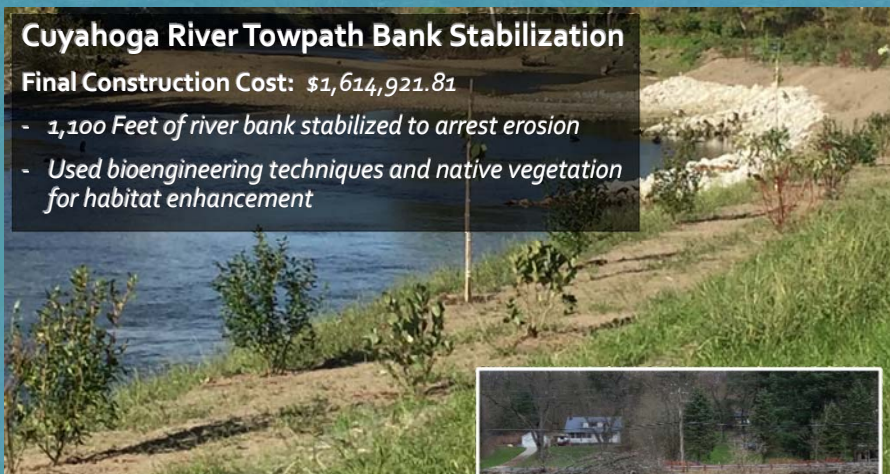
### Cuyahoga River Towpath Bank Stabilization

Final Construction Cost: \$1,614,921.81

- 1,100 Feet of river bank stabilized to arrest erosion
- Used bioengineering techniques and native vegetation for habitat enhancement

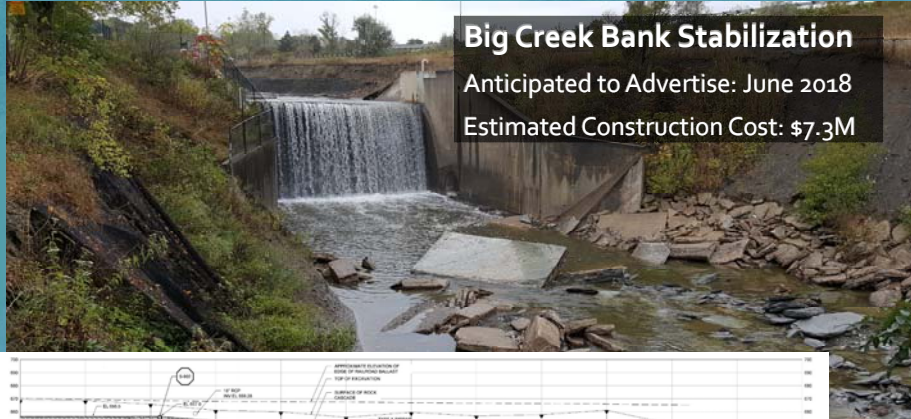
## Big Creek Bank Stabilization

Anticipated to Advertise: June 2018

Estimated Construction Cost: \$7.3M

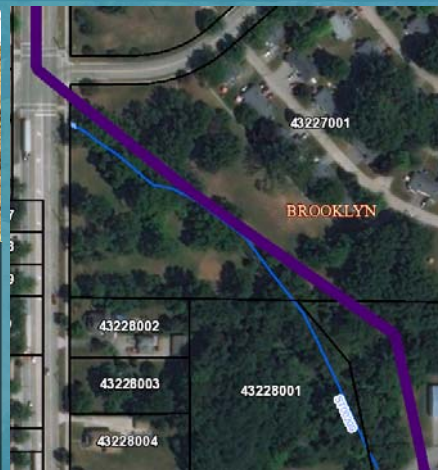
## Stickney Creek Stream Relocation and Utility Repair at Ridge Road in Brooklyn

Anticipated Construction NTP- Oct. 2018
