Watershed Advisory Committee

Cuyahoga River - North

October 2018

REGIONAL
STORMWATER
MANAGEMENT
PROGRAM

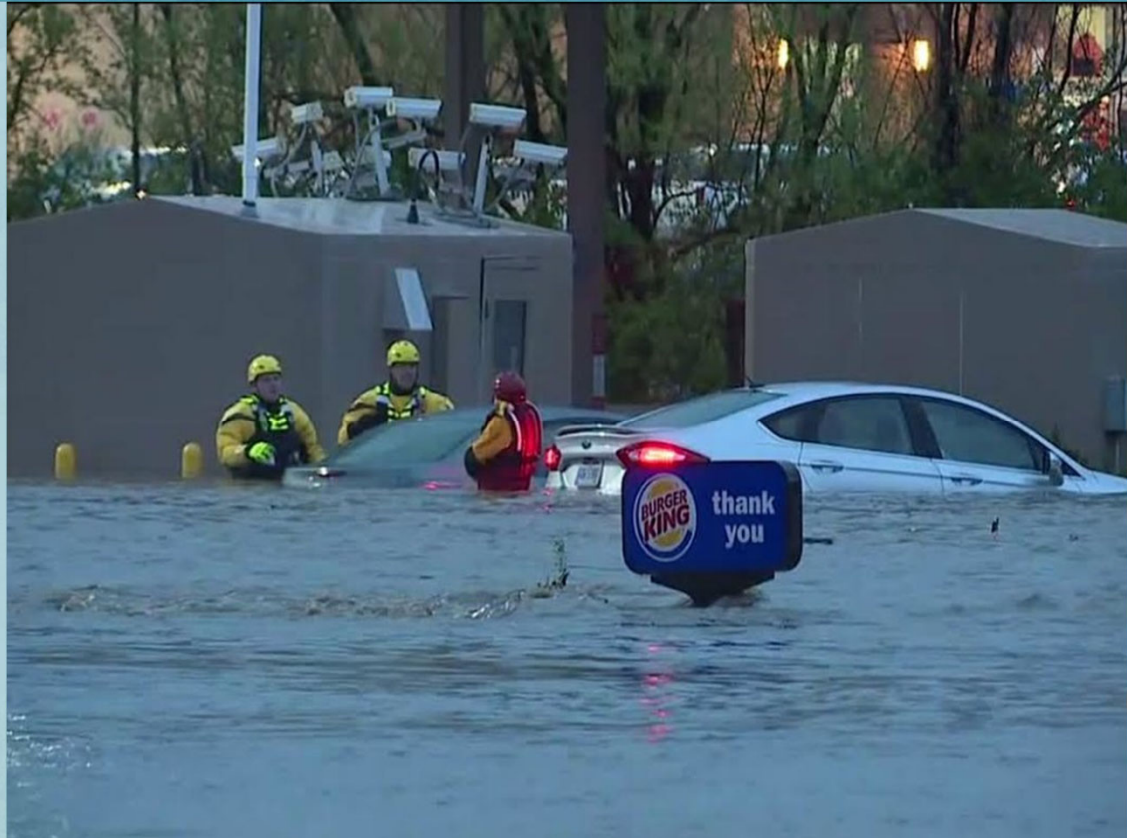
Sam's Club – Brooklyn, Ohio – Big Creek Subwatershed

- Stormwater inundation and impacts to Sam's Club, Brookpark Road & surrounding areas including fueling station
- Brookpark Road overtops around a 1-yr. storm
- Sam's Club parking lot begins to flood between the 2- and 5- yr storms
- Water enters the Sam's Club Building around the 10-yr storm

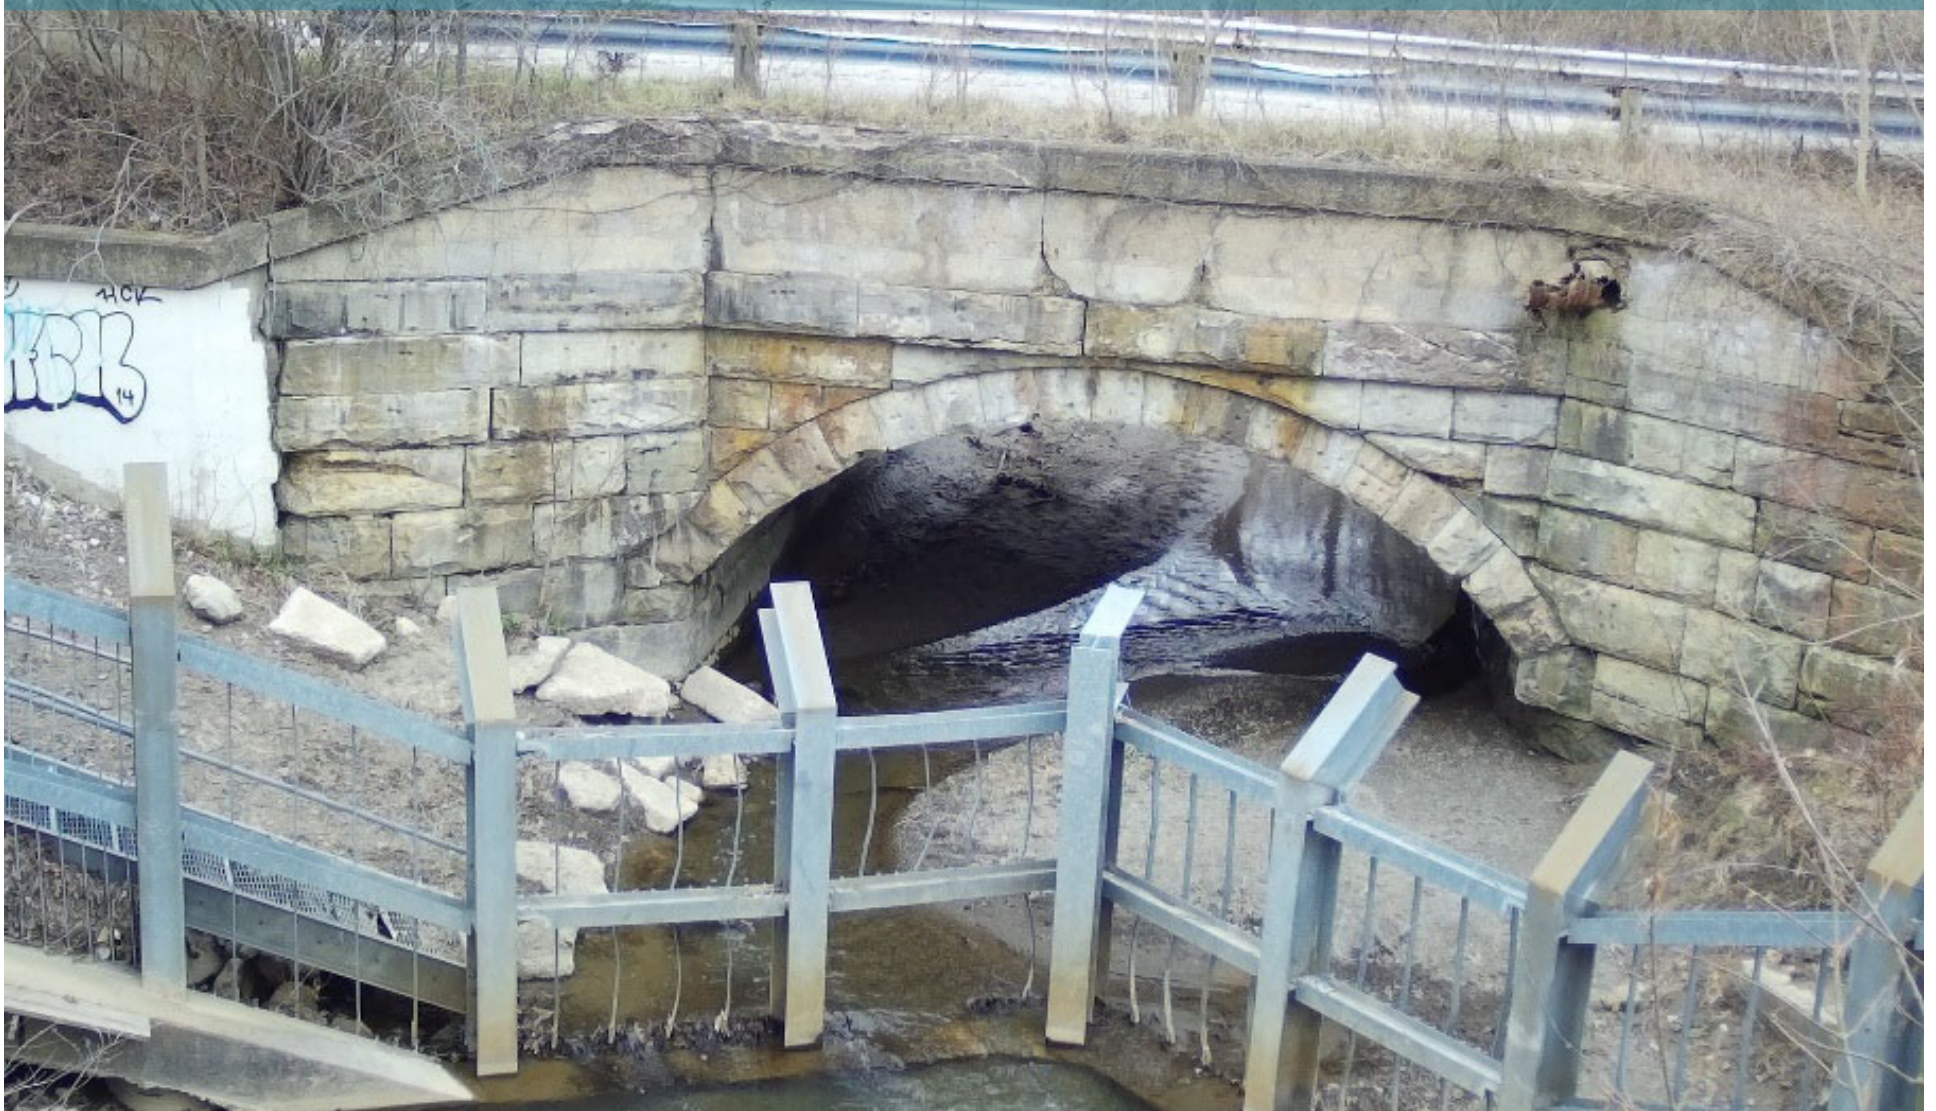
April 14, 2018: Debris Rack is clear before the storm event

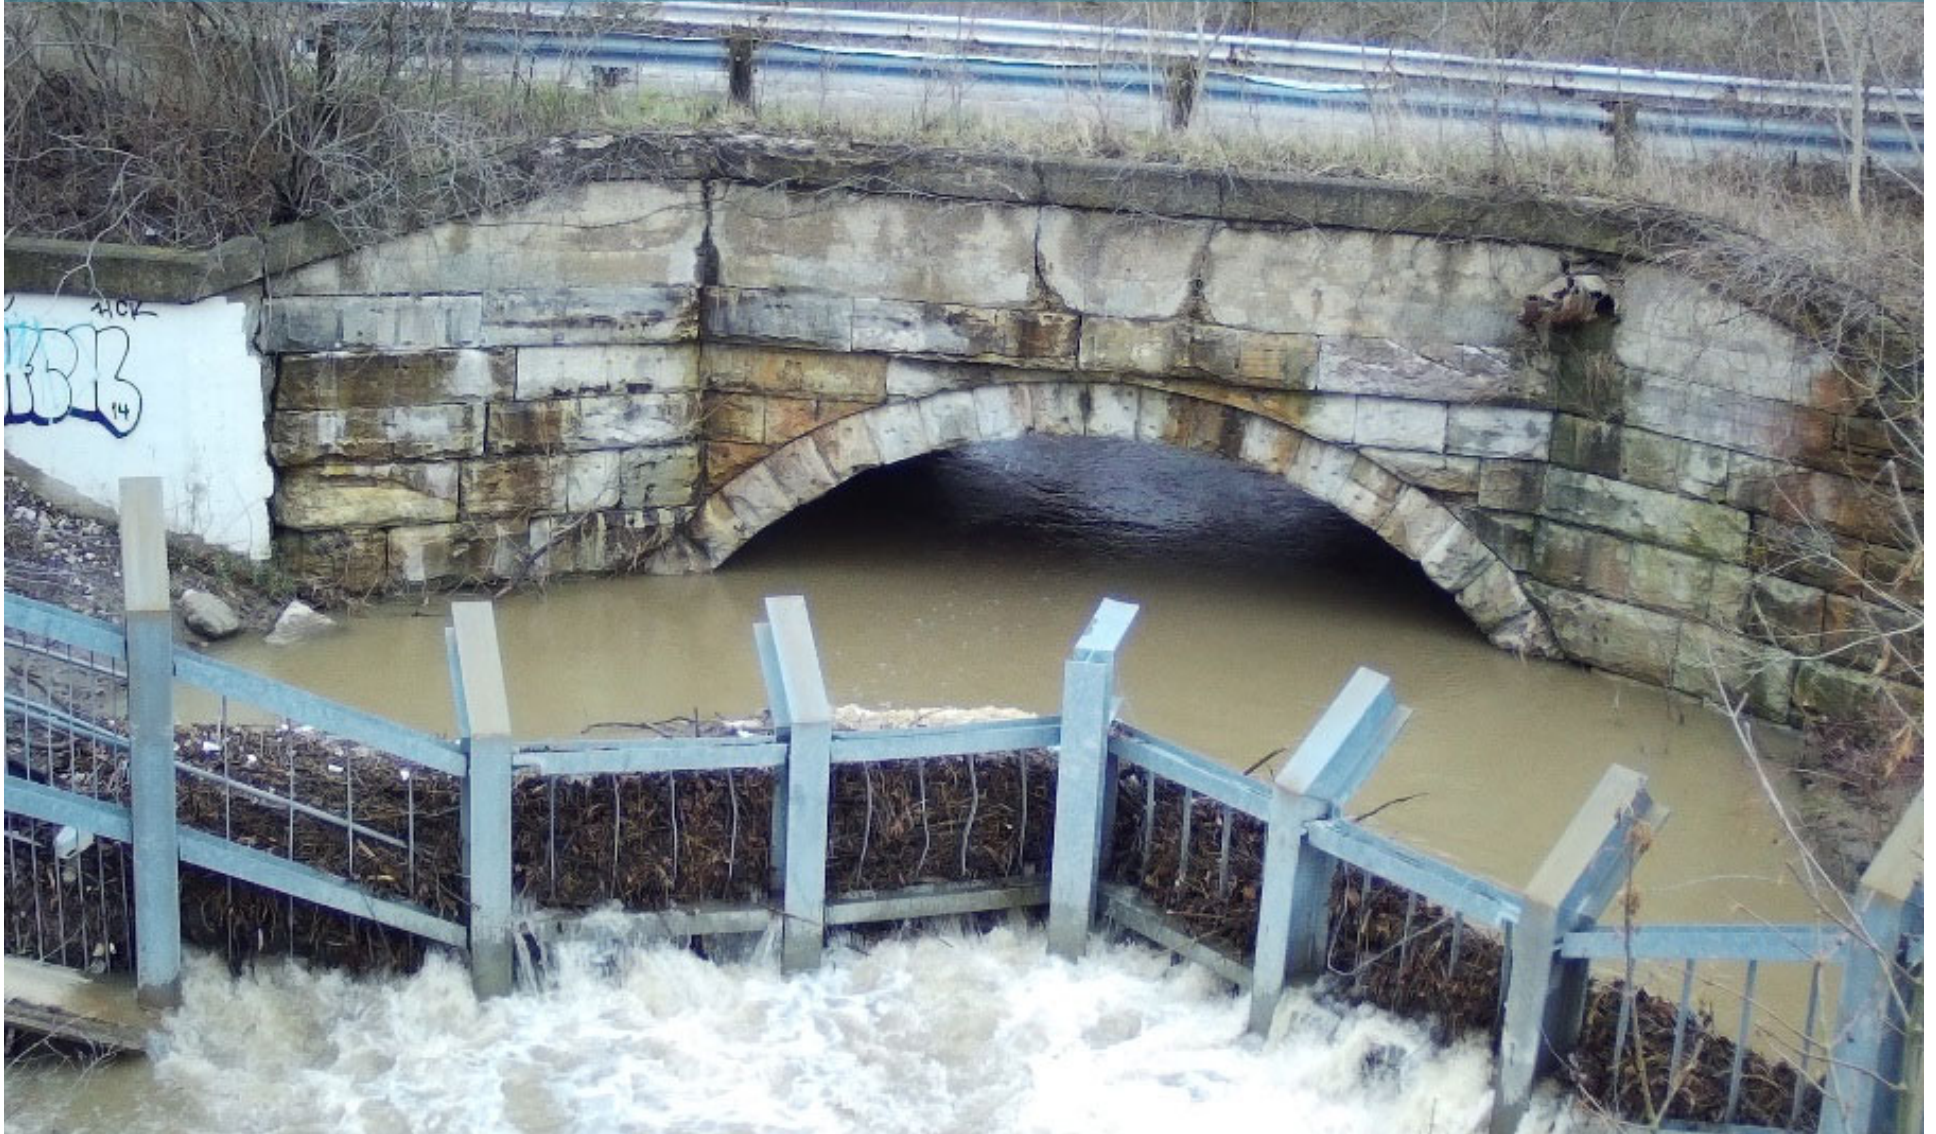
April 16, 2018: Peak storm and debris
accumulated on rack

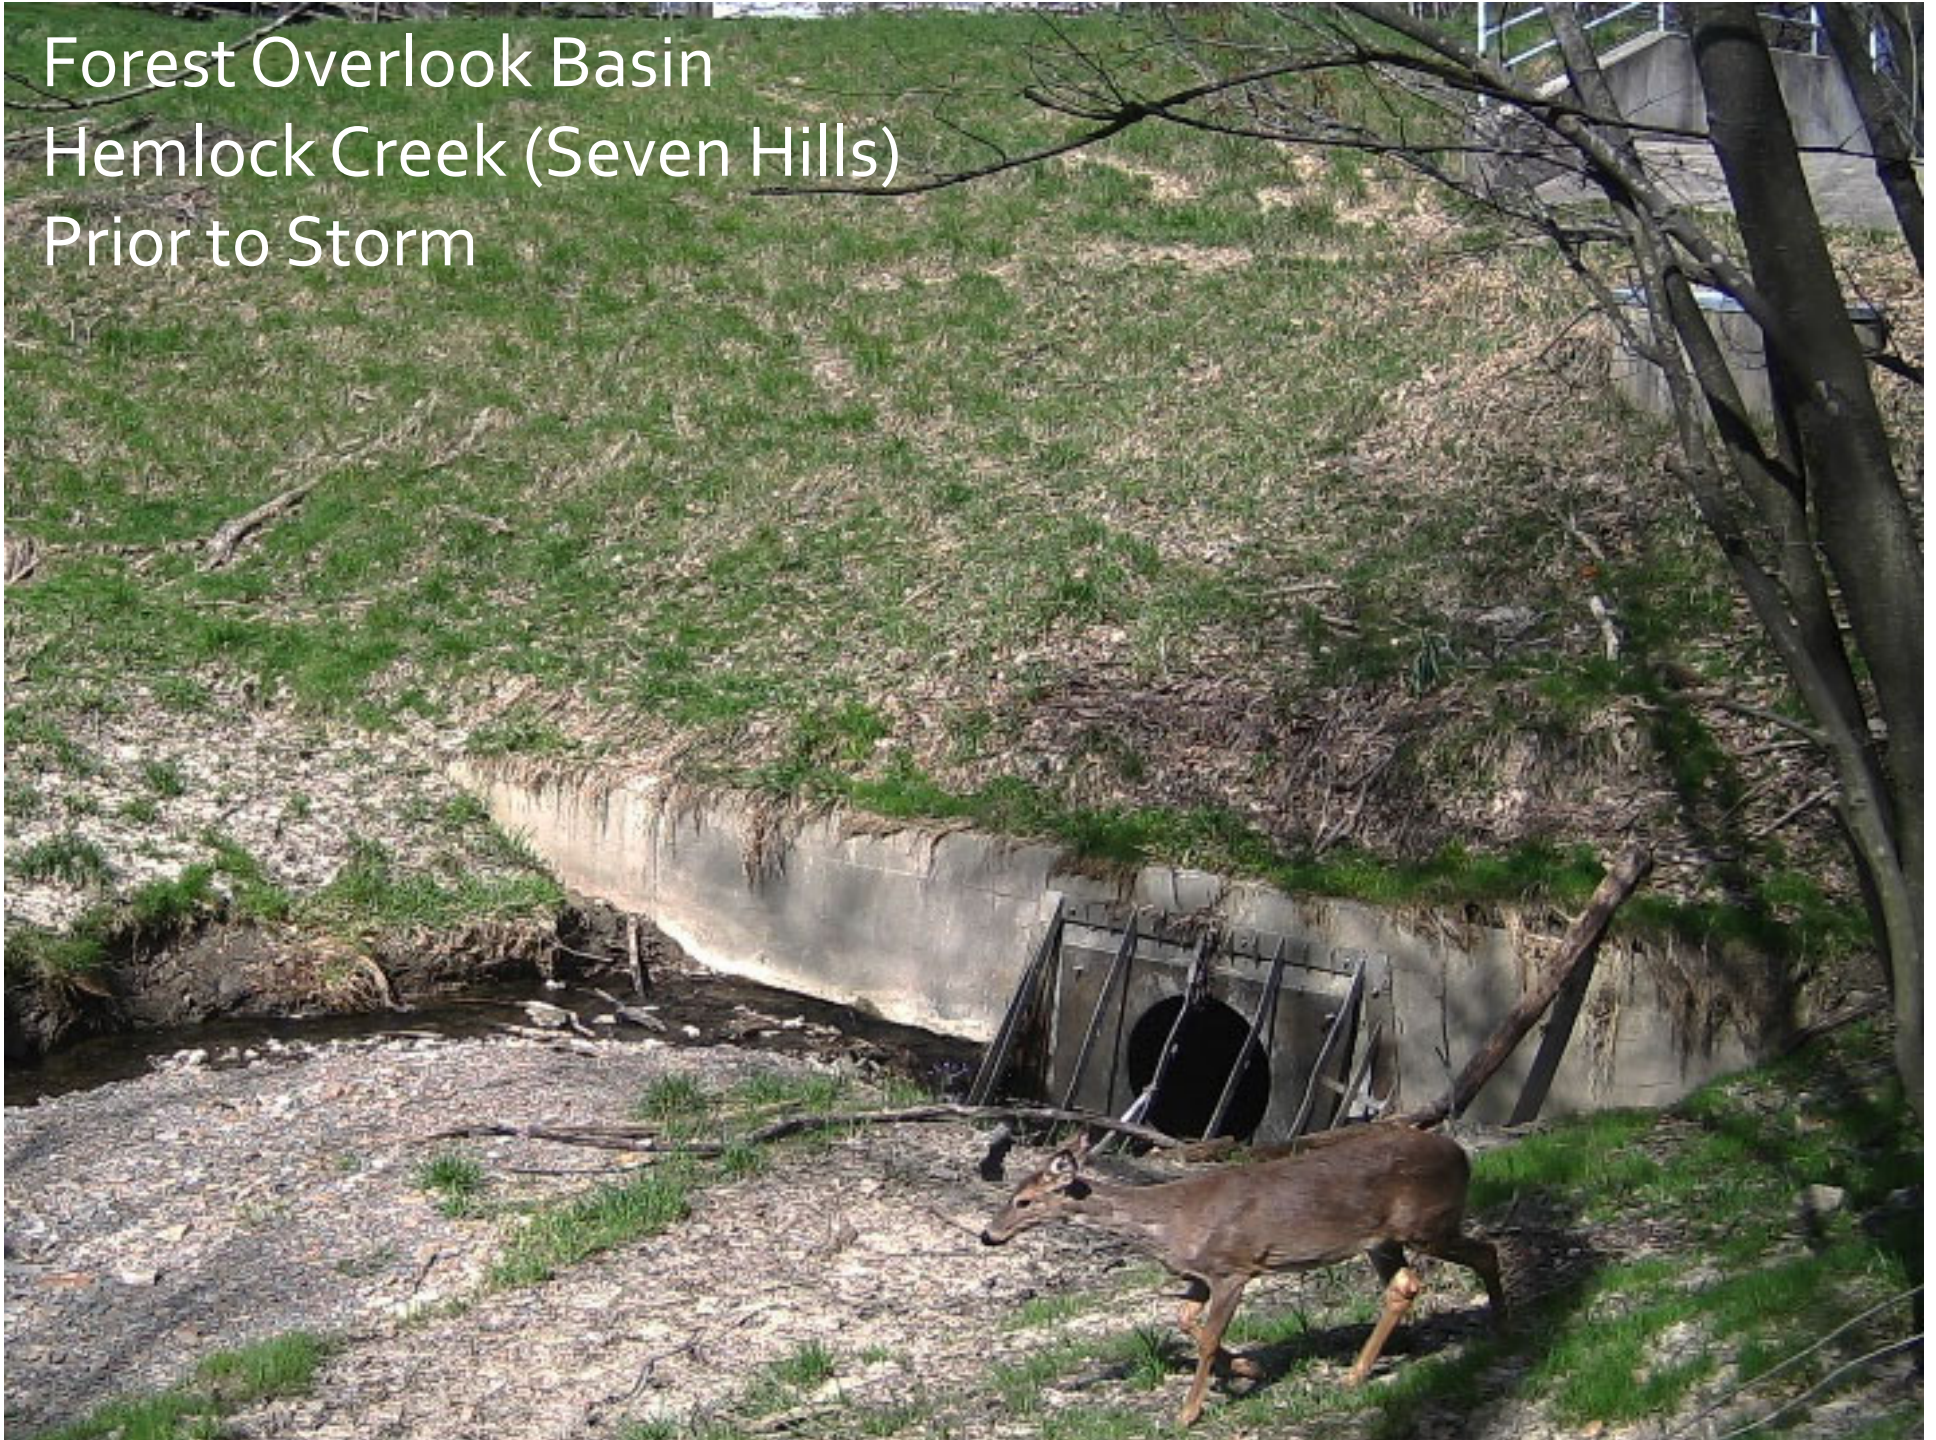
Forest Overlook Basin
Hemlock Creek (Seven Hills)
Prior to Storm

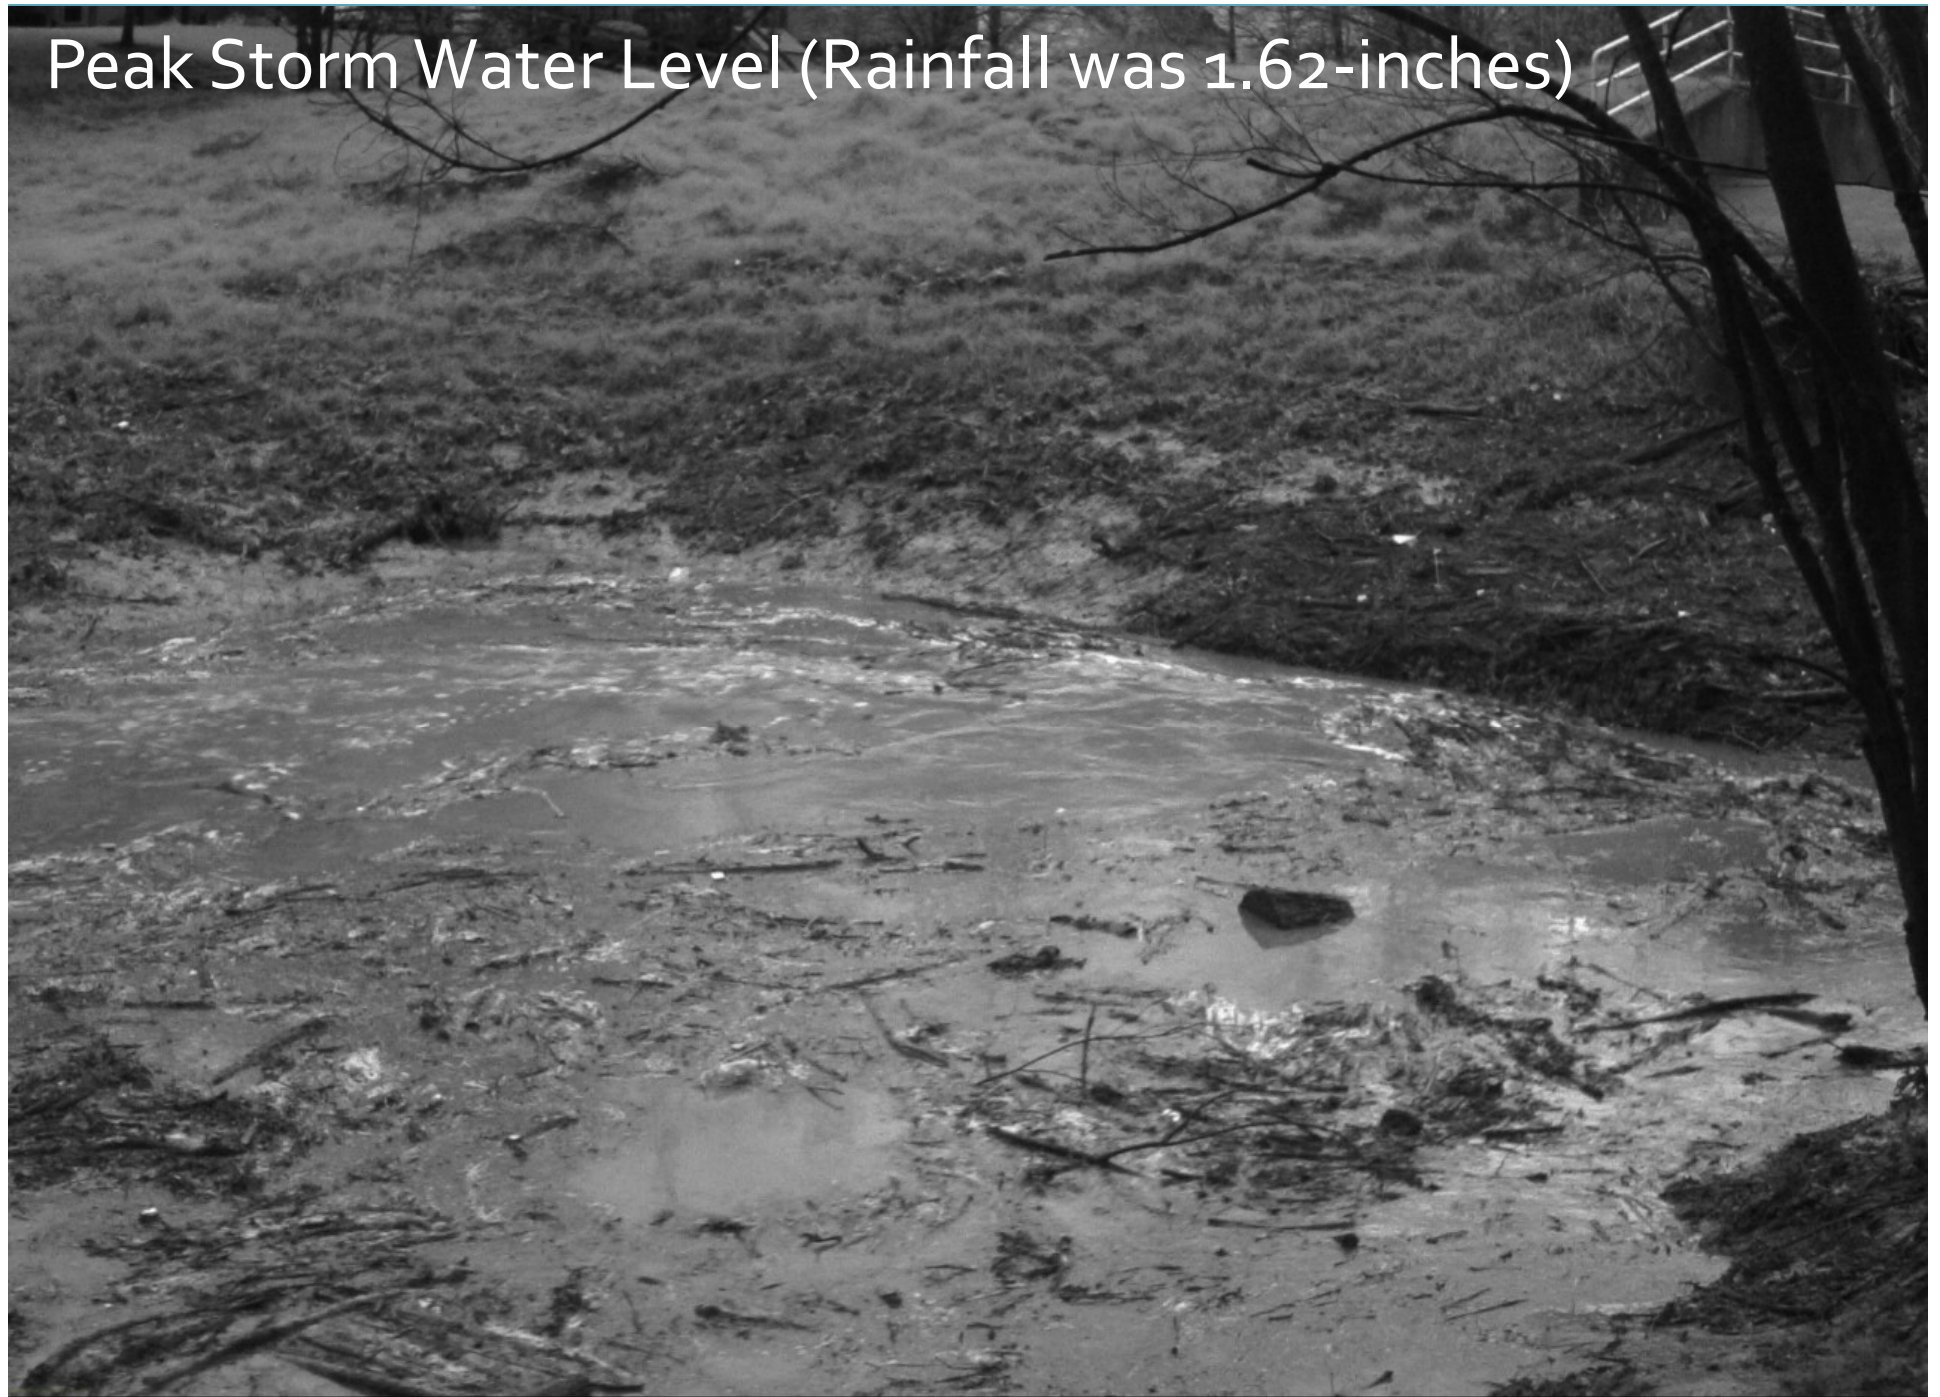
Peak Storm Water Level (Rainfall was 1.62-inches)

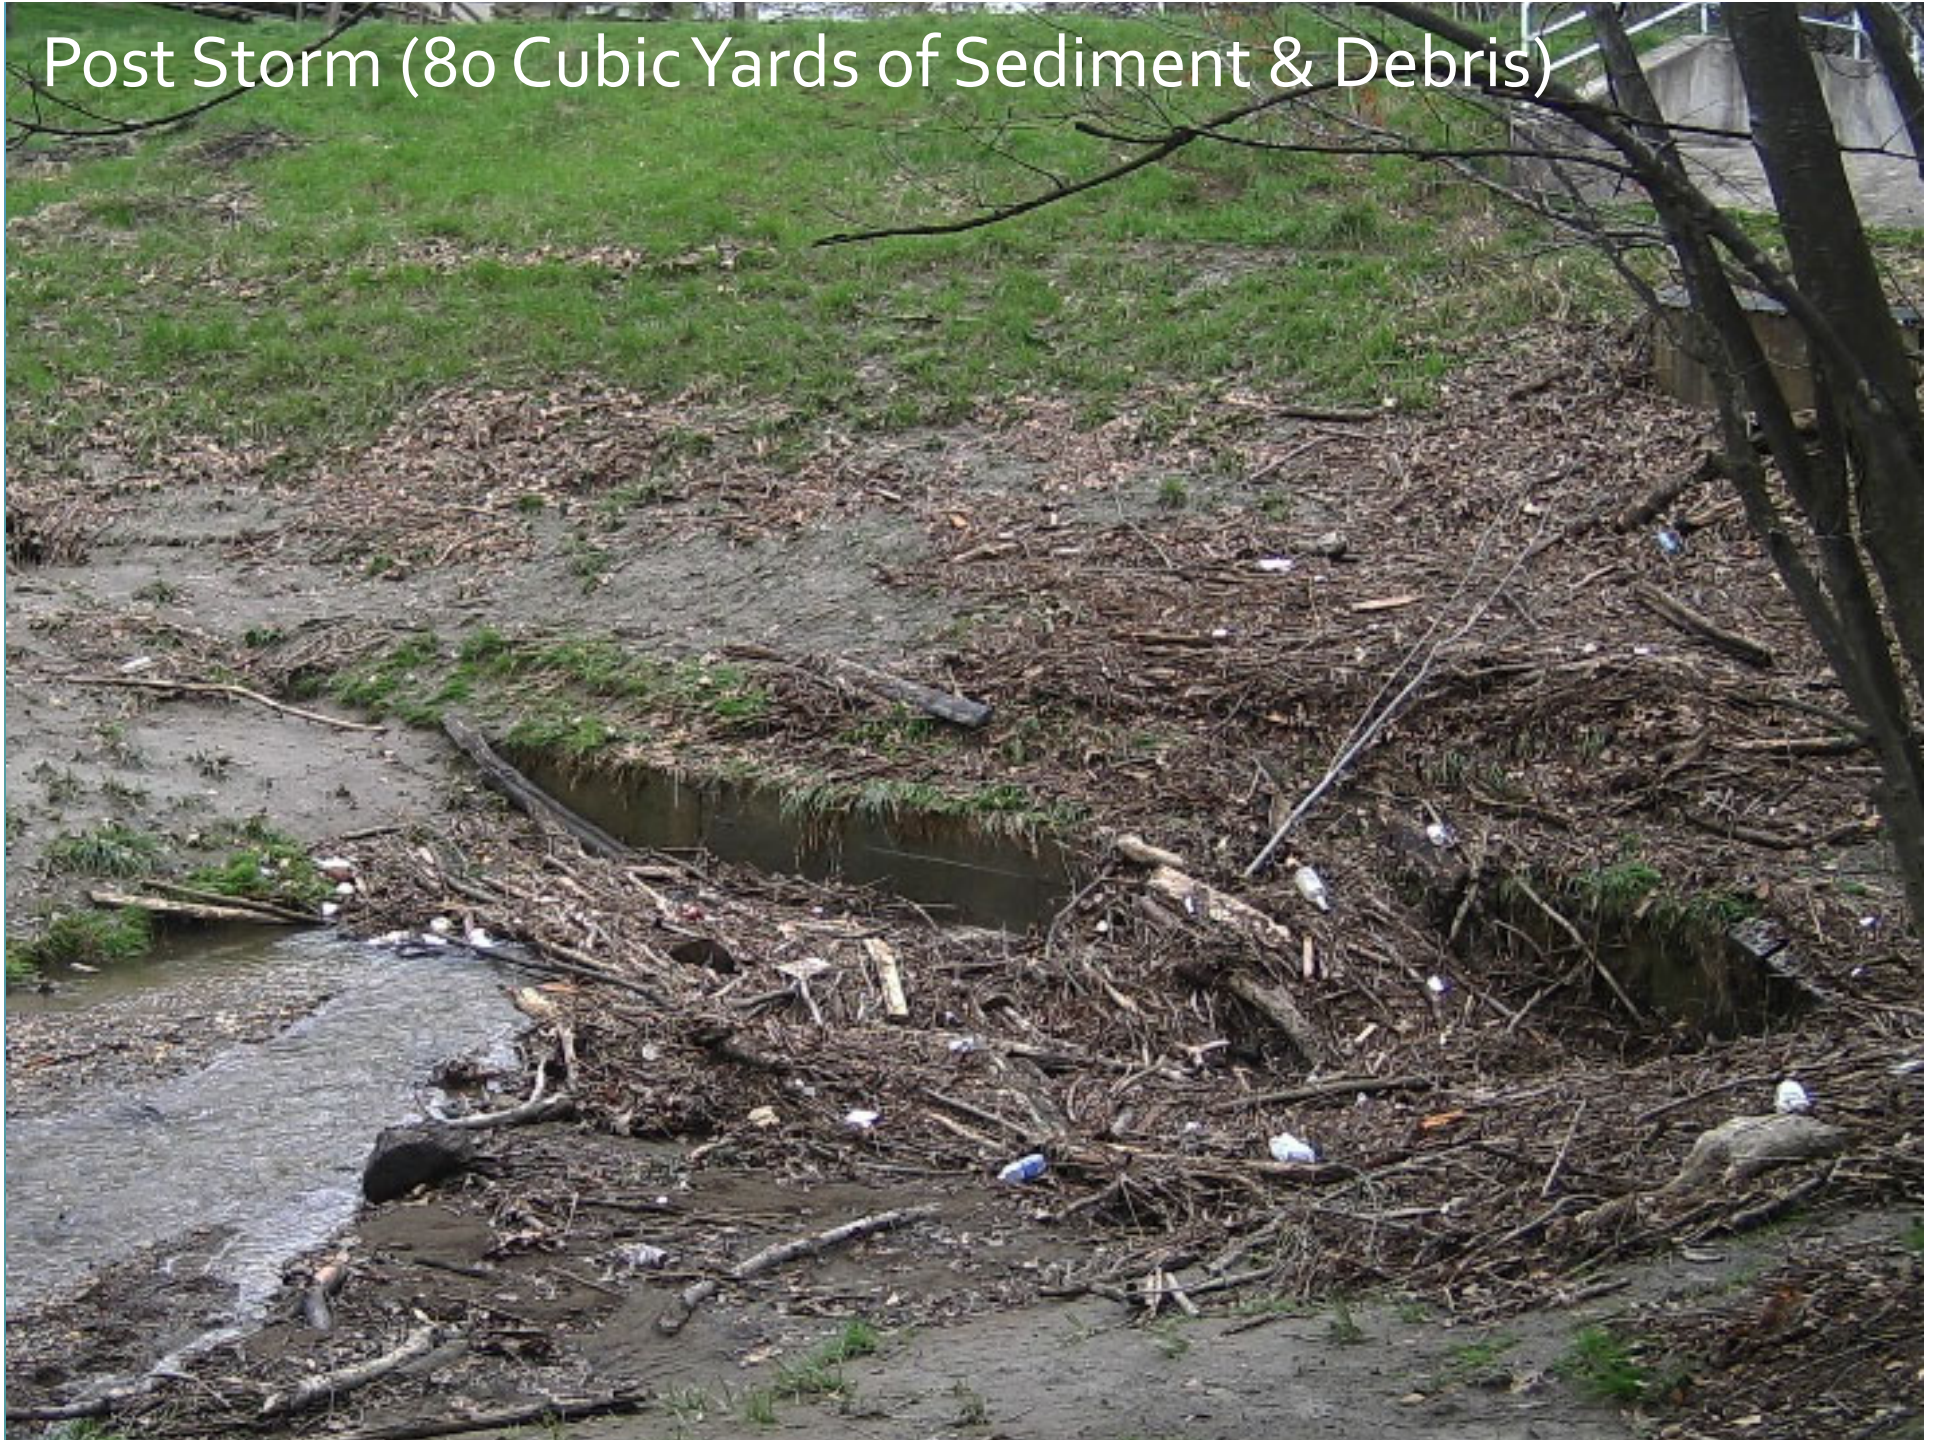
Post Storm (80 Cubic Yards of Sediment & Debris)

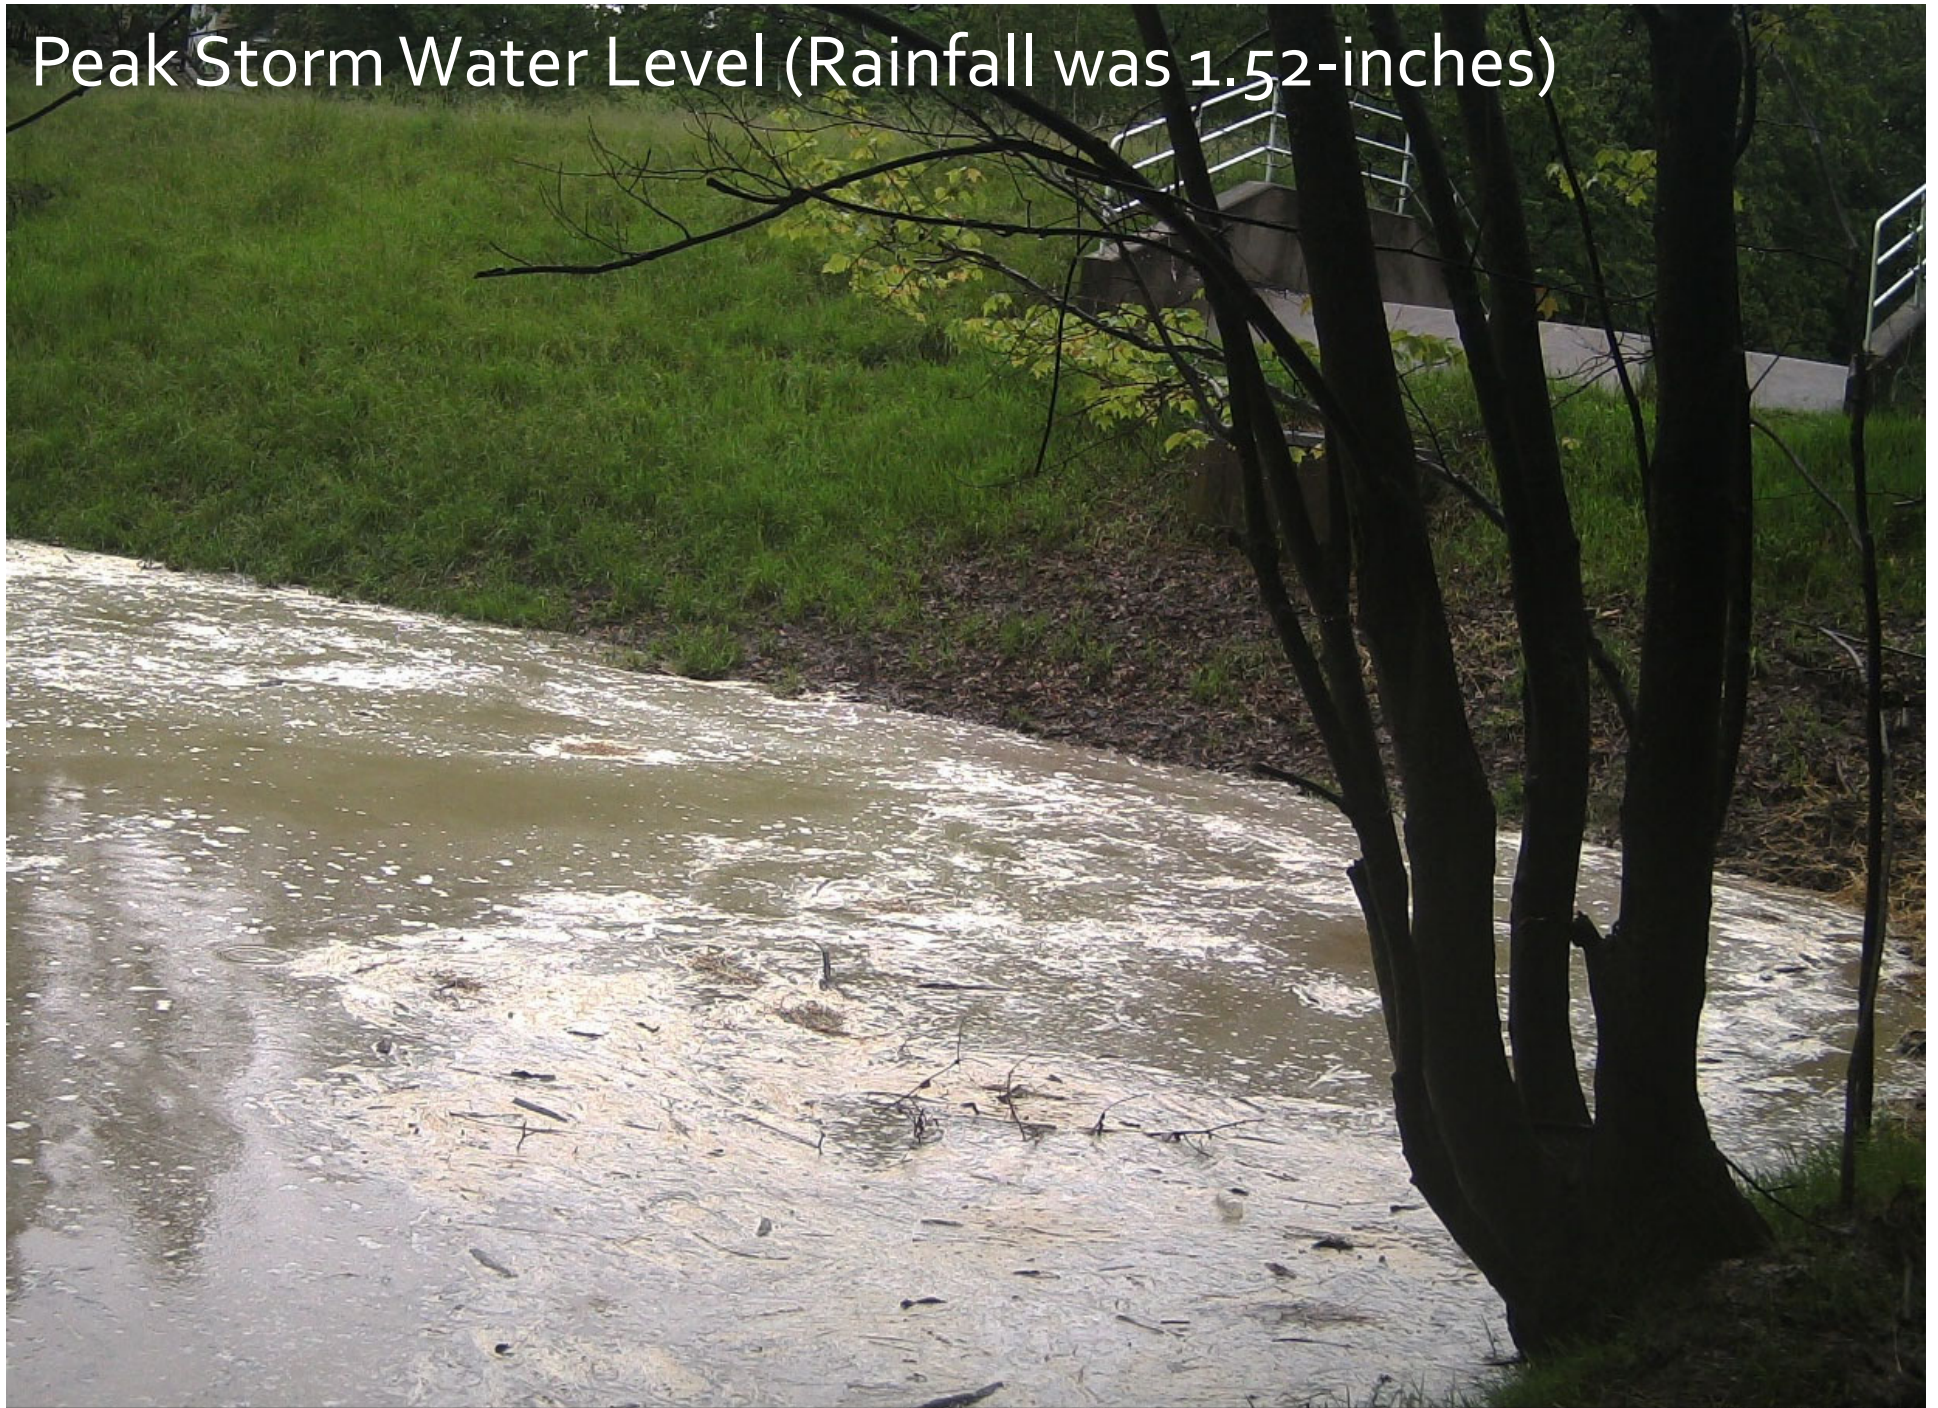
Peak Storm Water Level (Rainfall was 1.52-inches)

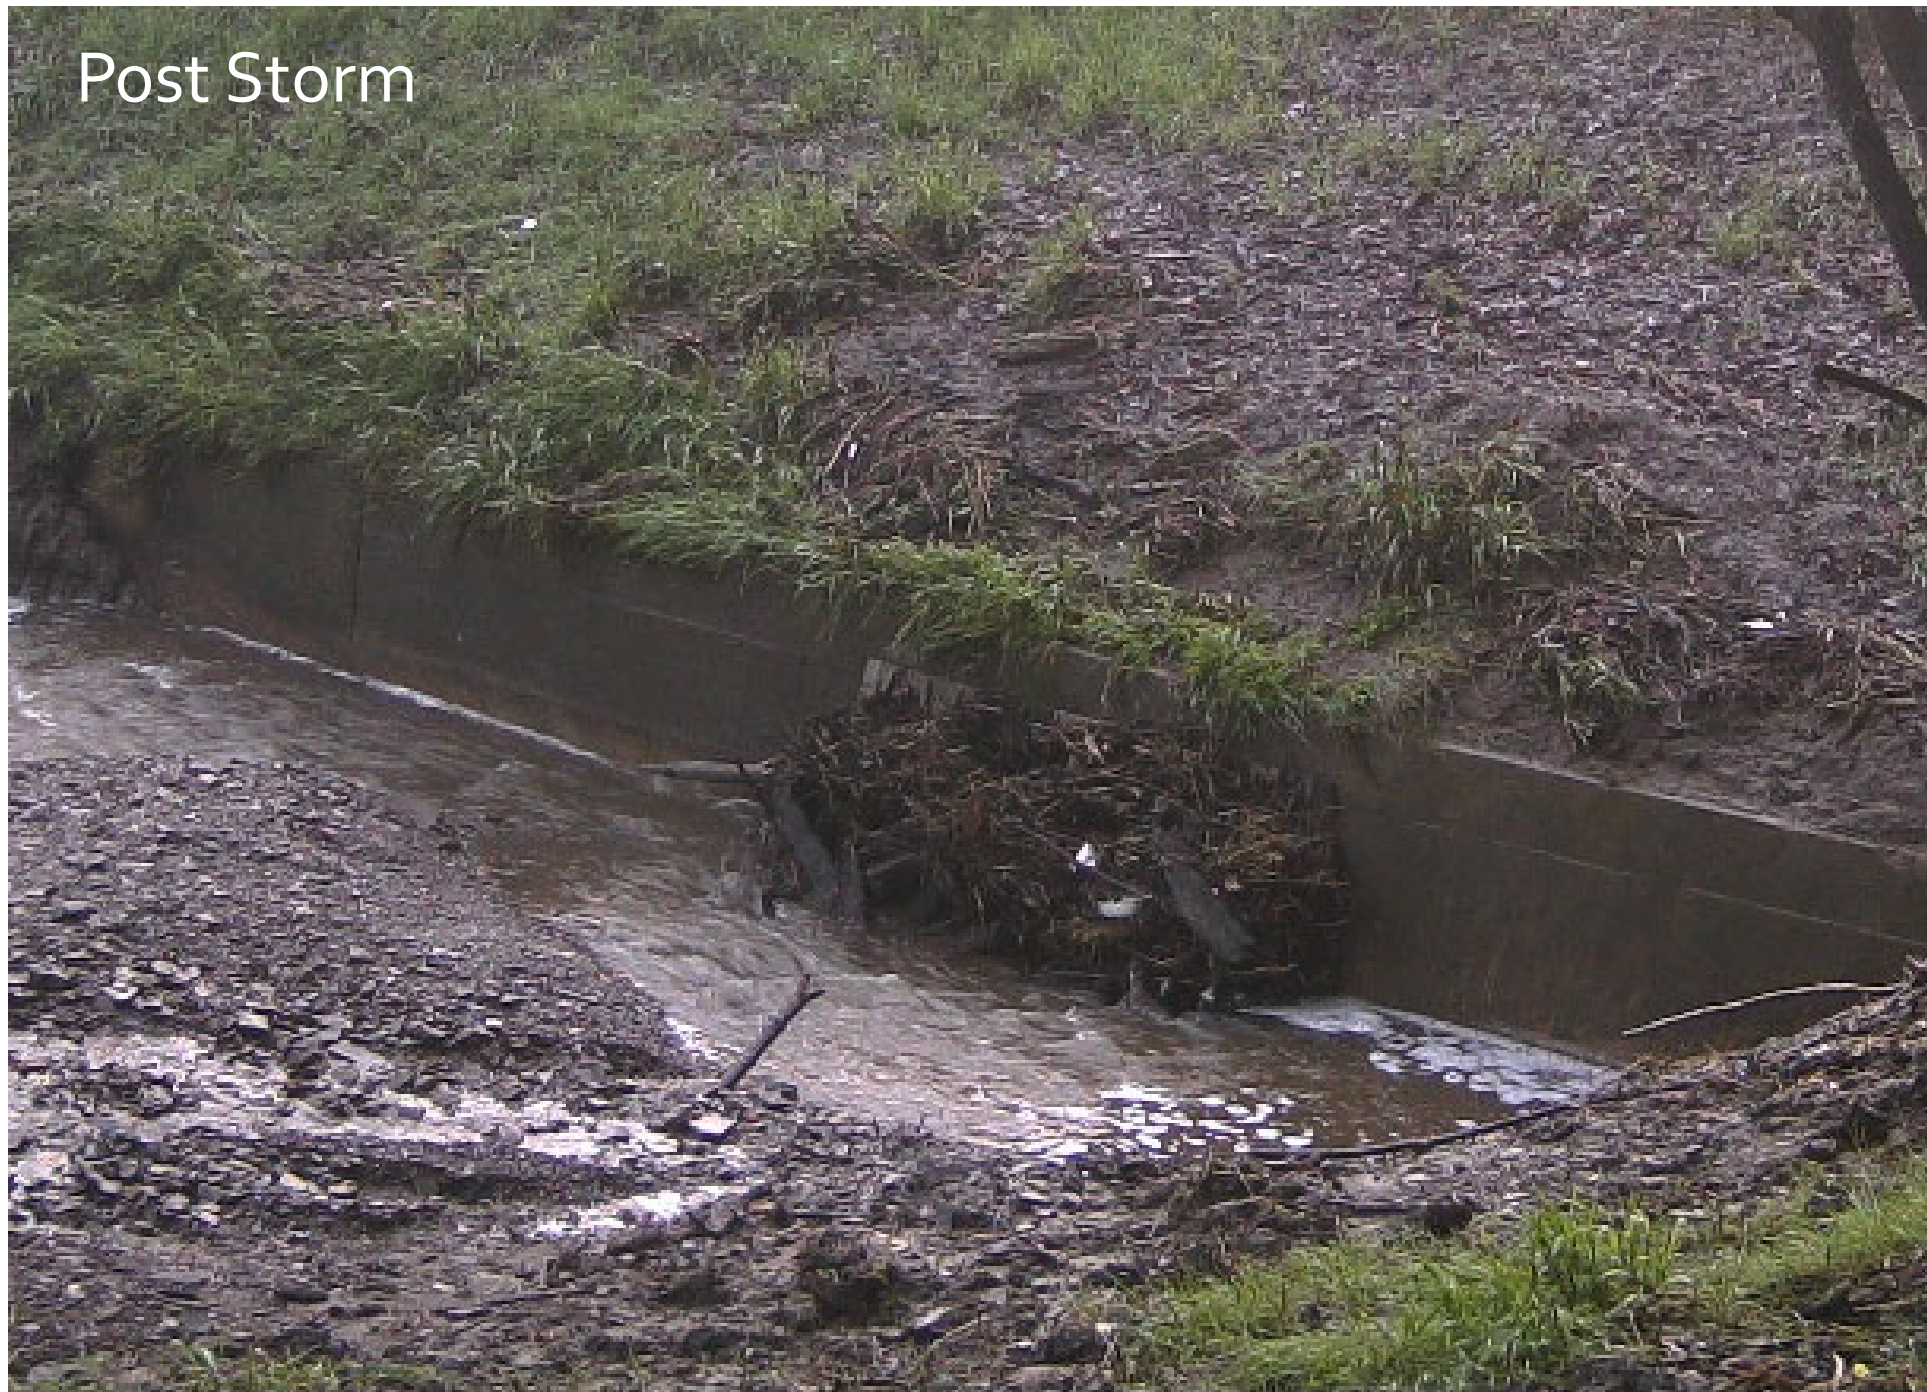
Post Storm

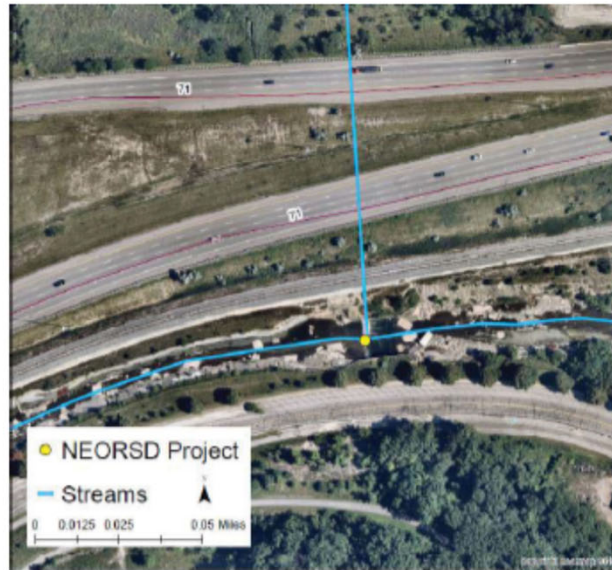
BIG CREEK STABILIZATION

The Big Creek Stabilization project will repair streambanks with riprap and construction of a rock cascade on top of the existing spillway structure to rehabilitate the existing channel.

The current concrete liner will be removed and reused as fill material, and the rock cascade will replace the existing 30-ft drop with a gently sloping cascade to provide energy dissipation.

A low flow channel will be constructed within the rock cascade and a 96-inch outfall will be extended to outlet at the end of the rock cascade.
