# *Watershed Advisory Committee*

## *Cuyahoga River North*

### *March 9, 2021*

REGIONAL  
STORMWATER  
MANAGEMENT  
PROGRAM

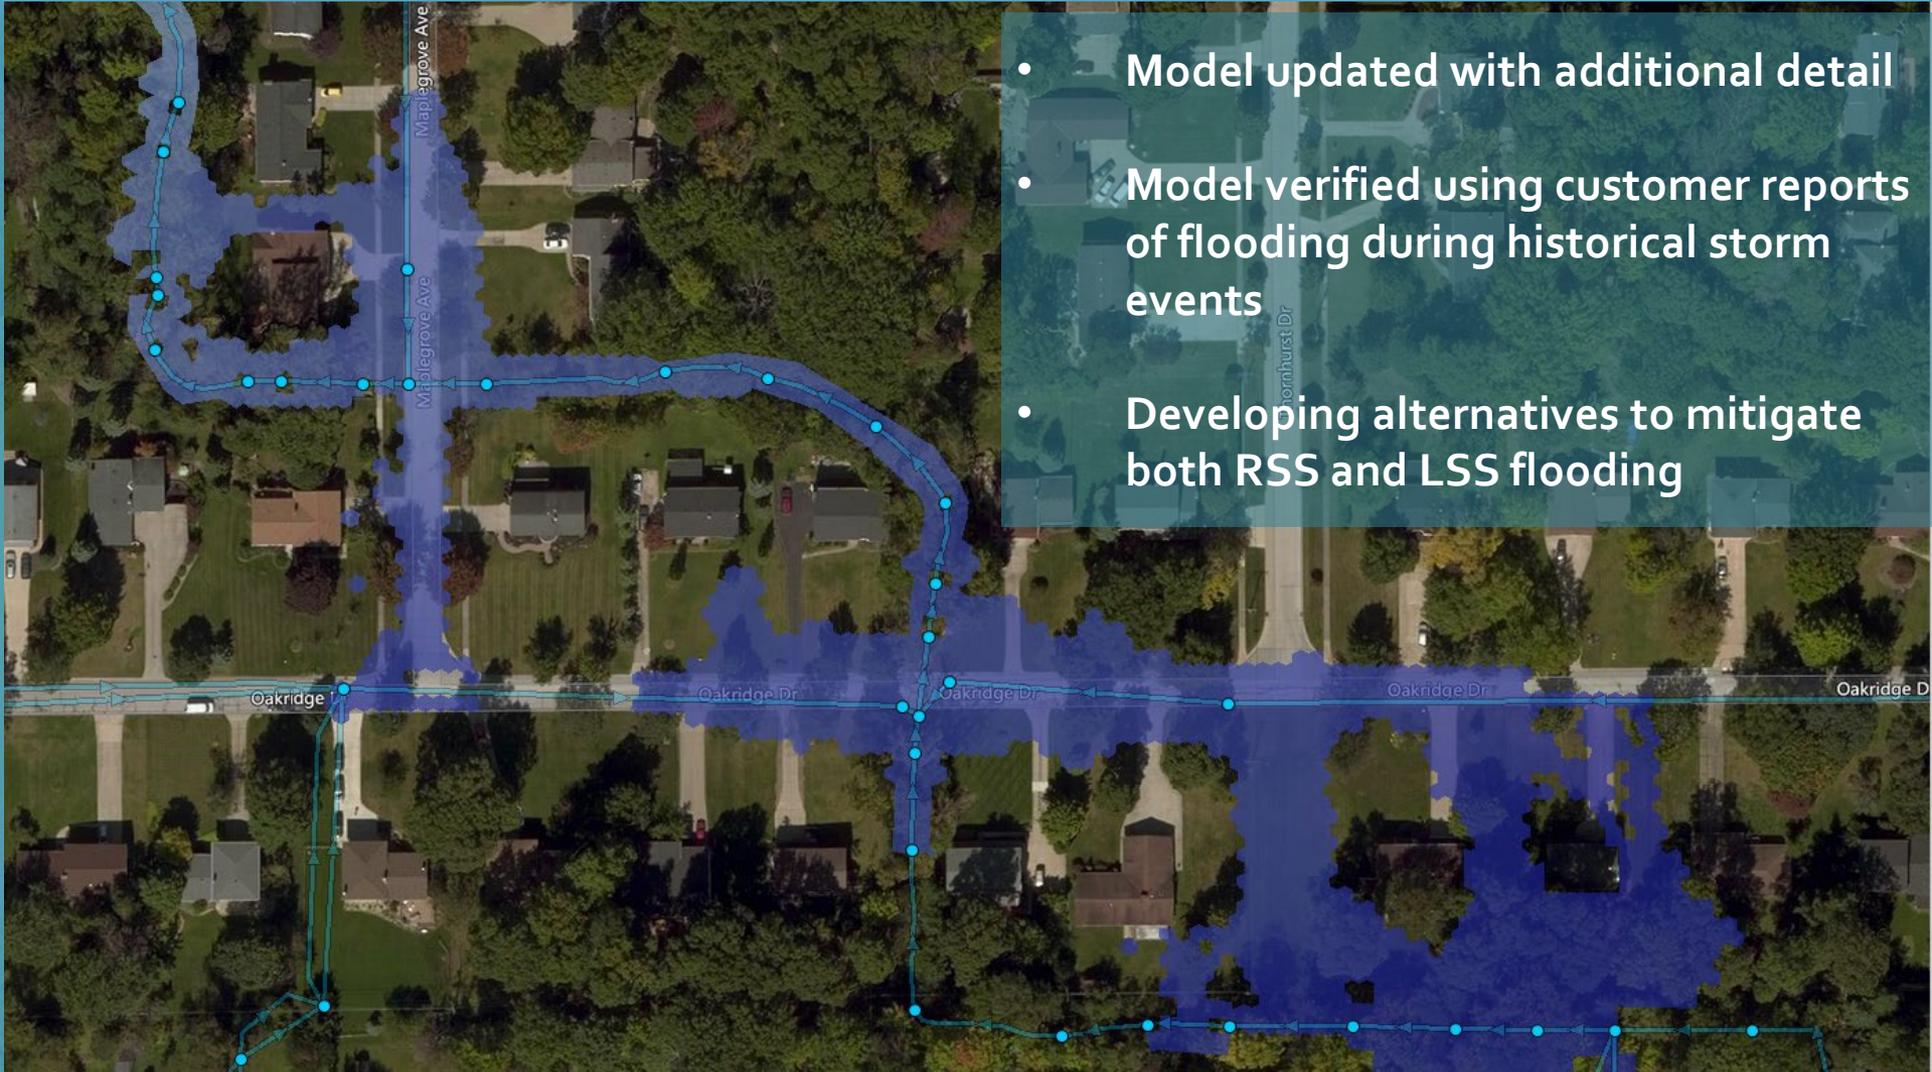
# Big Creek North Royalton Problem Area [BCNRo2]

- Model updated with additional detail
- Model verified using customer reports of flooding during historical storm events
- Developing alternatives to mitigate both RSS and LSS flooding

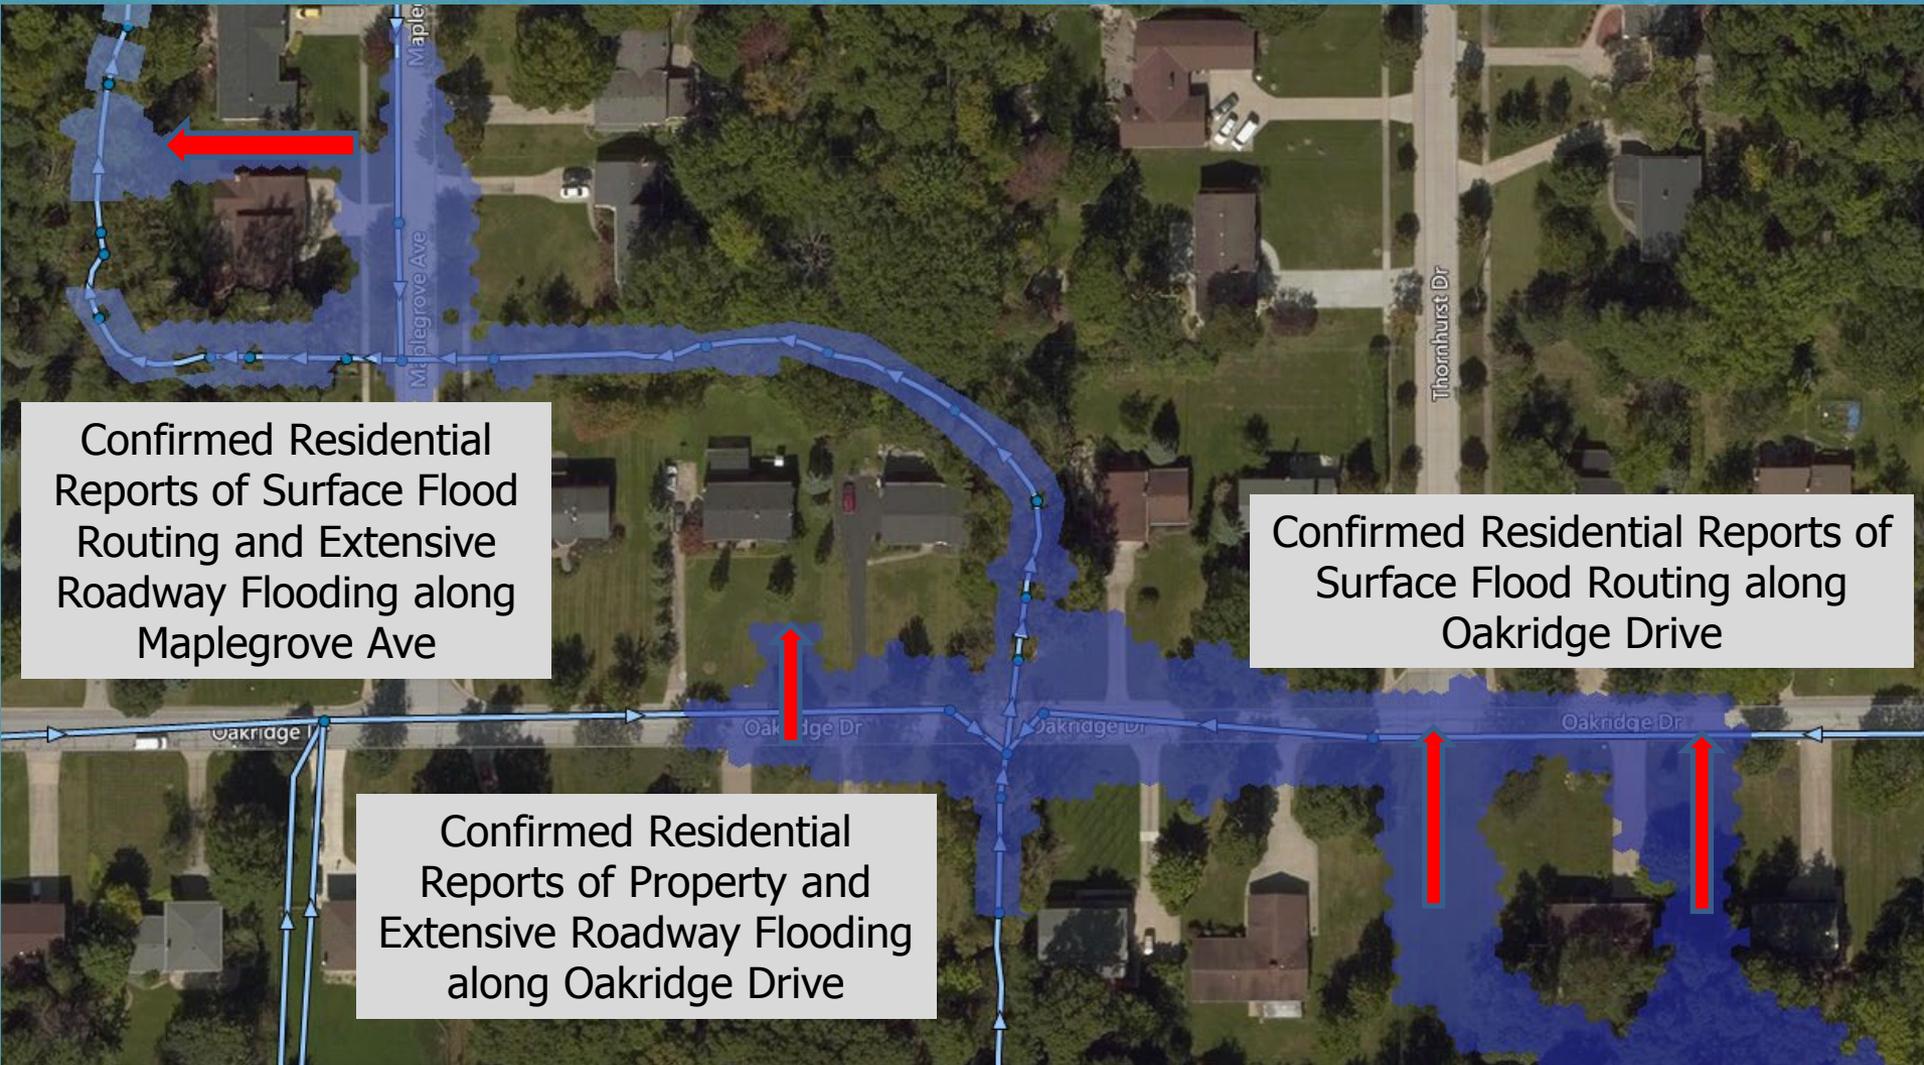
# April 16, 2018 Urgent Storm Event: Street Flooding

Confirmed Residential Reports of Surface Flood Routing and Extensive Roadway Flooding along Maplegrove Ave

Confirmed Residential Reports of Surface Flood Routing along Oakridge Drive

Confirmed Residential Reports of Property and Extensive Roadway Flooding along Oakridge Drive

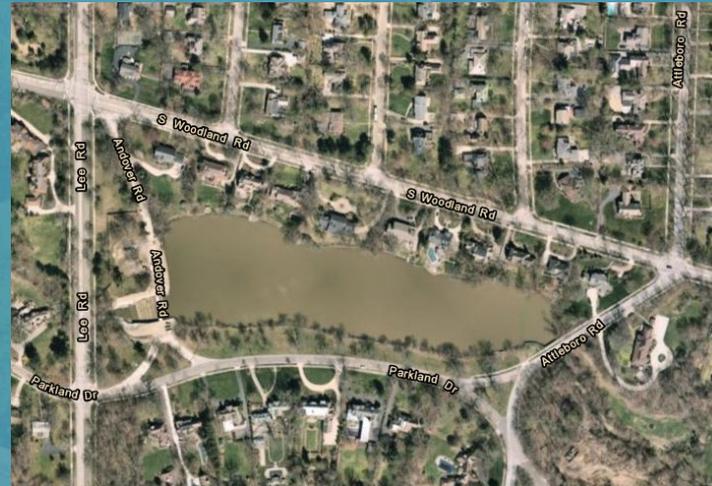
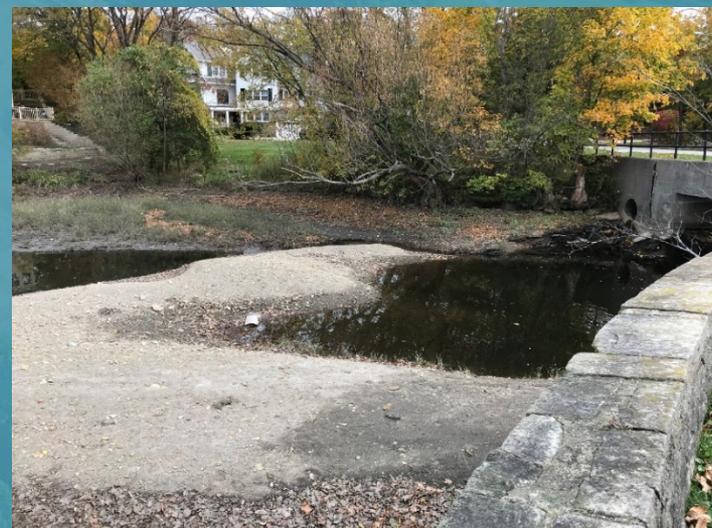
### *Problem Identification*

- Green Lake in Shaker Heights, Doan Brook Subwatershed
- Systemic erosion throughout the upstream tributary
- Sediment accumulation in Green Lake requires repeated maintenance

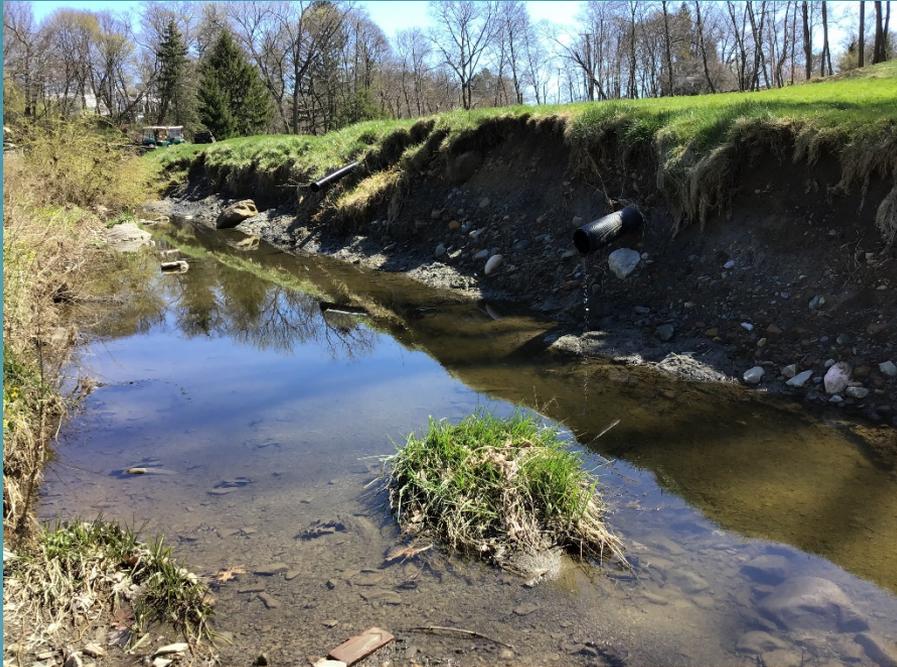
### *Data Collection*

- Goal: Identify the source of the sediment.
- Mapped the drainage area to Green Lake, including all outfalls 12" or greater in diameter.
- Performed STEPL analysis on all stream segments draining to Green Lake
- Height and length measured on each eroding bank
  - Assigned a Lateral Recession Rate for each bank, ranging from .01' to .5' per year based on bank material and surface protection (lack thereof).
- Calculated volume of sediment from each segment.

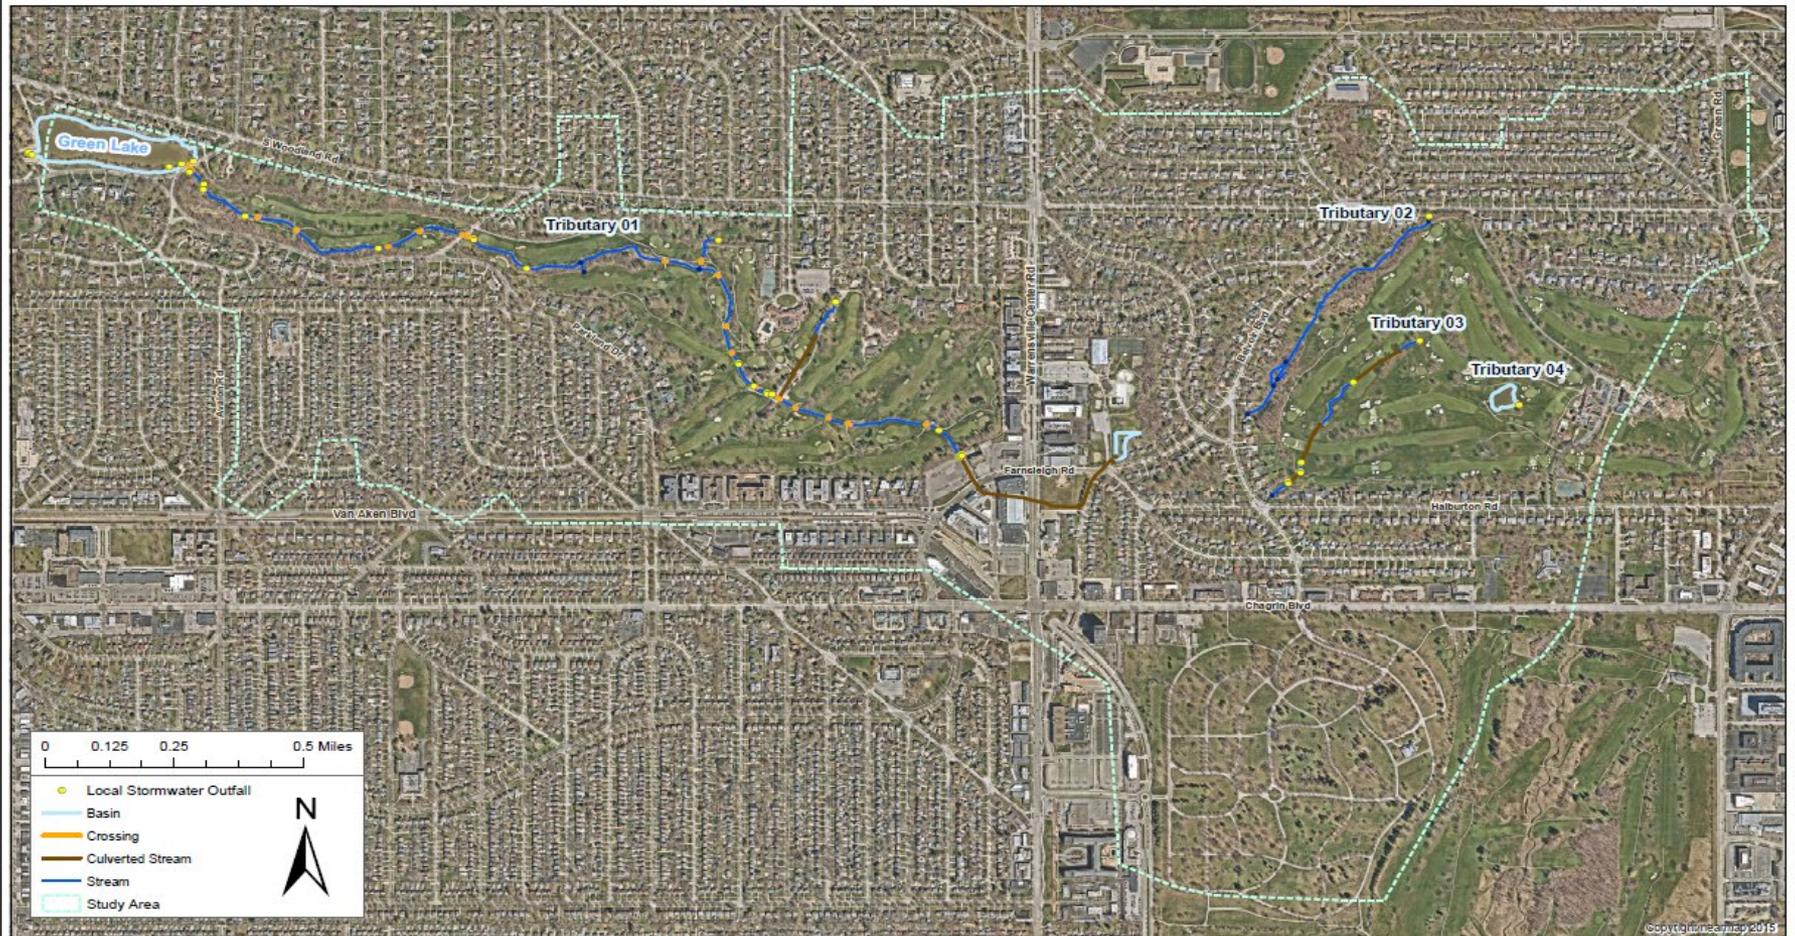
### Study Area

**Green Lake Local Stormwater System Assets**  
Overall View of Tributaries Within Study Area

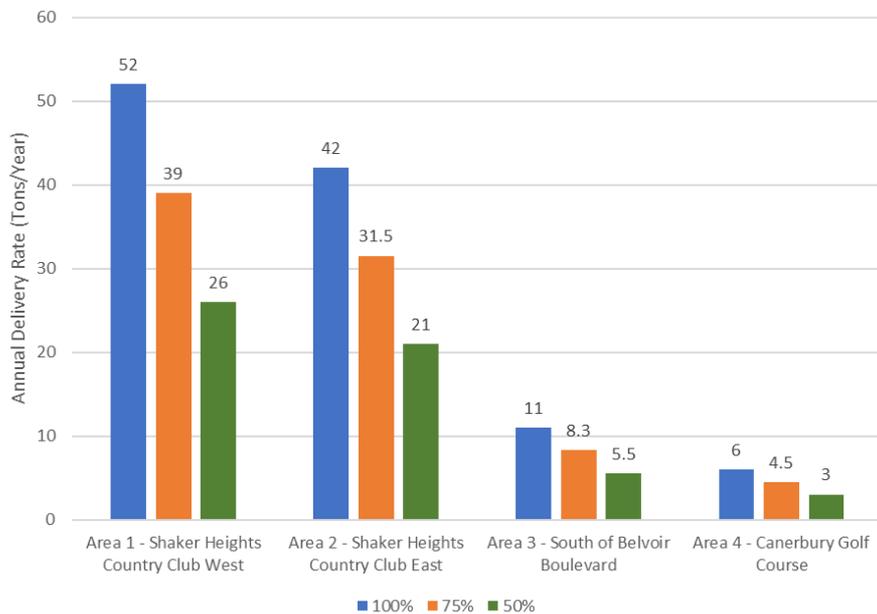
Annual Delivery Rate of Sediment to Green Lake (Tons/Year)

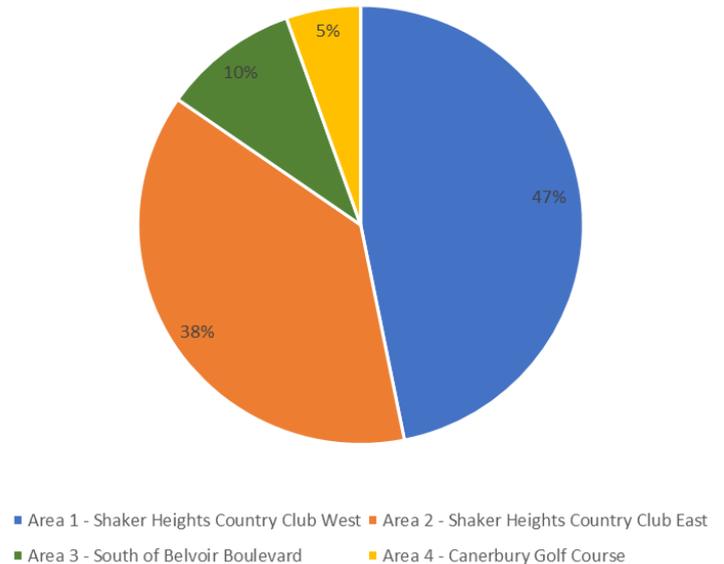
Percentage of Total Sediment Load to System

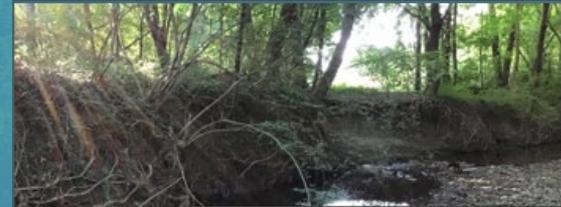
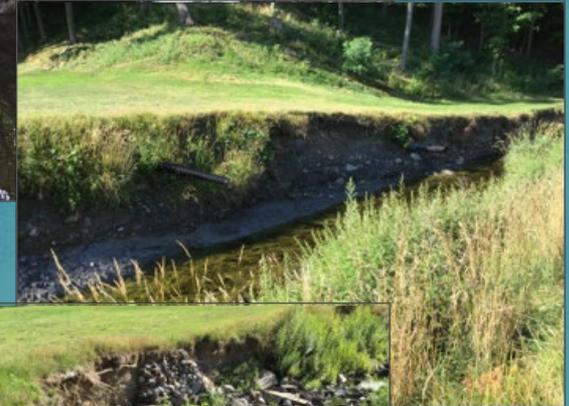
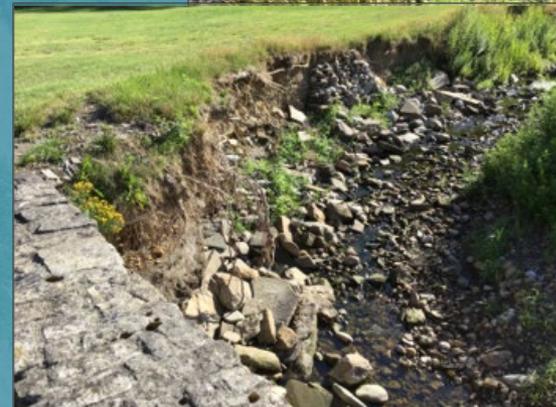
Address the top 5 “worst offenders”

- Incorporate streambank stabilization projects prioritized by highest sediment contributors.
- Projects incorporate grading back the banks to more gradual slopes, installation of native plantings with dense root structures, establishing clearly defined riparian buffer zones, installation of rip-rap protection, and hard armament where necessary.

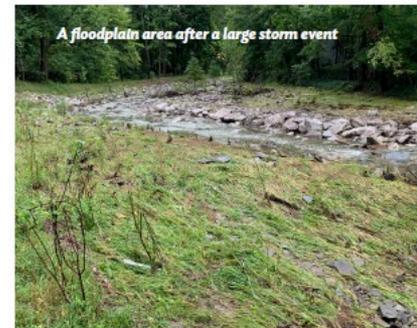
### Pools & Riffles

Pools are deeper sections of the stream usually built on the outside of bends. Riffles are shallow areas of the stream with protruding rocks at the surface. Both structures work together to reduce the energy of the stream.

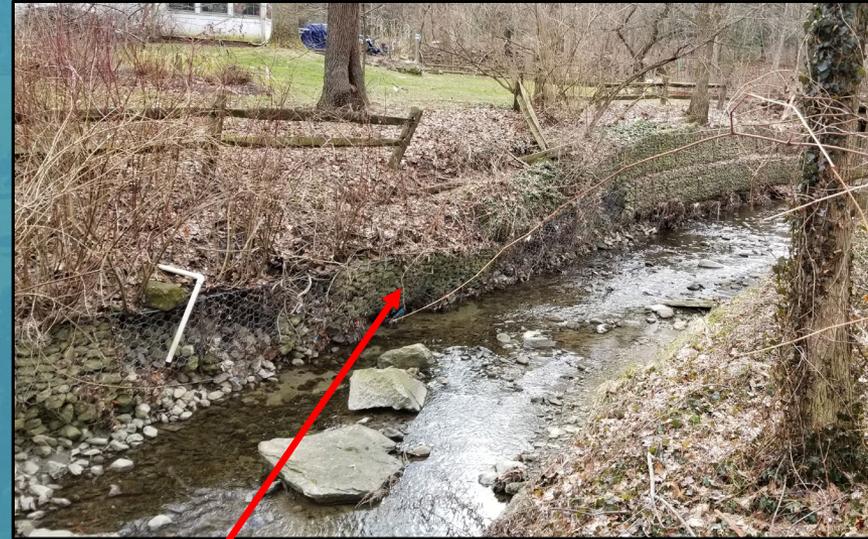
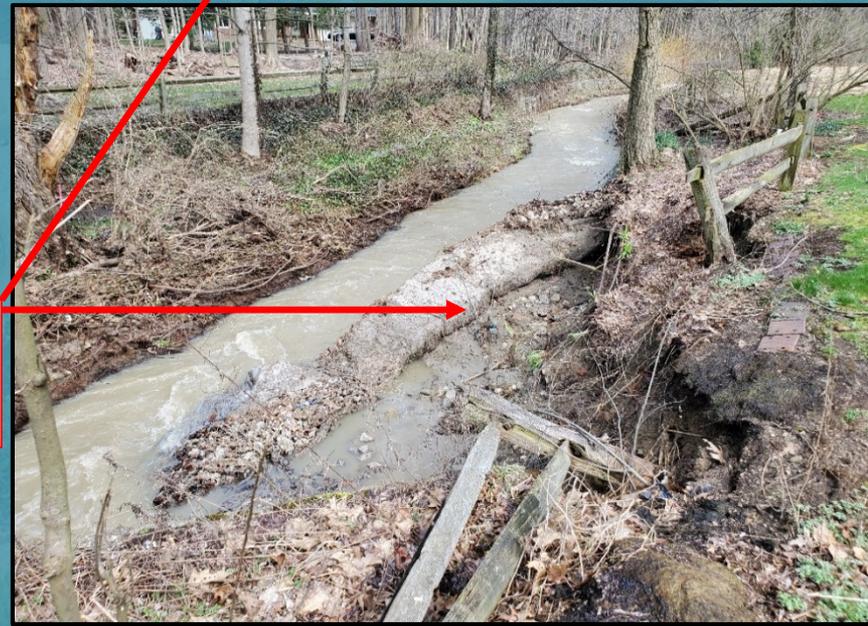
**Failed gabion baskets &  
streambank erosion**

- Purchased 1 residential property and acquired easements on several others
- Installation of Fabric Encapsulated Soil Lifts (FESLs)
- Expanding floodplain
- Tied into gabions at downstream end of project (had to shorten project due to easement refusal from 1 property owner)

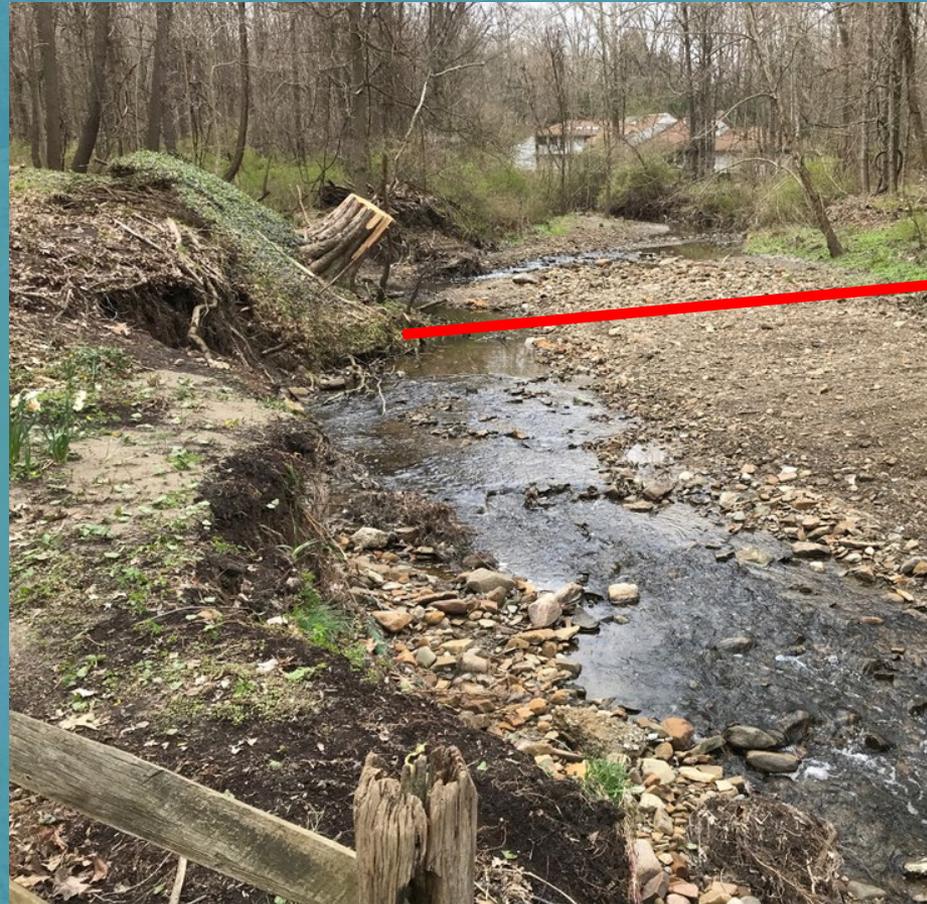
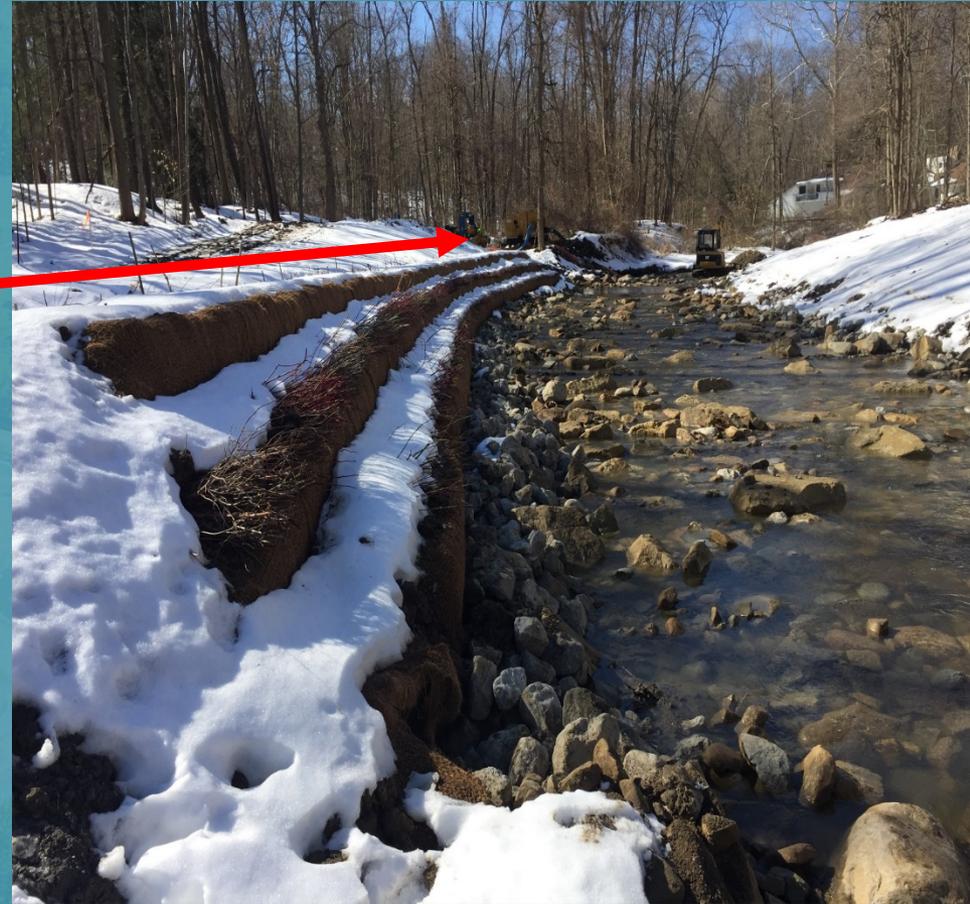
*before*

*after*

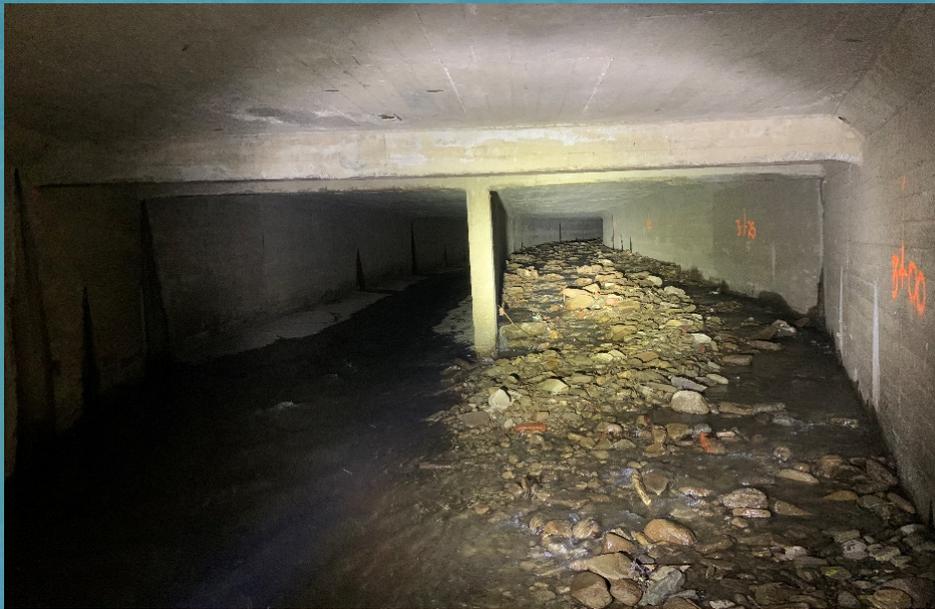
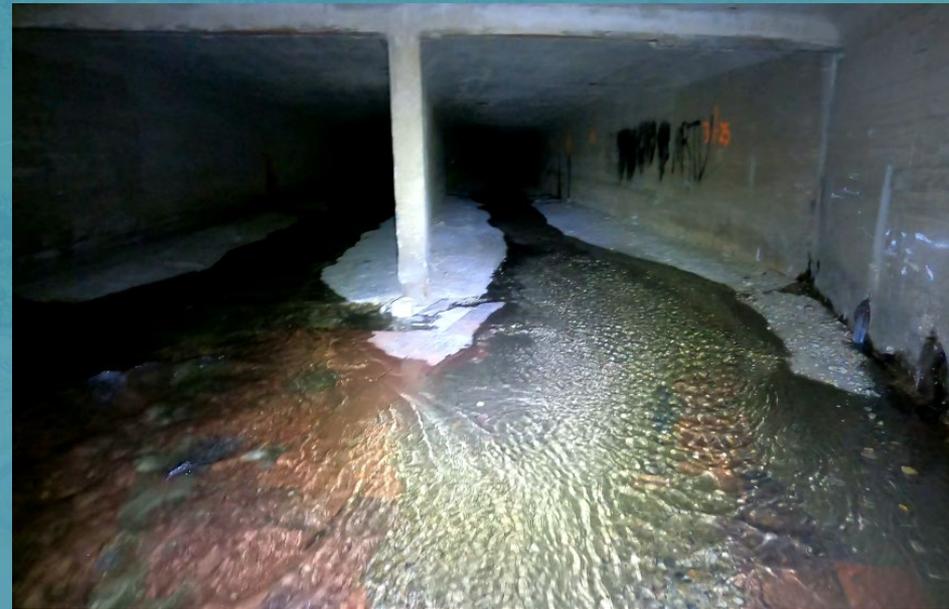
Doan Brook Culvert in Cleveland

before

after

*Remove 1950 cubic yards*

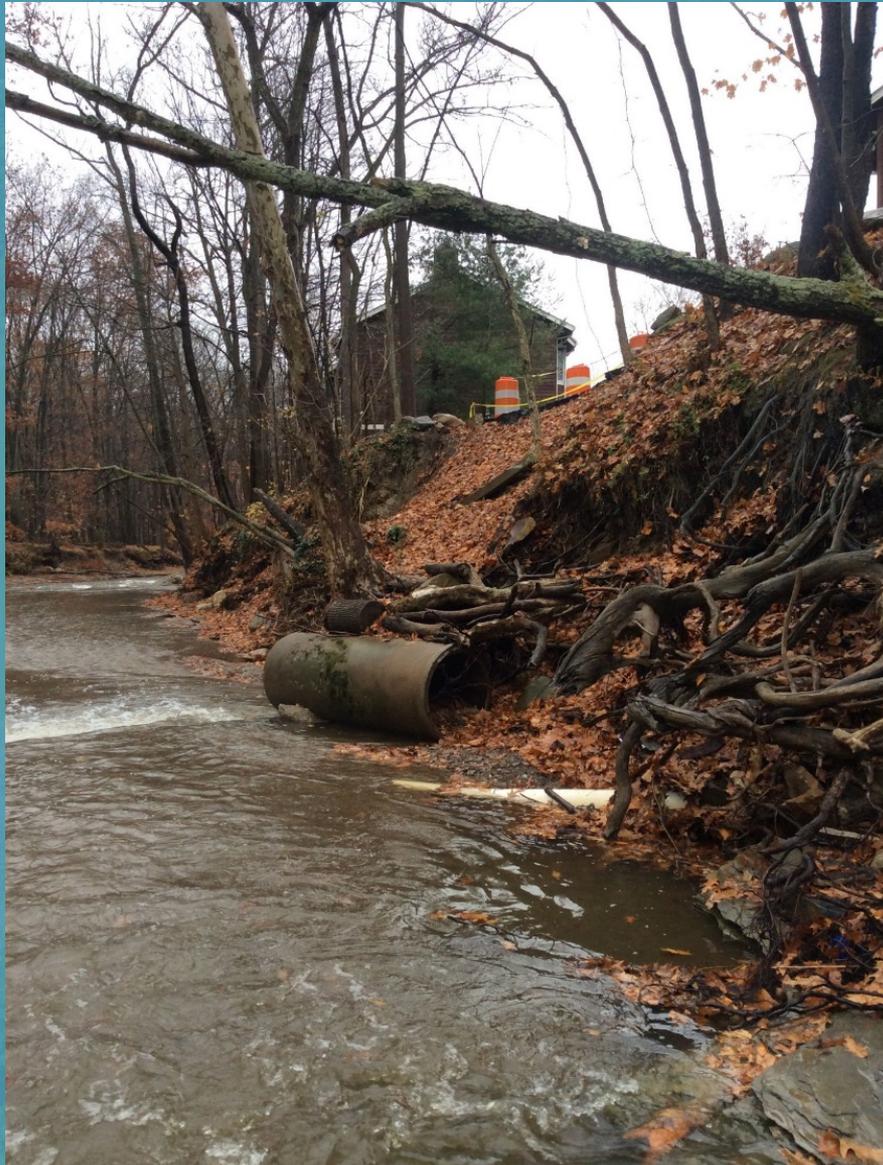
# Chippewa Creek Stabilization at Condominiums in Brecksville

- *Eroding streambank within 12 ft of the condominiums*
- *Erosion within 6 ft of local sanitary sewer*
- *Stream infrastructure more cost effective than acquisition*
- *Construction Award: \$1,282,013*
- *Excavate Floodplain on left bank*

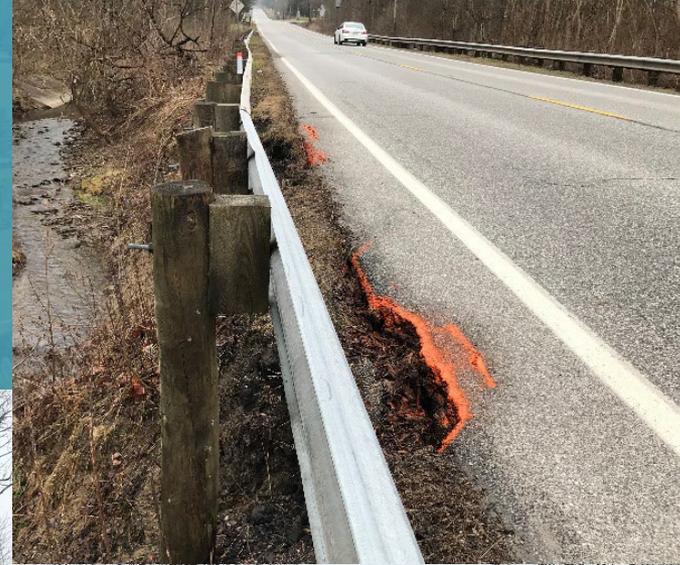
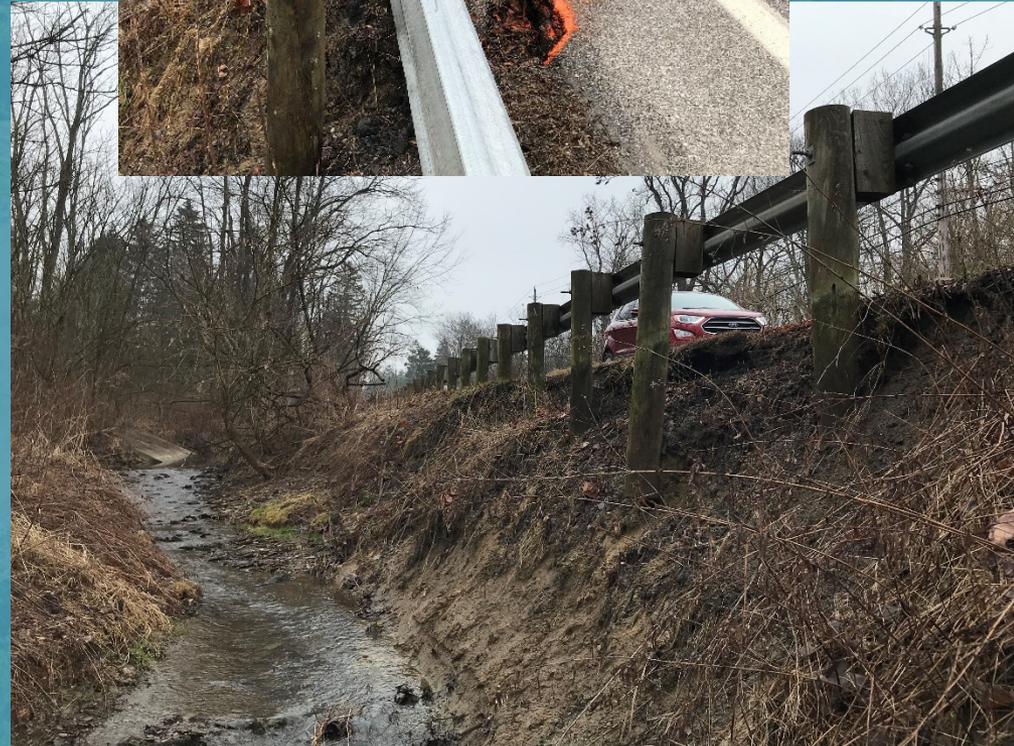
# *City of North Royalton - Ridge Road Repair and Rocky River Tributary Stabilization*

**Problem:** Bank erosion adjacent to Ridge Road

- Reduces sediment deposition
- Creates a new stable stream channel

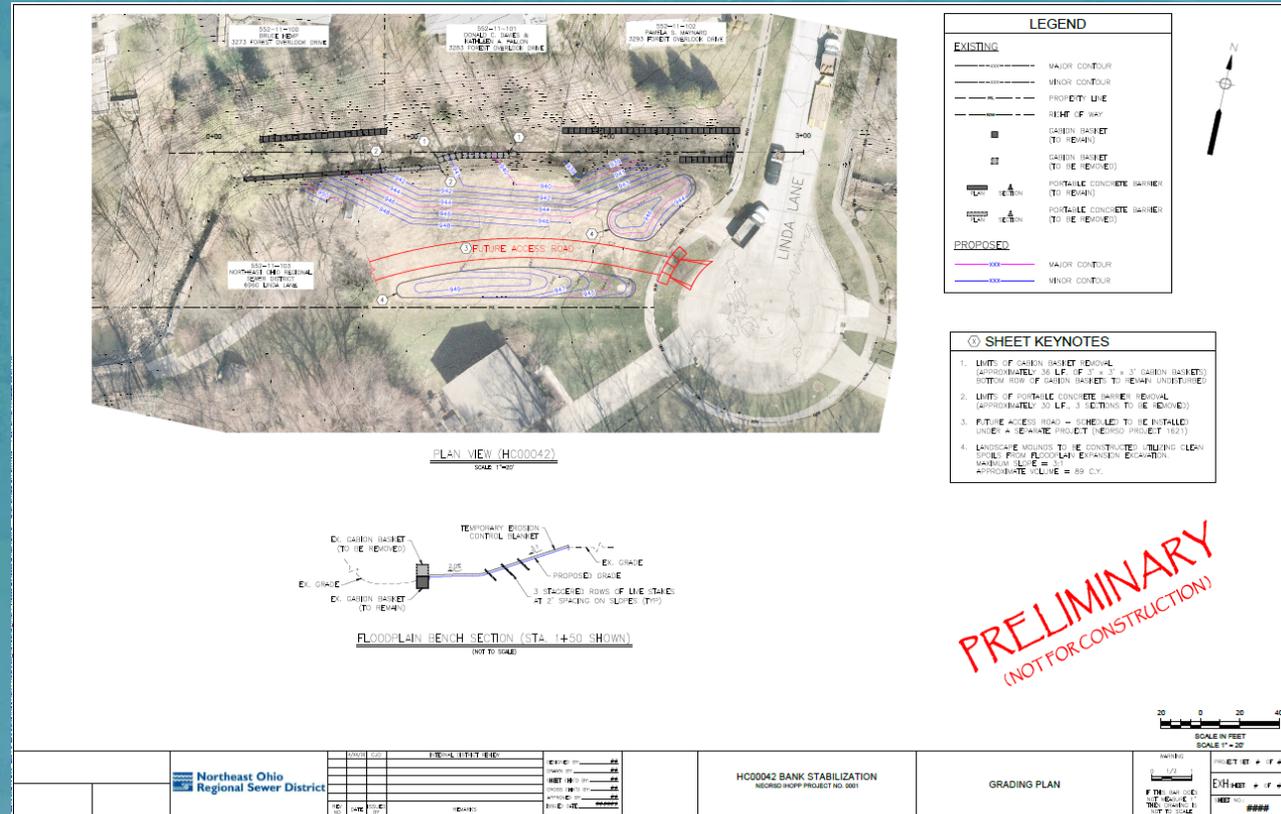
## Hemlock Creek in Seven Hills

- Excavate and grade south bank of stream to increase cross section and create more floodplain area to reduce energy on north eroding bank
- To be constructed 2<sup>nd</sup> Qrt 2021

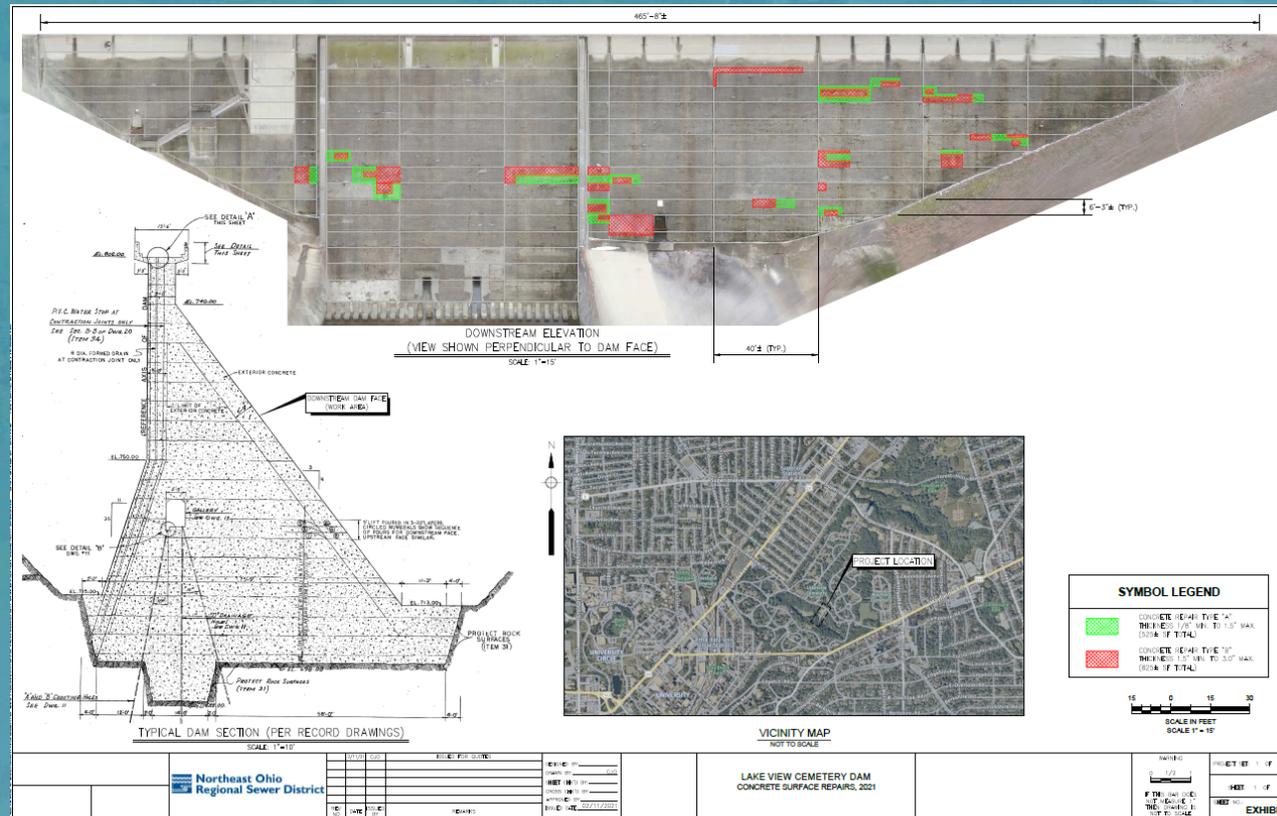
## Lakeview Dam Repairs

- ODNR inspection report maintenance items
- Concrete surface repairs on downstream face of dam
- Air vent modifications
- To be constructed 2021
