Watershed Advisory Committee

Cuyahoga River South

October 17, 2019

REGIONAL
STORMWATER
MANAGEMENT
PROGRAM

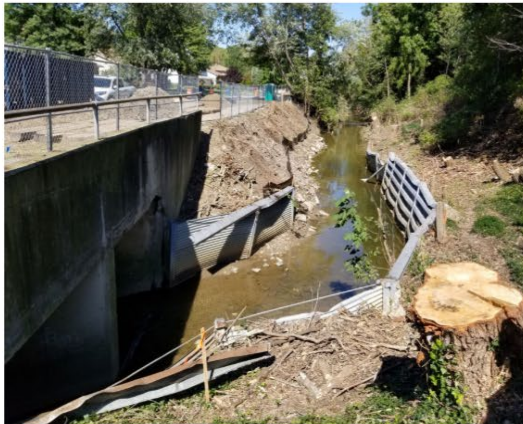
5 Baldwin Creek Bank Stabilization

Community: Parma

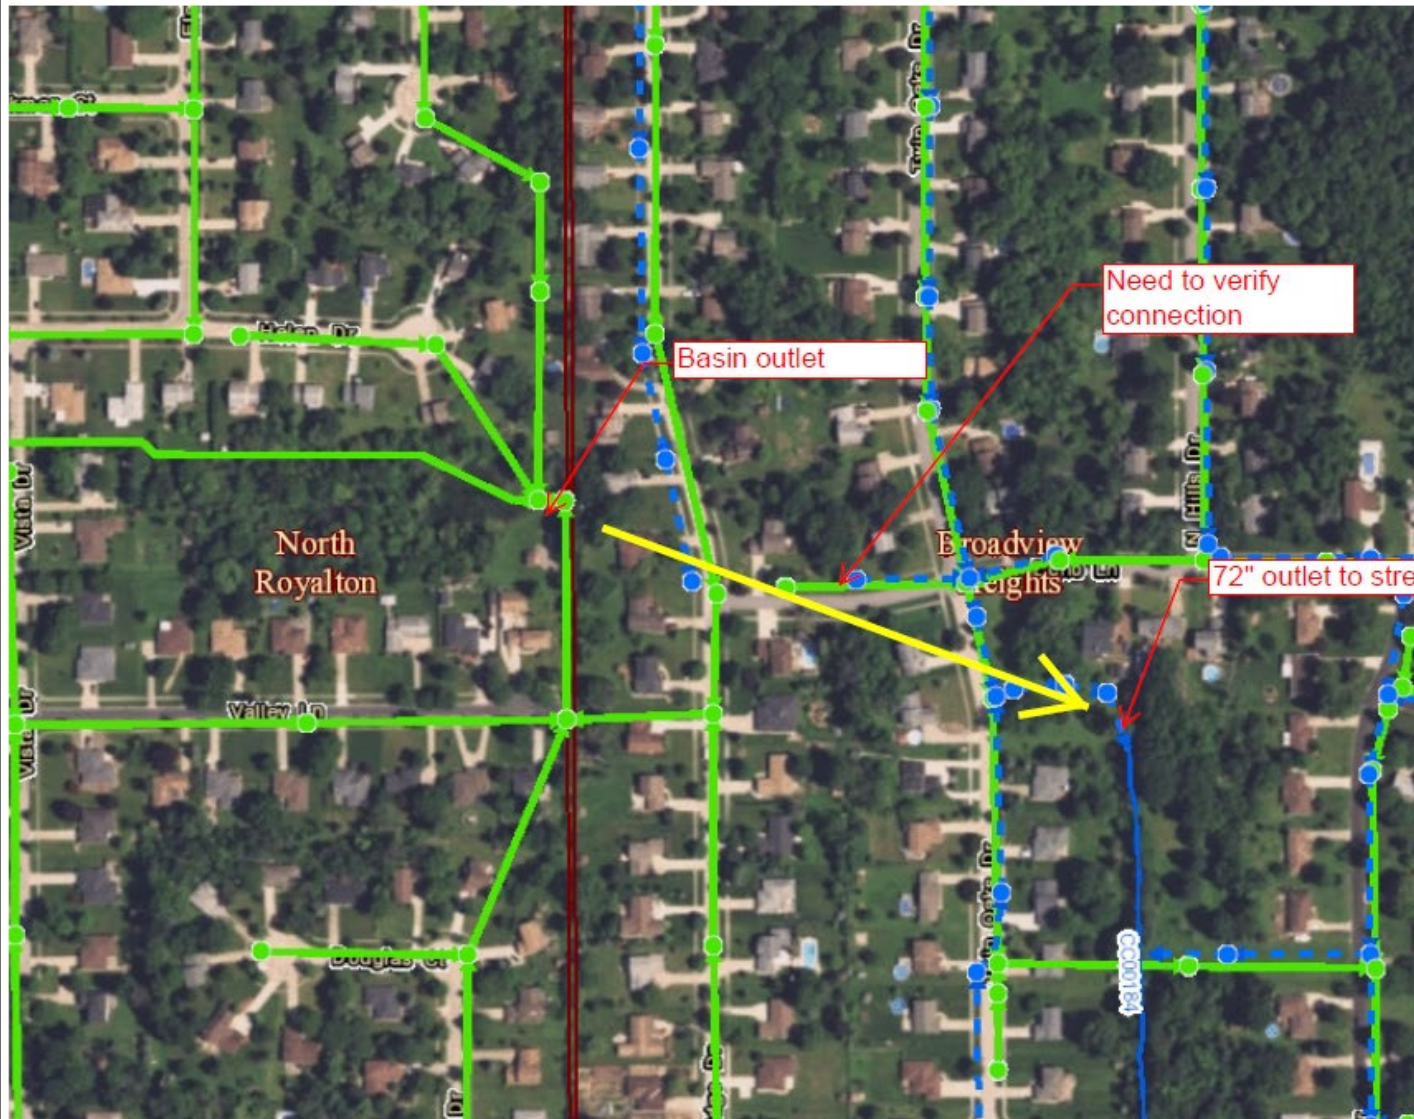
Basin Inspection- Broadview Heights/North Royalton

- CRS SWMP reviewed
 - RSS terminus extension - stream drainage area < 300 acres, but inter-community drainage causing flooding
- Problem Area includes:
 - Stormwater basin
 - Two Culverts through private property
 - Flooding impacts to 8 homes and 4 roads

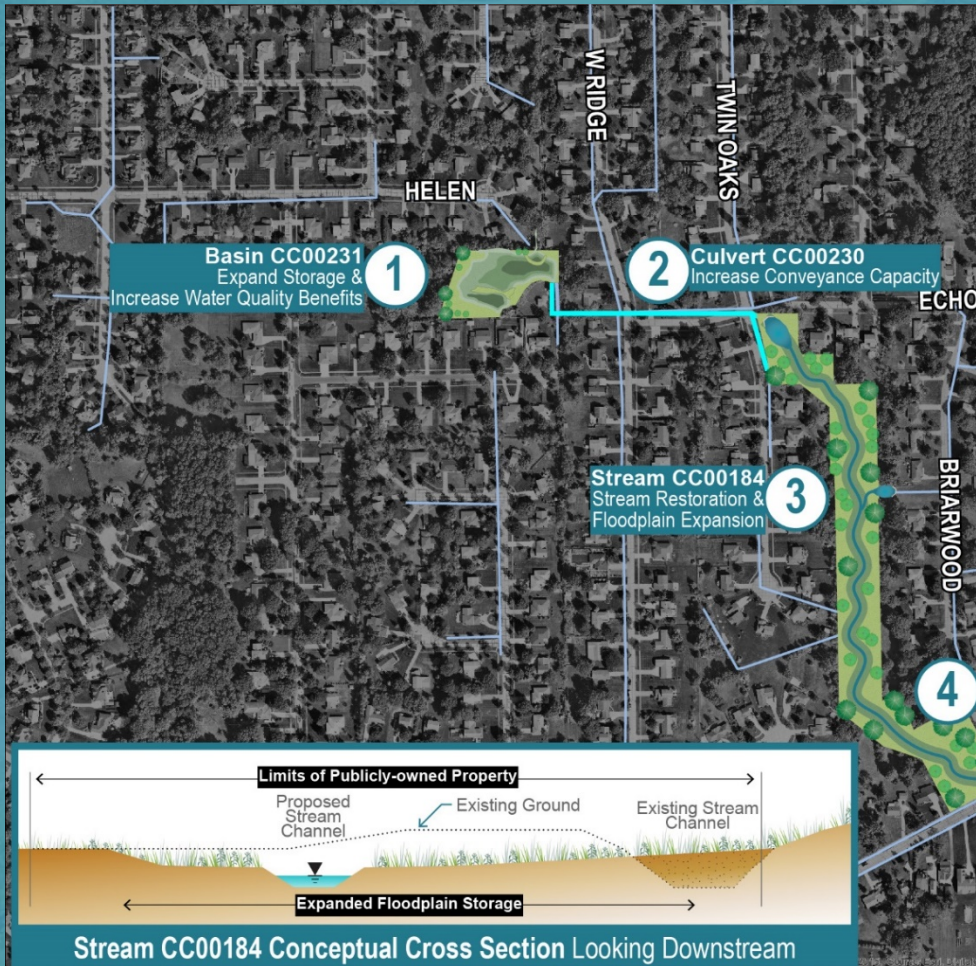
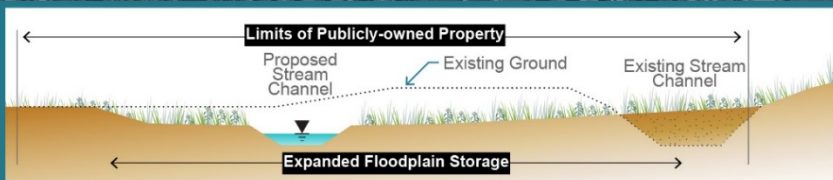
Proposed Project

- A101- Enlarge and deepen the basin
- A102 - 1,200 lf of channel restoration w/connected floodplain
- A103 - Demolish existing culverted stream; create 630 linear feet of channel restoration with connected floodplain

Stream CC00184 Conceptual Cross Section Looking Downstream

- Reduce flood risks to residential structures and roads
- Improve hydrology of basin by maintaining baseflow and regulating storm flow
- Increase channel roughness and sinuosity and reconnect channel to floodplain
- Biological and chemical water quality goals to be determined following collection of baseline data by WQIS

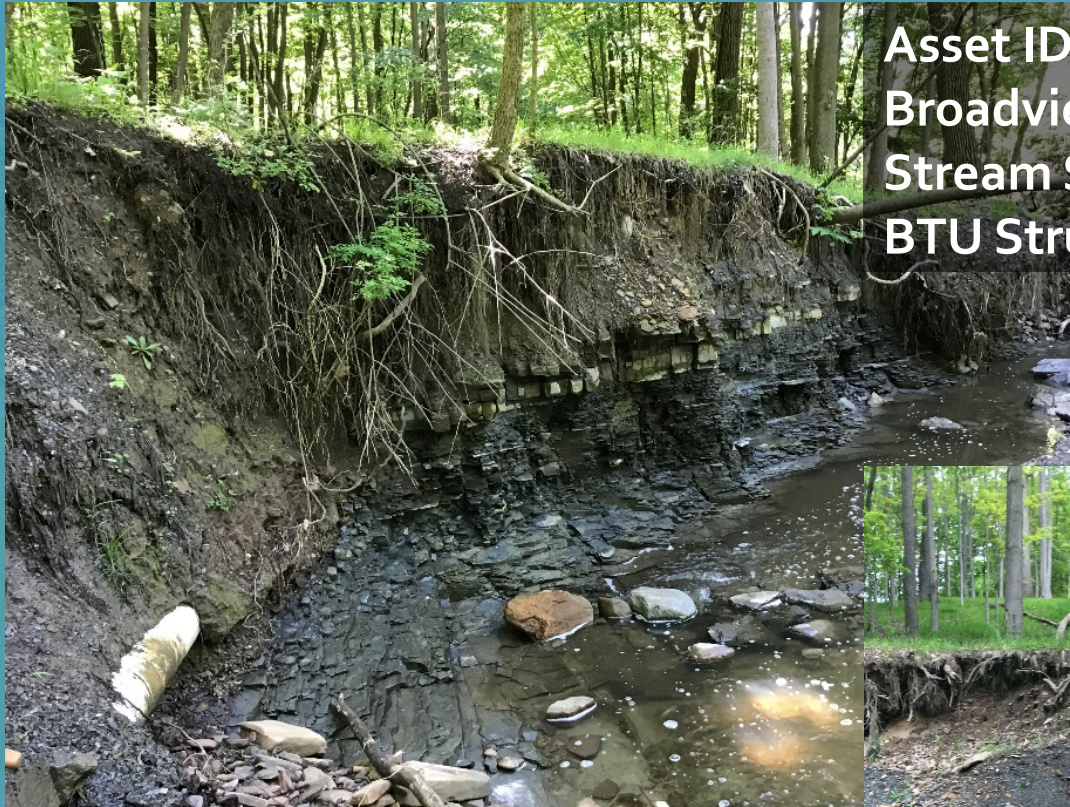
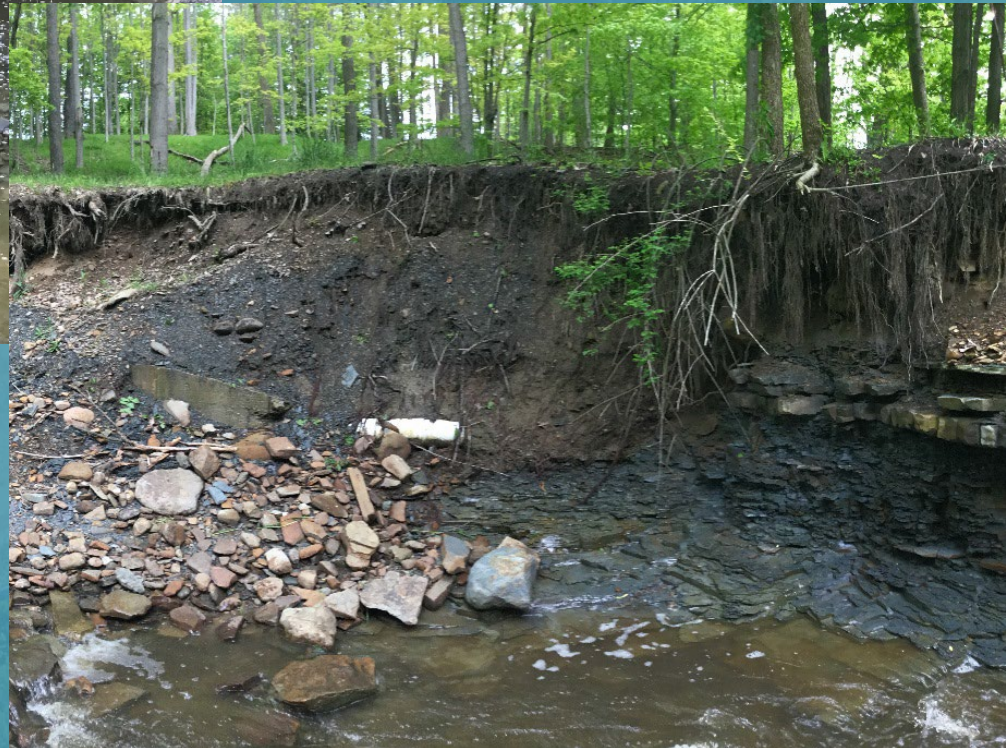
State of the Infrastructure: Stream Cuyahoga River South: Chippewa Creek

Asset ID: CC00084

Broadview Heights: South of Wallings Rd.

Stream Structural BRE=12

BTU Structural BRE=16

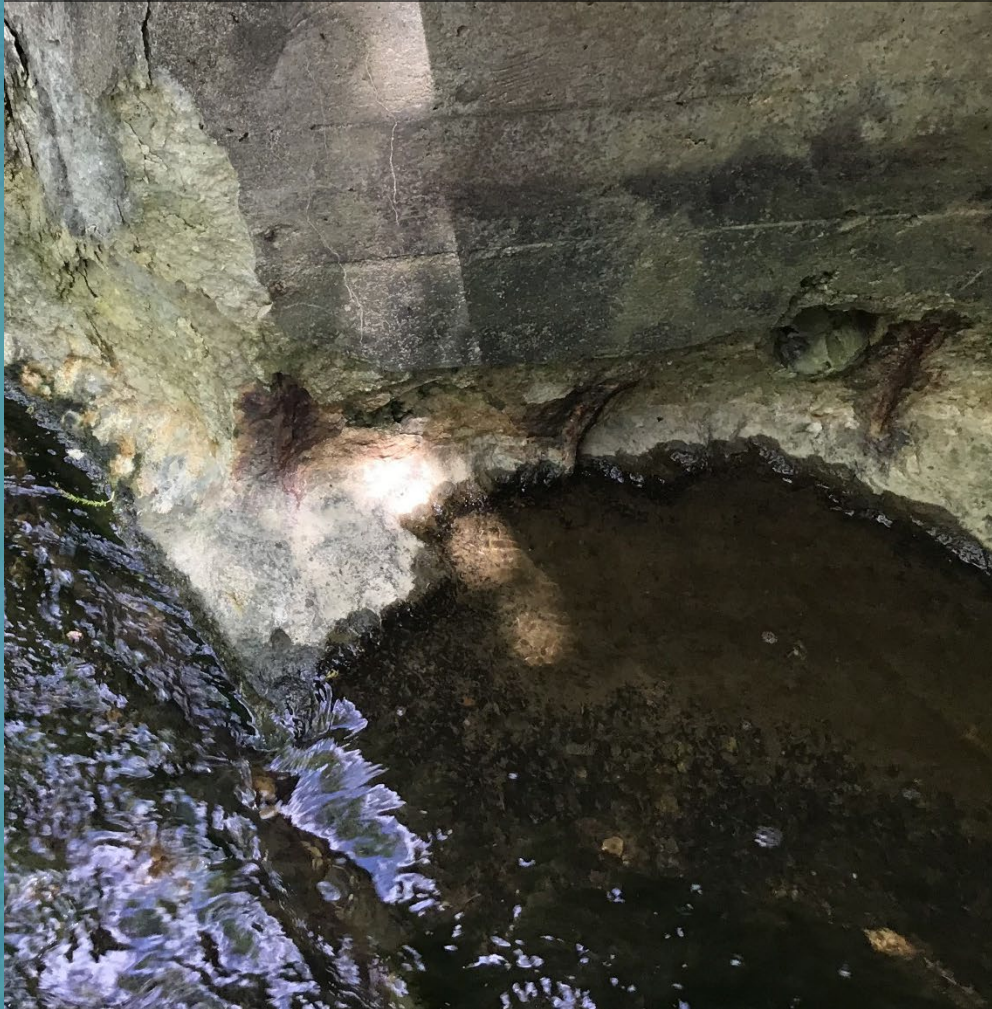
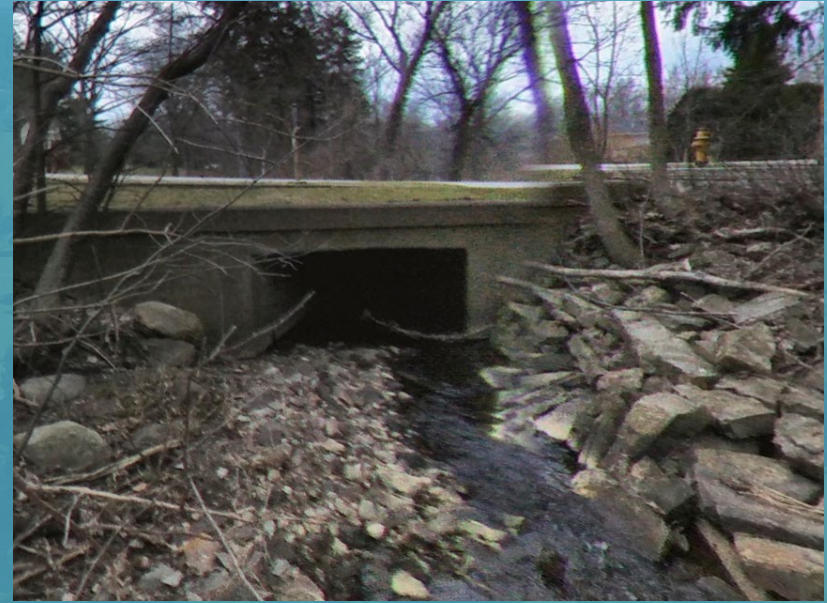
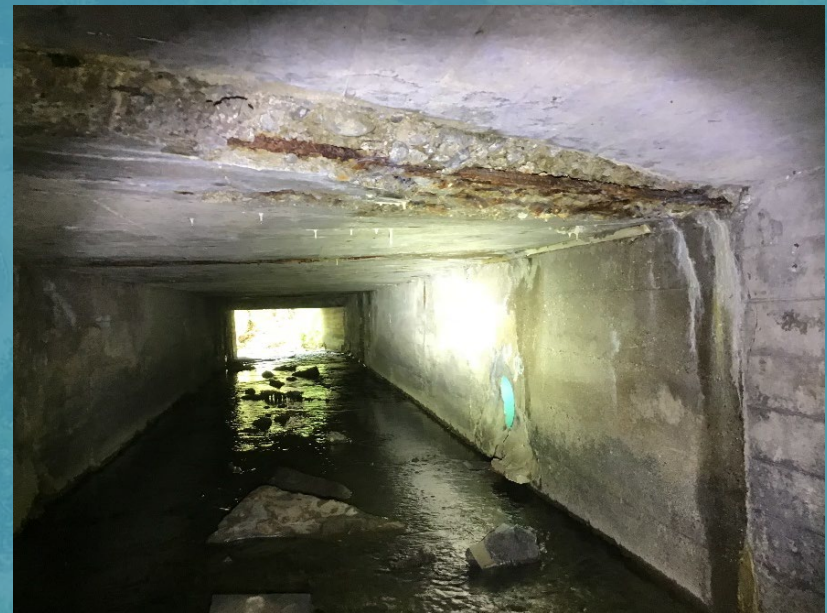
State of the Infrastructure: Crossing Cuyahoga River South: Chippewa Creek

Asset ID: CC00055

Brecksville: Highland Drive

Structural BRE=24

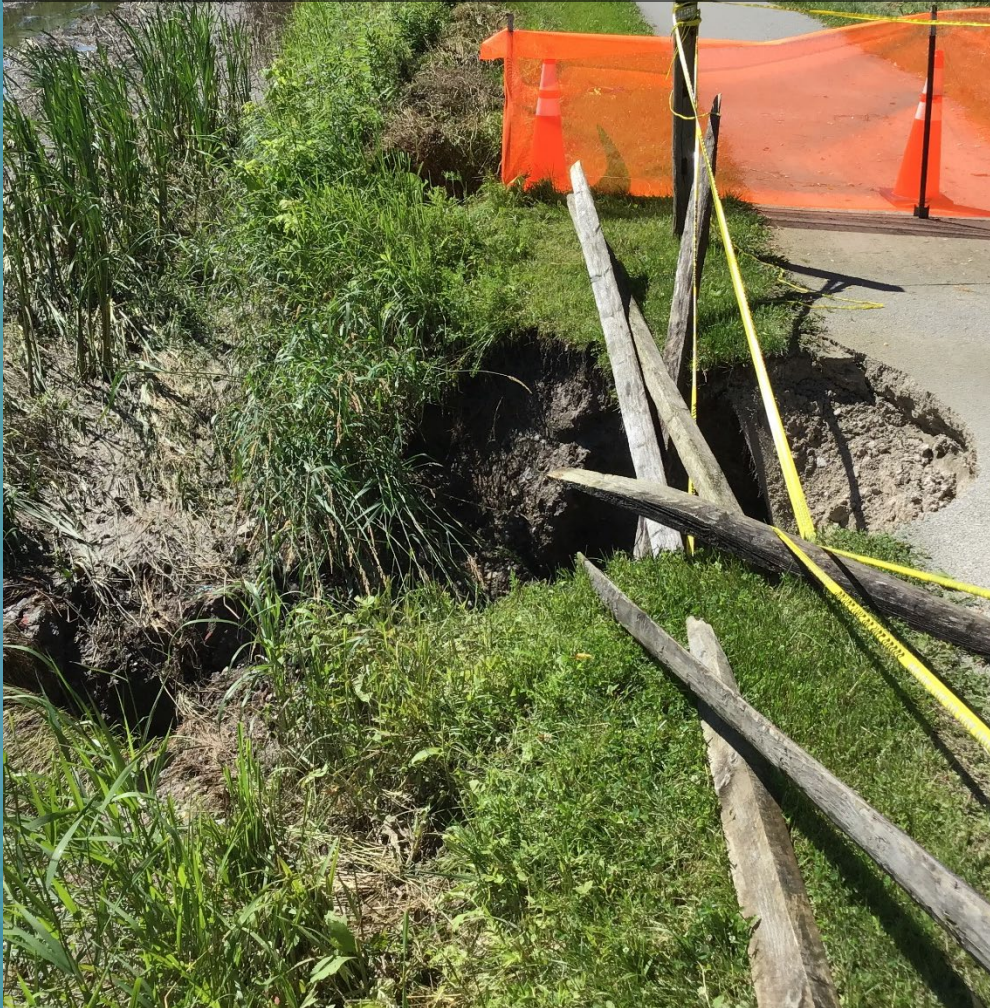
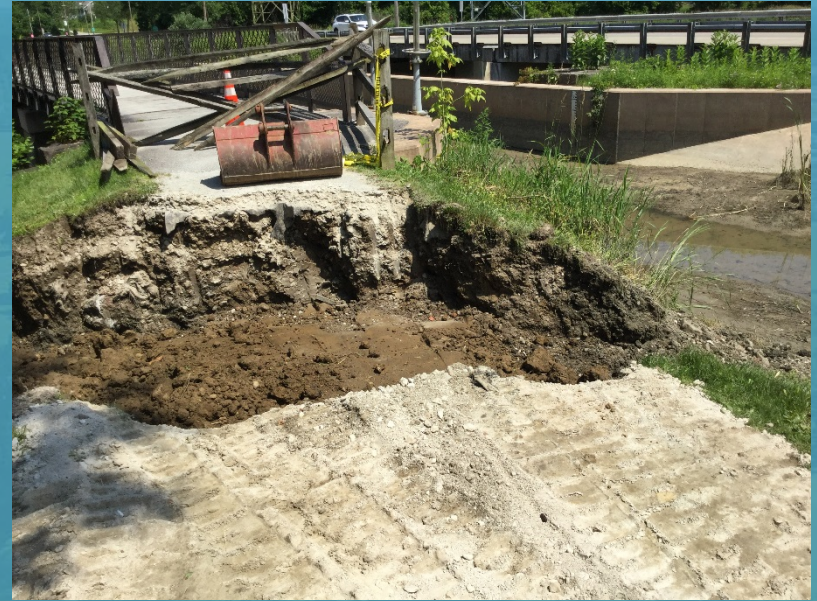
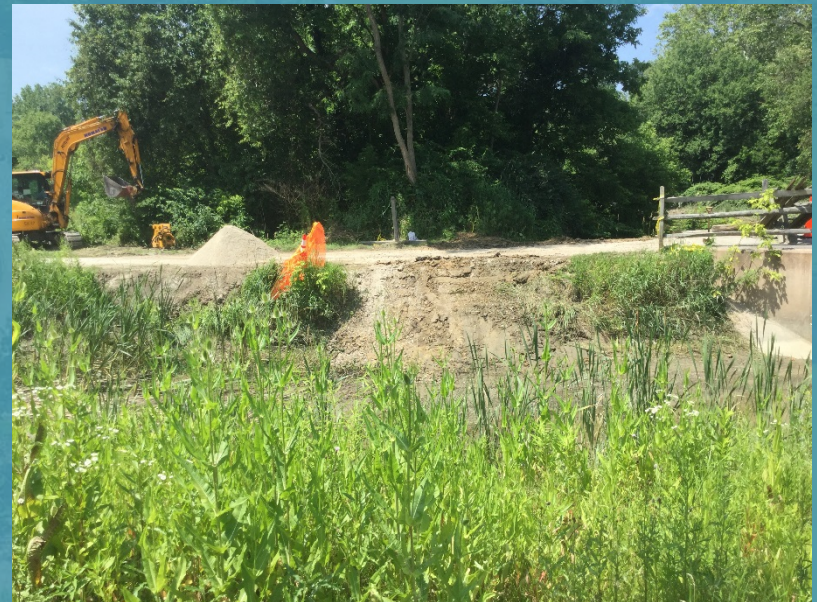
State of the Infrastructure: Maintenance

Ohio & Erie Canal

Asset ID: CE00035

Valley View: Canal Road at Tinkers Creek

Structural BRE= 15

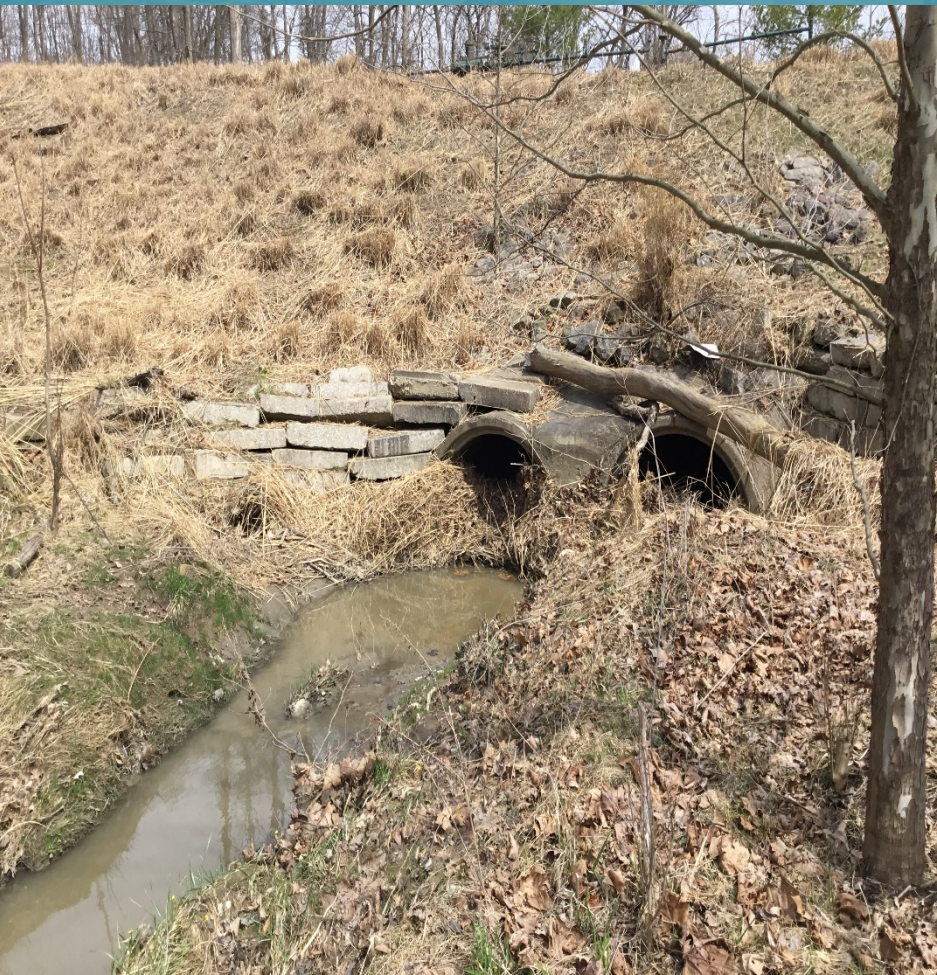
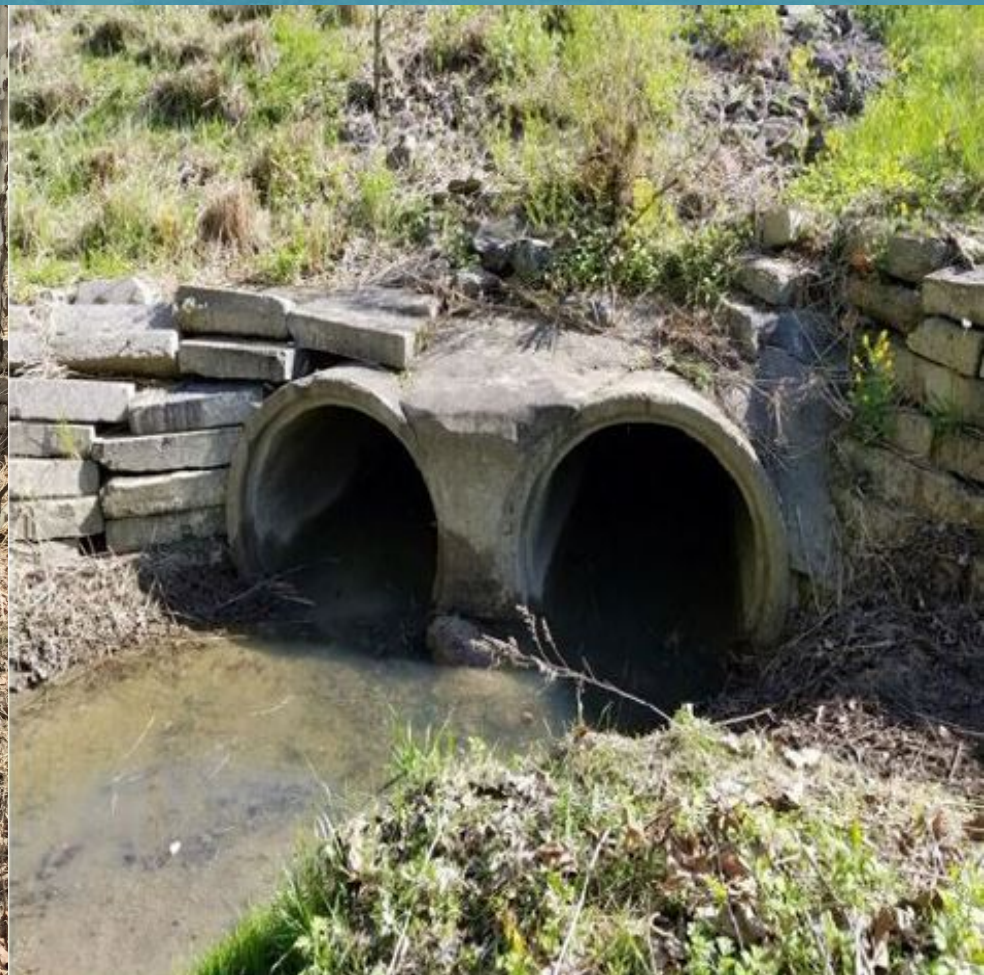
Debris Maintenance: Small Tribs. Southwest Cuyahoga River

Asset #: CW00012

Brecksville: Settlers Passage

Debris BRE=18

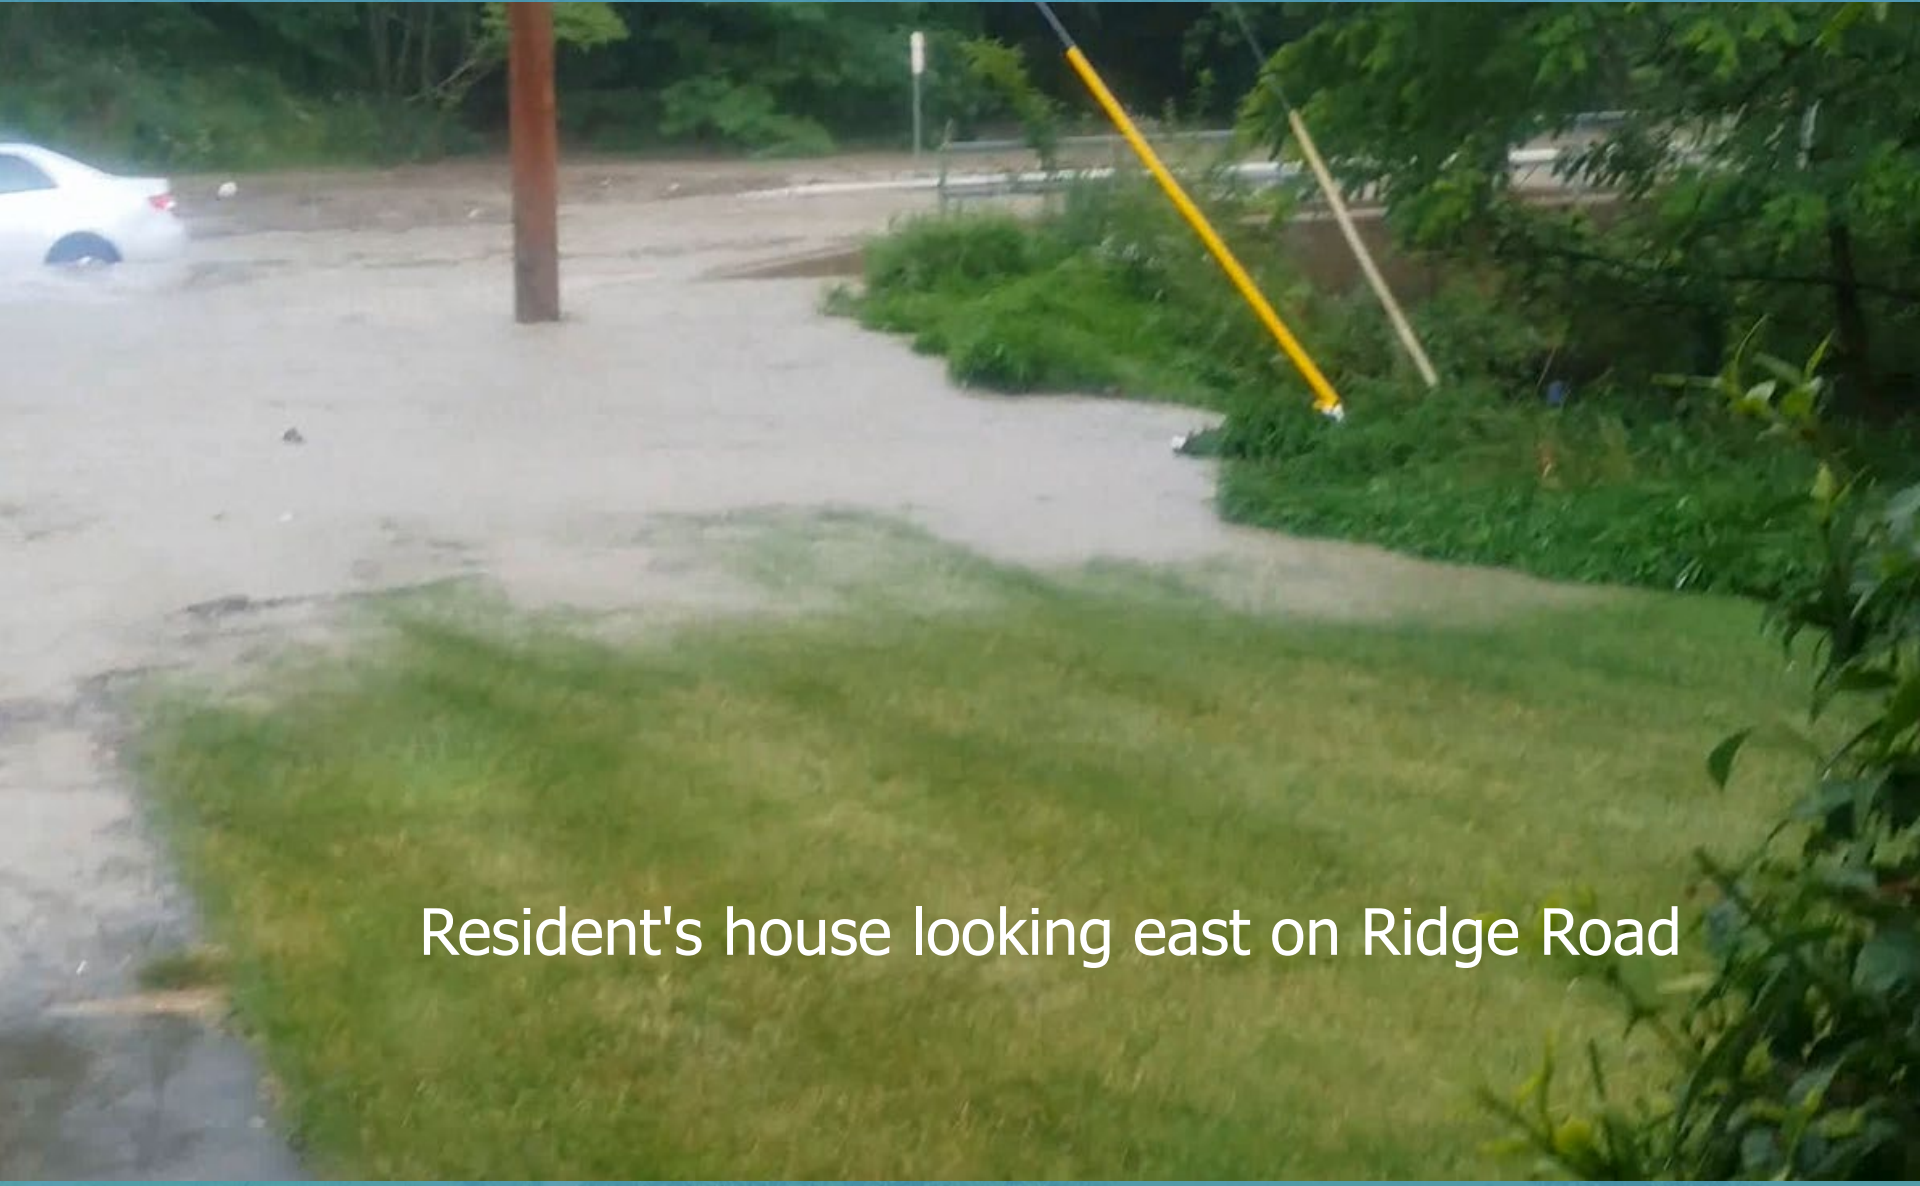
Resident's house looking east on Ridge Road

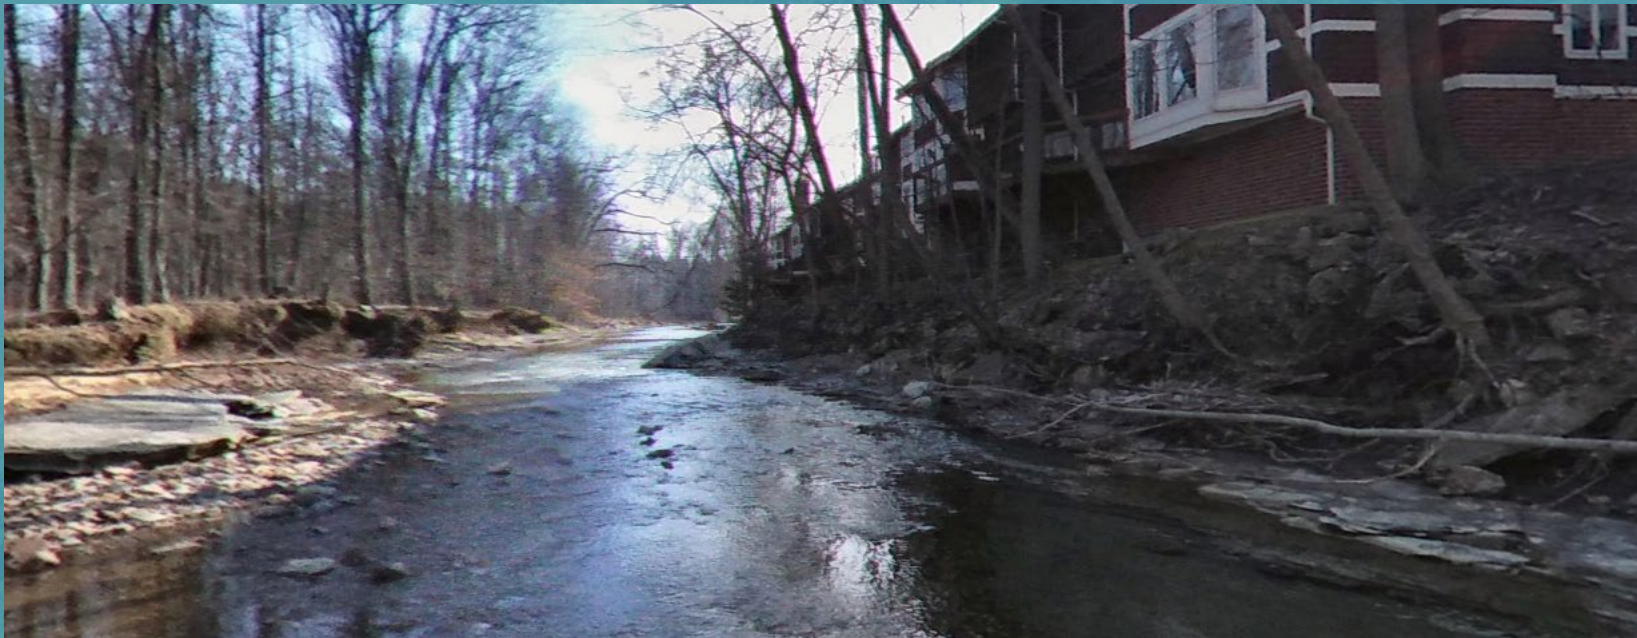
Chippewa Creek – Stabilization near Condominiums

- Arrest bank erosion to protect assets
- Improve stream function
- Expand floodplain on left bank

90% Design

Est. Construction Cost:
\$1,230,000

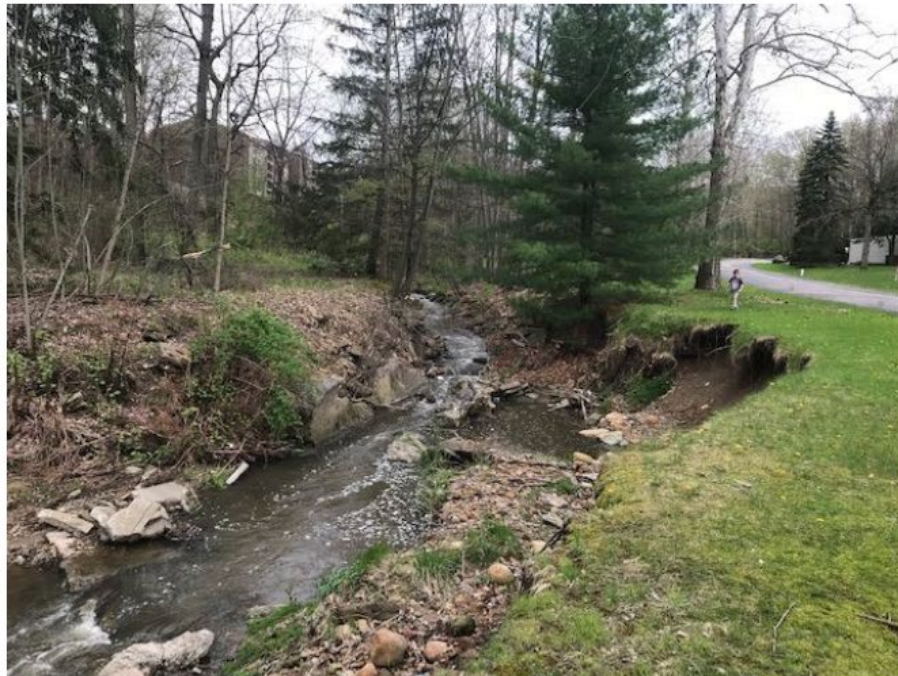
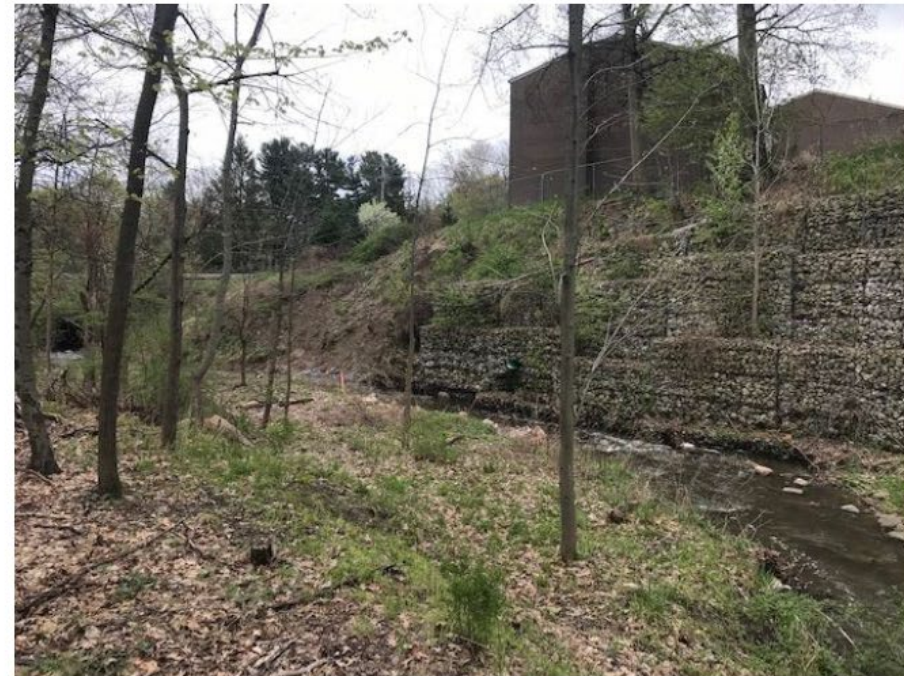
Chippewa Creek – Restoration near Broadview Road

- Stabilize stream banks
- Improve stream function
- Upsize existing crossing
- Protect transportation & utility assets

Current Design Phase:
Pre-Design

Est. Construction
Cost: \$1,162,000

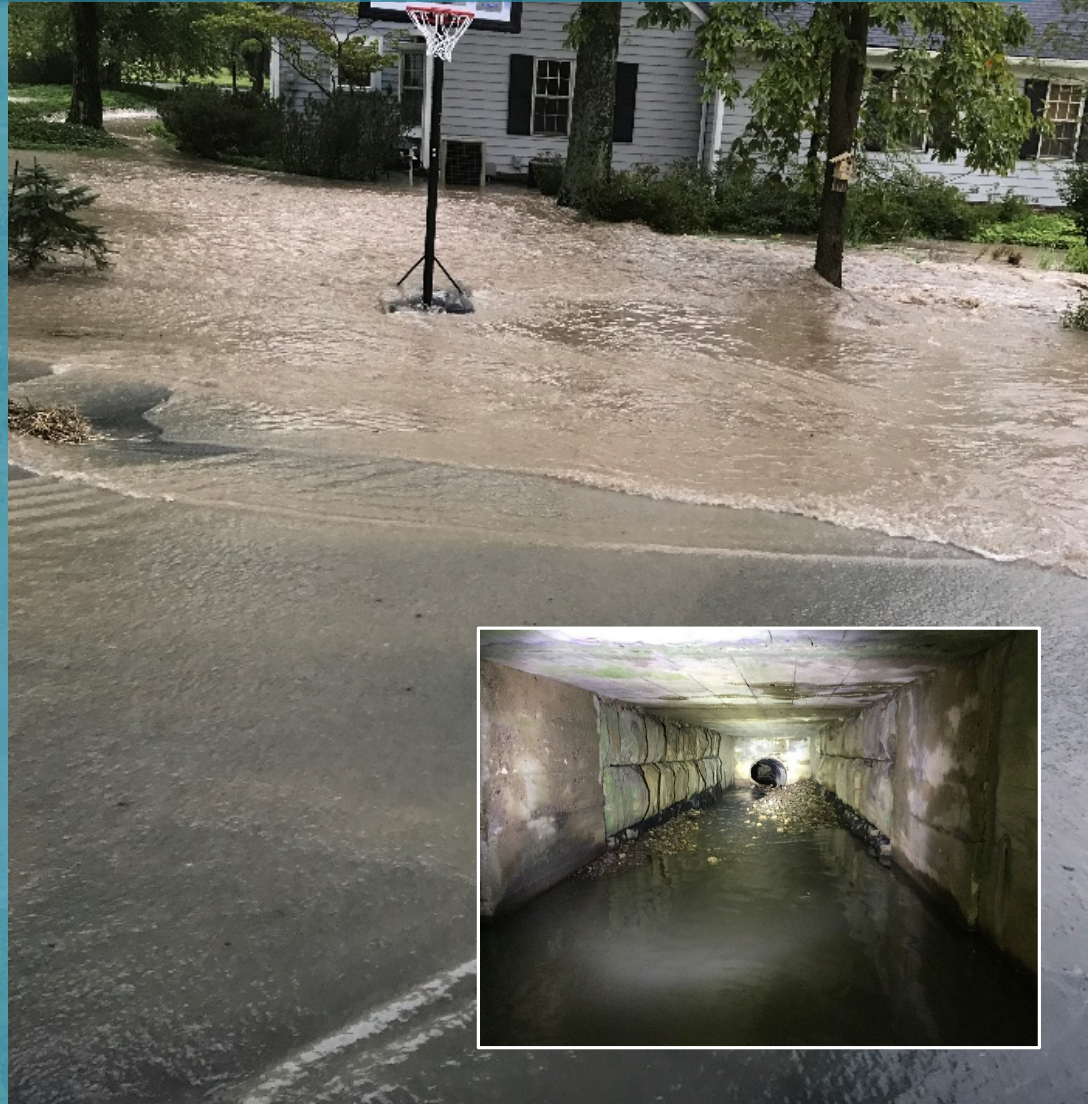
Pepper Luce at Shaker Blvd Culvert Deterioration

- Alleviate flooding of Shaker Blvd and nearby homes
- Improve stream function

Current Design Phase:
Final Design

Total Project Cost: \$750,000

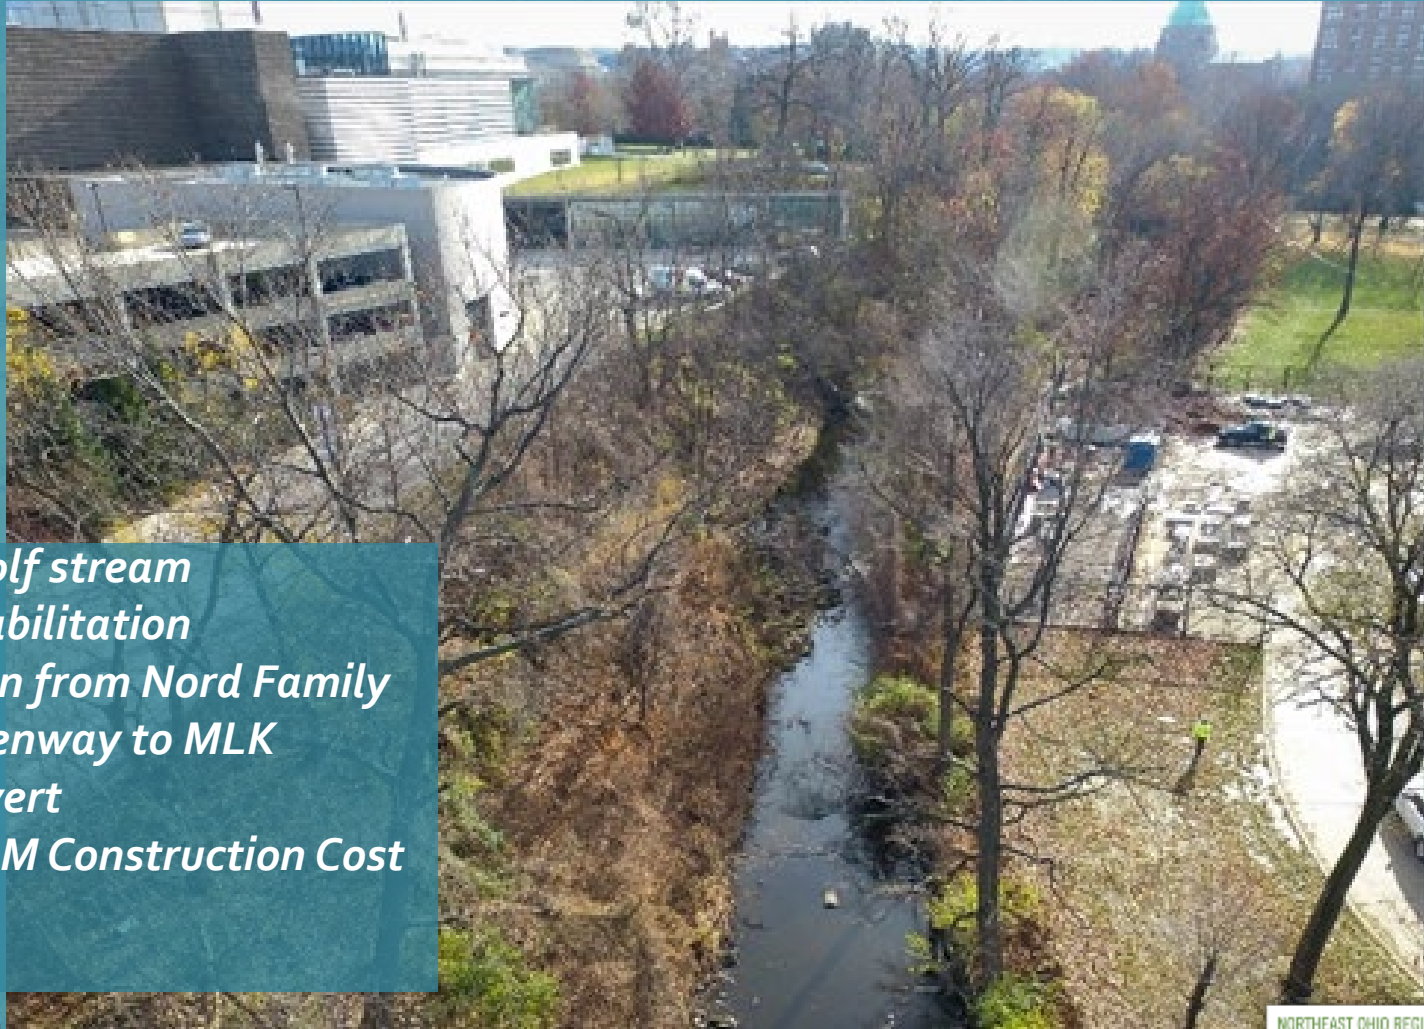
Doan Brook Streambank Stabilization

- *1000lf stream rehabilitation*
- *Tie in from Nord Family Greenway to MLK Culvert*
- *\$2.4M Construction Cost*

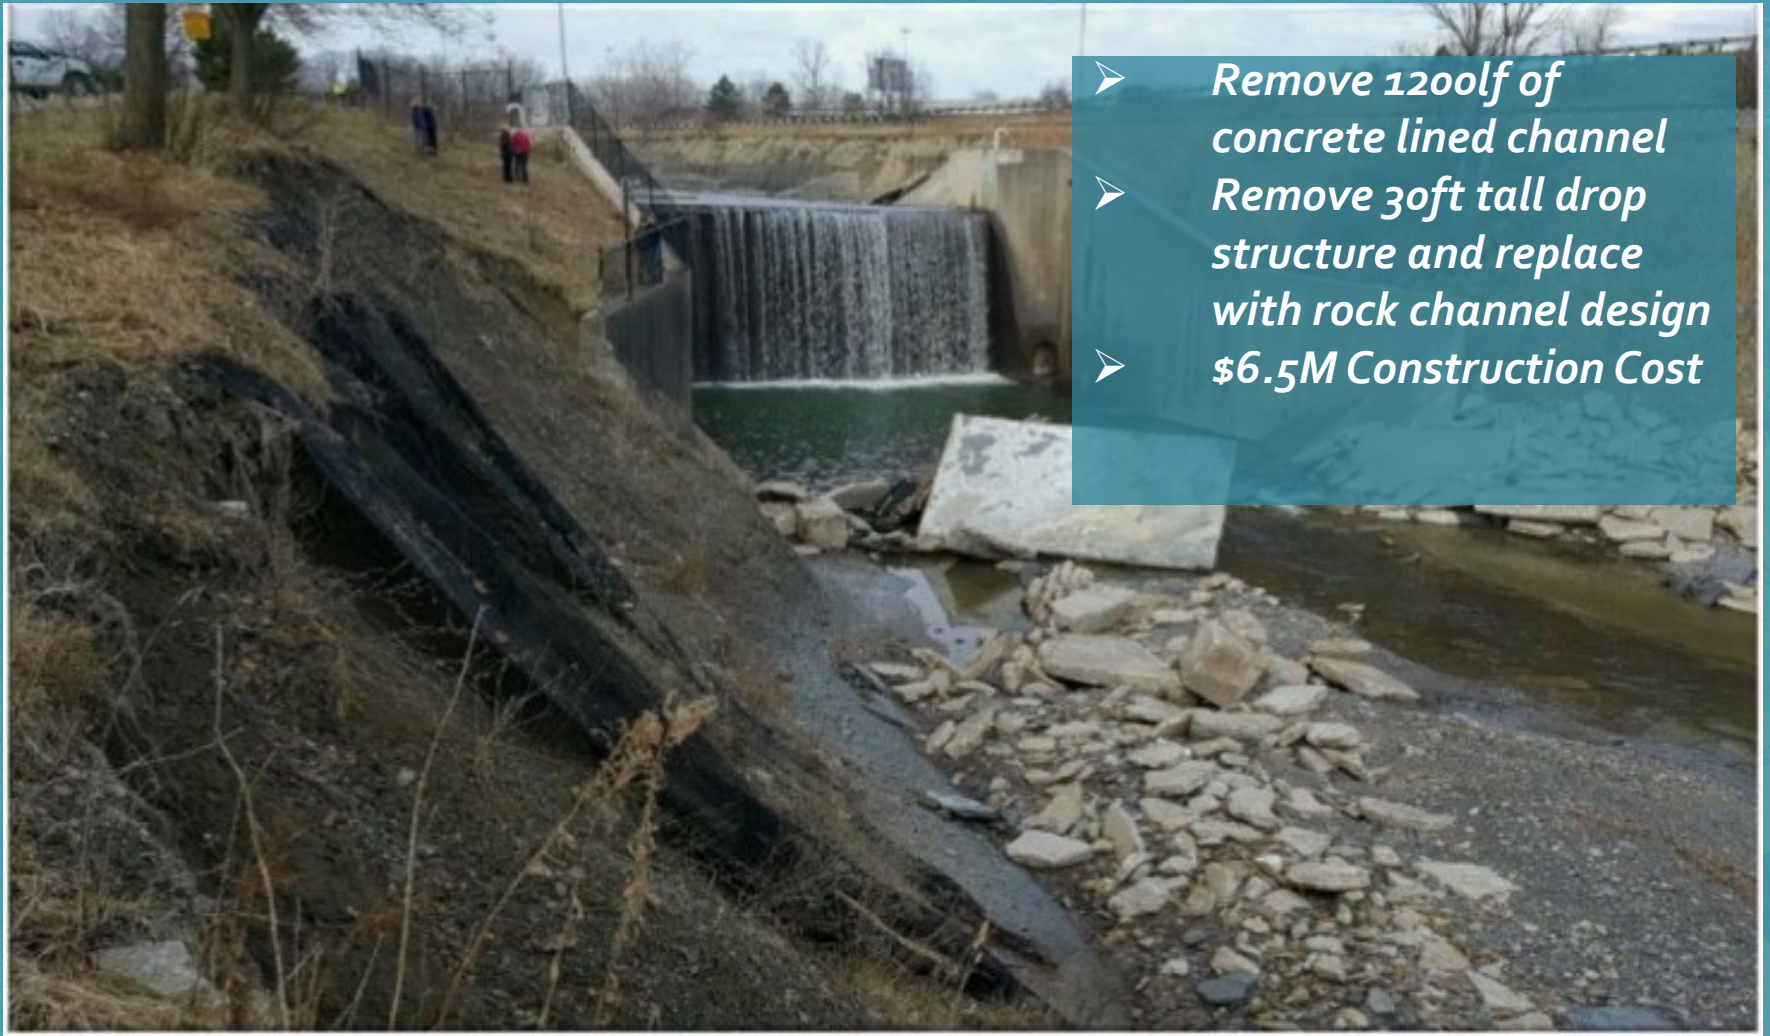
Big Creek Stabilization

When I-71 was constructed in 1966, Big Creek was straightened

- *Remove 1200lf of concrete lined channel*
- *Remove 30ft tall drop structure and replace with rock channel design*
- *\$6.5M Construction Cost*

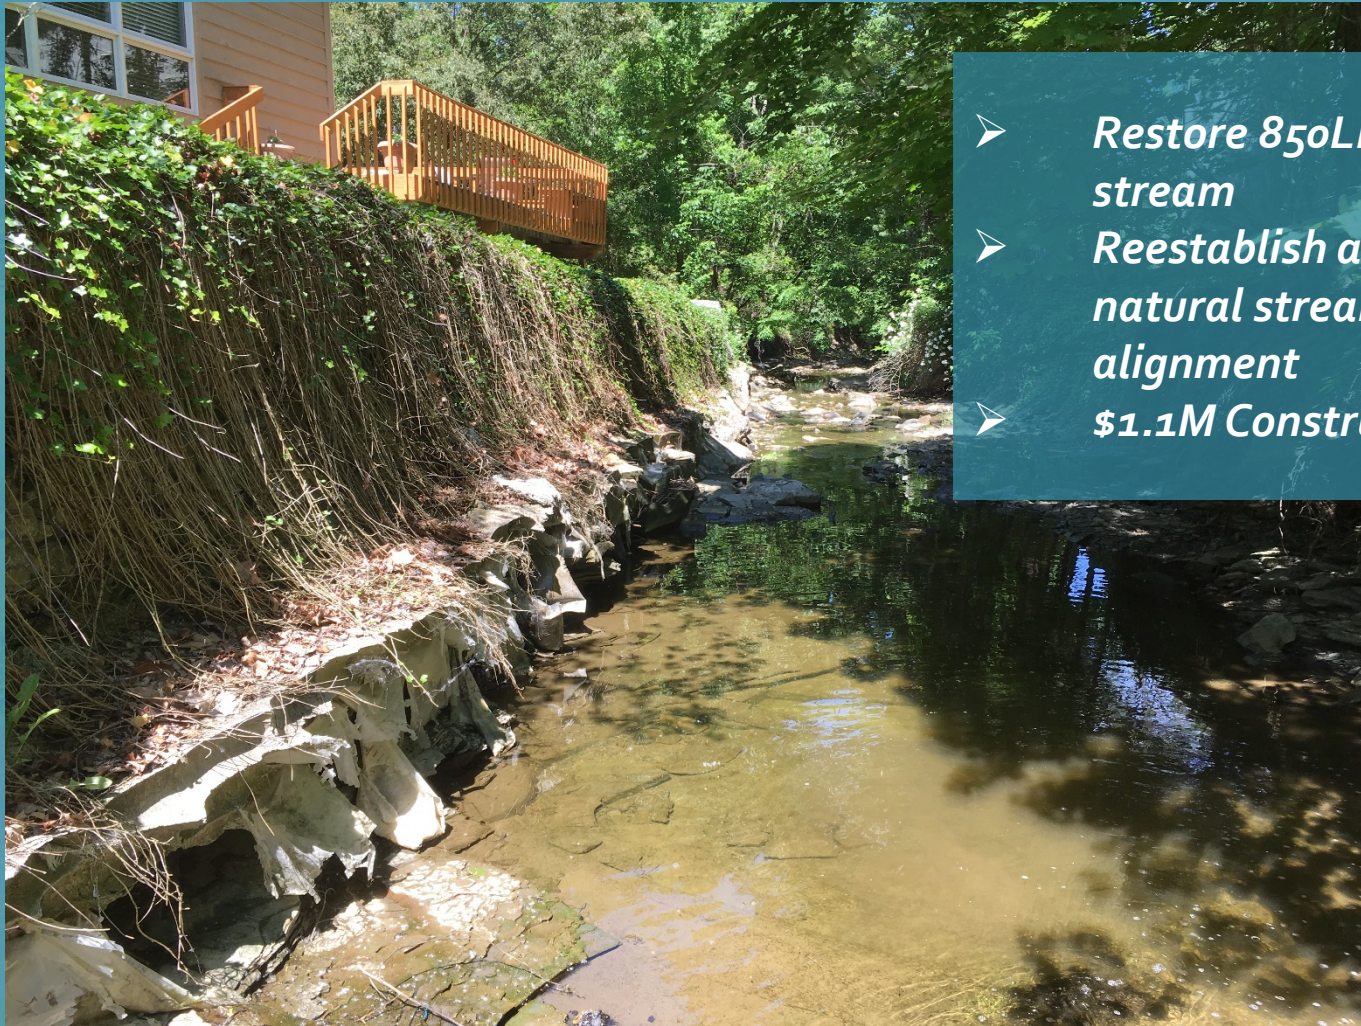
Pepper Creek Bank Stabilization

Severely eroding
stream segment
near Shaker
Blvd.

- *Restore 850LF feet of stream*
- *Reestablish a more natural stream alignment*
- *\$1.1M Construction Cost*
