Watershed Advisory Committee

Cuyahoga River South

October 17, 2019

REGIONAL
STORMWATER
MANAGEMENT
PROGRAM

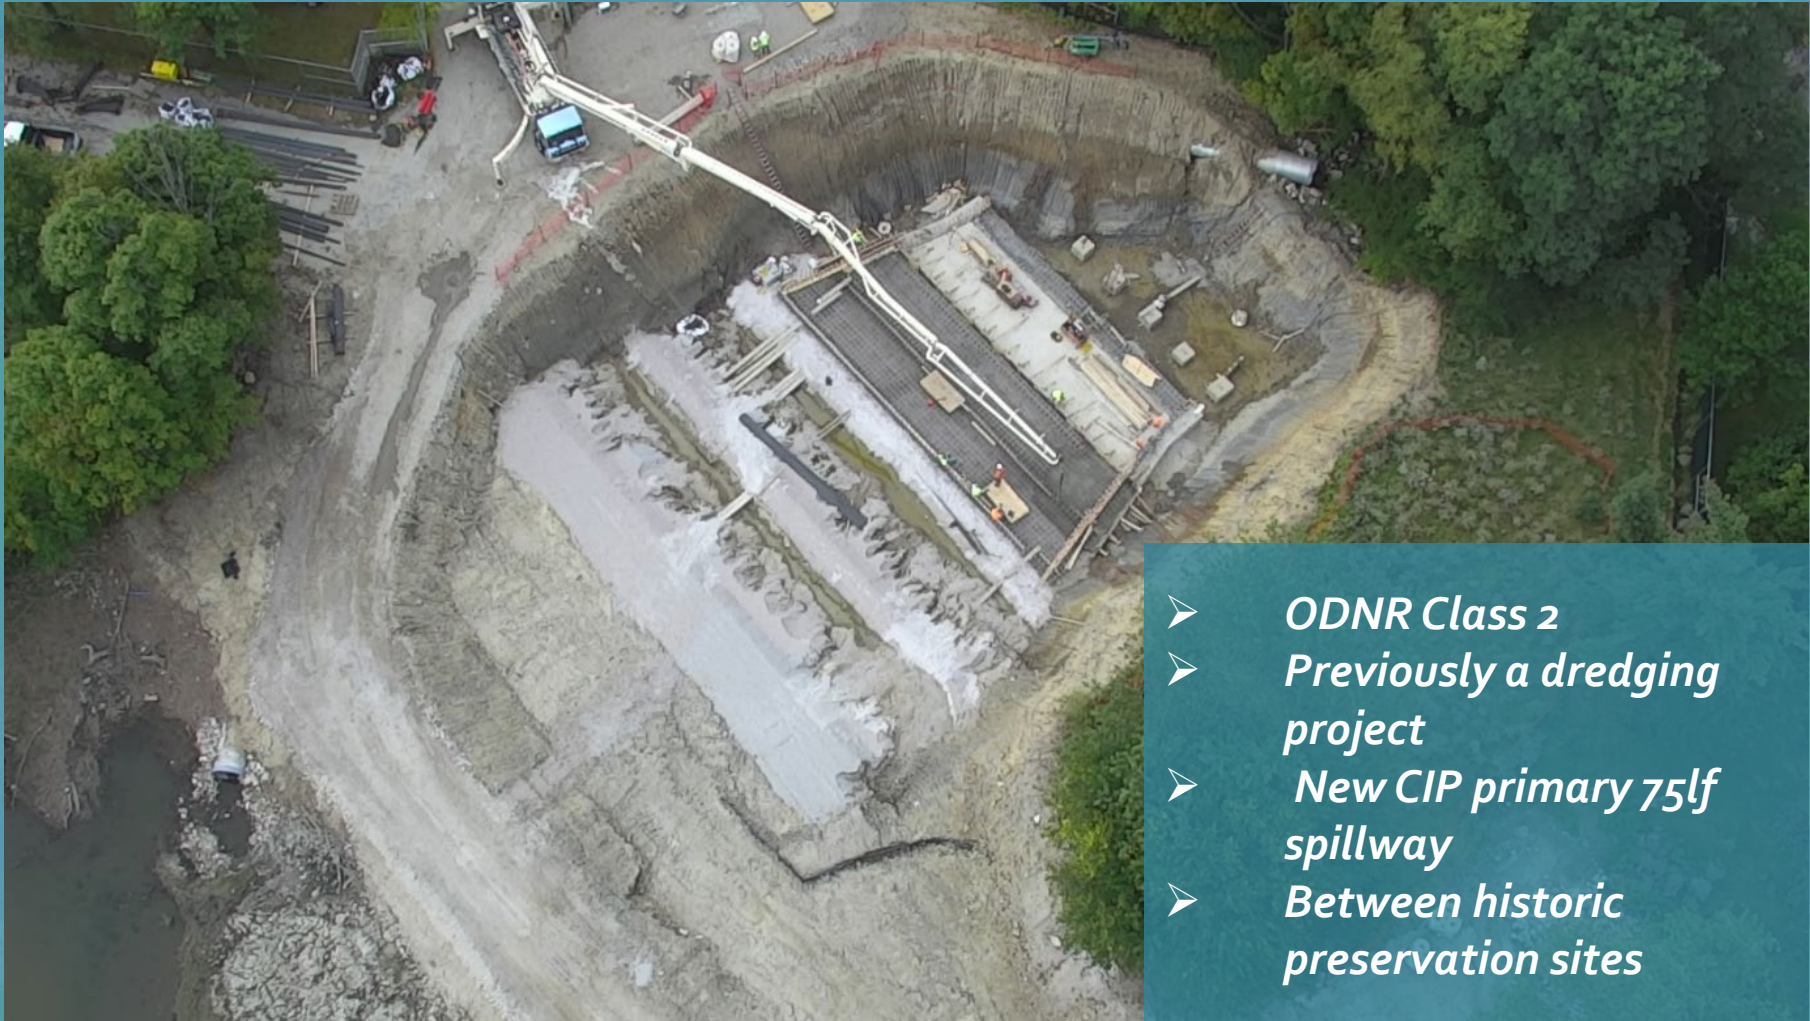
Green Lake Dam Rehabilitation

- *ODNR Class 2*
- *Previously a dredging project*
- *New CIP primary 75lf spillway*
- *Between historic preservation sites*
