Watershed Advisory Committee

Cuyahoga River - South

March 2018

**REGIONAL
STORMWATER
MANAGEMENT
PROGRAM**

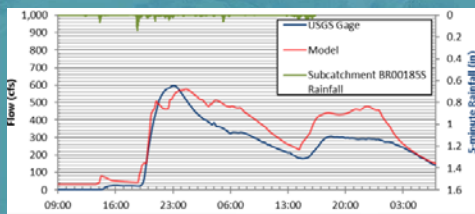
Flow

SW Master Plan Modeling Calibration - Brandywine

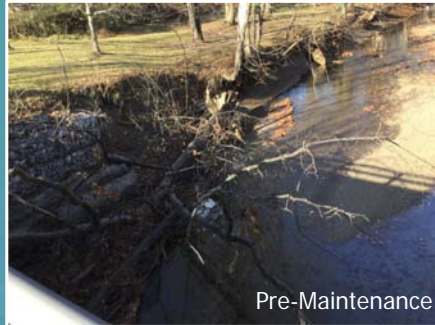
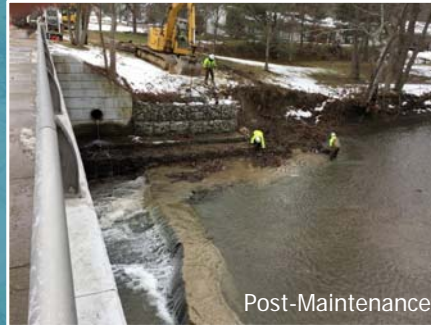
Asset ID: CC00078A

Cuyahoga River South: Chippewa Creek
Brecksville

Maintenance Project: Large Woody Debris Removal (150 CY)

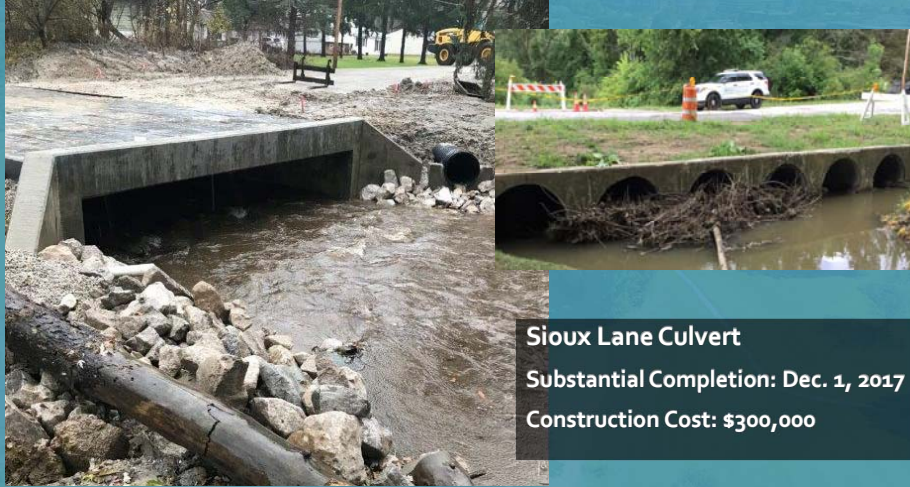
Sioux Lane Culvert
Substantial Completion: Dec. 1, 2017
Construction Cost: \$300,000

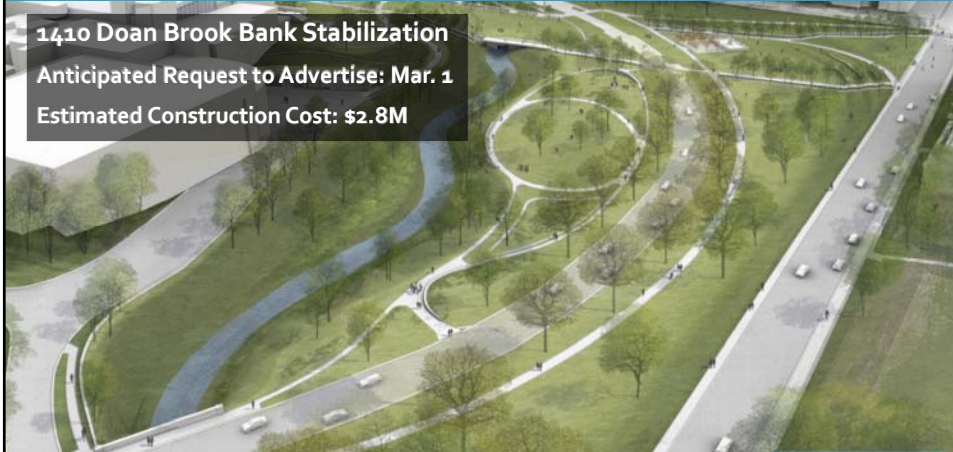
1410 Doan Brook Bank Stabilization
 Anticipated Request to Advertise: Mar. 1
 Estimated Construction Cost: \$2.8M

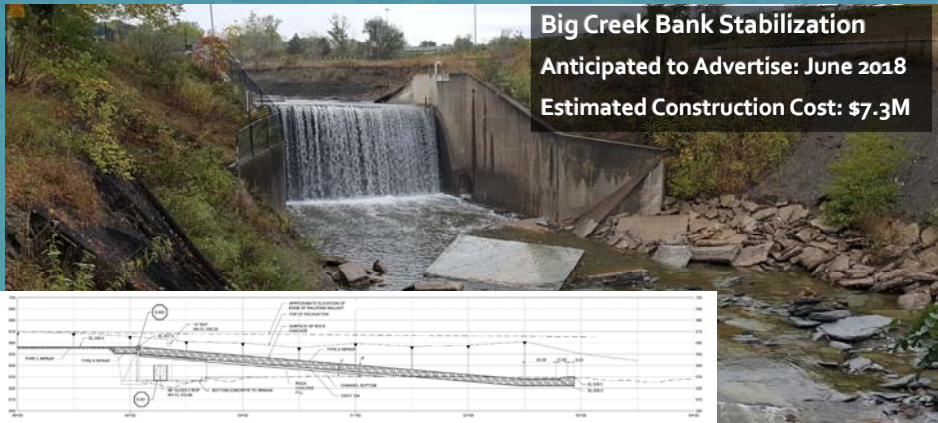
Big Creek Bank Stabilization
 Anticipated to Advertise: June 2018
 Estimated Construction Cost: \$7.3M

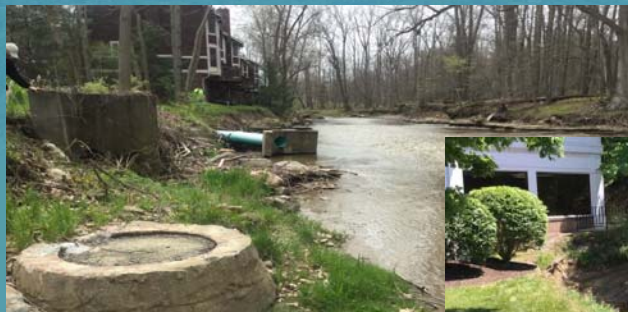
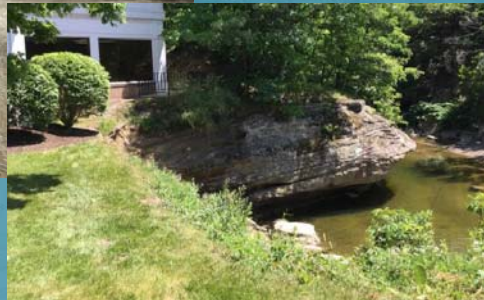
1500 & 1502 Chippewa Creek Bank Stabilizations in Brecksville
Design NTP: Early 2nd Qtr 2018

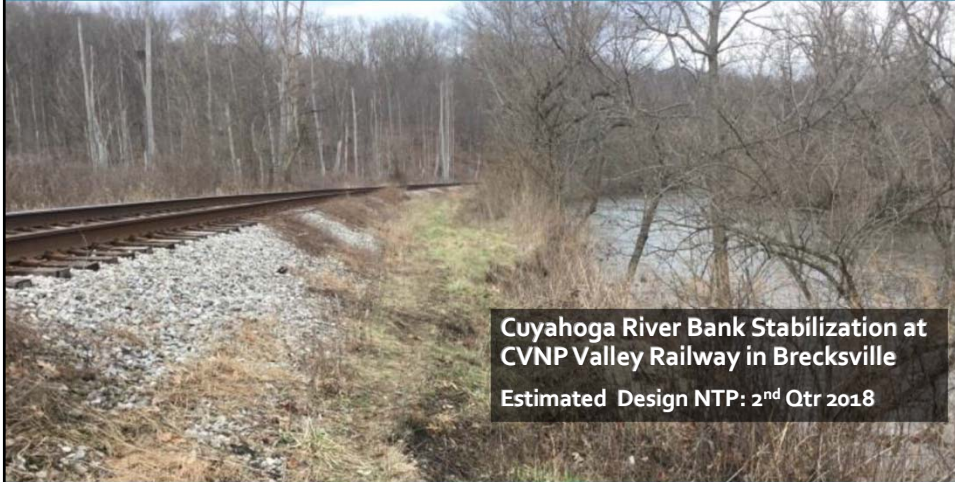
Cuyahoga River Bank Stabilization at
CVNP Valley Railway in Brecksville
Estimated Design NTP: 2nd Qtr 2018
