Watershed Advisory Committee

Cuyahoga River South

October 2018

REGIONAL
STORMWATER
MANAGEMENT
PROGRAM

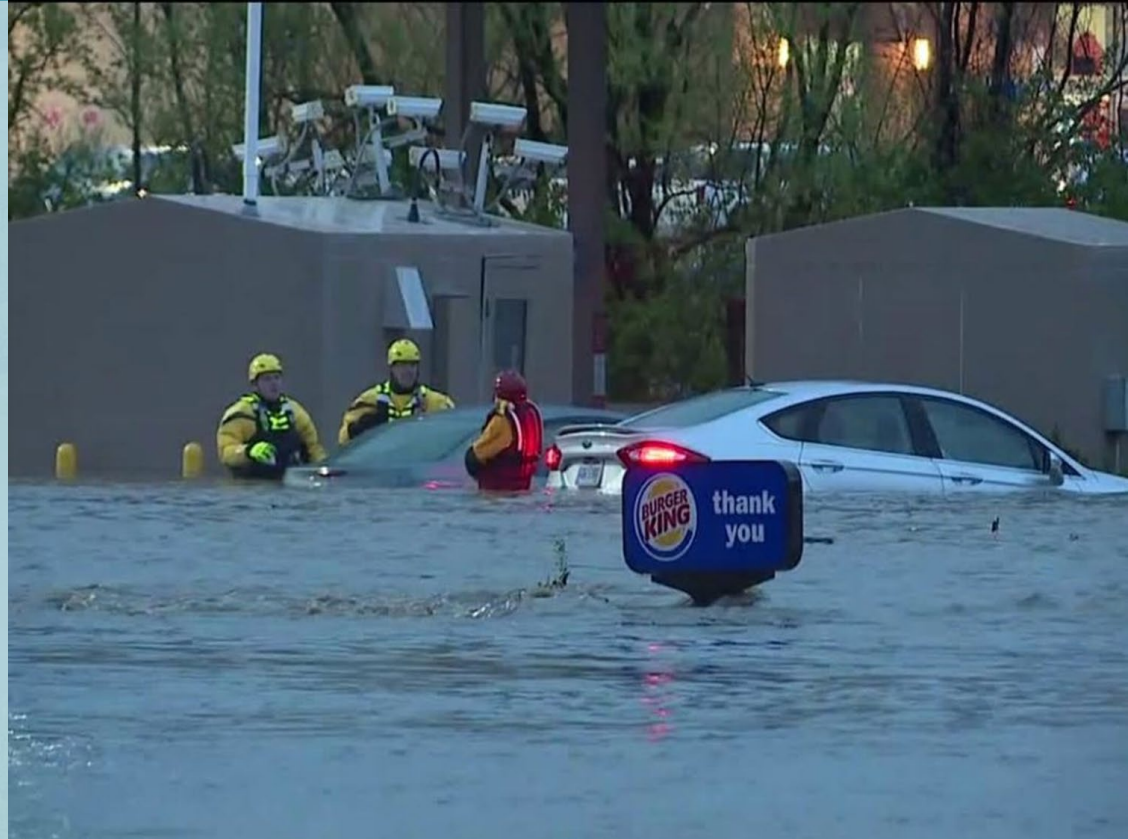
Sam's Club – Brooklyn, Ohio – Big Creek Subwatershed

- Stormwater inundation and impacts to Sam's Club, Brookpark Road & surrounding areas including fueling station
- Brookpark Road overtops around a 1-yr. storm
- Sam's Club parking lot begins to flood between the 2- and 5- yr storms
- Water enters the Sam's Club Building around the 10-yr storm

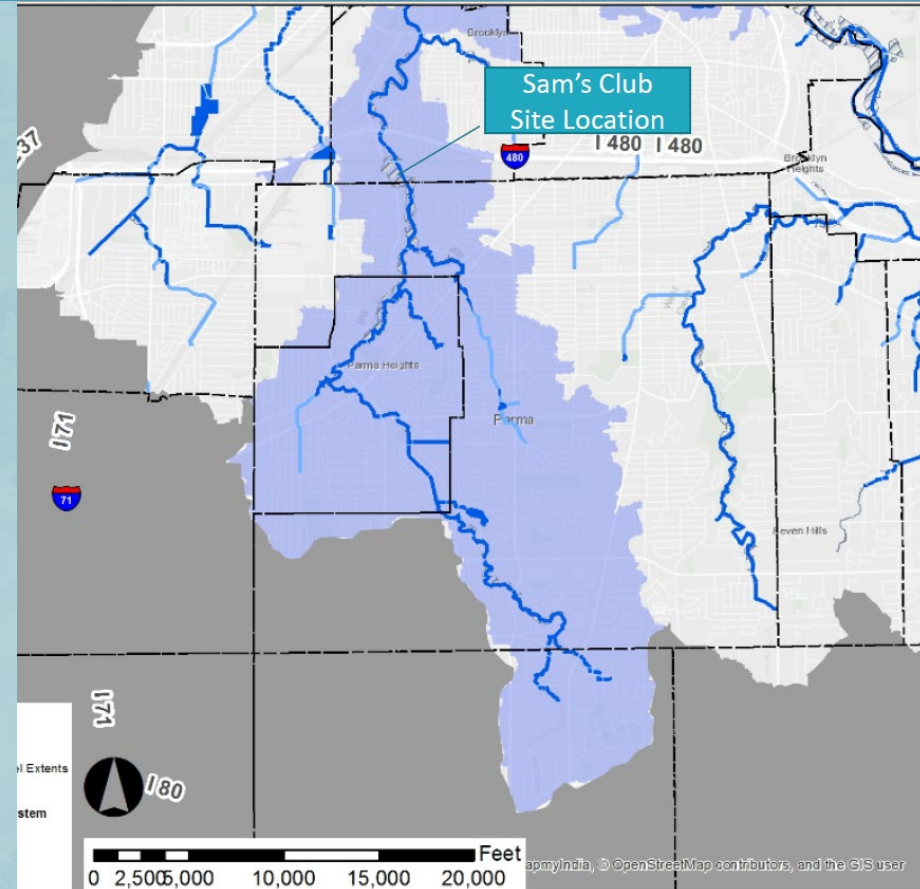
No upstream development at all

- All impervious area (development) removed
- Review 100-yr design storm (CRN SWMP parameter)
- Review depth at Sam's Club entrance
767.3

- Inundation depth 1 ft above Sam's Club entrance elevation

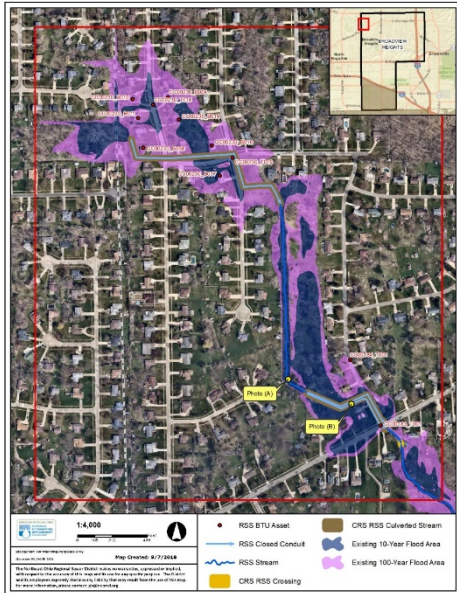
(A) View of open stream segment CC00184 taken facing downstream

(B) Culverted stream CC00183 at inlet facing downstream

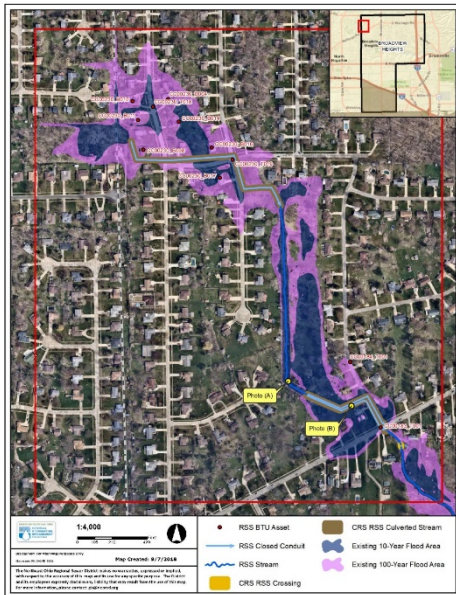
(A) View of open stream segment CC00184 taken facing downstream

(B) Culverted stream CC00183 at inlet facing downstream

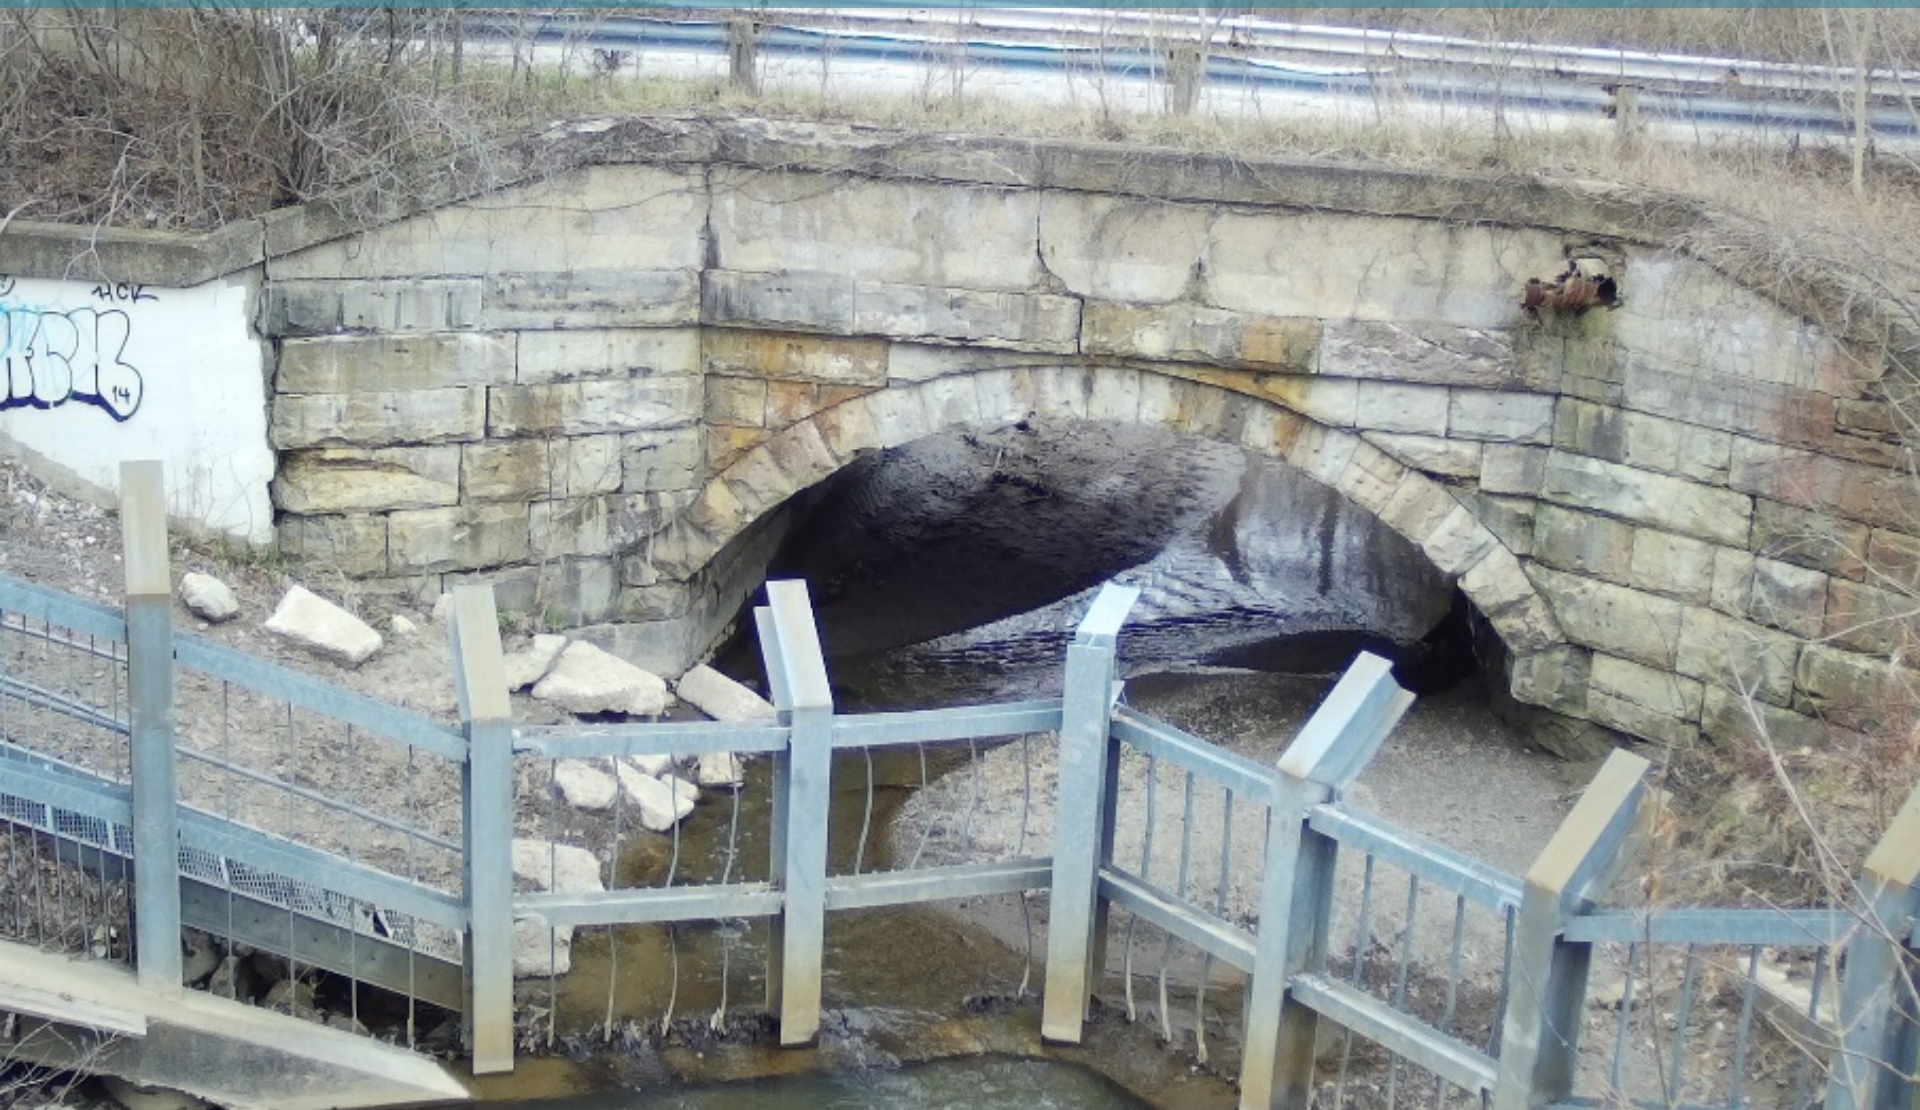
April 14, 2018: Debris Rack is Clear Before the Storm Event

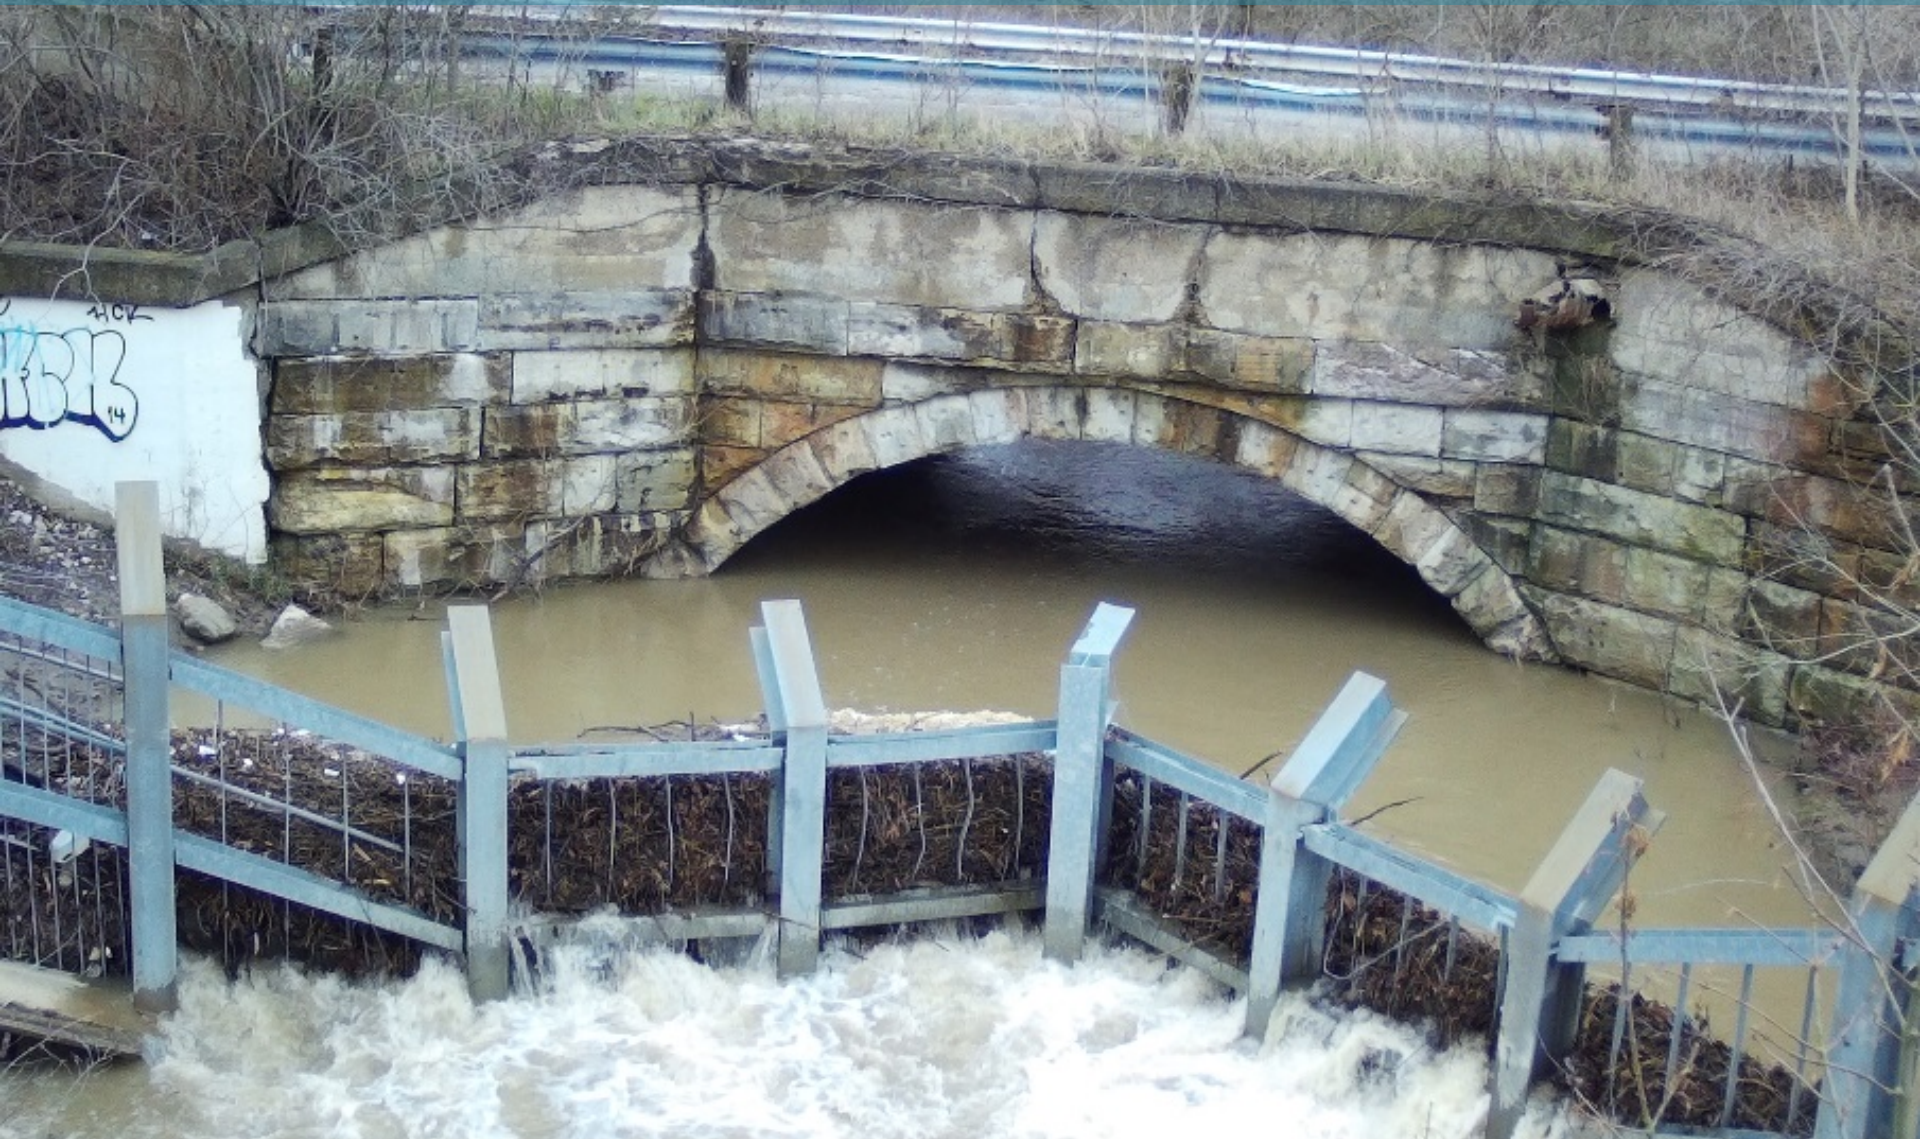
April 16, 2018: Peak Storm and Debris Accumulated on Rack

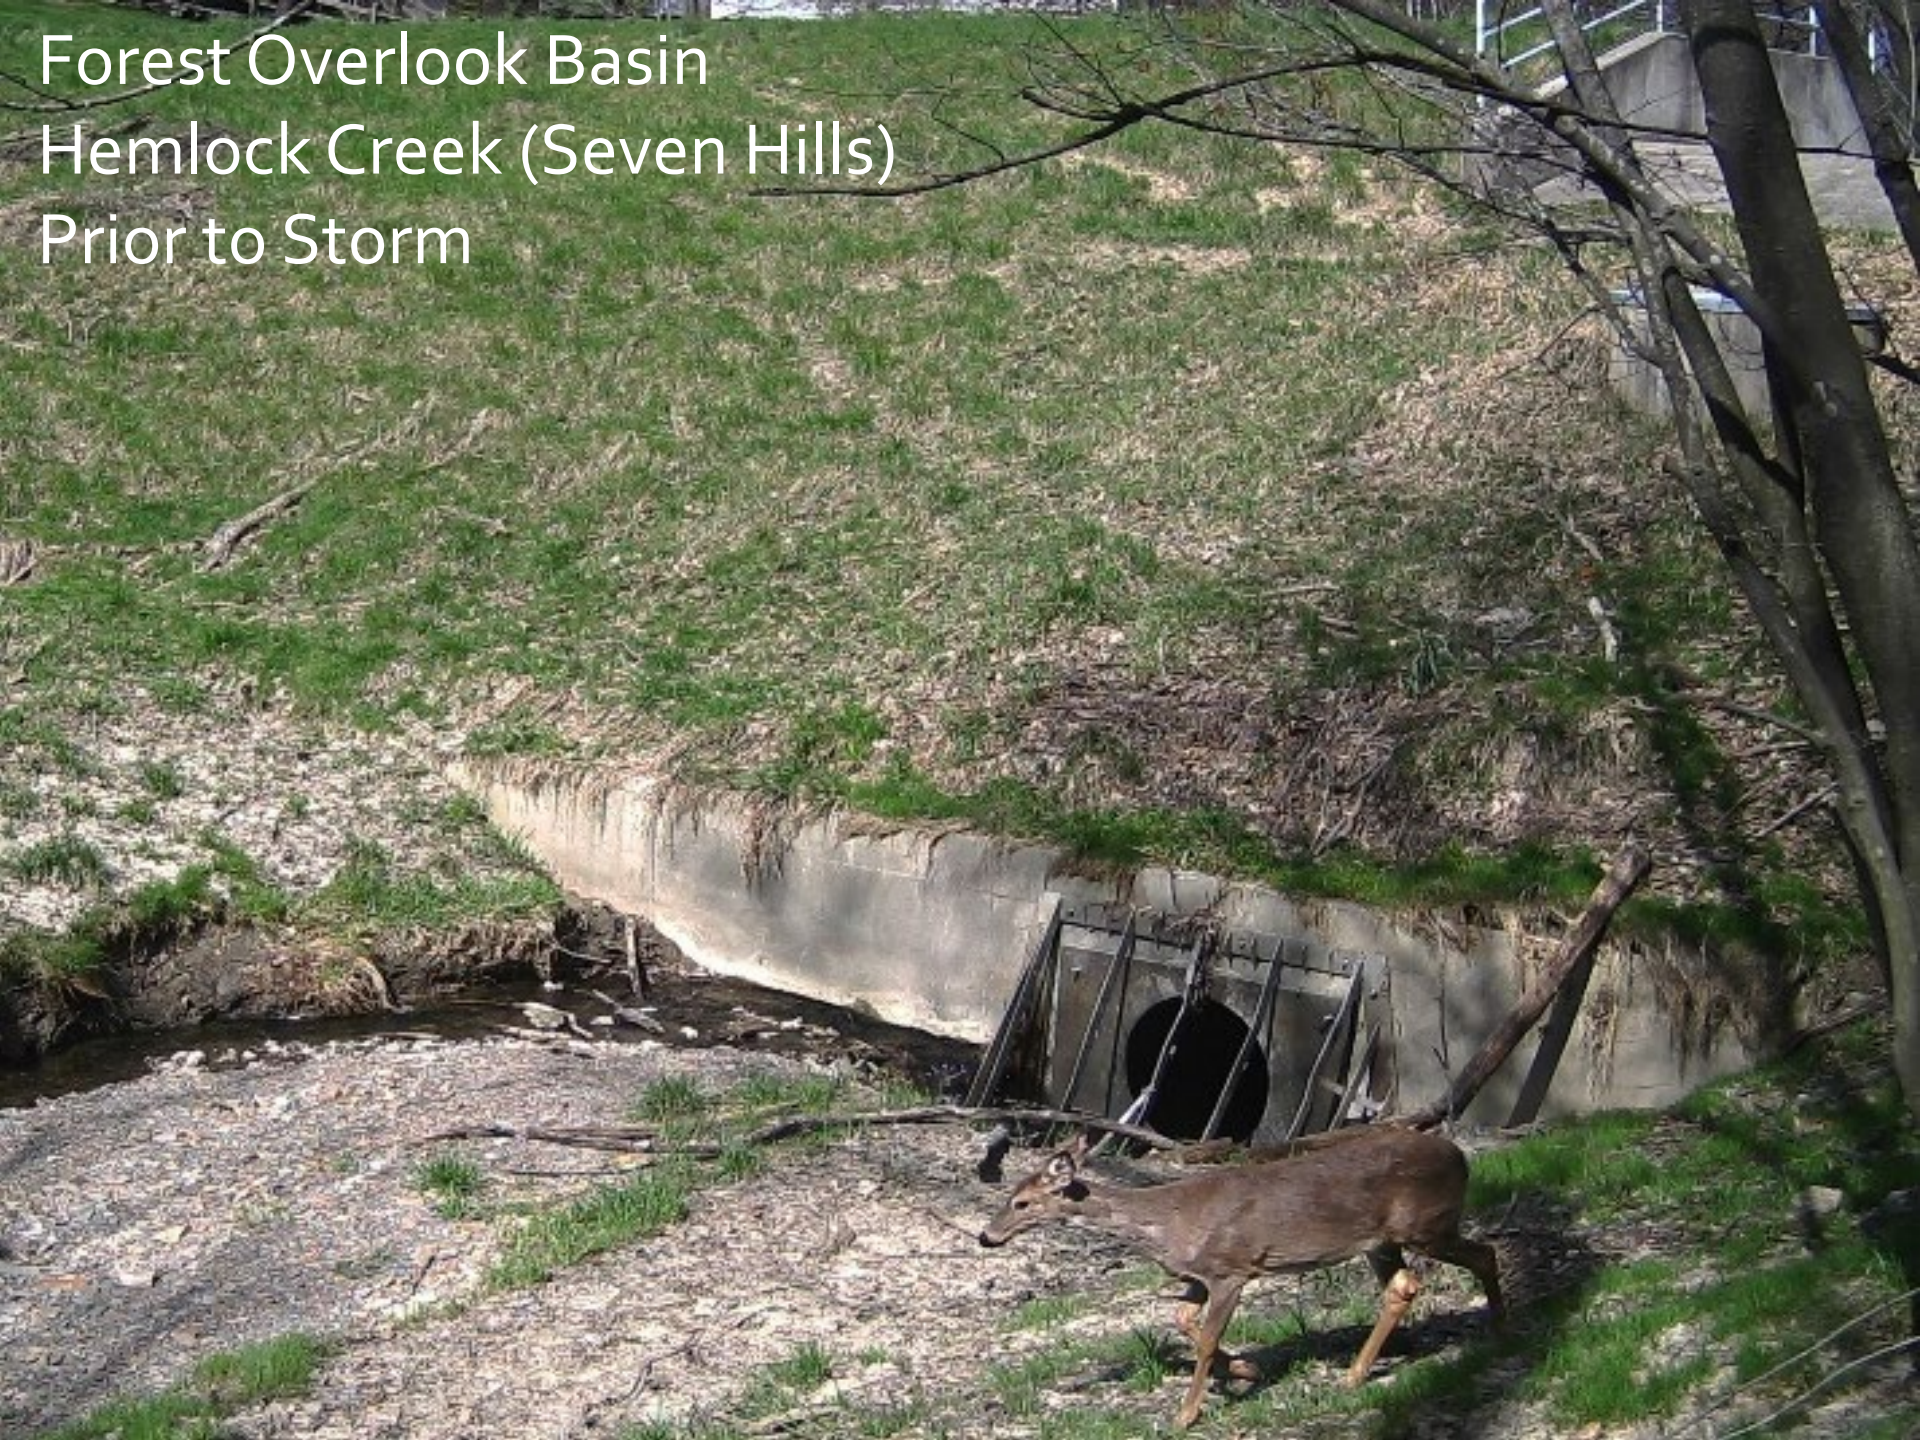
Forest Overlook Basin
Hemlock Creek (Seven Hills)
Prior to Storm

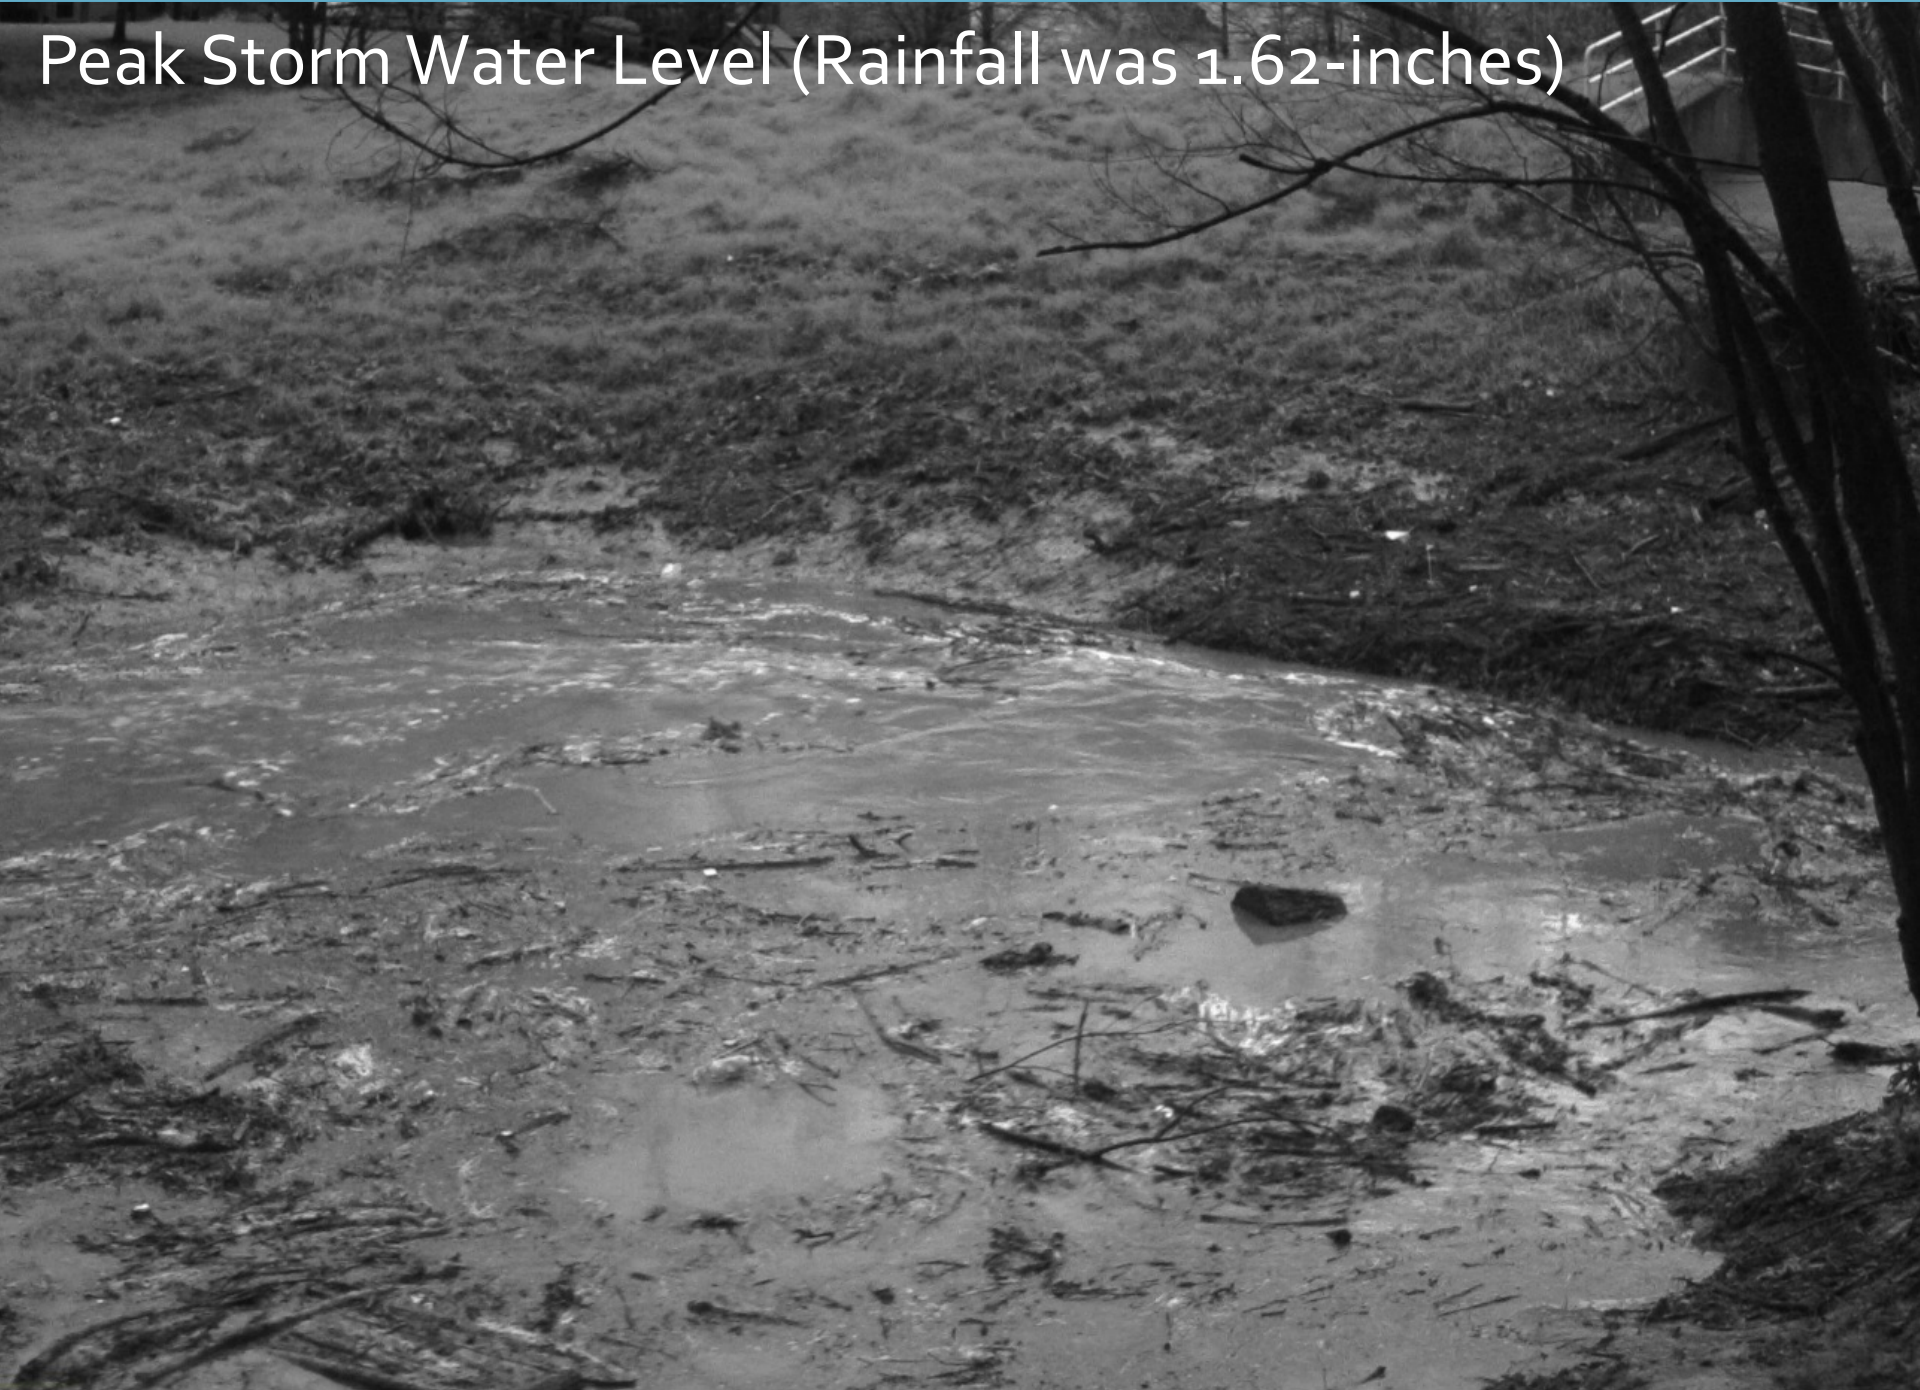
Peak Storm Water Level (Rainfall was 1.62-inches)

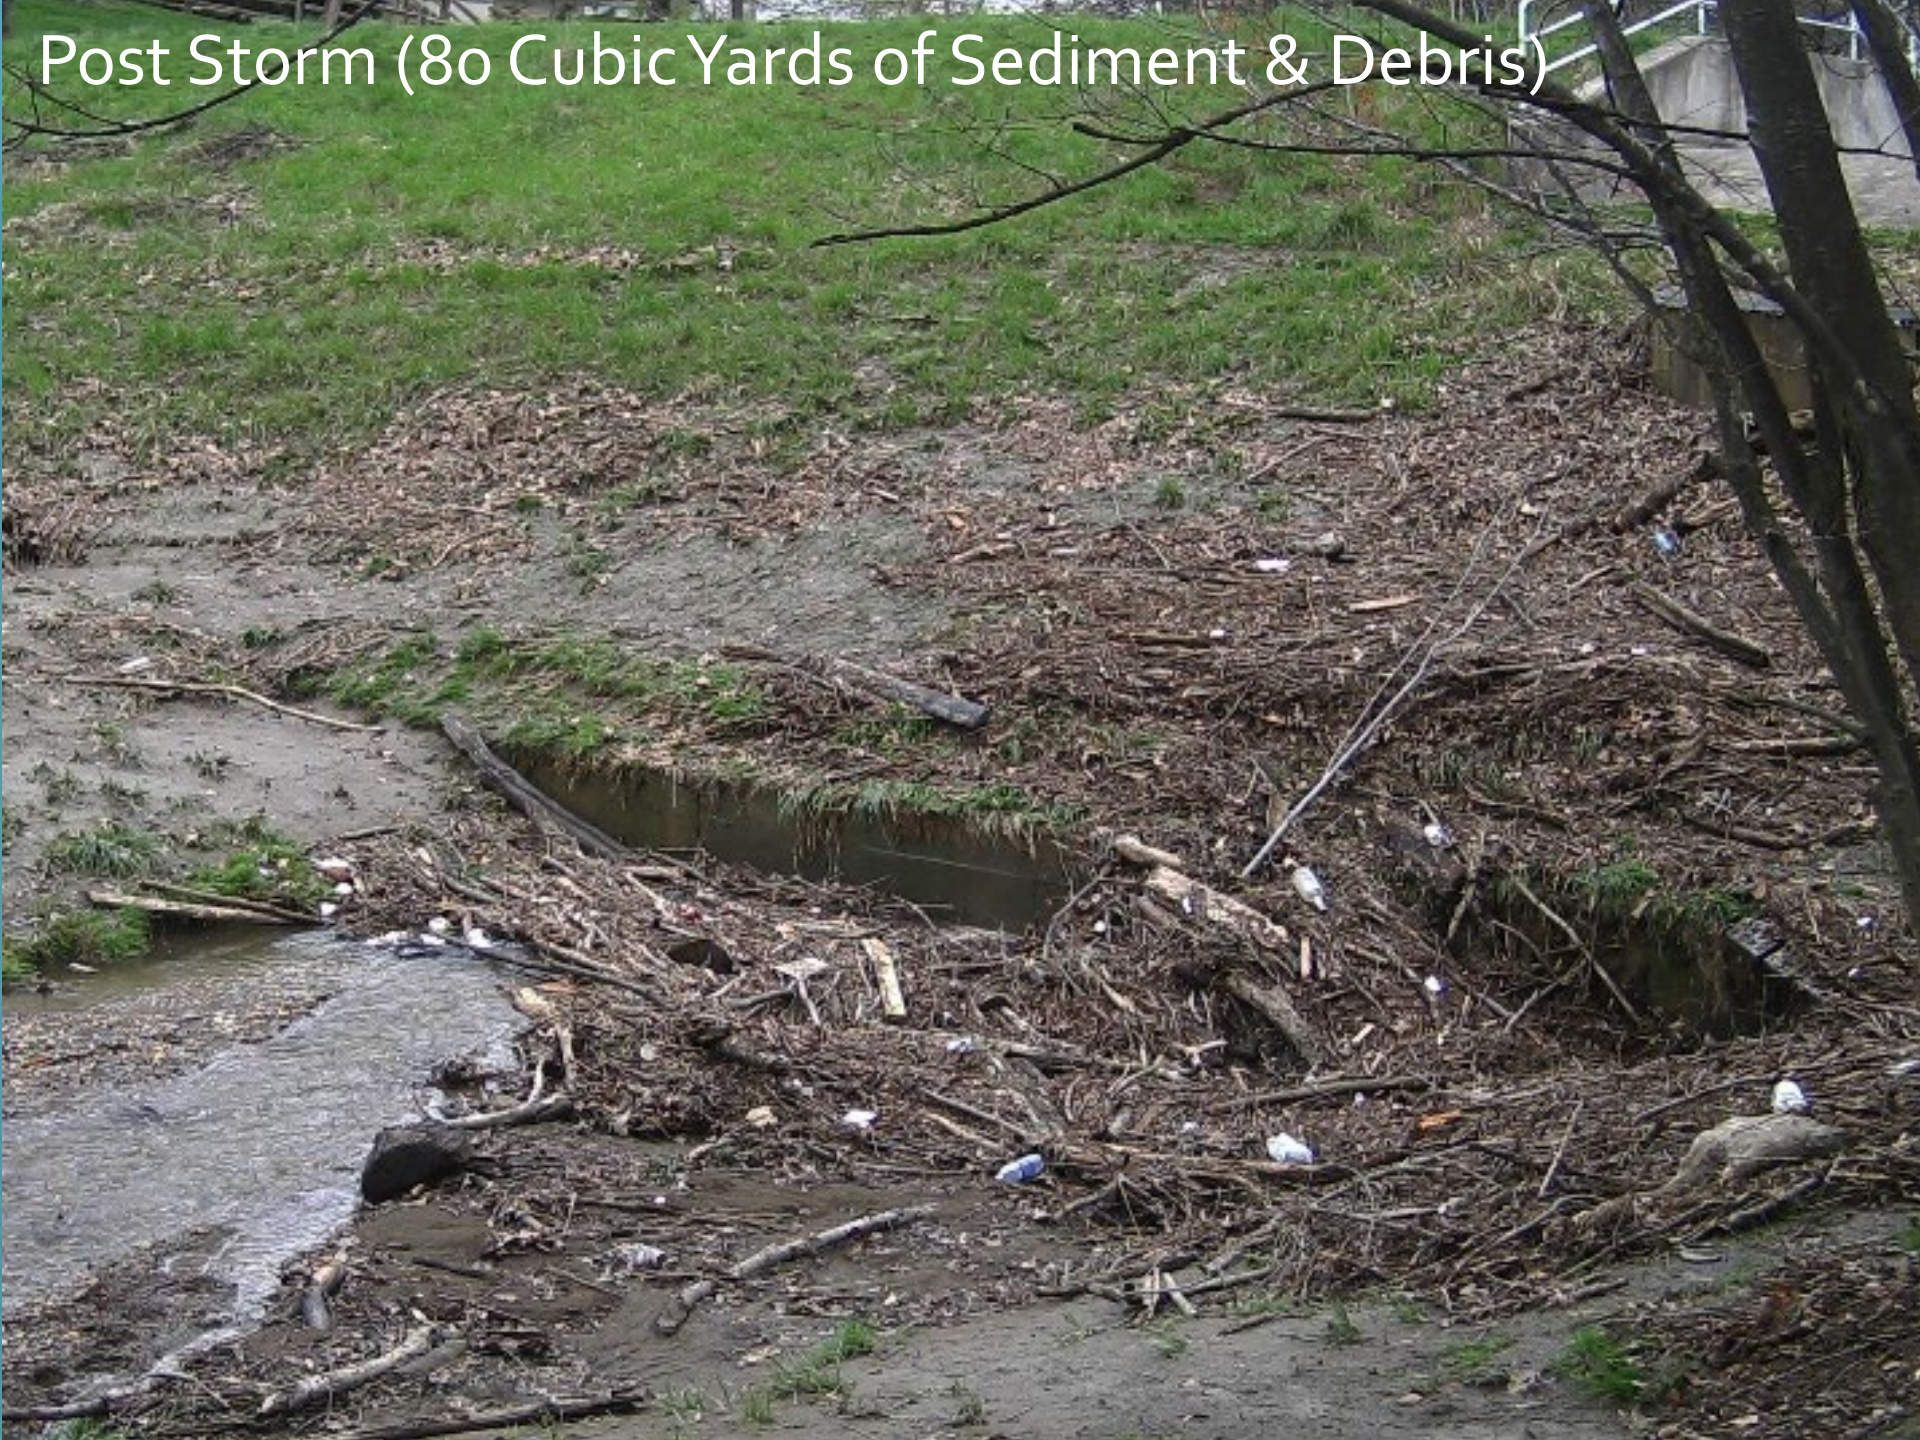
Post Storm (80 Cubic Yards of Sediment & Debris)

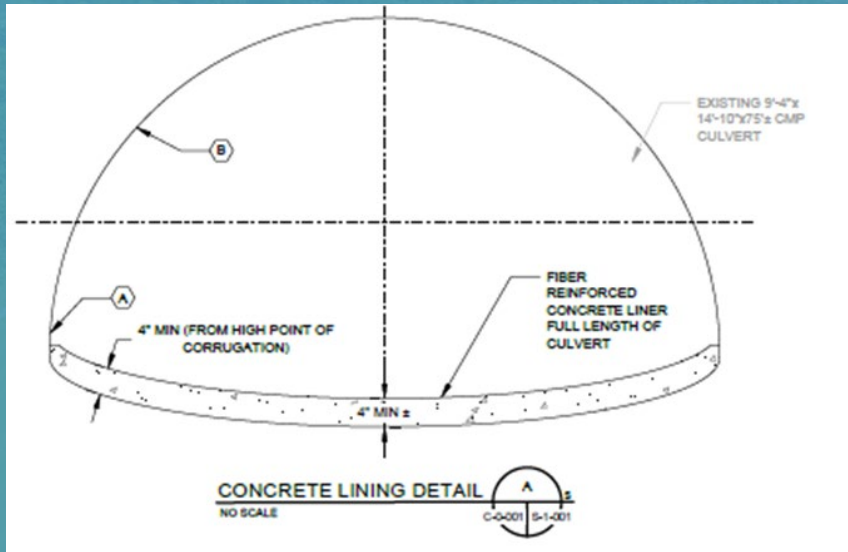
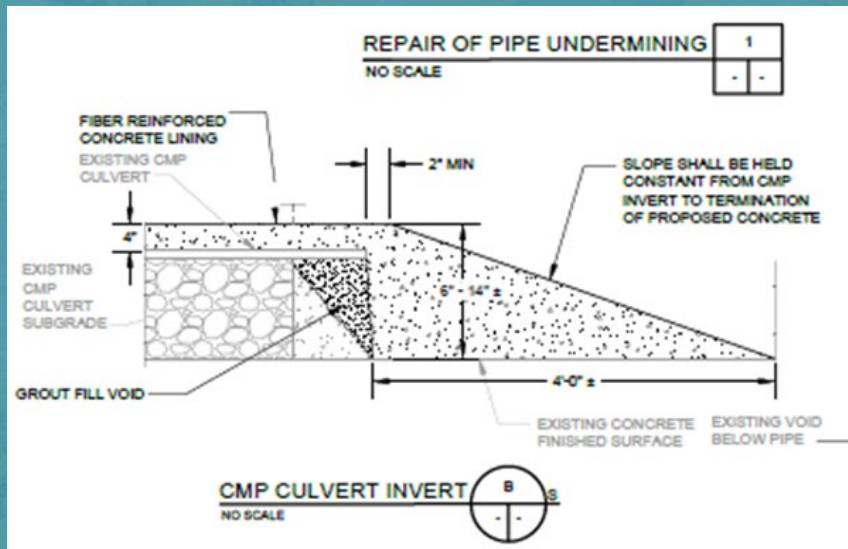
Small Scale Maint Project: Structural Repair Cuyahoga River South: Indian Creek

- Line invert to protect rusting CMP
- Provide structural concrete support in undermined area at outlet

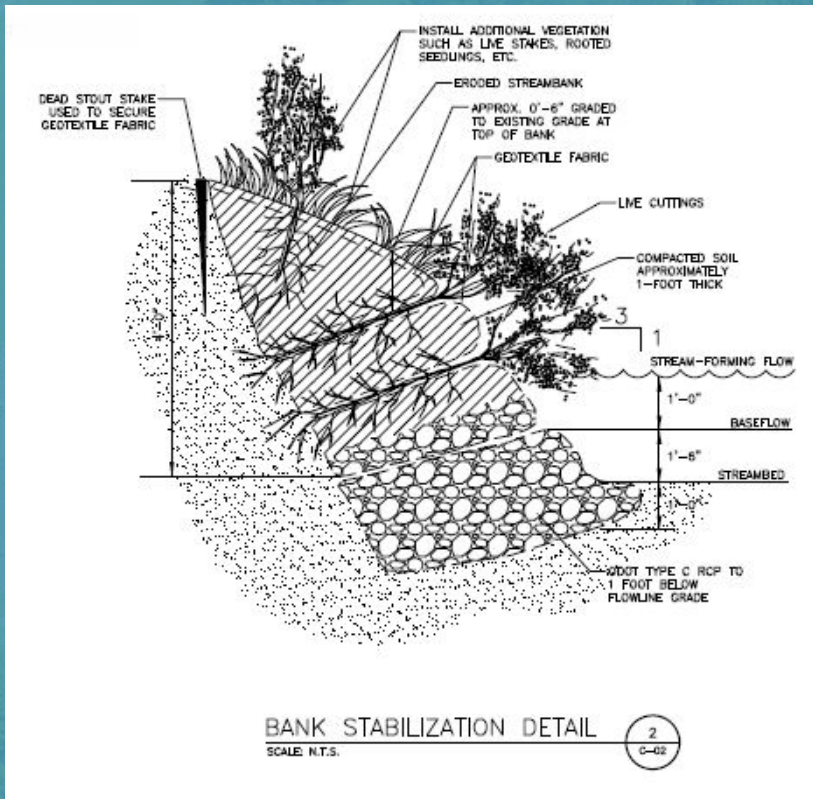
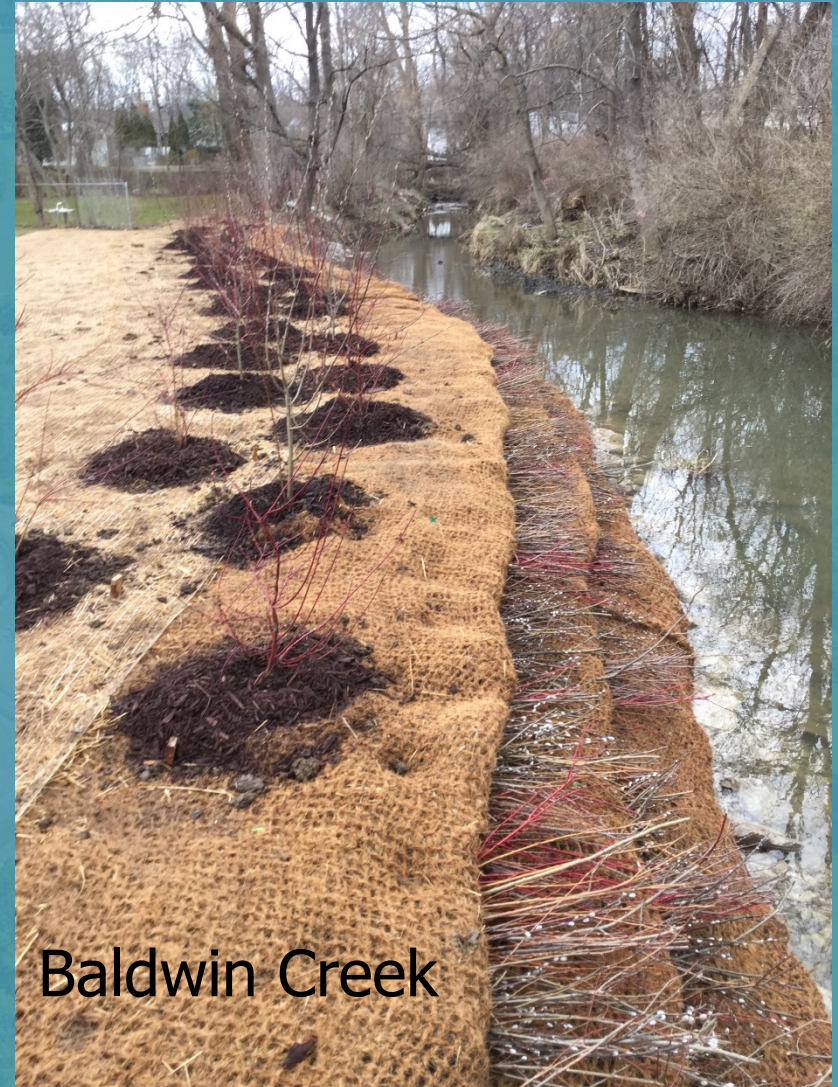
Small Scale Maint Project: Streambank Stabilization Cuyahoga River South: Furnace Run

- Lay banks to a stable slope
- Install live branch layering and rock toe protection

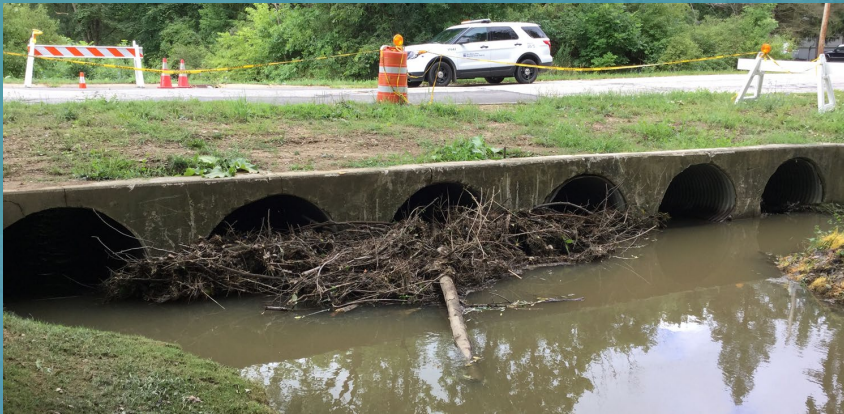
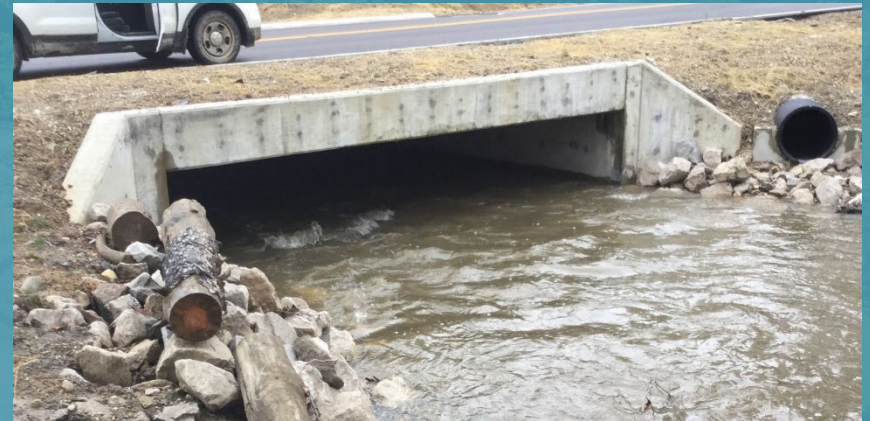
Sioux Lane Culvert Replacement

Before Construction: existing 6 corrugated metal culvert pipes

After: New structure restores flow capacity and improves maintenance by reducing debris build-up

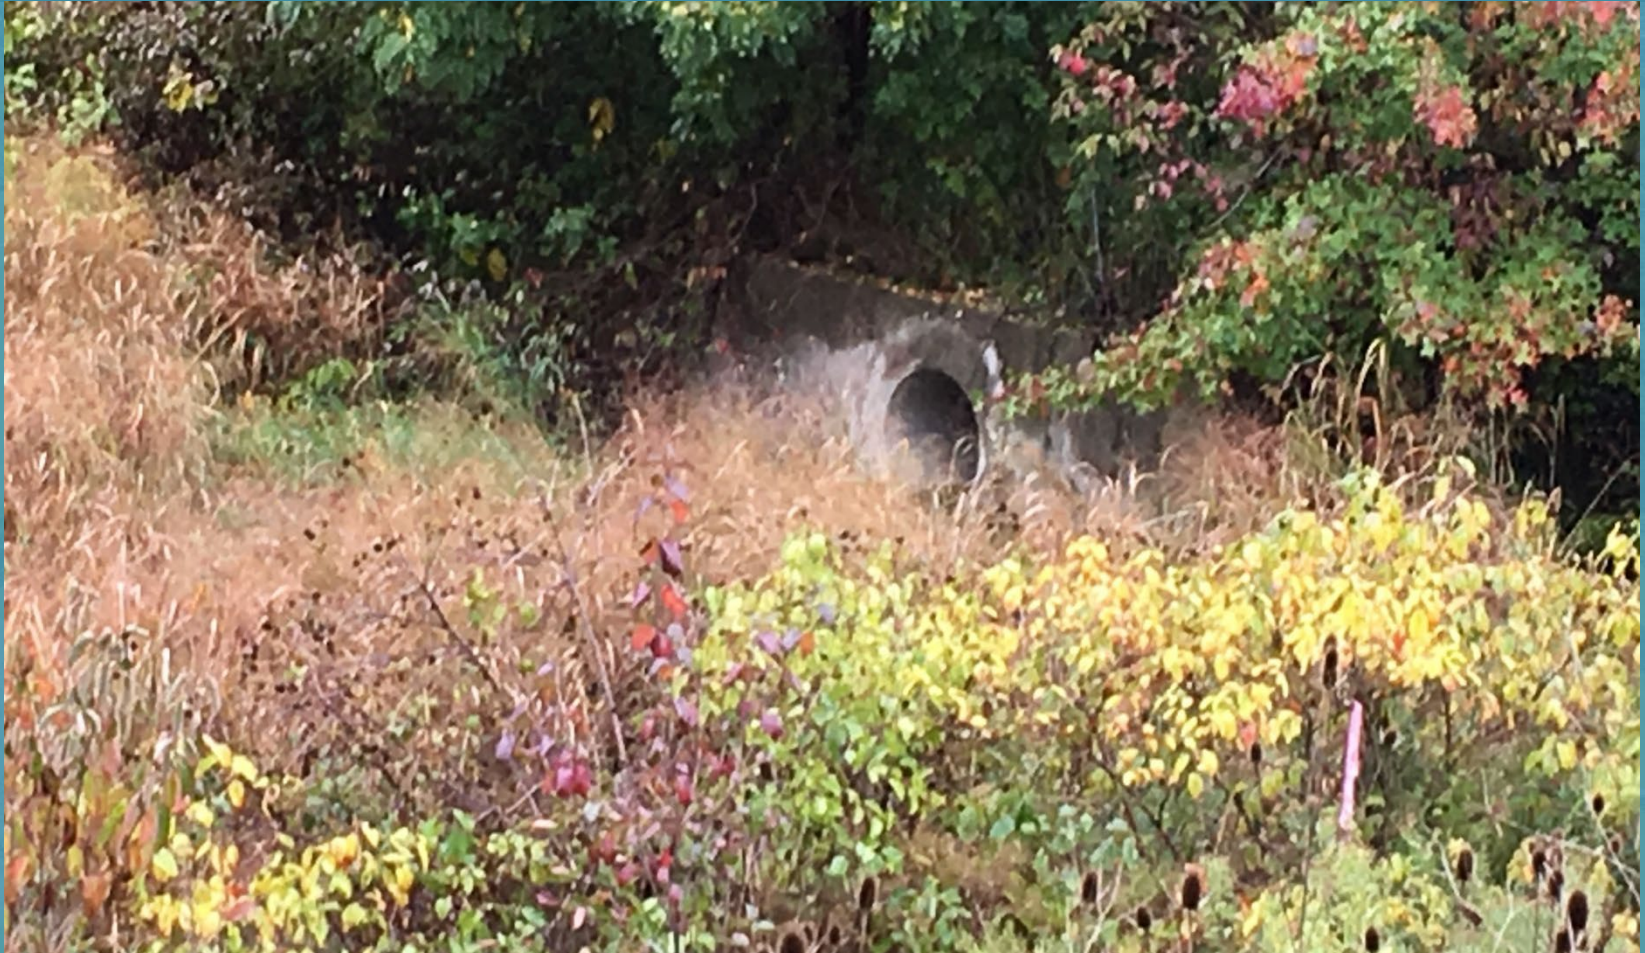
Beecher's Brook Culvert 2002

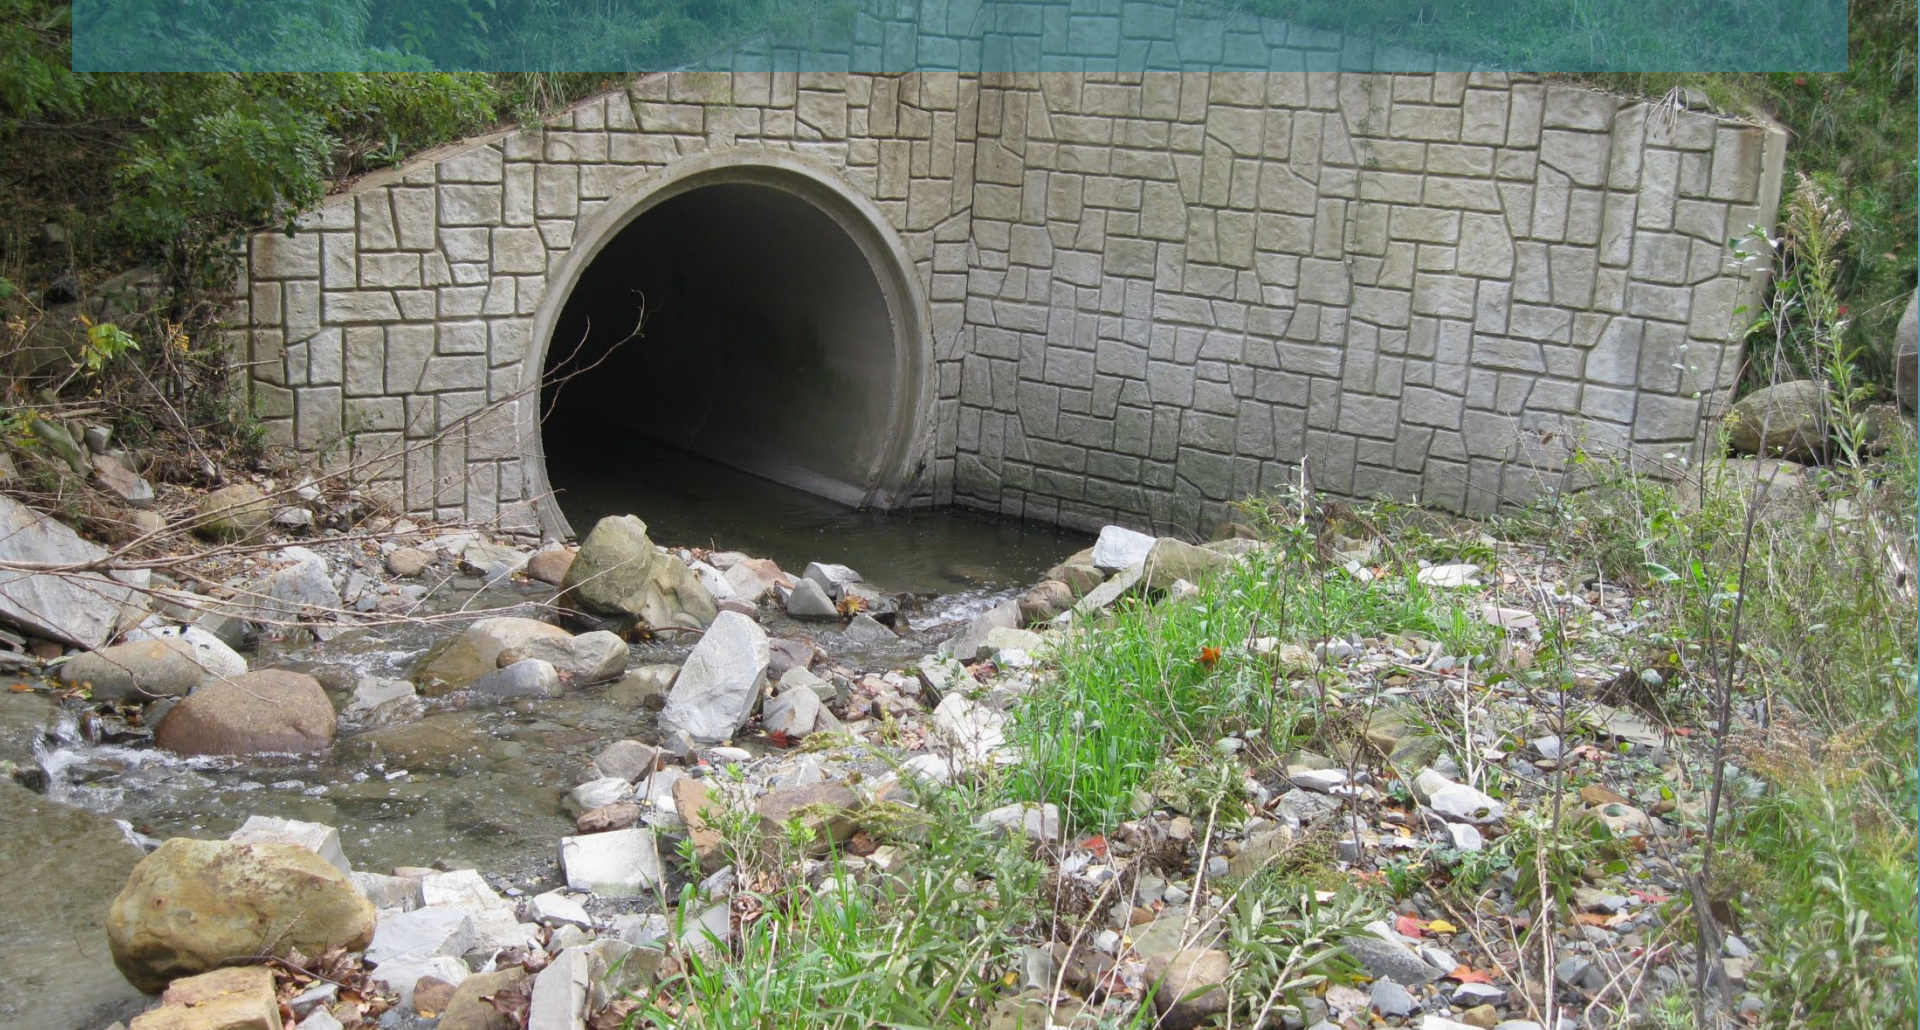
Beecher's Brook Culvert 2006

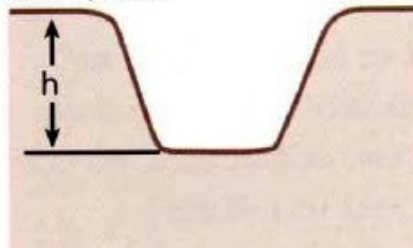
Class II. Channelized*
 $h < h_c$
floodplain

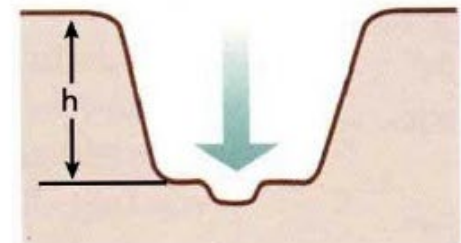
Class III. Degradation
 $h < h_c$

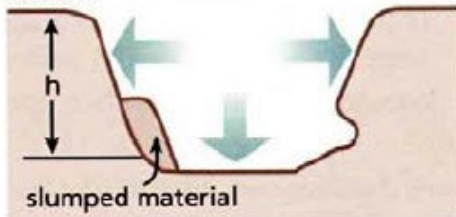
Class IV. Degradation and Widening
 $h > h_c$
terrace
