Watershed Advisory Committee

Cuyahoga River South

October 2018

REGIONAL
STORMWATER
MANAGEMENT
PROGRAM

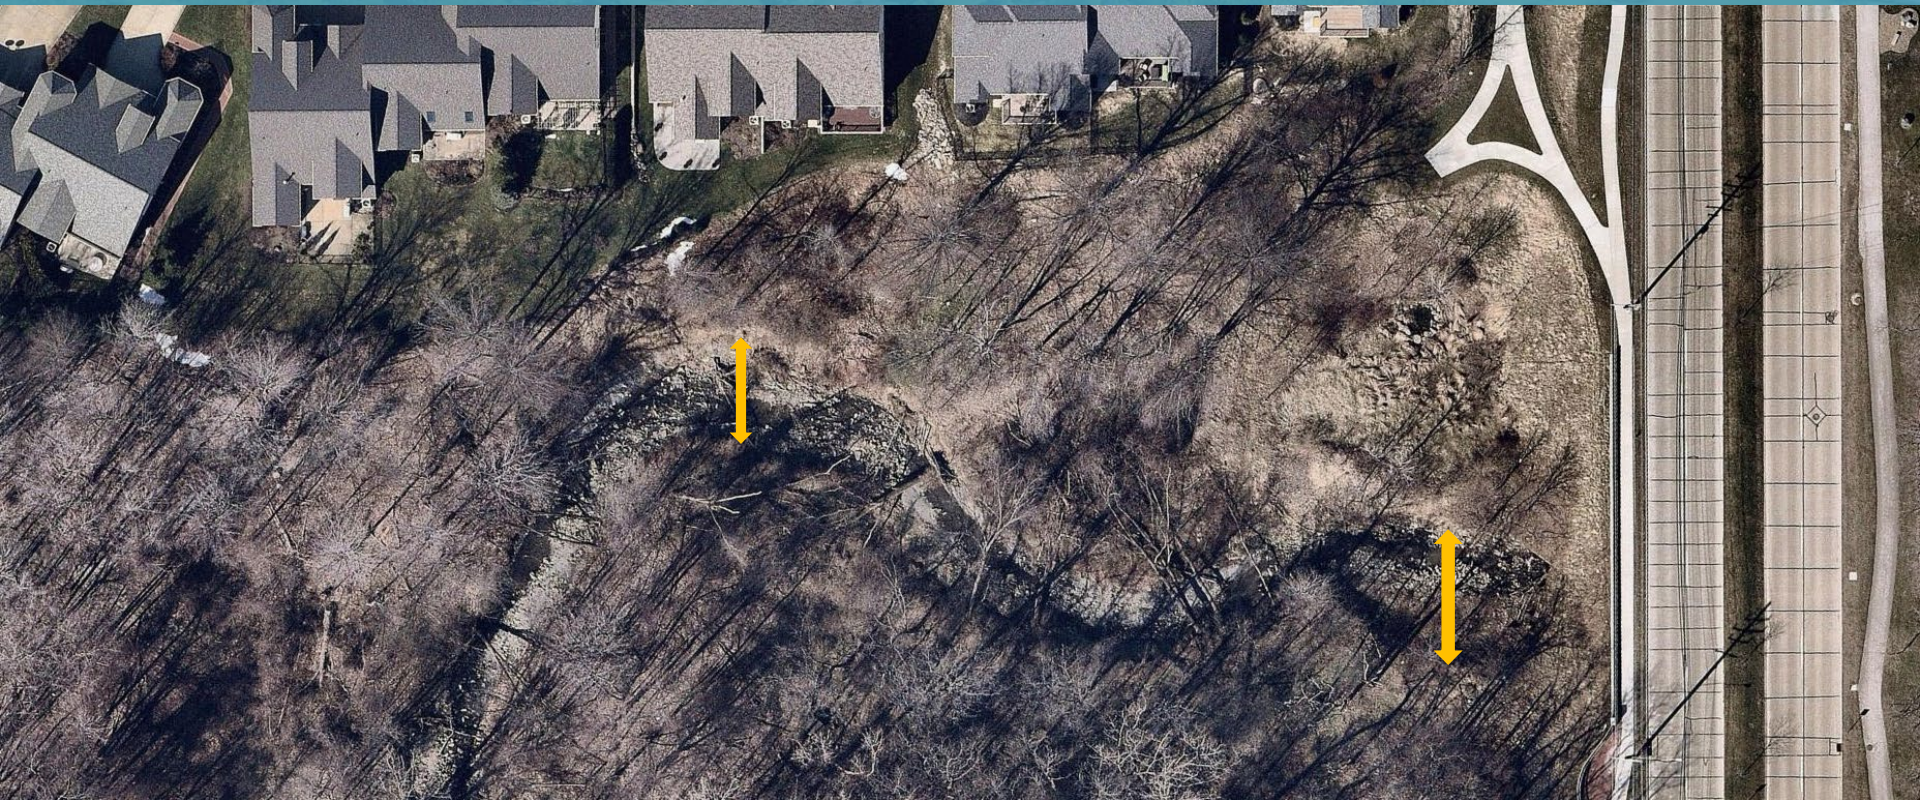
Beecher's Brook Culvert 2017
