Watershed Advisory Committee

Cuyahoga River South

NORTHEAST OHIO REGIONAL SEWER DISTRICT

REGIONAL
STORMWATER
MANAGEMENT
PROGRAM

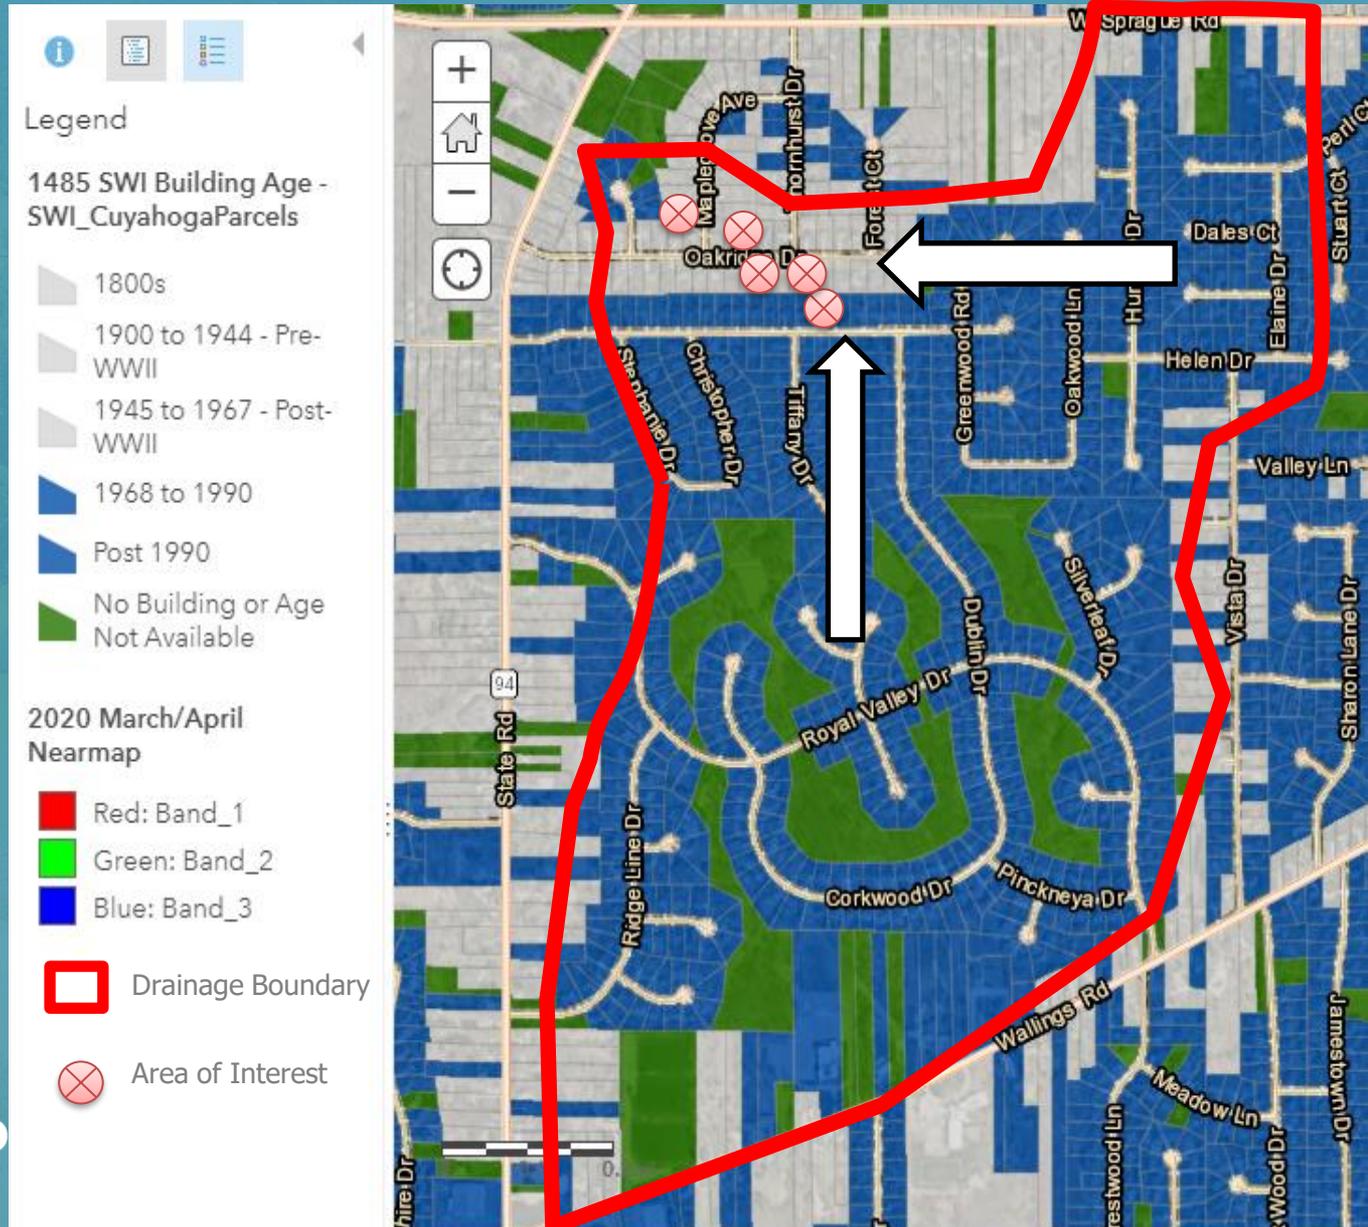
Development History

- Nearly all the houses upstream of the flooded properties were built later
- Several houses were built without any SCMs
- Some SCMs were constructed for flood control purposes

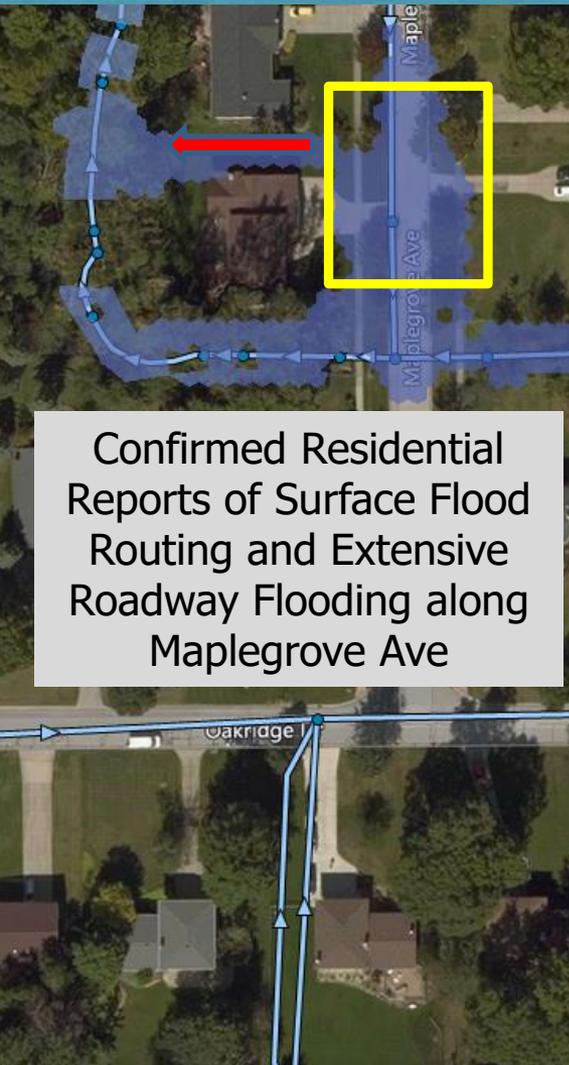
April 16, 2018 Urgent Storm Event: Street Flooding

Confirmed Residential Reports of Surface Flood Routing and Extensive Roadway Flooding along Maplegrove Ave

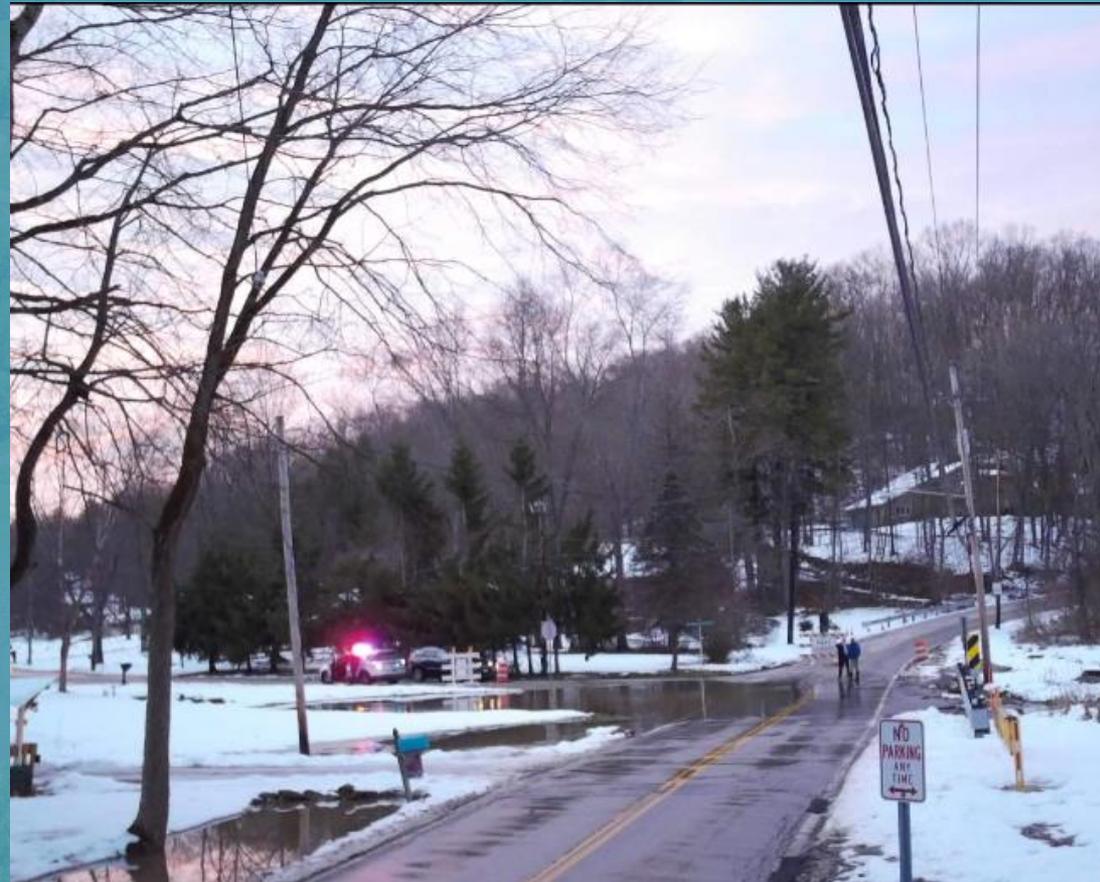
- Greenhaven Parkway and Riverview Road in Brecksville, Unnamed Trib to Cuyahoga
- Intersection frequently floods
- Sediment vaults require repeated maintenance

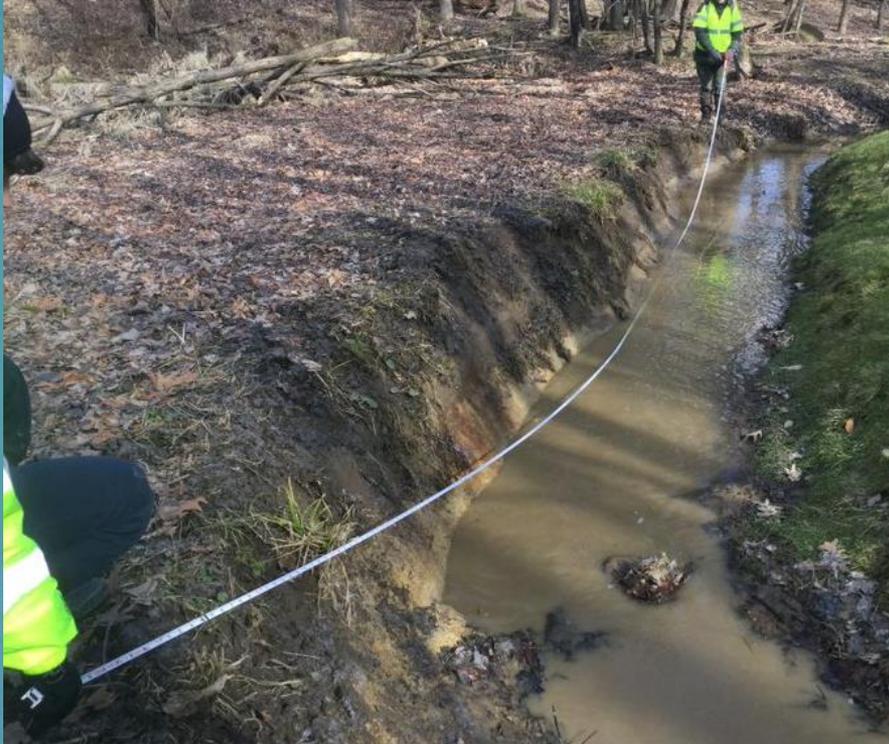
- Goal: Find the source of the sediment
- Mapped the LSS, including all outfalls >12" diameter
- Performed STEPL analysis on all stream segments draining to intersection
- Height and length measured on each eroding bank
 - Assigned a Lateral Recession Rate for each bank, ranging from .01' to .5' per year based on bank material and surface protection (lack thereof)
- Calculated volume of sediment from each segment

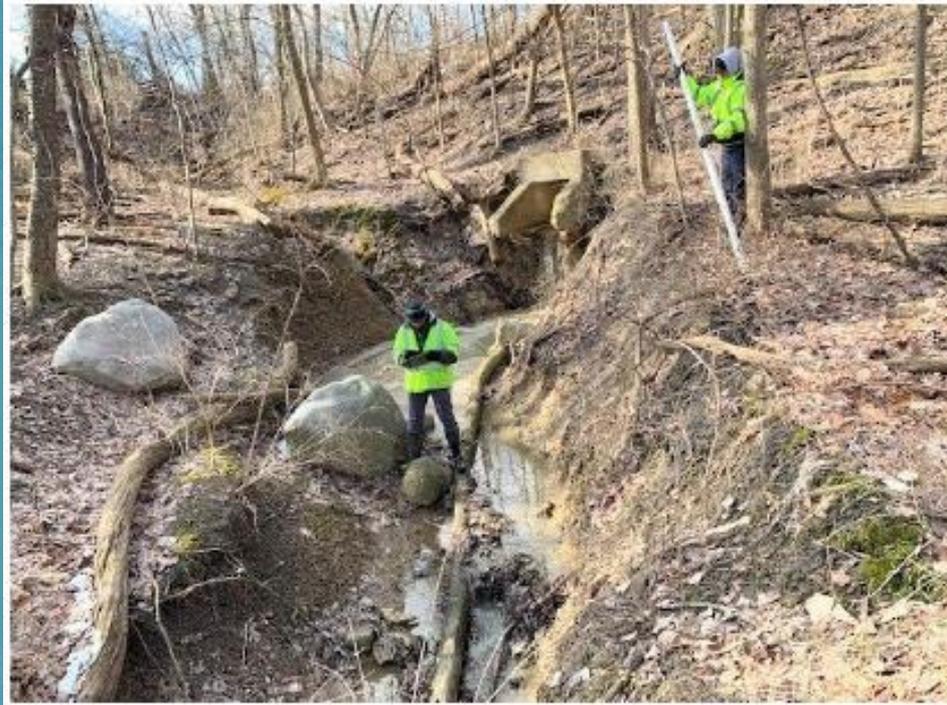
Brecksville Road culvert outlet
Contributes about 18 tons sediment/yr (6%)

- Reconnect Carriage Hill to floodplain
- Stabilize Brecksville Road culvert outlet
- Restore channel south of Whitewood Road to historic location
- Stabilize outfalls north of Whitewood Road
- Make sediment removal maintenance more effective and efficient – utilize existing detention basin
- Opportunities throughout to install engineered log jams, notably north and south of Whitewood Road

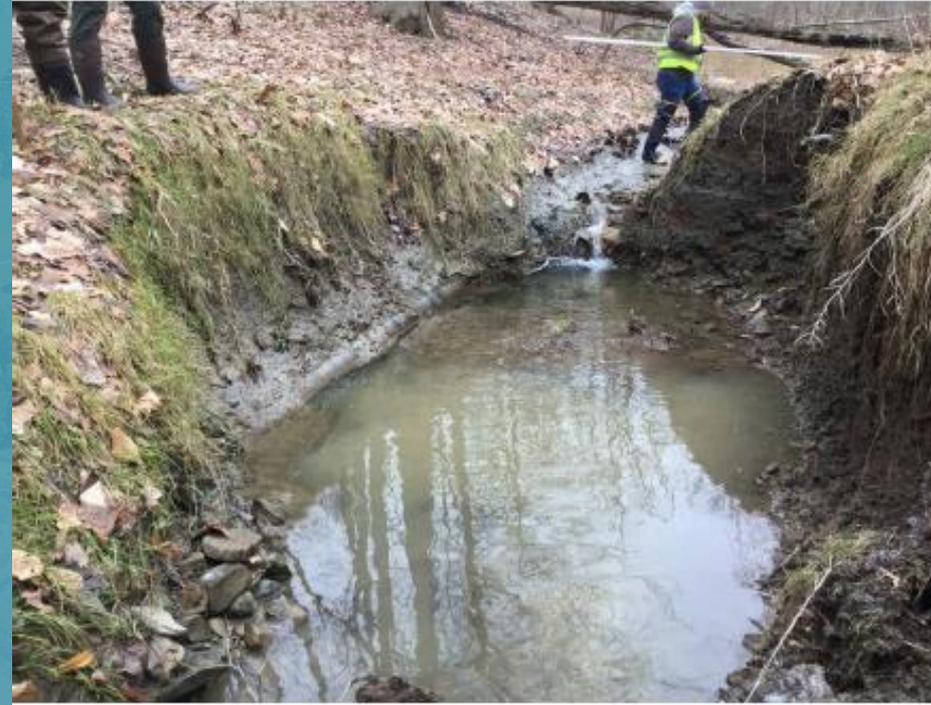
South of Whitewood Rd
Contributes 10 tons sediment/yr (3%)

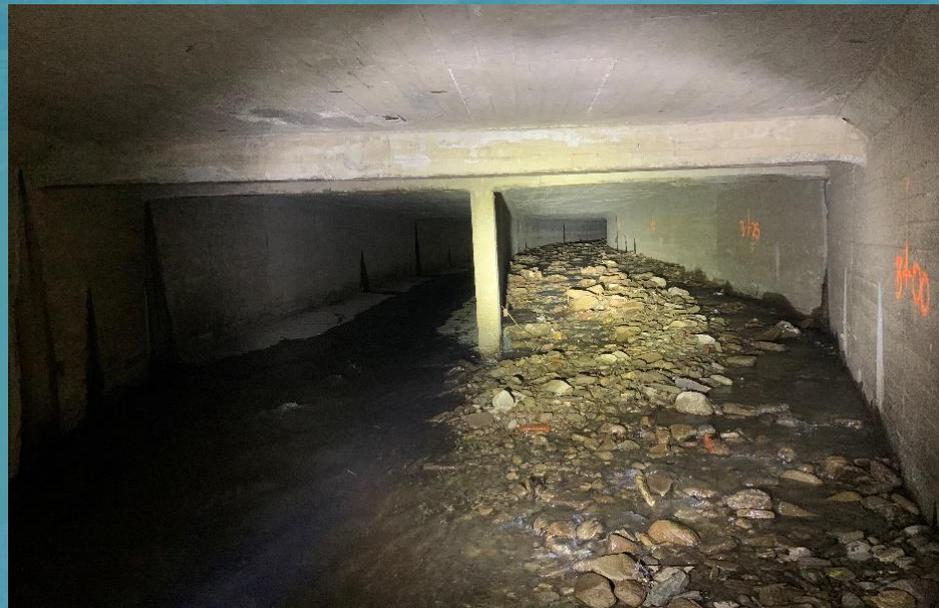
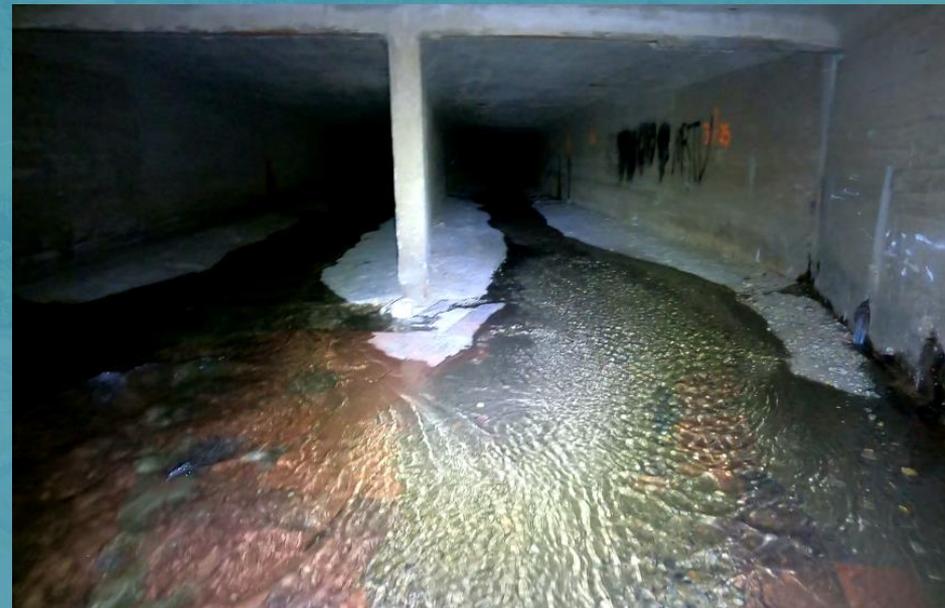
Doan Brook Culvert in Cleveland

Remove 1950 cubic yards

Construction Complete
