Watershed Advisory Committee

Lake Erie Direct Tributaries

Chagrin River

March 2018

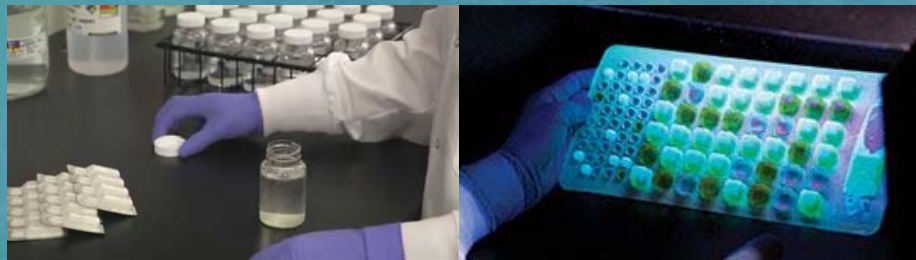
Illicit Discharge Detection & Elimination Summary of 2017 Sampling

- Outfalls Inspected = **4,148**
- Outfalls with *E. coli* >10,000 MPN/100 mL = **140**
- Outfalls with flow >10,000 GPD = **65**

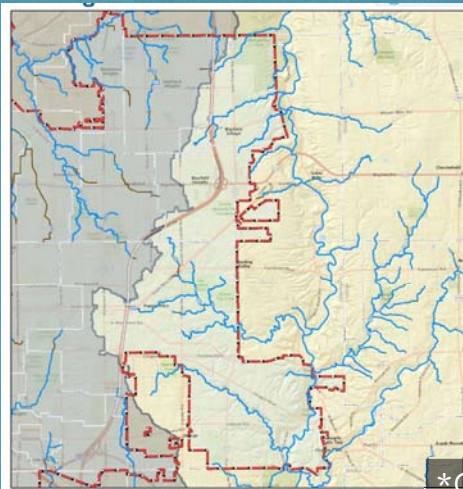
Chagrin River 2017 Inventory Update

Asset Class Type	RSS (Assets)	RSS (Miles)
Streams	163	24
Crossings	118	1
Culverted Streams	8	1
Basins	7	-
Major Structures	0	-
Total	296	26
SWSA	3,699	443

*CHA RSS: 26 Miles in 2016
Service Area RSS: 405 Miles in 2016

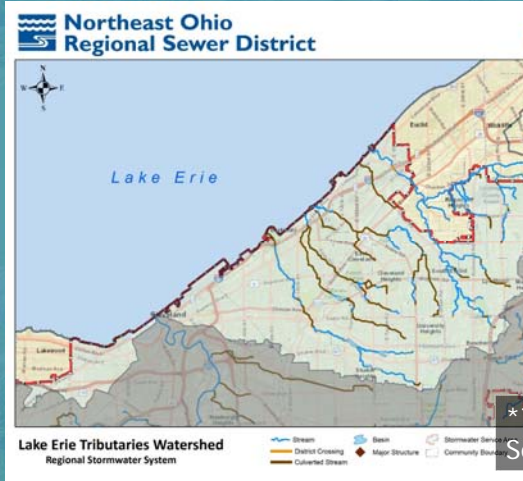
Lake Erie Tributaries 2017 Inventory Update

Asset Class Type	RSS (Assets)	RSS (Miles)
Streams	294	35
Crossings	203	3
Culverted Streams	61	32
Basins	21	-
Major Structures	1	-
Total	580	70
SWSA	3,699	443

*70 Miles of RSS in 2016
Service Area RSS: 405 Miles in 2016

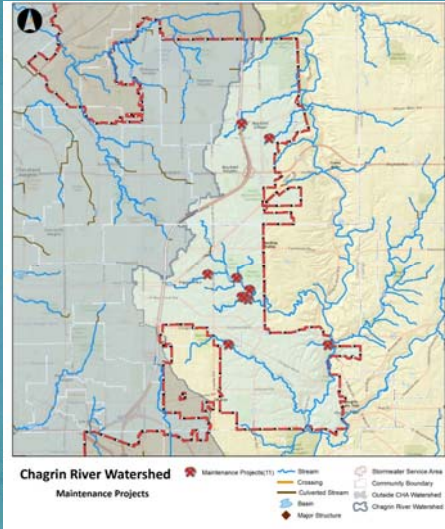
SWIM Maintenance: Chagrin 2017 Summary

11 Maintenance projects
(236 in Service Area)

301 CY sediment and debris removed
(9,179 CY in Service Area)

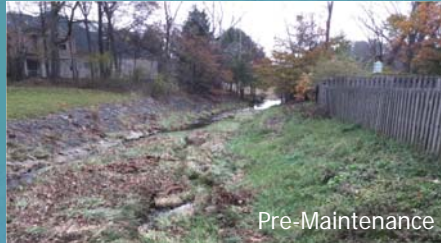
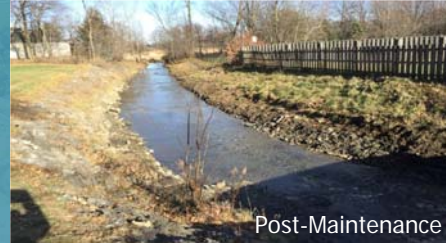
Asset ID: EE00320

Maintenance Project: Sediment (180 CY) and Debris Removal (24 CY)

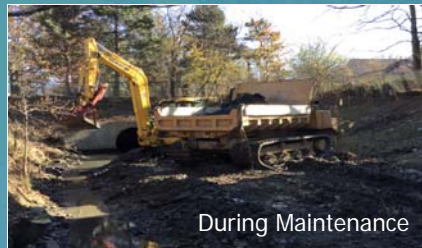
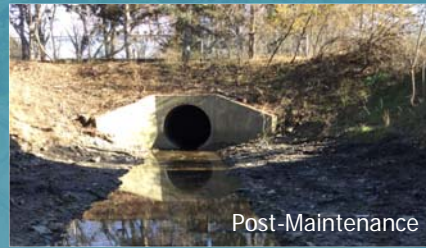
Asset ID: EE00220

Maintenance Project: Sediment Removal (250 CY)

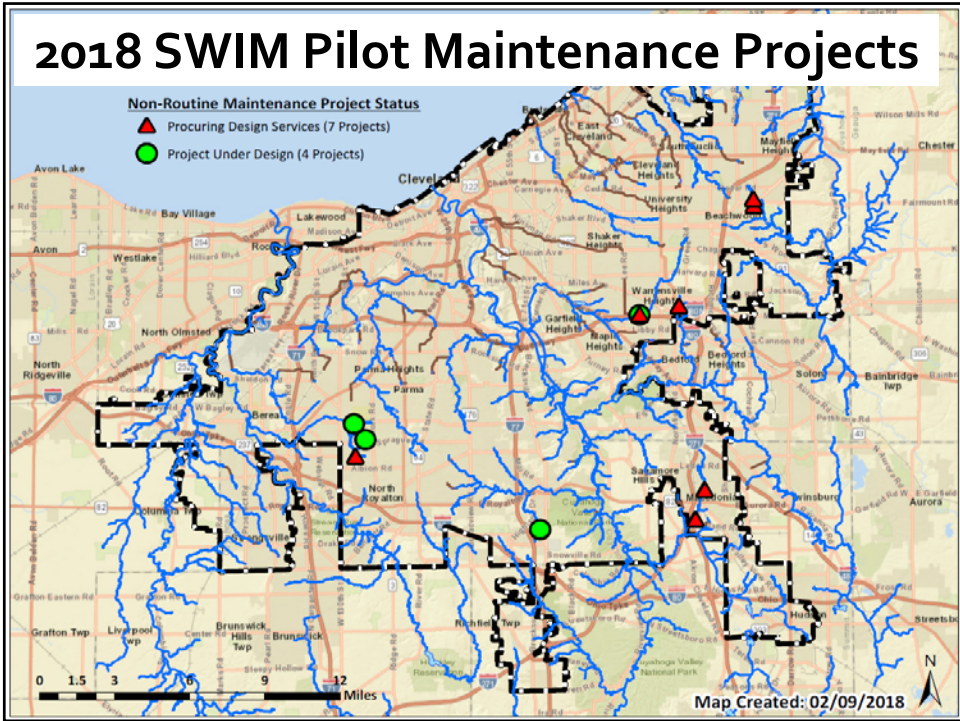
Non-Routine Maintenance Site

Rocky River: Baldwin Creek
Parma: W Pleasant Valley Road
Asset ID: BD00250 – Streambank Stabilization

1 BANK STABILIZATION SECTION

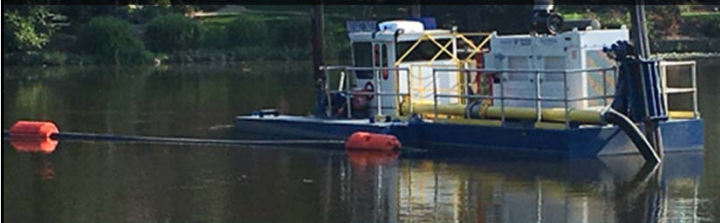
1365 Green Lake Dredging

- 11,252 Tons of sediment removed including five 55 gallon drums of golf balls
- Turtles will be returned home in spring

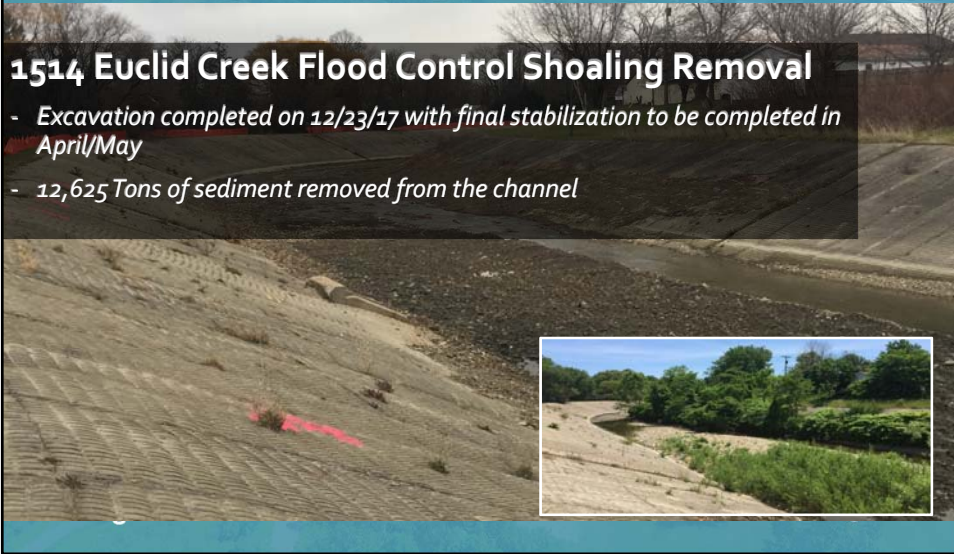
1514 Euclid Creek Flood Control Shoaling Removal

- Excavation completed on 12/23/17 with final stabilization to be completed in April/May
- 12,625 Tons of sediment removed from the channel

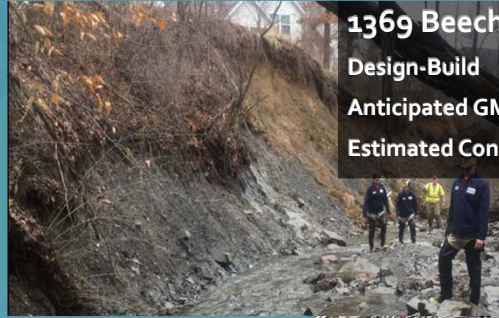
1369 Beechers Brook Bank Stabilization
Design-Build
 Anticipated GMP Request: April 5
 Estimated Construction Cost: \$1.5M

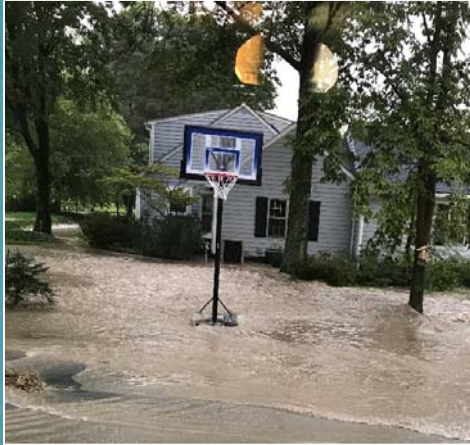
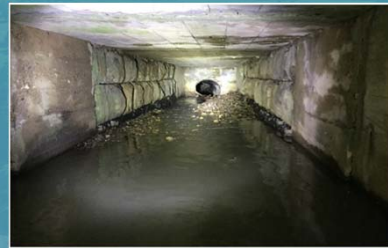
Pepper Luce at Shaker Blvd
Culvert Deterioration

Agreement with City to
Design/Construct
