Watershed Advisory Committee

ROCKY RIVER | OCTOBER 8, 2021

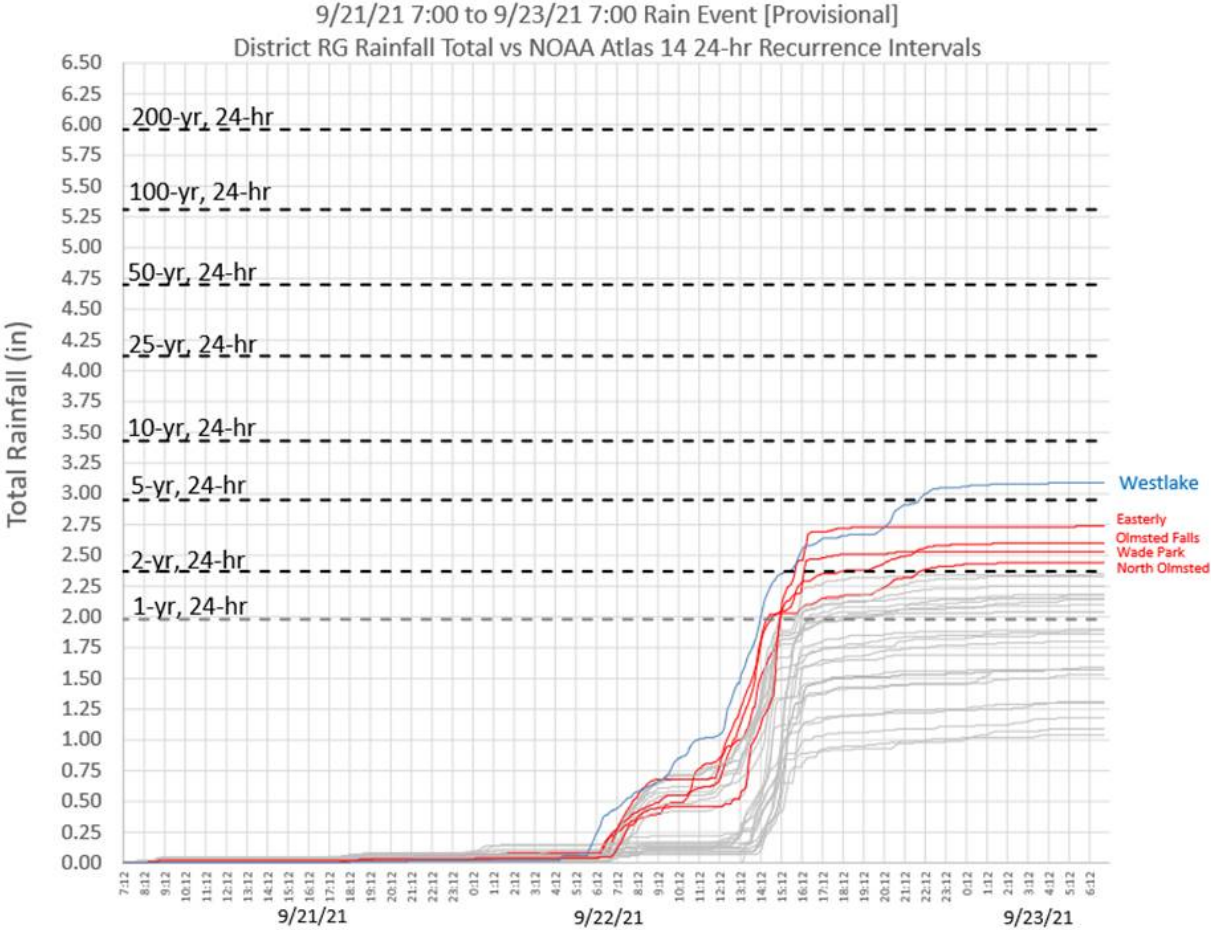
District RG Data is Evaluated to Determine Locations Recording High Intensity or Heavy Rainfall

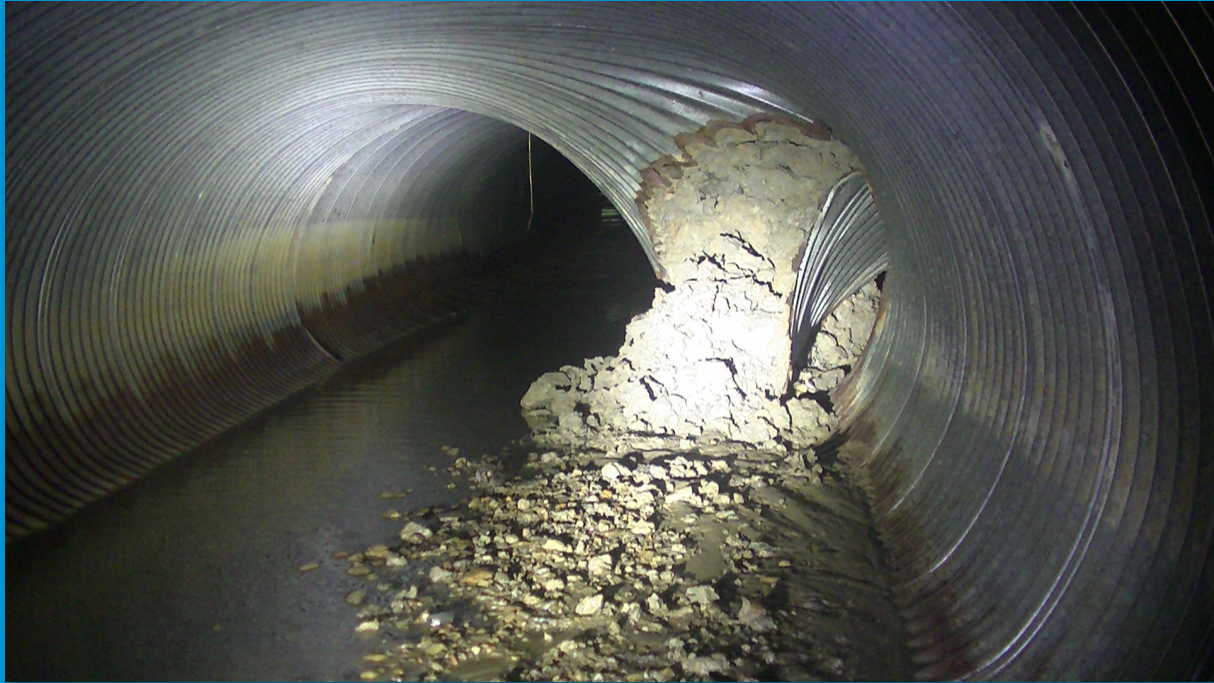
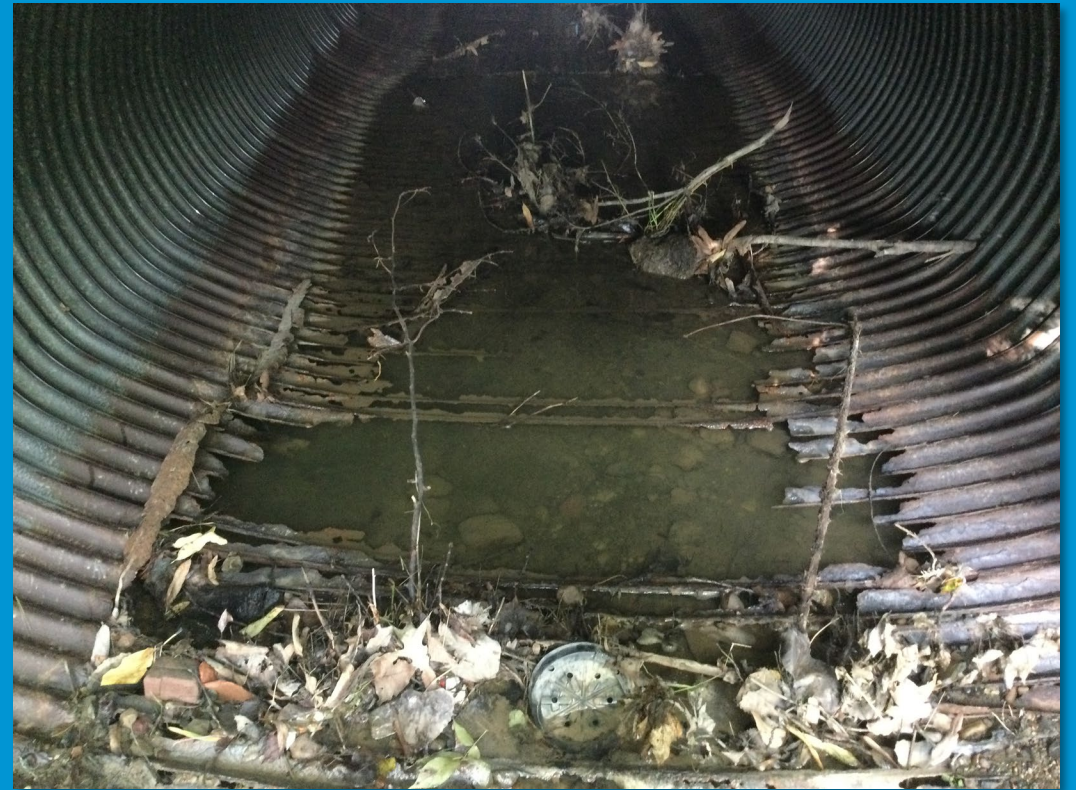
BD00296, Baldwin Creek, North Royalton

Pipe has failed at location of local storm tap-in, resulting in backyard sinkhole.

Culvert also exhibits section loss and deformations.

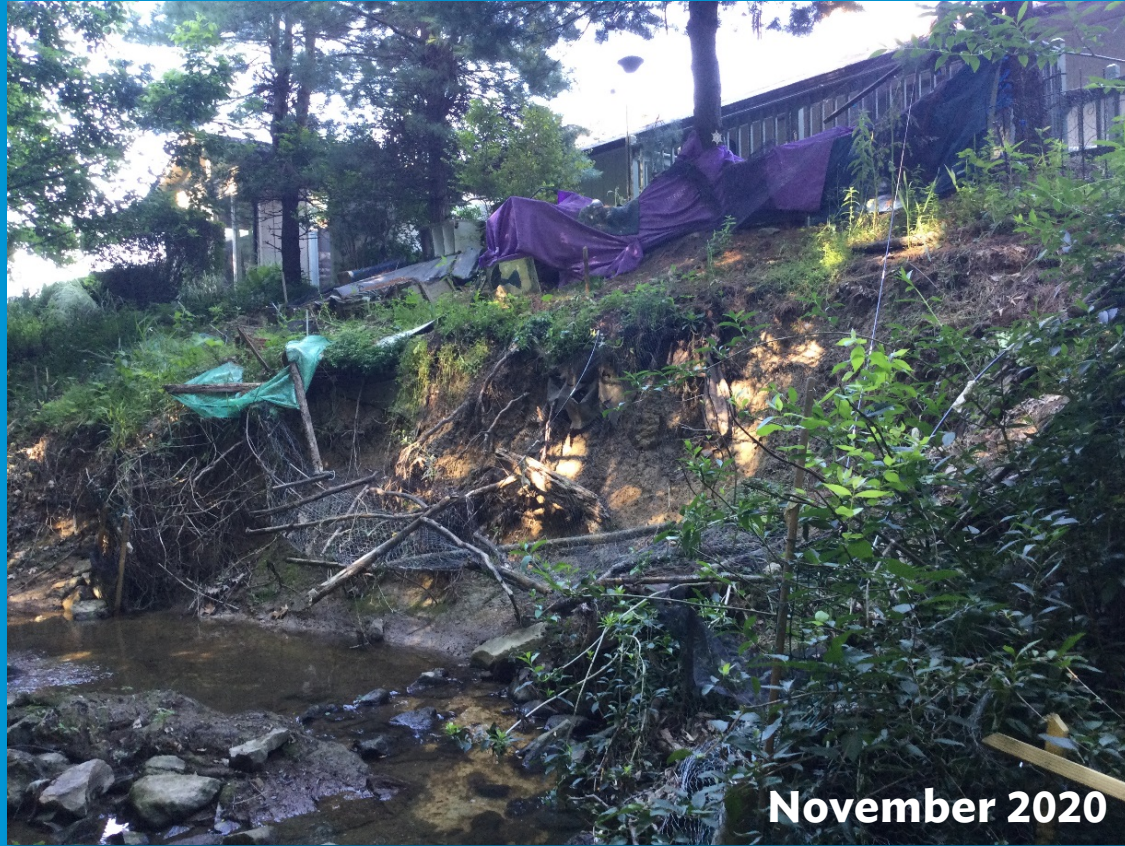
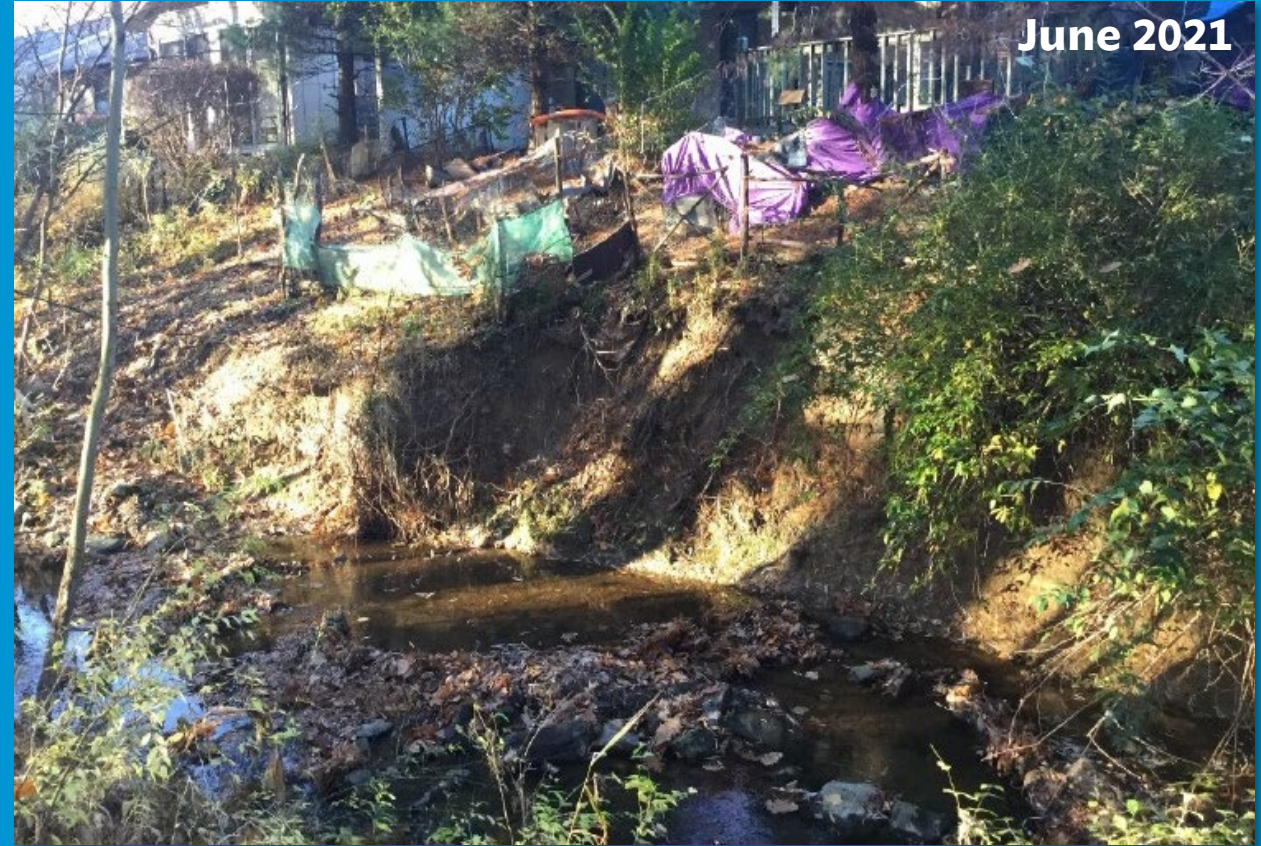
BL00211, Blodgett Creek, Strongsville

Home is 12' from TOB. Significant slough occurred, SWIM installed bank pins and will monitor biannually.

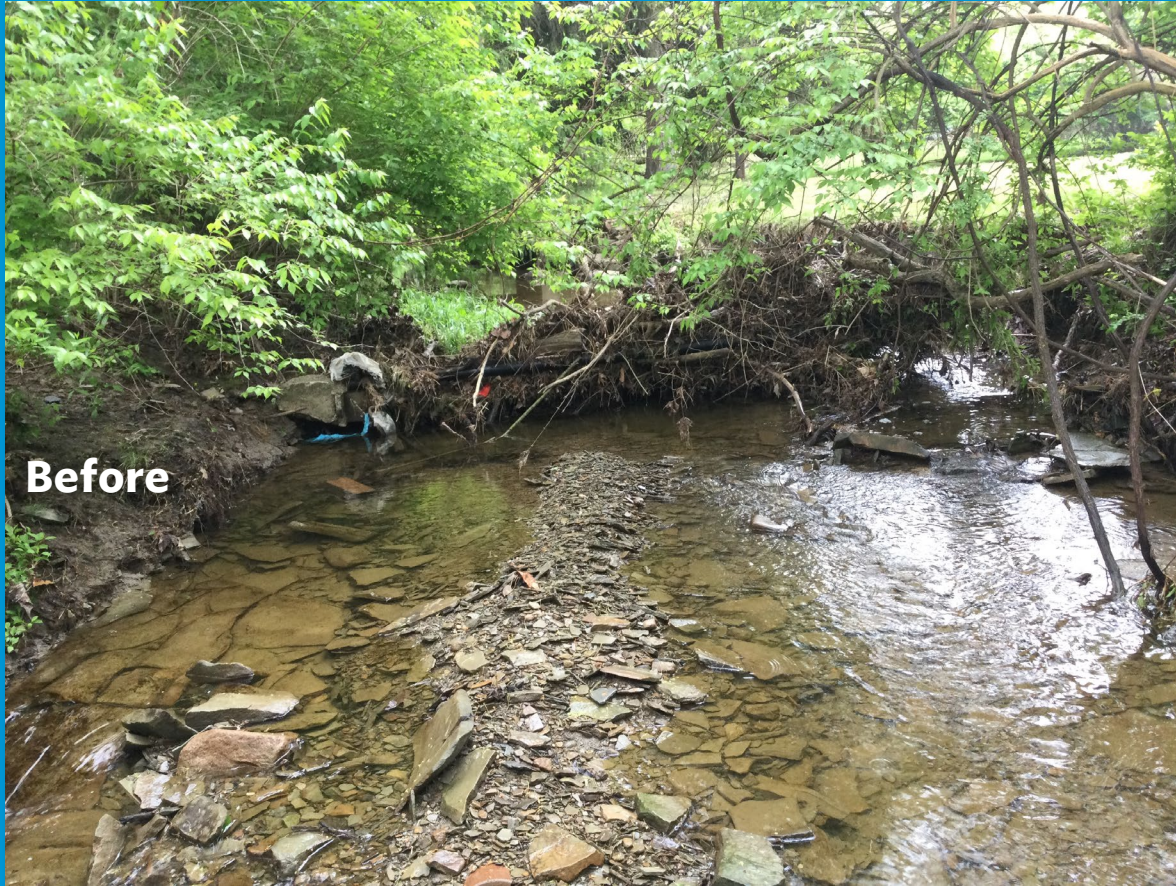
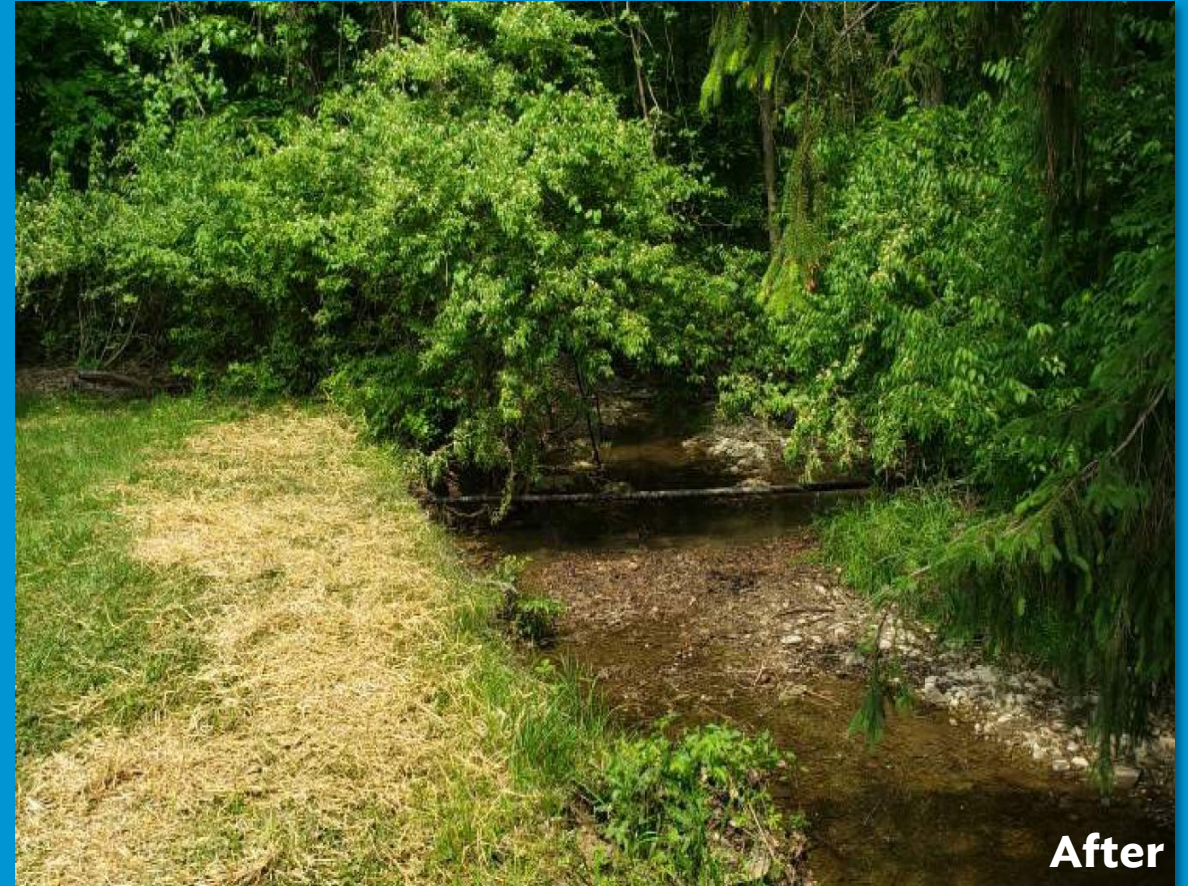
BK00188, Baker Creek, Strongsville – 4 Cubic Yards of debris removed that had accumulated on a local utility lateral.

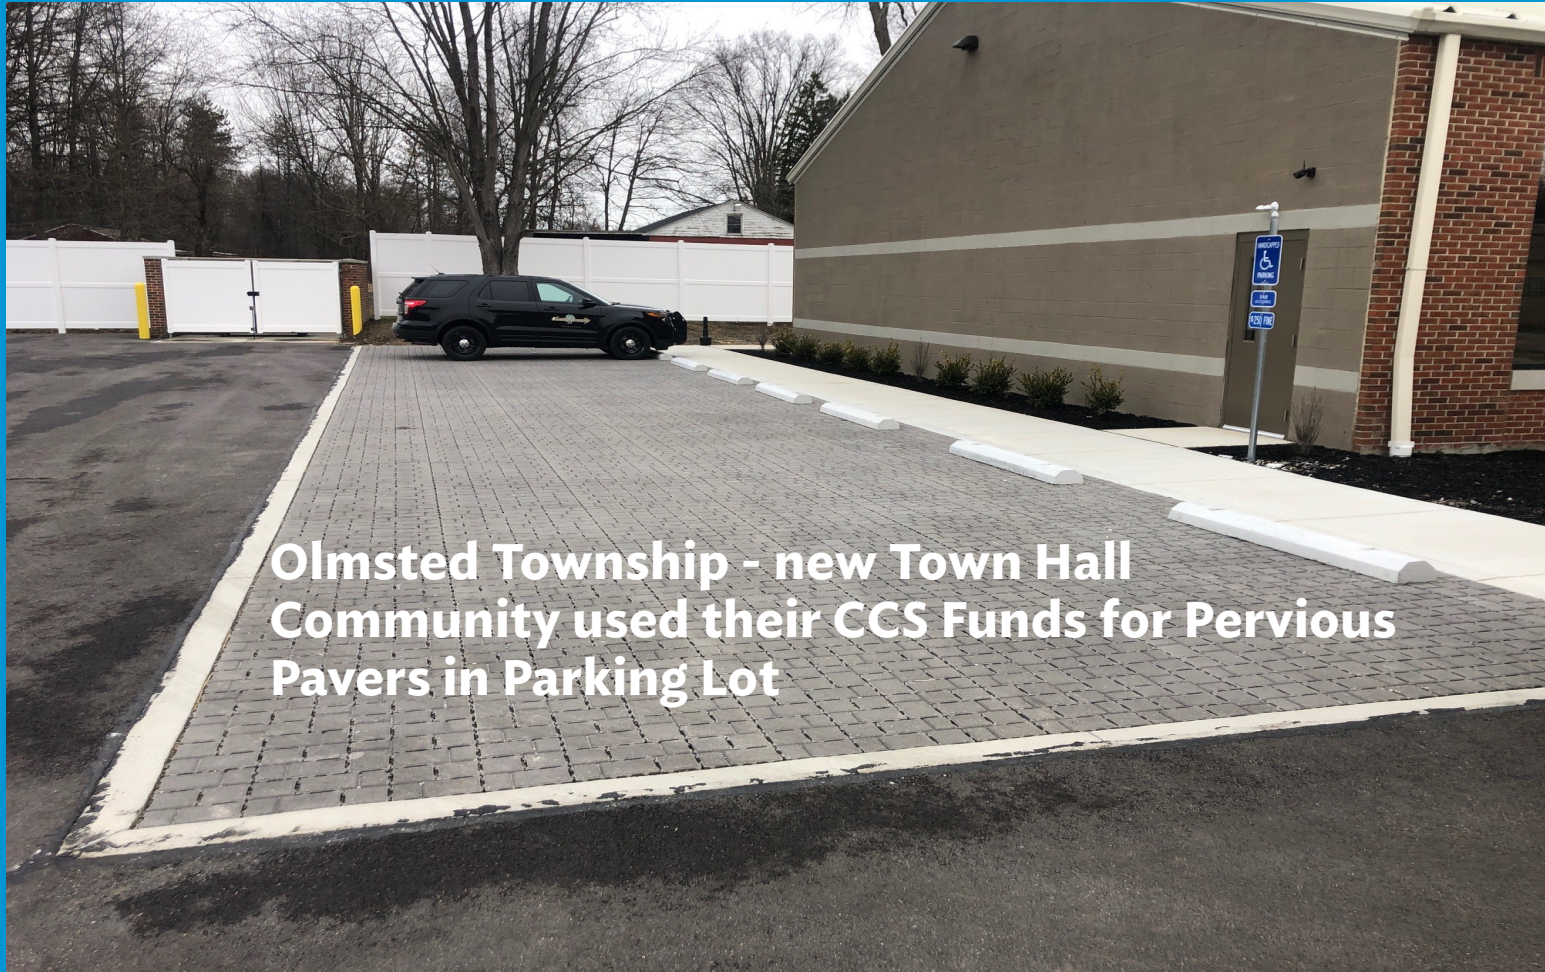
Olmsted Township - new Town Hall
Community used their CCS Funds for Pervious
Pavers in Parking Lot

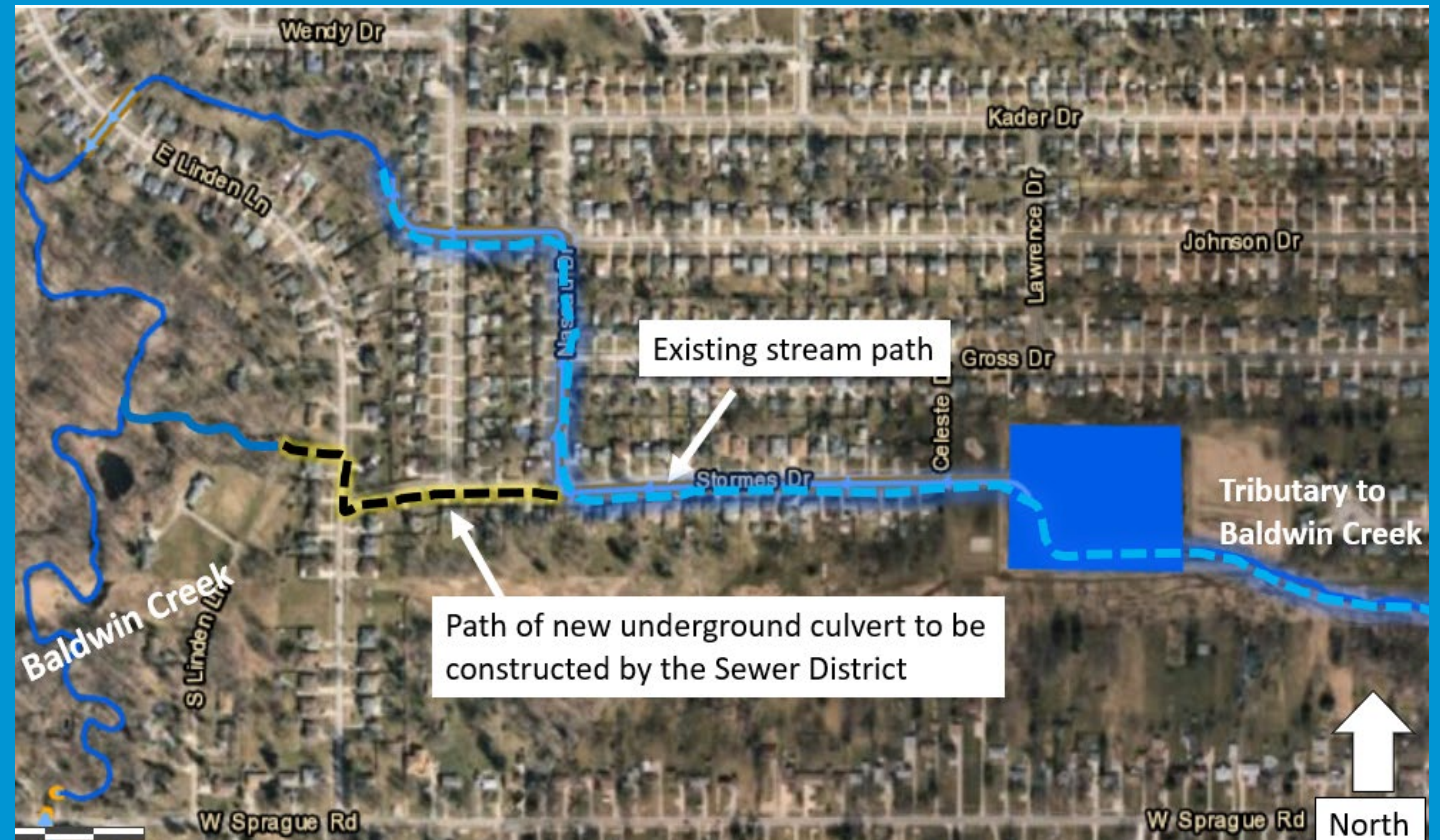
Baldwin Creek Relief Culvert at Stormes Drive

Project Goals:

- Reduce flood risk
- Increase conveyance with new culvert

- Almost all work is being performed in public R/W
- Future basin expansion project will continue to reduce flood risk in this neighborhood
