Watershed Advisory Committee

Rocky River

October 10, 2019

NORTHEAST OHIO REGIONAL SEWER DISTRICT

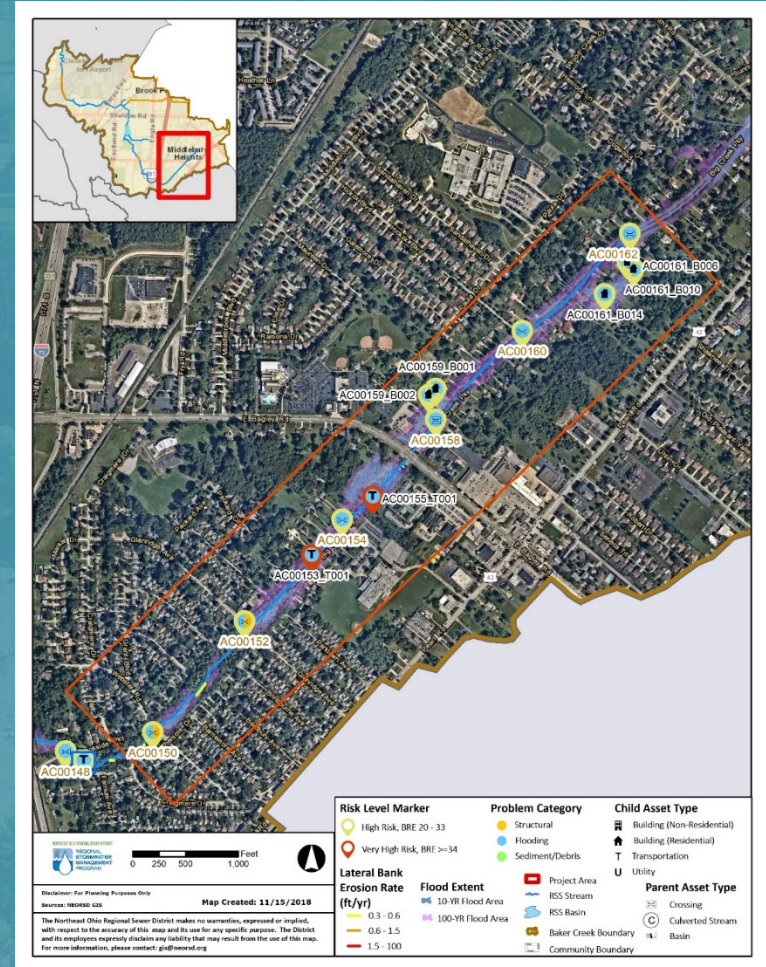
Big Creek Parkway – Existing Conditions

Asset ID	Problem Asset Type	Issue(s)
AC00150	Crossing	Hydraulic: overtopping in 100-year event, exceeds entrance/exit velocity in 2-year event
AC00152	Crossing	Structural: crossing inspection revealed poor cover and concrete conditions Hydraulic: overtopping in 100-year event, exceeds entrance/exit velocity in 2-year event
AC00154	Crossing	Hydraulic: overtopping in 100-year event
AC00158	Crossing	Hydraulic: overtops in 100-year event
AC00160	Crossing	Hydraulic: overtops in 100-year event
AC00162	Crossing	Hydraulic: overtops in 100-year event
AC00153	Open Stream and BTU – Transportation	Hydraulic: child asset AC00153_T001 overtops in the 100-year event
AC00155	Open Stream and BTU – Transportation	Hydraulic: child asset AC00155_T001 overtops in the 100-year event
AC00159	Open Stream and BTU- Buildings	Hydraulic: child asset AC00159_B001 is predicted to suffer flooding damage in the 100-year storm
		Hydraulic: child asset AC00159_B002 is predicted to suffer flooding damage in the 100-year storm

Hydraulic: child asset AC00161_B006 is predicted to suffer flooding damage in the 100-year storm
AC00161	Open Stream and BTU- Building	Child asset AC00161_B010 is predicted to suffer flooding damage in the 100-year storm
		Child asset AC00161_B014 is predicted to suffer flooding damage in the 100-year storm

Under existing conditions, street flooding begins in ~2-year design storm

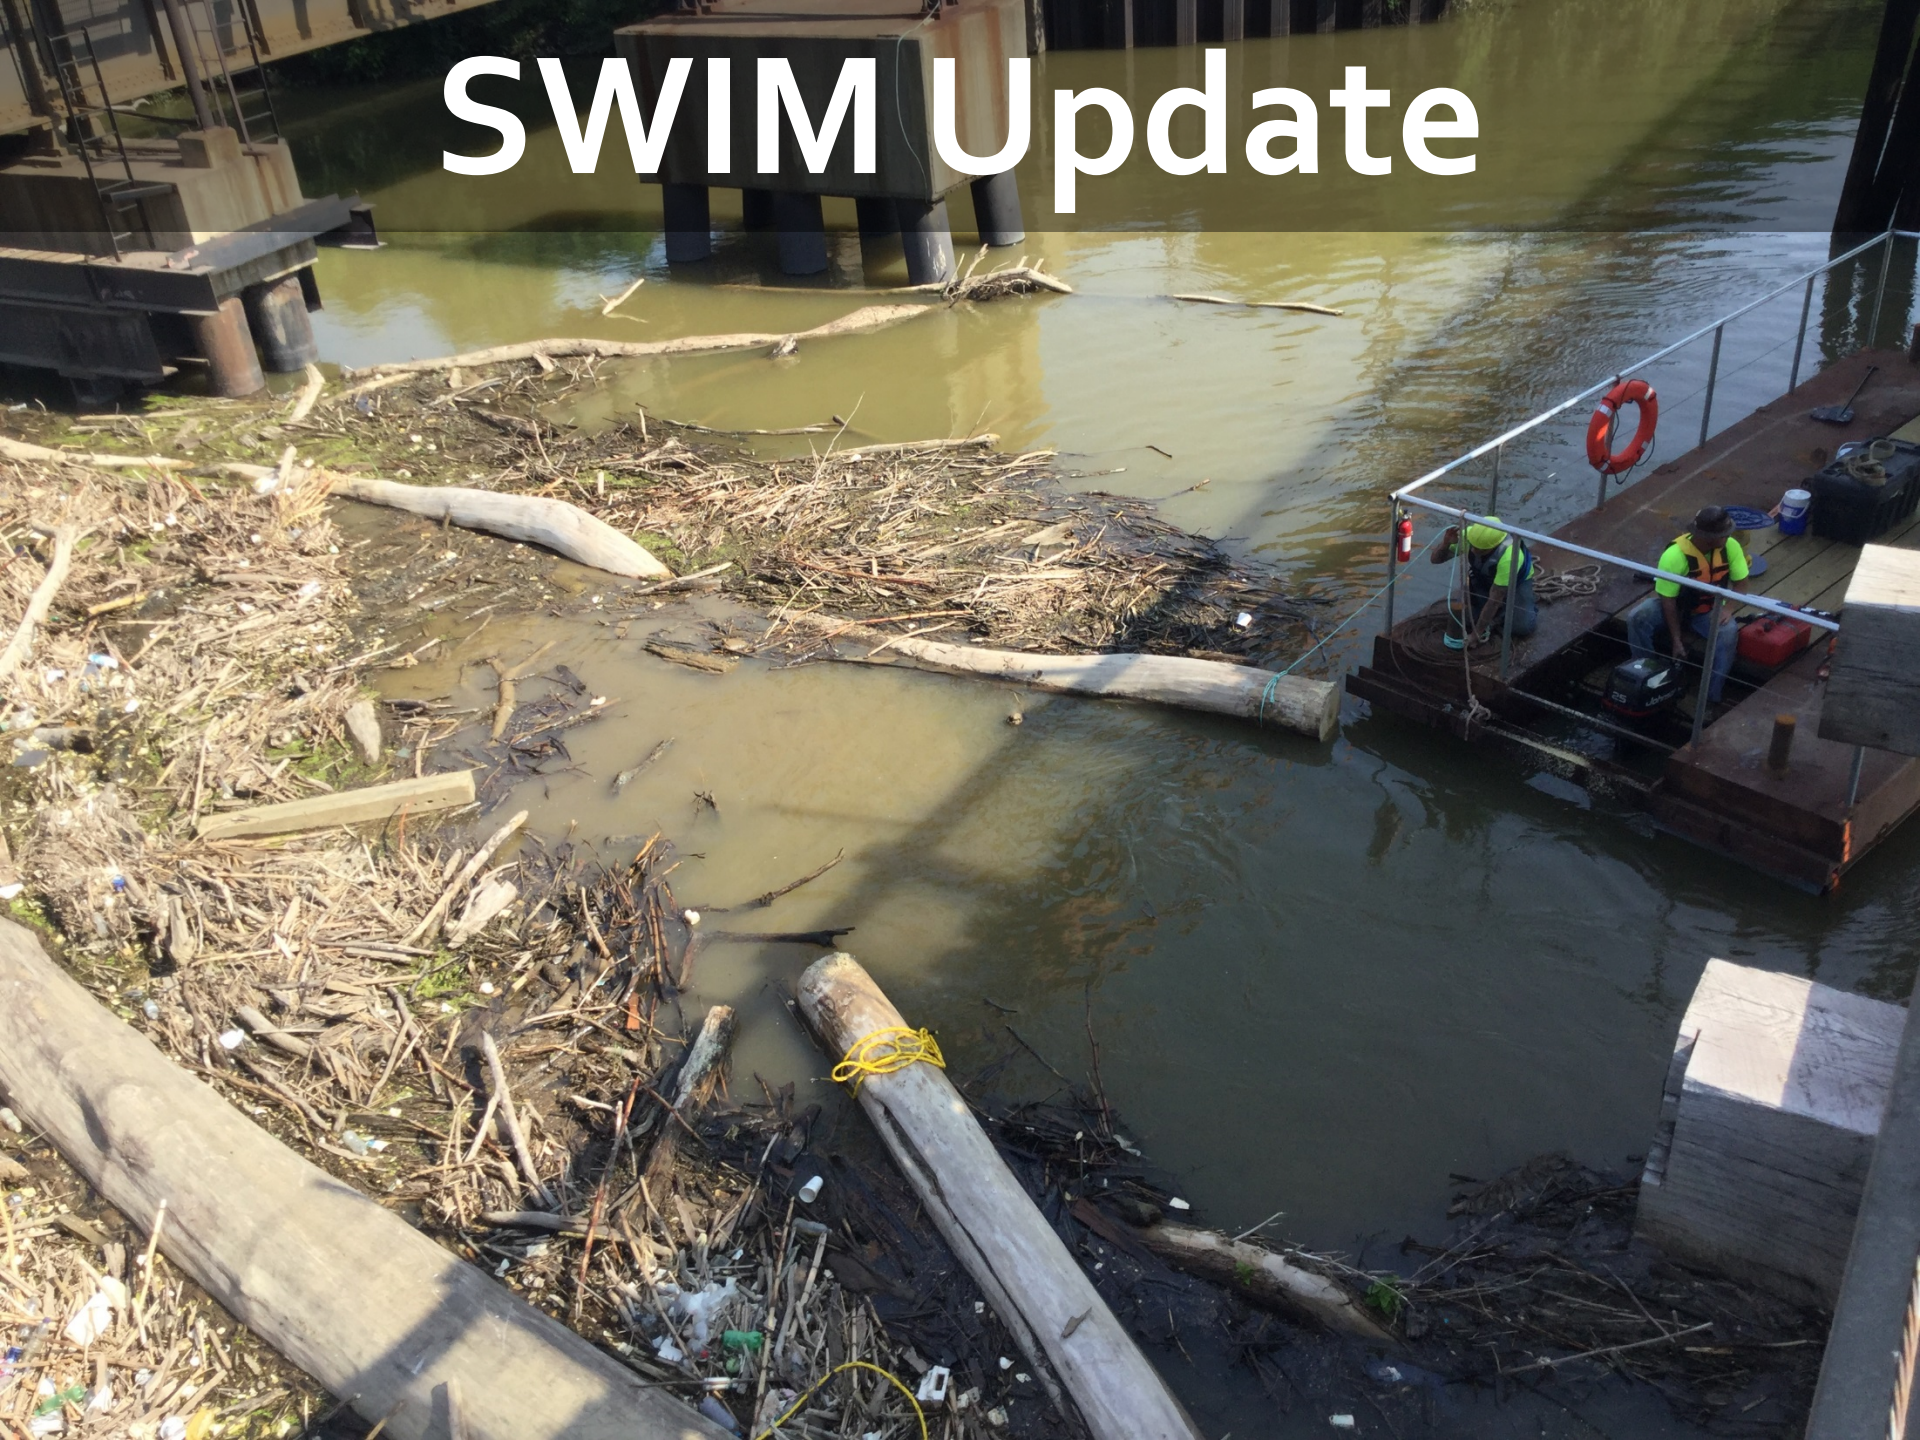
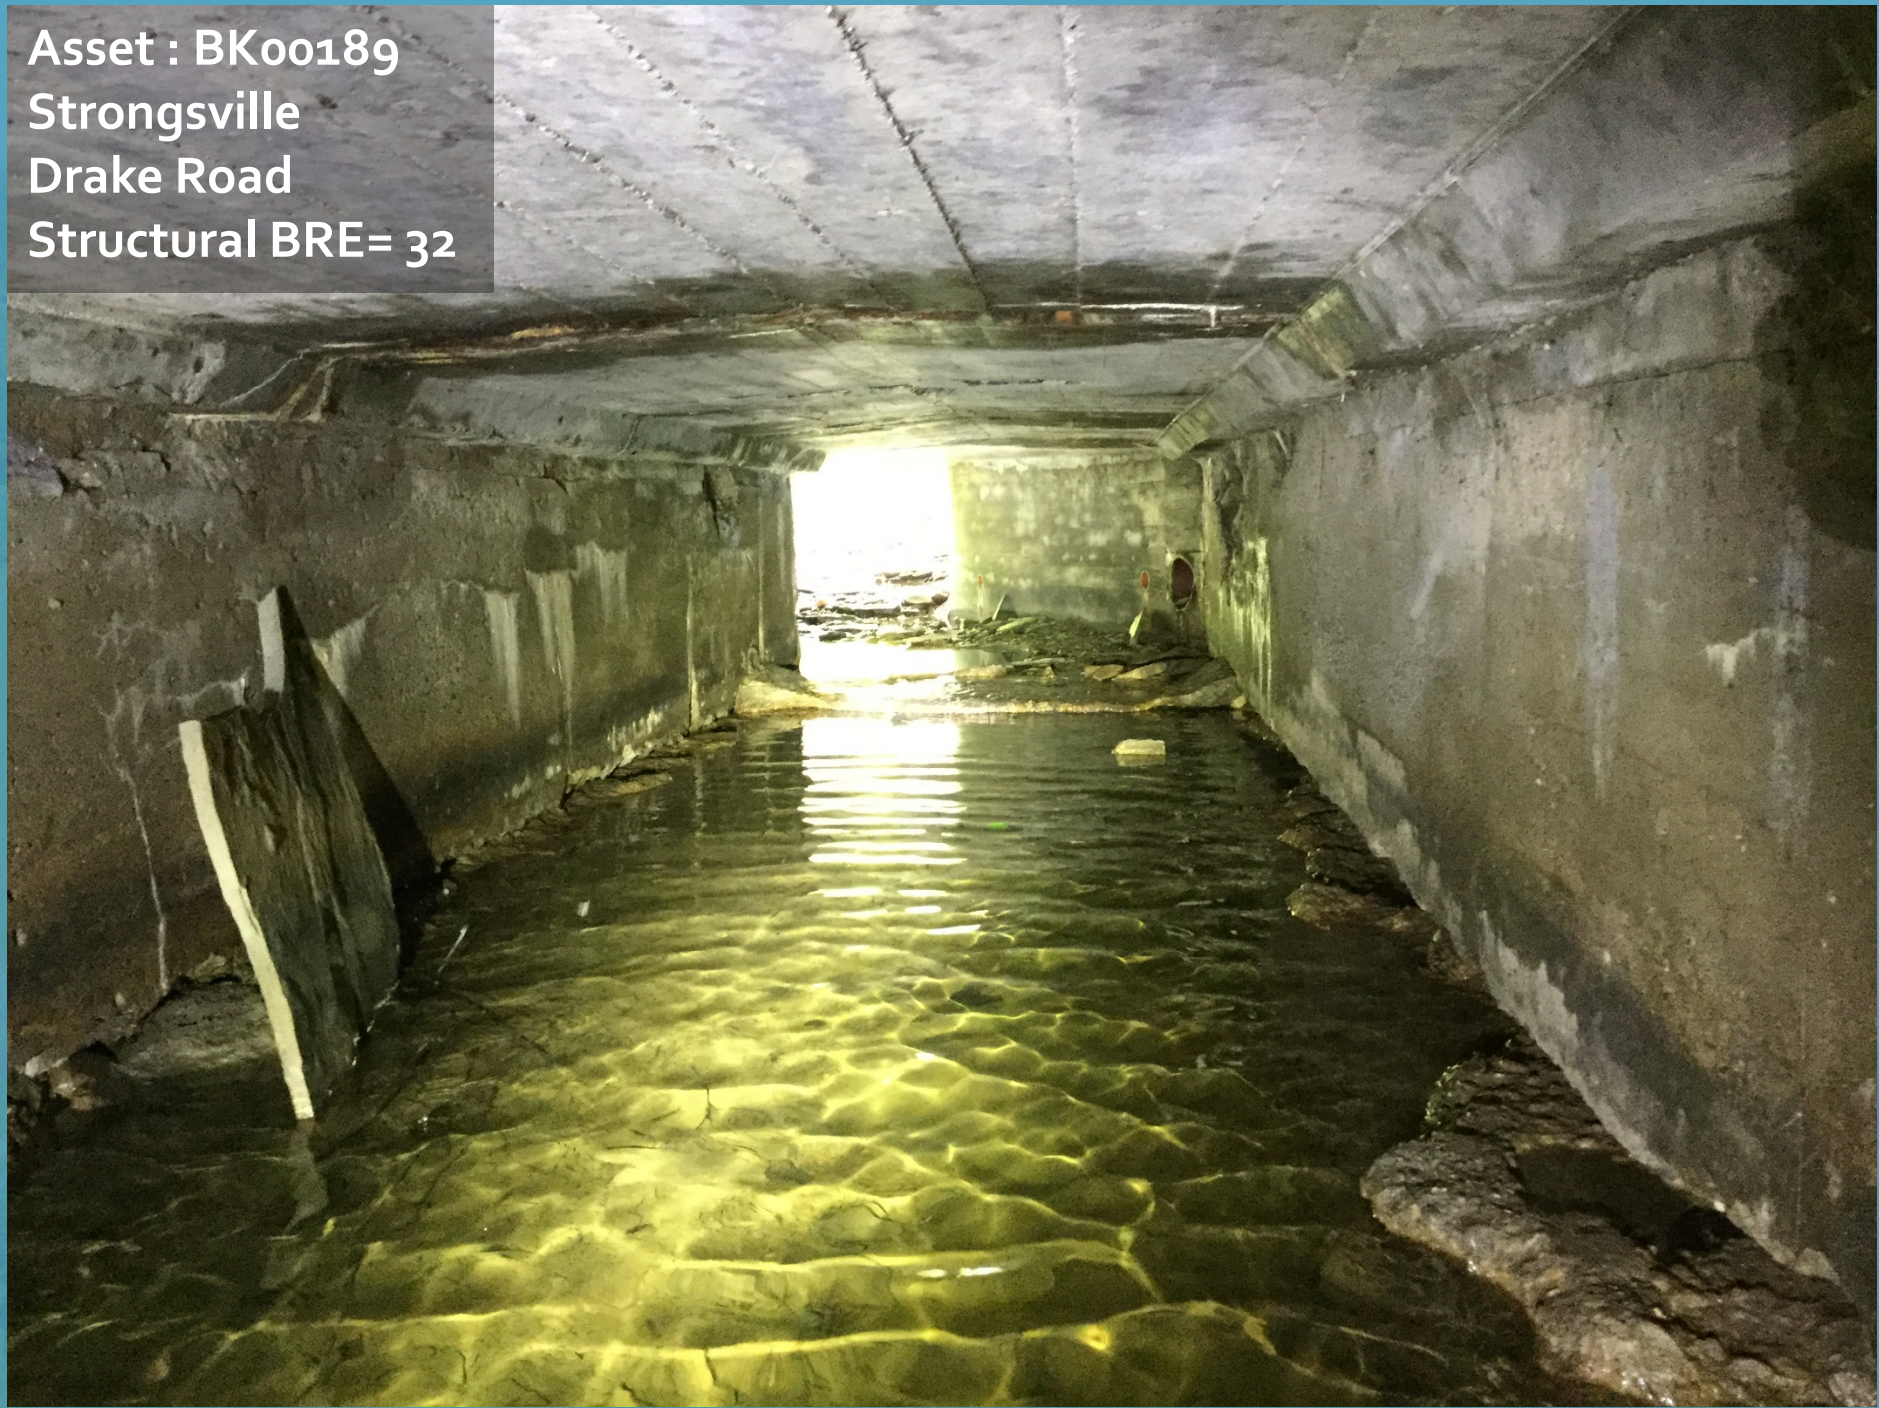
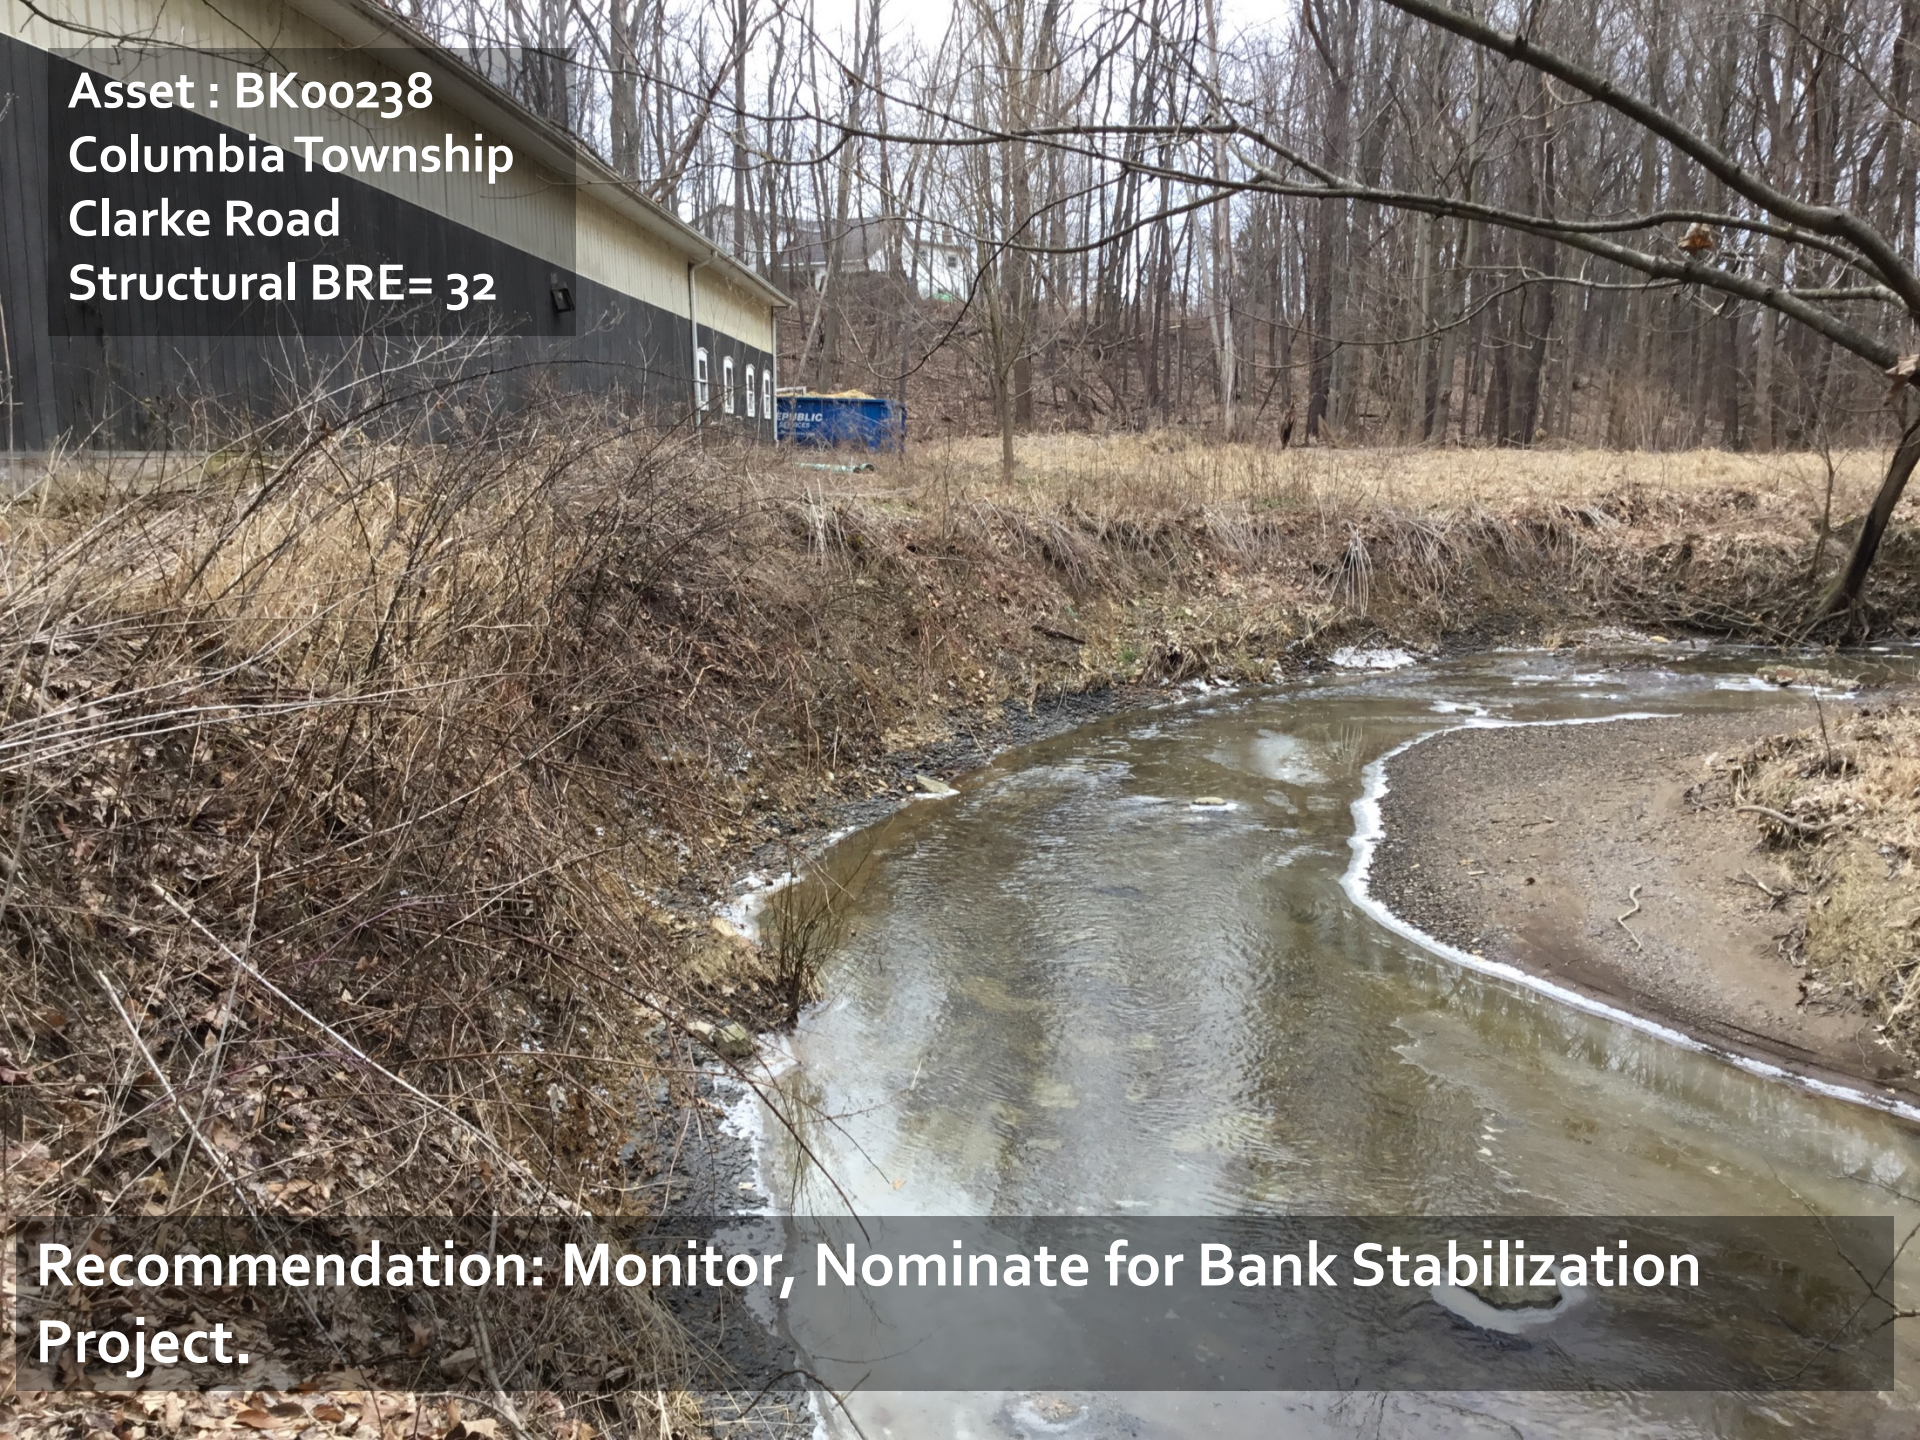
Asset : BK00238
Columbia Township
Clarke Road
Structural BRE= 32

Asset : BK00189
Strongsville
Drake Road
Structural BRE= 32

A photograph of a stream with a dark building on the left bank and a wooded area in the background. The stream is in the foreground, with a dark, possibly black, building on the left bank. The building has several windows and a blue dumpster in front of it. The background is a wooded area with bare trees. The stream is surrounded by dry grass and brush. The water is dark and reflects the sky. The overall scene is in a rural or semi-rural setting.

Recommendation: Monitor, Nominate for Bank Stabilization Project.

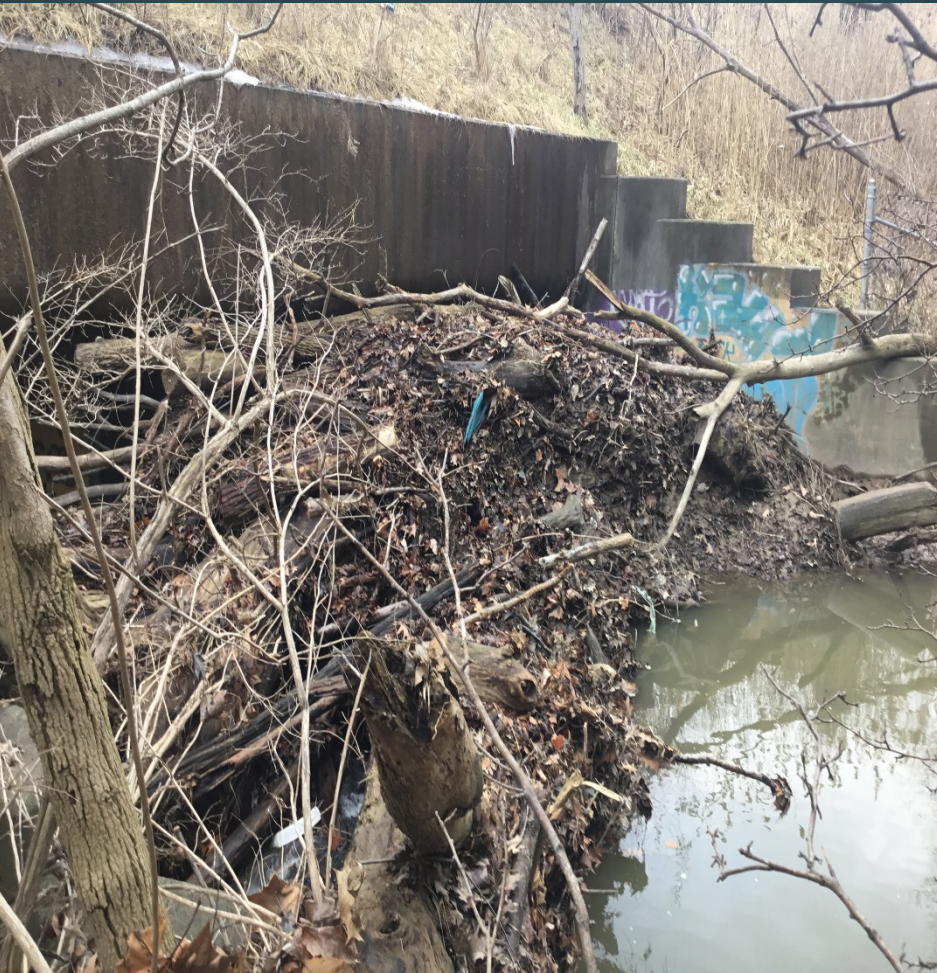
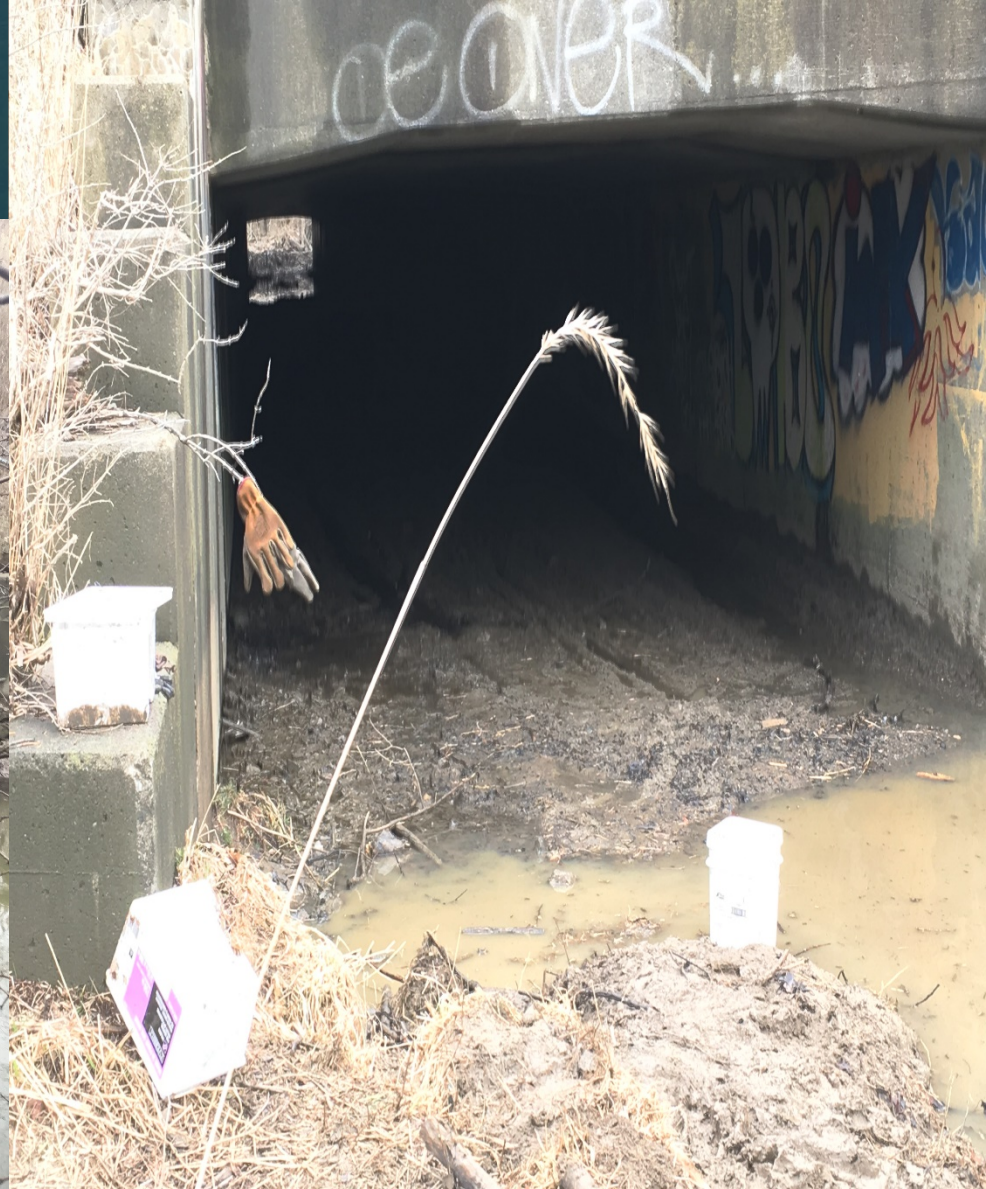
Debris Maintenance: Baldwin Creek

Asset #: BD00233

Middleburg Hts: I-71 Crossing Club

Debris BRE=45

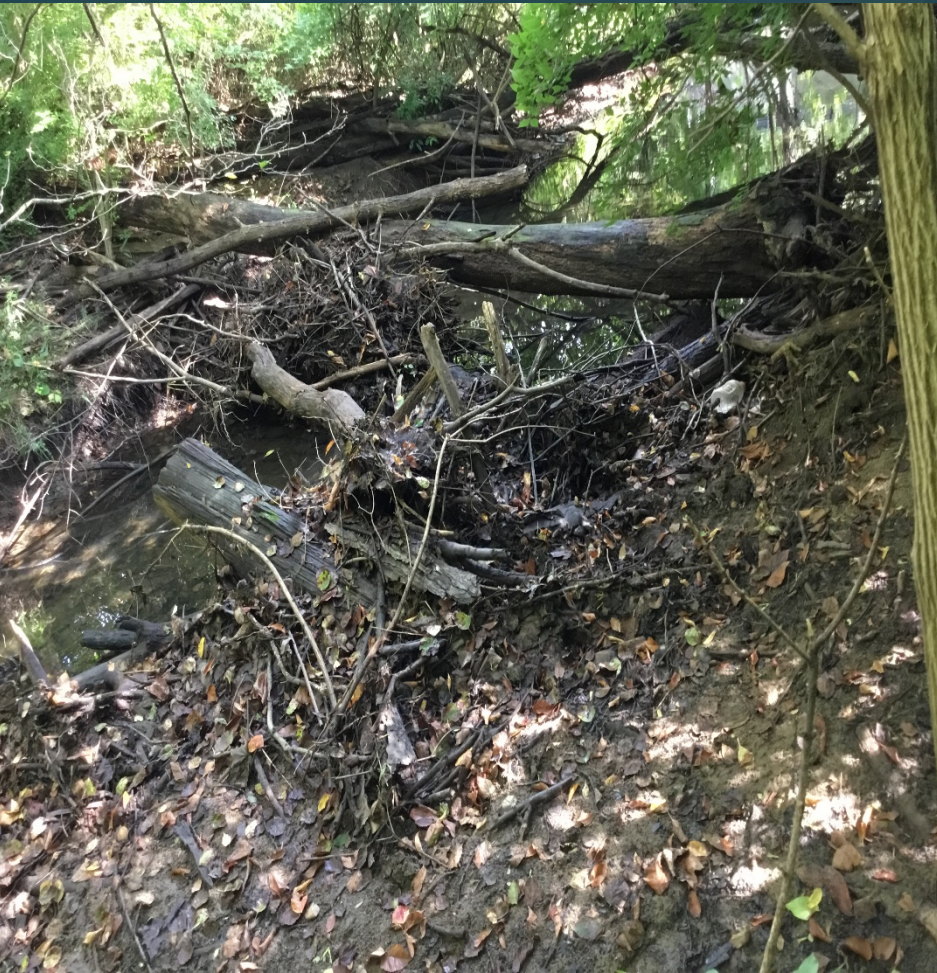
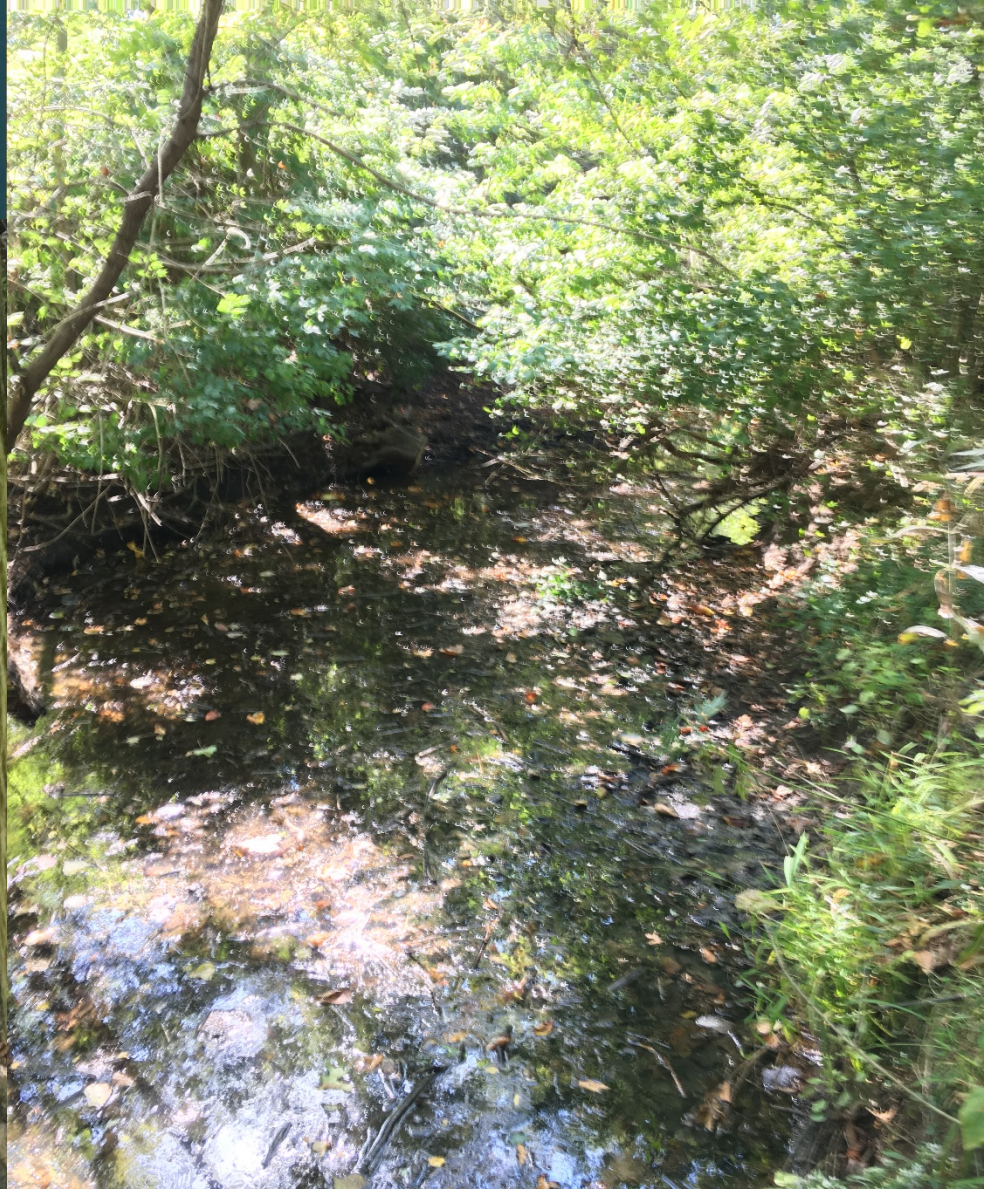
Debris Maintenance: Minnie Creek

Asset #: MN00102

Olmsted Twp: Columbia Park

Debris BRE=12

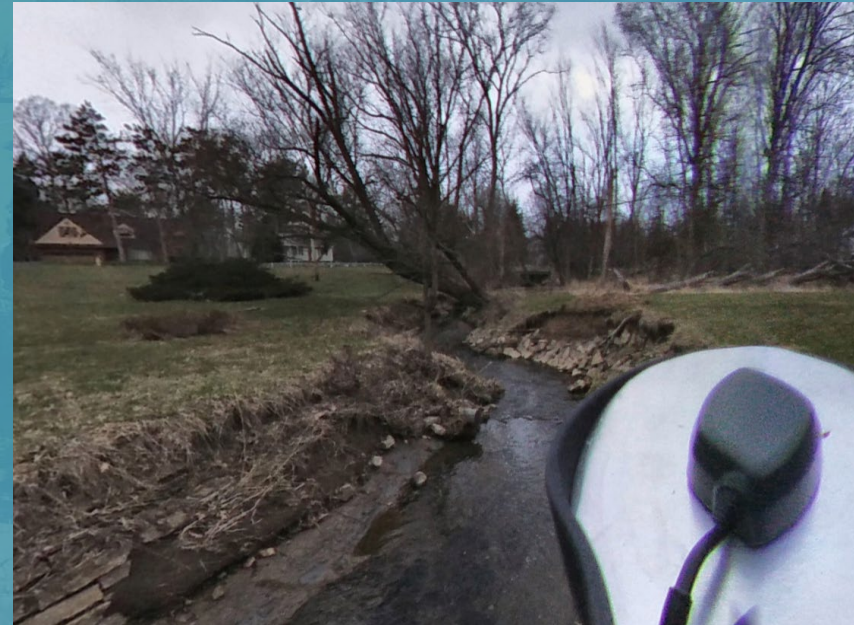
Baldwin Creek – Stabilization near Abbey Road

- Stabilize stream banks from lateral and vertical erosion
- Improve stream function
- Upsize existing crossing

Current Design Phase: 30% Design
Est. Construction Cost: \$330,000

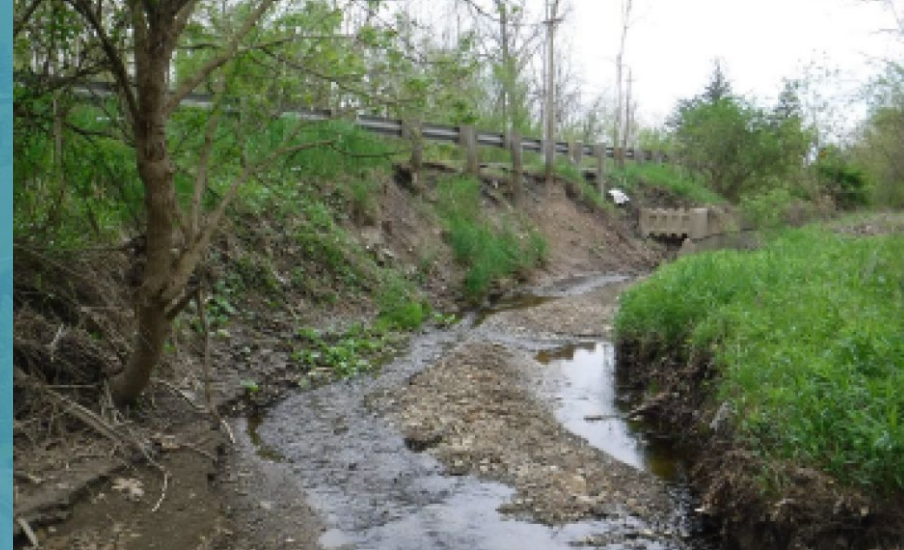
Baldwin Creek – Stabilization along Ridge Road

- Relocate channel to reduce future erosion risks
- Improve stream function and habitat
- Mitigate risk to Ridge Road embankment

Current Design Phase: 90% Design
Est. Construction Cost: \$430,000

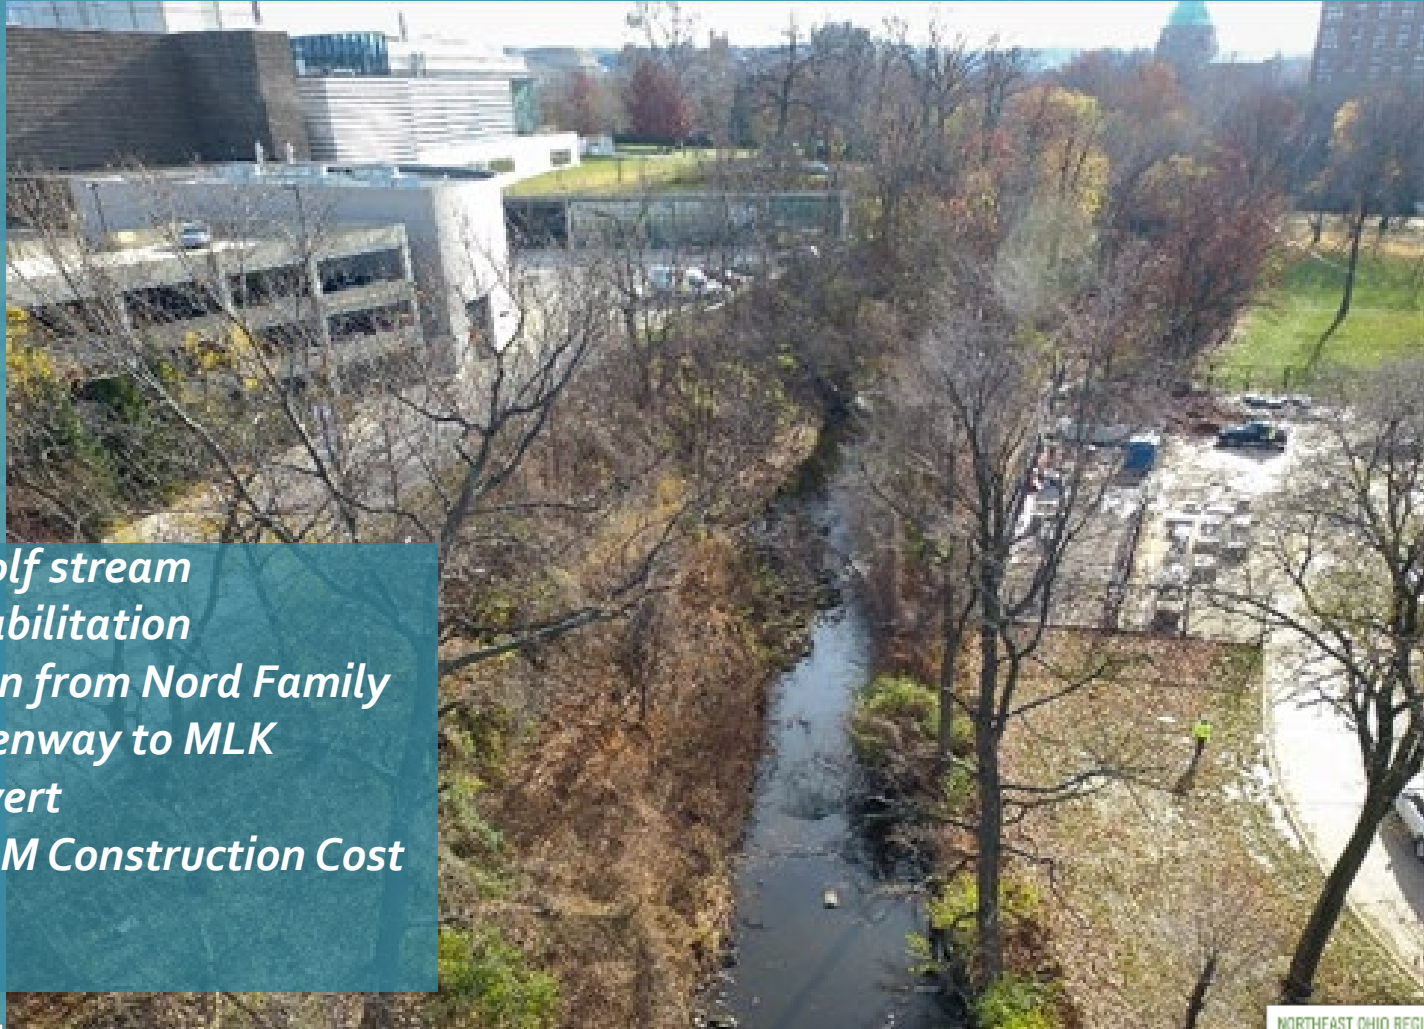
Doan Brook Streambank Stabilization

- *1000lf stream rehabilitation*
- *Tie in from Nord Family Greenway to MLK Culvert*
- *\$2.4M Construction Cost*

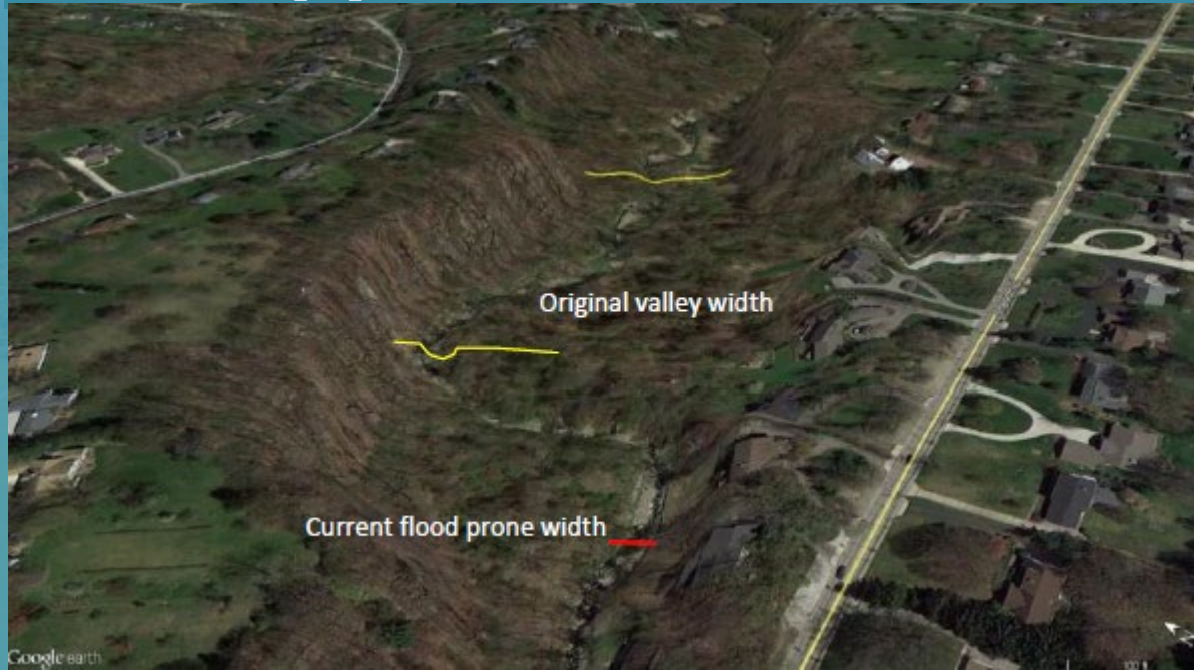
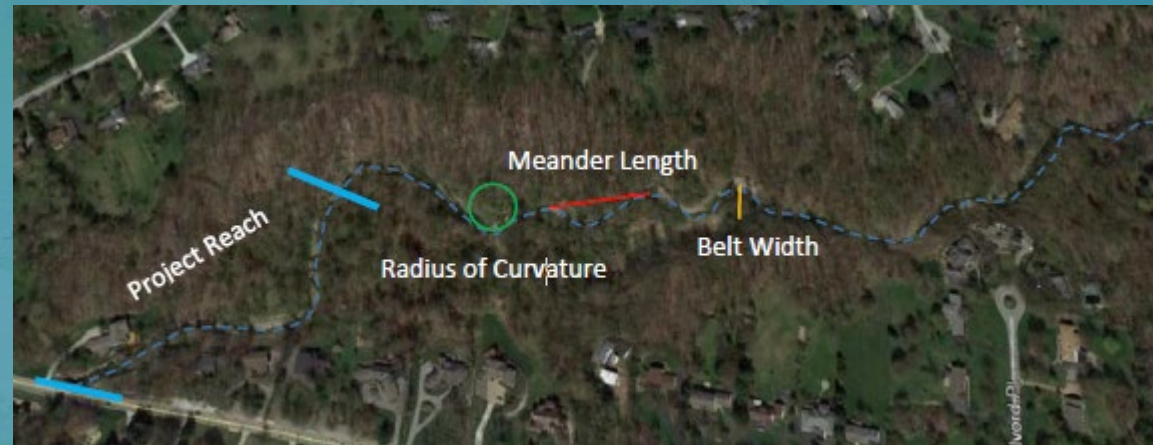
Pepper Creek Bank Stabilization

- *Subject reach was significantly modified to accommodate construction of Shaker Boulevard Bridge and residential home sites*

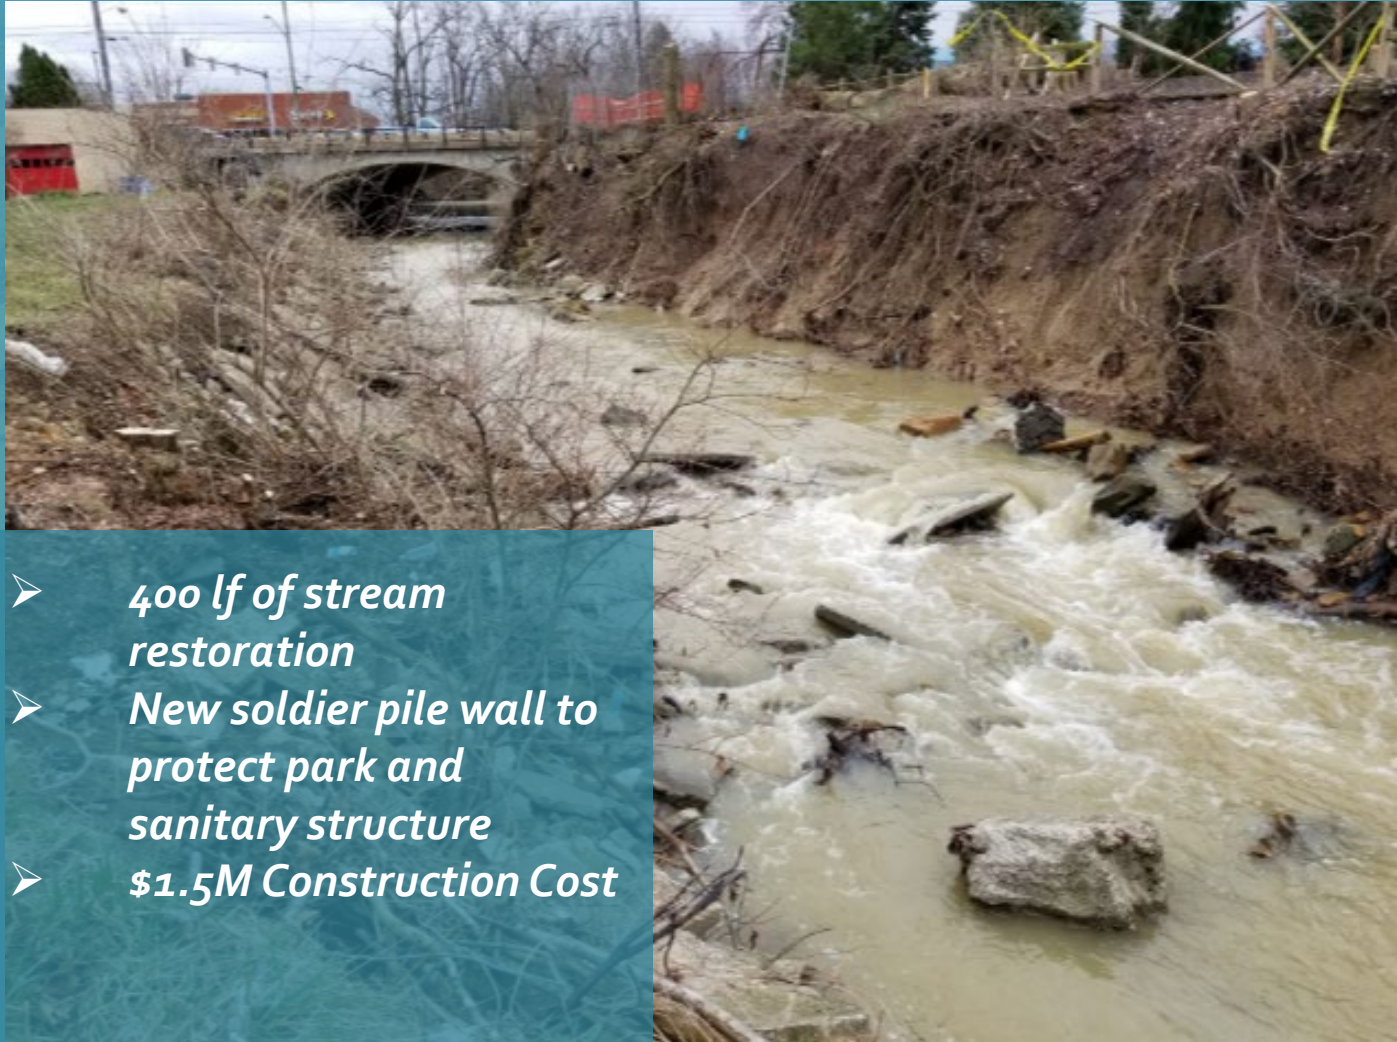
Colombo Park Stream Restoration

- *400 lf of stream restoration*
- *New soldier pile wall to protect park and sanitary structure*
- *\$1.5M Construction Cost*

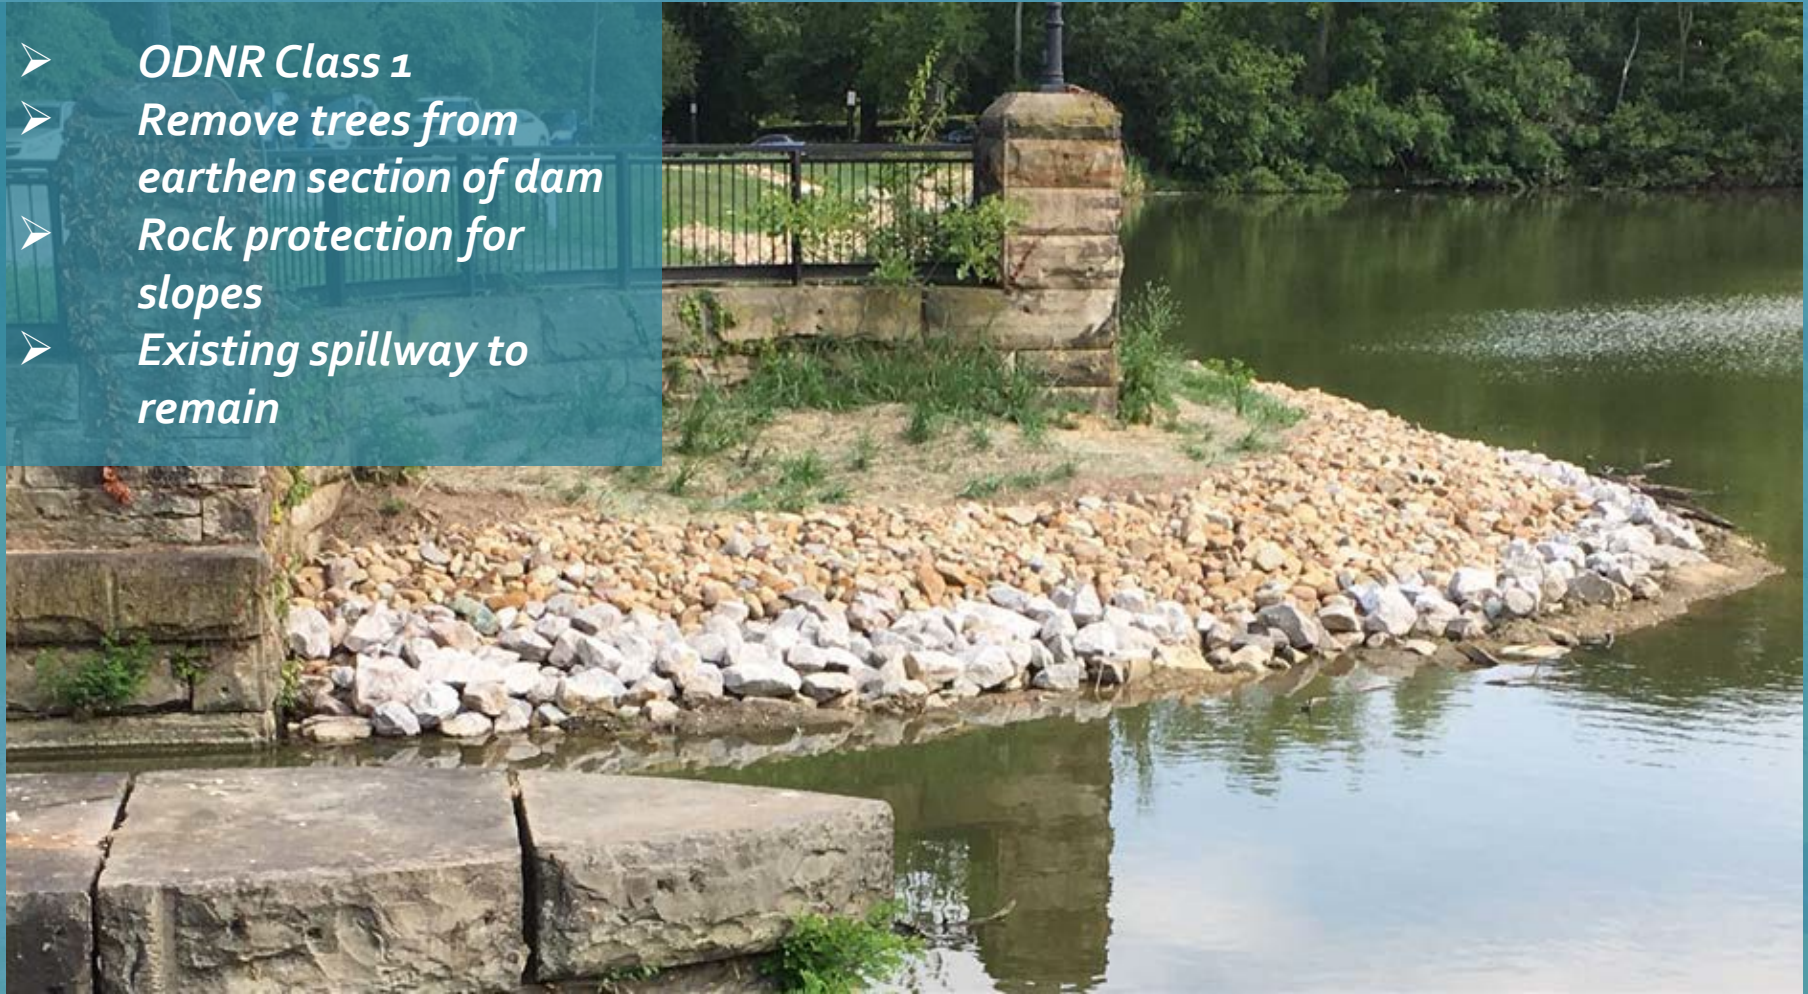
Lower Lake Dam Rehabilitation

- *ODNR Class 1*
- *Remove trees from earthen section of dam*
- *Rock protection for slopes*
- *Existing spillway to remain*

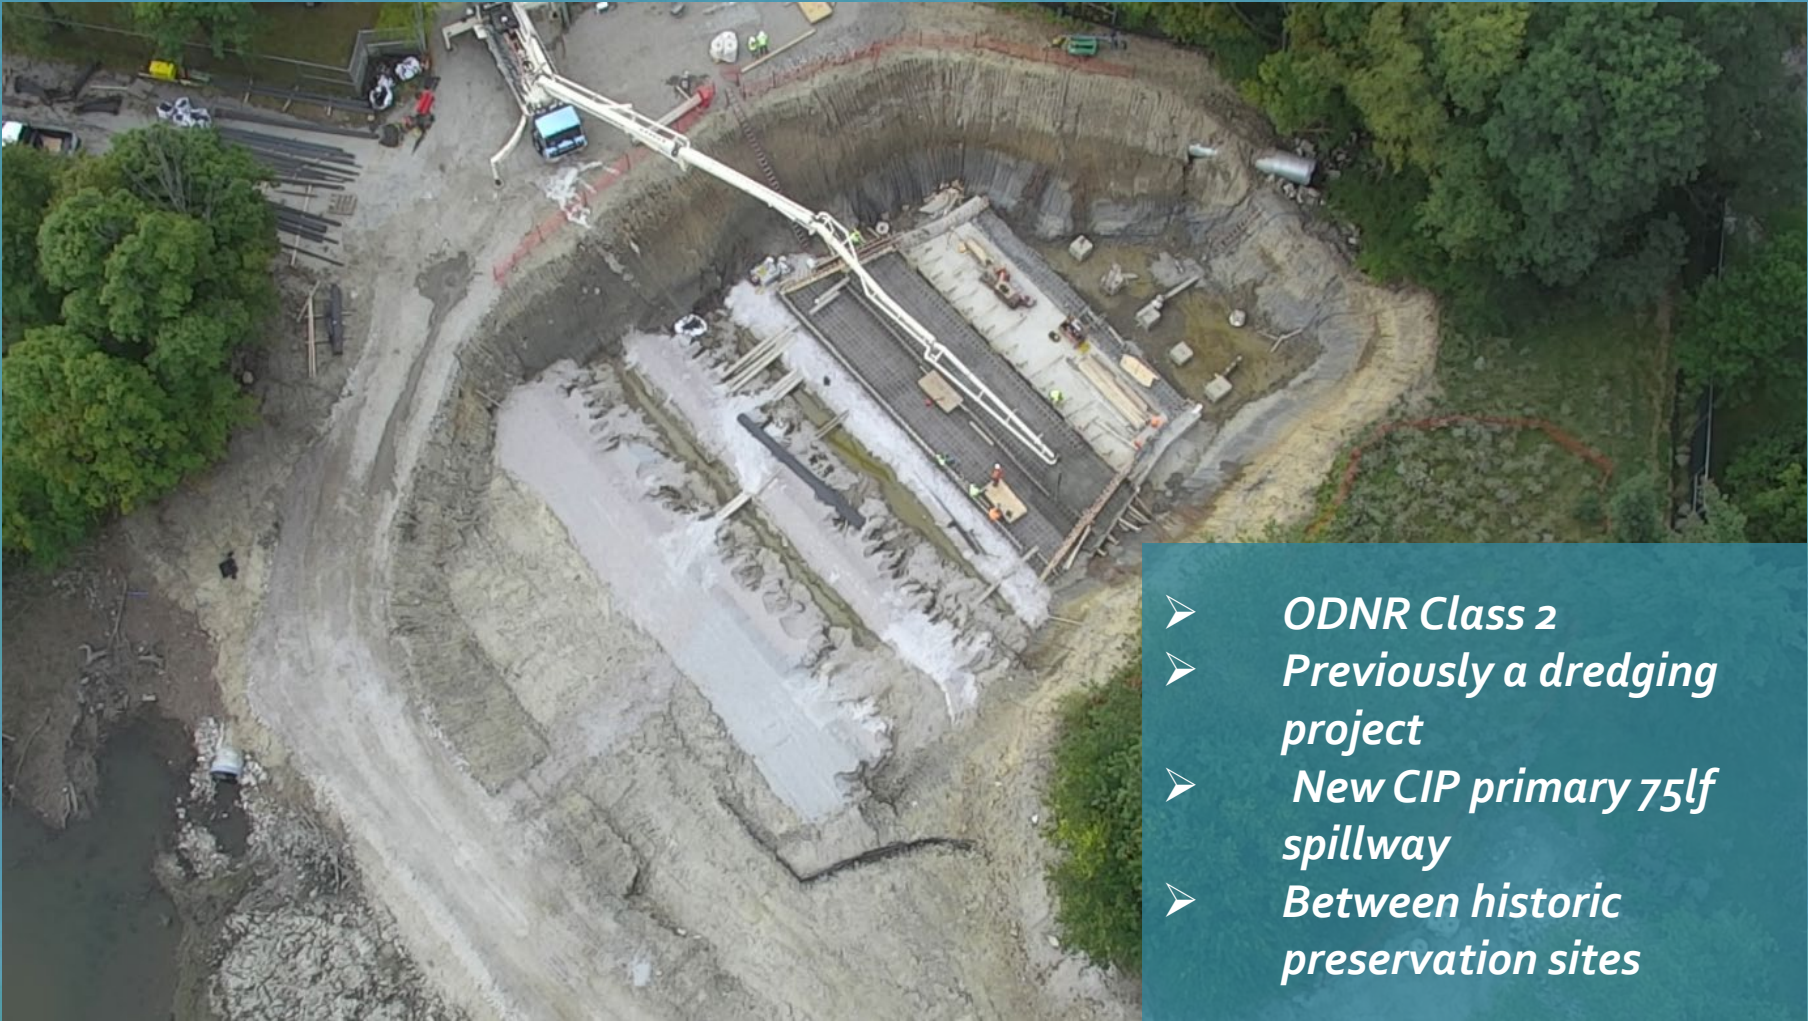
Green Lake Dam Rehabilitation

- *ODNR Class 2*
- *Previously a dredging project*
- *New CIP primary 75lf spillway*
- *Between historic preservation sites*
