*Watershed Advisory Committee
 Rocky River
 March 2018*

NORTHEAST OHIO REGIONAL SEWER DISTRICT

REGIONAL STORMWATER MANAGEMENT PROGRAM

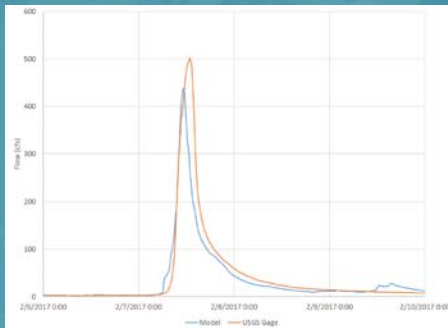
Flow

Modeling Calibration – Baker

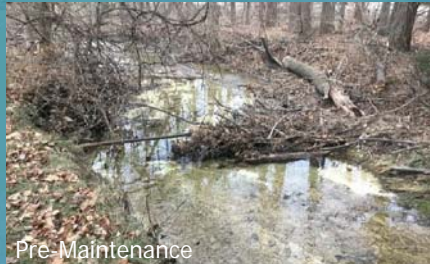
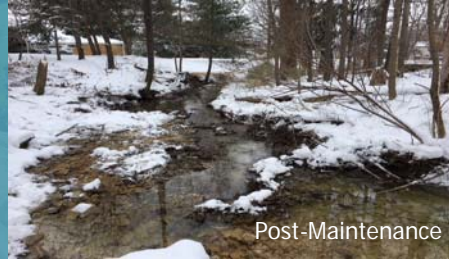
Asset ID: BK00188

Maintenance Project: Debris Removal (12 CY)

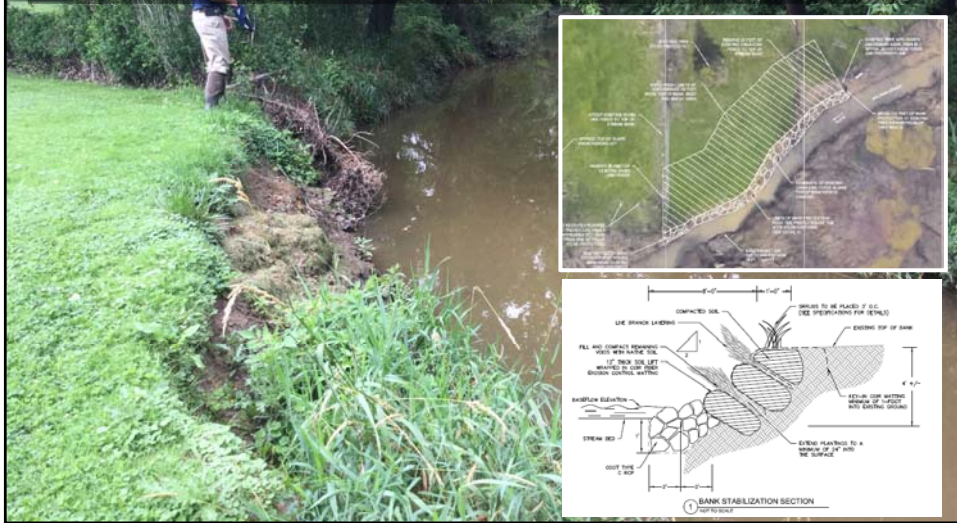
Asset ID: BD00250 – Streambank Stabilization

Non-Routine Maintenance Site

Parma: W Pleasant Valley Road

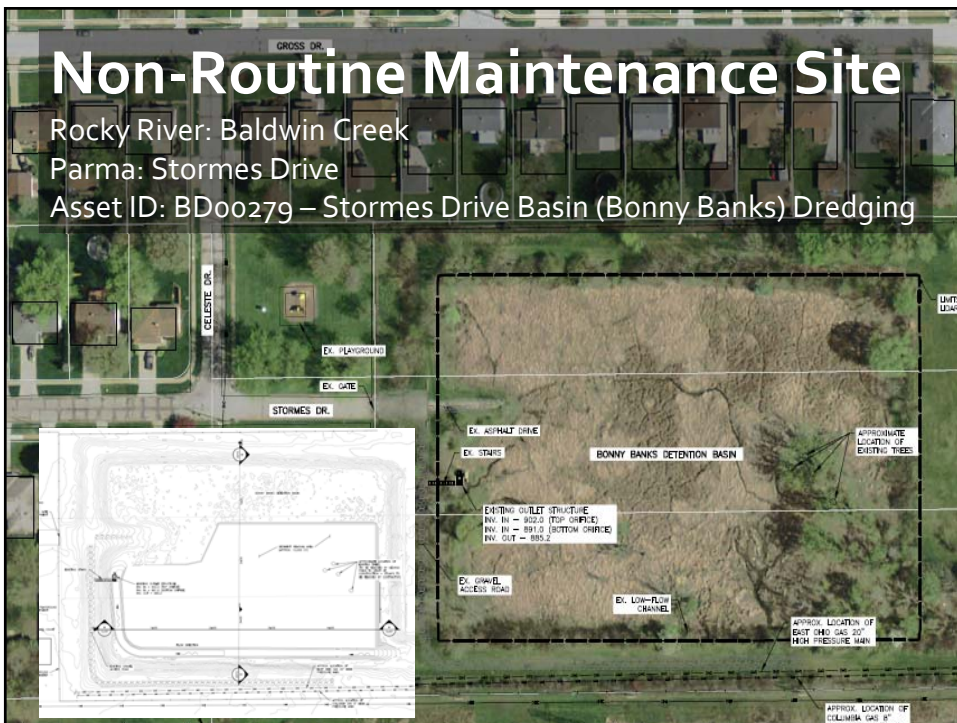
Asset ID: BD00279 – Stormes Drive Basin (Bonny Banks) Dredging

Non-Routine Maintenance Site

Parma: Stormes Drive

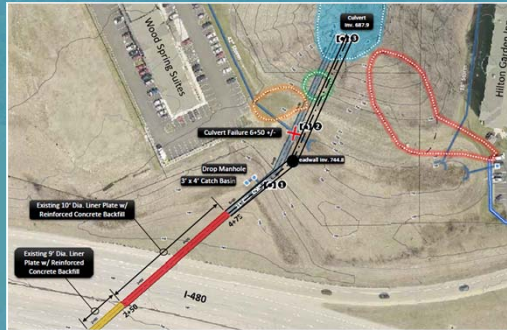
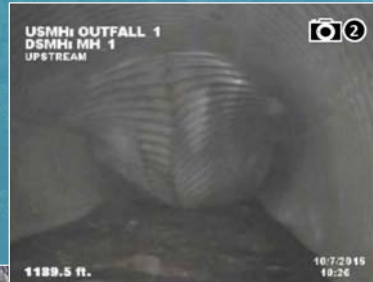
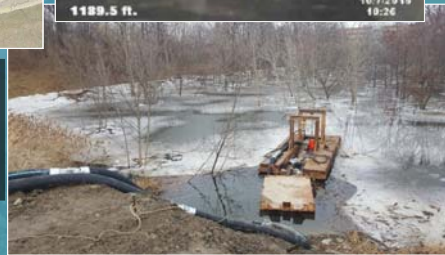
Emerald Parkway Culvert Repair
 Est. Substantial Completion: June 1, 2018
 Construction Cost: \$4,700,000

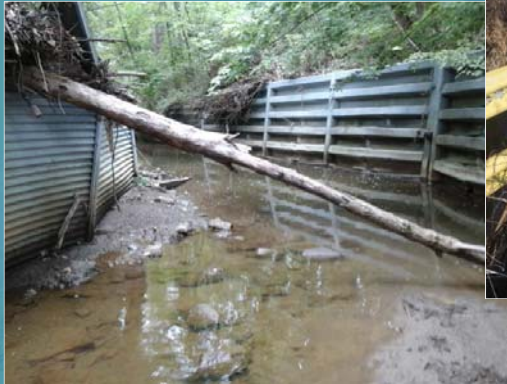
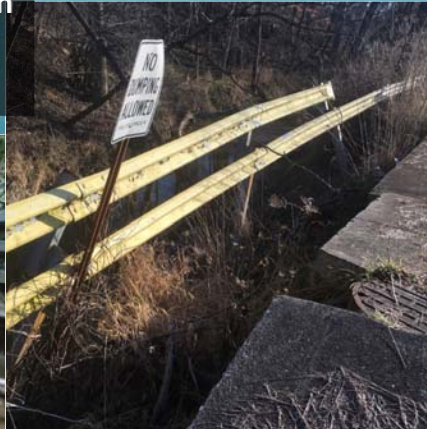
Baldwin Creek Bank Stabilization

Anticipated Construction NTP: June 2018

Estimated Construction Cost: \$1,170,000

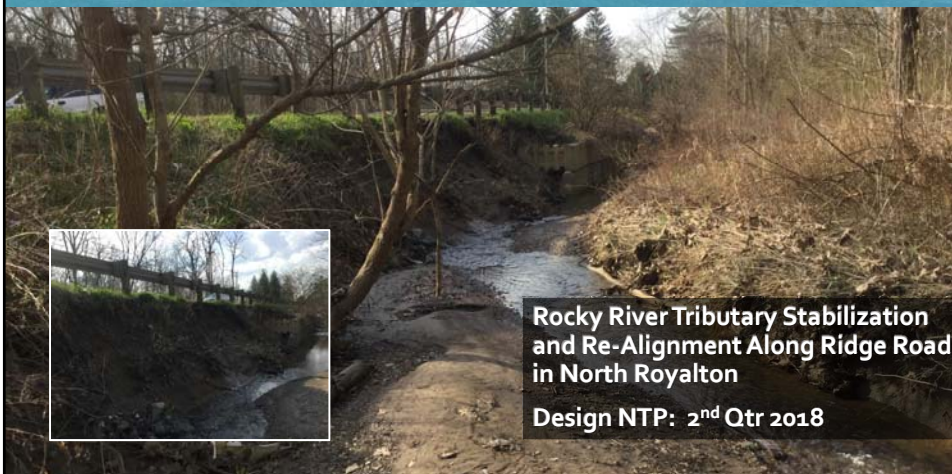
Rocky River Tributary Stabilization and Re-Alignment Along Ridge Road in North Royalton

Design NTP: 2nd Qtr 2018

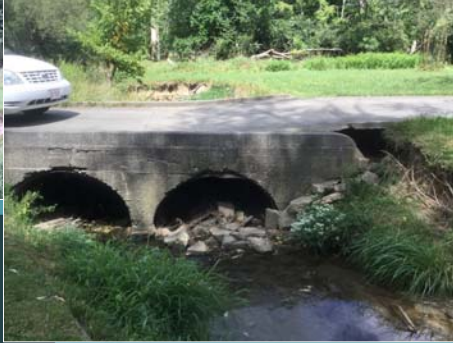
**Baldwin Creek Stabilization
Near Abbey Road in North
Royalton**

Design NTP: 2nd Qtr 2018

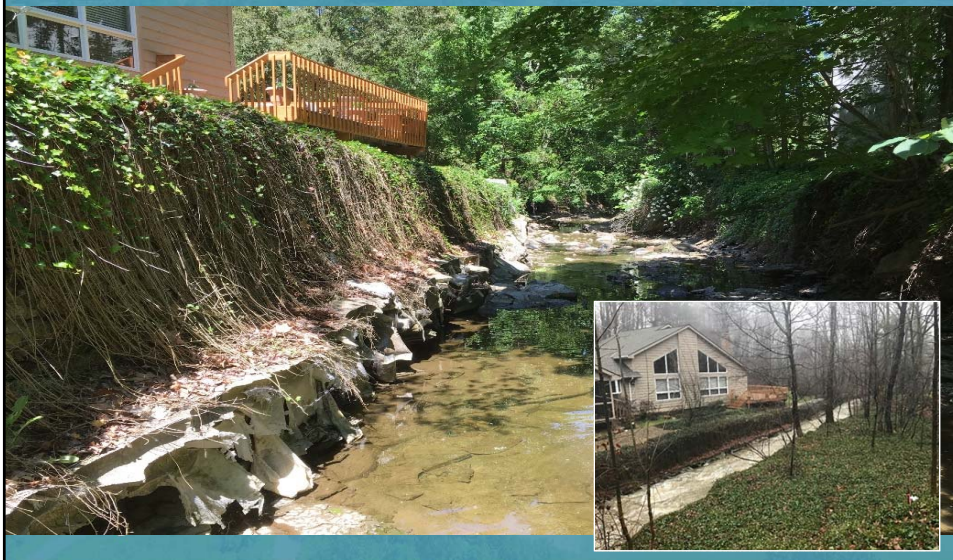
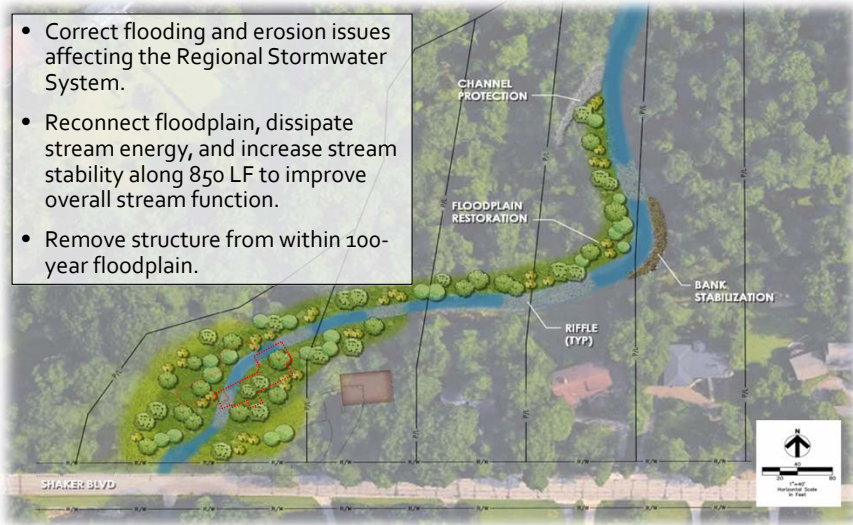
Pepper Creek Restoration Pepper Pike

Pepper Creek Restoration Project Concept

- Correct flooding and erosion issues affecting the Regional Stormwater System.
- Reconnect floodplain, dissipate stream energy, and increase stream stability along 850 LF to improve overall stream function.
- Remove structure from within 100-year floodplain.
