Watershed Advisory Committee
Rocky River
October 18, 2018

REGIONAL STORMWATER MANAGEMENT PROGRAM

Stormwater Master Plan

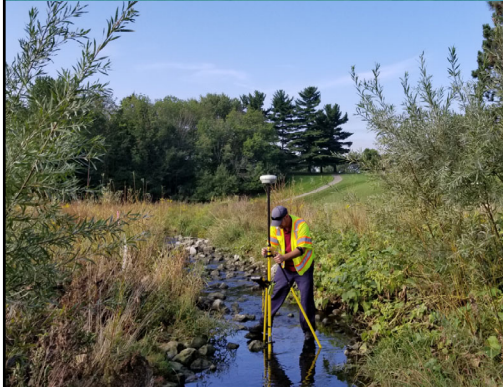
Field Work Project Status

Task Item Status – 80% Complete

- Survey work (646 cross sections)
- Culverted Stream Inspection (5.3 miles)
- Open Channel Streams (52 miles)
- Crossings (198 total)
- Major Structures (10 total)
- Basins (15 total)
- High Water Mark Monitoring
- Spherical Imagery (104 stream miles)

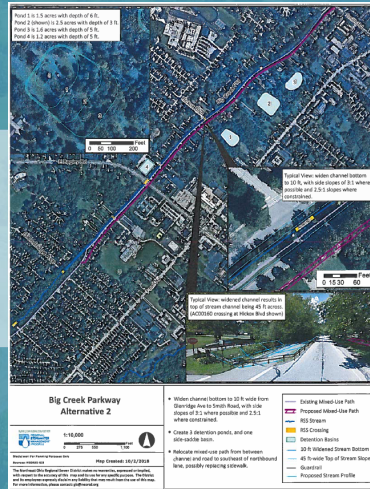
Alternative Evaluation Project Status

Task Item Status: 11% Complete

- Abrams Creek – In Progress
- Baker Creek – In Progress
- Big Creek Parkway - Complete
- Basin Evaluations – In Progress

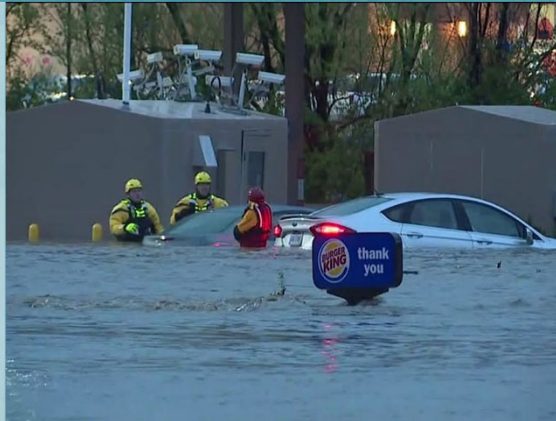
Sam's Club – Brooklyn, Ohio – Big Creek Subwatershed

Problem:

- Stormwater inundation and impacts to Sam's Club, Brookpark Road & surrounding areas including fueling station
- Brookpark Road overtops around a 1-yr. storm
- Sam's Club parking lot begins to flood between the 2- and 5- yr storms
- Water enters the Sam's Club Building around the 10-yr storm

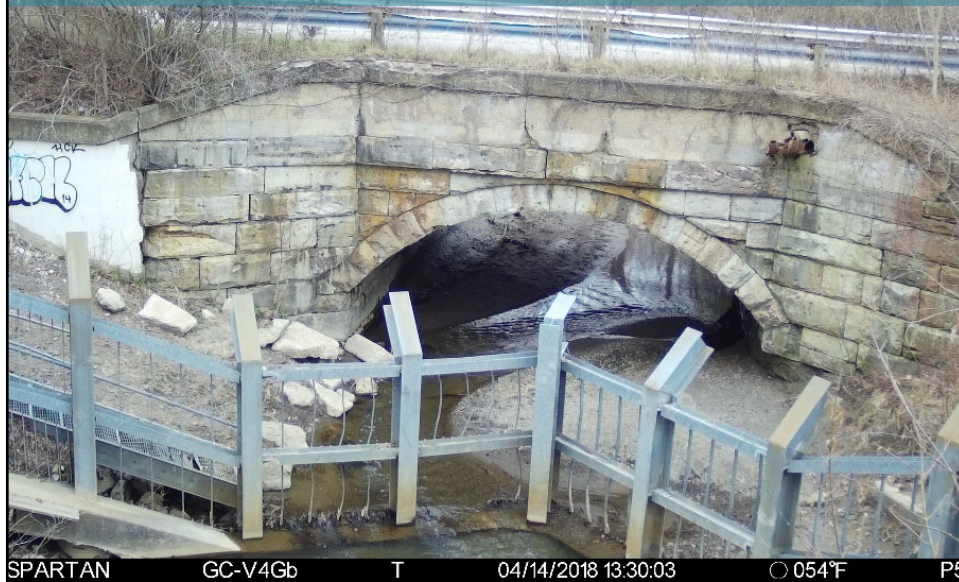
April 14, 2018: Debris Rack is Clear Before the Storm Event

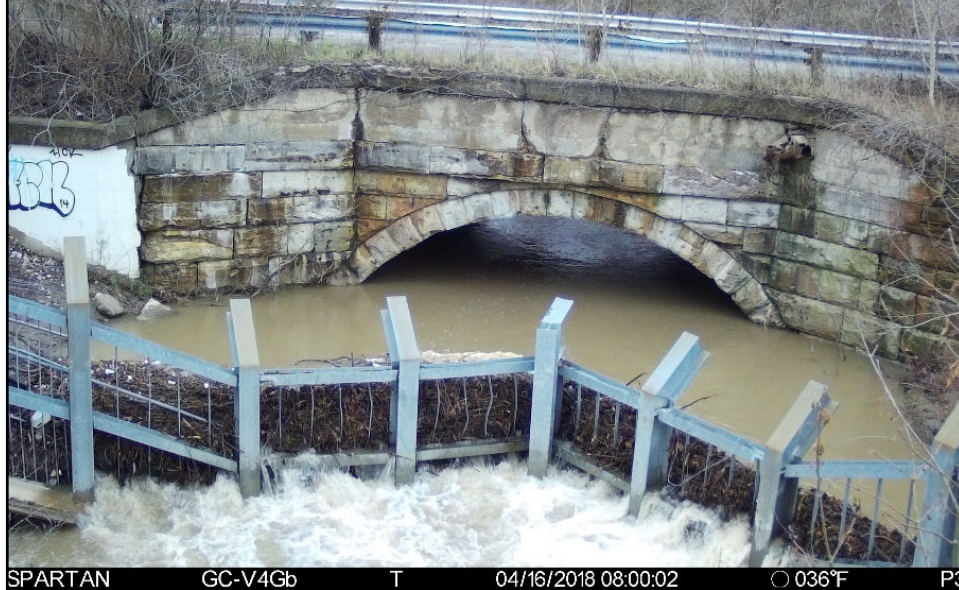
April 16, 2018: Peak Storm and Debris Accumulated on Rack

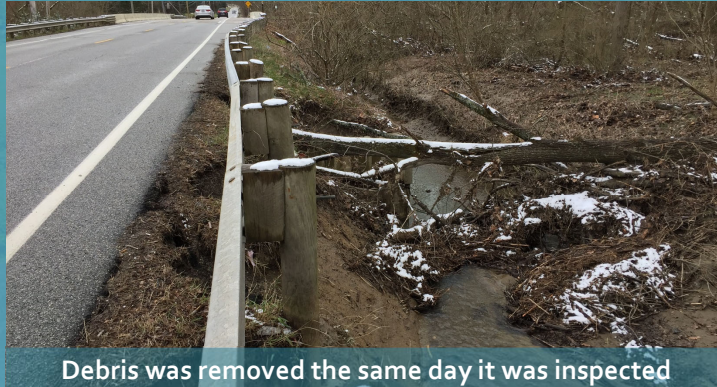
Rocky River: Rocky River East Branch
Member Community: North Royalton
Asset ID: RY00434
Maintenance Project: Debris Removal (10 CY)

Debris was removed the same day it was inspected

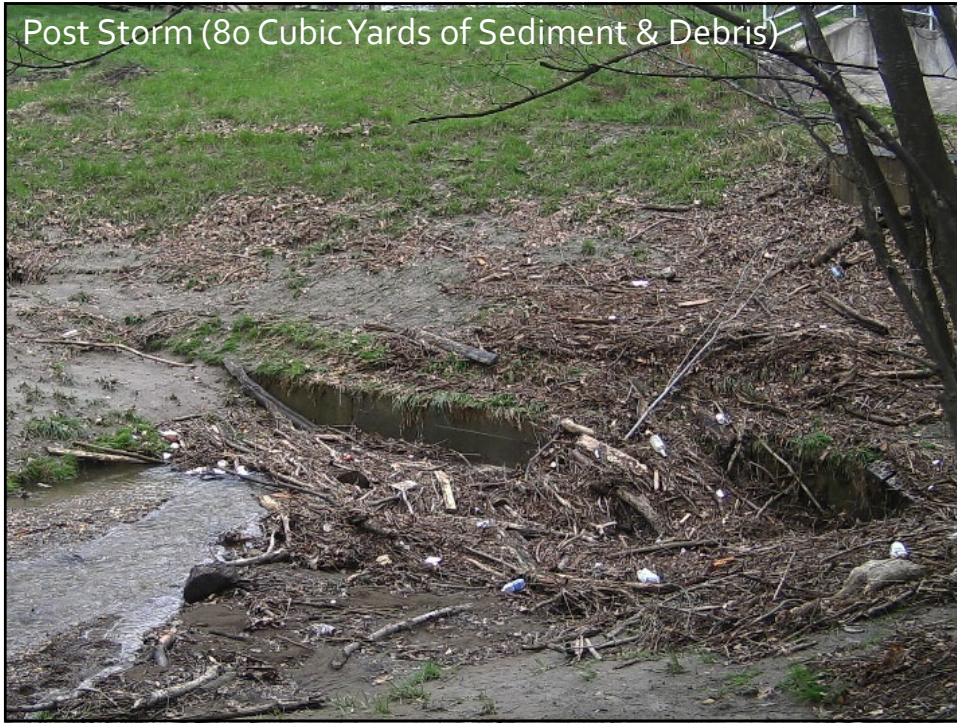
Post Storm (80 Cubic Yards of Sediment & Debris)

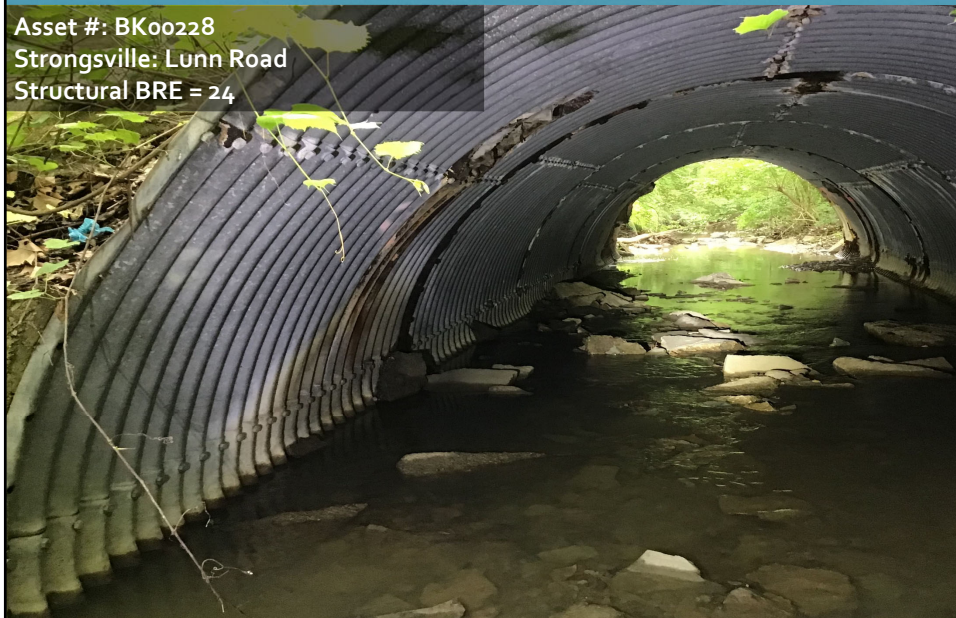
**Small Scale Maint Project: Structural Repair
Rocky River: Baker Creek**

Asset #: BK00228
Strongsville: Lunn Road
Structural BRE = 24

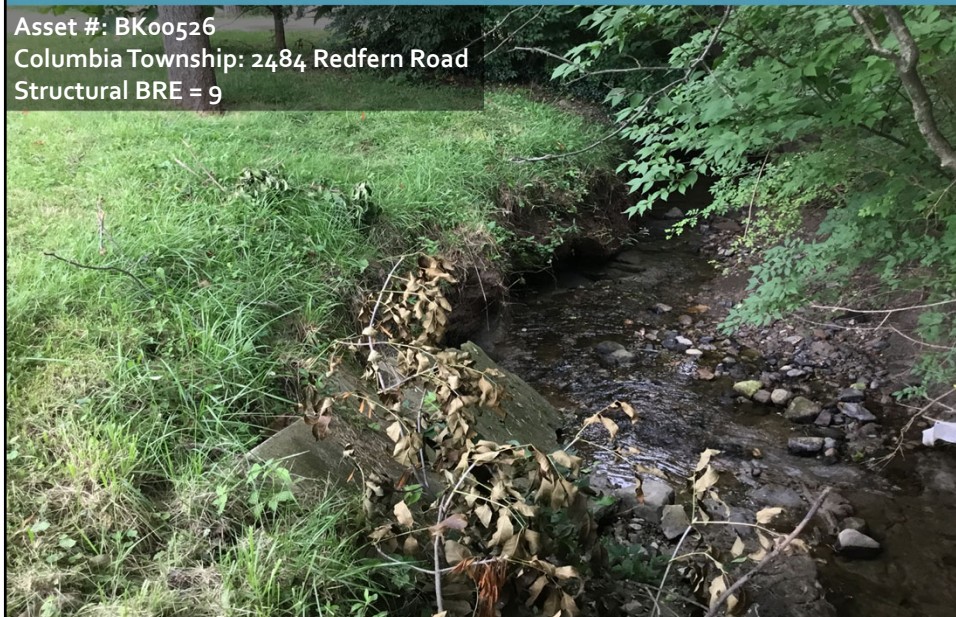
**Small Scale Maint Project: Structural Repair
Rocky River: Baker Creek**

Asset #: BK00526
Columbia Township: 2484 Redfern Road
Structural BRE = 9

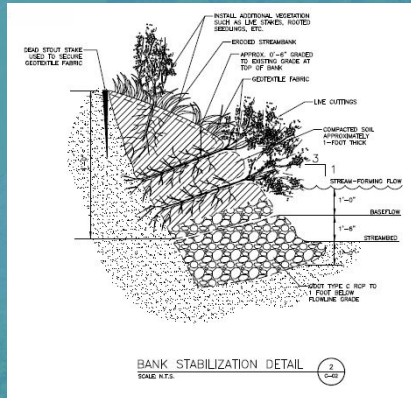
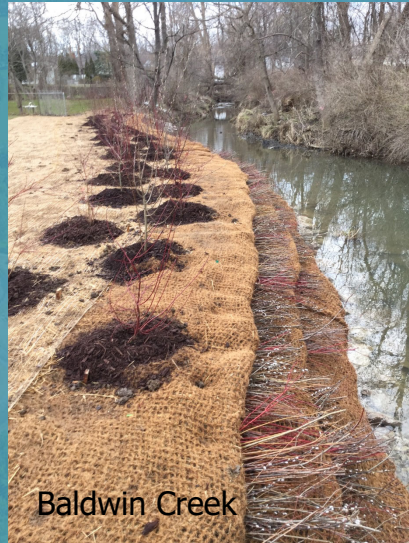
Small Scale Maint Project: Streambank Stabilization Rocky River: Baker Creek

- Lay banks to a stable slope
- Install live branch layering and rock toe protection

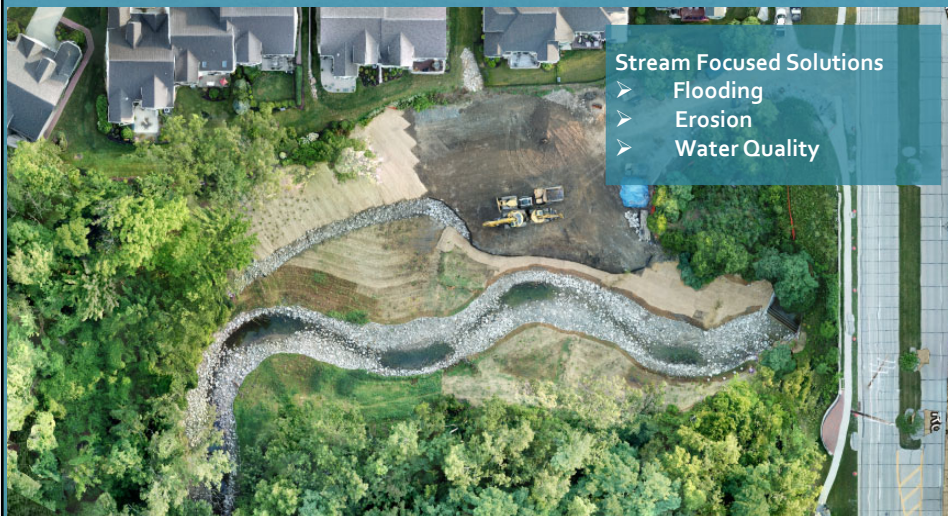
Beecher's Brook Bank Stabilization

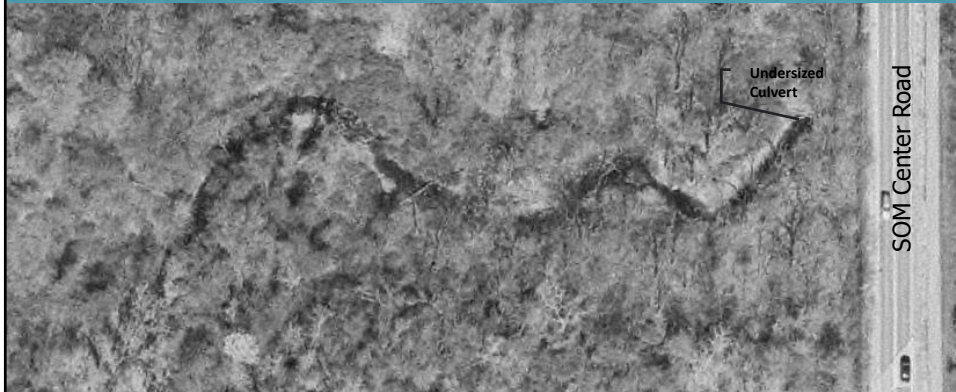
Beecher's Brook Culvert 2002

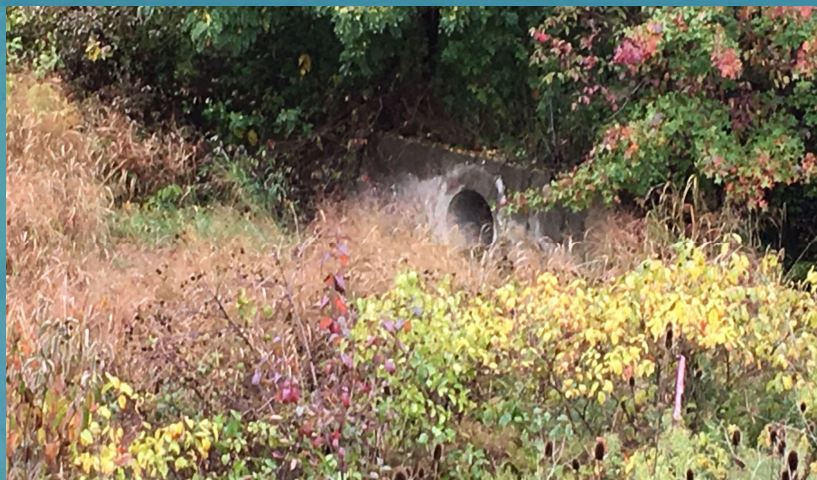
Beecher's Brook Culvert 2002

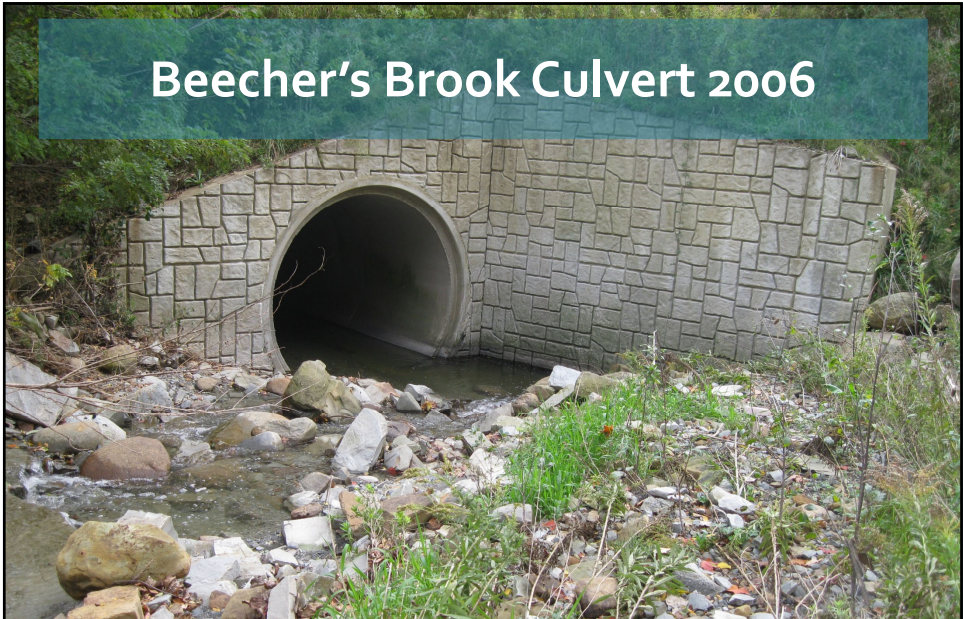
Beecher's Brook Culvert 2006
