*Watershed Advisory Committee
Rocky River Watershed
March 10, 2020*

NORTHEAST OHIO REGIONAL SEWER DISTRICT

REGIONAL
STORMWATER
MANAGEMENT
PROGRAM

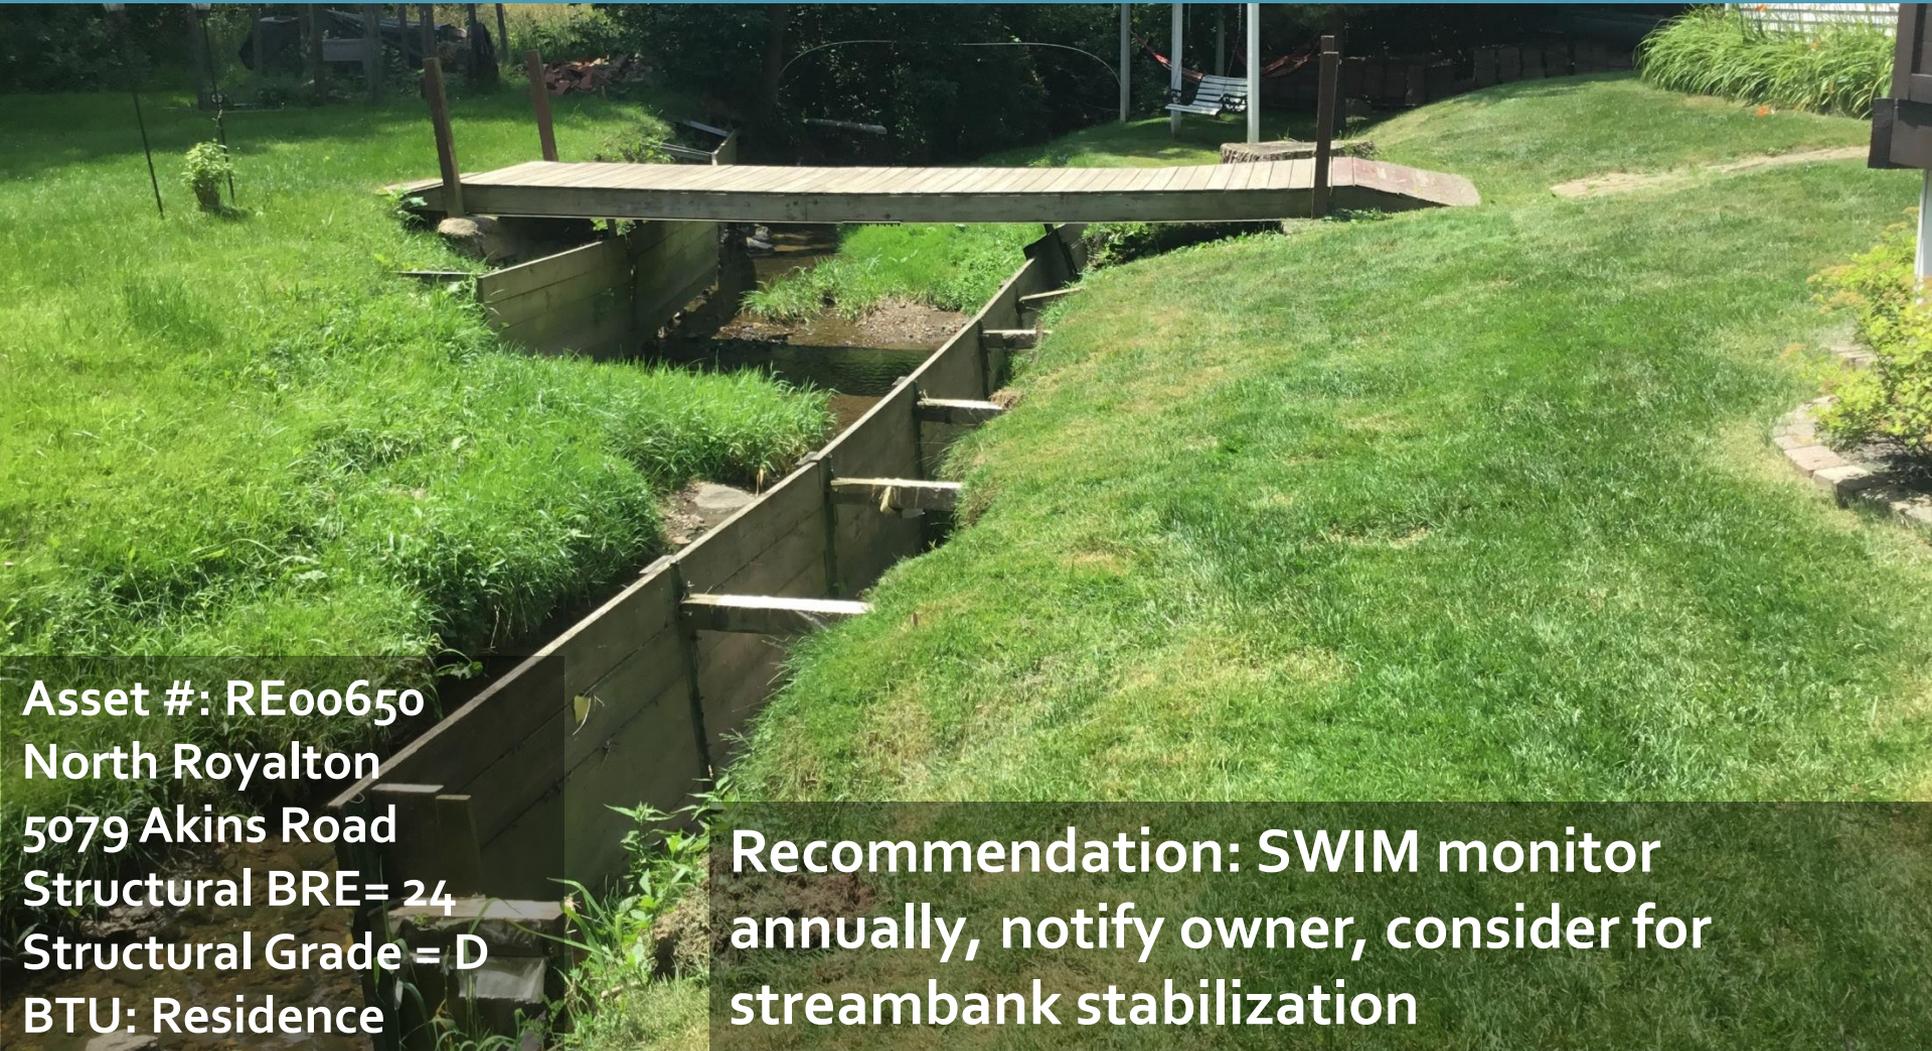
State of the Infrastructure: Stream & BTU Rocky River East Branch

Asset #: RE00650
North Royalton
5079 Akins Road
Structural BRE= 24
Structural Grade = D
BTU: Residence

Recommendation: SWIM monitor annually, notify owner, consider for streambank stabilization

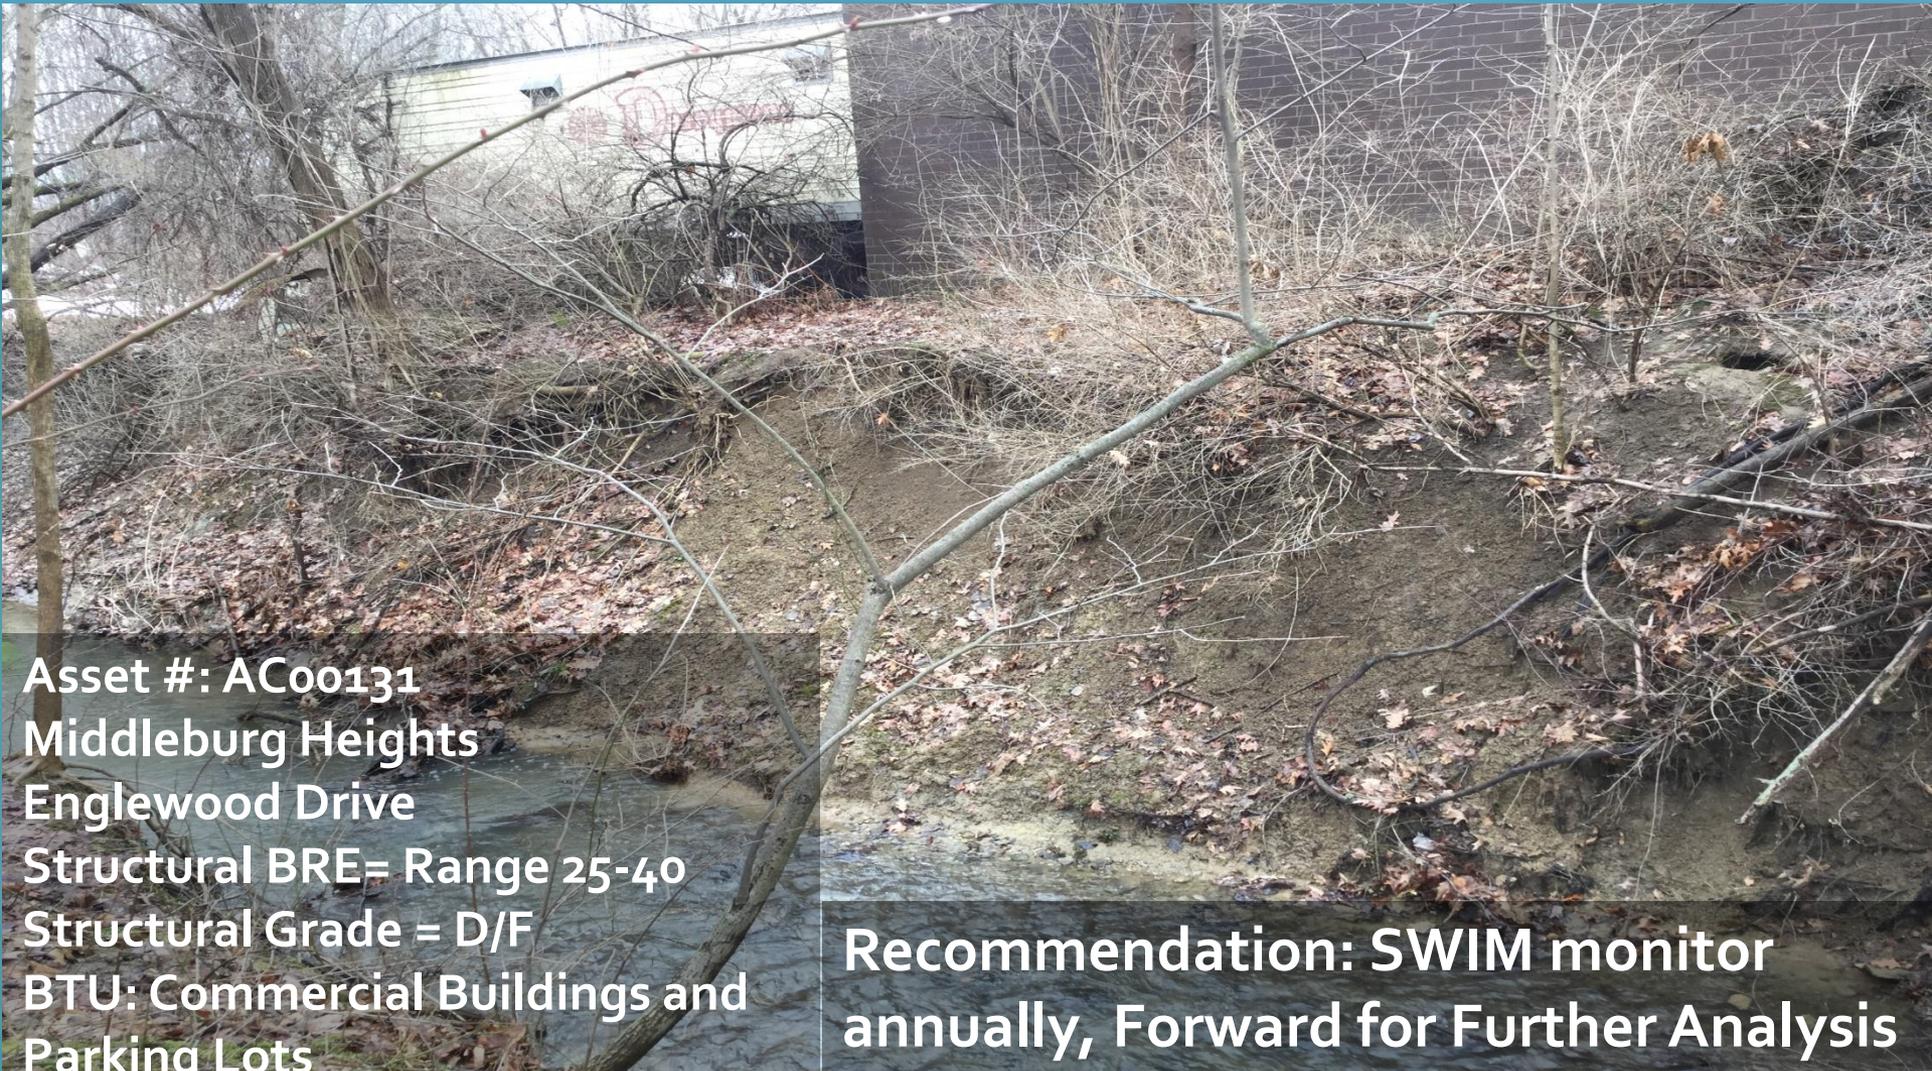
State of the Infrastructure: Stream & BTU Abram Creek

Asset #: AC00131
Middleburg Heights
Englewood Drive
Structural BRE= Range 25-40
Structural Grade = D/F
BTU: Commercial Buildings and
Parking Lots

**Recommendation: SWIM monitor
annually, Forward for Further Analysis**

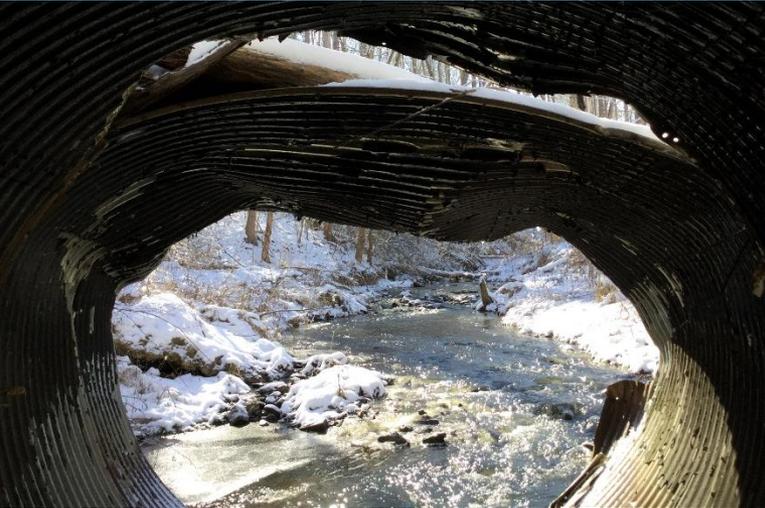
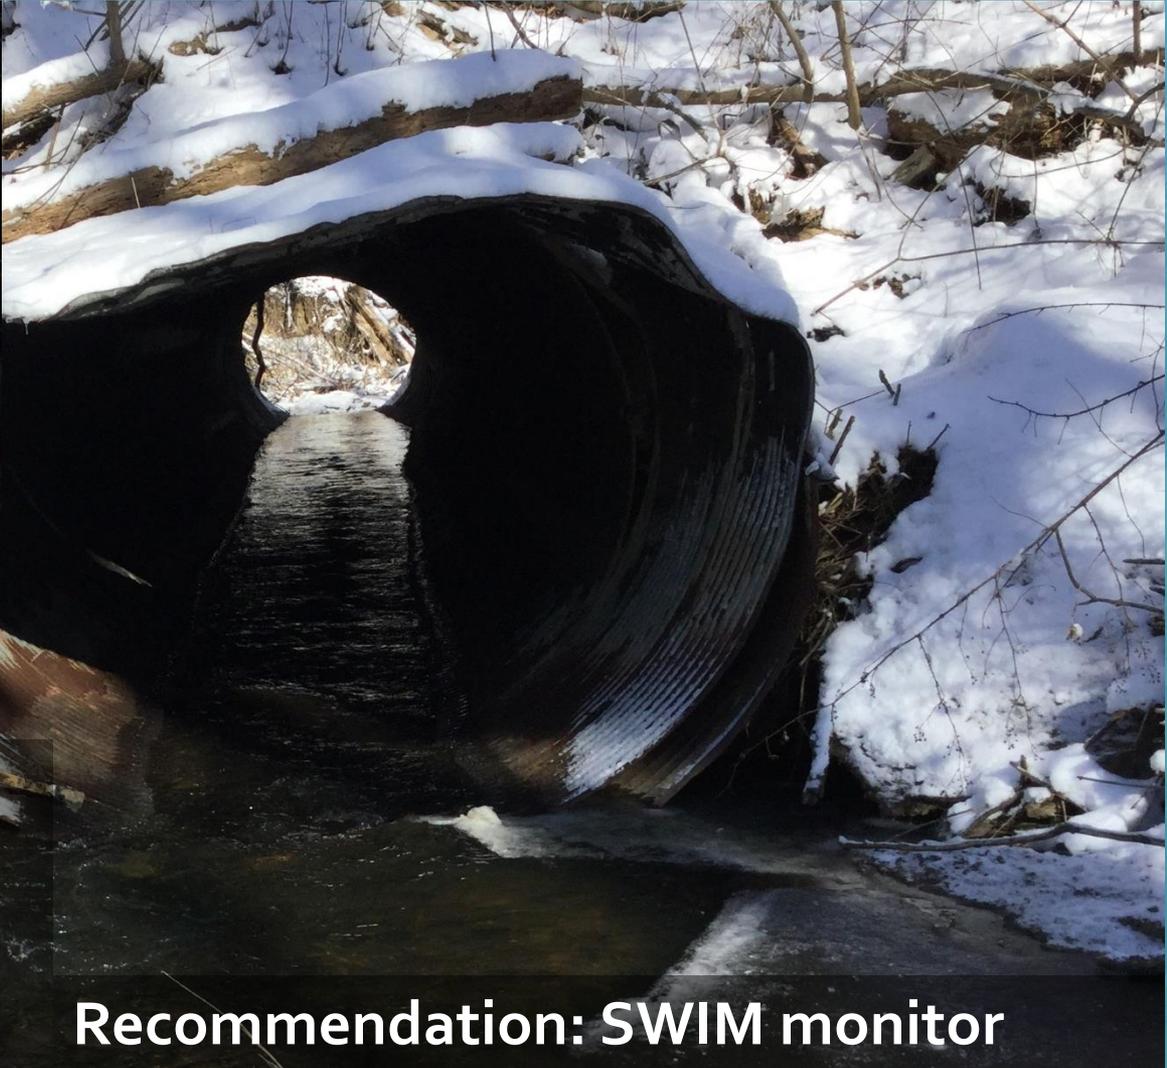
State of the Infrastructure: Stream & BTU Minniee Creek

Asset #: MN00099
Olmsted Falls
Access Road East of Columbia
Structural BRE= 18
Structural Grade = C

Recommendation: SWIM monitor

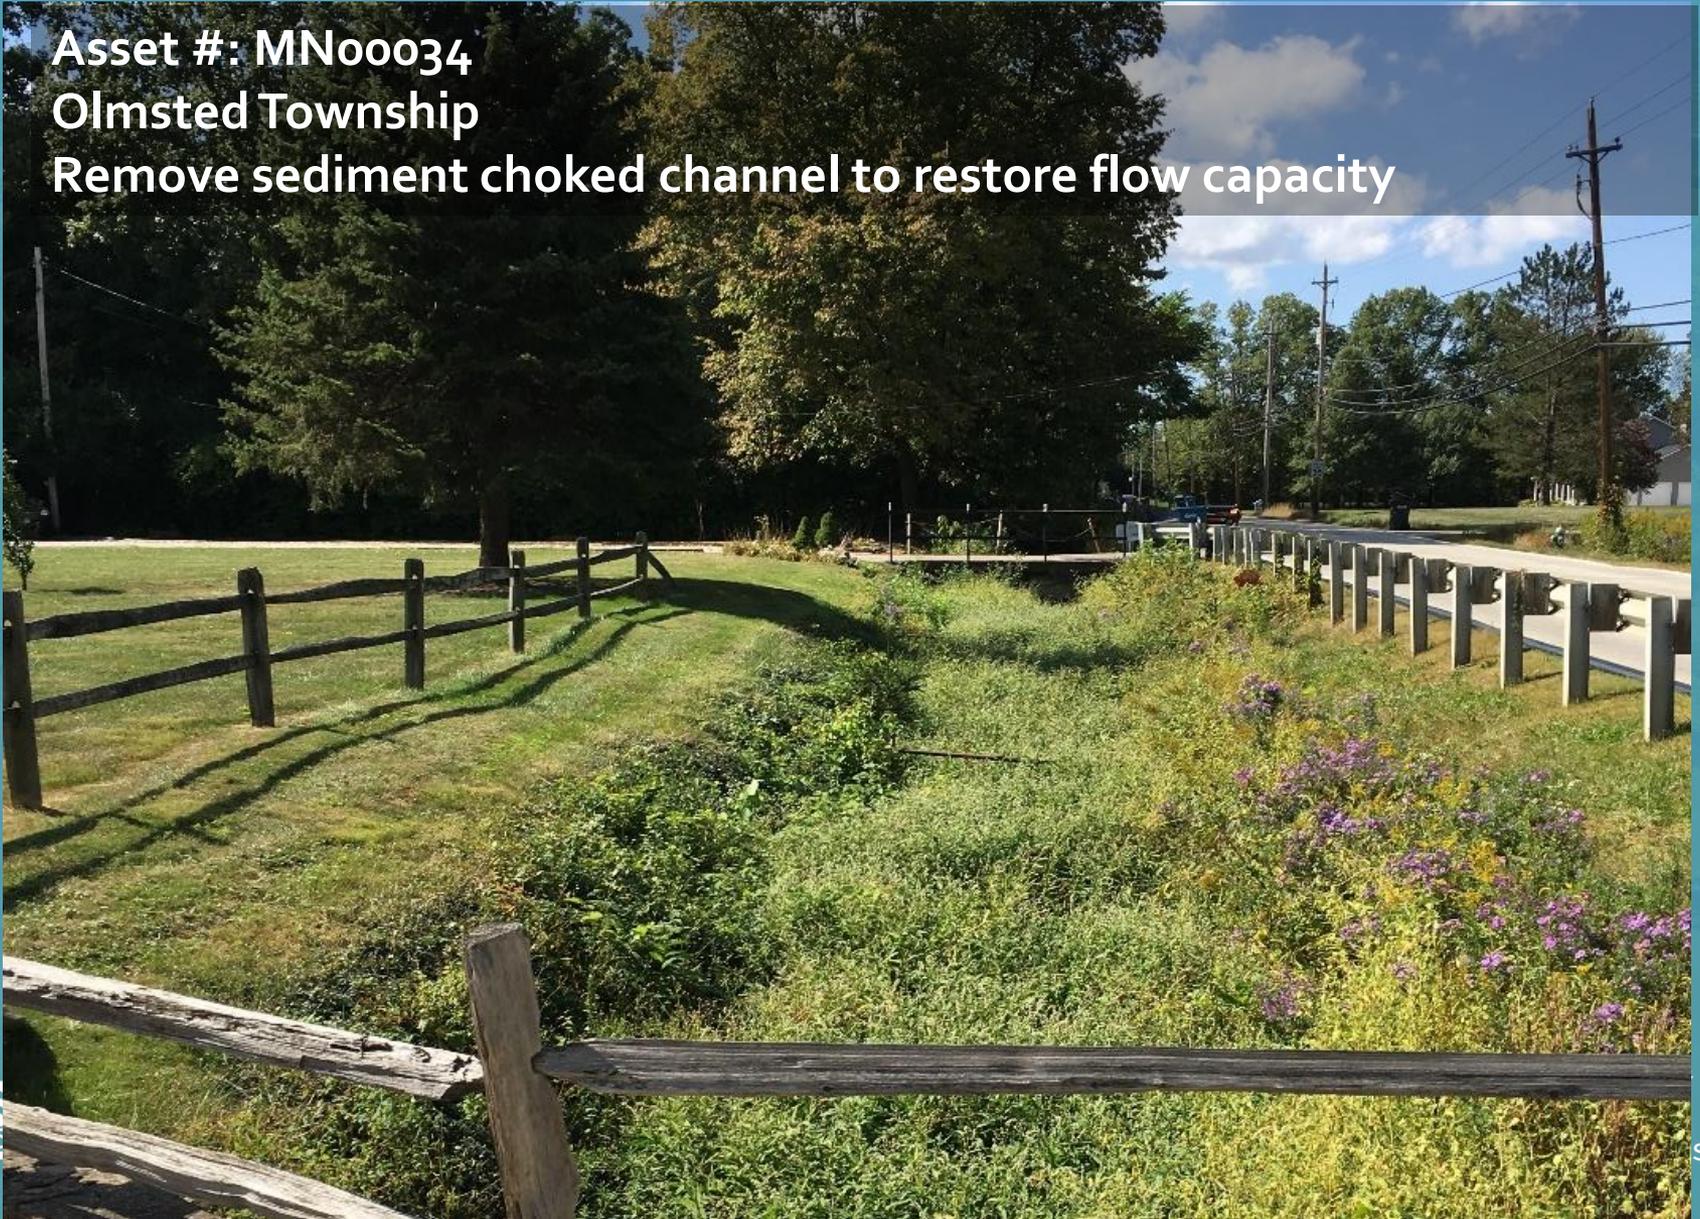
Sediment Maintenance: Dredging Minnie Creek

**Asset #: MN00034
Olmsted Township**

Remove sediment choked channel to restore flow capacity

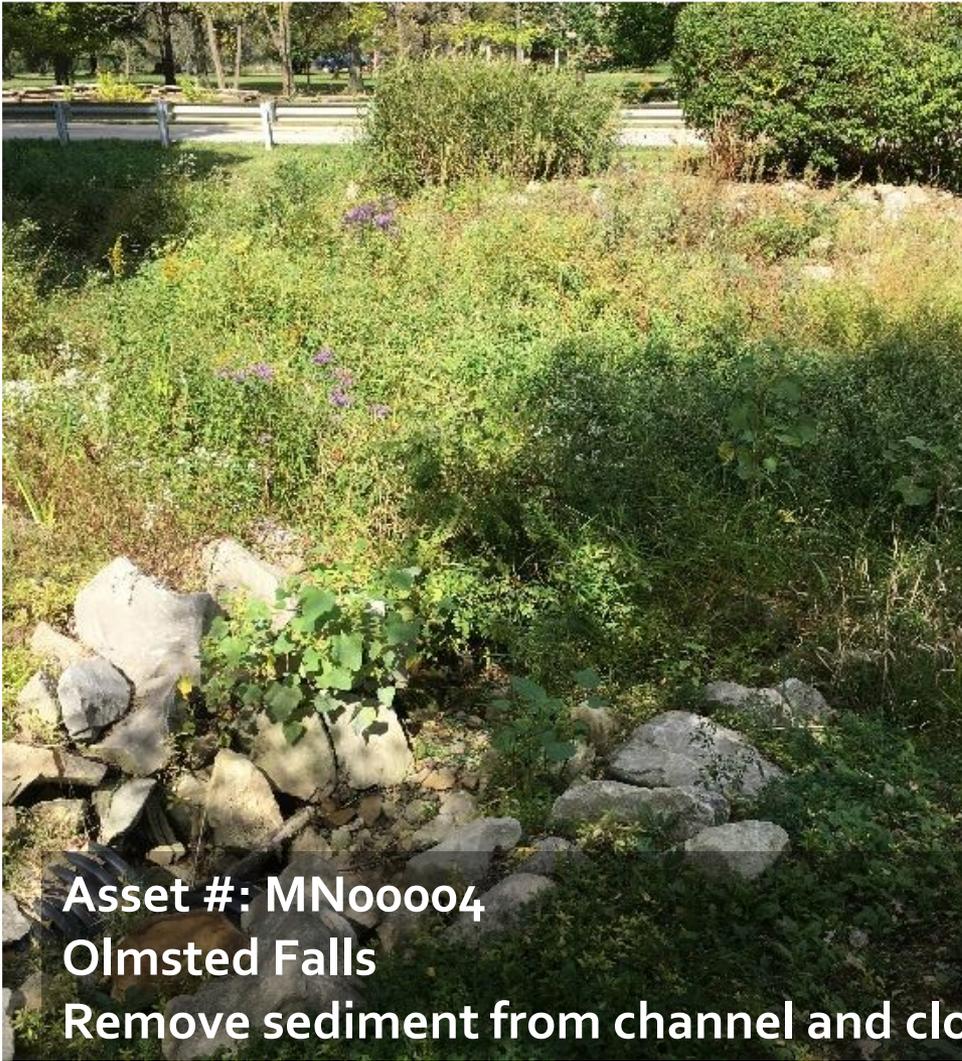
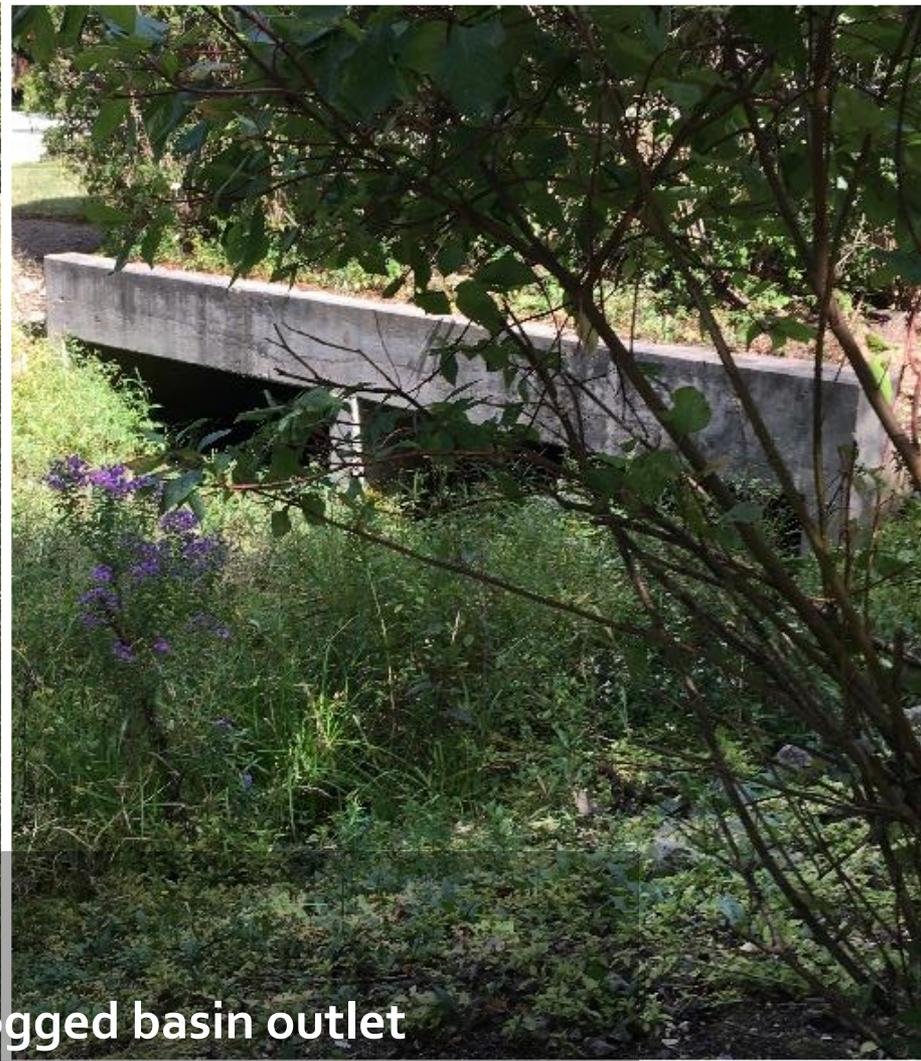
Sediment Maintenance: Dredging Minnie Creek

Asset #: MN00004
Olmsted Falls

Remove sediment from channel and clogged basin outlet

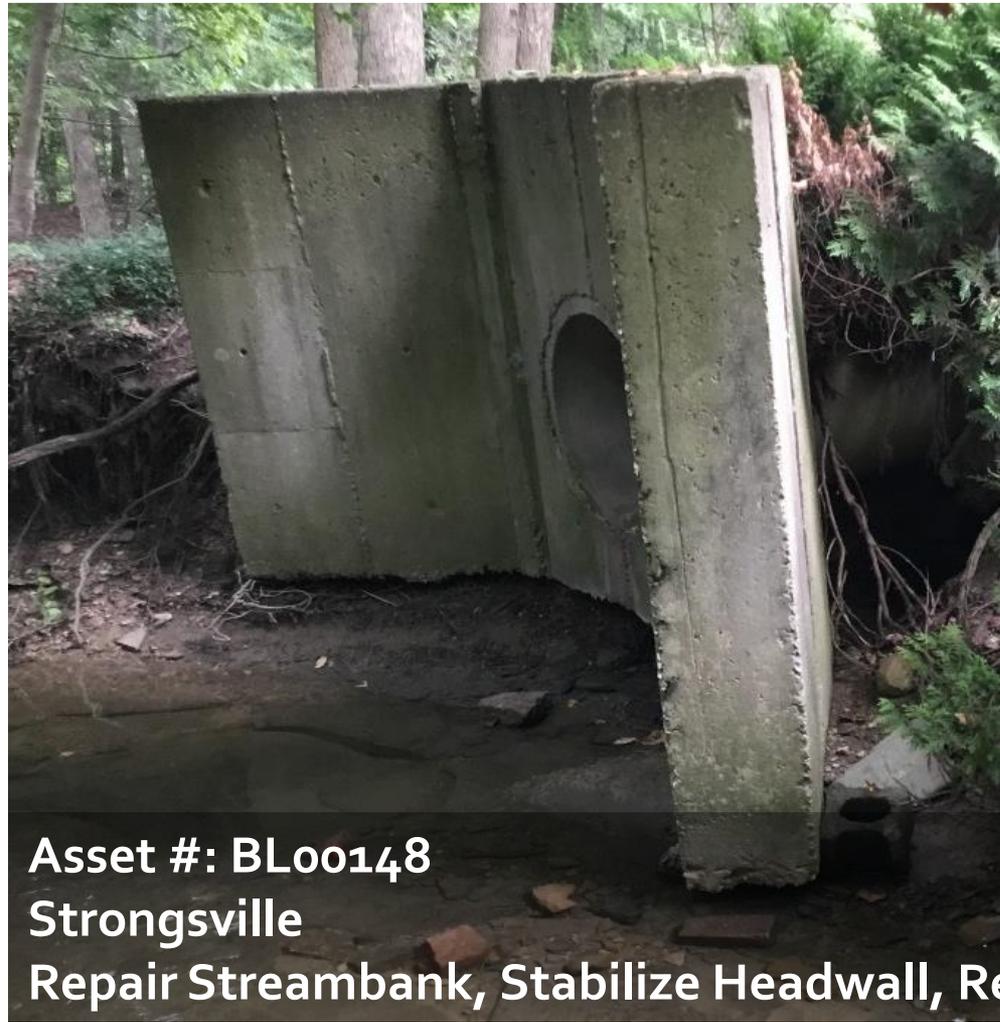
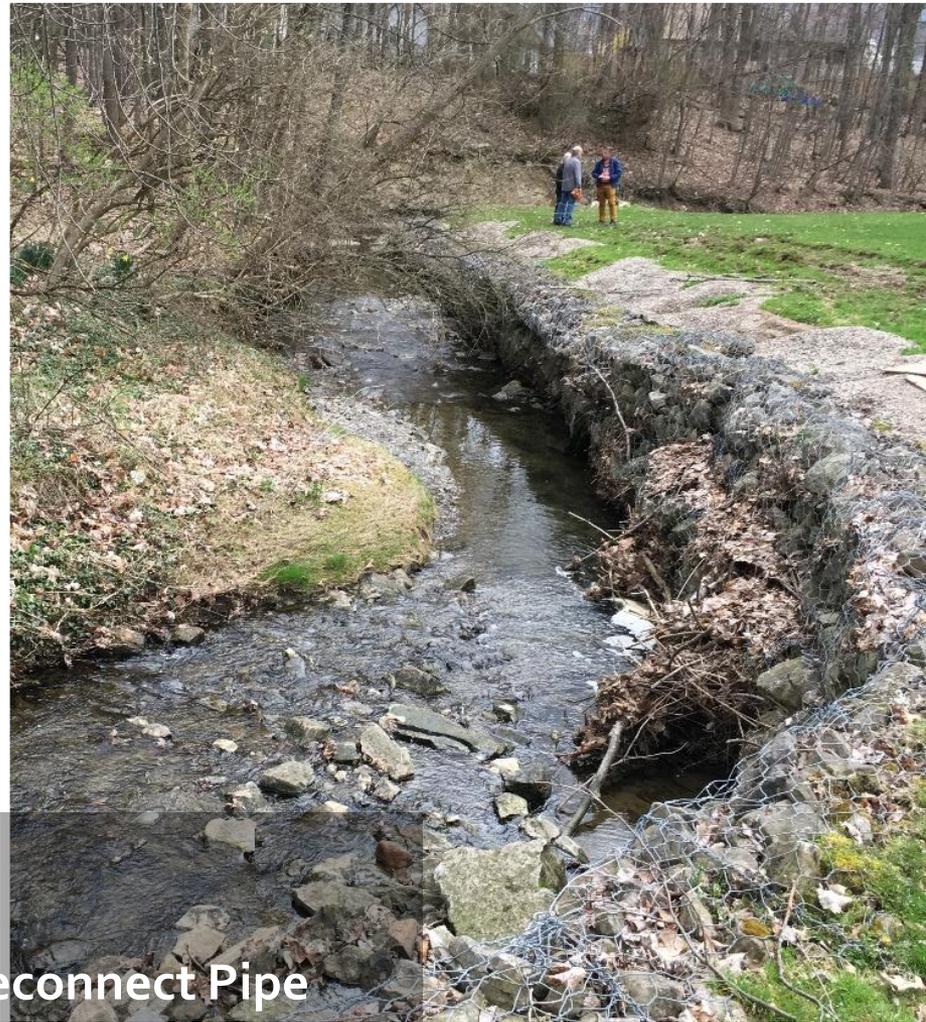
Small Scale Maintenance: Streambank / Structural Repair Blodgett Creek [Planned Small Scale Project]

Asset #: BL00148

Repair Streambank, Stabilize Headwall, Reconnect Pipe

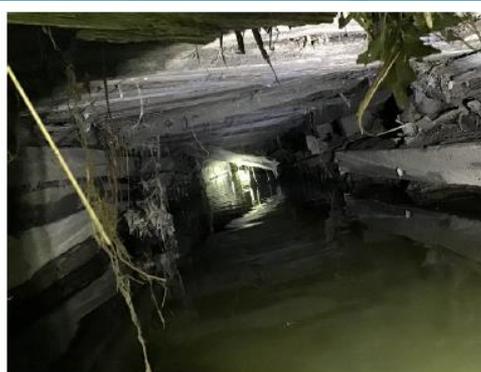
Figure 6: BA00013 Deteriorated Timber Section

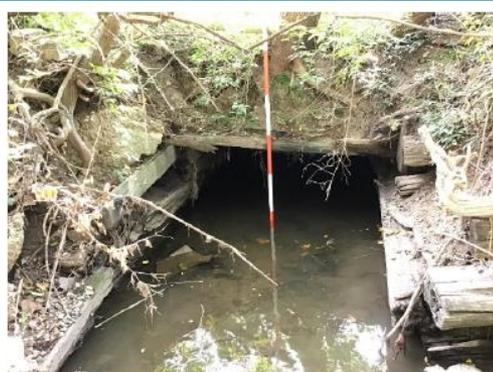
Figure 7: BA00013 Failing Timber at Outfall Section

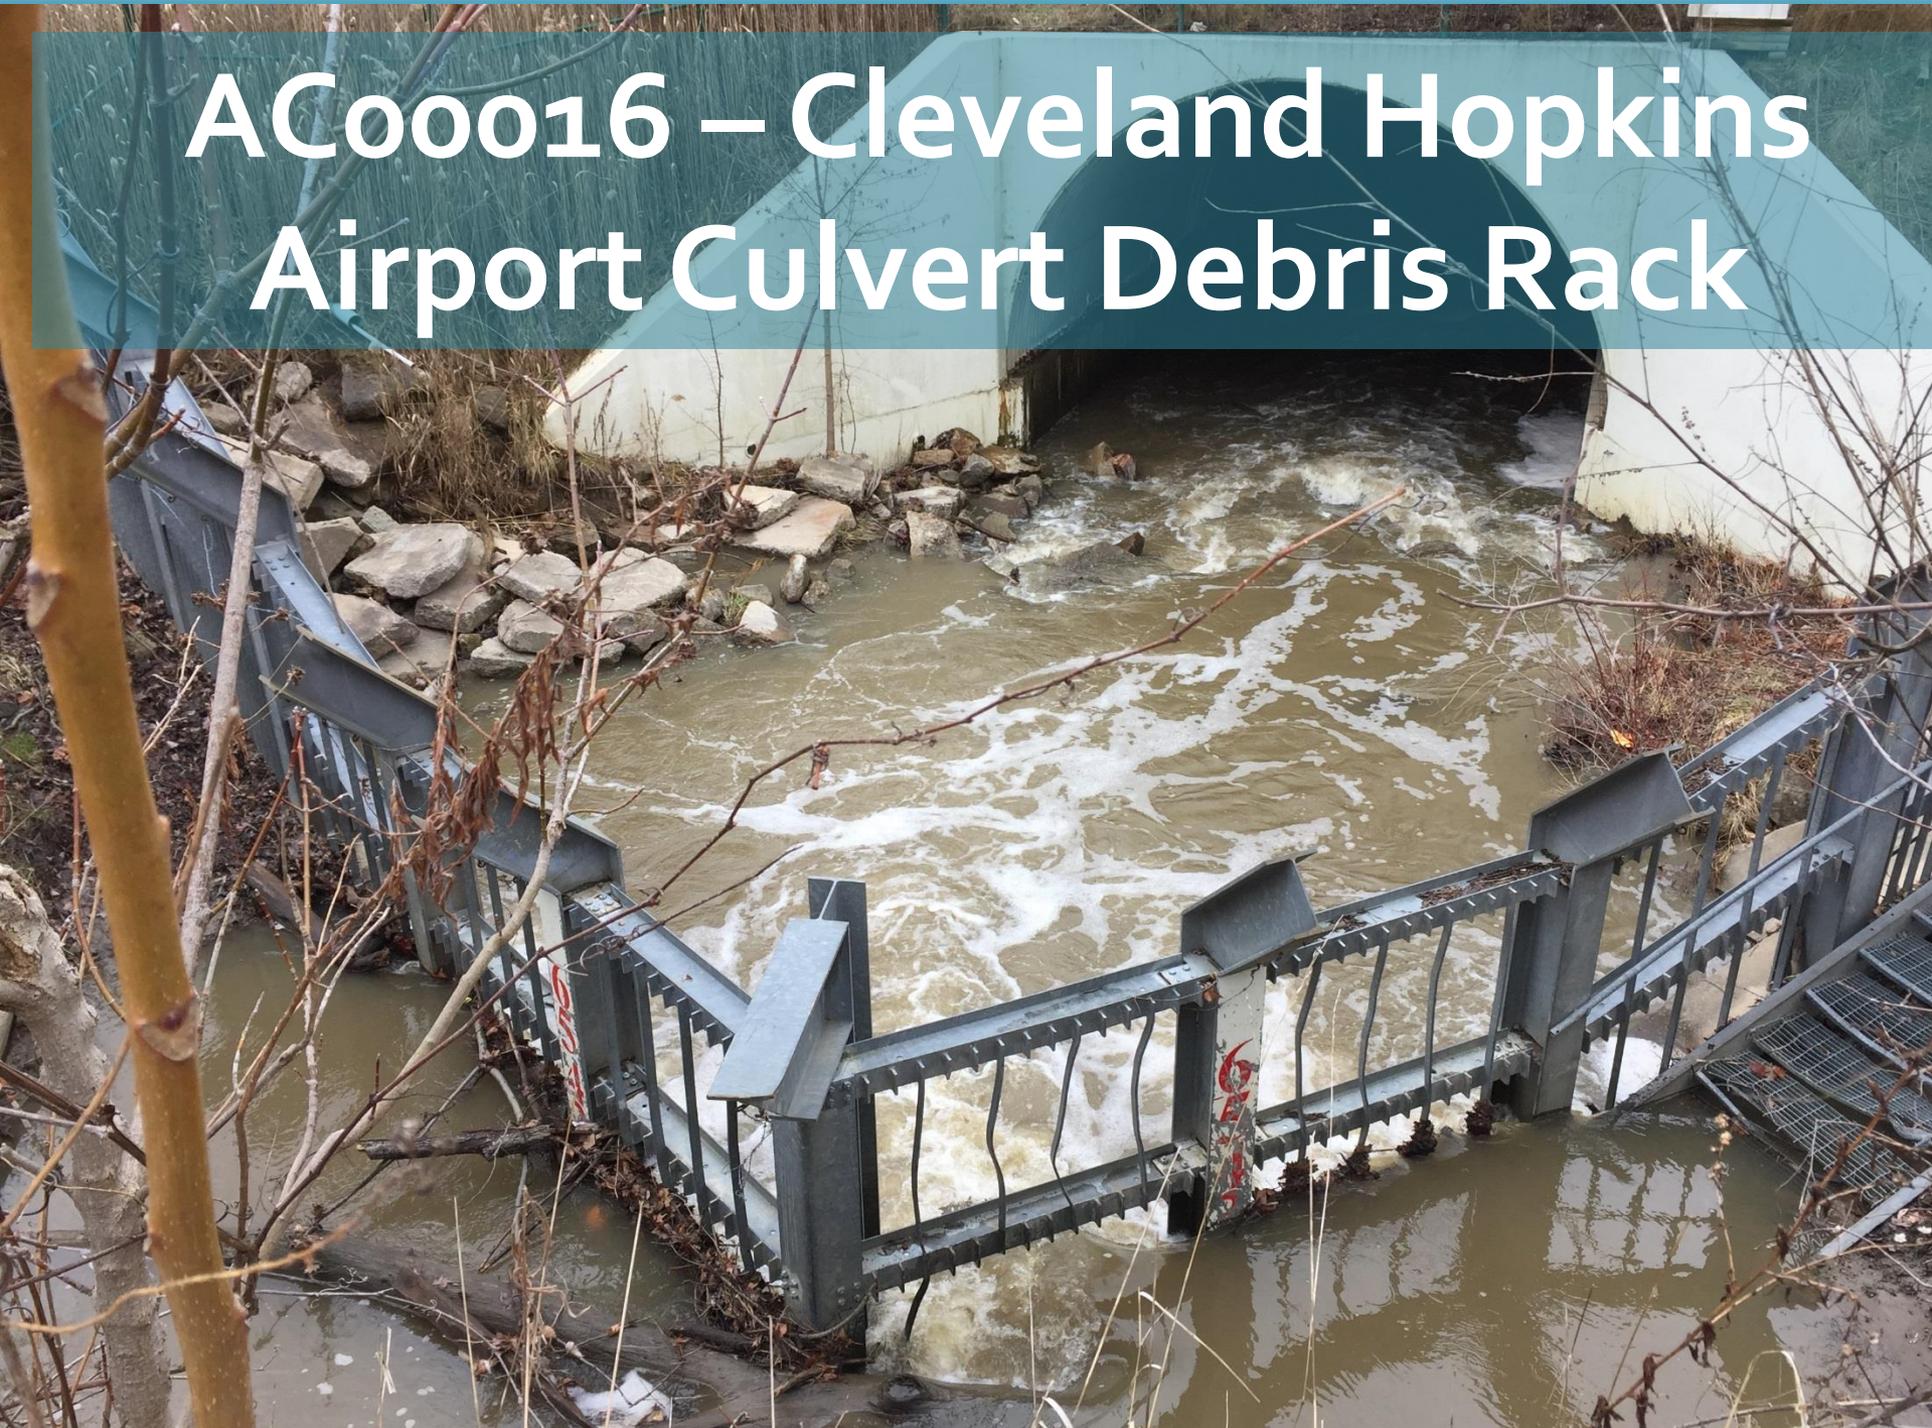
AC00016 – Cleveland Hopkins Airport Culvert Debris Rack

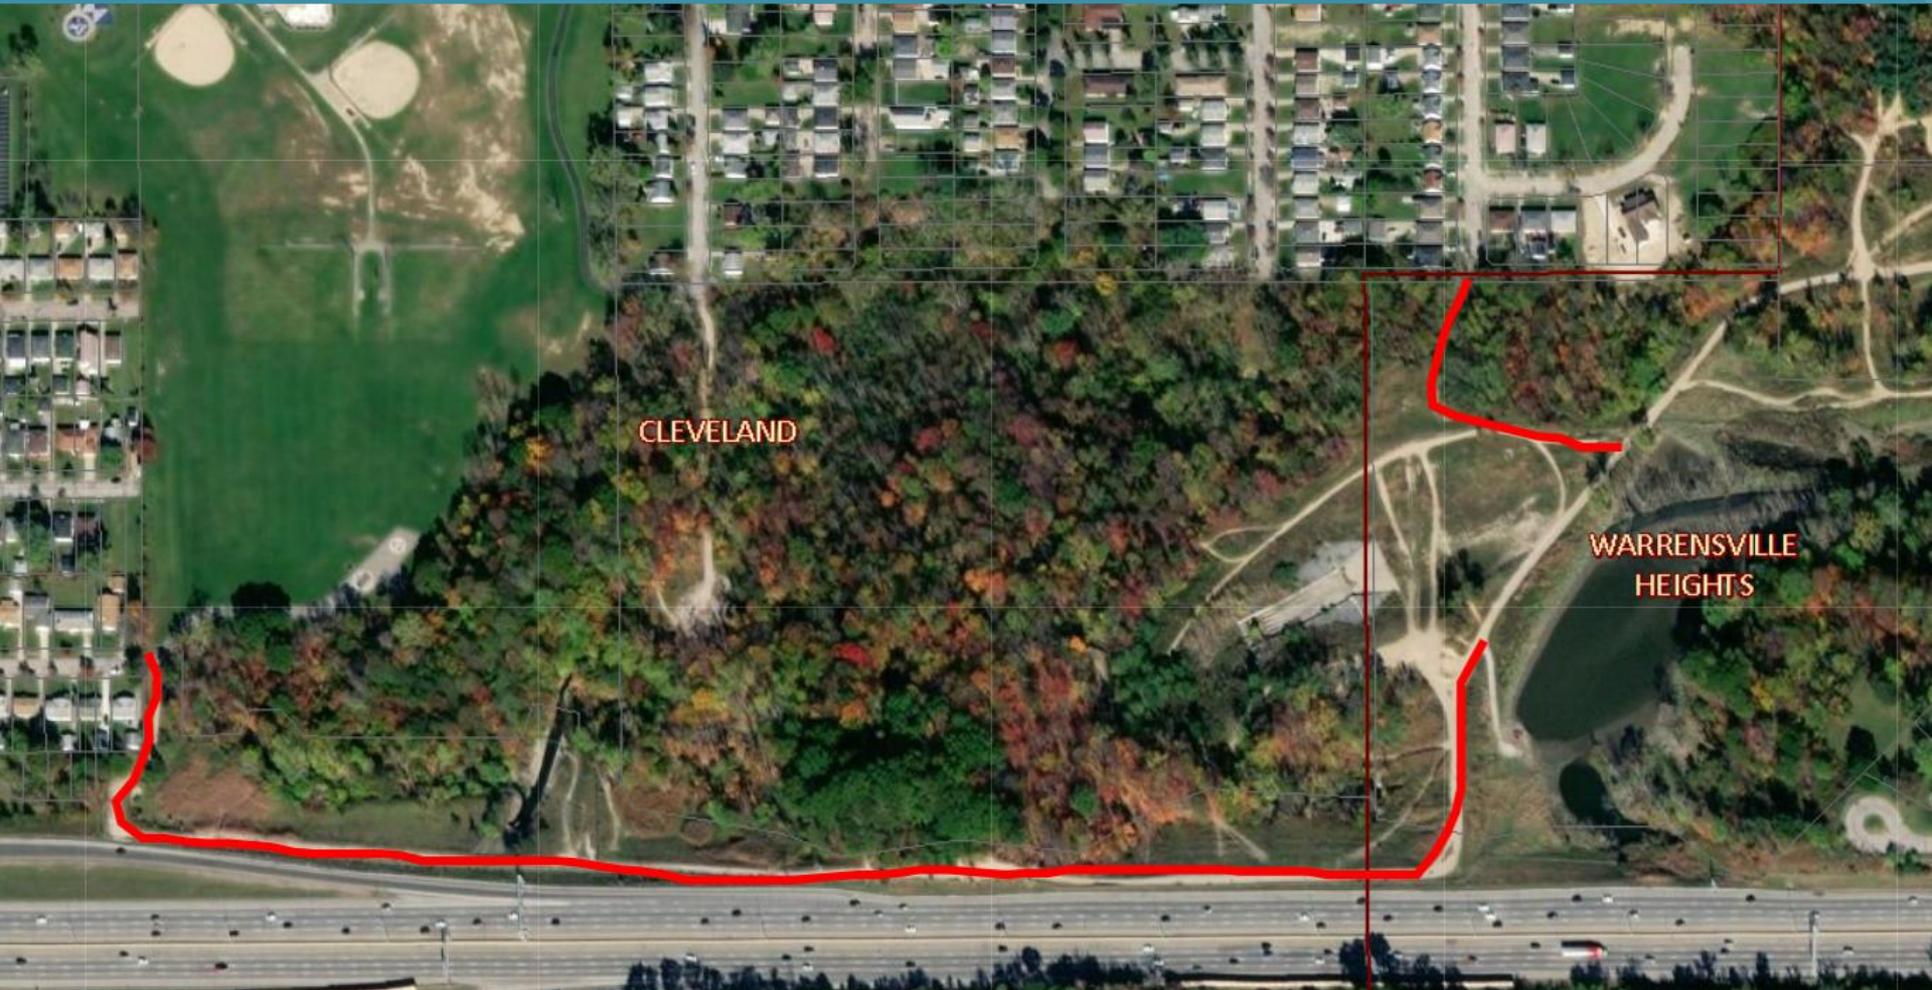
MC00114 - Kerruish Basin Access Drives

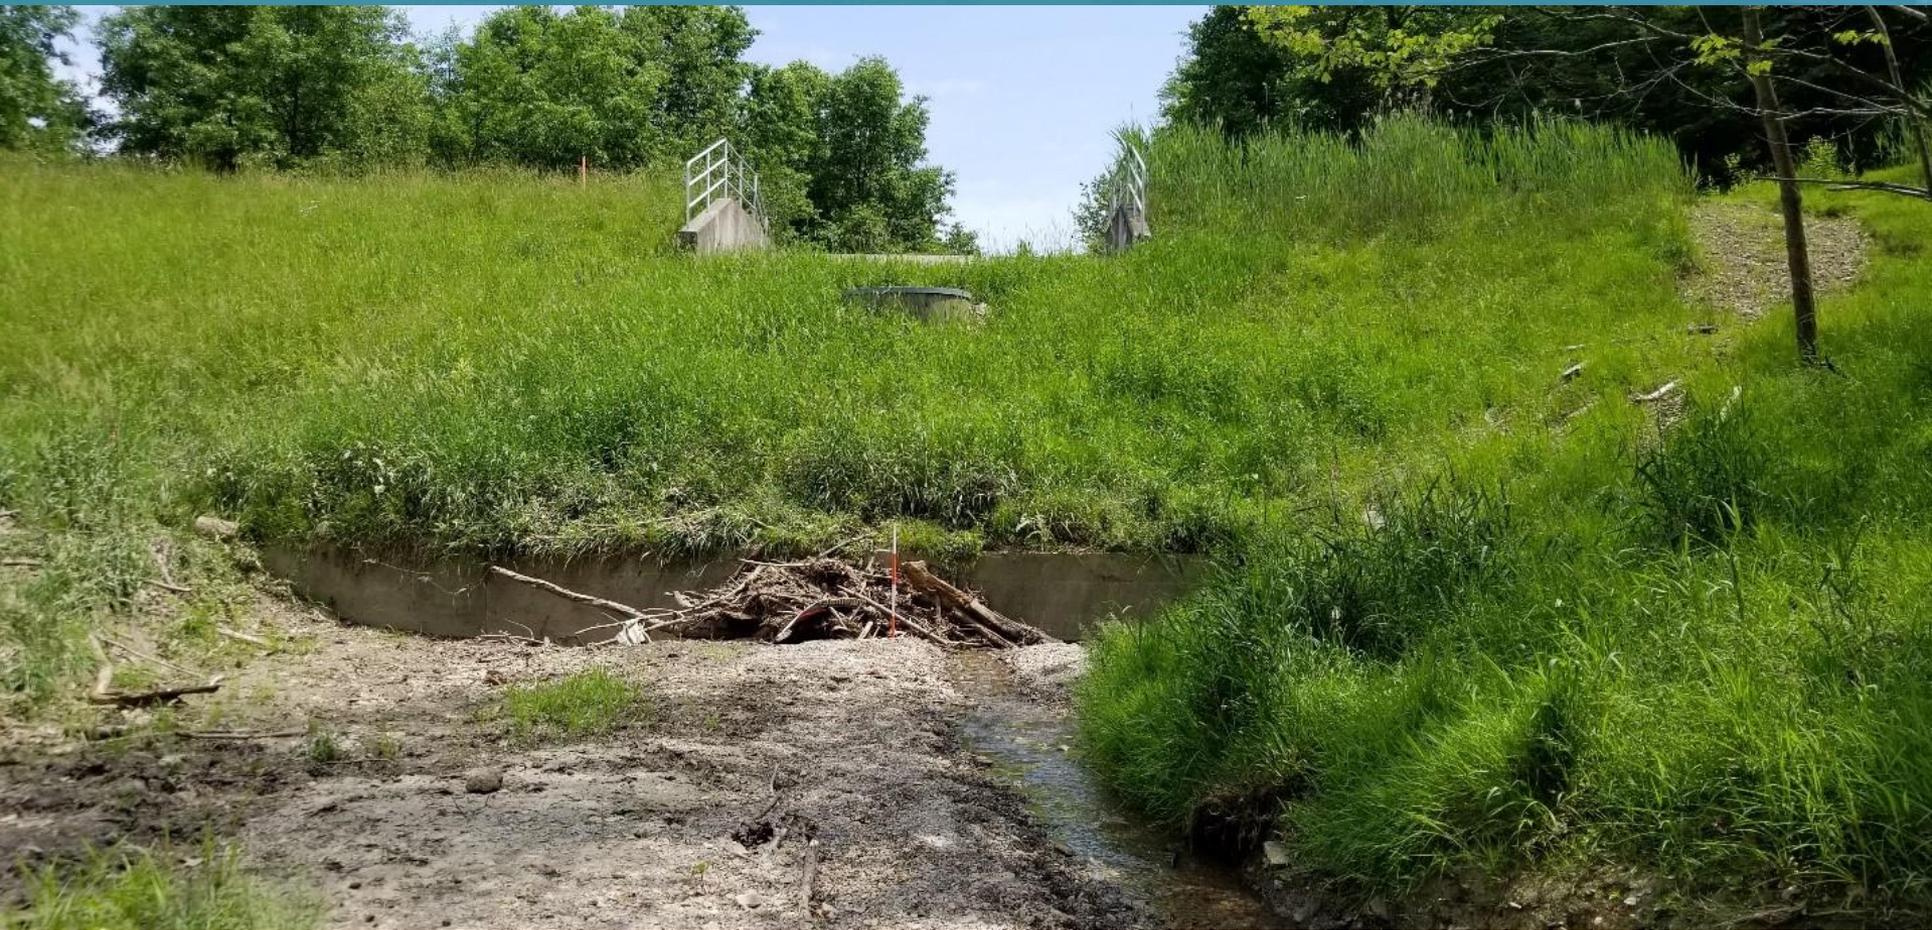
HC00043 – Hemlock Creek Basin Debris Rack and Access Road

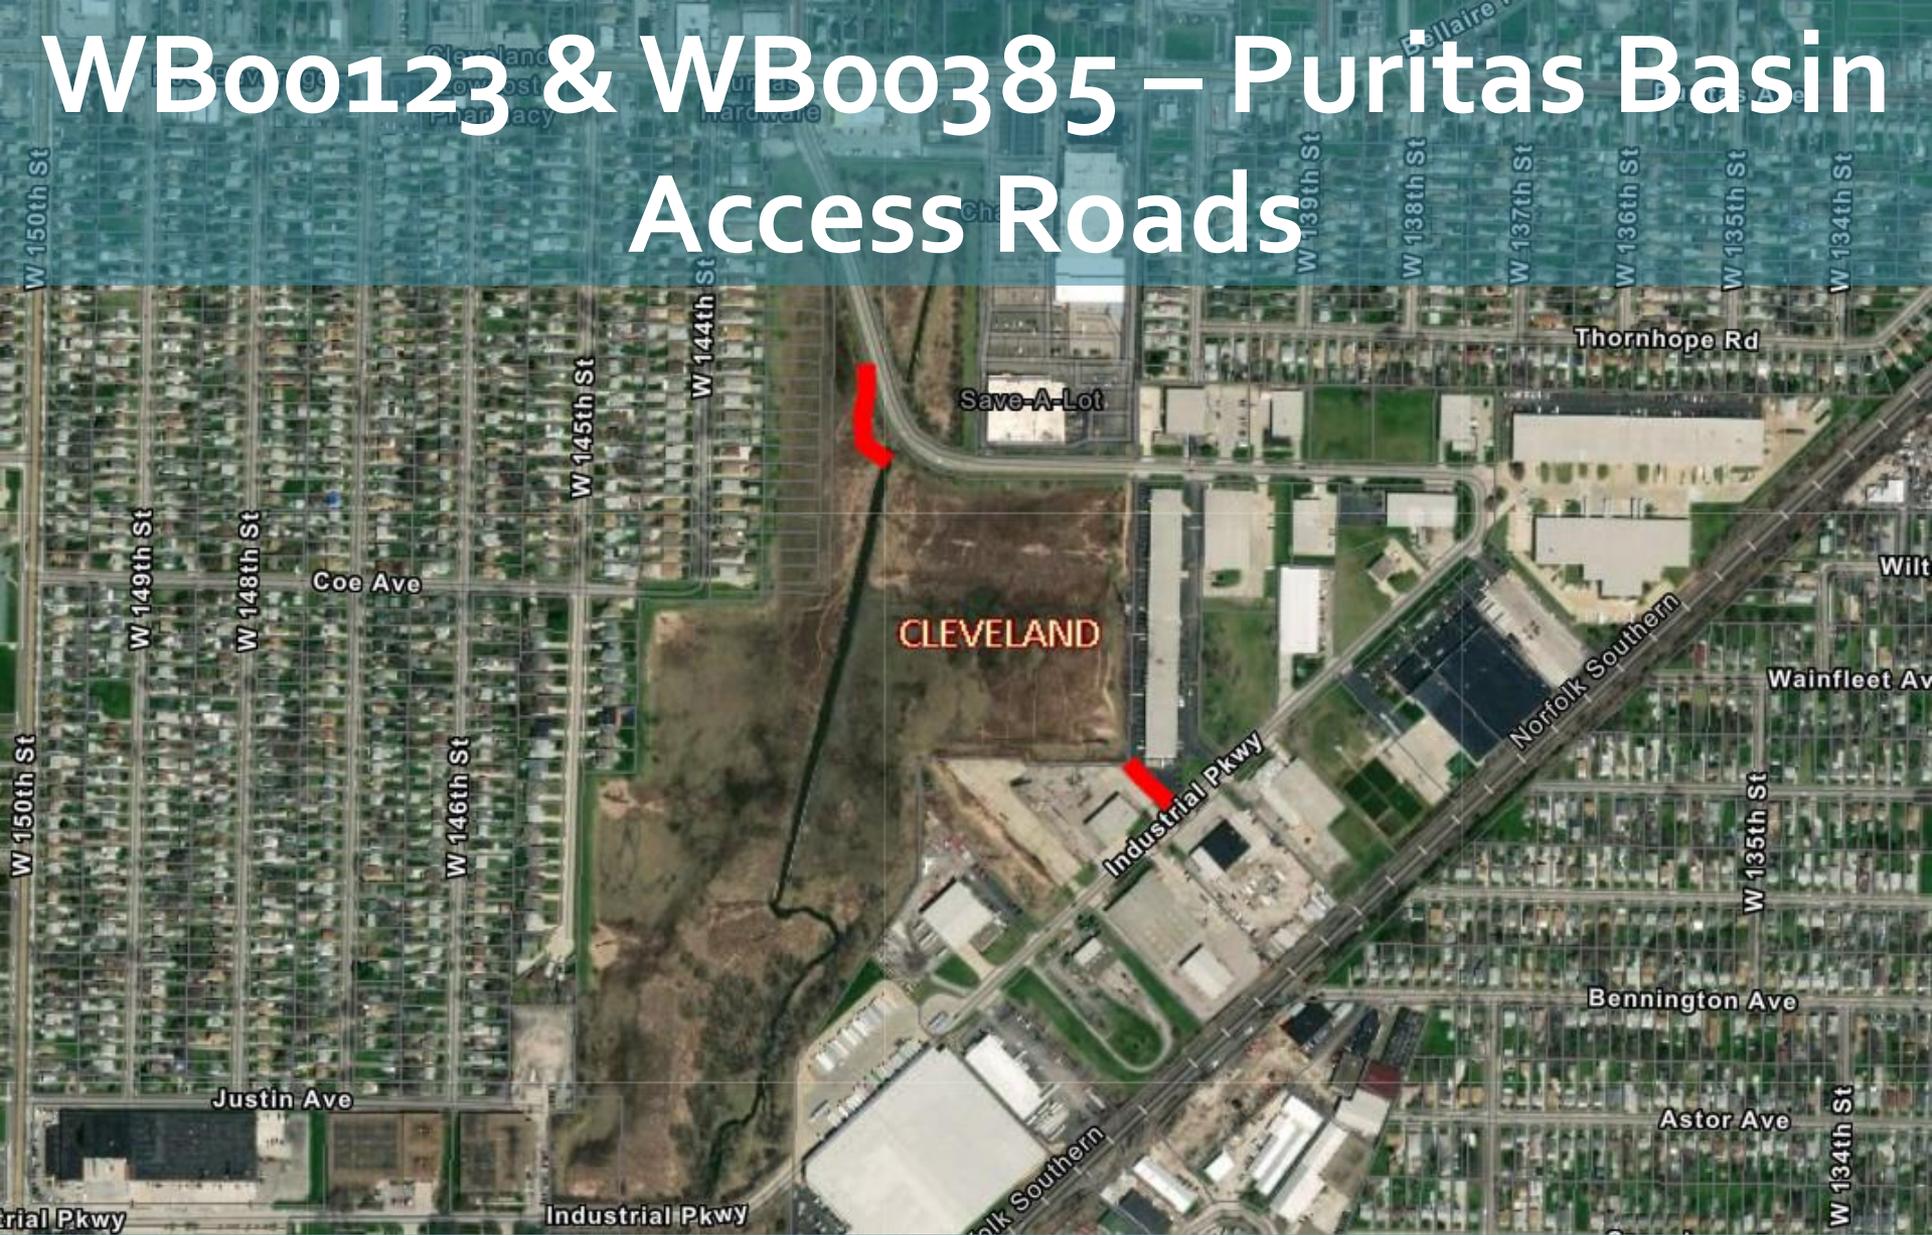
WB00123 & WB00385 – Puritas Basin Access Roads

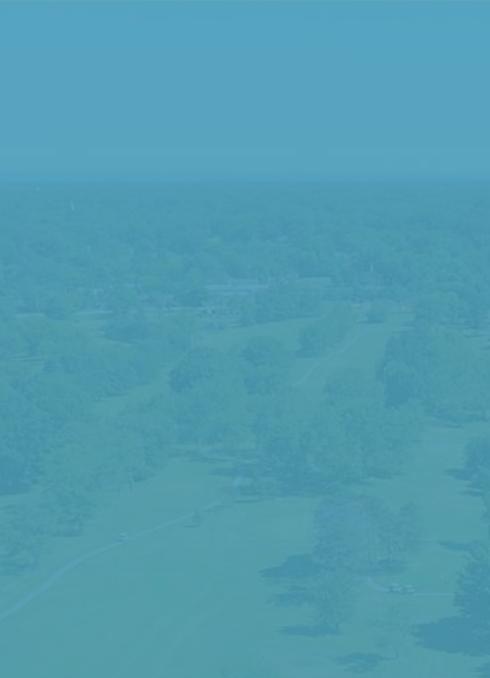
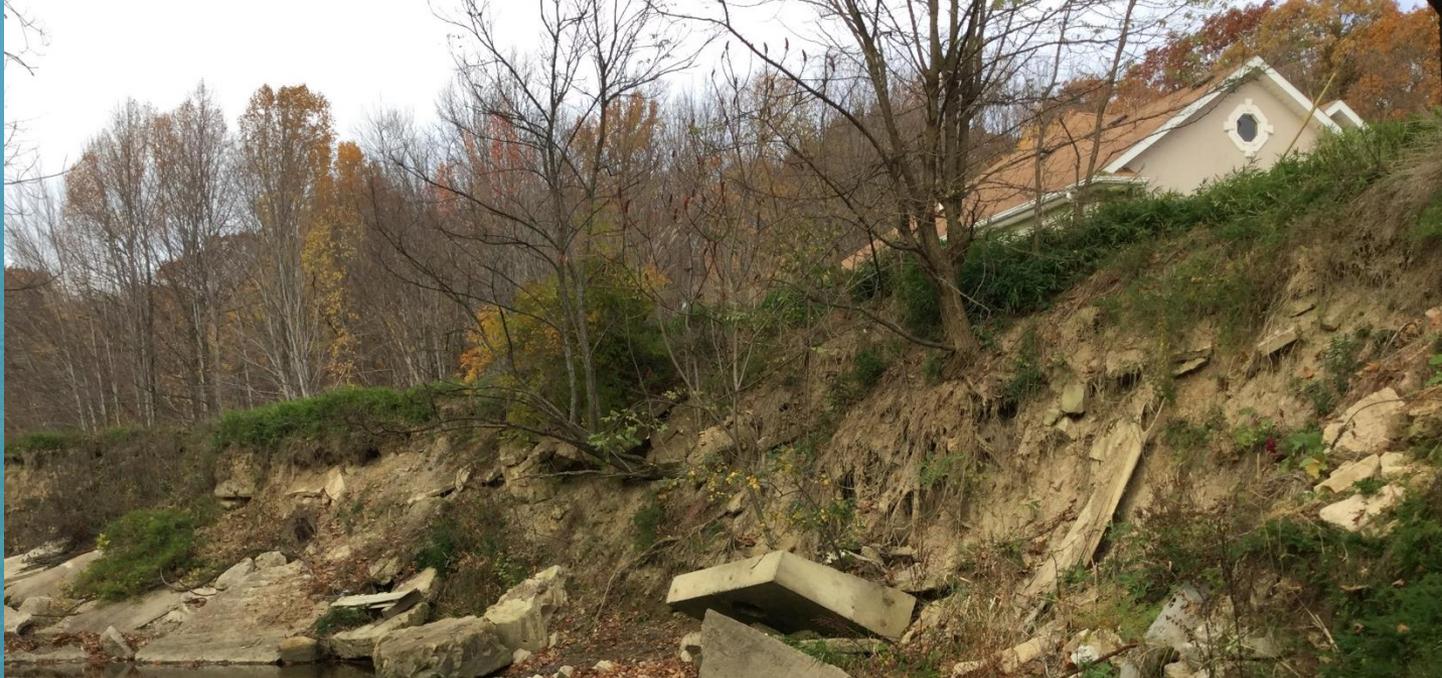
Exposed Manhole
(BC00355_U001)
