*Watershed Advisory Committee
Rocky River Watershed
March 10, 2020*

NORTHEAST OHIO REGIONAL SEWER DISTRICT

REGIONAL
STORMWATER
MANAGEMENT
PROGRAM

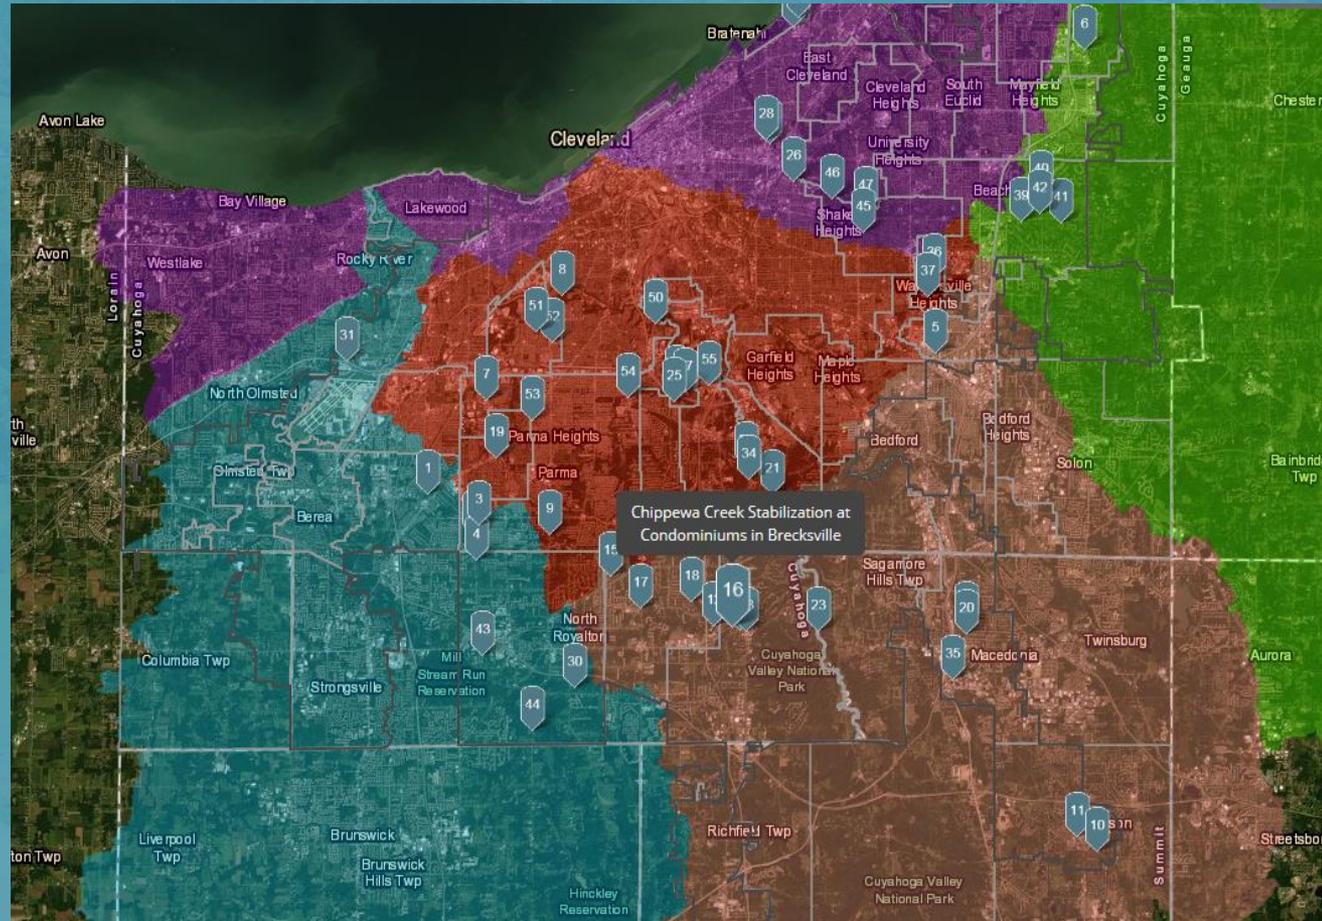
Eroding right bank by Condominiums in Brecksville

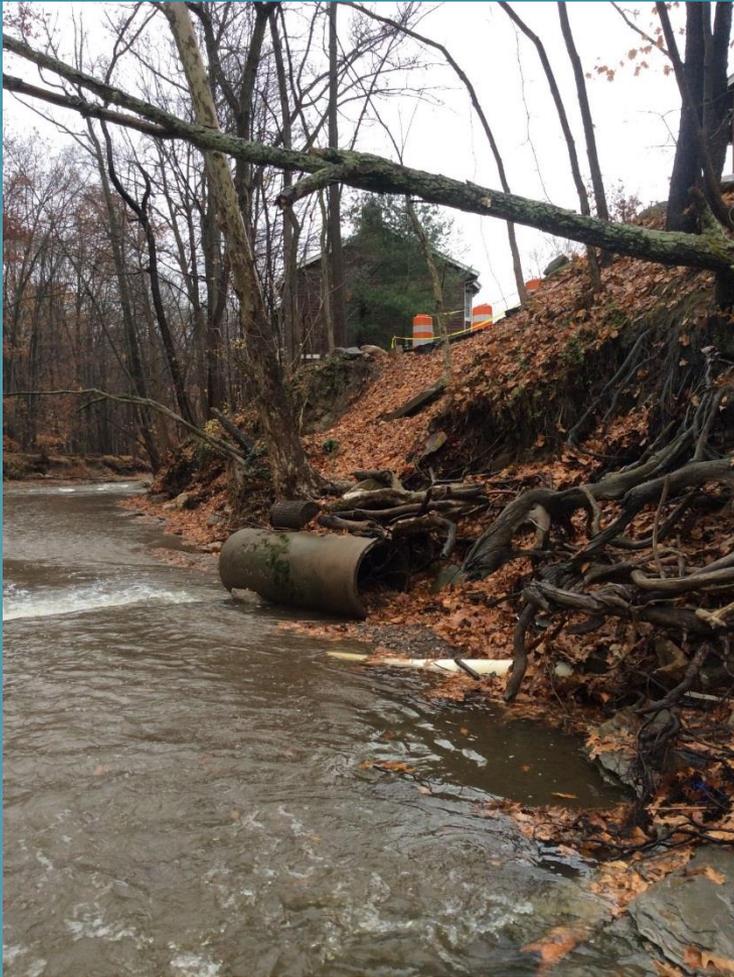
Chippewa Creek Stabilization at Condominiums in Brecksville

- *Eroding streambank within 12 ft of the condominiums*
- *Erosion within 6 ft of local sanitary sewer*
- *Stream infrastructure more cost effective than acquisition*
- *Approx. \$1.2M Construction Cost*
- *Excavate Floodplain on left bank*

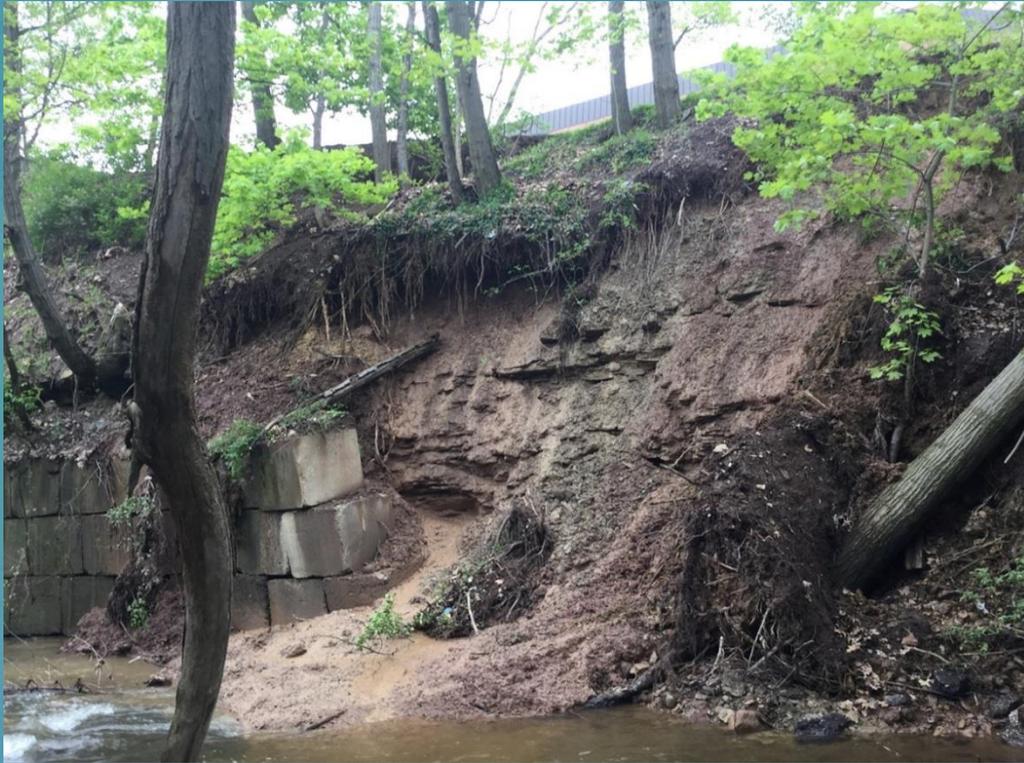
West Creek Stabilization by Sandpiper Drive

- *Stream infrastructure more cost effective than acquisition*
- *Large area of property impacted including large trees*
- *Approx. \$2.3M Construction Cost*
