# 2013 Illicit Discharge Detection and Elimination Program Annual Report

Northeast Ohio Regional  
**Sewer District**

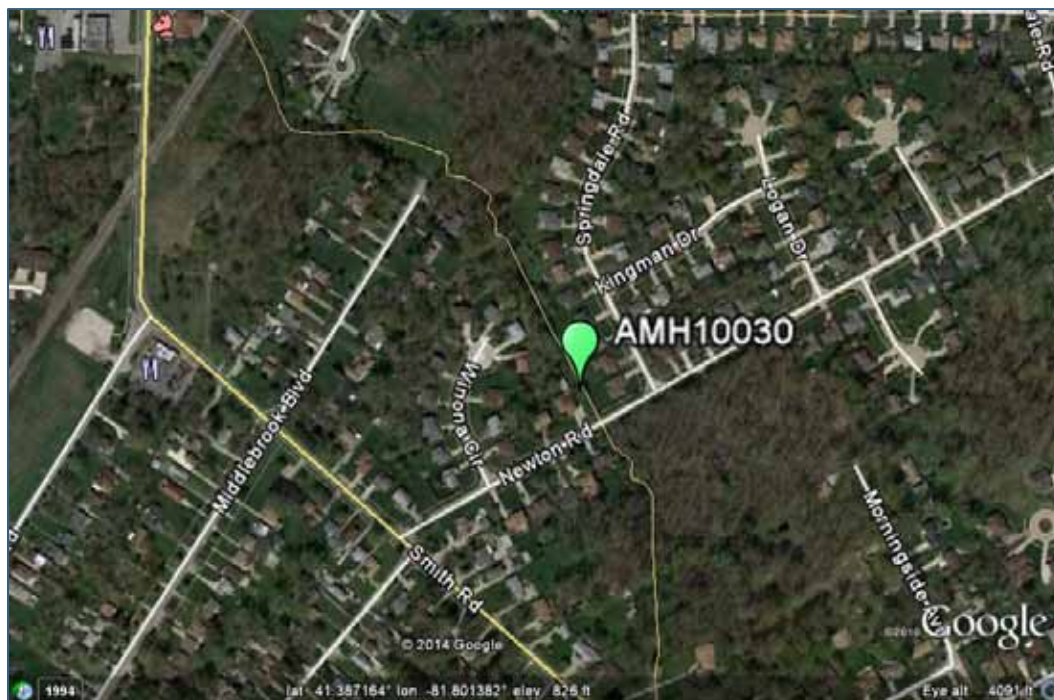
**Problem Summary:** Problem is intermittent. Dry weather flow was traced to between 14200 Newton Road and 14400 Newton Road. Improper connection between the home at 14223 Newton Road and the storm sewer has already been documented. Other possible improper connections may also be present in area; dye testing by the City of Middleburg Heights should be conducted to determine all sources of sanitary sewage to the storm sewer.

**Community Notification:** A letter was sent to the City of Middleburg Heights on February 6, 2014, detailing need to conduct dye testing of homes.

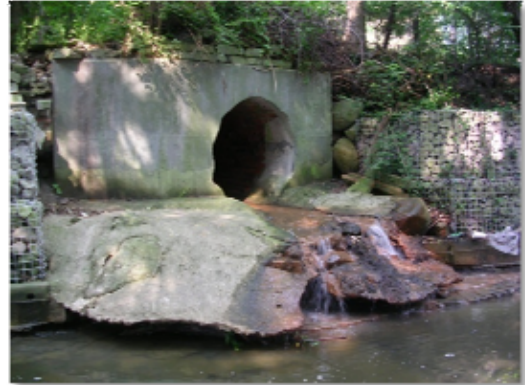
**Problem Summary:** Previous investigations traced dry-weather flow with elevated *E. coli* densities to between Lilac Road and the outfall. The results from the most recent sampling indicate that the problem potentially may have been remediated.

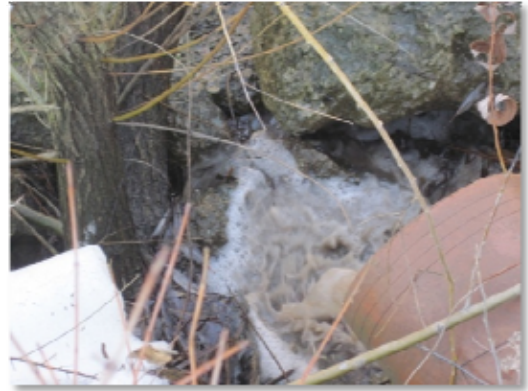
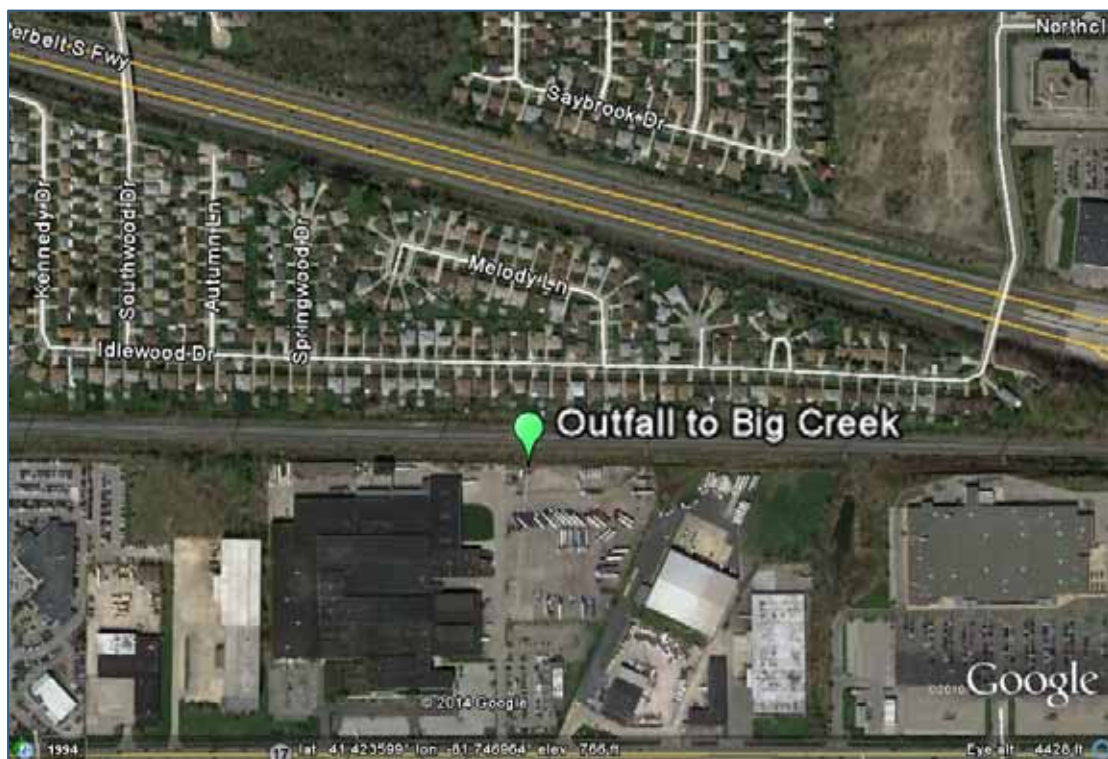
**Problem Summary:** On January 9, 2013, the Ohio EPA alerted WQIS to a white substance present in catch basins in a parking lot at 8700 Brookpark Road that was discharging to the tributary. It was unknown what quantity of material was present. The source of the material also could not be determined. The Ohio EPA later determined that the substance was milk. The parking lot is used by truck drivers as a rest stop, so it may have come from a delivery truck.

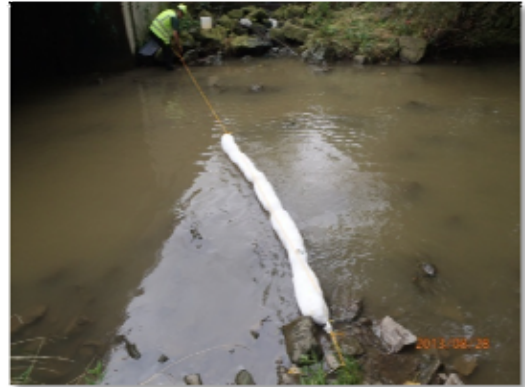
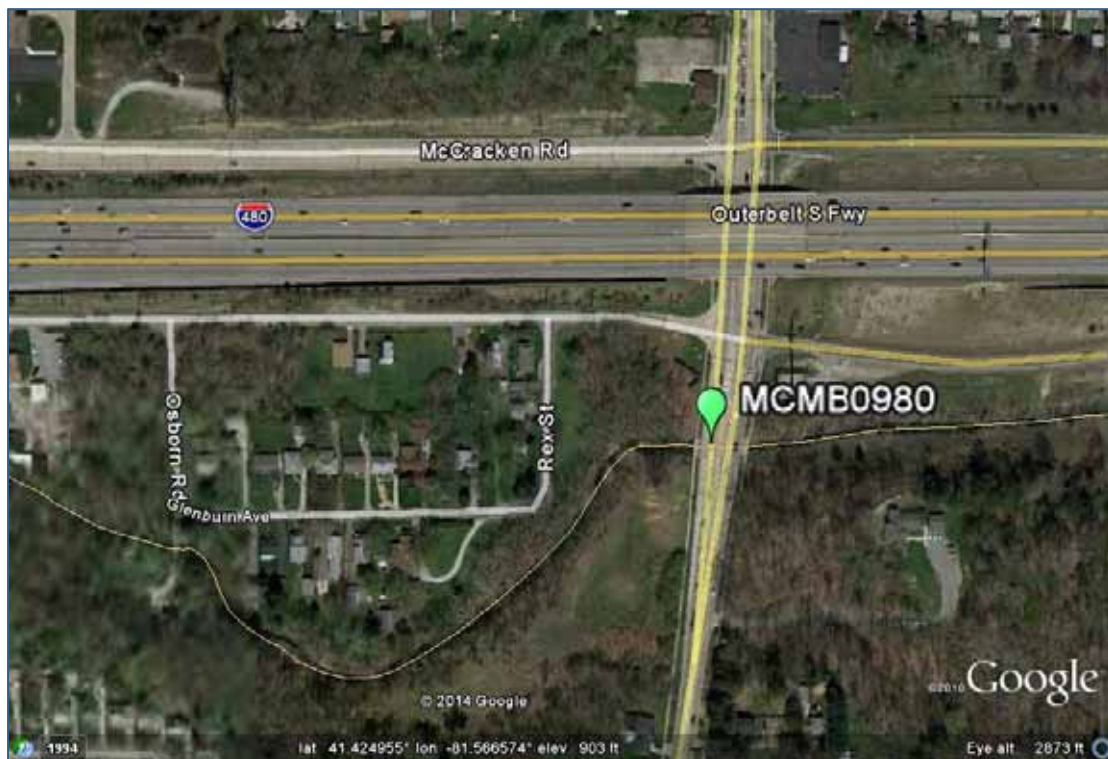
**Problem Summary:** As a result of a motor vehicle accident on August 28, 2013, diesel fuel was released to Lee Road. Absorbent material was used to help contain the spill, but an unknown amount went to the storm sewer and Mill Creek. Absorbent booms were installed across Mill Creek downstream of the outfall to help collect fuel present in the stream.

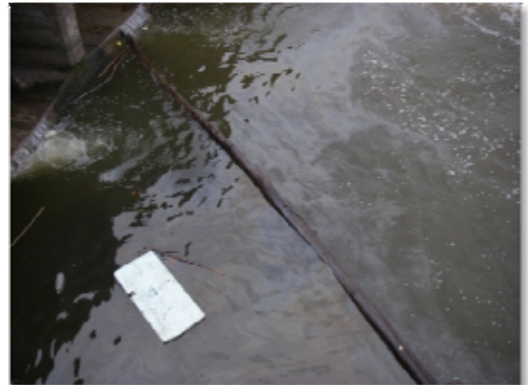
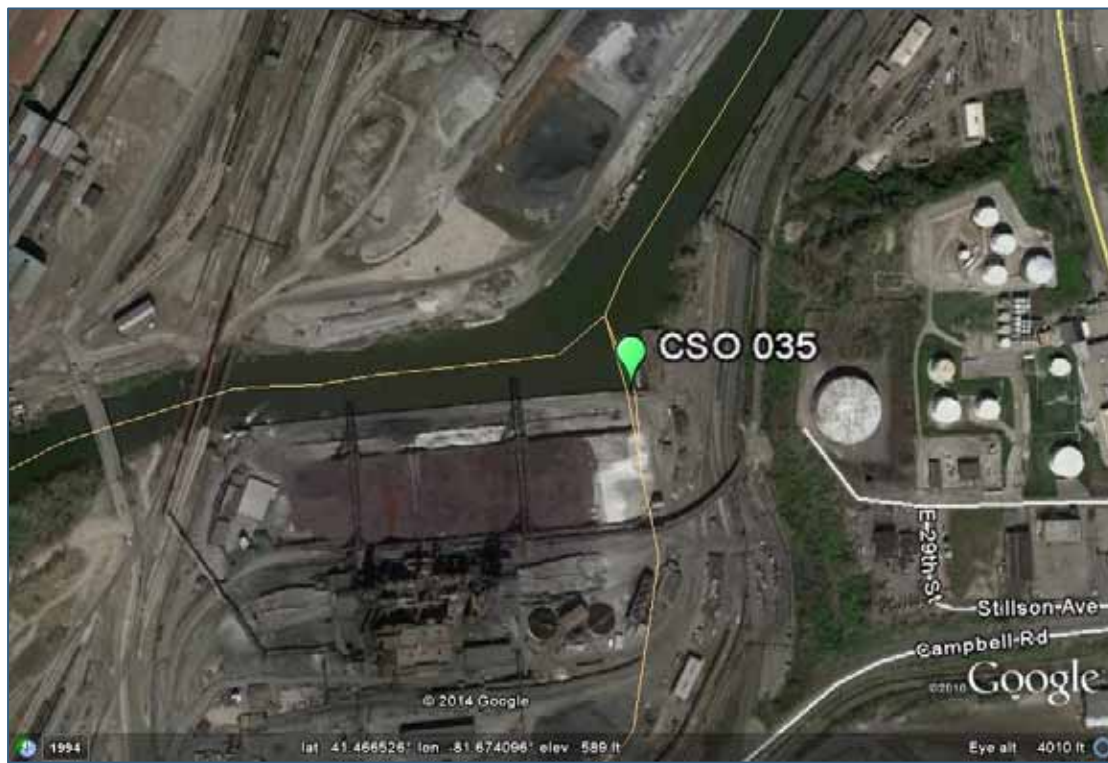
**Problem Summary:** On December 6, 2013, a diesel fuel spill occurred following a coil tractor fire. Most of the fuel that was released was contained on the asphalt near the spill, but an unknown volume went to CSO 035 and the Cuyahoga River. Inland Waters was contracted for cleanup of the fuel present in the river.
