2014 Illicit Discharge Detection and Elimination Program Annual Report

Northeast Ohio Regional
Sewer District

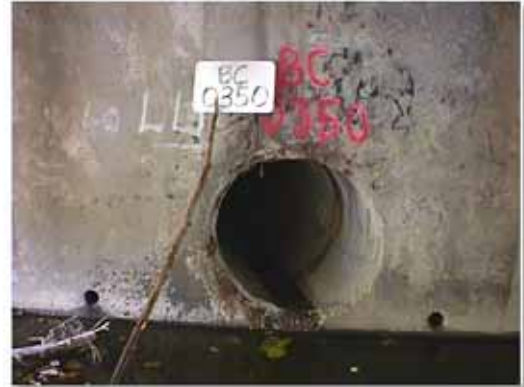
Flow: 1,966 gallons/day

E. coli Density: 5,595 MPN/100mL

Problem Summary: Dry-weather flow with elevated *E. coli* densities traced to Anthony Lane at Independence Boulevard.

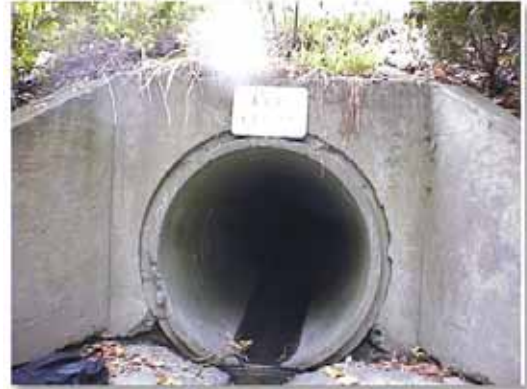
BGMB0370

Flow: 10,271 GPD

E. coli Density: 5,460 MPN/100mL

Problem Summary: Dry-weather flow with elevated *E. coli* densities traced to Brandywine Road, Lantern Lane and Valley York Apartments.

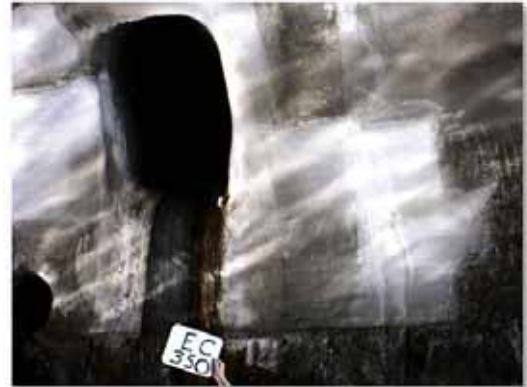
Problem Summary: Flow with elevated *E. coli* densities was traced along Euclid Avenue to Grand Boulevard. A video inspection of the area indicated improper connections between the apartment buildings located at 20200 and 20240 Grand Boulevard and the storm sewer. Recommend that the City of Euclid conduct dye testing to verify improper connections.

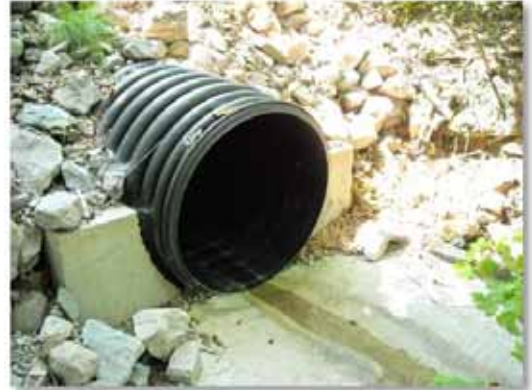
Problem Summary: Dry-weather flow with elevated *E. coli* densities traced to Vezper Drive.

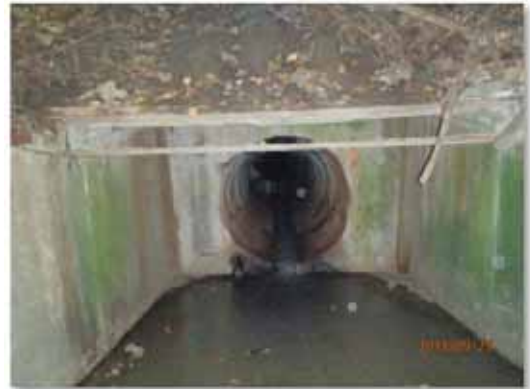
Flow: 17,280 gallons/day

E. coli Density: 99,320 MPN/100mL

Problem Summary: Dry weather flow with elevated *E. coli* densities was traced to Westdale Avenue and to North Rocky River Drive.

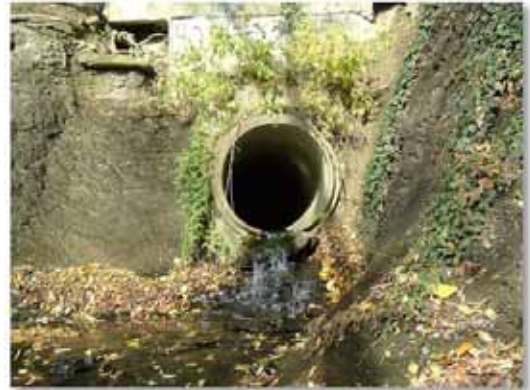
RREB0570

Flow: 27,490 gallons/day

E. coli Density: 3,665 MPN/100mL

Problem Summary: Dry-weather flow with elevated *E. coli* densities traced to between 346 Edgewood Drive and the intersection of Edgewood Drive and West Street. Dye testing of homes in the area began on December 15, 2014.

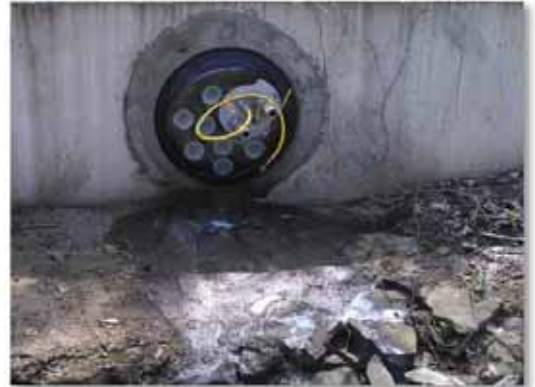
CRBH0030 (LUBRICANT)

Problem Summary: On May 1, 2014, a spill of Tuf Draw 1919 lubricant occurred at the Die-Matic Corporation. This material traveled through a storm drain and entered an un-named tributary to the Cuyahoga River. After the spill was discovered, a plug was put into the outfall to prevent the further discharge of the substance to the stream. The lubricant remaining in the storm sewer was later pumped into a nearby sanitary sewer.
