2015 Illicit Discharge Detection and Elimination Program Annual Report

Northeast Ohio Regional
Sewer District

IDDE Investigations-2015 Report

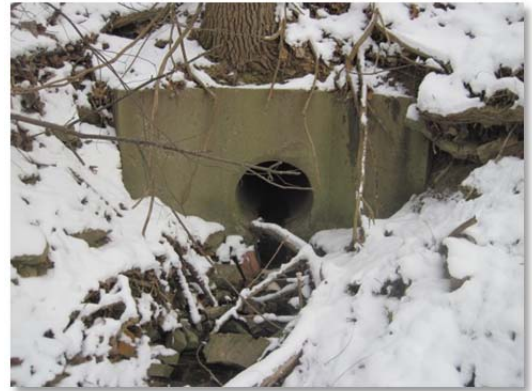
BC2A0020

Flow: 2,633 gallons/day

E. coli Density: 120,980 MPN/100mL

Problem Summary: Samples collected with elevated bacteria. Investigators traced flow to Debby Drive in Parma. CCDPW is conducting dye tests in the area.

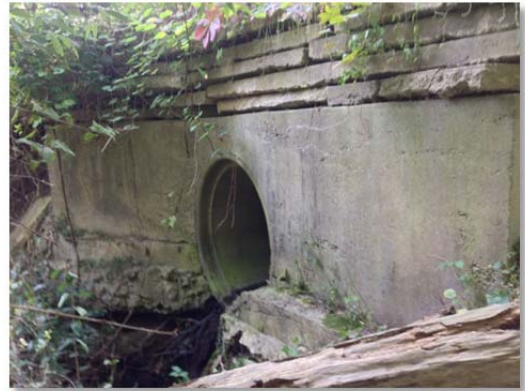
BGMB0080

Flow: 20,000 gallons/day

E. coli Density: 82,150 MPN/100mL

Problem Summary: Dry-weather flow with elevated *E. coli* densities was traced to between the intersection of State Road and Coral Gables Drive and 4865 Coral Gables Drive and to between the intersection of State Road and Ocala Drive and 4419 Ocala Drive. Recommend dye testing homes in these areas to determine improper connections. Community is in the process of completing dye tests on Ocala Drive.

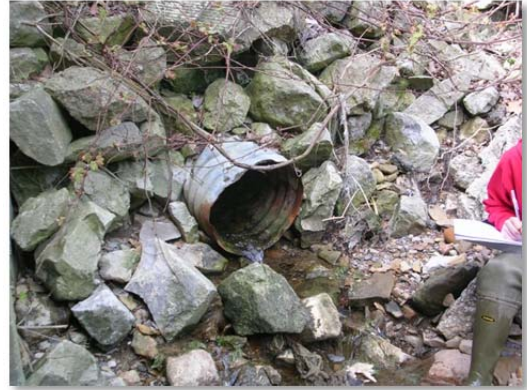
BGMB0155

Flow: 10,966 gallons/day

E. coli Density: 10,378 MPN/100mL

Problem Summary: Dry-weather flow with elevated *E. coli* densities was traced to between 7580 and 7592 Ridge Road. Recommend dye testing homes in this area to determine improper connections. Community has sent notifications to residents for CDDPW dye testing.

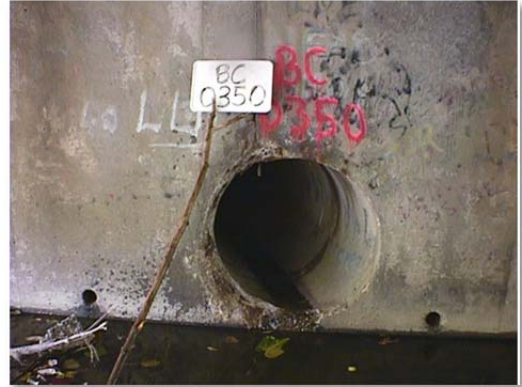
BGMB0350

Flow: low flow

E. coli Density: 1,460 MPN/100mL

Problem Summary: Dry-weather flow with elevated *E. coli* densities traced to Anthony Lane at Independence Boulevard.

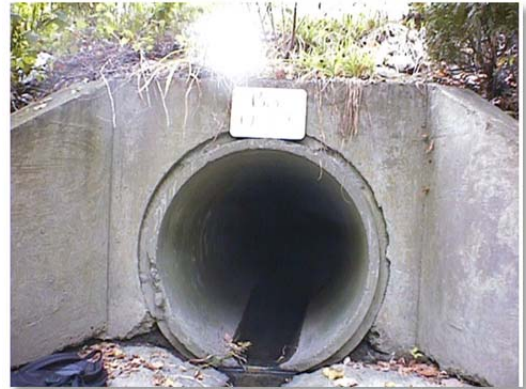
BGMB0370

Flow: 1,630 gallons/day

E. coli Density: 3,443 MPN/100mL

Problem Summary: Dry-weather flow with elevated *E. coli* densities traced to Brandywine Road, Lantern Lane and Valley York Apartments. Dye testing of these streets is in process. A blocked sewer at Valley York Apartments was corrected.

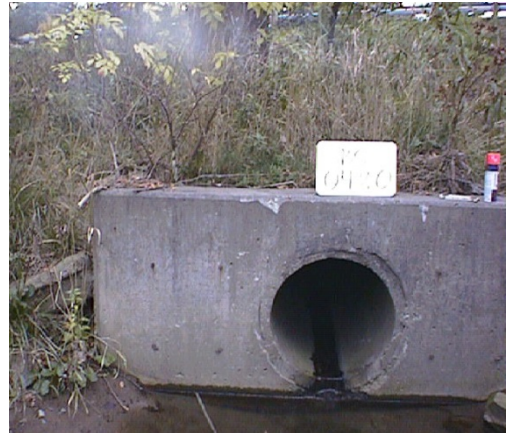
BGMB0480

Flow: 19,600 gallons/day

E. coli Density: 39,696 MPN/100mL

Problem Summary: Flow tracing and source tracking in the system revealed a need for dye testing or CCTV to be completed on York Road between West Ridgewood Drive and 7155 York Road, on the east and west sides of the street. This is scheduled to be completed in early 2016.

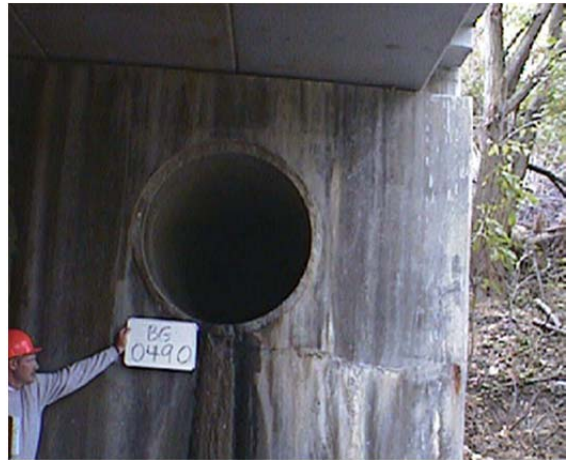
BGMB0490

Flow: 12,300 gallons/day

E. coli Density: 5,955 MPN/100mL

Problem Summary: This is an intermittent problem; this outfall and outfall BGMB0480 are tied together. Flow tracing and source tracking in the system revealed a need for dye testing or CCTV to be completed on York Road between West Ridgewood Drive and 7155 York Road, on the east and west sides of the street. This is scheduled to be completed in early 2016.

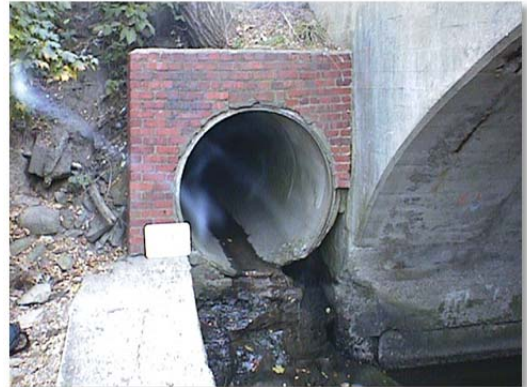
BGMB0600

Flow: no data

E. coli Density: 17,850 MPN/100mL

Problem Summary: Dry weather flow was traced to Sherborn Drive between Glendora Lane and Appleton Drive. Recommend dye testing of homes between 11661 and 12067 Appleton Drive and on Sherborn Road between Appleton Drive and Glendora Avenue. Dye tests are completed and one improper connection was found. An NOV was issued and NEORS D will resample when repair is complete.

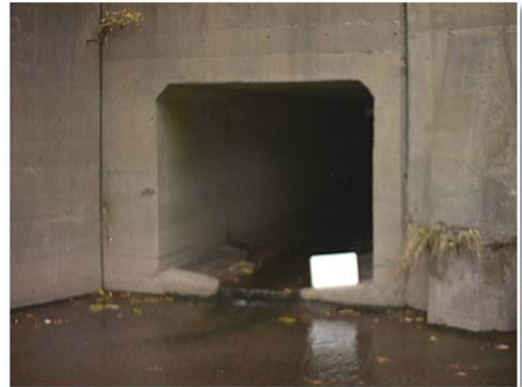
BGMB1550 (CSO-051)

E. coli Density: 193,650 MPN/100mL

Problem Summary: A CCTV investigation along Clybourne Avenue bracketed suspected improper connection to two residential addresses requiring dye-test to confirm: 4123 Clybourne Avenue (single family home) and 4129/4119 Clybourne Avenue (duplex). WPC dye-tested 4129 & 4119 Clybourne Avenue; both were negative for illicit connection. WPC to investigate further.

Additionally, due to sanitary/storm sewer configuration, three sanitary sewer overflows (SSOs) exist along Memphis Ave. b/w E.35th & E.38th Streets. OEPA requiring WPC to include SSO locations in MS4 annual report and show proof of budgeting on CIP for corrective measures.

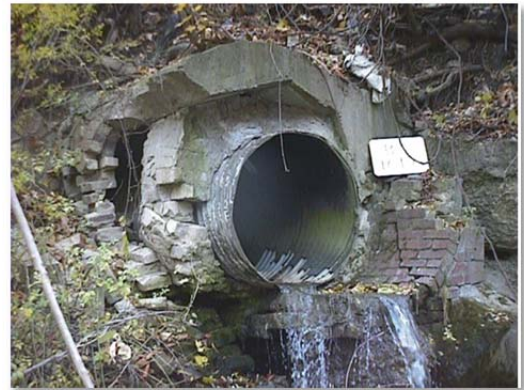
BGMB1610 (CSO-050)

E. coli Density: 192,675 MPN/100mL

Problem Summary: A potential illicit discharge was found by NEORSD Engineering and Construction staff coming from the 12" storm sewer/SWO at Henninger Road on July 28, 2015. WQIS sampling on 7/30/15 confirmed 804 MPN/100ml *E. coli* level. WPC to assess need for sewer cleaning and further investigate possible residential improper connections on western portion of Henninger Road in November 2015.

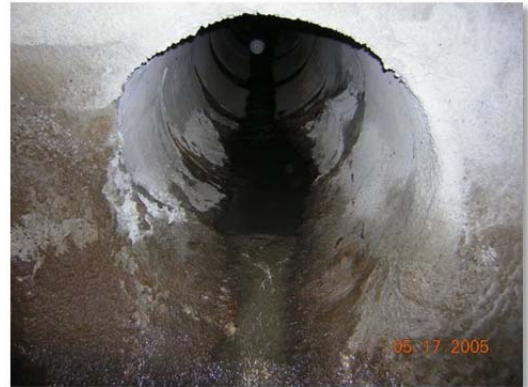
BCRC0080

Flow: no data

E. coli Density: 20,530 MPN/100mL

Problem Summary: NEORSD was notified of an improper connection to storm sewer by a resident. Dry-weather flow with elevated *E. coli* densities was traced to Pearl Road. A NOV was sent to the resident on Pearl Rd.

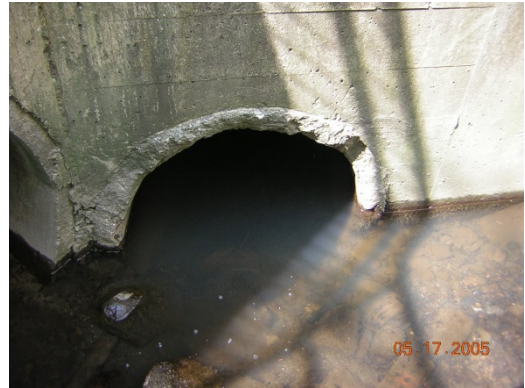
BCRC0110

Flow: no data

E. coli Density: 120,980 MPN/100mL

Problem Summary: CCDPW provided email confirmation to M. Scharver that the sanitary manhole at Brookmere Drive & Roxbury Road has been repaired by CCDPW. This was the last remaining, known repair to be completed by the County in this sewershed.

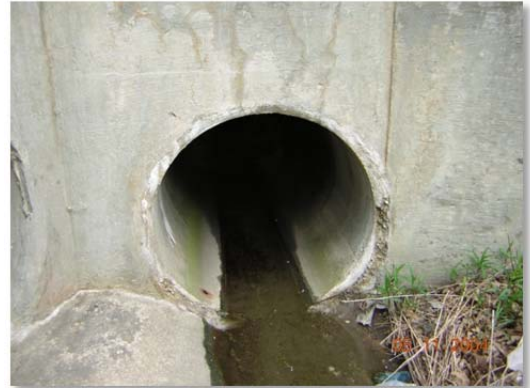
CT112080

Flow: ~100 gallons/day

E. coli Density: 61,310 MPN/100mL

Problem Summary: Dry-weather flow traced to between the intersection of Golden Gate Boulevard and Maplewood Road. The City of Mayfield Heights is working with CCDPW to identify and remediate these problems. One improper connection fixed; the other improper connection to be fixed in January 2016.

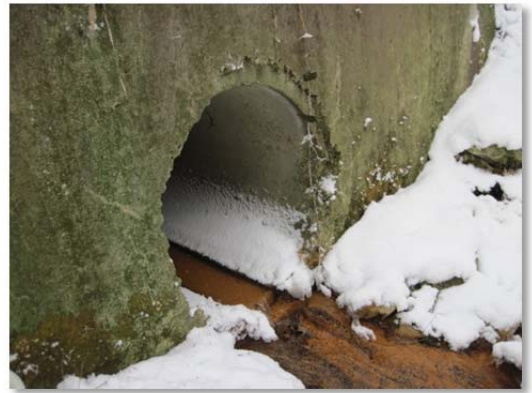
CBT60030

Problem Summary: Failing home sewage treatment systems are located immediately upstream of the outfall. Dry-weather flow with elevated *E. coli* densities was also found upstream of 7395 Winding Way. The City of Brecksville is working to identify and remediate any improper connections to the storm sewer. NEORS D resampled in September 2015. CCDPW completed repair work after this sampling, and requested that NEORS D resample in early 2016.

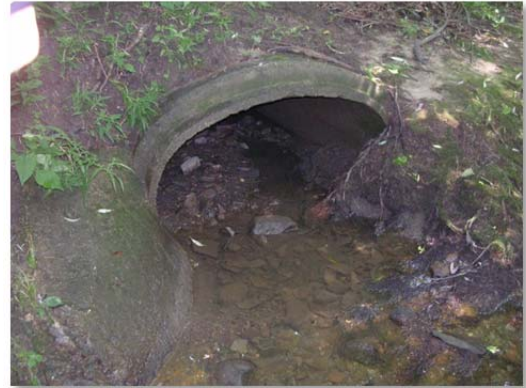
DBMB2120

Problem Summary: Dry-weather flow with elevated *E. coli* densities was traced to Shelburne Avenue. Recommend that City of Shaker Heights conduct dye testing to determine any improper connections on that street.

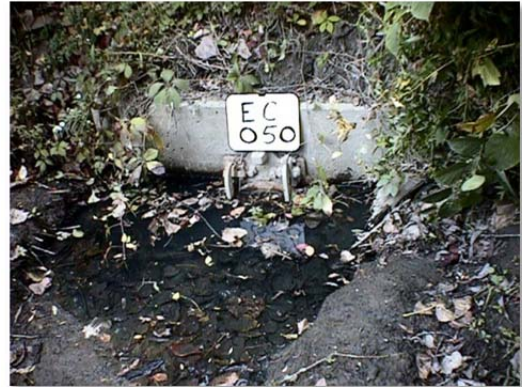
ECMB0050

Problem Summary: An improper connection was found between the basement of a home at 817 Hoover Avenue and the storm sewer. The problem was fixed on August 29, 2014.

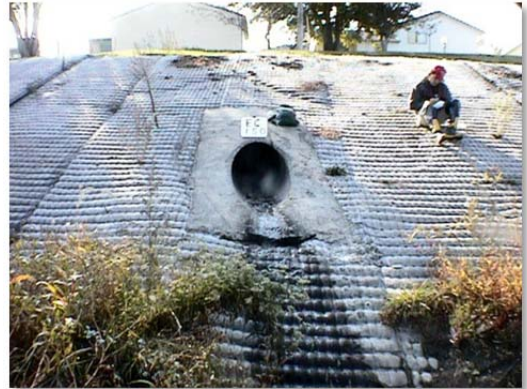
ECMB0150

Problem Summary: A SSO located at 959 E. 178th Street has not been remediated. The City of Cleveland Division of Water Pollution Control monitored the SSO in 2014 to determine the frequency of activation; no events were found.

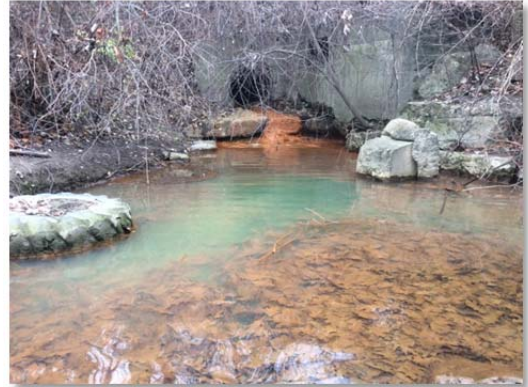
ECMB0290

Problem Summary: Low *E. coli* densities, but high iron in the water prompts further investigation.

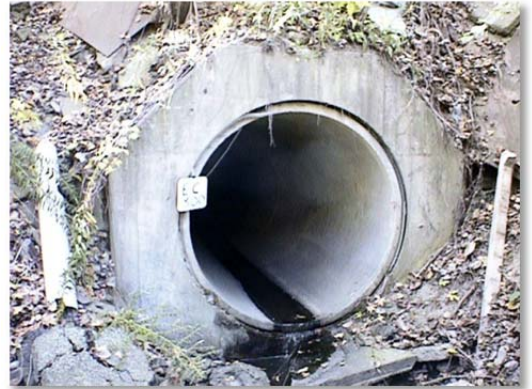
ECMB0300

Problem Summary: Improper connections were found between two of the buildings at Indian Hills Apartments and the storm sewer; these problems were remediated. Additional improper connections from one of the buildings were found on October 15, 2014.

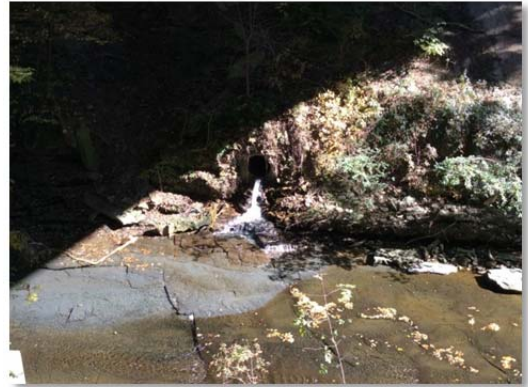
ECWB3350

Problem Summary: Resident of South Euclid voiced concern at NEORSD open house over a water leak near the resident's property. The leak had been reported, but no progress had been made. Investigation revealed a several water leaks which sourced the outfall.

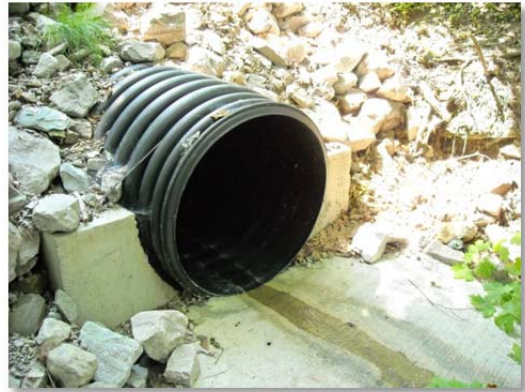
HEMB1050

Problem Summary: Problem traced to possible illicit discharges on Alla Drive. City to complete, via AECOM contract, 5 dye-tests of residences w/ positive smoke test results, both for possible improper connections and downspout connections to sanitary sewer (inflow) during December 2015

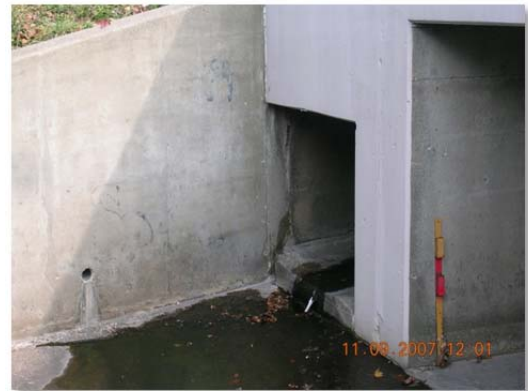
MCMB2005

Problem Summary: A blocked sanitary sewer was found in Shaker Heights along Warrensville Center Road. This blockage was cleared on March 14, 2014. Dry-weather flow with elevated *E. coli* densities was still present in area afterwards. Two water leaks were found and remediated. An improper connection to the storm sewer was also found at 20207 Harvard Avenue.

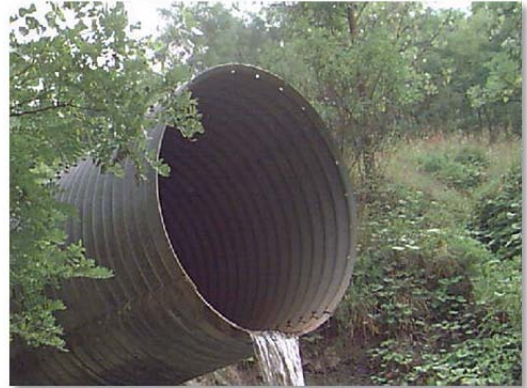
RRMB0100 (CSO-068)

Problem Summary: Dry-weather flow with elevated *E. coli* densities was traced to Montrose Avenue and upstream locations. Improper connections were found between St. Mark School and Rectory and the storm sewer. WPC is working with St. Mark to remediate the problems.

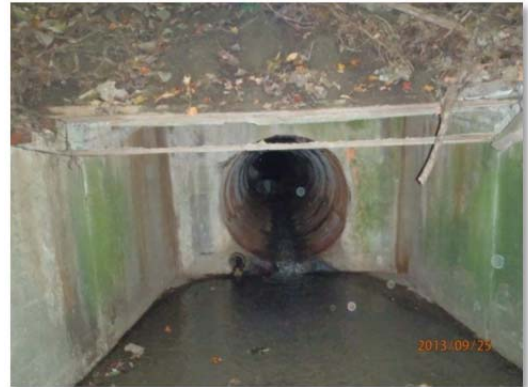
RRMB0630 (CSO-064)

Problem Summary: Dry weather flow with elevated *E. coli* densities was traced to Westdale Avenue and to North Rocky River Drive.

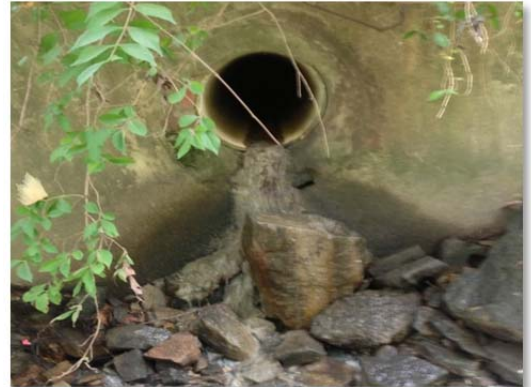
RREB0880

Problem Summary: Dry-weather flow with elevated *E. coli* densities was traced to Front Street between 31 Riverside Drive and 87 Front Street. A water main break was also found between 44 and 54 Front Street. The City of Berea is conducting dye tests and working to remediate any problems with improper connections and water leaks in the area.

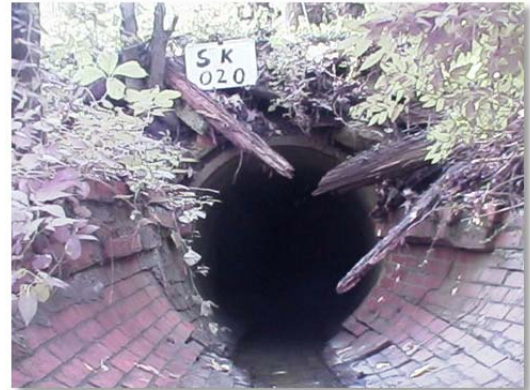
SKMB0020

Problem Summary: Improper connections were found on several streets in the drainage area of SKMB0020.

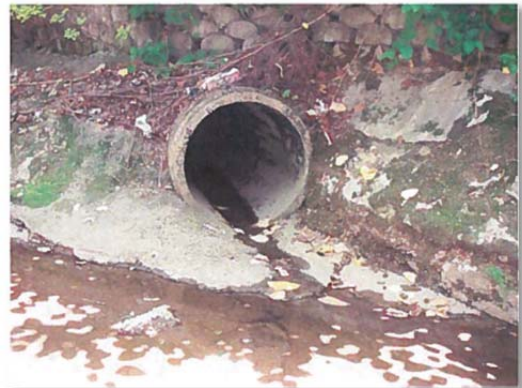
WMMB0080

Problem Summary: Dry weather flow with elevated *E. coli* was traced to East 117th and East 119th Streets. Garfield Heights City Engineer to speak to CCDPW regarding request for historical CCTV videos of sewers in that area. If historical videos are not available, Garfield Heights has requested CCDPW to complete new CCTV of requested sewers for IDDE investigation.

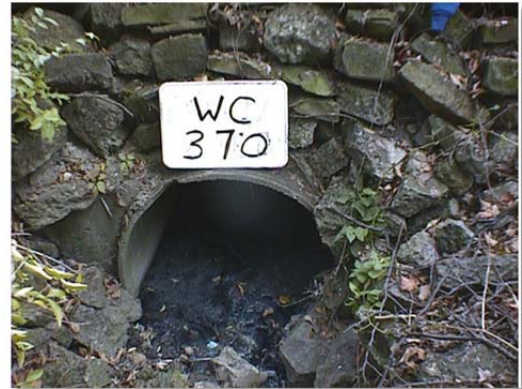
WCMB0370

Problem Summary: NOACA has indicated that all of Parma is prescribed to be sewered; however, several areas remain without sanitary sewer access and planning for some unsewered areas within the City are pending. The District plans to meet with CCBH regarding known failing HSTS in the area.

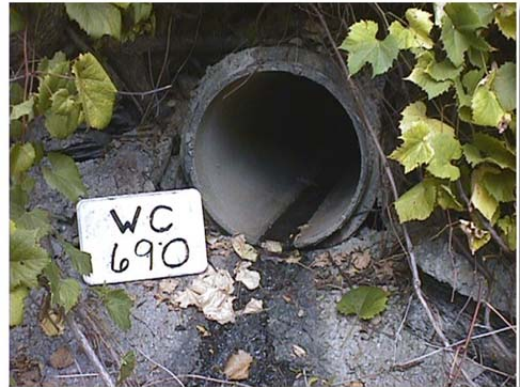
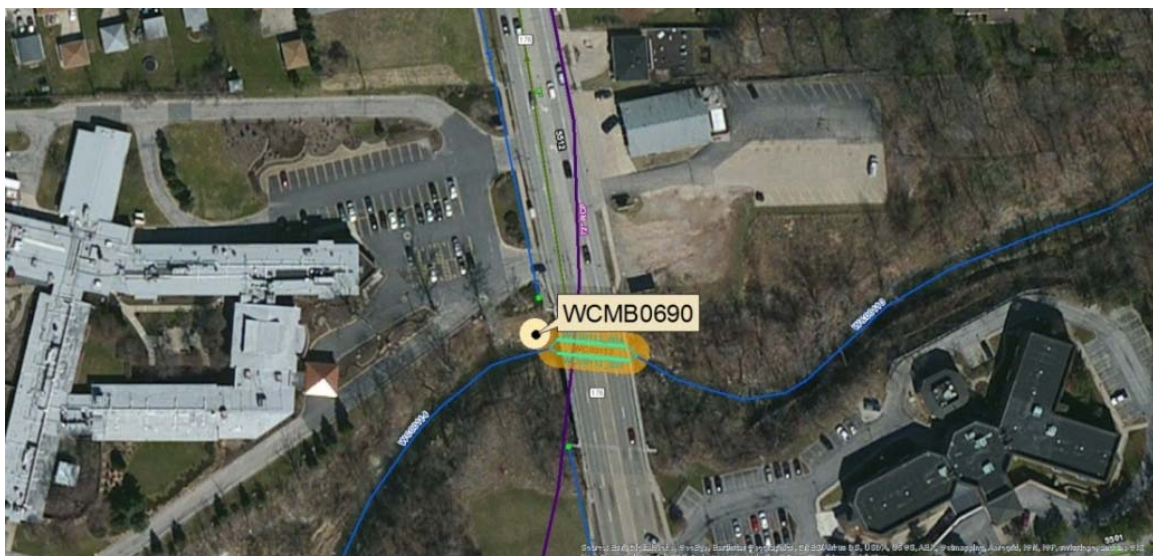
Flow: 500 gallons/day

E. coli Density: 21,750 CFU/100mL

Problem Summary: CCDPW confirmed 10/27/15 that the Broadview Road drill drop is complete, which will now provide sanitary sewer access/capacity for additional gravity sanitary sewers, under design and yet to be installed, to provide service to 13 residences located on Brookdale Avenue and 4 residences on Broadview Road that currently have HSTs. CCDPW confirmed 10/27/15 that the Broadrock Road drill drop design is complete contingent on acquiring temporary easements. Once these are acquired, the design will be finalized, funding secured, and project bid for construction. This drill drop provides access/capacity for the HSTs on Broadrock Court and Old Rockside Road to be provided sanitary sewer service.

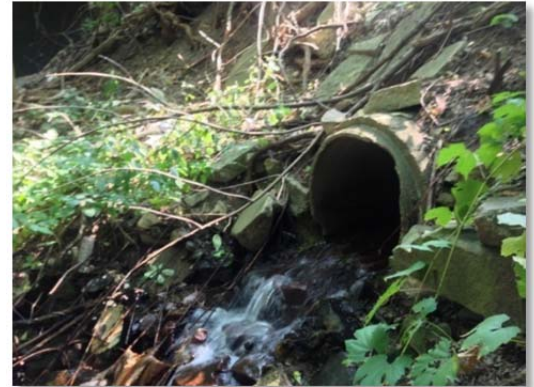
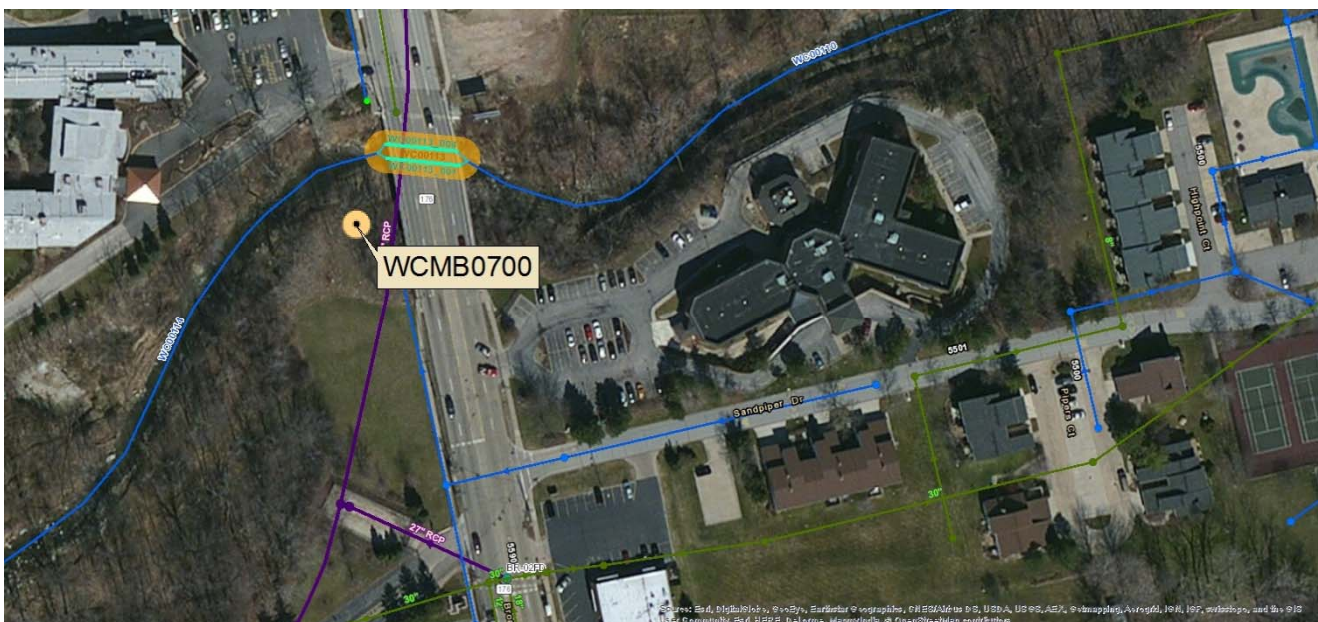
WCMB0700

Flow: 20,000 gallons/day

E. coli Density: 397,260 MPN/100mL

Problem Summary: A blockage within the sanitary sewer at Broadview Road and Broadrock Court was remediated; however, during the Sewer District's September 22, 2015, re-inspection following corrective action by the City/CCDPW, the Sewer District observed that the hole in the sanitary sewer was allowing sewage to exit the sanitary sewer during high flows/surcharging and enter the adjacent storm sewer.

Community Notification: During the 10/27/15 meeting, the City of Parma was informed of the new findings and CCDPW was made aware of the new work order to complete repairs.

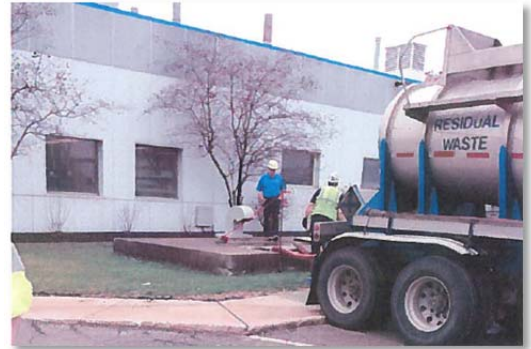
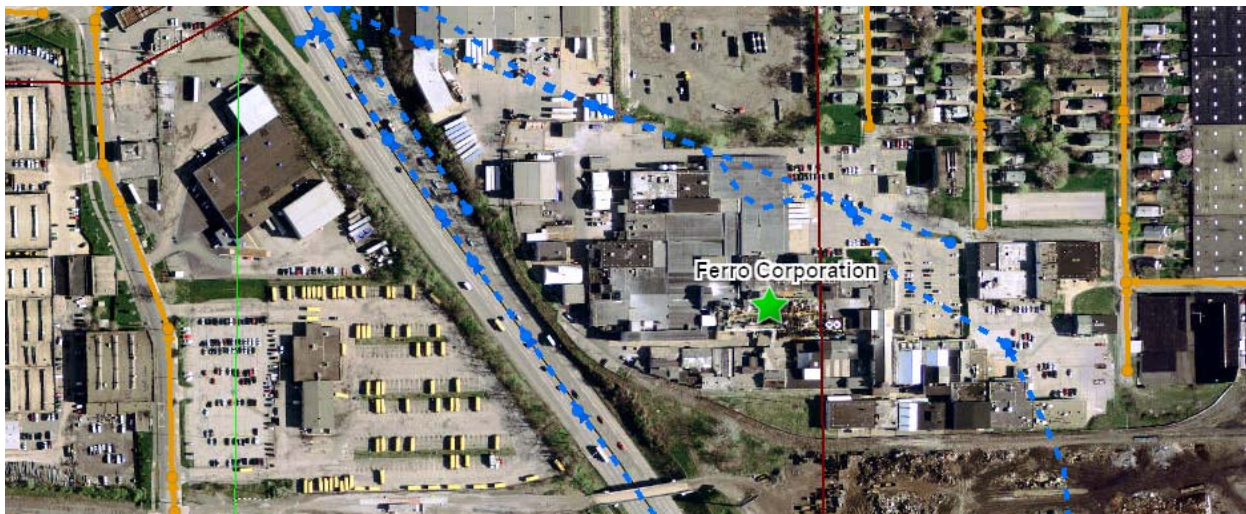
ILLICIT DISCHARGE TO BURKE BROOK

Problem Summary: On April 9, 2015, Ferro Corp had two pumps fail which caused an overflow to Burke Brook. The pumps mixed the sanitary waste with the industrial waste. The pipe discharged to the brook for approximately 45 minutes. Enviroserve vacuumed out the overflow from the storage tank. New pump parts had been ordered and would be replaced once the situation was under control.

Status: Problem remediated.

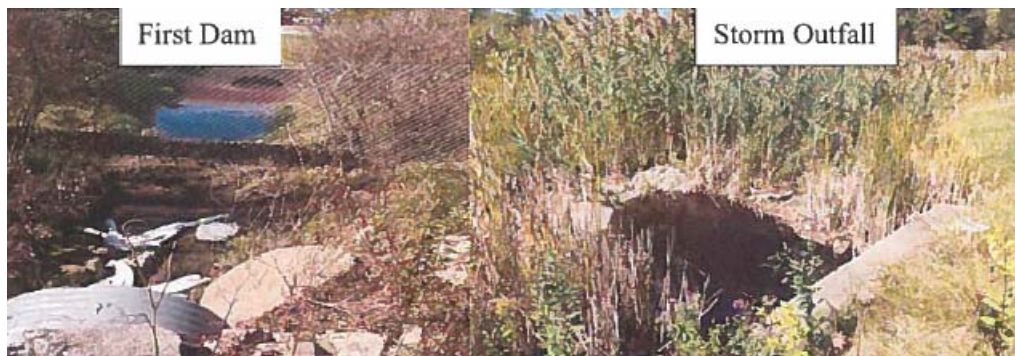
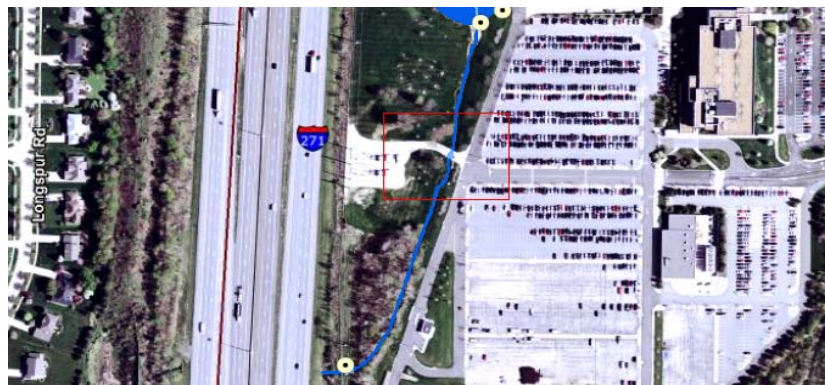
CONTAMINATED RUNOFF FROM A TRUCK FIRE

The truck contained hazardous materials related to hair products and the Chagrin/Southeast Regional Hazardous Material Team was called out to assist. The contaminated runoff flowed out to Euclid Creek and, although there was a dam constructed to contain the flow, some traveled down the creek prior to the dam being built. A fish kill resulted, with approximately 500 fish dead of 8 species. The flow contained oil/grease, zinc and copper, all exceeding the Aquatic Life Tier 2 Outside Mixing Zone Maximum standard. Sunpro Inc. was in charge of the clean-up and they vacuumed the creek multiple times.

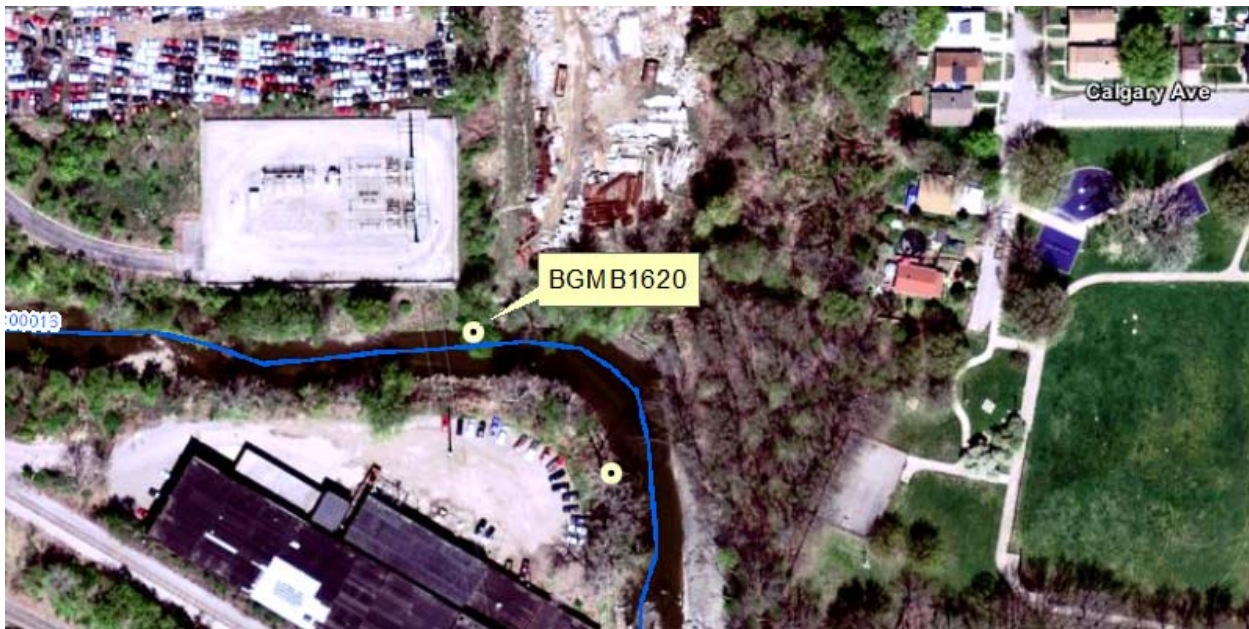
BGMB1620 (OIL DISCHARGE)

Problem Summary: Oil was leaking from several pieces of equipment owned by Terrace Construction at 3965 Pearl Road and Brookside Auto at 3979 Pearl Road. The oil was collecting in the storm system and then discharging from outfall BGMB1620 on Big Creek. Terrace Construction and Brookside Auto were issued notices of interest from the Ohio EPA and asked to clean up their sites and stop illicit discharges.

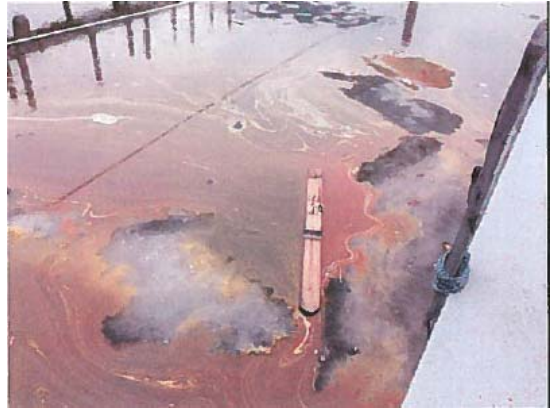
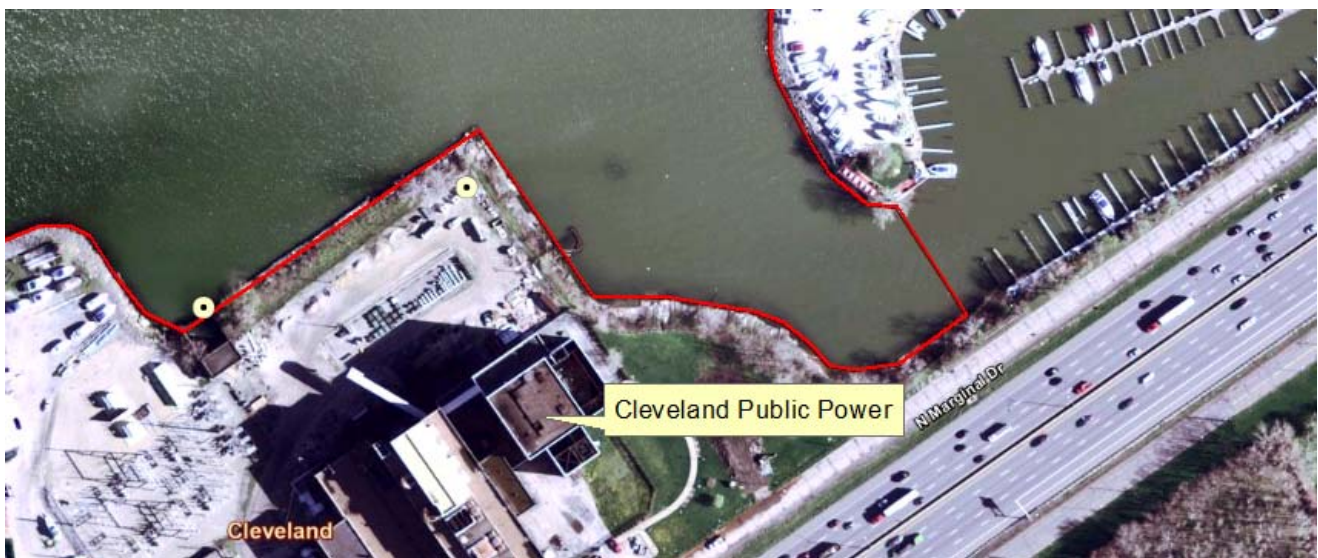
CLEVELAND PUBLIC POWER OIL SPILL TO LAKE ERIE

Clean Harbors was called in to assist with the clean-up. NEORSRD also responded along with the Coast Guard. Clean Harbors vacuumed out about 2,900 gallons and skimmed the surface of the lake as well.
