Northeast Ohio Regional Sewer District

### Watershed Advisory Committee

CUYAHOGA RIVER NORTH | OCTOBER 5, 2021

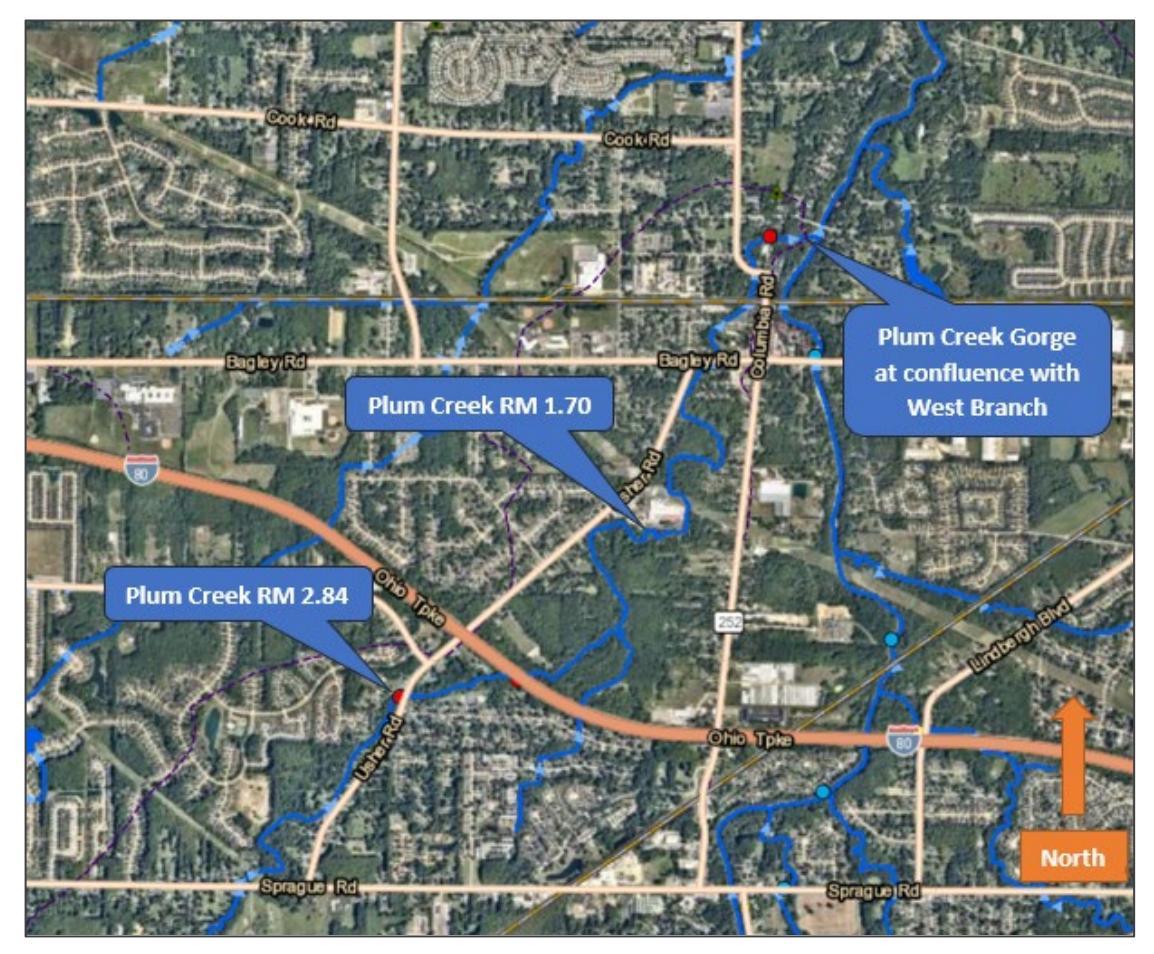
**Plum Creek seed/translocation locations**

- All source locations within the Rocky River watershed
- Goal: minimum of 200 fish/species/year into Plum Creek at two seed locations
- Minimum of 3 consecutive years of translocation
  - Reduces environmental variability of a bad spawning/weather year
  - Increases genetic diversity

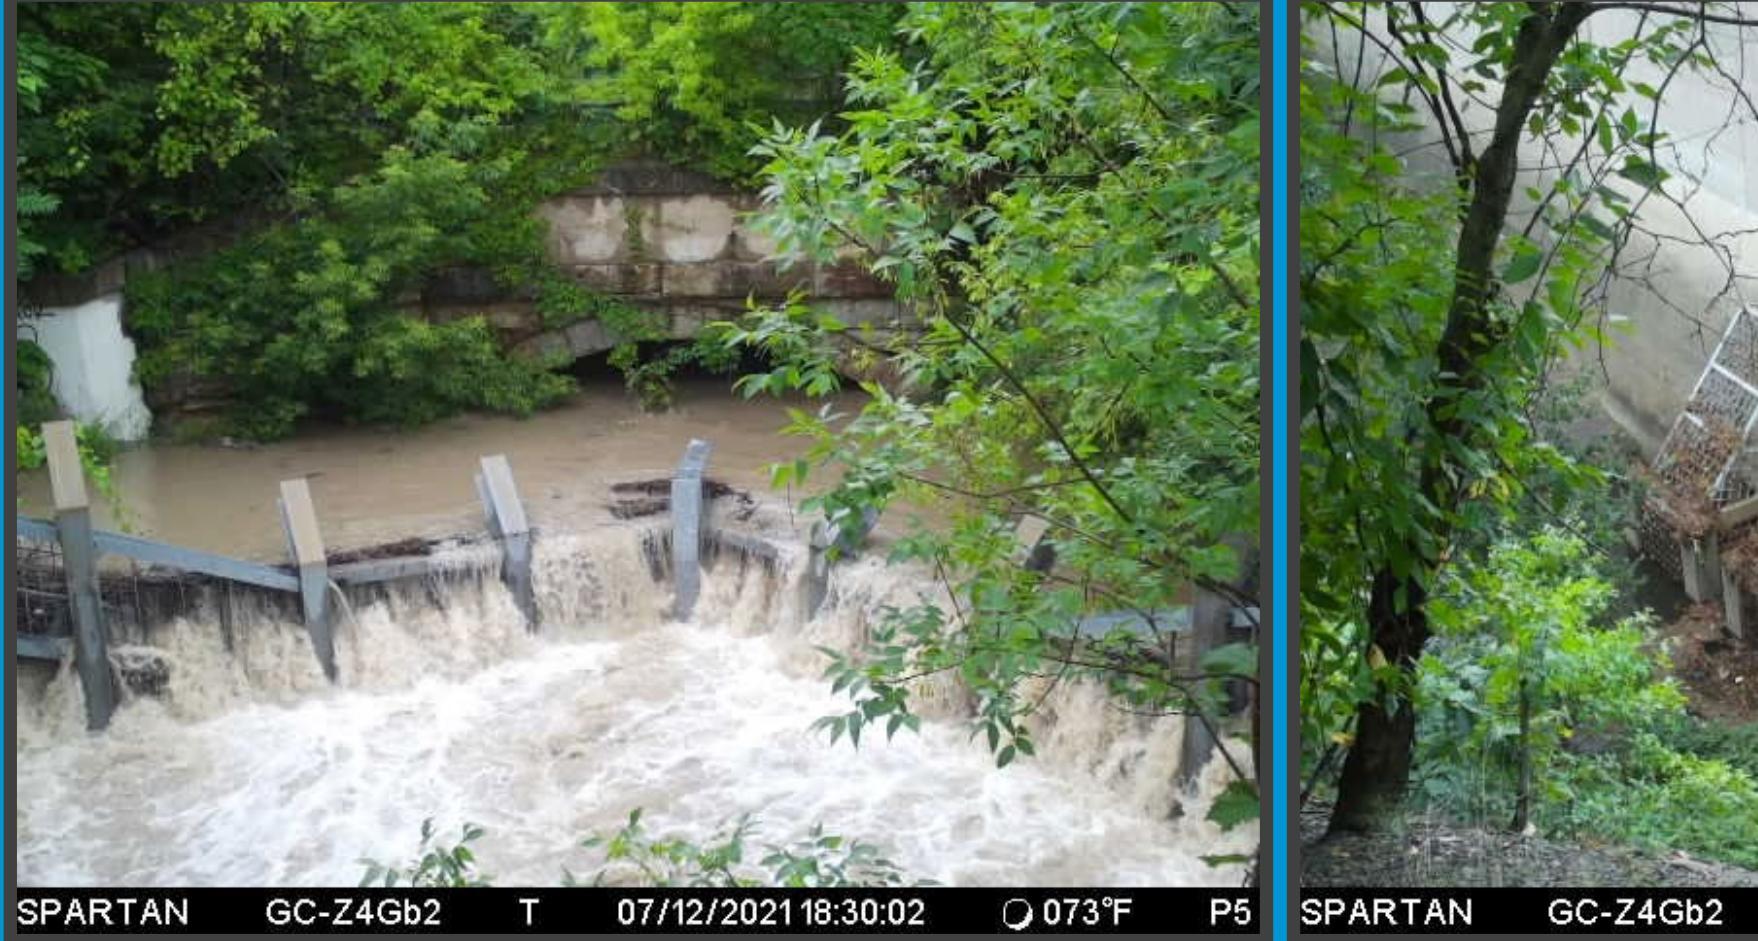
#### Airport Debris Rack

# Trail Cams are Reviewed to Identify Potential Stormwater Issues for Field Response

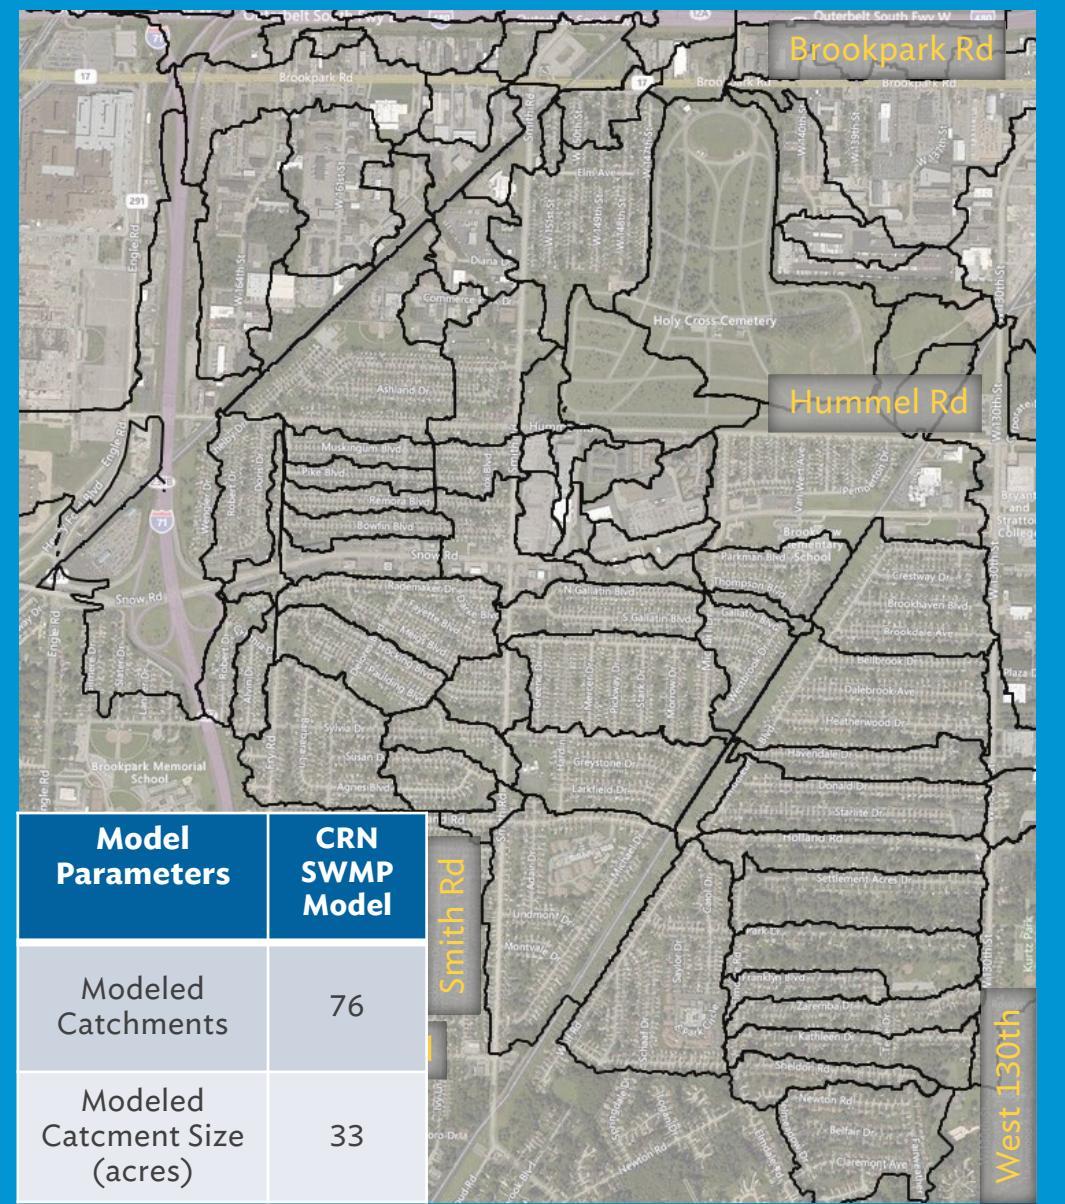
#### CRN SWMP Model: Catchments

The CRN SWMP model was extended from the RSS into the Local Storm Sewer System (LSS). Hydrologic catchments were also refined as part of the model extension.

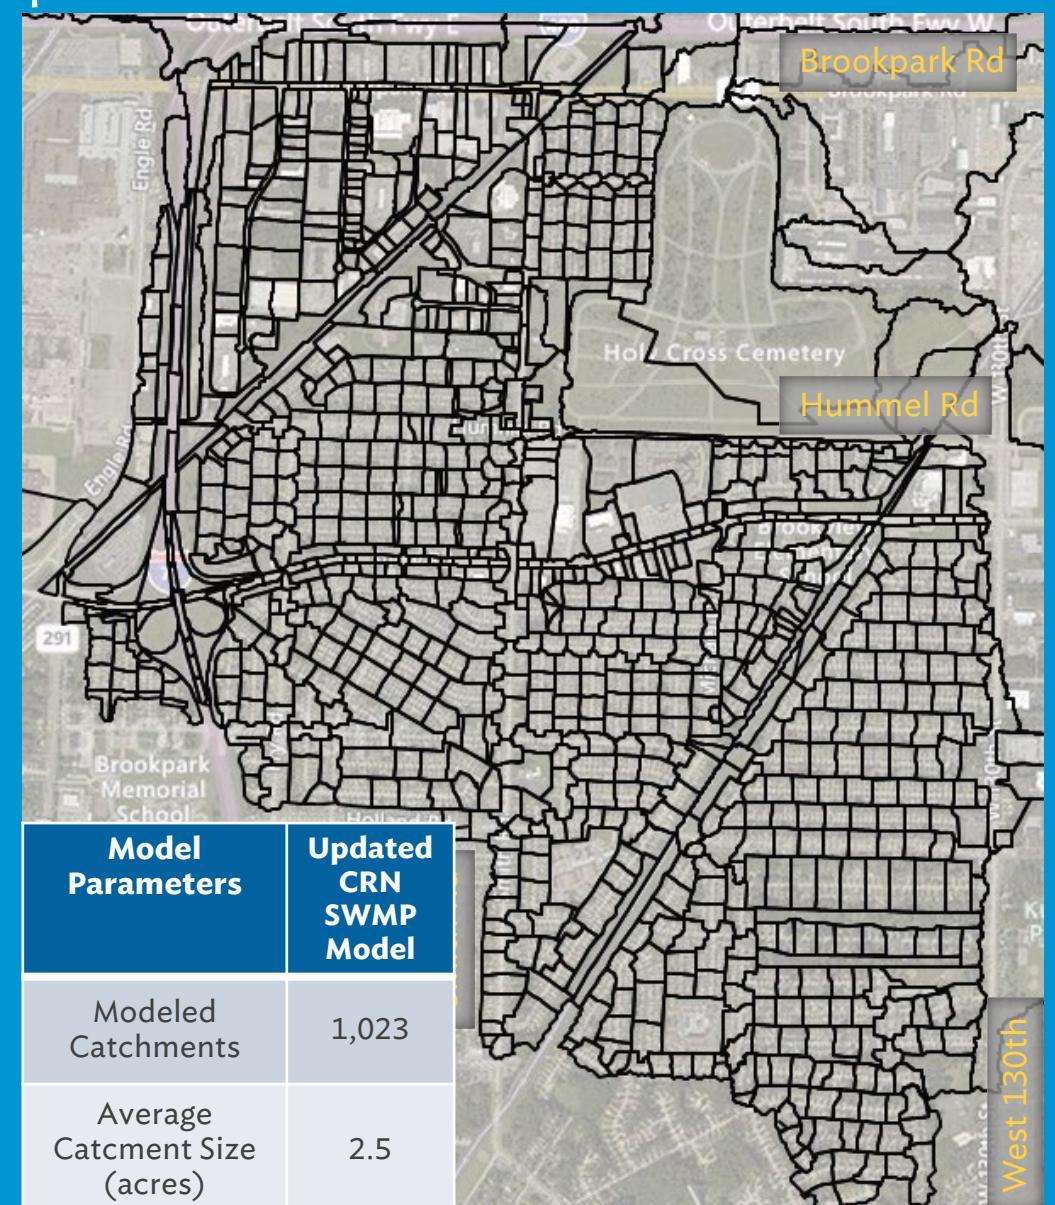
### Updated CRN SWMP Model: Catchments

Model Parameters	CRN SWMP Model	Updated CRN SWMP Model (LSS Extensions)
Modeled Catchments	76	1,023
Average Catchment Size (acres)	33	2.5
Modeled Conduits	222	1,119
Total Conduit Length (feet)	53,367	249,522

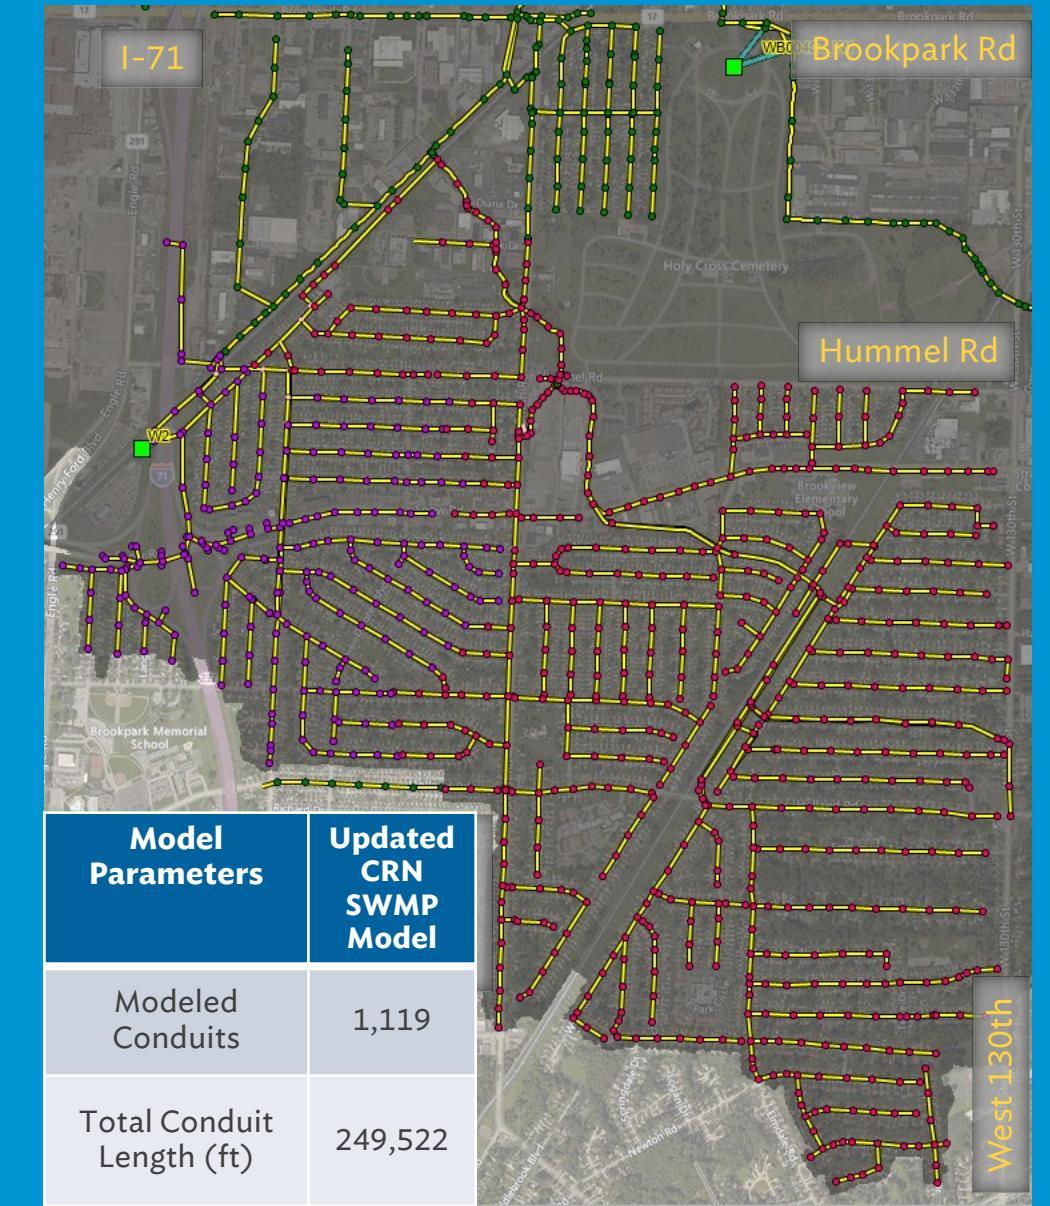
#### Updated Hydraulic Model with LSS Extensions

- Better understanding of the LSS flooding problems
- Potential RSS influence on LSS flooding problems
- Identifying potential opportunities to mitigate flooding at the local level
- Identifying potential RSS benefit from local solutions.

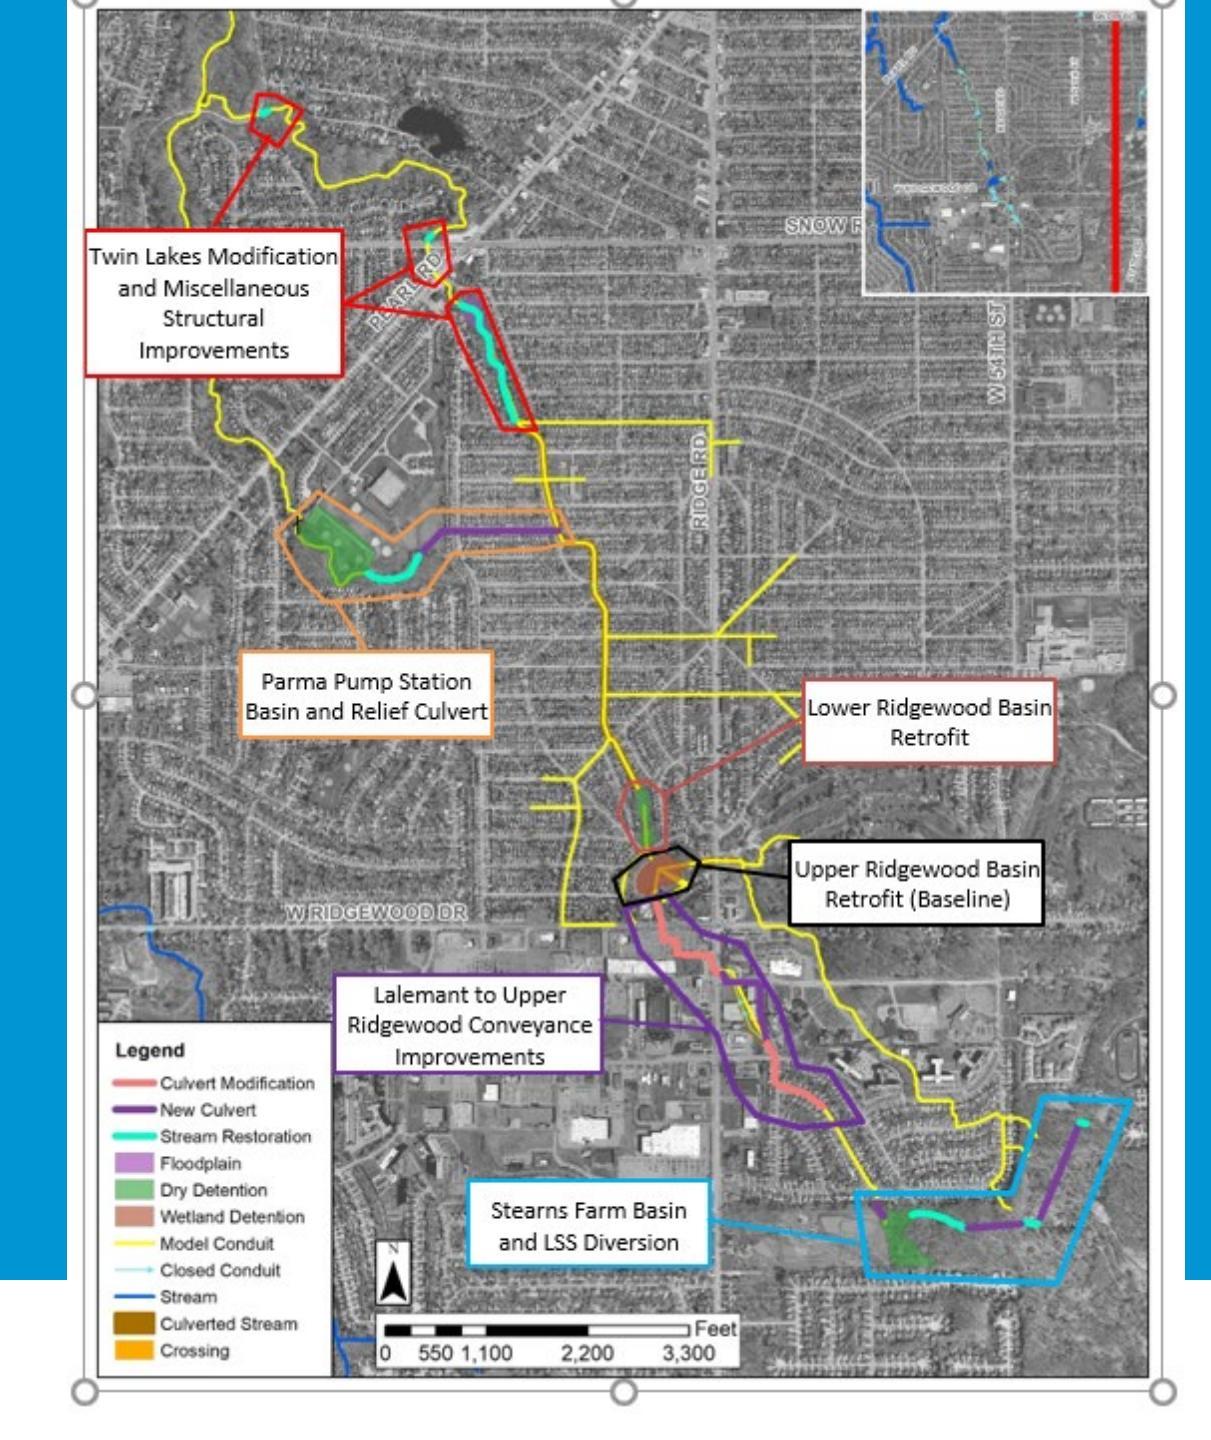
### ASP: Problem Area BCPA07

- Six Project Phases
- Baseline Upper Ridgewood
- Stearns Farm Detention Basin and LSS Diversion
- Lalemant Drive to Upper Ridgewood Conveyance Improvements
- Stormwater Diversion near the Parma Pump Station
- Lower Ridgewood Retrofit
- Upper/Lower Twin Lakes

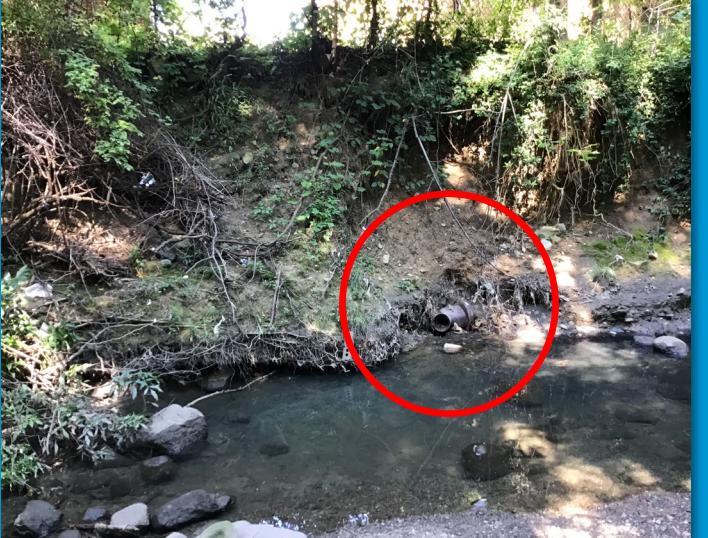
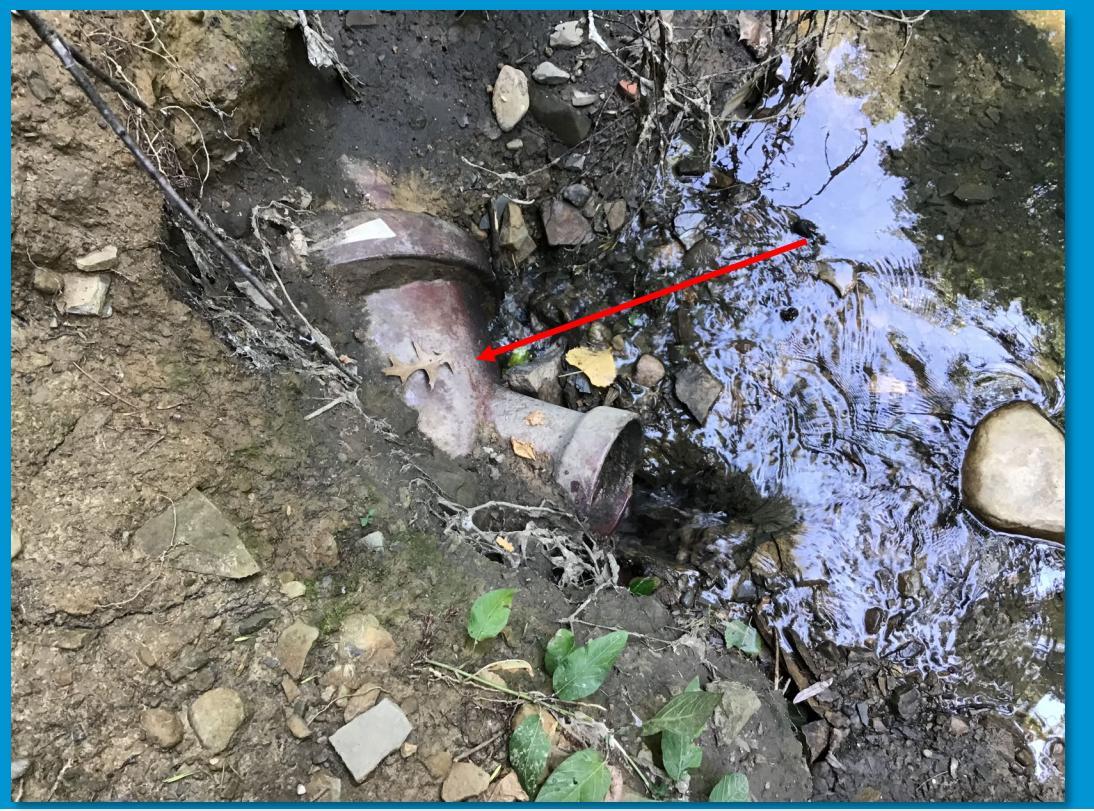
#### Mill Creek, Garfield Heights

Regular monitoring for the erosion adjacent to an apartment complex.

Broken sanitary pipe has exacerbated erosion and streamflow is entering the local sanitary sewer under the exposed storm sewer pipe.

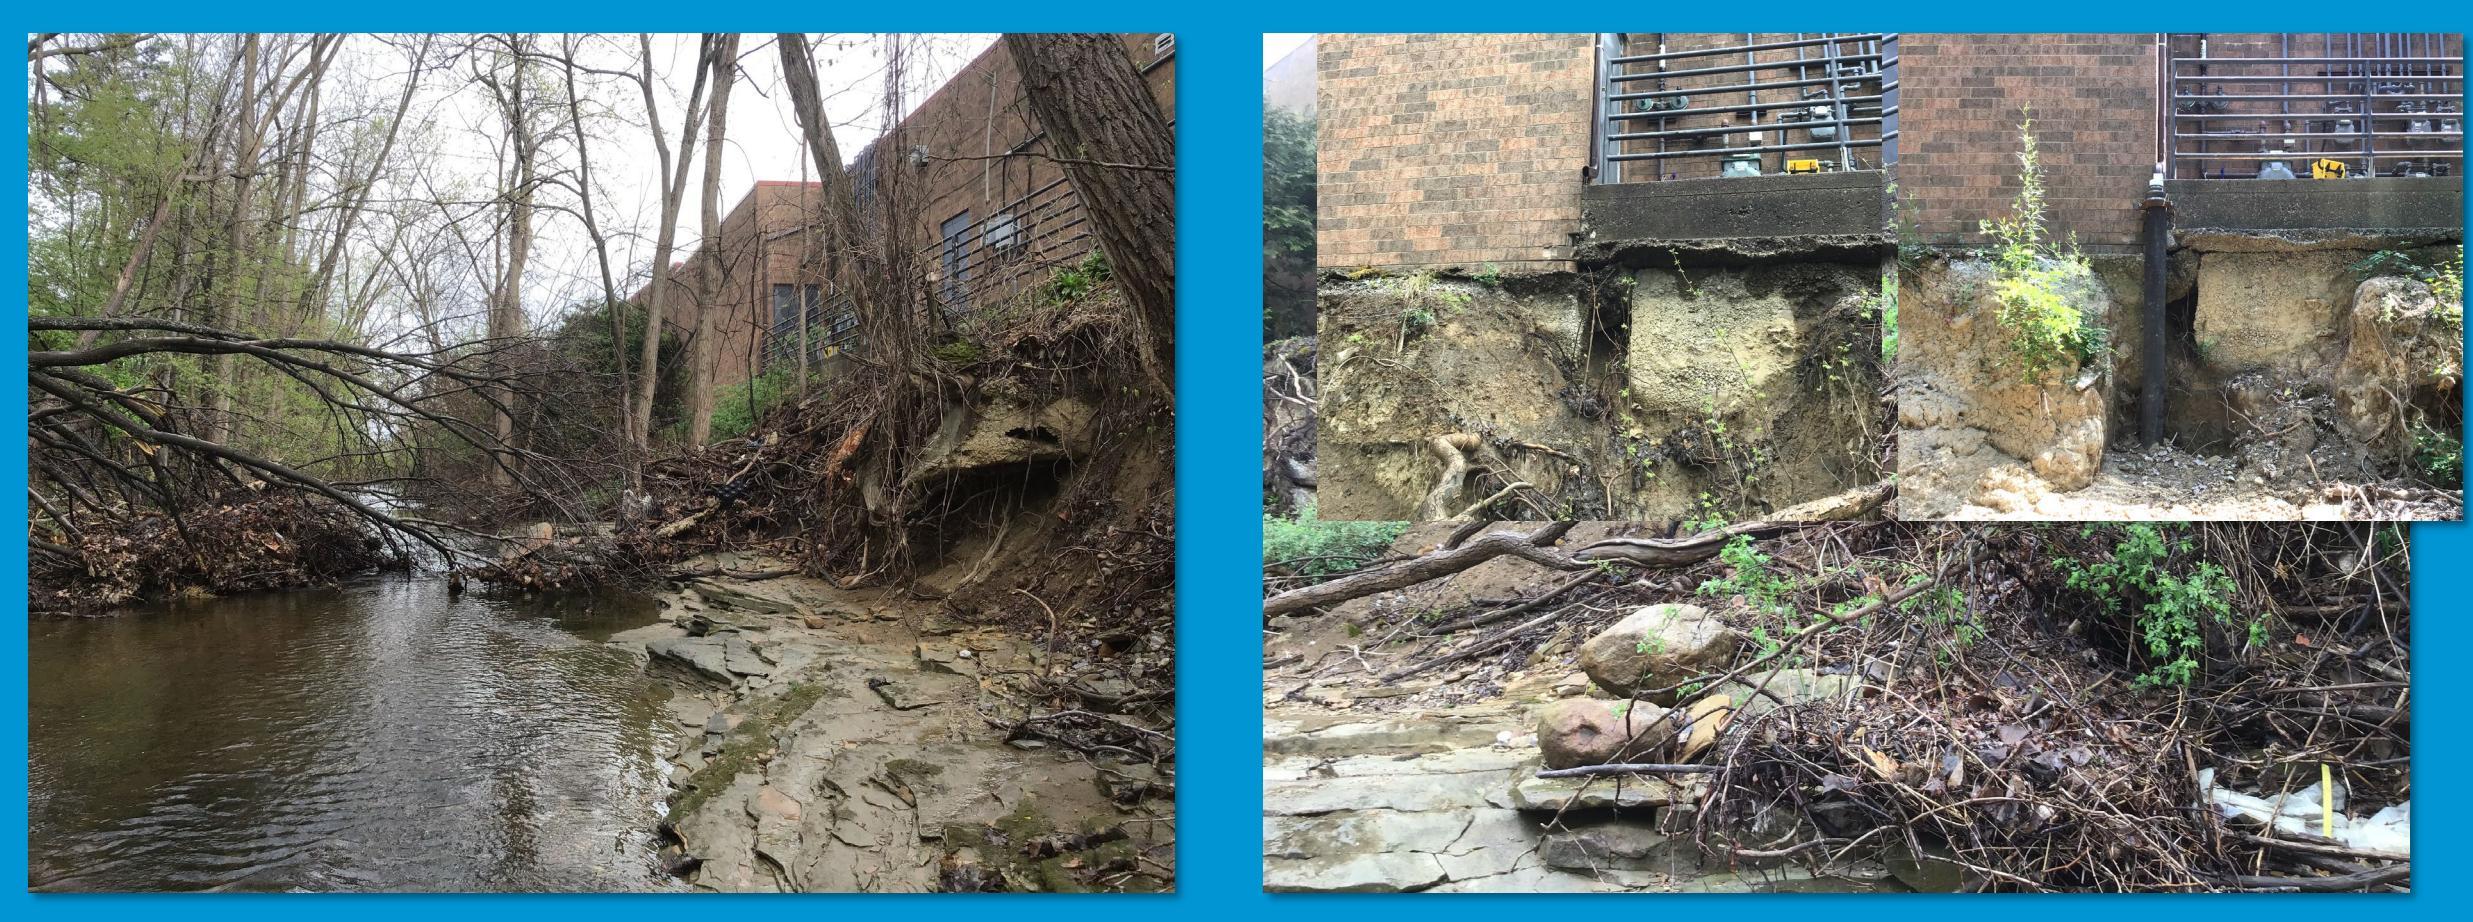
Big Creek, Parma Heights - Streambank erosion undermining the foundation of a strip mall.

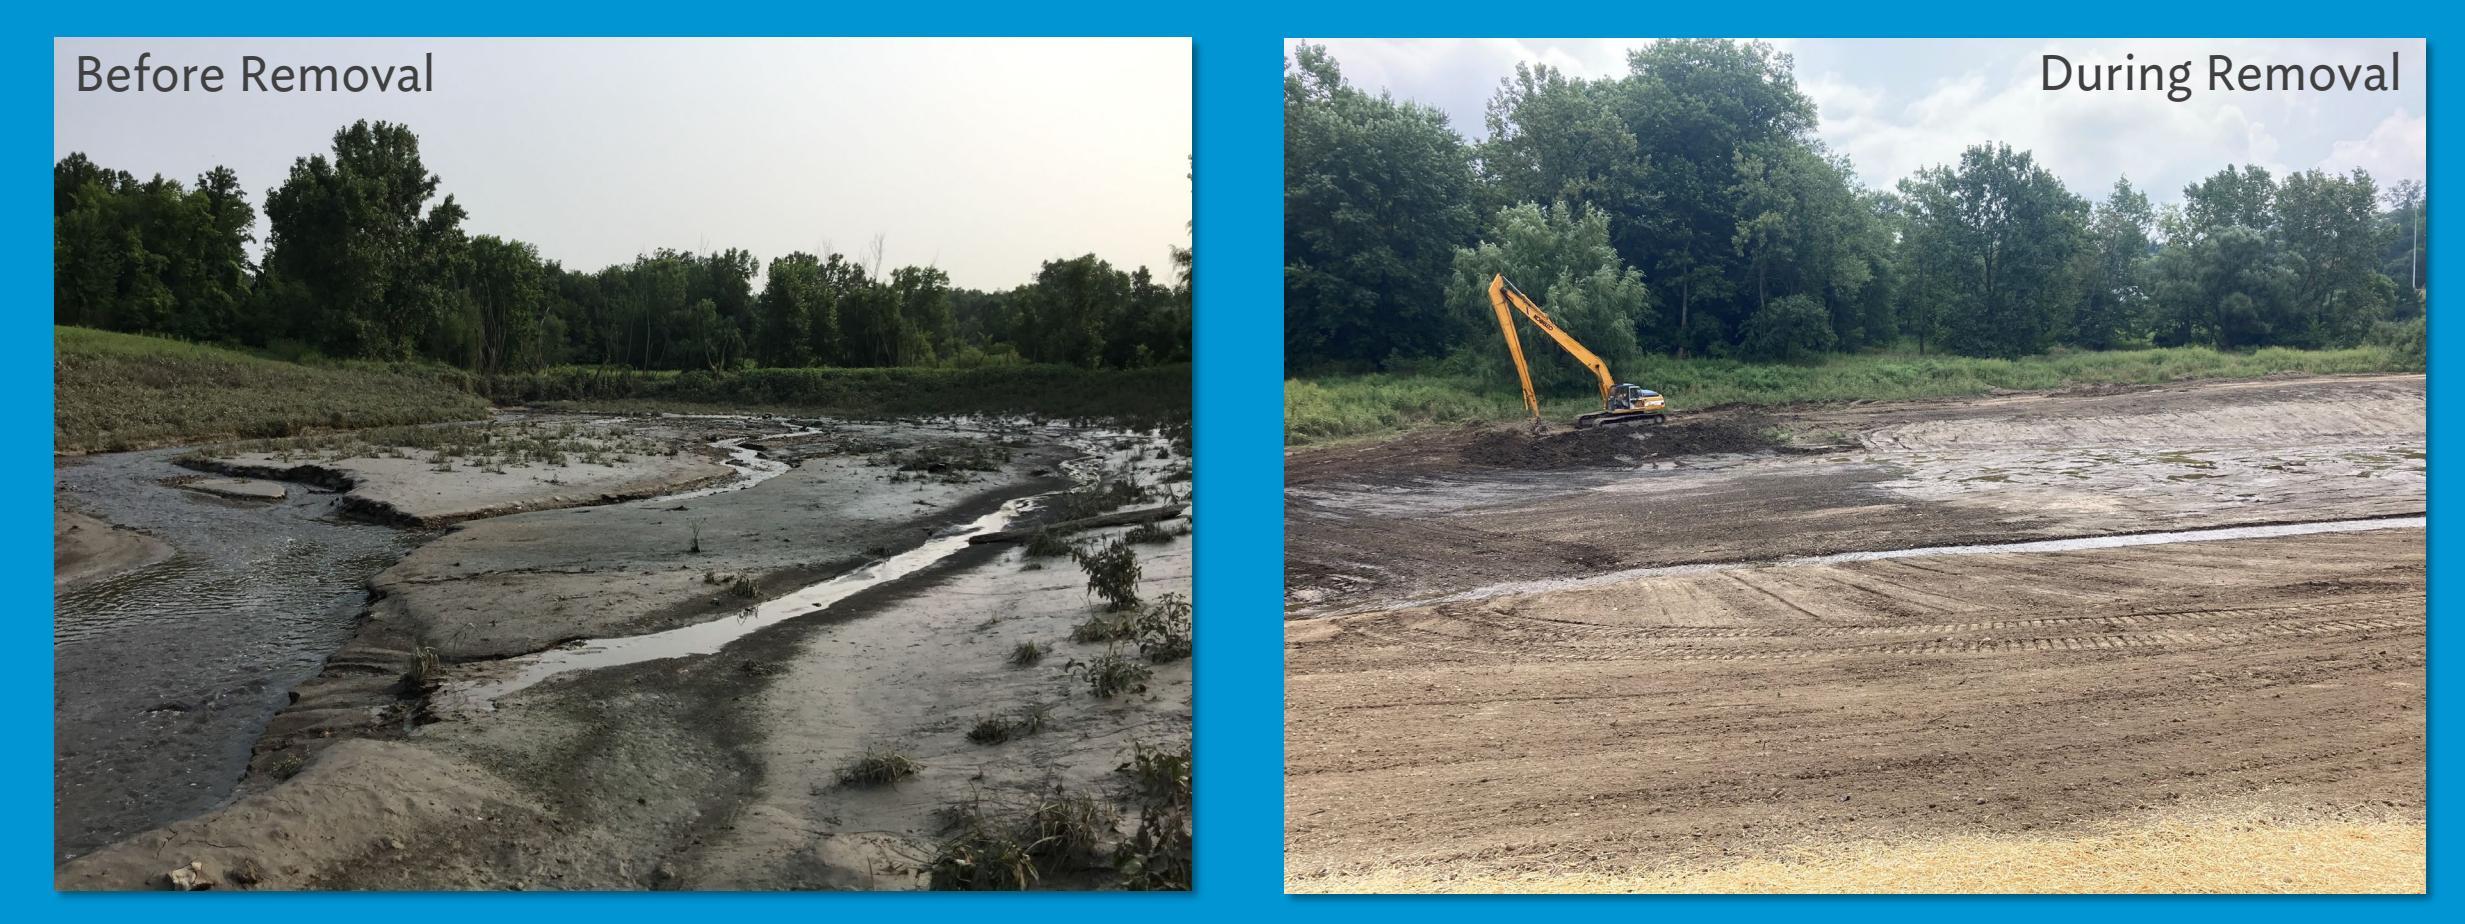
Mill Creek, Warrensville Heights - 1,000 Cubic Yards of sediment removed from Kerruish Basin.
