Watershed Advisory Committee

Rocky River

October 13, 2020

REGIONAL
STORMWATER
MANAGEMENT
PROGRAM

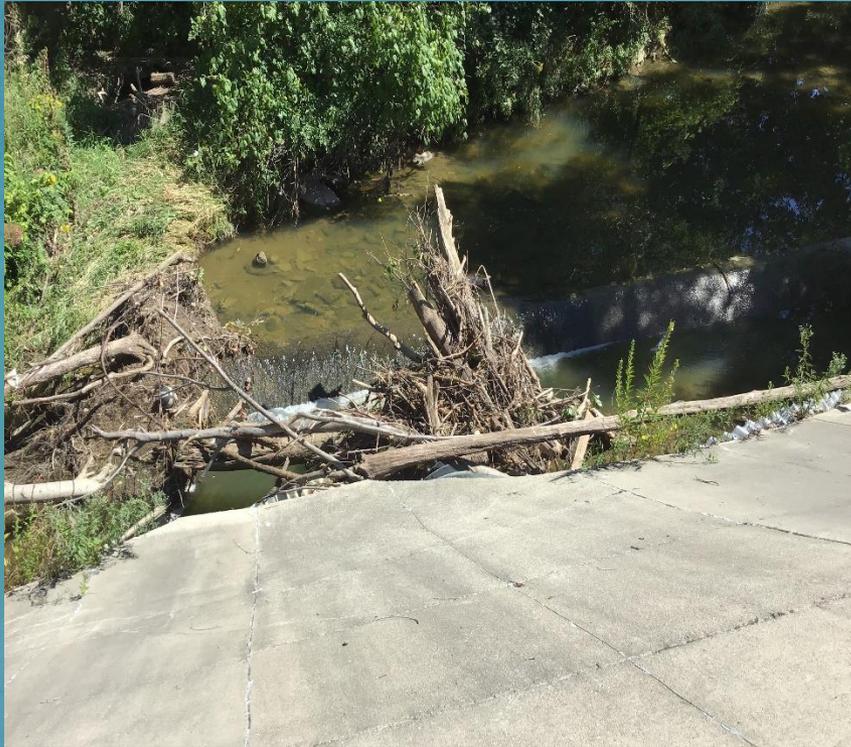
Asset #: BD00237 Middleburg Heights, Debris Removal

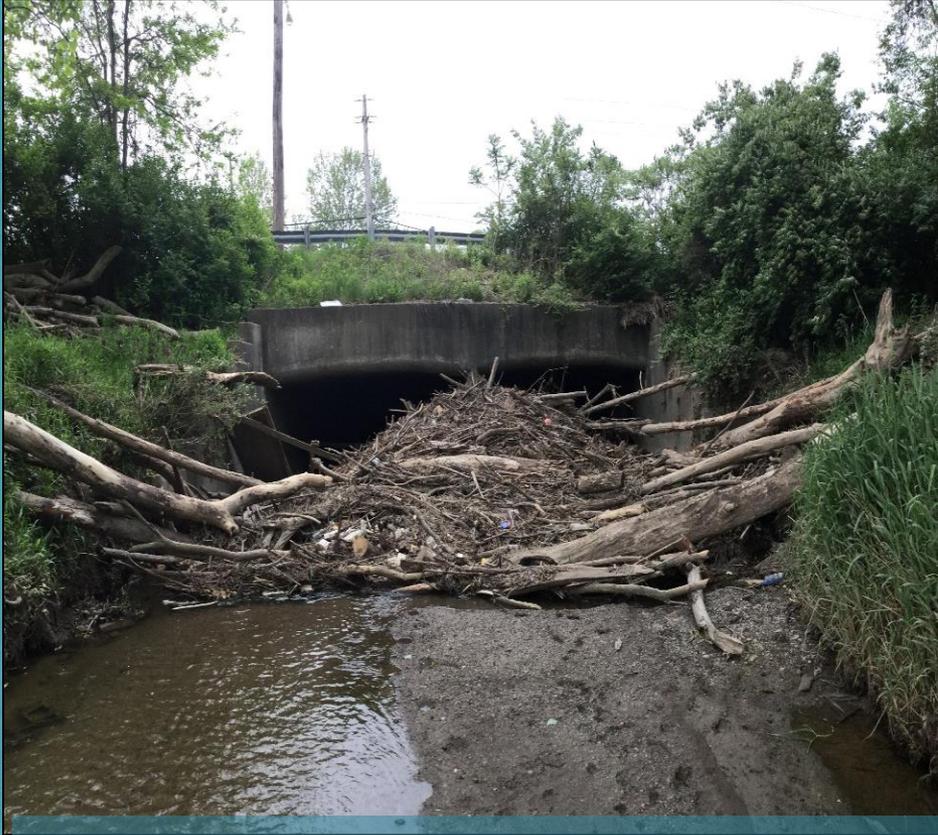
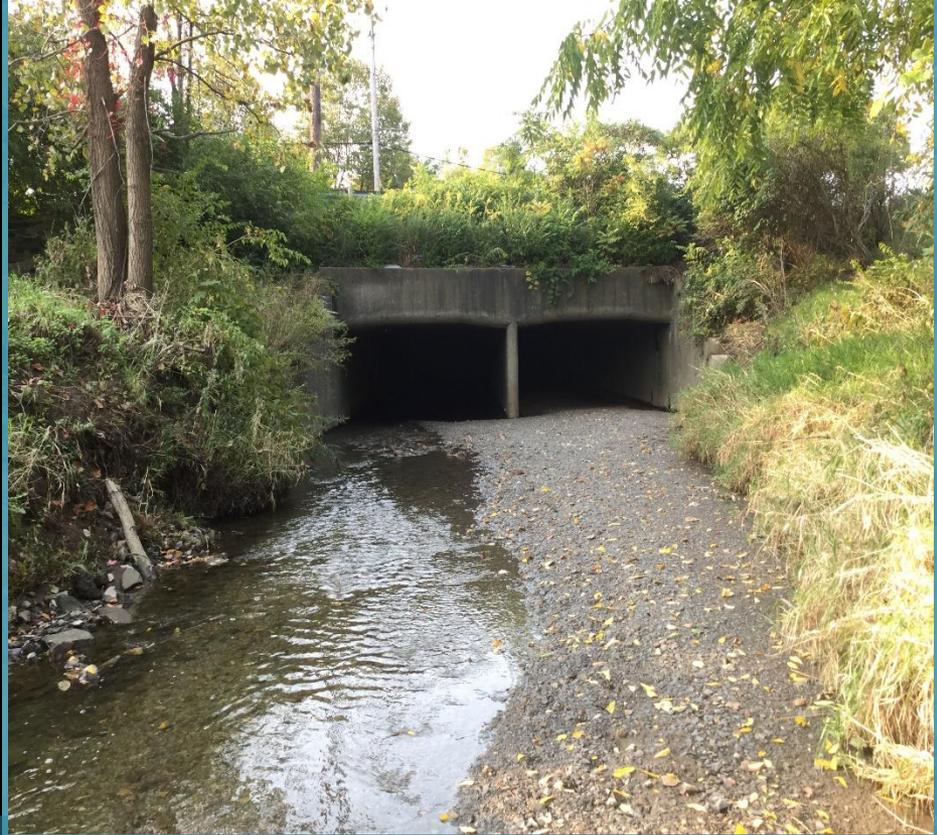
Baldwin Creek/ Middleburg Heights / 36 Cu. Yds. debris removed

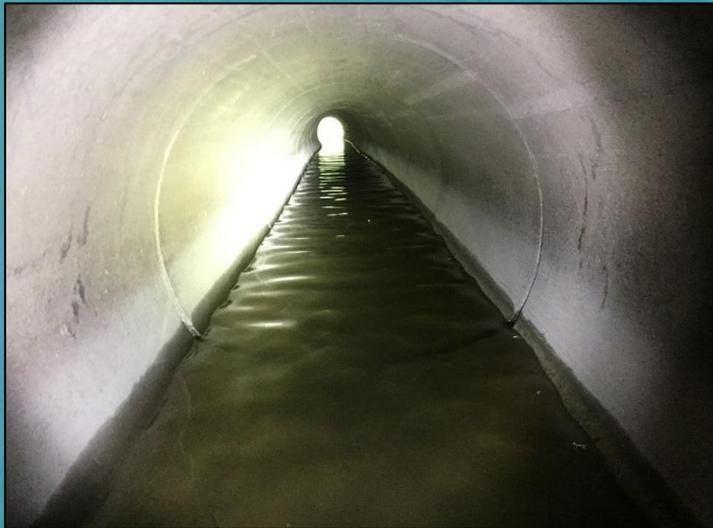
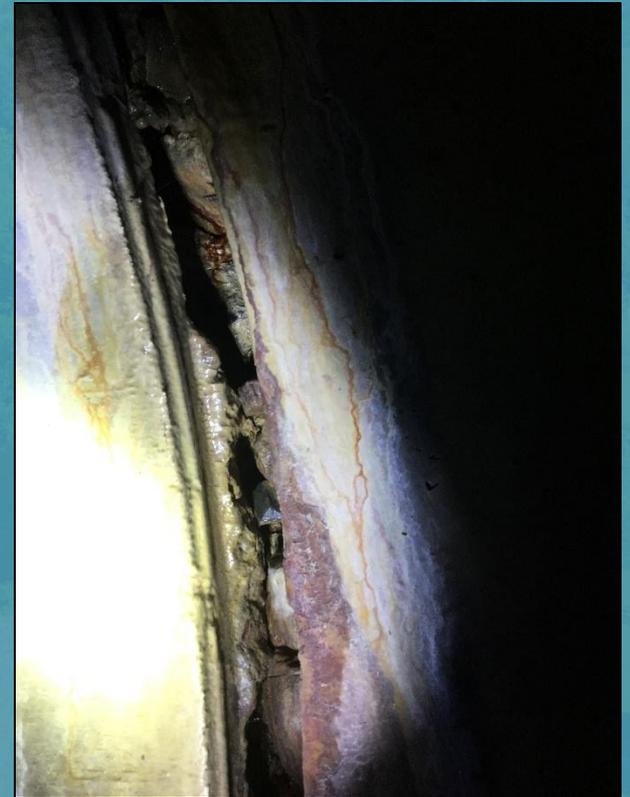
Asset BD00265

E. Linden Lane, Parma

Inspection revealed a joint separation with visible backfill and an increase in water level under the roadway

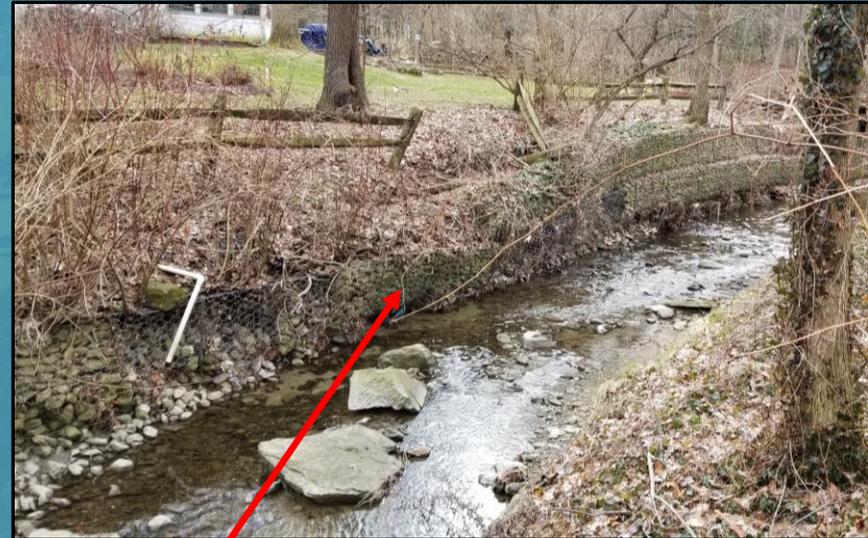
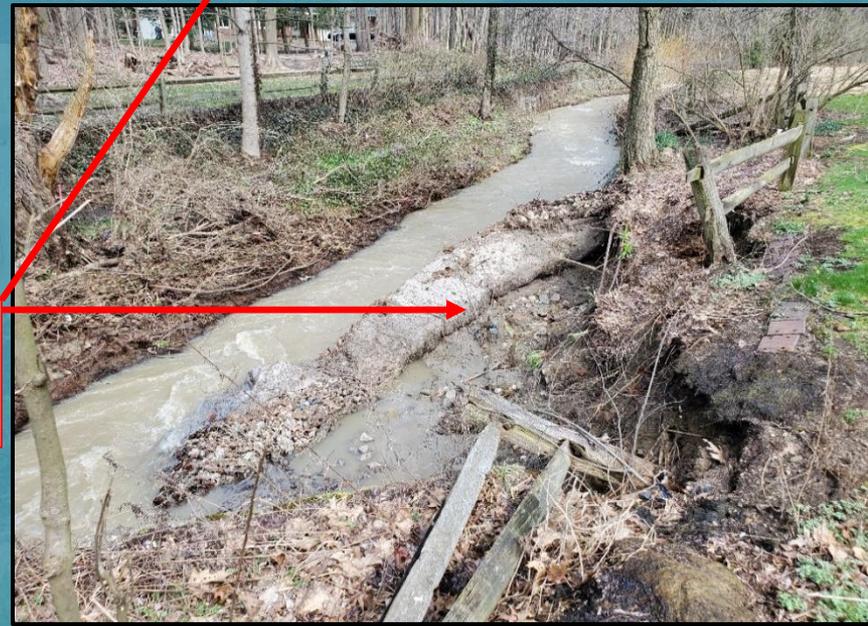
**Failed gabion baskets &
streambank erosion**

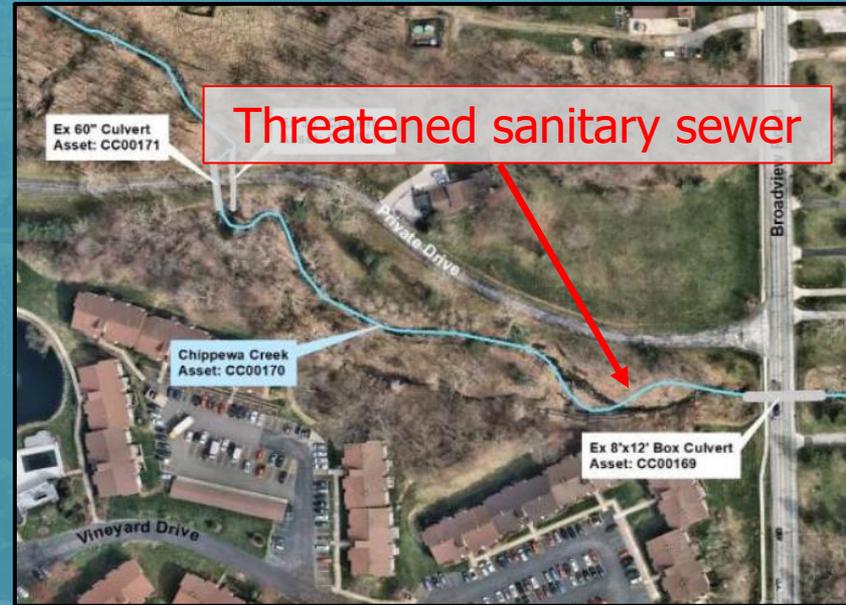
Threatened gabion basket retaining wall

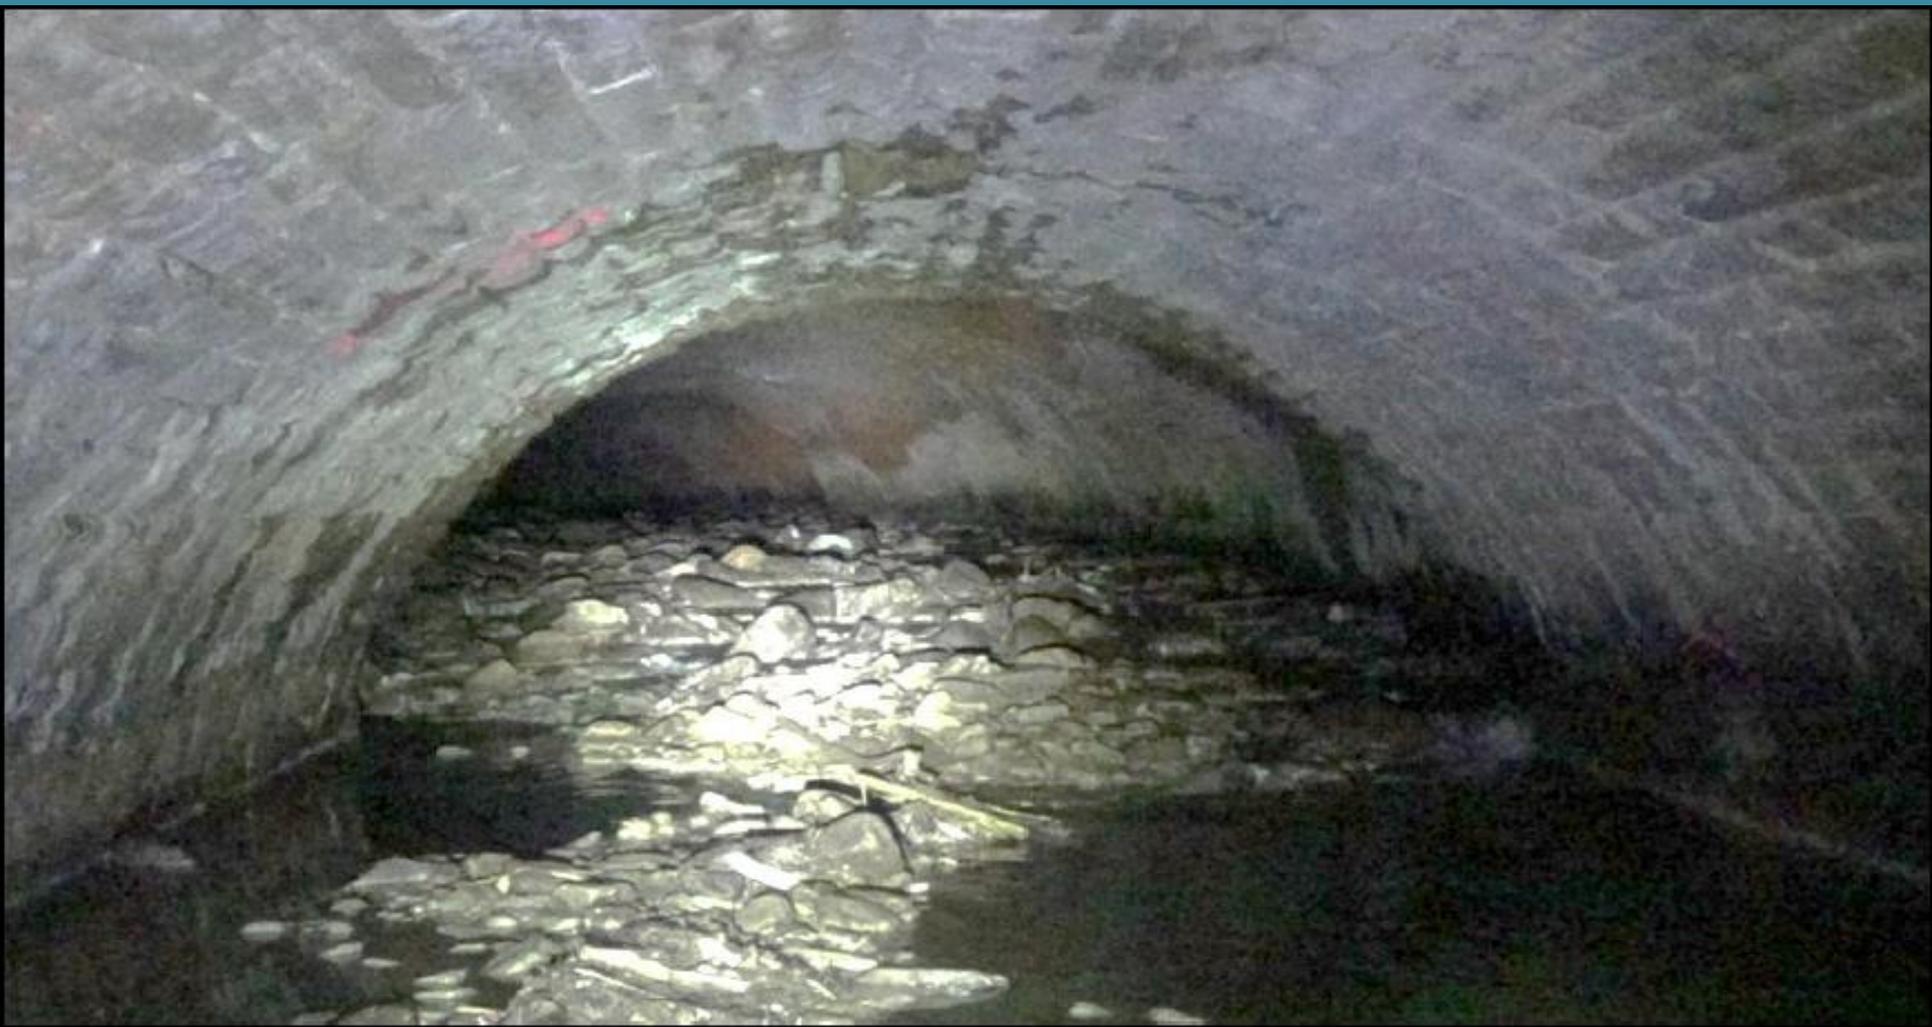
Remove approximately 700 cubic yards of river rock & sediment
